# Building and Timber Pest Inspection Report VR

Inspection Date: Thu, 26 Mar 2026

Property Address: 103 Sharpless Rd, Springfield QLD 4300,  
Australia

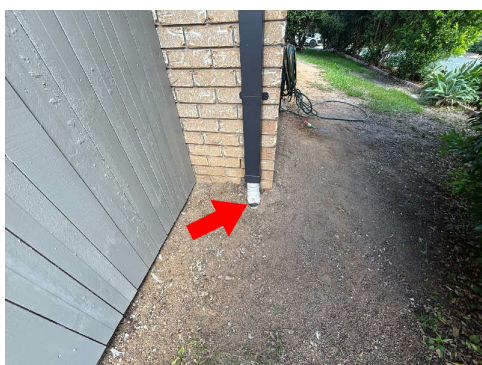
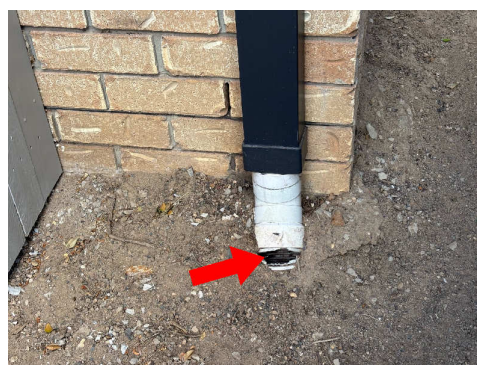
#### Finding 3.01

Location: Rear Elevation

Finding: Down pipe - damaged

Information: At the time of the inspection, it was noted that the bottom section of the down pipe at the rear of the dwelling is damaged. This affects the functionality of the down pipe and allows water to escape near the foundation.

Excessive moisture next the foundations of the dwelling creates a conducive environment for termite activity and can cause damage to the associated building materials.

A licensed plumber should be engaged to carry out this repair. This can be done at the clients discretion.

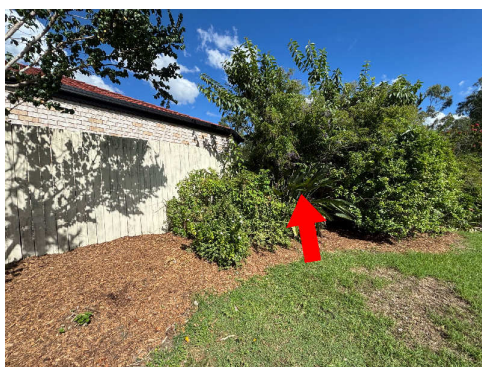
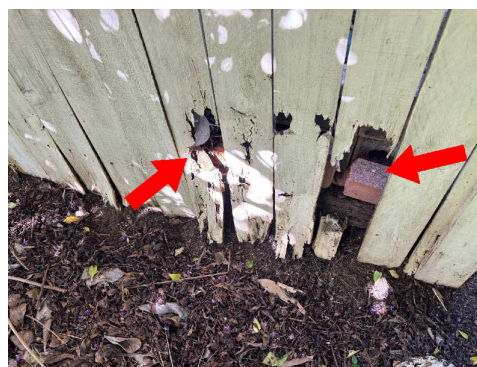
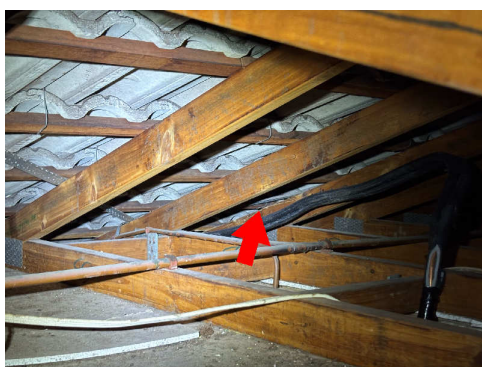
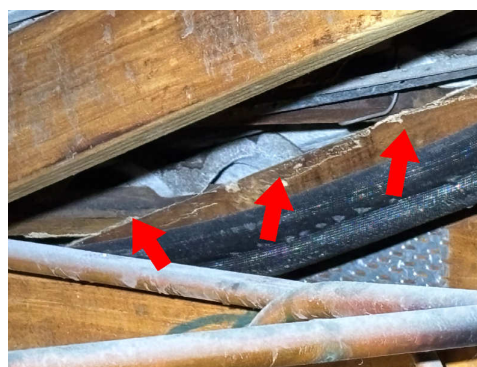
### Finding 5.01

Location: Boundary fences

Finding: Evidence of termite damage

Information: At the time of the inspection, it was noted that there was termite damage to a section of the timber boundary fence on the right hand side of the dwelling and to a rafter in the roof void.

It is advised that the area be visually inspected frequently to ensure that the condition of affected building materials does not worsen.

A building contractor may be appointed to provide a further invasive inspection if further damage is evident.

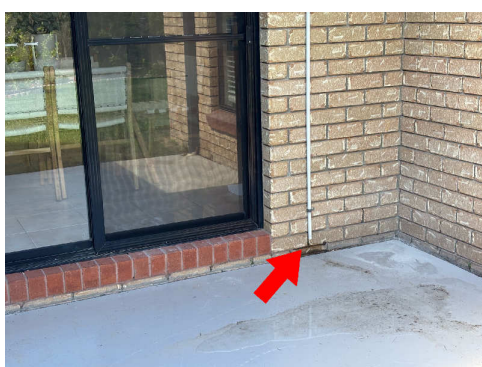
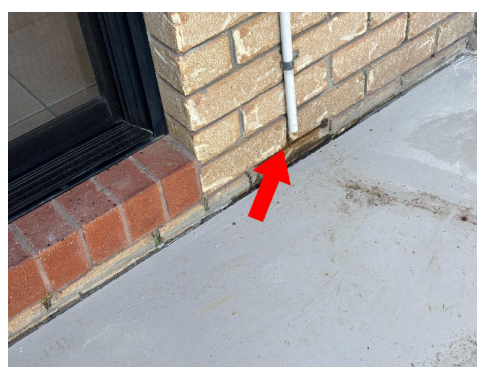
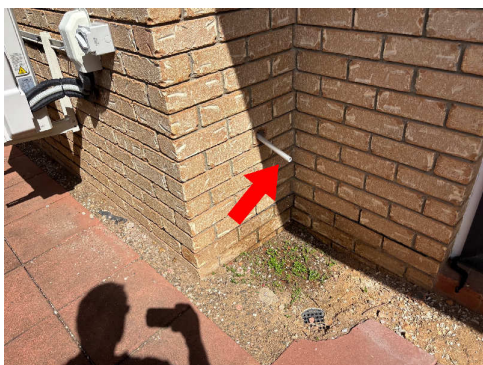
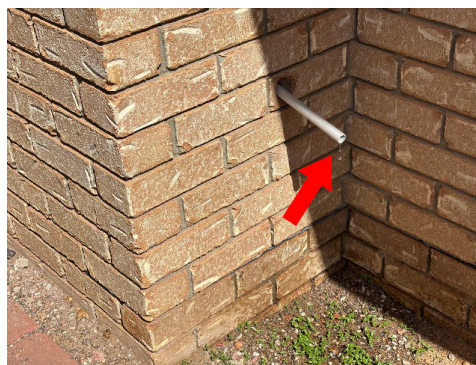
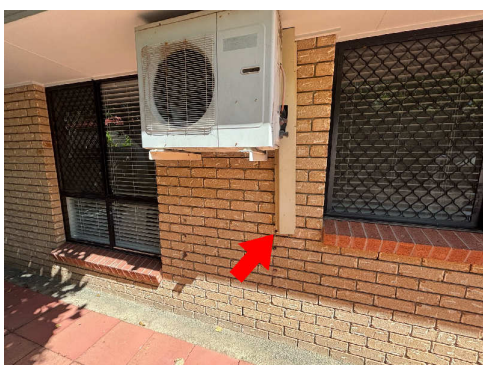
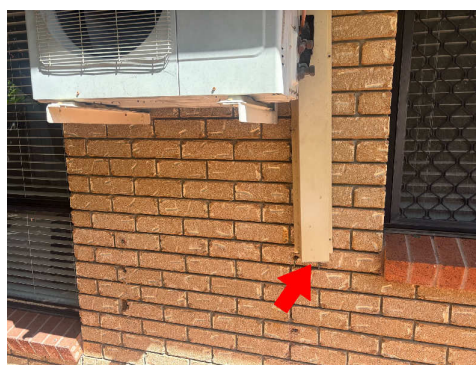
### Finding 6.01

Location: All External Areas

Finding: Air conditioner - Disconnected overflows

Information: At the time of the inspection, it was noted that the air conditioner drain overflows to all the units were not connected to the storm water drainage and as a result are draining next to the foundations of the dwelling.

Air conditioning overflows that are not connected to the storm water drainage and are draining near the foundation can create excessive moisture in the surrounding area.

Such leaking creates an environment which is conducive to an array of defects, including water damage to associated building elements and the attraction of termite or timber pest infestation.

It is highly recommended that a licensed plumber be appointed to connect the A/C overflow in order to prevent such an environment from being created. These minor works should be carried out as soon as possible.

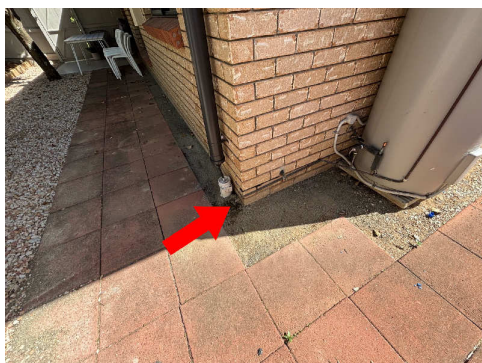
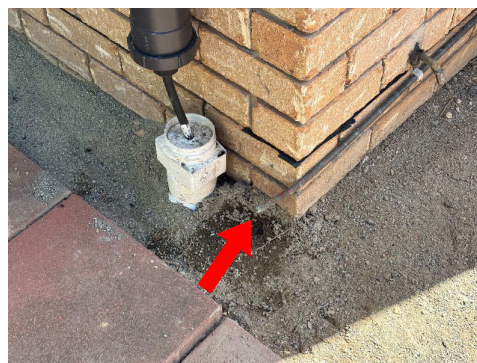
### Finding 6.02

Location: Rear elevation

Finding: Hot water tank - not plumbed to stormwater

Information: At the time of the inspection, it was noted that the overflow for the hot water tank was not plumbed to the storm water system. This overflow pipe is draining next to the foundations of the dwelling.

Excessive moisture next to the foundations of a dwelling creates a conducive environment for termite activity. Moisture may also damage the associated building materials.

A licensed plumber should be engaged to plumbing the overflow into the storm water system. This should be done as a matter of urgency.

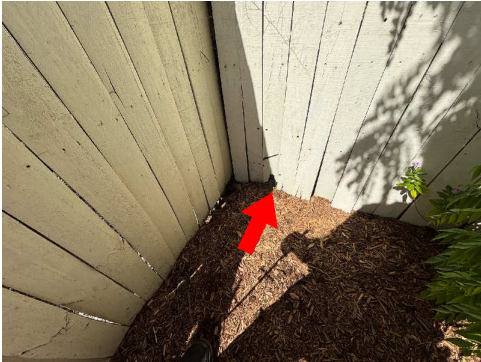
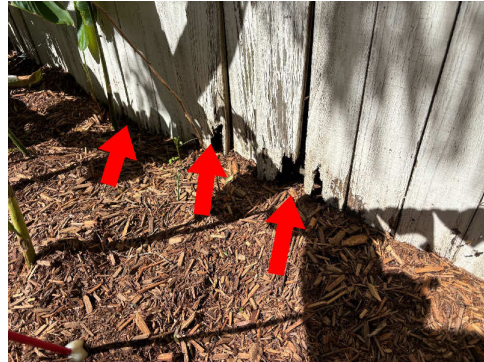
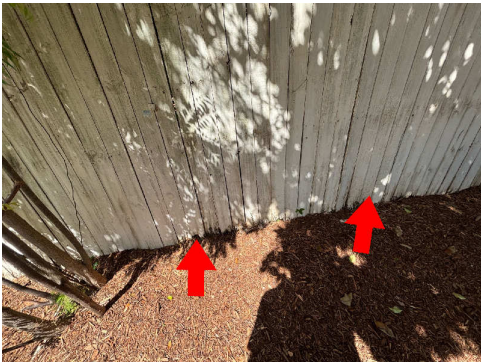
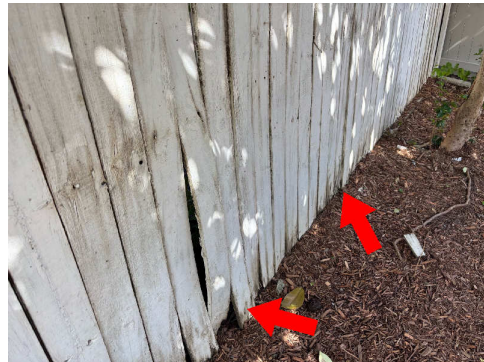
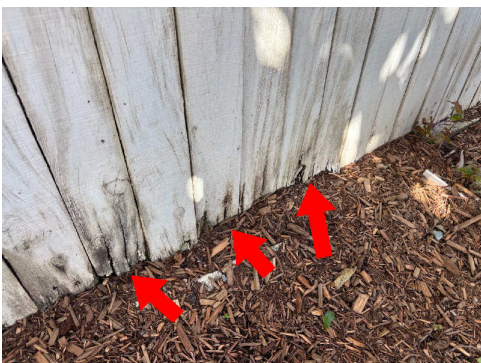
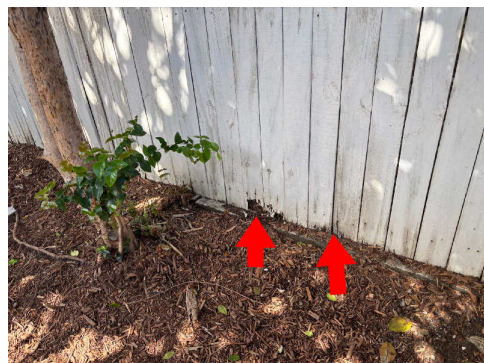
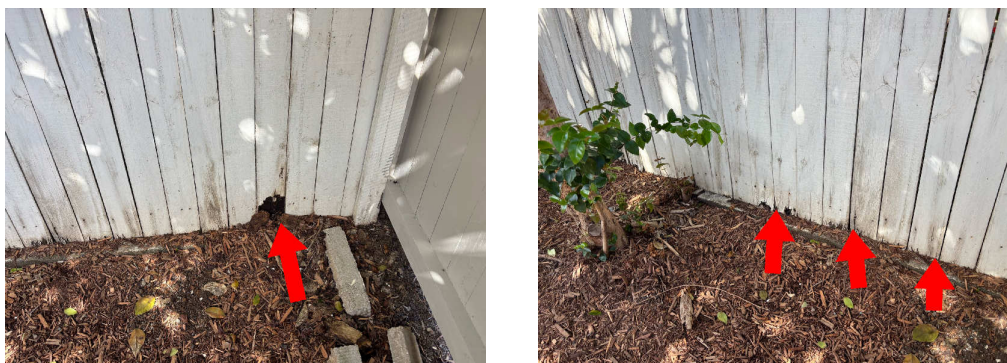
### Finding 7.01

Location: Boundary fences

Finding: Wood rot - timber fence

Information: At the time of the inspection, it was noted that there was evidence of wood rot to the timber boundary fence. This may be due to the age of the timber building elements and general weathering.

This building element shows evidence of wood rot. Wood rot, also known as Fungal Decay, occurs when timbers and other cellulose building materials are exposed to damp conditions on an ongoing basis.

Wood rot is often associated with general damp problems and is evidenced by a 'musty' smell or mould and mildew occurring on surfaces. If left unmanaged, damp conditions can lead to further health problems and the decay of timbers will continue.

Early intervention and regular maintenance, particularly of exterior timbers, will prolong the useful life of these building elements. Prior to any works being performed, the cause of the moisture that has created the visible wood rot should be identified and addressed in a suitable manner. Replacement of affected timbers may then be a necessary step in protecting surrounding building elements from such deterioration.

A qualified carpenter or registered builder may also be required to replace affected building materials.

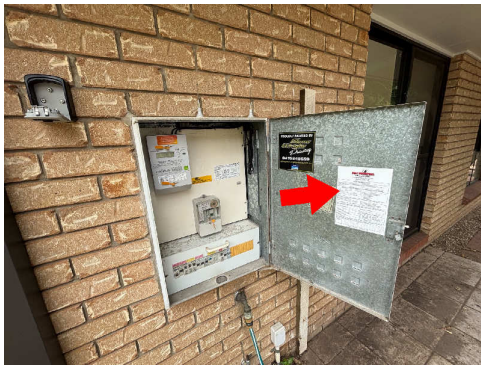
#### Finding 9.01

Building:	Main Building
Location:	All External Areas
Finding:	Evidence of a current chemical termite management system was identified.
Information:	At the time of the inspection, evidence of a current chemical termite management system was found by way of a durable notice in the electricity meter box.

A chemical soil treatment was carried out to the soil around the perimeter of the dwelling, including under the concrete. This chemical termite treatment system was carried out on the 15/12/2025. This system has an expected life span of 8 years. Annual termite inspections must be carried out as part of the warranty for this treatment system.

On the 18/10/2025 and the 08/11/2025, a chemical treatment was carried out to termite workings.

The client should have annual termite inspections carried out as per AS 3660 to help protect the dwelling. Annual termite inspections must be carried out in partnership with any termite treatment system, physical or chemical as termite treatment systems cannot be relied on to be 100% effective.

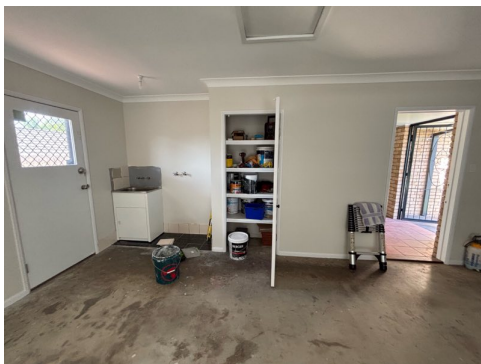
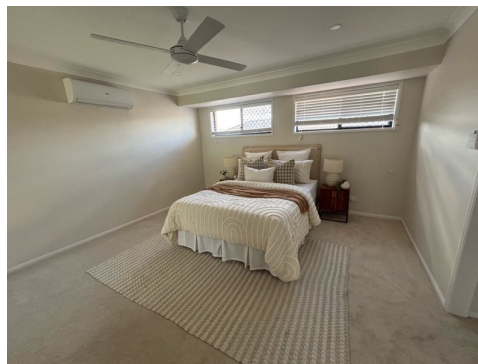
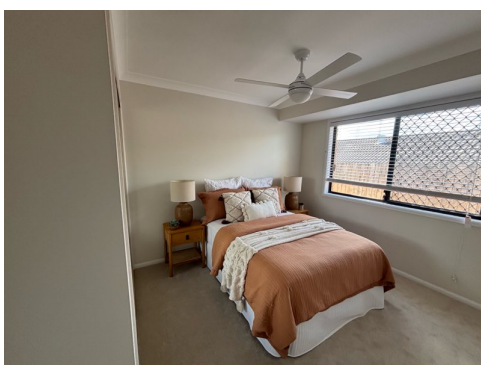
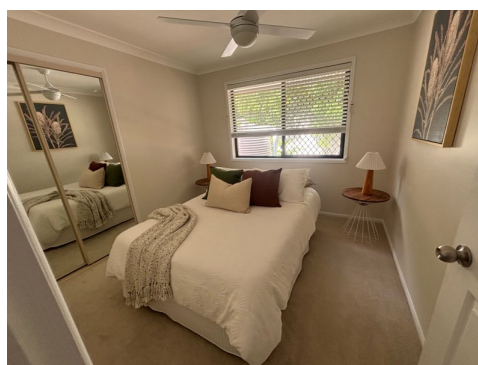
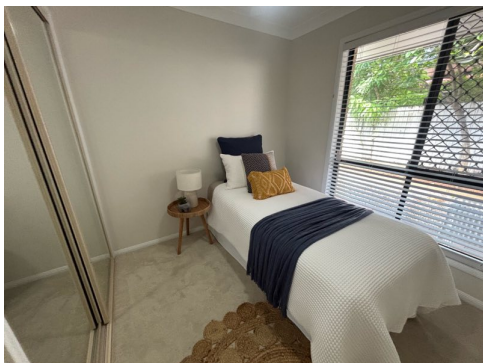
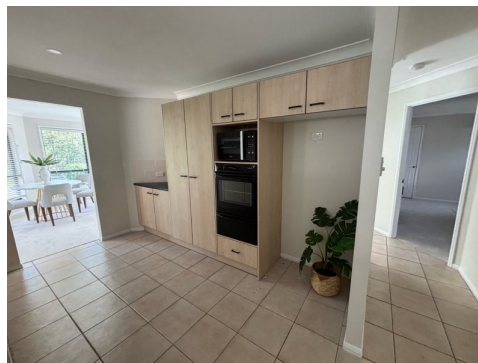
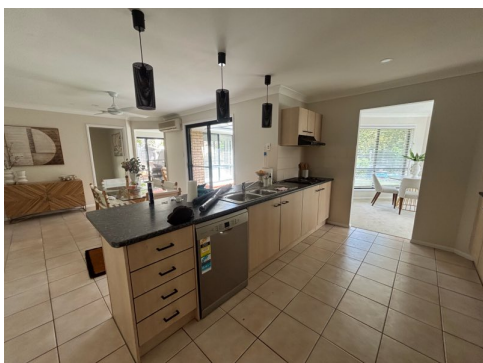
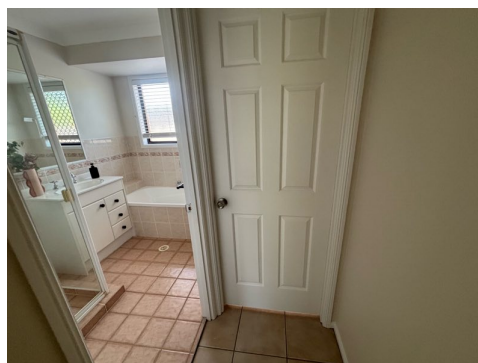
Location: All Internal Areas

Finding: Obstructions and Limitations - Internal areas

Information: These photographs are an indication of the obstructions and limitations which impeded full inspection of the property of the internal areas at the time of inspection. These obstructions can hide an array of defects and should be removed to allow full inspection to be carried out. A re-inspection is recommended once the areas are made accessible.

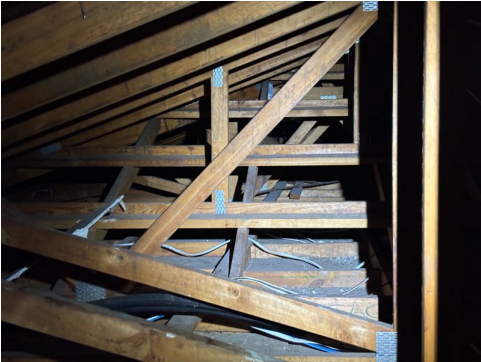
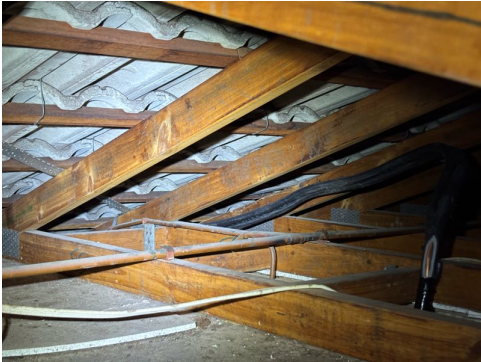
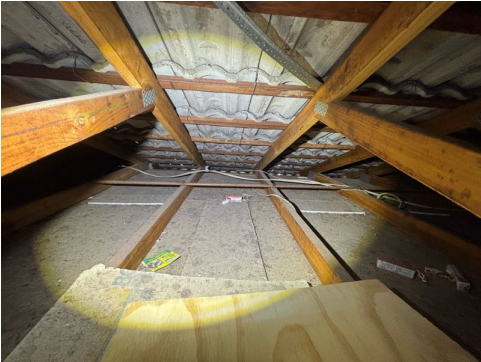
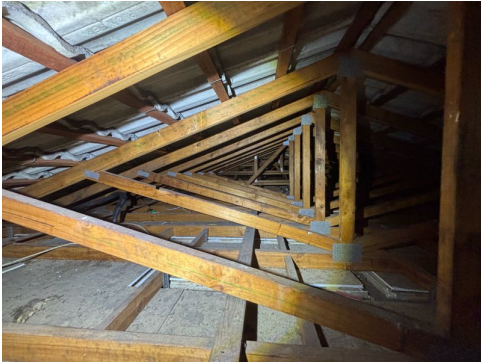
Location: Roof Void

Finding: Obstructions and Limitations - Roof cavity

Information: These photographs are an indication of the obstructions and limitations which impeded full inspection of the property of the roof cavity at the time of inspection. These obstructions can hide an array of defects and should be removed to allow full inspection to be carried out. A re-inspection is recommended once the areas are made accessible.
