# Building and Timber Pest Inspection Report

Inspection Date: Thu, 5 Feb 2026

Property Address: 41 Symonds Rd, Dean Park NSW 2761,  
Australia

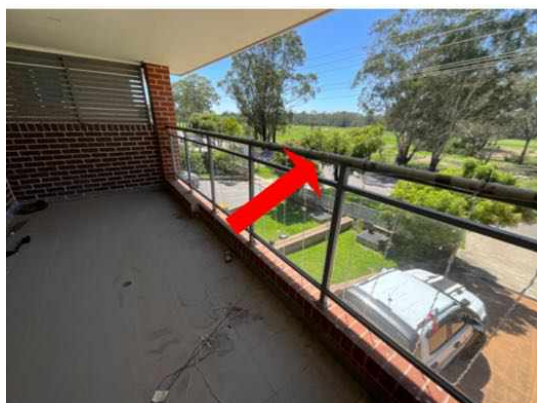
Building:	Main Building
Location:	Balcony
Finding:	Loose handrail — Fall from heights
Information:	The handrail was lacking appropriate support and fixing to the adjacent wall or floor at the time of inspection.

The handrail was further loose and moving upon minimal force applied with hand.

These handrails pose a risk and persons coming in contact may fall from heights if these handrails fail, thus causing sever injury.

A licensed builder must be appointed as soon as possible to rectify any non-compliance.

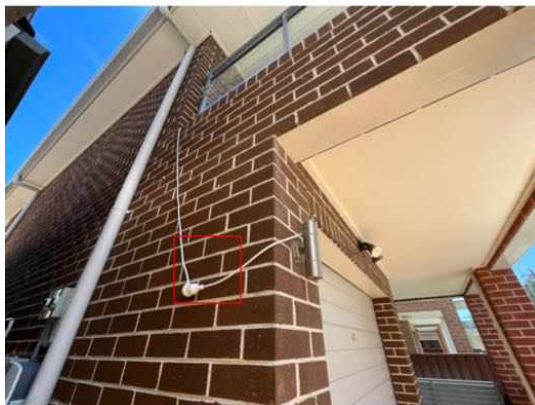
Building:	Main Building
Location:	Garage
Finding:	Electrical wiring - Exposed/Messy
Information:	Instances of exposed wiring, messy wiring, not in junction boxes or unprotected with electrical tape was identified in this area at the time of inspection.

We highly recommend that a licensed electrician be engaged to check this area and make safe all exposed wiring before any further inspections or works are carried out.

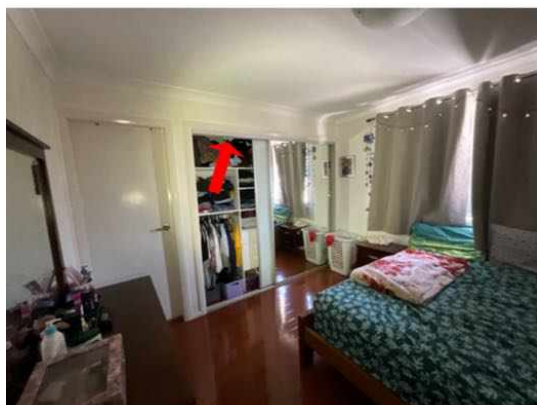
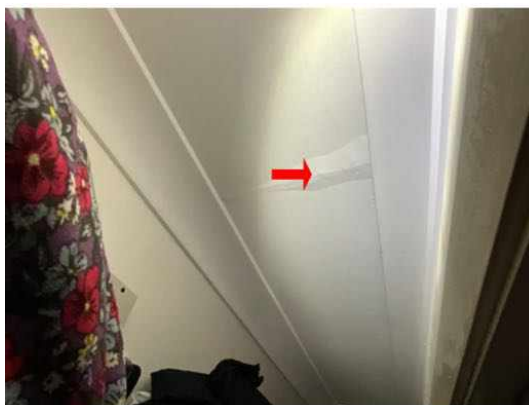
Building:	Main Building
Location:	Master BIR
Finding:	Ceiling - Sagging
Information:	This section of the ceiling was found to be sagging at the time of inspection.

A further invasive inspection of the area maybe considered by a licensed carpenter.

Where minor sagging is evident, comparatively minor works, such as re-gluing of ceiling sheets, may be required.

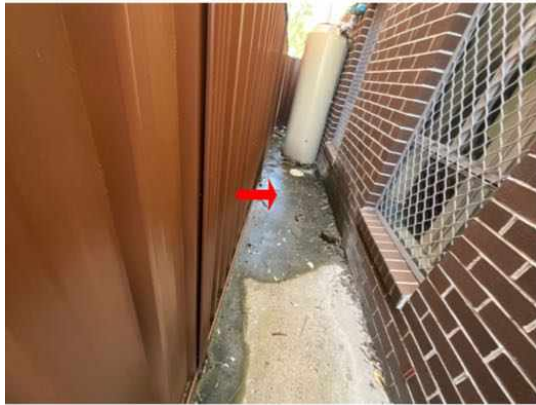
### Finding 3.02

Building:	Main Building
Location:	Yard. - side
Finding:	Site drainage— Inadequate
Information:	The site drainage in this area was found to be inadequate at the time of inspection, creating potential for subsequent water damage to associated building elements. This is additionally conducive to termite activity.

Where site drainage is inadequate, installation of an Agricultural (Aggie) Drain may be required. A licensed plumber should be appointed to further inspect the property and perform any remedial works as necessary. Water damage and secondary defects are

likely to occur if left unmanaged.

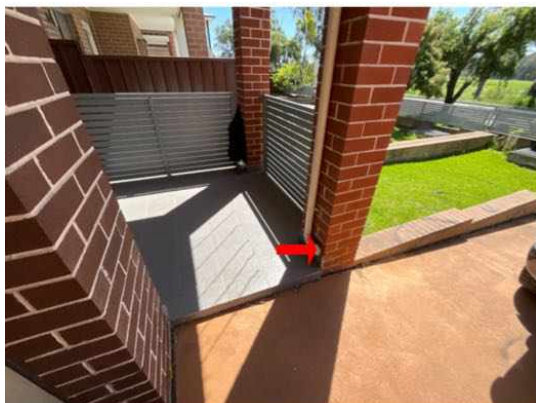
### Finding 3.03

Building:	Main Building
Location:	Porch
Finding:	Balcony floor waste -- Not connected
Information:	AS/NZS 3500.3 - Stormwater Drainage states

Where roof plumbing doesn't drain adequately, the area at the base perimeter can become excessively damp, potentially creating an environment that is susceptible to rust and corrosion of surrounding building elements, as well as attracting termites and other pests.

It is highly recommended that a licensed plumber be appointed to further inspect the area and to install adequate drainage equipment where necessary.

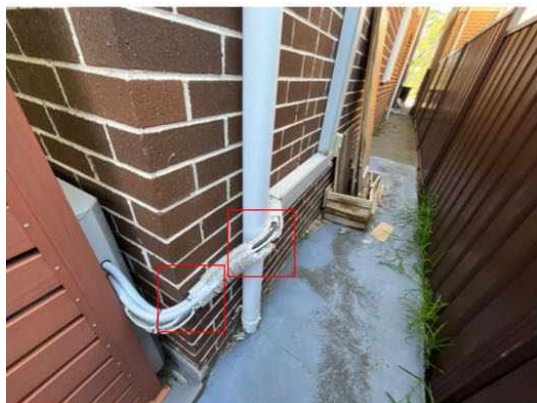
### Finding 3.04

Location:	Rear right corner
Finding:	Deteriorated components
Information:	It was identified that some elements around the exterior of the home have suffered from environmental effects with replacement required.

Secondary defects are likely if the issue is not addressed. A general handyman should be appointed for repairs immediately.

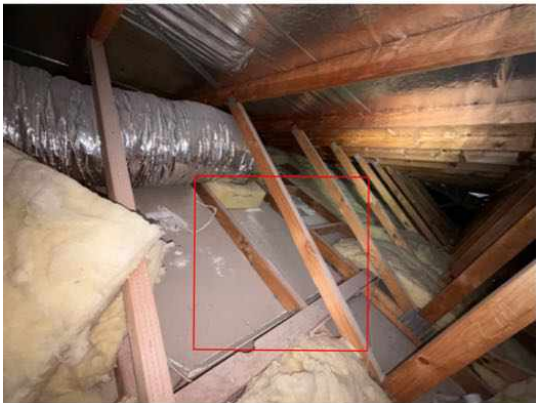
### Finding 3.05

Building:	Main Building
Location:	Roof Void
Finding:	Insulation - Inadequate
Information:	Upon inspection of the roof void it was noted that there is a lack of adequate insulation.

The level of insulation in the property does not meet current Australian Standards. Installation of adequate insulation is required and should be conducted as soon as possible.

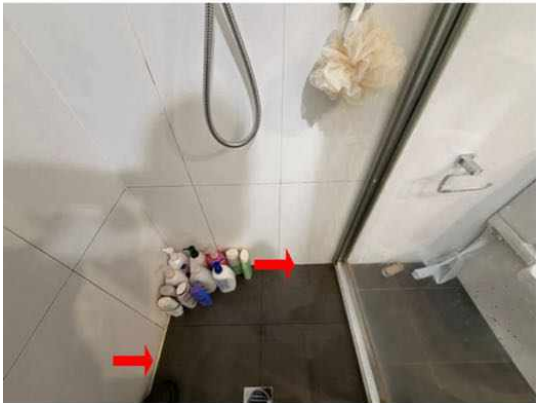
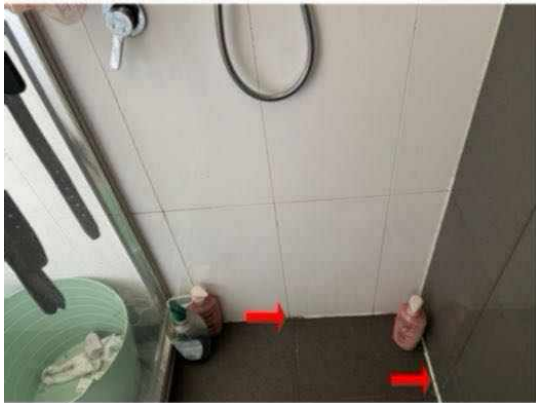
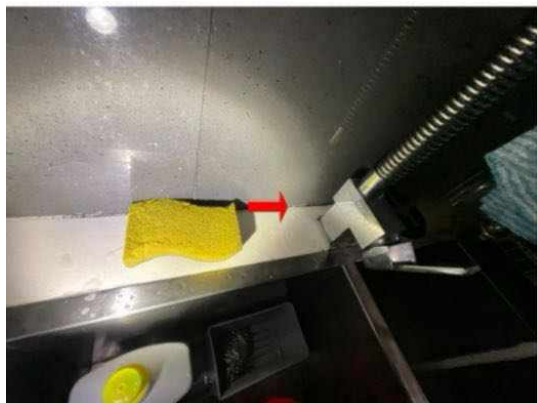
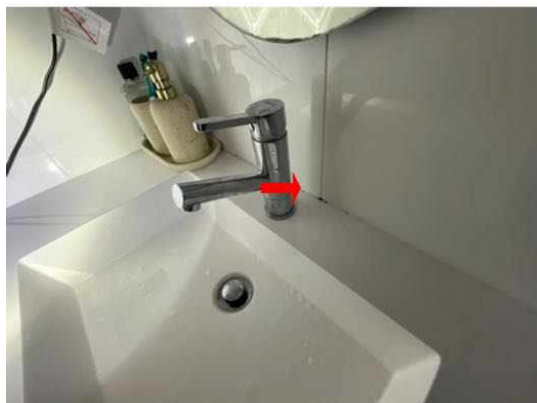
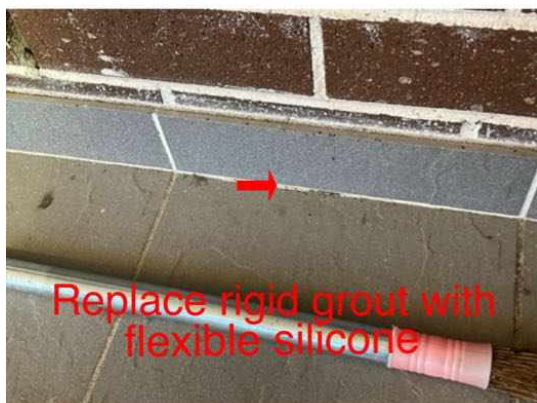
**Finding 3.06**

Building: Main Building  
Location: All Wet Areas  
Finding: Sealant and grouting - Missing or damaged  
Information:

It was noted on inspection that sealant or grout is degraded to this area.

Different materials and floor areas move at different rates, generally causing cracking to grout or sealant at this point. A flexible sealant is required to allow for expected expansion and contraction, while keeping the joint water tight and protective of all associated building materials.

Flexible and mould resistant materials should be applied to affected areas to prevent any subsequent water damage that is likely to occur. Regular maintenance and replacement of damage or missing or damaged sealant and grout is highly recommended to the wet areas, as this is a regular wear and tear defect. Sealant and grouting in areas that come into regular contact with water should be maintained for the long term care of your property.

A sealant specialist should be appointed to complete these works as soon as possible.

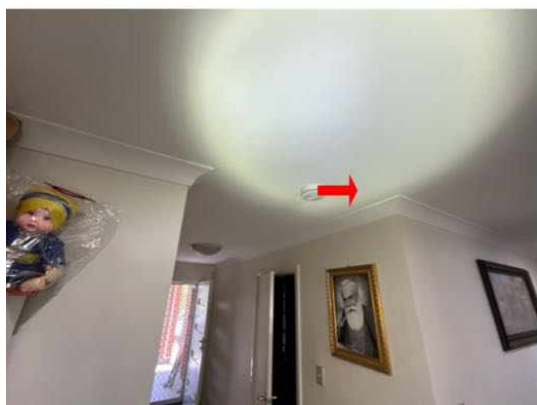
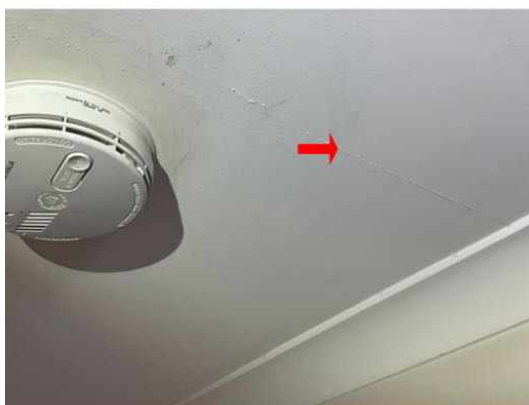
### Finding 3.07

Building:	Main Building
Location:	Hallway
Finding:	Cracking - Damage Category 1 - Fine (up to 1mm)
Information:	Although fine cracks are quite noticeable, they are often only considered to be an appearance defect, and usually do not indicate any structural damage. Generally, the cause of a fine crack is indicative of a separation between building materials and finishes (e.g. paint, plaster, etc.) along joins.

Cracking of this nature can generally be repaired with minor sanding, filling and/or repainting. Such works should be performed by a qualified painter or a general handyman.

Monitoring of all cracking should be conducted frequently. Always contact a building inspector should cracks widen, lengthen, or become more numerous.

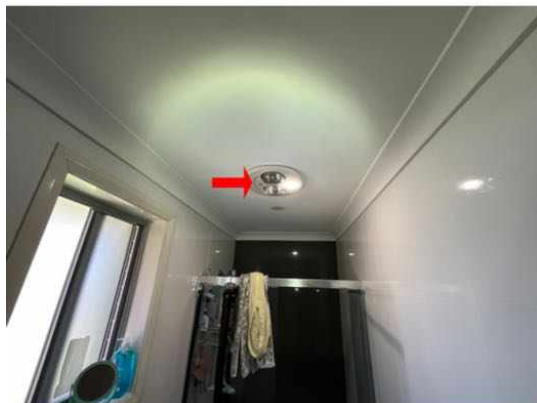
### Finding 3.08

Building:	Main Building
Location:	Ensuite
Finding:	Exhaust fan - Not operating
Information:	The exhaust fan in this area appears to be damaged or blocked and is not operating as intended. If left unmanaged, a lack of general maintenance is likely to lead to the development of more significant defects, such as water damage to surrounding building materials from inadequate ventilation. If left unattended for a prolonged period of time, poor ventilation in this area may also be conducive to the development of mould.

Where no secondary damage has developed, the Homeowner may undertake minor cleaning of the area and consider replacement of the exhaust fan. Alternatively, consultation with a Licensed Electrician is required to check for any secondary or concealed damage and consider repair or replacement.

Please be advised that a cabinet maker or qualified carpenter may also be required if water damage has occurred and that an additional specialist mould inspection may be required if severe mould has resulted.

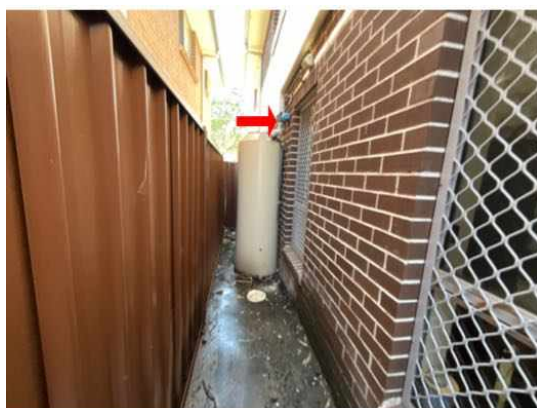
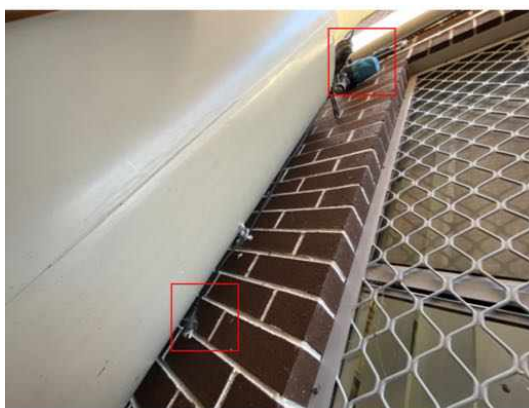
### Finding 3.09

Building:	Main Building
Location:	Water tank
Finding:	Building element - Not operating
Information:	Rainwater tank appears to be inoperable and the plug disconnected. Non-operational items should be addressed to ensure that the full function of the building structure is available. Where some building elements are not operating as intended, it is possible that secondary building defects could arise due to their non-operation.

Repair and/or replacement of the faulty building element is recommended. It is highly recommended that the relevant tradesperson be engaged to perform any necessary works.

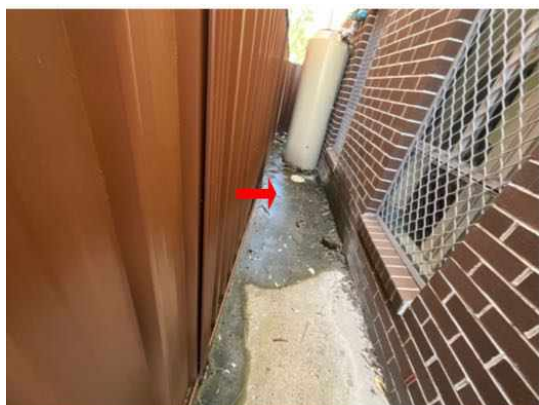
Building:	Main Building
Location:	Yard. - side
Finding:	Site drainage— Inadequate
Information:	The site drainage in this area was found to be inadequate at the time of inspection, creating potential for subsequent water damage to associated building elements. This is additionally conducive to termite activity.

It is important that water does not lie against the base of walls; surrounding paths and ground levels should be sloped to drain water away from walls. Downpipes should not discharge stormwater onto lower walls or plinths. Stormwater should be carried away by large, regularly cleaned drains. Ground levels may need to be lowered to expose a buried DPC.

Where site drainage is inadequate, installation of an Agricultural (Aggie) Drain may be required. A licensed plumber should be appointed to further inspect the property and perform any remedial works as necessary. Water damage and secondary defects are likely to occur if left unmanaged.

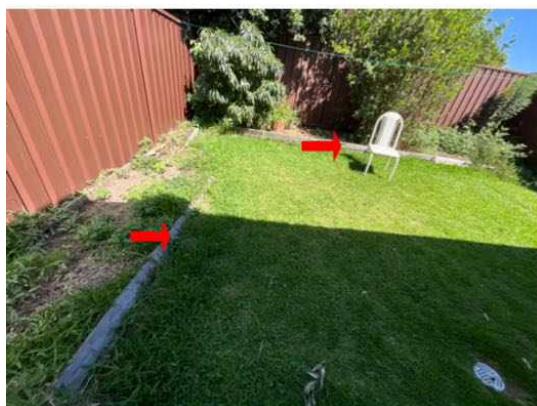
#### Finding 6.04

Information: Where timber elements are in direct contact with the ground and consequently moisture or dampness they become conducive to termite activity. Whether timber is used as a building element part of a fencing structure or stored as an unused item they can provide an environment that is attractive to termite infestation.

When met with excessive moisture timber begins to decay and develop wood rot. Any timbers that are in direct contact with external grounds especially if left untreated or non-durable also provide ingress for subterranean termites into that particular element.

The removal of any such materials that may be conducive to termite activity should be removed as soon as possible to minimise the risk of termite attack.

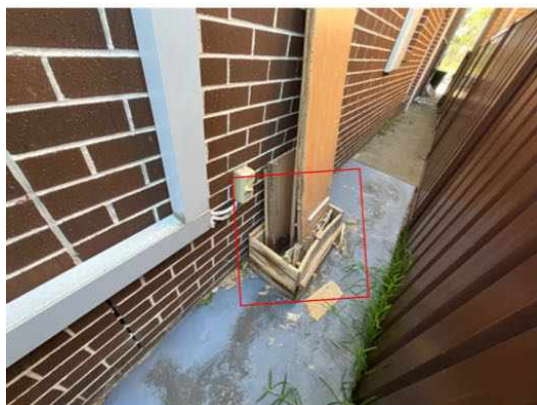
### Finding 6.05

Building:	Main Building
Location:	Yard
Finding:	Stored timbers - subfloor space or external area
Information:	The storing of timbers in the subfloor space or around the external property increases the risk of termite activity being present. As they are likely to come into contact with weather conditions or excessive moisture wood rot is likely to develop on timbers that are not treated.

It is highly recommended that any stored timbers be immediately removed from areas in which they may attract any termite / timber pest attack. Minimisation of risk / prevention of termite attack is far more adequate than dealing with the presence of termite activity.

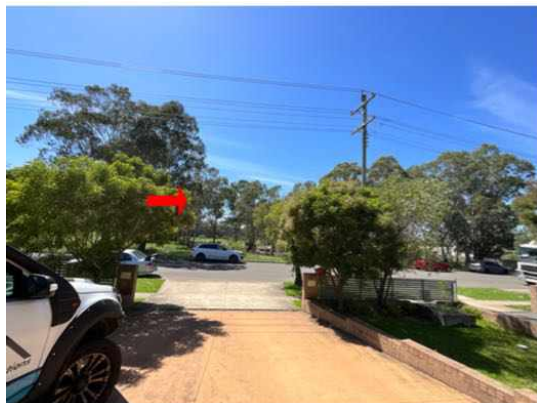
### Finding 6.06

Building:	Main Building
Location:	
Finding:	Surrounding bushland - Conducive
Information:	Home and or building is situated in a high risk area for termite activity, due to close proximity to surrounding bushland.

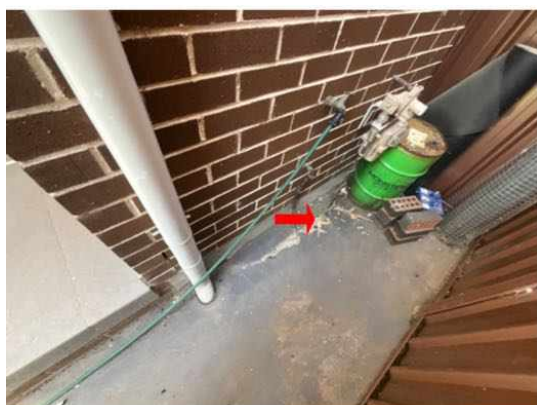
### Finding 6.07

Building:	Main Building
Location:	External tap
Finding:	Tap - No drain
Information:	The external tap in this area was noted to have no drain at the time of inspection.

This keeps the surrounding surfaces damp while using the tap, which becomes conducive to termite activity.

A licensed plumber must be appointed to ensure an appropriate drain is installed.

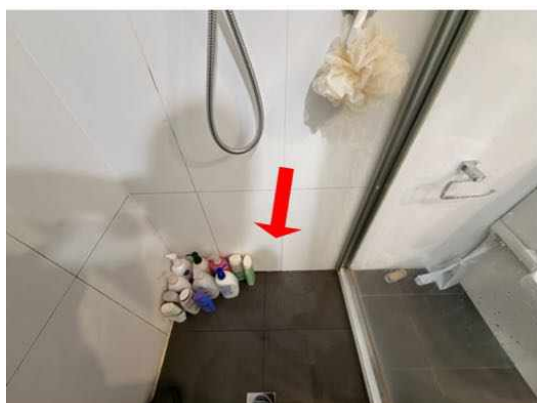
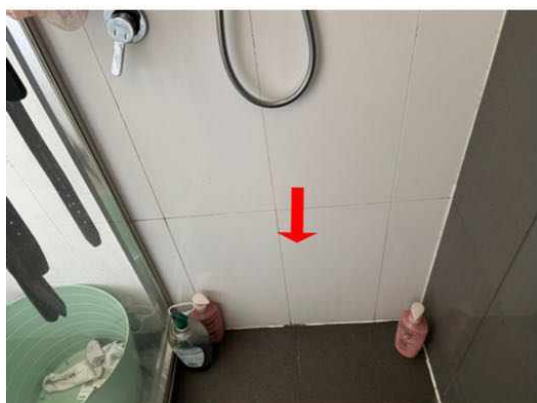
### Finding 6.08

Building:	Main Building
Location:	Bathroom, ensuite
Finding:	Shower damp - Sealant and grout
Information:	Damp is evident to the lower 400mm of wall to the shower alcove. This defect is quite common, and is suspected to have been caused by moisture permeating or leaching through the grouting and sealant in this area, which shows evidence of deterioration. Leaking pipes within the wall is also a possible cause however this seems unlikely in this instance as there is no moisture build up around the taps or transferring to the other side of the wall. There appears to be no sealant around the tap spindles which

Damp (or structural damp) refers to the presence of unwanted moisture in the structure of a building, either as the result of intrusion from outside, or condensation from within the structure. In the shower area, internal water leaks, degraded materials or other sources of excessive moisture are generally the cause of damp.

Unmanaged damp in the shower recess is likely to facilitate the formation and development of mould and fungi growth, decaying associated building materials and compromising their structural integrity of associated elements. It is important to address damp conditions, as the World Health Organisation notes that excess moisture leads - on almost all indoor materials - to growth of microbes such as moulds, fungi and bacteria, which subsequently emit spores and other matter into the indoor air. Exposure to these contaminants is associated with a wide range of respiratory and other health-related problems. Damp conditions also create a conducive environment for termite infestation.

Consultation with a bathroom sealant specialist is advised immediately to identify the cause of damp and to perform remedial works as required.

Always ensure that sealant and grout is in good condition to prevent any moisture issues occurring in the future.
