# Building and Timber Pest Inspection Report

Inspection Date: Thu, 5 Mar 2026

Property Address: 2-18 Shepreth Ave, Noble Park VIC 3174,  
Australia

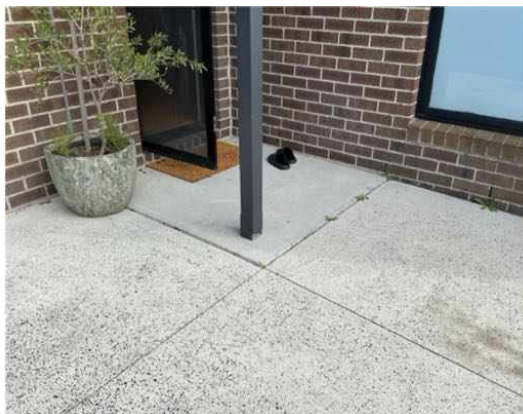
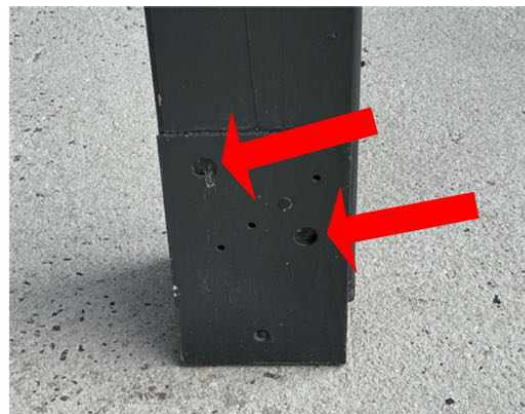
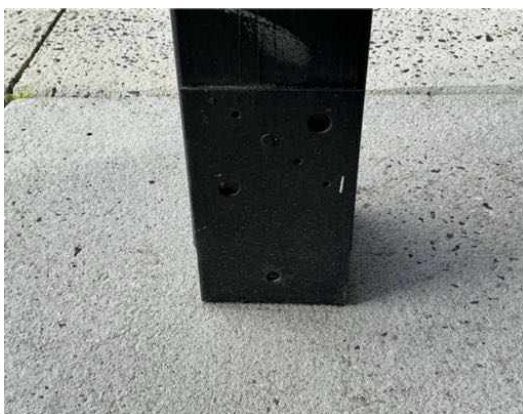
Finding: Missing fixings

Information: The entry post is missing its bolts/screws. Recommend engaging a carpenter to install bolts/screws to reduce the risk of any movement as soon as possible.

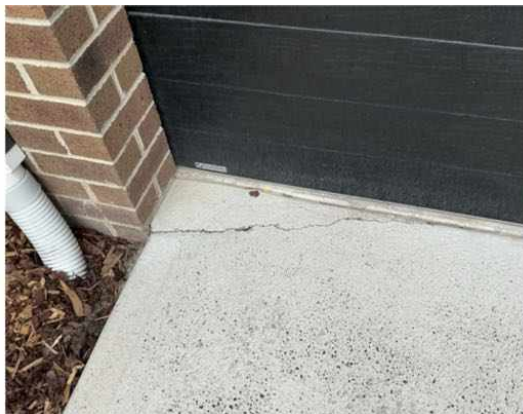
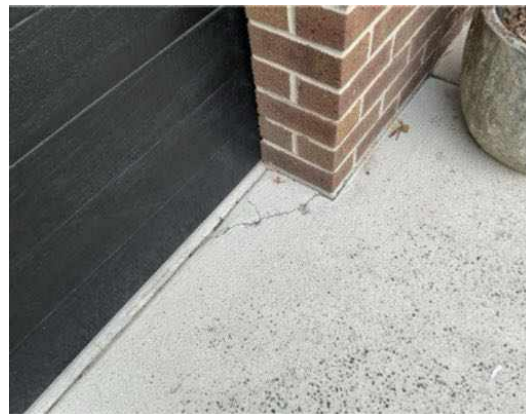
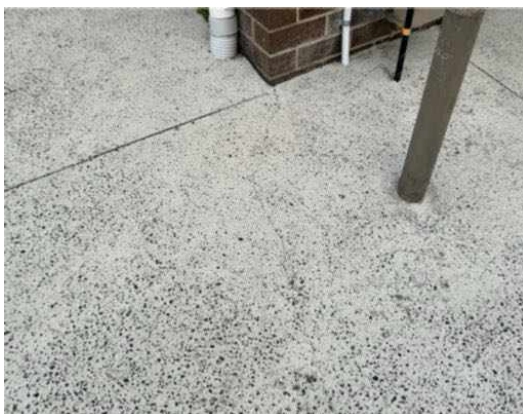
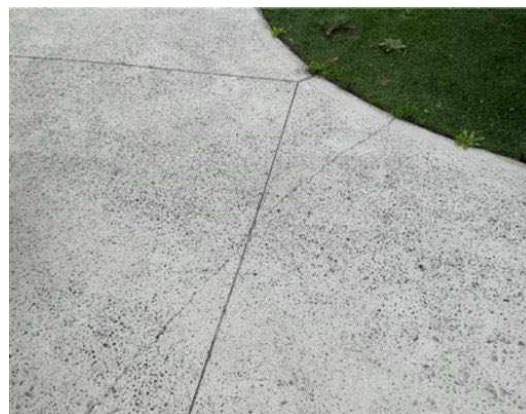
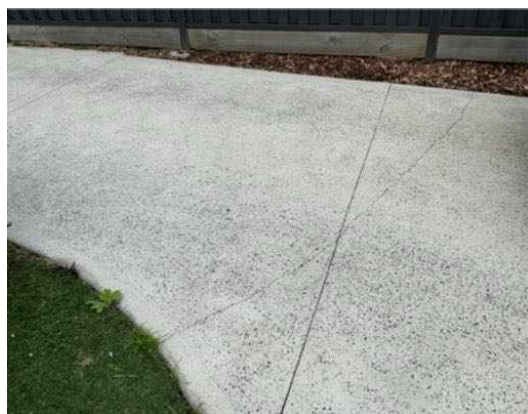
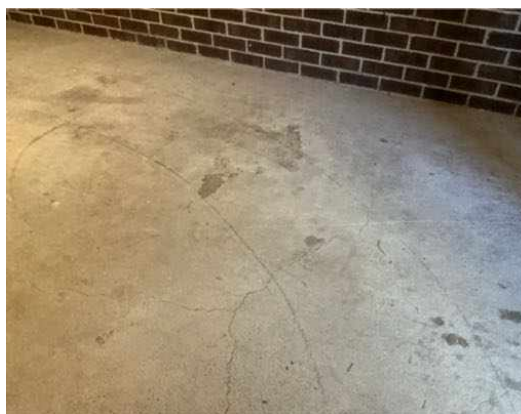
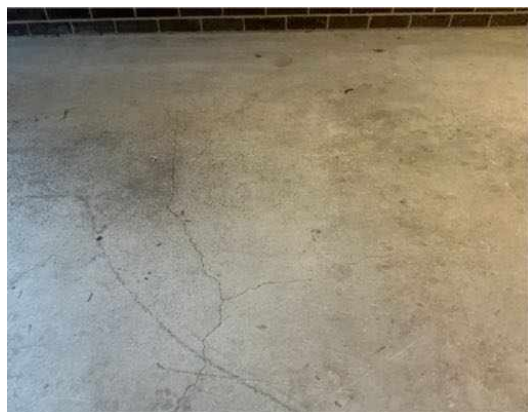
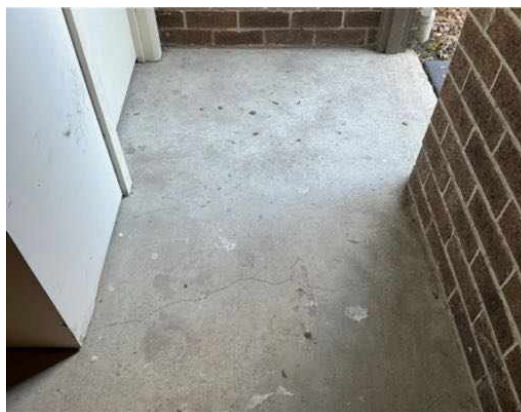
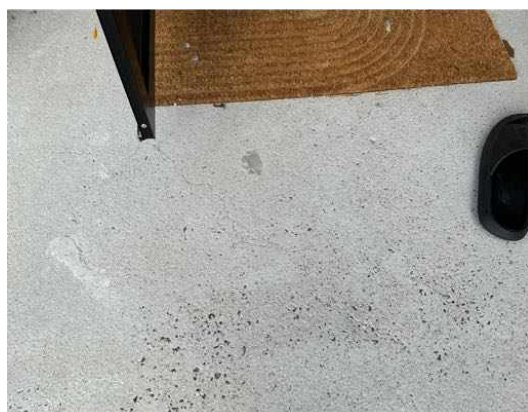
#### Finding 3.02

Location: Driveway/pathway  
Finding: Driveway/pathway Cracking  
Information: Cracks were identified in the driveway and pathways concrete paving. Although cracks are quite noticeable, they are often only considered to be an appearance defect, and usually do not indicate any structural damage.

Generally the cause of the cracks in existing concrete paving such as driveways and pathways is indicative of the expansion and contraction of the concrete. Such causes are generally due to environmental factors, such as moisture levels, weather conditions, root systems of nearby trees or the soil types on which they are laid.

Cracks may also be due to poor original installation of the concrete. Factors such as poor compaction of the sub surface and/or inadequate reinforcing of the slab may create cracking and other secondary defects.

Monitoring of all cracking should be conducted frequently. Always contact a building inspector should cracks widen, lengthen, or become more numerous.

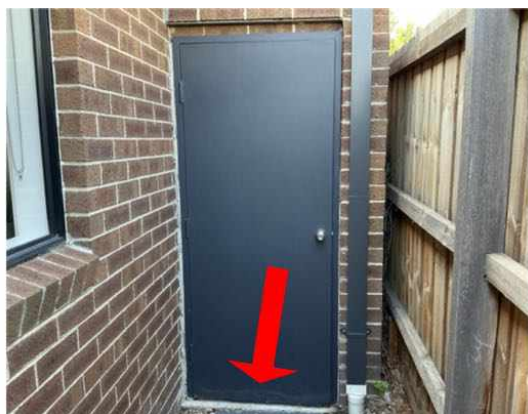
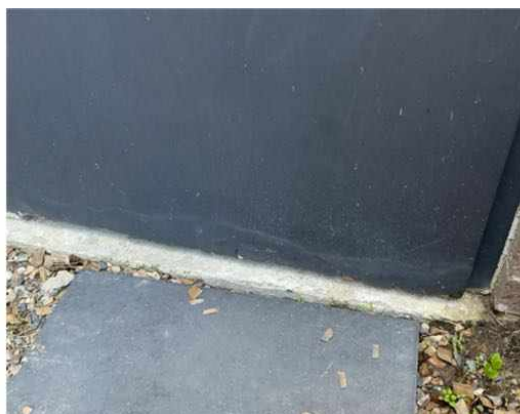
### Finding 3.03

Building:	Main Building
Location:	Garage
Finding:	Damaged/deteriorated garage door
Information:	The garage door is deteriorated/damaged due to deterioration of the paint work overtime. Recommend engaging a carpenter/painter to repair or replace to reduce the risk of further damage at the owners discretion. Whilst incomplete or missing paint finish is generally an appearance defect, it can also lead to the development of secondary building defects over time. Incomplete areas of paint finish expose the area to moisture, potentially accelerating the deterioration of underlying building materials.

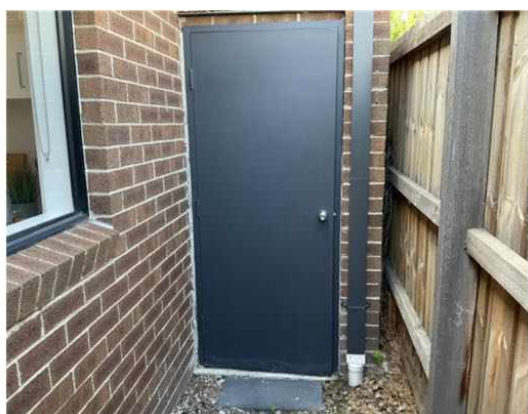
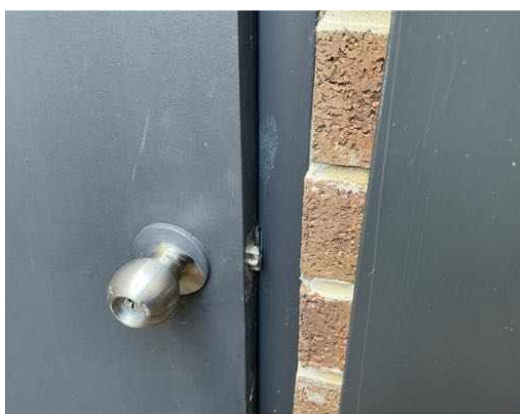
### Finding 3.04

Building: Main Building  
 Location: Garage  
 Finding: Door - Binding/jamming garage  
 Information: Binding and/or jamming of the garage door is evident during standard operation. This defect inhibits the functionality of the affected door as well as creating potential for secondary defects to associated building elements, such as damage to the floor covering.

A door that binds to flooring or to the associated door frame may have several causes, ranging from minor defects, such as poor installation of the door or deteriorated hinges.

For minor causes, a qualified carpenter or general handyperson should be appointed to perform minor rectification works at client discretion.

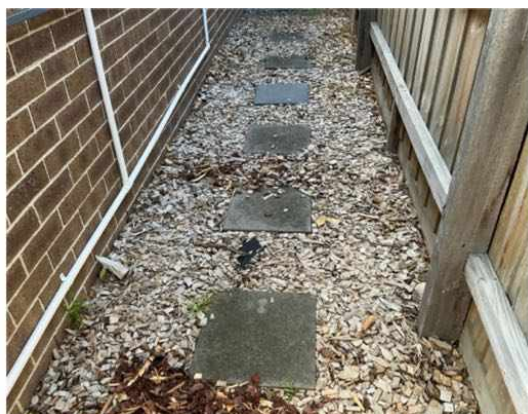
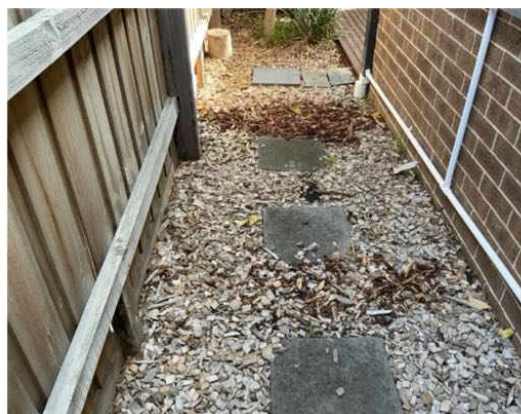
### Finding 3.05

Building: Main Building  
 Location: Yard - Back  
 Finding: Paving - Uneven  
 Information: Sections of the external paved area are uneven, creating a potential trip hazard. It

appears as though the area has been subject to rough installation, or that paving sections have lifted due to movements in the foundation of the property.

Where paving creates a trip hazard, personal injury may ensue if due caution is not taken by all persons within this area.

Re-paving of the area is required as soon as possible to remedy this situation. Further consultation with a specialist paver is advised.

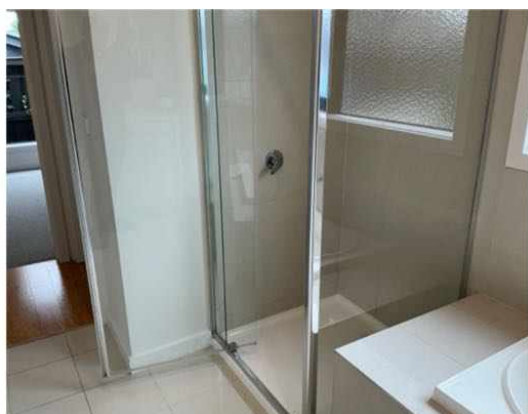
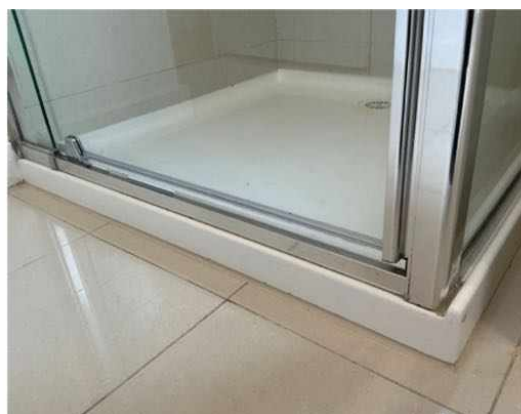
### Finding 3.06

Building:	Main Building
Location:	Bathroom
Finding:	Shower screen Door - Binding/jamming bathroom
Information:	Binding and/or jamming of the bathroom shower screen door is evident during standard operation. This defect inhibits the functionality of the affected door as well as creating potential for secondary defects to associated building elements.

A door that binds to the associated door frame may have several causes, ranging from minor defects, such as poor installation of the door or deterioration overtime.

For minor causes, a qualified carpenter or general handyperson should be appointed to perform minor rectification works at client discretion.

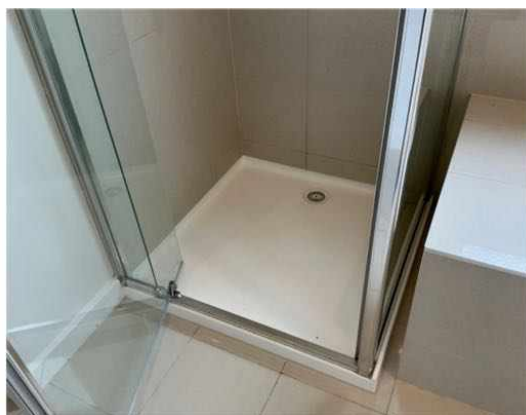
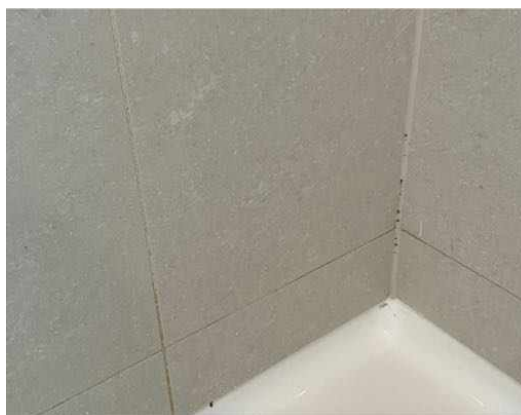
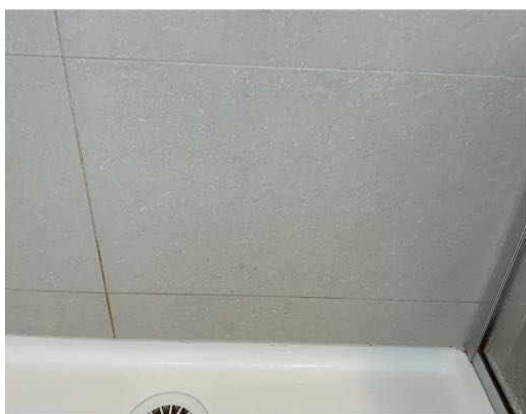
### Finding 3.07

Building:	Main Building
Location:	Bathroom
Finding:	Bathroom Sealant and grouting - Missing or damaged
Information:	It was noted on inspection that sealant or grout is degraded to the tiled shower alcove and or other areas of the bathroom.

Different materials and floor areas move at different rates, generally causing cracking to grout or sealant at this point. A flexible sealant is required to allow for expected expansion and contraction, while keeping the joint water tight and protective of all associated building materials.

Flexible and mould resistant materials should be applied to affected areas to prevent any subsequent water damage that is likely to occur. Regular maintenance and replacement of damage or missing or damaged sealant and grout is highly recommended to the wet areas, as this is a regular wear and tear defect. Sealant and grouting in areas that come into regular contact with water should be maintained for the long term care of your property.

A sealant specialist or tiling contractor should be appointed to complete these works as soon as possible

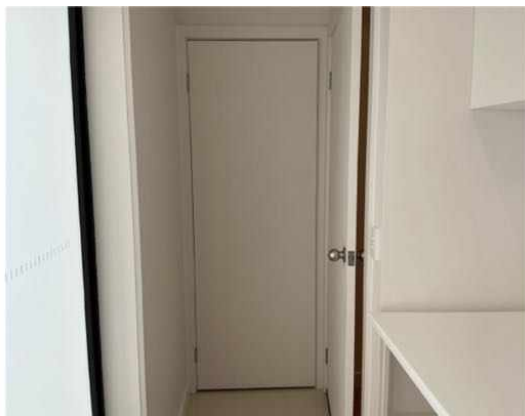
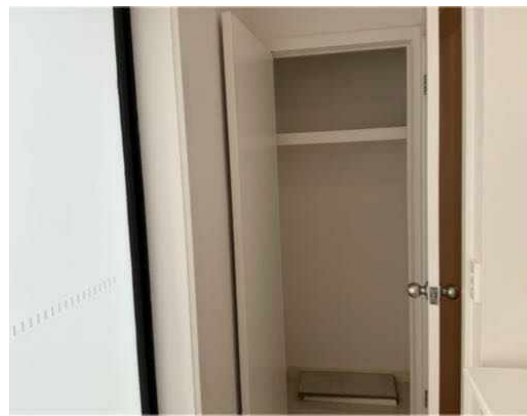
### Finding 3.08

Building: Main Building  
 Location: Laundry  
 Finding: Door - missing handle and latch  
 Information: The door handle and latch to the laundry cupboard door was found to be missing at the time of inspection.

Fitting of the door handle and latch is advised to improve the operational state of the associated door.

A qualified carpenter or general handyman should be appointed to fit the door handle and latch at the client's discretion.

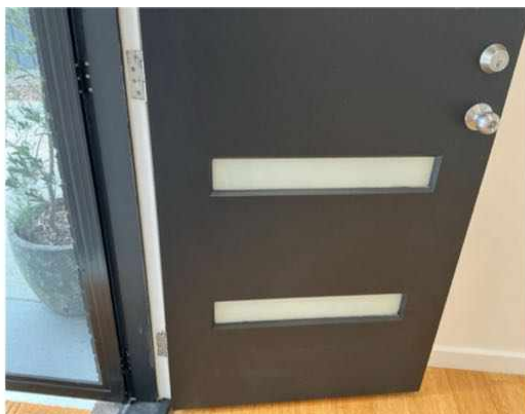
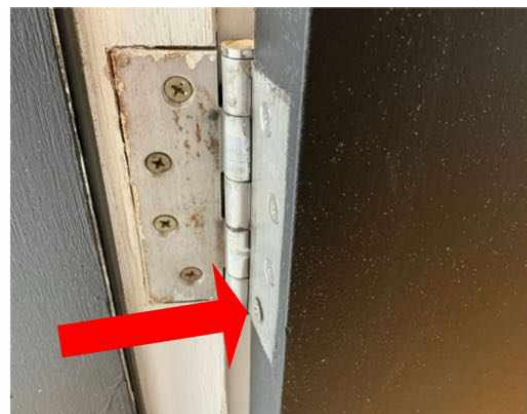
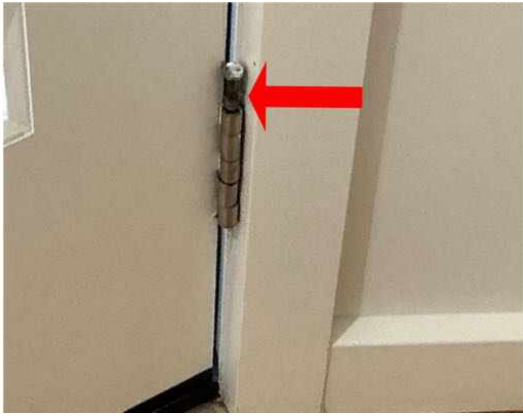
### Finding 3.09

Building: Main Building  
 Location: Entry  
 Finding: Hinge screws loose  
 Information: The front door hinge screw and pin is coming loose. This can happen overtime with deterioration or lack of maintenance. Recommend engaging a carpenter to repair/maintain the door at the owners discretion.

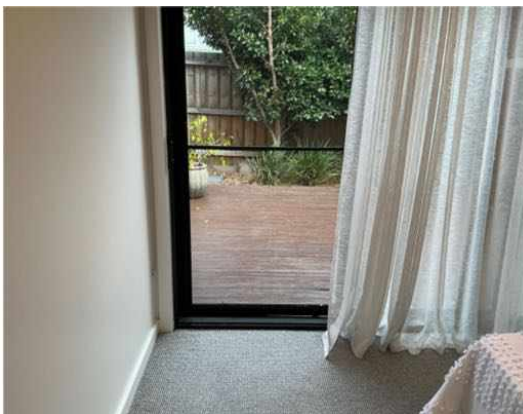
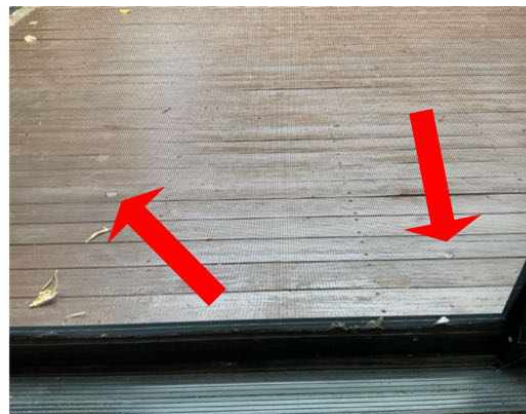
### Finding 3.10

Finding: Flyscreen damaged

Information: The bedroom flyscreen was found to be damaged at the time of inspection. This can happen overtime with deterioration in harsh weather conditions or accidental impact damage.

Where not replaced, damaged flyscreens allow pest and insect ingress into the adjoining room/s. It is advised that all damaged flyscreens be replaced in order to ensure the full function of all building structures.

A general handyperson may be appointed to replace flyscreens at the discretion of the client.

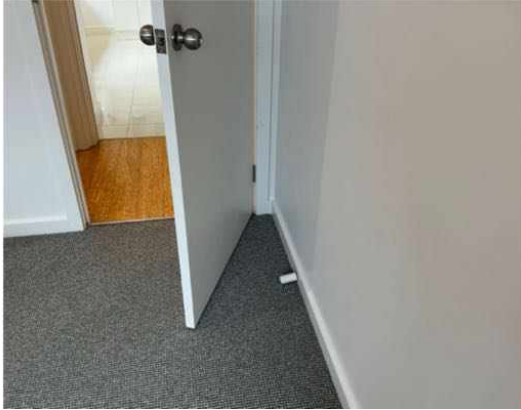
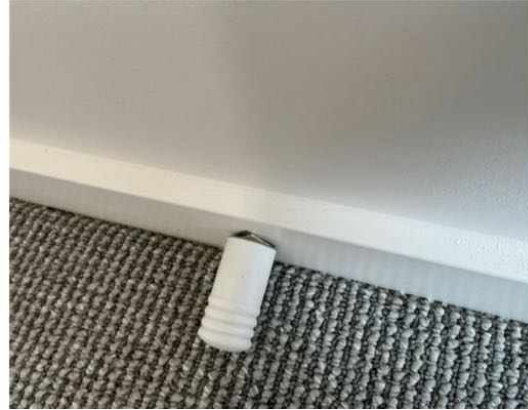
### Finding 3.11

Information: The bedroom door stop is loose and needs tightening. Although some building elements may seem irrelevant or unnecessary, all building elements play a key role in

the operation and function of the overall structure and its performance.

Re-installation or replacement of the door stop is advised as soon as possible to prevent any subsequent damage to the door or associated structures. A general handyman may be appointed to perform these works at client discretion.

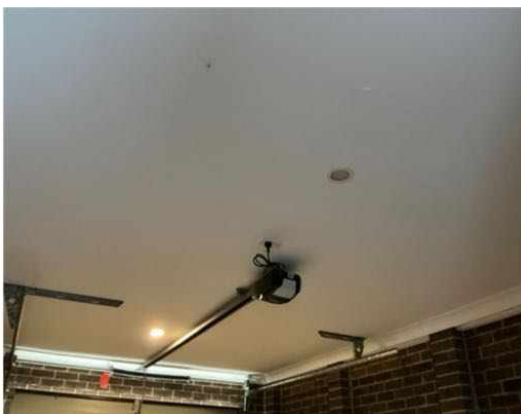
### Finding 3.12

Building:	Main Building
Location:	Garage
Finding:	Light fitting - not working
Information:	The light fitting in the garage was found to be not working at the time of inspection. Damage occurs generally when the building materials have aged and decayed, but may also be indicative of impact damage to the building element (accidental or deliberate).

Left unmanaged, the fitting is unlikely to cause further damage to surrounding building elements.

Repair and/or replacement of the damaged fitting is advised. A Licensed electrician should be appointed to repair/replace the light fitting at the client's discretion.

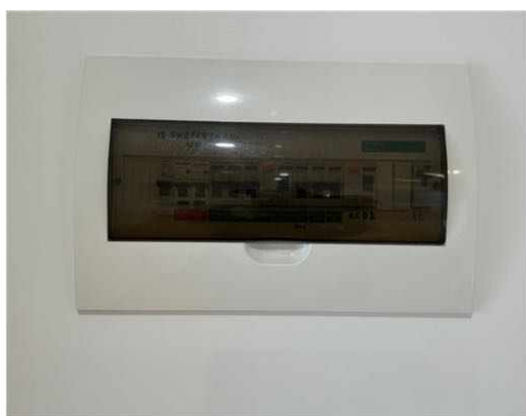
Building: Main Building  
 Location: All External Areas  
 Finding: No Termite Management System - no evidence of a chemical installation  
 Information: The application of a post-construction chemical termite barrier is highly recommended for all properties, particularly if live termite activity has been found on the site previously. Such barriers are highly effective in preventing termite attack on any timber building elements throughout the property.

A durable notice should be placed in the switchboard unit to indicate current termite barriers. At the time of inspection, it appeared as though no termite management system has been installed, with no evidence to suggest preventative works taking place.

The client may consider gaining further advice from a pest controller as to the costs and procedures involved with this application. It is recommended that obtaining such advice be a short-term priority.

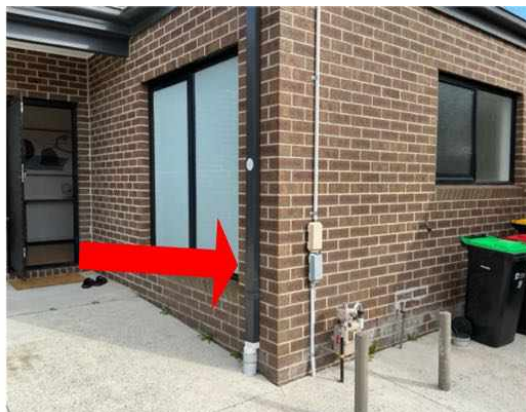
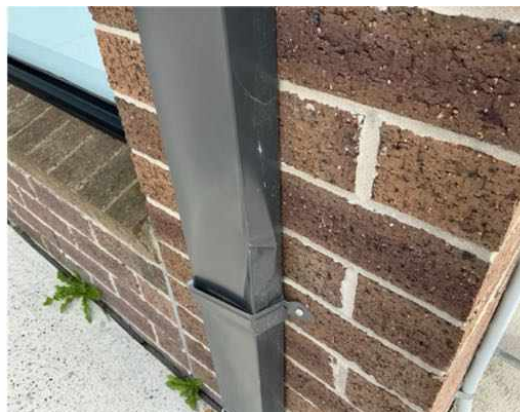
### Finding 6.02

Building: Main Building  
 Location: Exterior walls - front  
 Finding: Damaged down pipe

Information: The down pipe to the front of the property is damaged due to impact damage. This disconnection negatively impacts the functional capacity of the roof plumbing.

Where roof plumbing doesn't drain adequately, the area at the base perimeter can become excessively damp, potentially creating an environment that is susceptible to rust and corrosion of surrounding building elements, as well as attracting termites and other pests.

It is highly recommended that a plumber be appointed to further inspect the area and to install adequate drainage equipment where necessary.

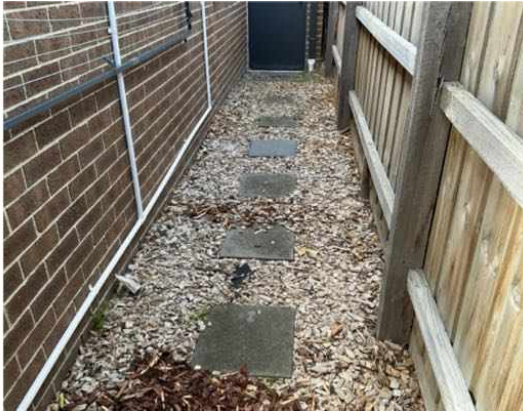
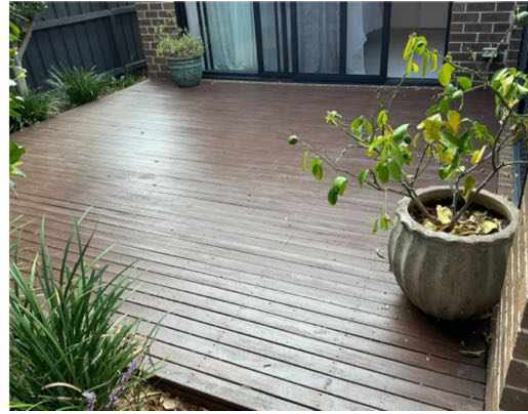
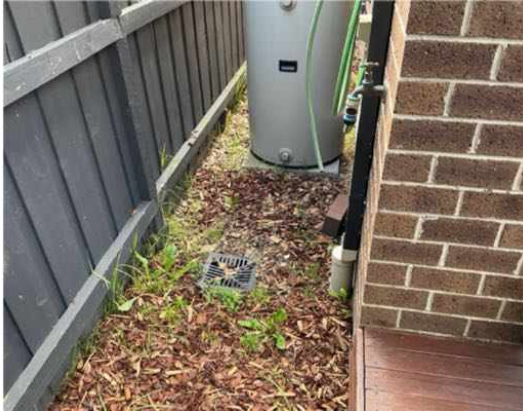
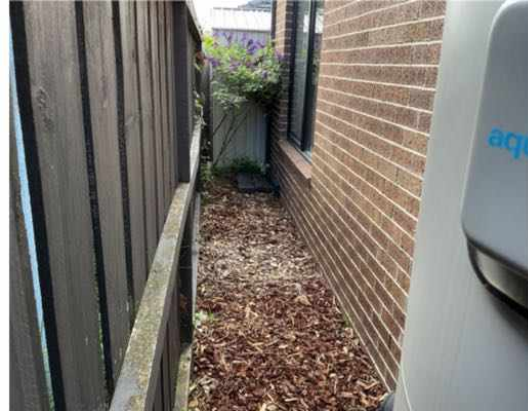
### Finding 6.03

Building: Main Building  
 Location: Yard - Back  
 Finding: Site drainage - poor/inadequate  
 Information: The site drainage to parts of the rear yards was found to be inadequate at the time of inspection, creating potential for subsequent water damage to associated building elements. Excessive moisture will attract termites.

It is important that water does not lie against the base of walls; surrounding paths and ground levels should be sloped to drain water away from walls. Downpipes should not discharge stormwater onto lower walls or plinths. Stormwater should be carried away by large, regularly cleaned drains. Ground levels may need to be lowered to expose a buried DPC.

Where site drainage is inadequate, installation of an Agricultural (Aggie) Drain may be required. A qualified plumber should be appointed to further inspect the property and perform any remedial works as necessary. Water damage and secondary defects are likely to occur if left unmanaged.

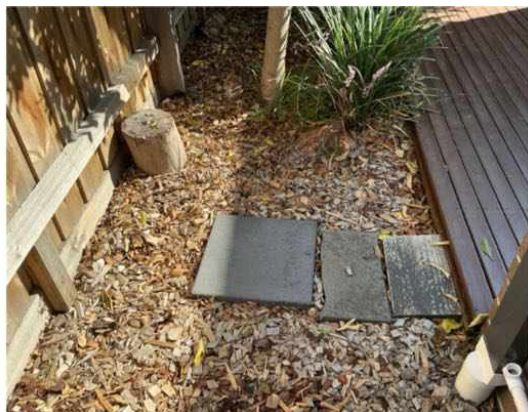
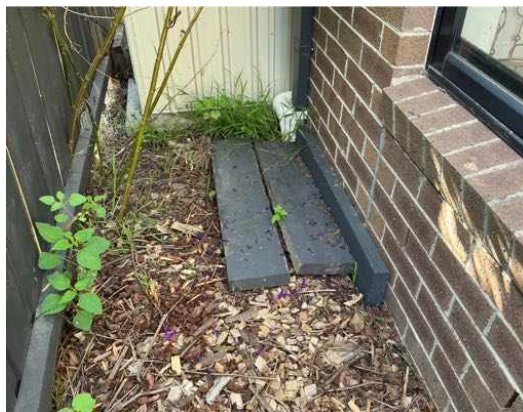
### Finding 6.04

Building:	Main Building
Location:	Yard - Back
Finding:	Stored timbers/stumps - external area
Information:	The storing of timbers or stumps to the external property increases the risk of termite activity being present. As they are likely to come into contact with weather conditions or excessive moisture wood rot is likely to develop on timbers that are not treated.

It is highly recommended that any stored timbers or stumps be immediately removed from areas in which they may attract any termite / timber pest attack. Minimisation of risk / prevention of termite attack is far more adequate than dealing with the presence of termite activity.

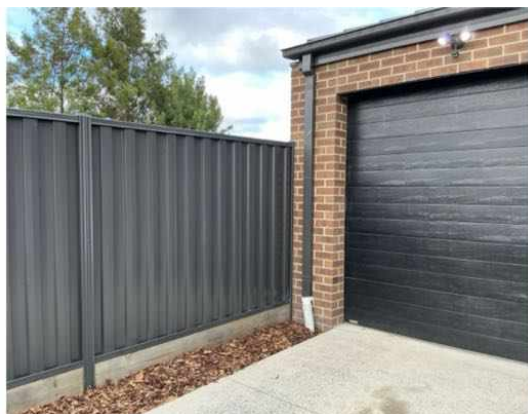
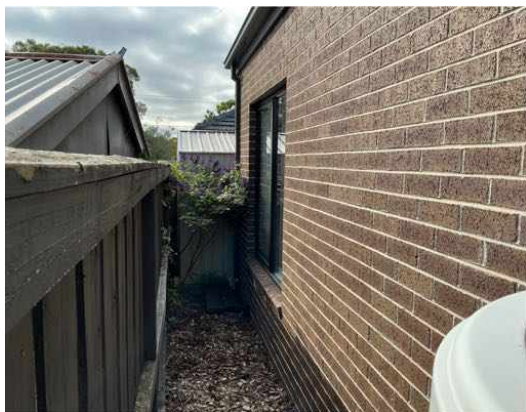
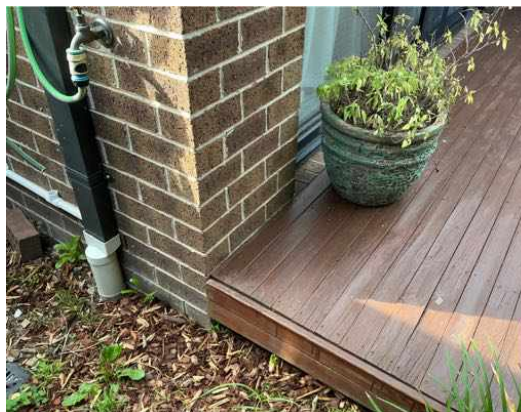
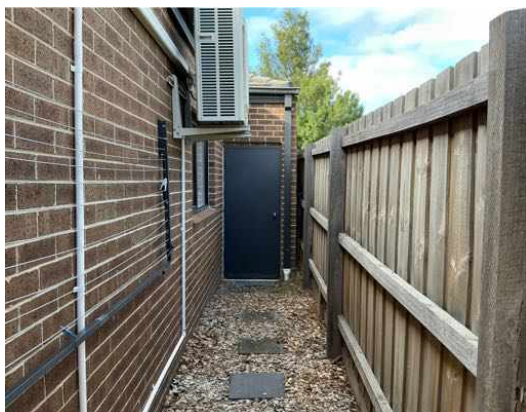
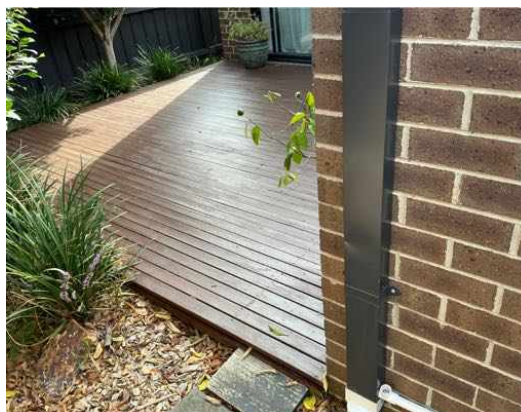
**Finding 6.05**

Building: Main Building  
 Location: Various parts of the building  
 Finding: Bridging attachments to buildings  
 Information: Bridging occurs when items against a building provide a concealed entry point for termites into the building or by passing around a termite management system.

Where any part of an attachment to a building is not isolated and is not provided with a clear gap of not less than 25mm from building, bridging occurs. Attachments to buildings such as hot water services, downpipes, verandahs, decks, steps, fences, service conduits and the like provide the opportunity for concealed entry.

Building attachments of this nature need to be frequently inspected for termite activity by a qualified inspector.

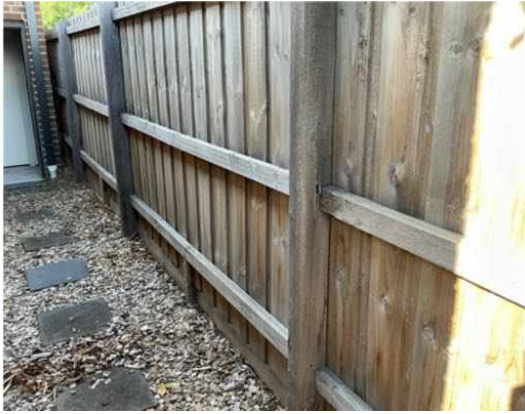
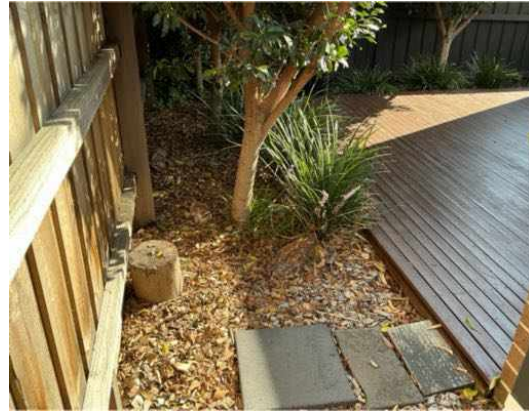
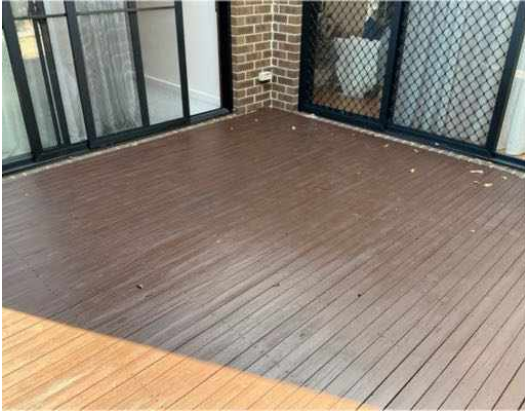
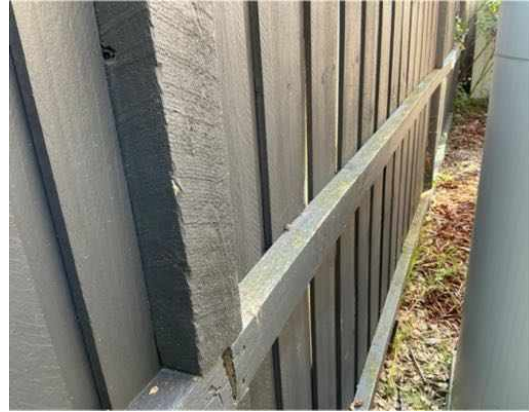
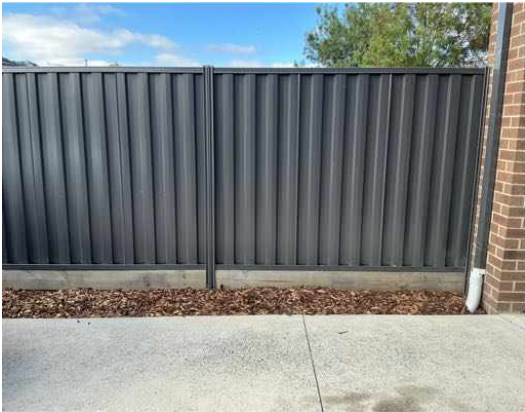
### Finding 6.06

Building:	Main Building
Location:	Various parts of the building
Finding:	In ground contact
Information:	Any timbers in direct ground contact provide opportunity for concealed termite entry and are likely to be subject to premature rot and decay as the soil retains moisture or damp conditions against the timbers.

Remove untreated timber that is in direct contact with external grounds. Consider replacement with more durable materials i.e. treated timber or non timber elements. Frequent pest inspections are advised to readily identify any termite activity in these areas.

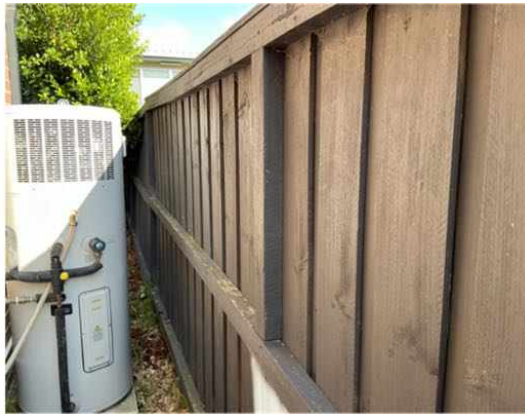
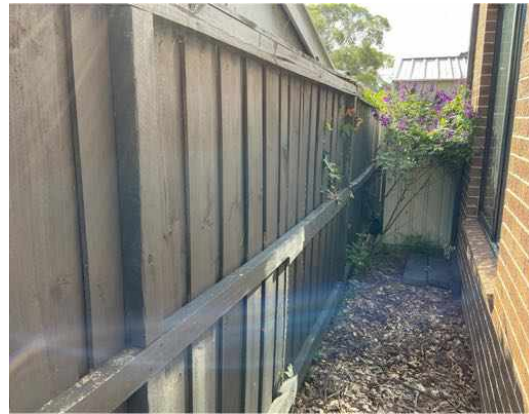
### Finding 7.01

Building:	Main Building
Location:	Yard - Back
Finding:	Fencing - wood rot-fungal decay
Information:	It was noted at the time of inspection that sections of the rear fencing to the property have deteriorated and have fungal decay/wood rot present. Typically fencing deteriorates due to age and or wear, rot and or rust which is generally expected for a structure of this age, due to prolonged exposure to weather conditions. Sometimes

inadequate installation or maintenance can be to blame.

If left unattended, it is likely that further damage will occur. It is suspected that repair of several elements of the fencing may be required however replacement may be a consideration of the client also.

A licensed fencing contractor should be appointed to provide further advice and perform rectification works as necessary.

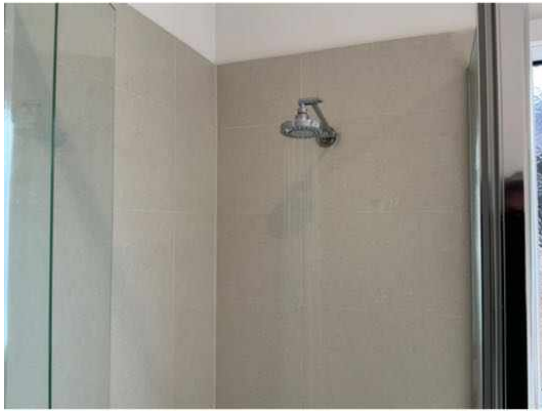
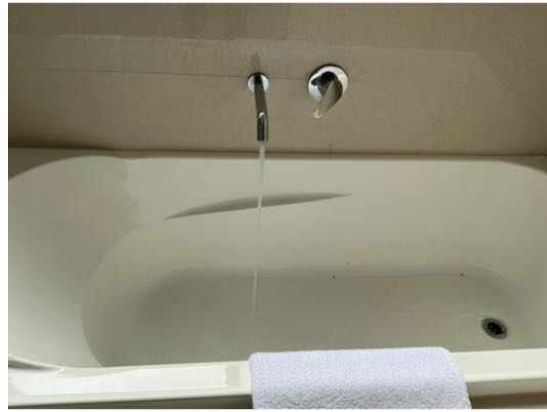
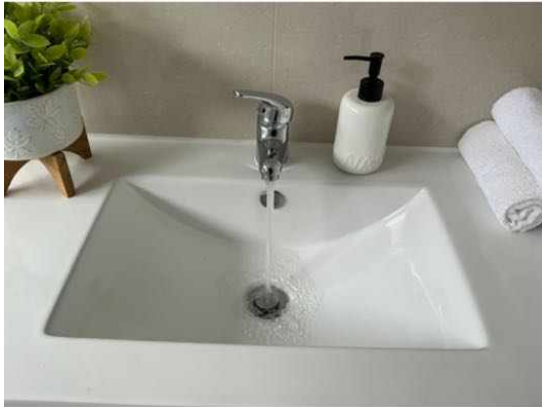
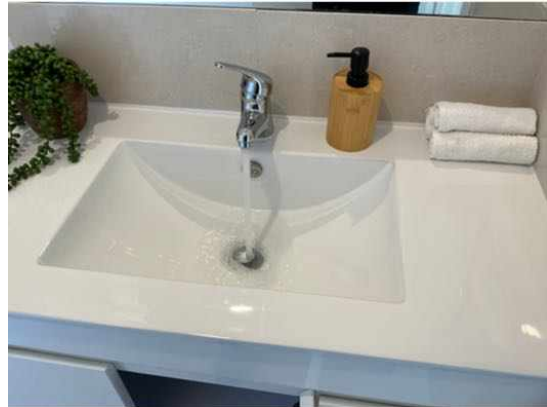
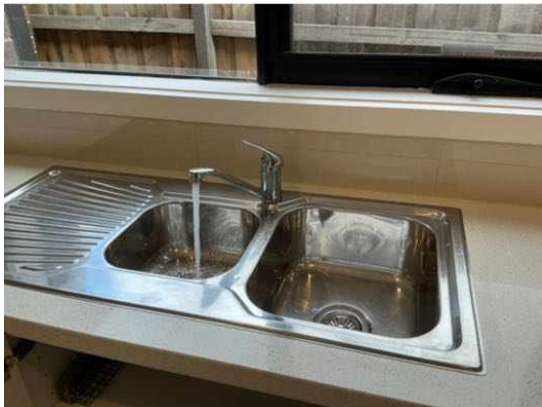
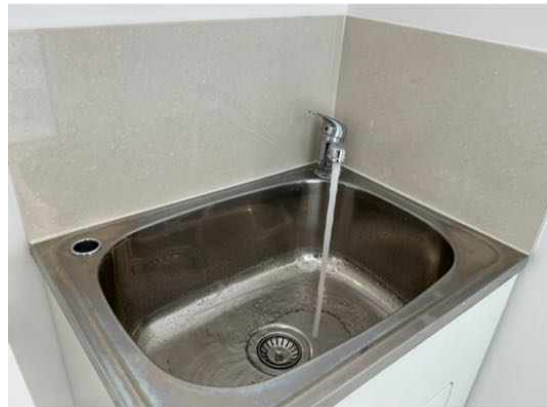
Building: Main Building  
 Location: Various parts of the building  
 Finding: Went running the hot taps. the water was only lukewarm.  
 Information: Recommend engaging an electrician to inspect and provide appropriate advice and recommendation on why there is only lukewarm water from the hot water system and to rectify.
