Building and Timber Pest Inspection Report

Inspection Date: Tue, 10 Mar 2026

Property Address: 63 Martins Rd, Cooroy QLD 4563, Australia

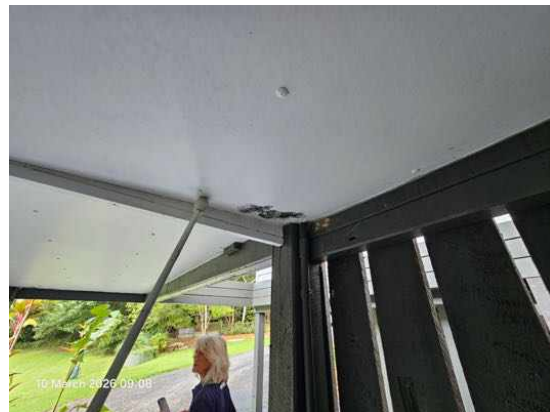
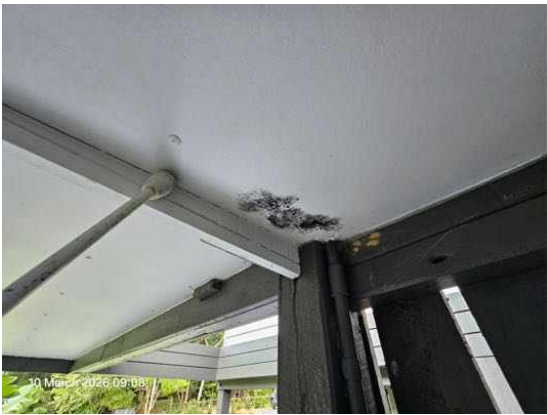
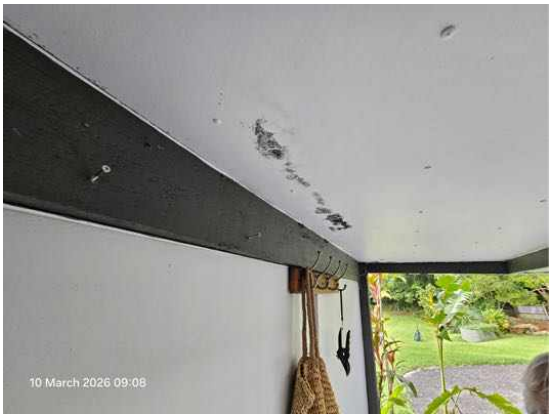
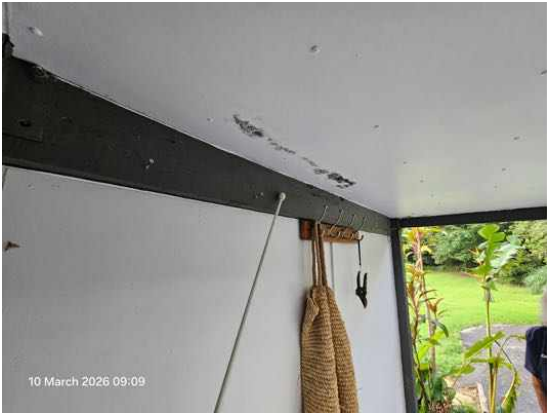
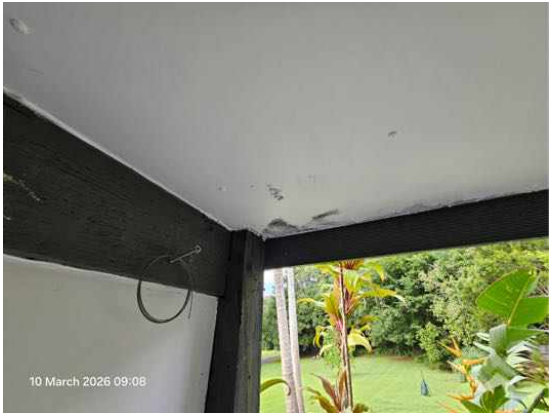
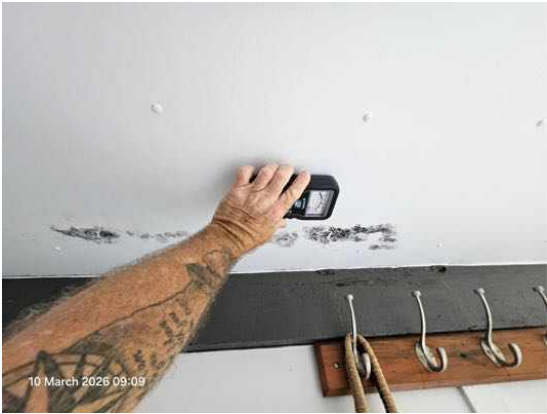
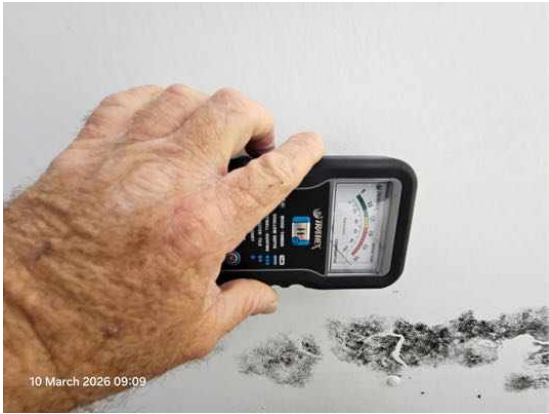
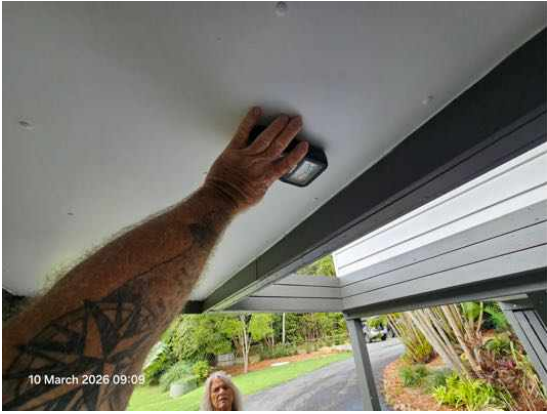
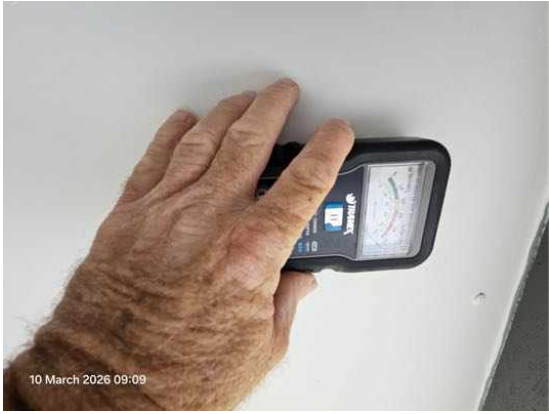
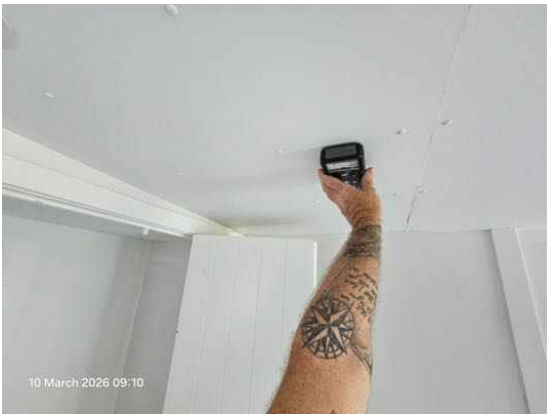
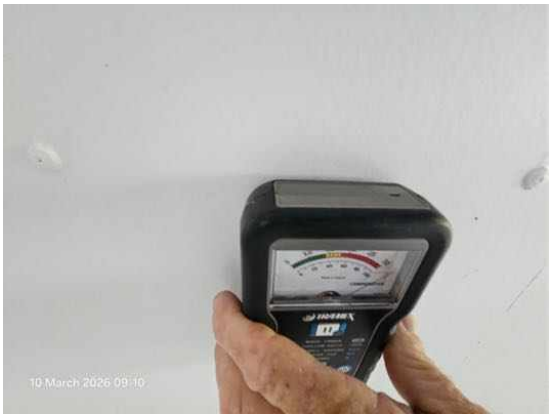
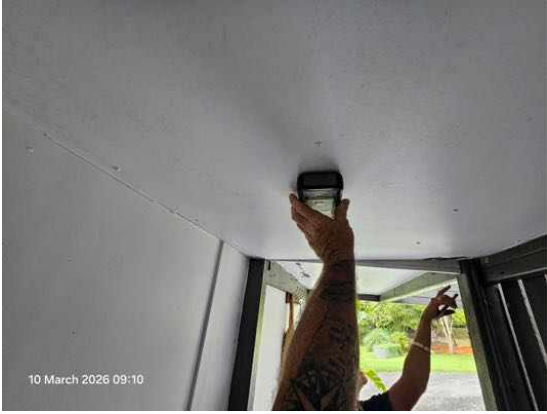
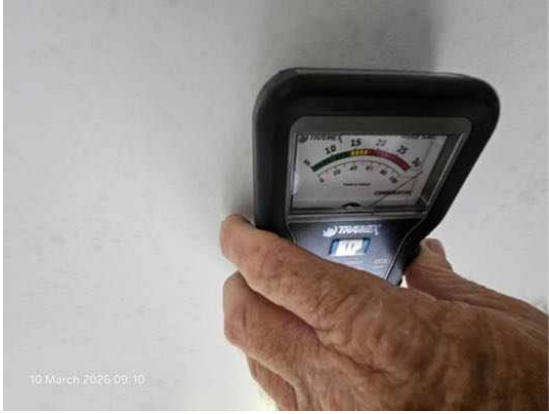
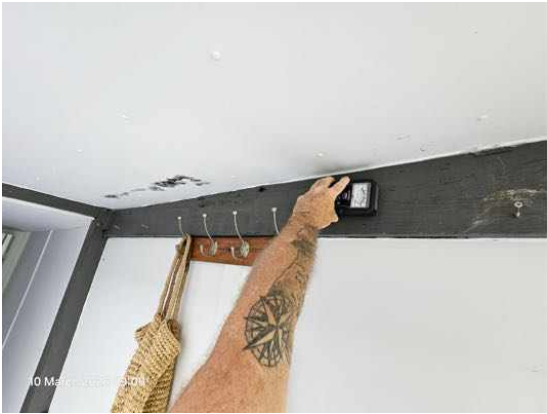
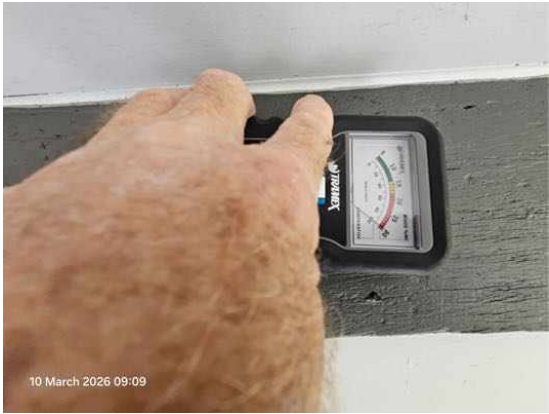
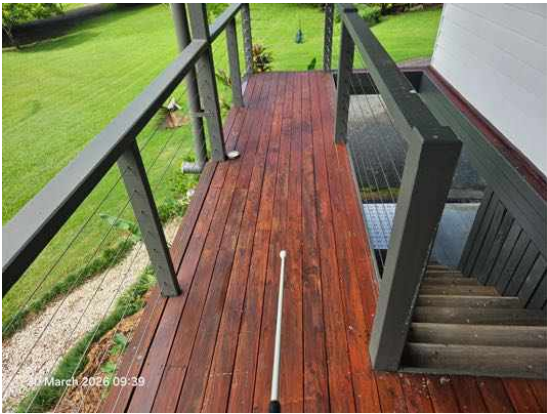
Building: Main Building
 Location: Laundry
 Finding: Ceiling - moisture / mildew / mould stained
 Information: Moisture staining to the laundry ceiling lining and the subsequent mildew / mould staining is an indication of environmental moisture / high humidity being present in the immediate area and generally from exterior weather conditions. The sheets are fixed directly to the underside of the rear deck and are constantly exposed to weather conditions. The presence of black mould signifies the level of moisture present, confirmed by the moisture meter, 30%+. Excessive moisture levels were also noted in the timber beam at the front of the deck, this is possibly due to excess moisture being directed toward the edge from the sheets pitch.

This has the potential cause further damage and can become a health risk if not treated.

The ceiling sheets outside the laundry will require removal due to mould growth and retained moisture. A more effective purpose built method should be considered.

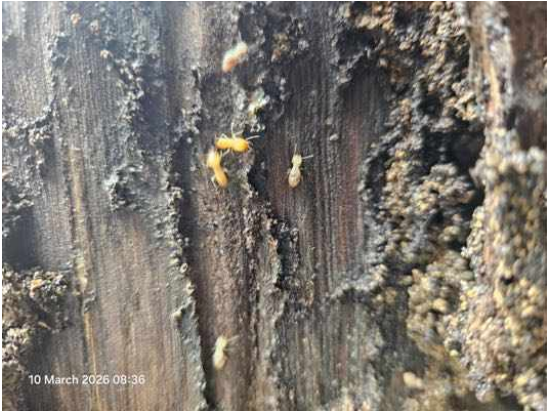
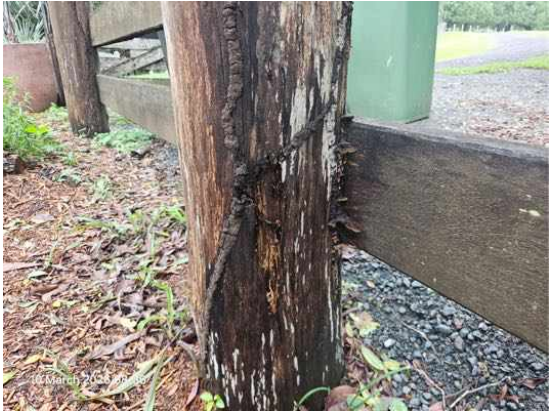
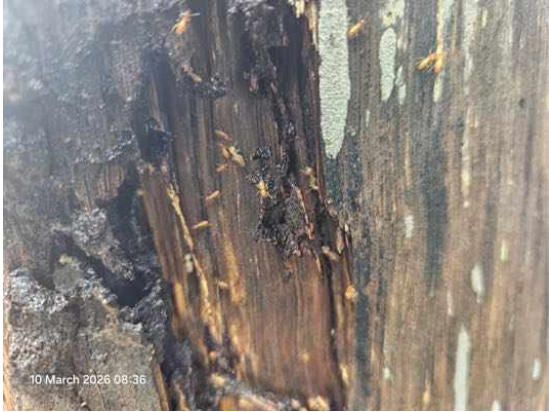
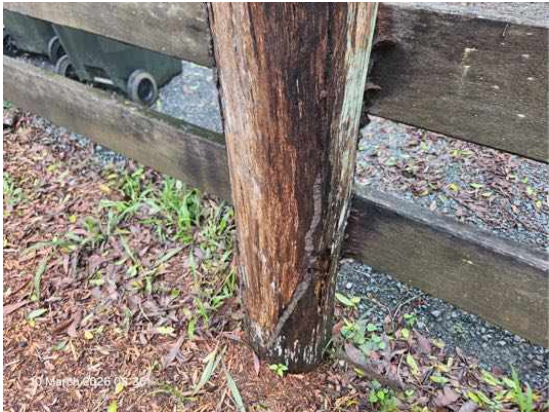
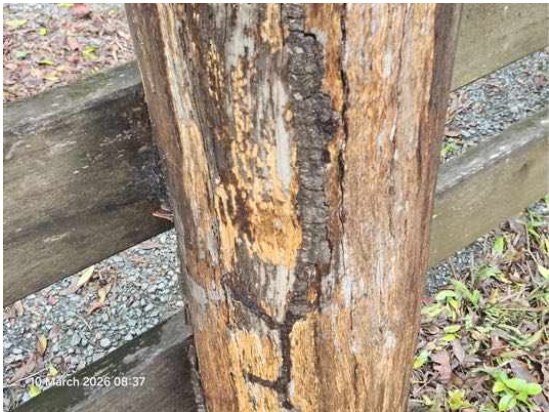
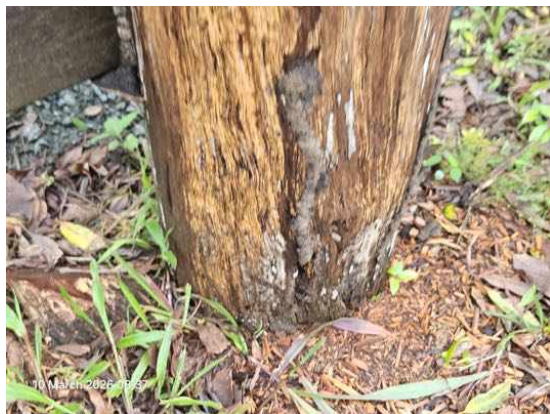
Building: Yard
Location: Front fence
Finding: Termite damage - active presence
Information: During the inspection of the property grounds termite activity was found in the fence posts at the front entry to the property. As shown in the photographs, active termites are seen. The species appear to be Coptotermes, a more destructive member of the species.

It is highly recommended that a pest controller be engaged to carry out the required inspection of the area and the property to provide a proposal for a barrier and the treatment of the active pests.

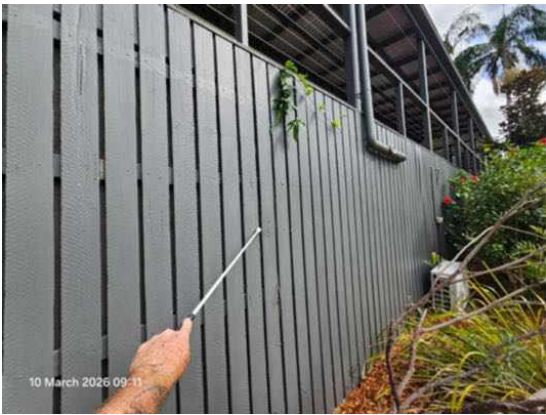
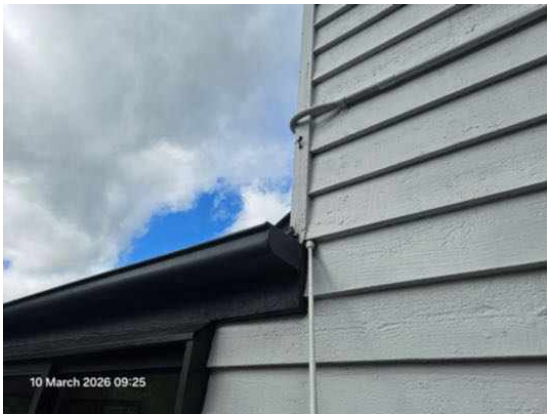
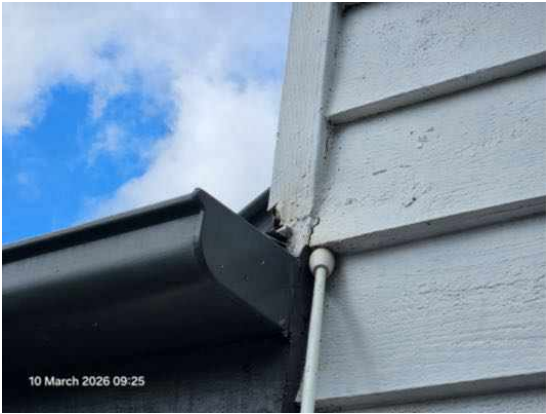
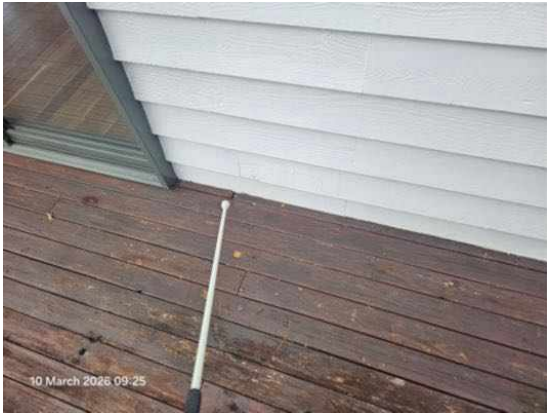
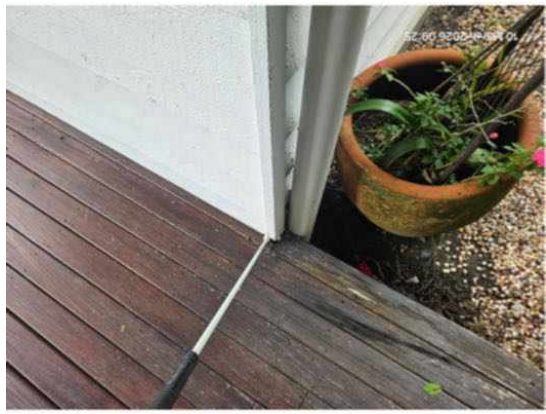
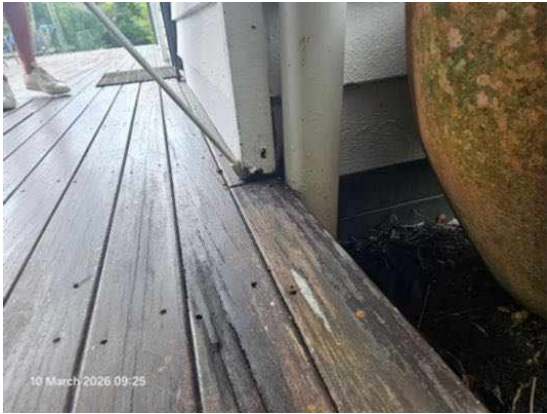
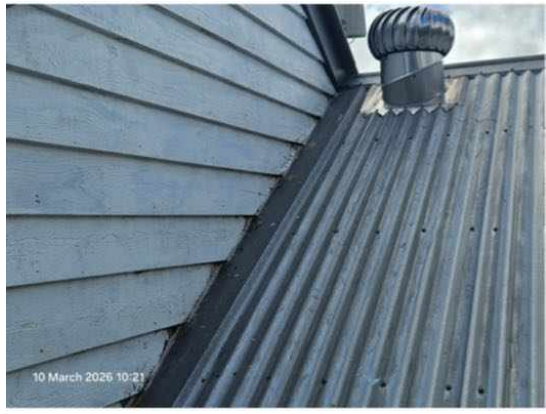
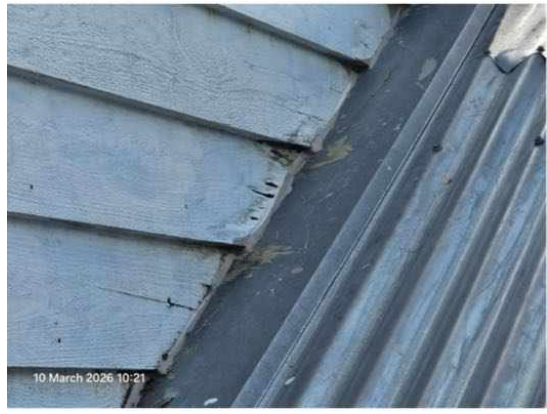
Building: Main Building
Location: As shown
Finding: Wood rot / fungal decay
Information: The timber building components shown have evidence of wood rot in various sections of the timber. Different areas are at differing stages of degradation ranging from pre-stage to established; however, it would be prudent to have all areas existing and pre-stage wood rot rectified.

Wood rot, also known as Fungal Decay, occurs when timbers and other cellulose building materials are exposed to damp conditions on an ongoing basis. This could be the result of exposure to weathering over a prolonged period of time, or the attraction of excessive moisture from other abutting building materials.

Early intervention and regular maintenance, particularly of exterior timbers, will prolong the useful life of these building elements. Prior to any works being performed, the cause of the moisture that has created the visible wood rot should be identified and addressed in a suitable manner. Replacement of affected timbers may then be a necessary step in protecting surrounding building elements from such deterioration.

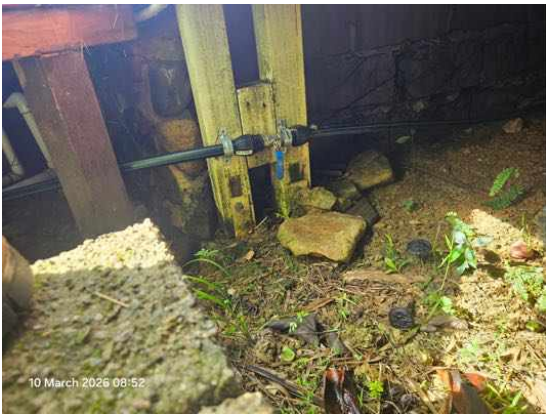
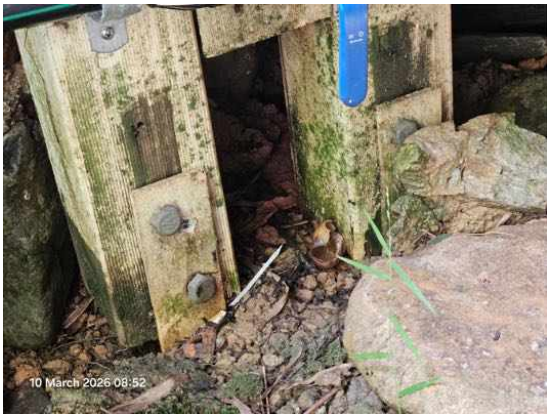
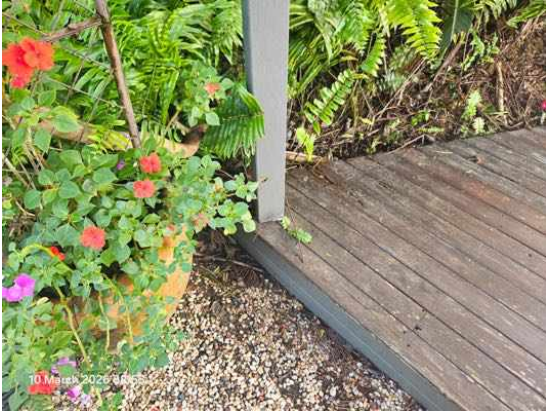
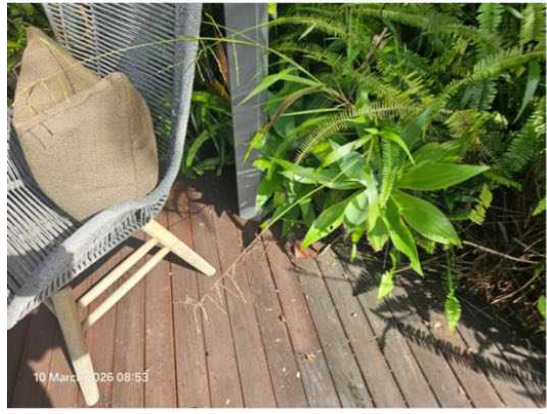
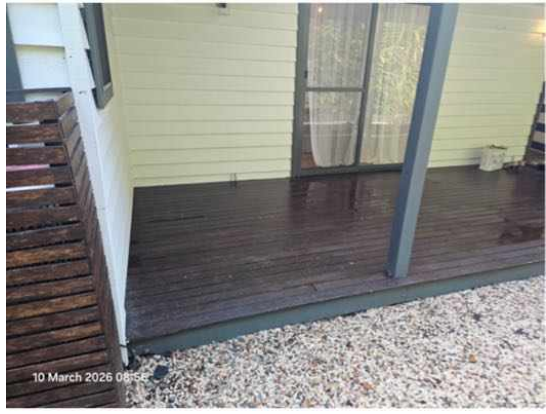
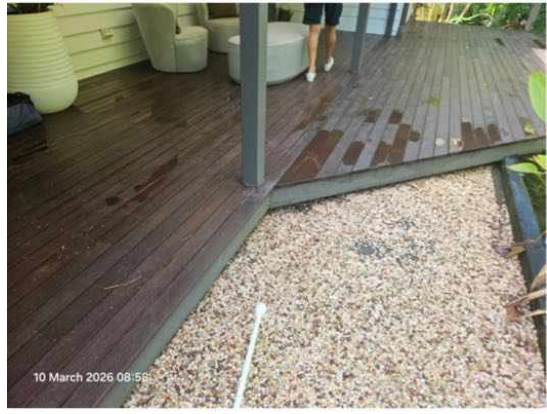
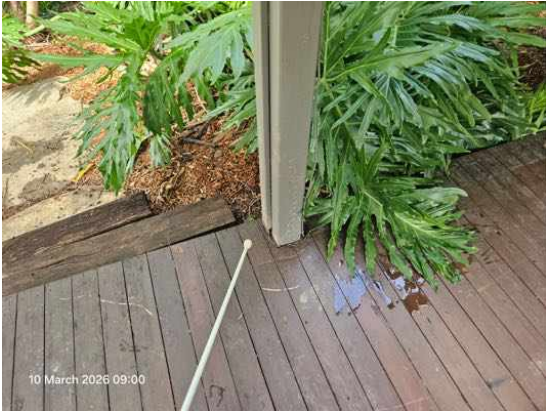
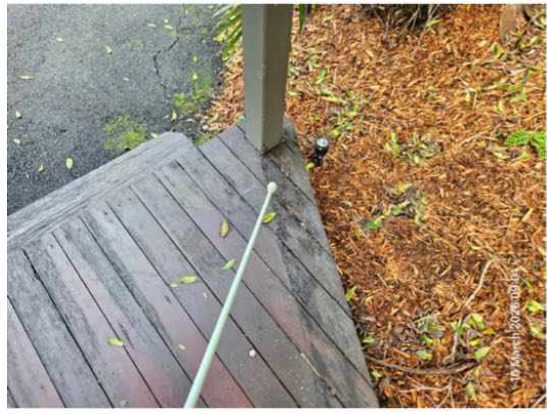
Finding 6.03

Building: Main Building
Location: Decks
Finding: Timber contact with ground - posts
Information: It was noted during inspection, that many of the timber post of the deck are in contact with the ground and do not have sufficient clearance to provide and adequate inspection zone. These could be a possible entry point for timber pests. The posts of the deck / verandah are concealed and cannot be inspected. These will be considered in the same way when assessing risk.

The soil and debris should be cleared away from the base of all timber structural members to provide clear visible access to view the post bases. Where this cannot be done, advice from the timber pest controller maintaining the inspection programme should be sought.

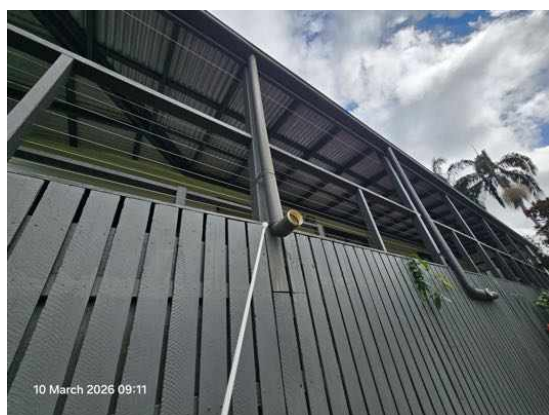
Finding 6.04

Building: Main Building
 Location: As shown
 Finding: Downpipe - Connection broken
 Information: The downpipes of the house show evidence of breakage or disconnection and are not connected to the stormwater system adequately or directed away from the property.

This leads to excessive moisture in the areas around the pipes and against the foundations of the house. This can lead to conducive conditions for timber pests and vermin infestation and have adverse effects on the foundations.

A licensed plumber may be appointed to repair the downpipe connections and provide adequate extensions to the pipes..

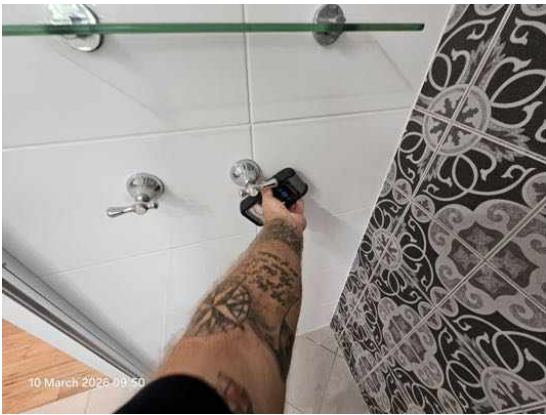
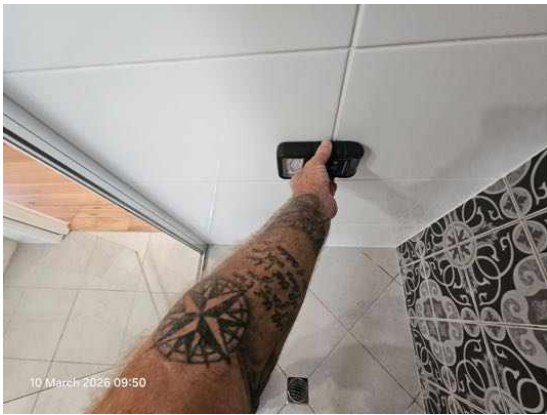
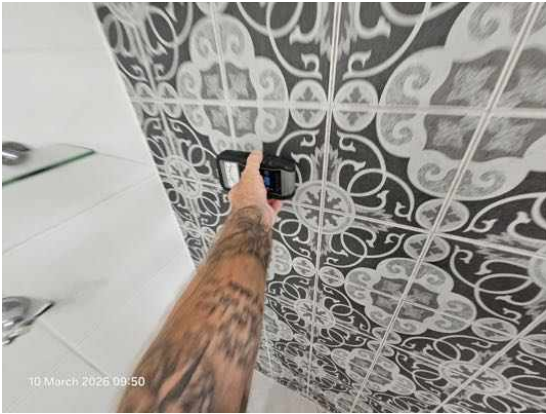
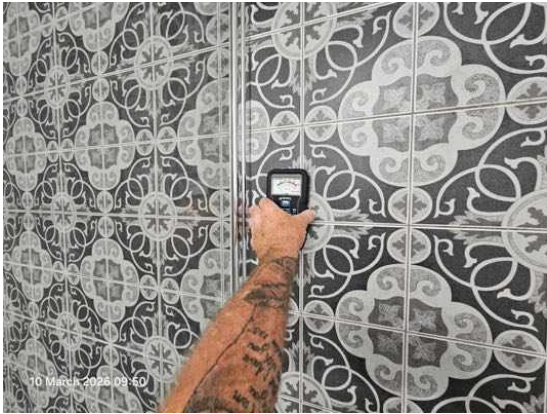
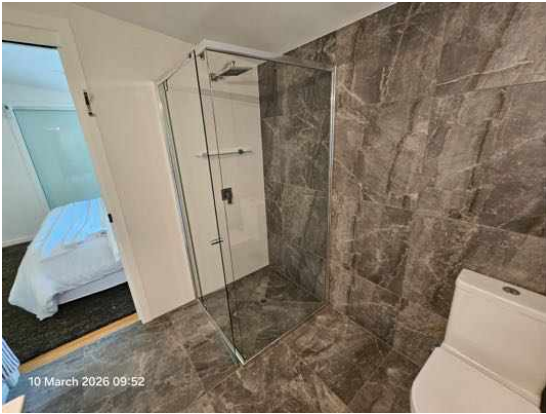
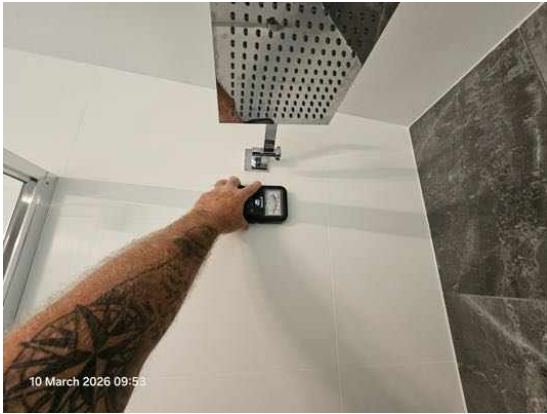
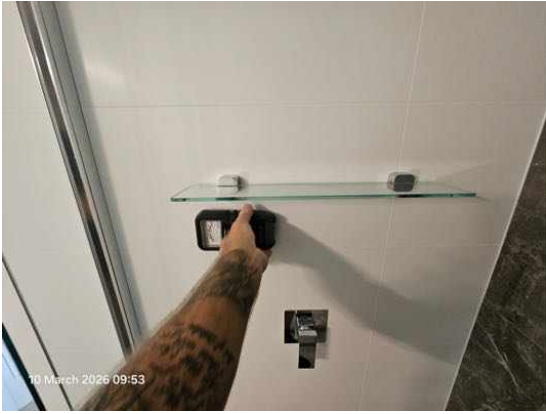
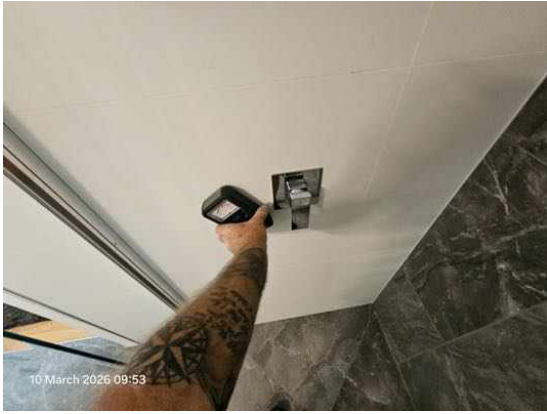
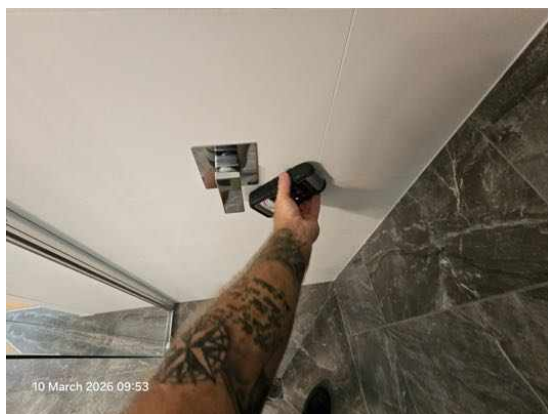
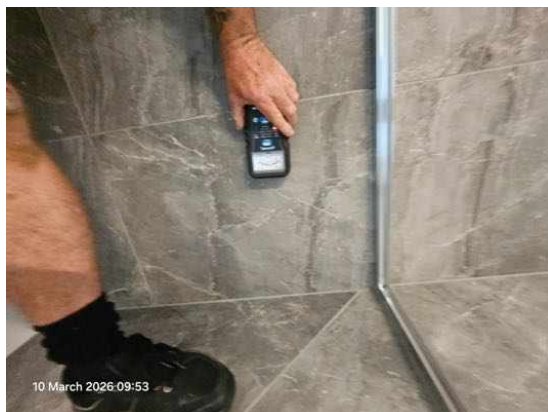
Building: Main Building
Location: Bathroom, ensuite
Finding: No moisture detected in bathroom / ensuite
Information: On the day of inspection the showers in the bathroom/s and ensuite are measure for moisture using a "Tramex" moisture meter. During this inspection no moisture was detected in these areas and the tiled / sheeted surfaces appear to be in good order.

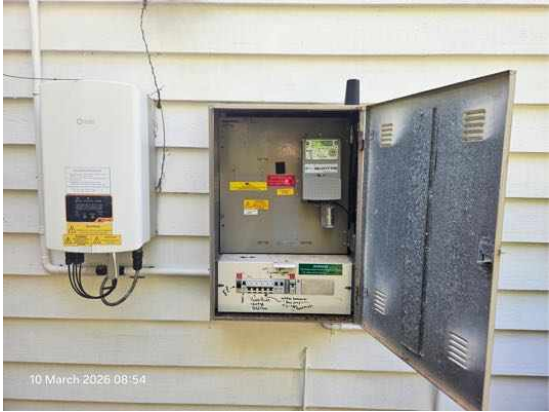
Building: Main Building
 Location: Meter box, kitchen cupboard
 Finding: Durable pest inspection notice - not assessable
 Information: On the day of inspection it was noted that the durable timber pest inspection / treatment notice was missing, not visible or out of date. These notices / stickers are to verify the timber pest inspection dates, the inspector, the currency and type of timber pest system / barrier in place or being used in and around the property.

It is recommend that a licensed timber pest controller be contacted to assess the properties needs and provide costings for an annual inspection programme.

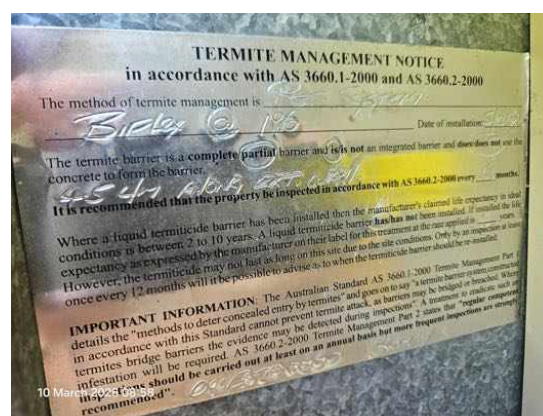
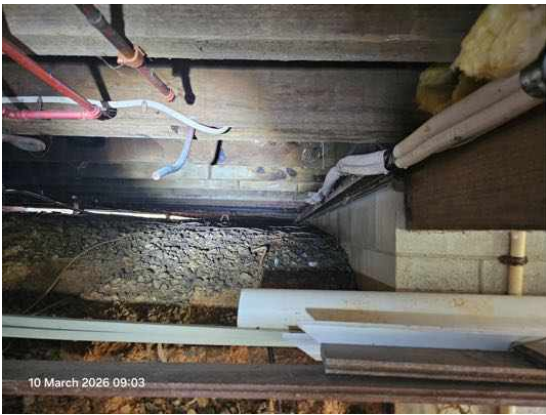
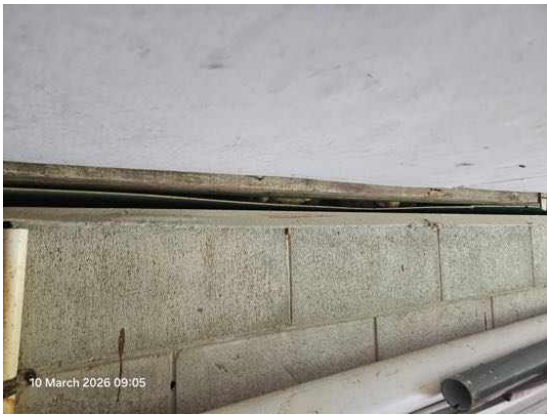
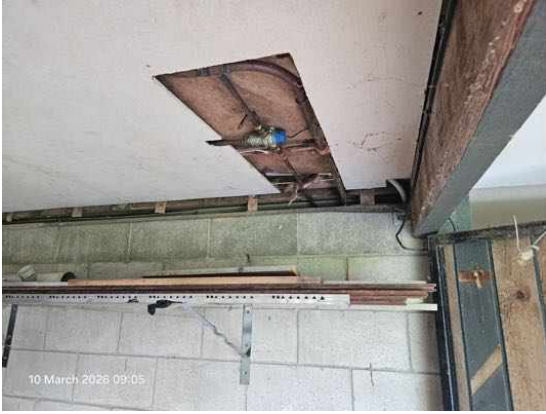
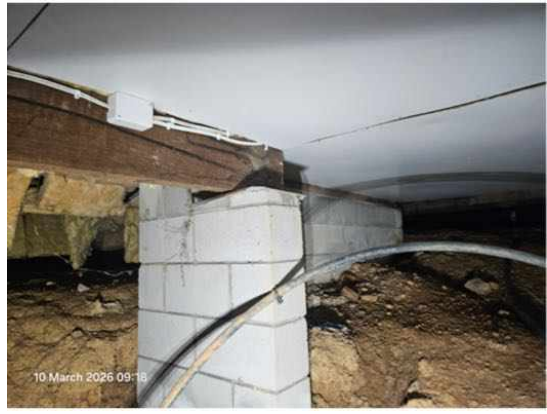
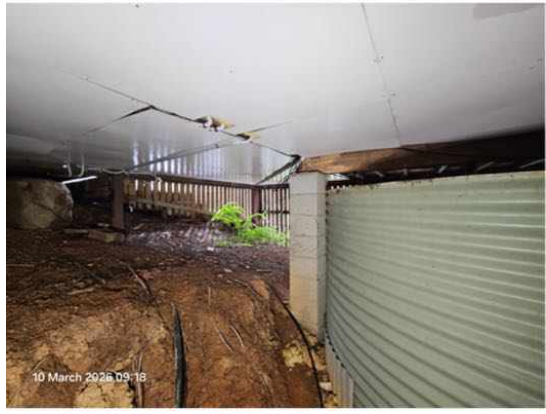
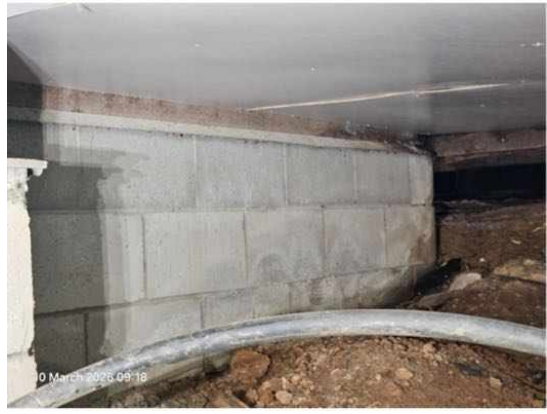
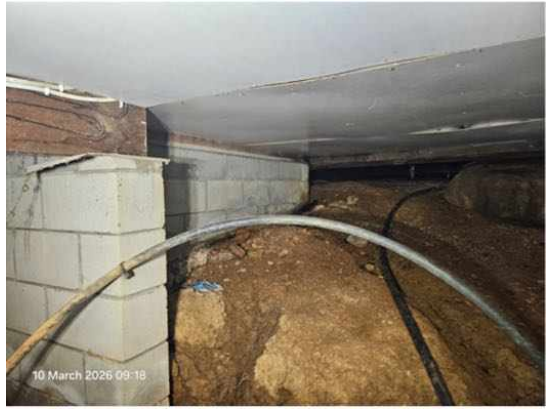
The building employs a physical barrier system to the subfloor in the form of ant-caps. In 2002 a partial chemical barrier was applied to a portion of the perimeter. Given the high risk nature of the property, it is strongly advised that a licensed timber pest controller be engaged to assess the properties needs.

In order for a barrier system to be effective, the property must have regular inspections at intervals of not greater than 12 months. Depending on the risk profile attributed to the property, these inspections may be recommended at lesser time periods.
