# Building and Timber Pest Inspection Report

Inspection Date: Fri, 20 Feb 2026

Property Address: 5/18a-22 Wyatt Avenue, Burwood NSW  
2134

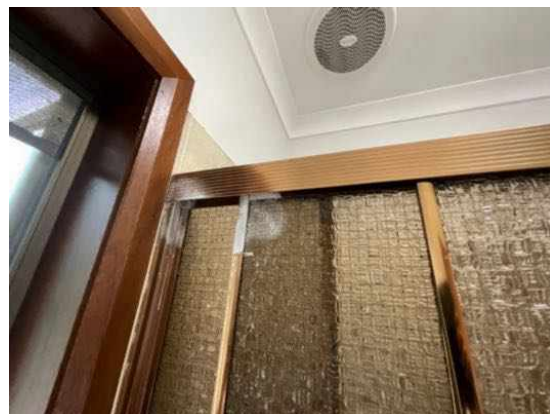
Information: The shower screen door was jamming and not closing smoothly at the time of inspection. This is likely due to worn or loose hinges, screws, or rollers causing the door to drop out of alignment.

Continued use may result in further misalignment or possible glass failure, presenting a safety risk. Prompt assessment and repair by a qualified glazier is recommended.

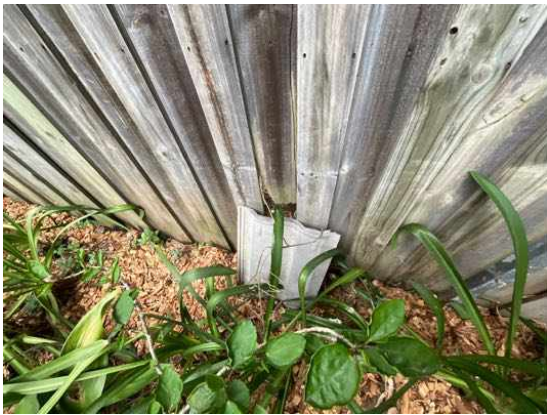
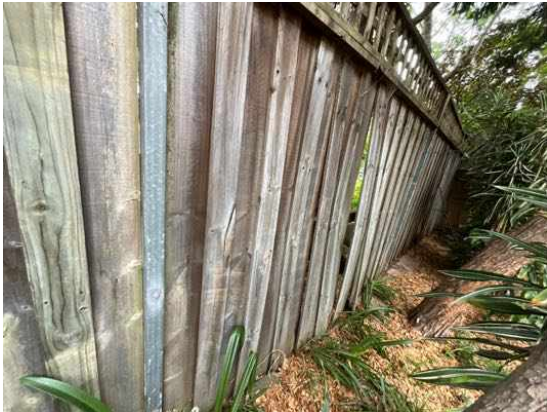
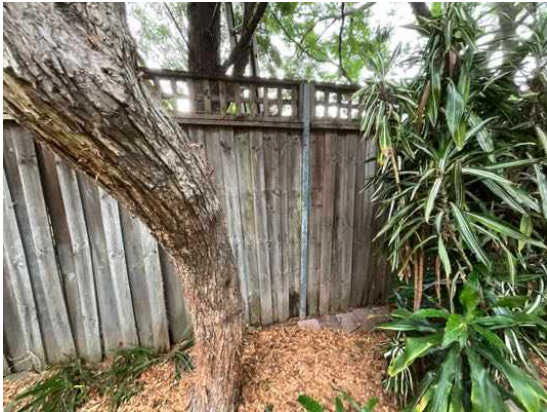
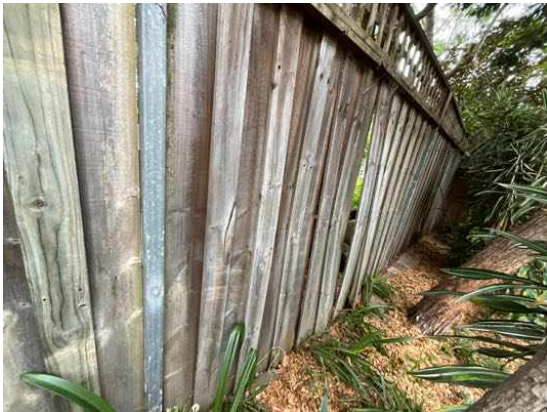
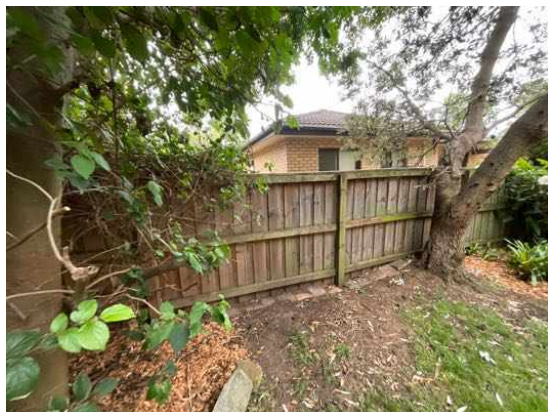
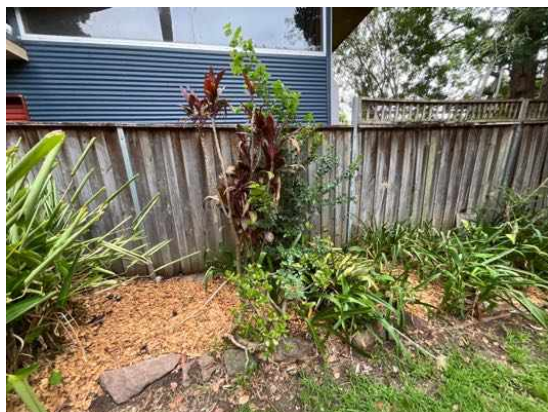
Building:	Main Building
Location:	All Areas
Finding:	Deteriorated fence
Information:	The fence along the property boundary has deteriorated significantly, showing signs of rot, rust, and structural weakness. Several sections are leaning or have become detached, compromising the integrity of the fence and its ability to perform its intended function.

The deteriorated fence poses multiple risks:

1. **Safety Hazard:** The unstable fence may collapse, posing a risk of injury to residents, visitors, and passersby.
2. **Security Concern:** The compromised fence may allow unauthorized access to the property, increasing the risk of theft, vandalism, or trespassing.
3. **Property Damage:** Falling sections of the fence could damage nearby structures, plants, or other property features.

- **Licensed Fencing Contractor:** A professional fencing contractor should be hired to assess the extent of the damage and either repair or replace the deteriorated sections.
- **Handyman Services:** For minor repairs, a qualified handyman could be engaged to reinforce or repair specific sections of the fence.
- **Landscaper (if the fence is part of a larger garden feature):** If the fence is integrated into the landscape design, a landscaper with experience in fencing could be involved in the repair or replacement process.

It's important to ensure that whoever is hired is experienced and qualified to ensure the fence is restored to a safe and functional condition, compliant with local regulations.

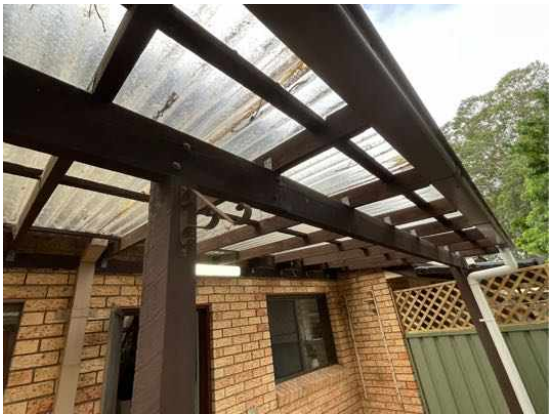
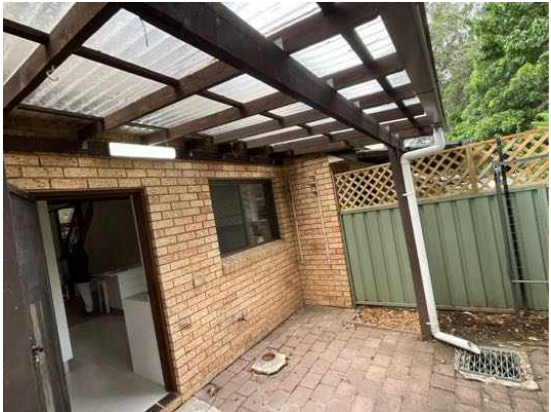
### Finding 3.02

Building:	Main Building
Location:	All Areas
Finding:	Timber - exposed to weather
Information:	External timbers that are frequently exposed to harsh weather conditions require adequate protection in order to maintain their condition. Where timbers have not been painted or treated adequately, general deterioration is likely to occur at an accelerated rate.

If left unattended, replacement of these timbers is likely to be necessary in the short-term future. Adequate treatment of these timbers is required as soon as possible by a painting contractor or general handyman.

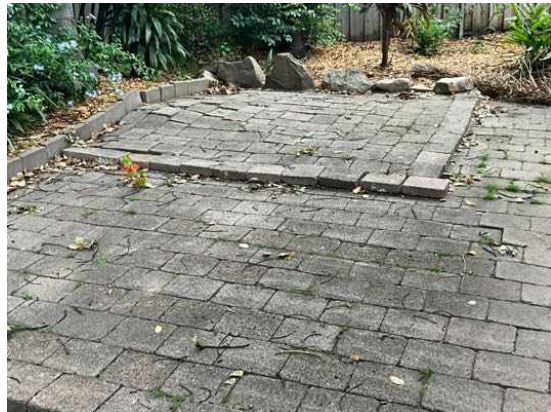
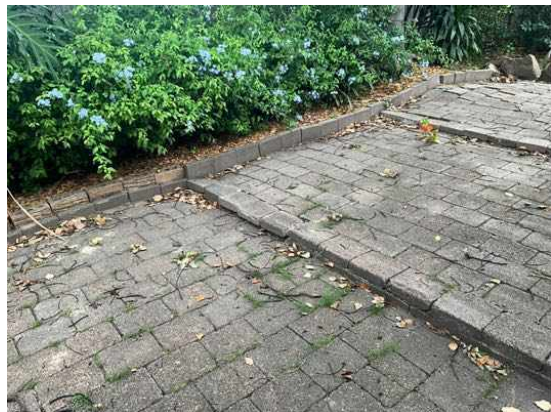
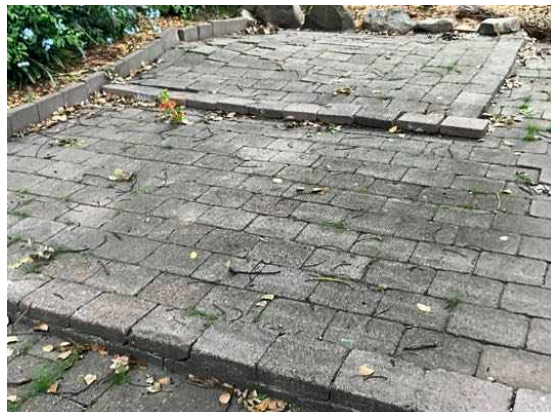
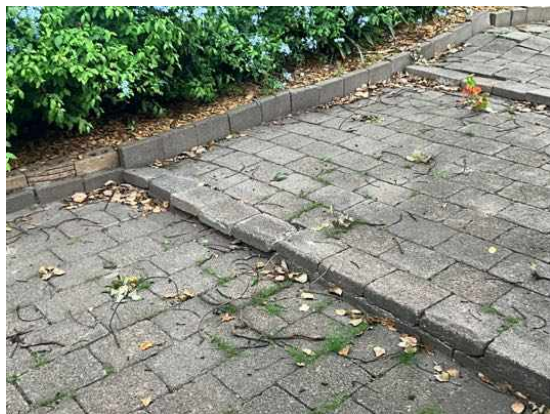
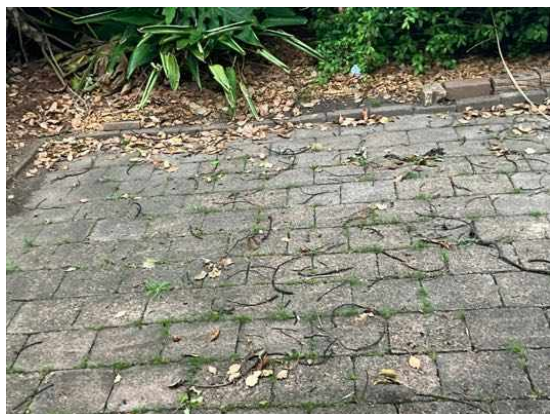
**Finding 3.03**

Building: Main Building  
Location: All Areas  
Finding: Bricks / Pavers uneven and displaced....  
Information: Cracked, uneven, and displaced pavers were observed. Several pavers appear loose, misaligned, or deteriorated.  
Risk:  
The uneven surface poses a significant trip hazard for pedestrians and may impact the usability of the driveway. Displacement and cracking can worsen over time due to vehicle traffic, poor subbase compaction, or water ingress. Wall cracking may lead to

moisture entry or structural wear if left untreated.

- A qualified paving contractor should be engaged to lift, relevel, and relay the affected pavers with proper bedding and compaction.
- A licensed builder or bricklayer should repair and seal the masonry wall crack around the pipe to prevent further water ingress and deterioration.
- Drainage should also be checked to ensure water is not contributing to the issue.

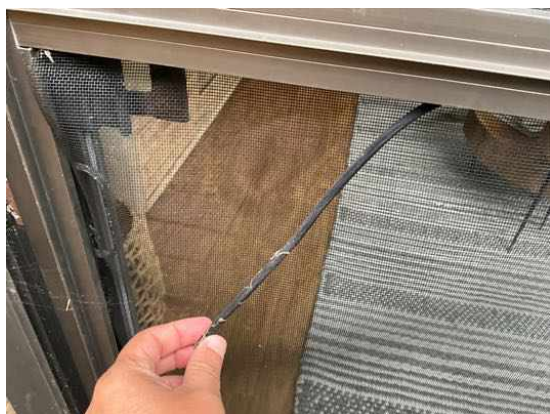
Building: Main Building  
Location: Front Elevation  
Finding: Beadings - damaged or deteriorated.  
Information: Damaged or deteriorated beadings pose several risks. They compromise the integrity , allowing drafts, moisture, and even pests to enter the building. This can lead to energy loss, water damage, and decreased indoor air quality.

A qualified repair technician should be contacted to assess and repair the damaged or deteriorated beadings. They can replace worn-out beadings, and ensure it is properly installed and function to maintain energy efficiency and structural integrity.

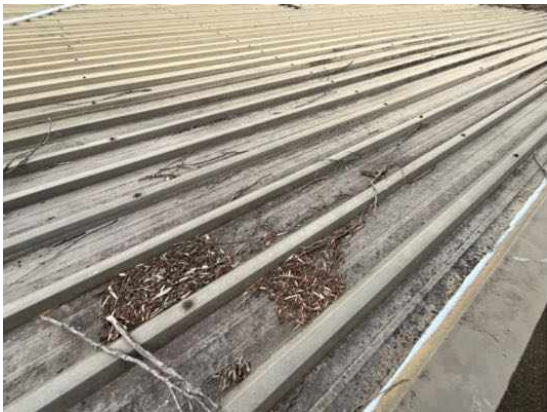
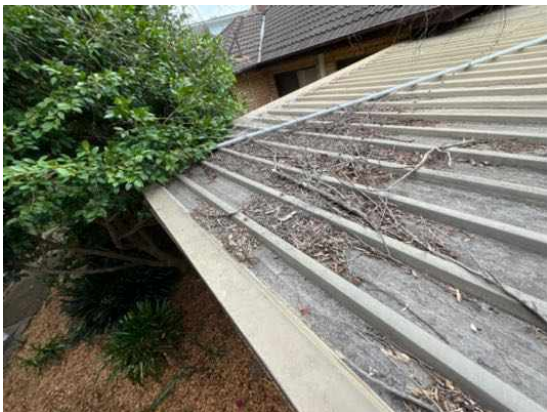
### Finding 3.06

Information: The roof sheeting shows visible weathering, surface oxidation, and deterioration of fastener washers. Some sheet overlaps appear uneven and may not provide adequate weatherproofing at joints near the dormer. The sealant and flashing junctions also show signs of age and deterioration.

Prolonged weather exposure and rusting can lead to corrosion, potential roof leaks, and reduced lifespan of the sheeting. Deteriorated fasteners may allow water ingress, particularly around joints and penetrations.

Engage a licensed roofing contractor to inspect and maintain the affected areas. Replace rusted screws and washers, resecure loose or uneven sheets, and apply protective roof coating or repainting as required. Check flashings and sealants to ensure watertightness.

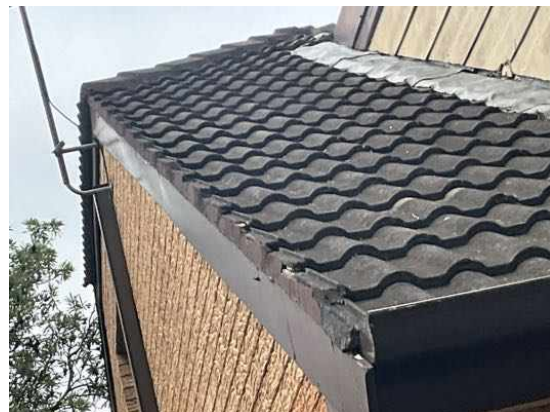
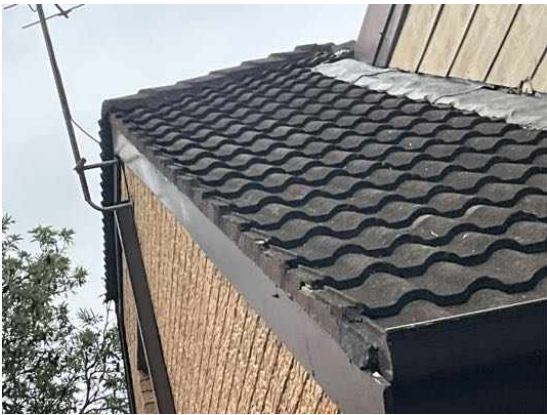
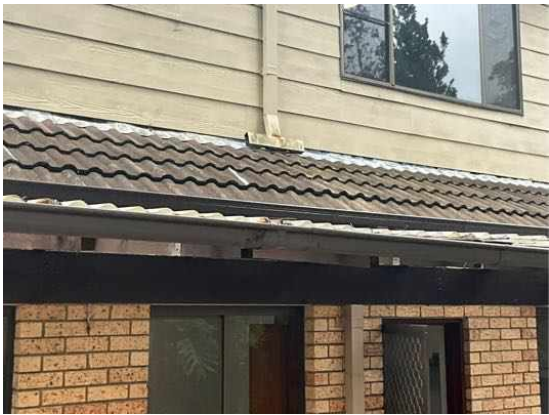
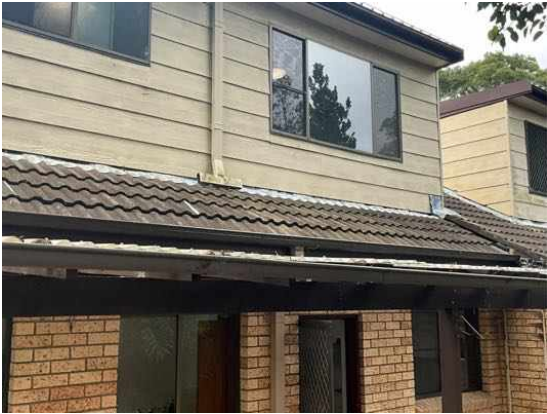
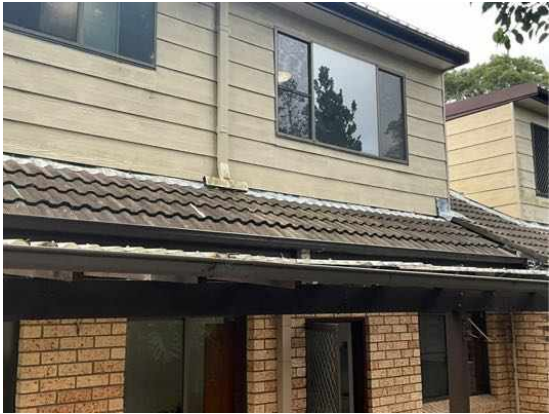
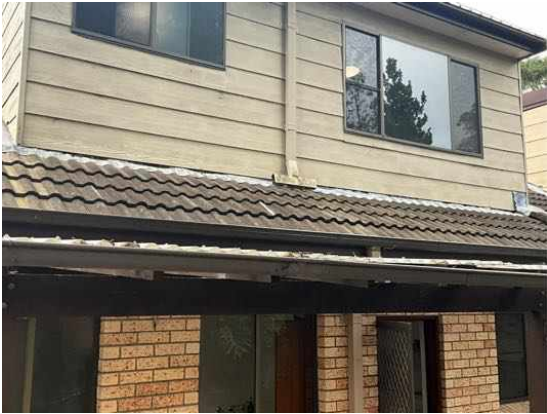
### Finding 3.07

Building:	Main Building
Location:	All Areas
Finding:	Roof Weathered
Information:	Upon inspection of the exterior roofing, the majority of roof was not in a fair condition. While weathering of the roof is consistent with the age of the property, maintenance works are required.

Isolated areas of mortar have come loose in the valleys and minor cracking is also present. Re-pointing and re-sealing the may be considered as an interim solution by the client to help preserve and extend the life span of the tiles.

Where left unmanaged, deteriorating roof are likely to lead to a number of secondary defects, including minor water leaks and weather exposure to internal roofing structures.

Consultation with a roofing contractor is highly advised to gain advice on cost of remedial works that may be required in the short to medium term. Remedial works are likely to increase the longevity of the exterior roofing structure.

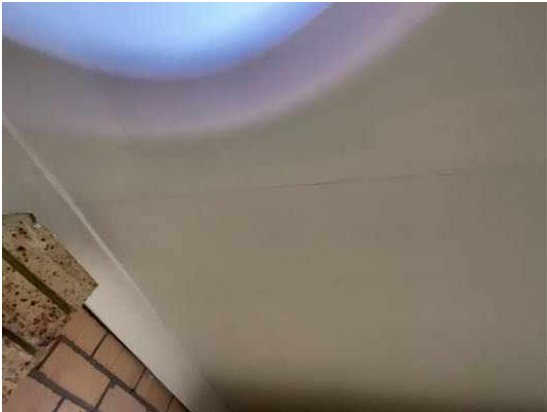
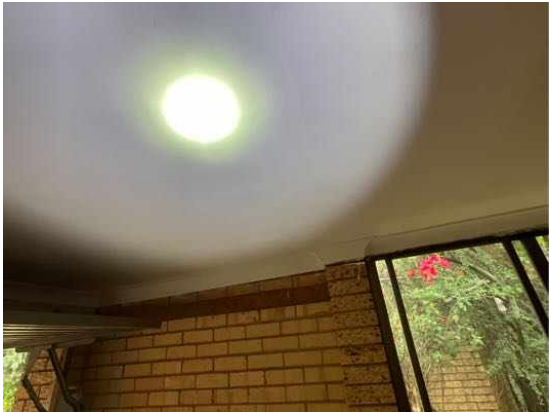
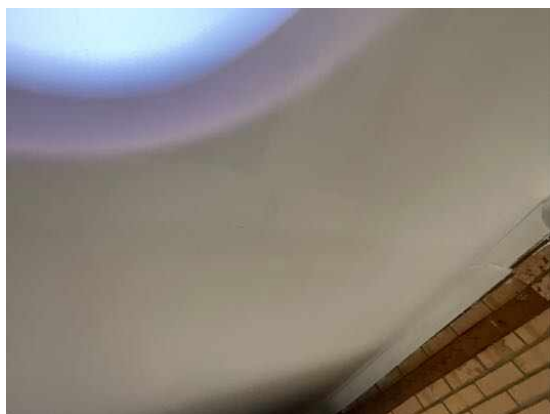
Finding 3.08

Building: Main Building  
Location: Garage  
Finding: Gyprock - Crack ( Fine )  
Information: Fine cracks have appeared in the gyprock of the ceiling, suggesting potential issues with settling or structural movement.

The fine cracks in the gyprock ceiling pose a risk of further widening, compromising the aesthetic appeal of the space, and potentially indicating underlying structural problems.

A skilled plasterer or a contractor specializing in drywall repairs should assess the extent of the cracks and address them promptly. Identifying and fixing the root cause of the issue, whether related to settling or structural concerns, is essential to prevent further damage and maintain the integrity of the ceiling.

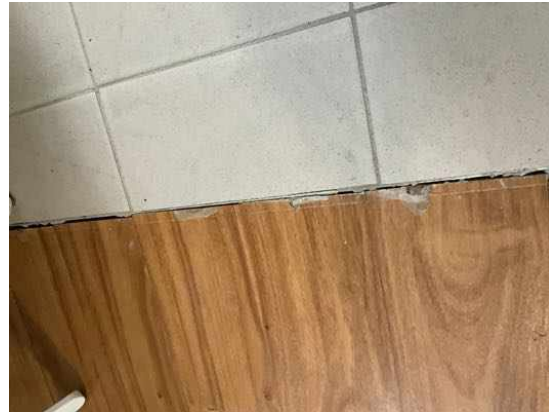
Finding: Water damage

Information: The area has sustained water damage resulting in potential structural issues. This damage compromises both the aesthetic and functional aspects.

1 **Plumber:** If the water damage is due to plumbing issues, a plumber can fix leaks and ensure there are no further water-related problems.

2 **General Contractor:** If the damage is extensive and affects the surrounding area, a general contractor can coordinate the repair work, including any related structural or cosmetic repairs.

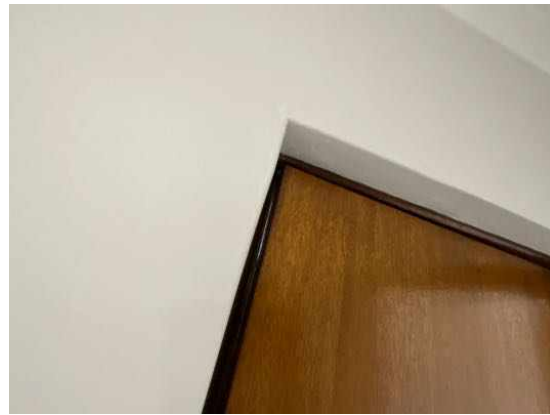
### Finding 3.13

Building:	Main Building
Location:	Kitchen
Finding:	Door - Binding/jamming
Information:	Binding and/or jamming of this door is evident during standard operation. This defect inhibits the functionality of the affected door as well as creating potential for secondary defects to associated building elements.

A door that binds to flooring or to the associated door frame may have several causes, ranging from minor defects, such as poor installation of the door or deteriorated hinges, through to major structural issues. For minor causes, a qualified carpenter or general handyperson should be appointed to perform minor rectification works at client discretion.

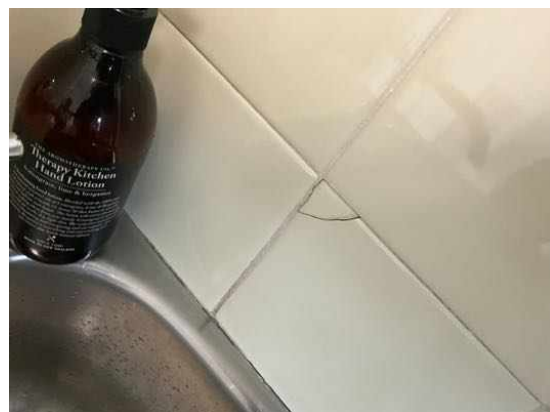
### Finding 3.14

Finding: Tiles - Cracked or damaged

Information: Cracking was evident to the tiling in this area at the time of inspection. While the cracking appears to be minor, this area is frequently exposed to water, allowing potential for water penetration into adjoining sections of walls or flooring.

If left unmanaged, water penetration to these areas may lead to subsequent water damage, which is likely necessitate repair work to affected building elements.

A tiling contractor should be appointed to ensure that no further water damage occurs. The re-application of silicone and grouting throughout remaining tile work is also advised, to further protect the area against water penetration.

Where water penetration has led to water damage, appointment of a relevant tradesperson may be required to repair damaged building elements.

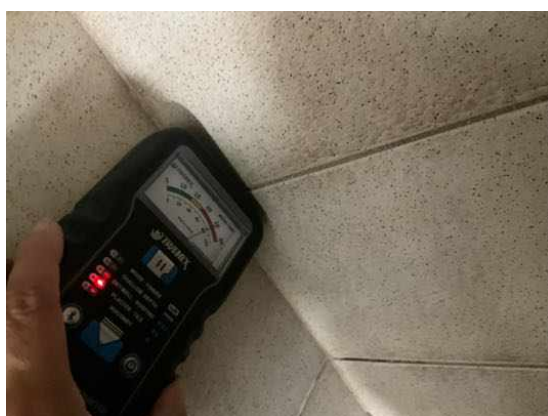
Information: Damp is evident to the lower 300mm of wall to the shower alcove. This defect is quite common, and is suspected to have been caused by moisture permeating through the grouting in this area, which shows evidence of deterioration. Leaking pipes within the adjoining wall is also a possible cause.

Damp (or structural damp) refers to the presence of unwanted moisture in the structure of a building, either as the result of intrusion from outside, or condensation from within the structure. In the shower area, internal water leaks or other sources of

excessive moisture are generally the cause of damp.

Unmanaged damp in the shower recess is likely to facilitate the formation and development of mould and fungi growth, decaying associated building materials and compromising their structural integrity. It is important to address damp conditions, as the World Health Organisation notes that excess moisture leads - on almost all indoor materials - to growth of microbes such as moulds, fungi and bacteria, which subsequently emit spores and other matter into the indoor air. Exposure to these contaminants is associated with a wide range of respiratory and other health-related problems.

Consultation with a qualified plumber or bathroom specialist is advised immediately to identify the cause of damp and to perform remedial works as required. Where excessive mould growth is present, further inspection by a specialist environmental health inspector should also be considered.

Always ensure that sealant and grout is in good condition to prevent any moisture issues occurring in the future.

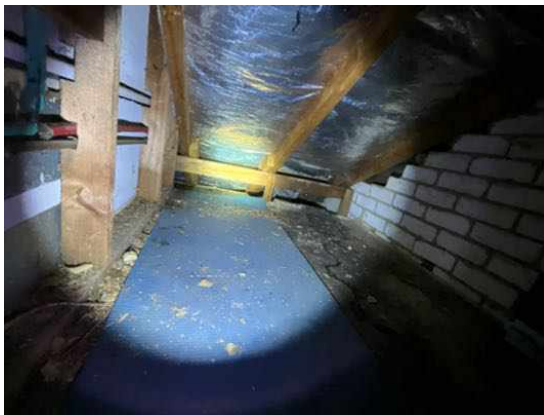
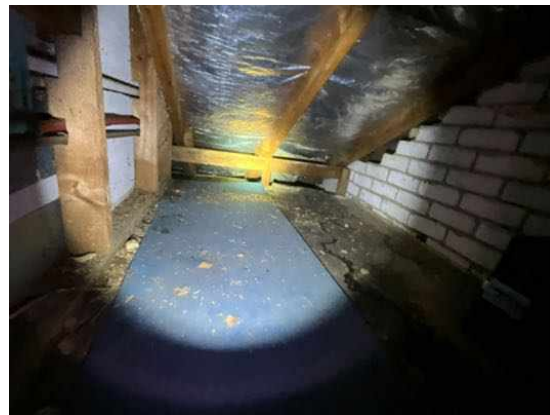
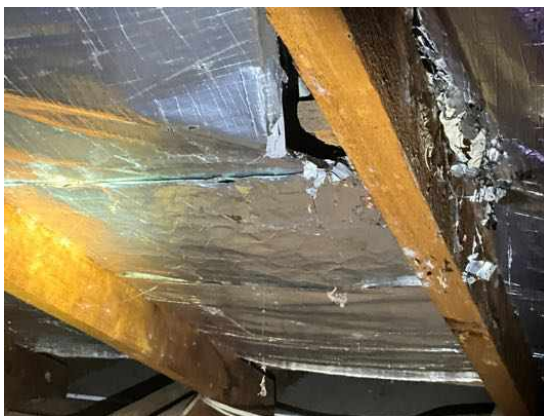
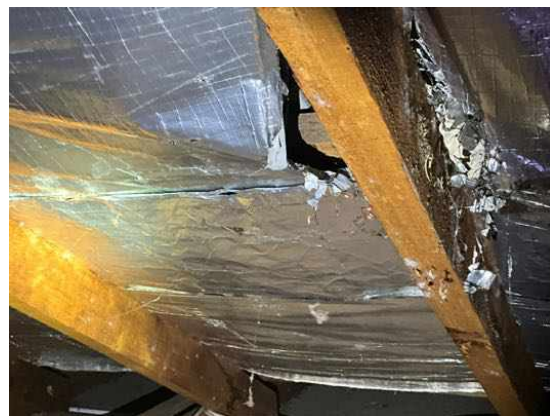
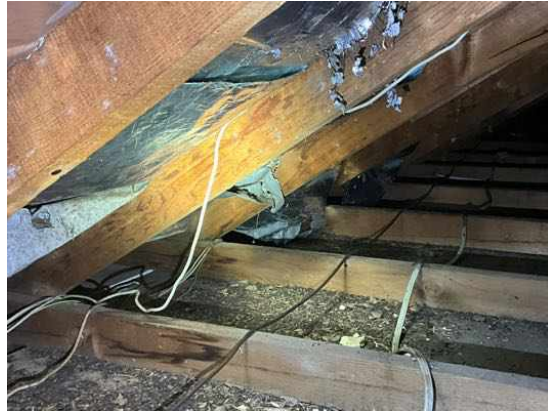
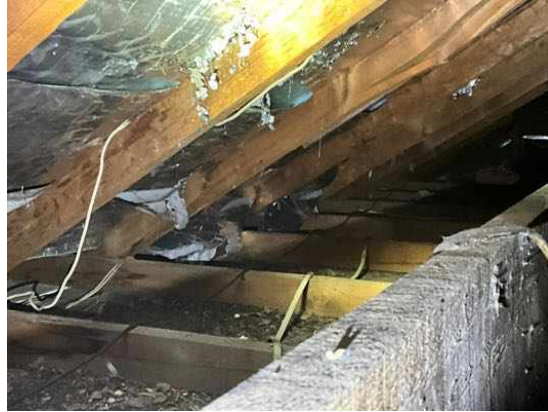
Finding: Sarking - Damaged

Where sarking is damaged, both insulation and moisture protection of the property are inhibited. This creates a loss of energy and thus negatively impacts the energy efficiency of the property, allowing potential for moisture ingress from condensation or leaking roof tiles.

It is important to repair any holes or damaged sections of sarking to ensure that the building material is fully functional. A registered builder or qualified carpenter should be consulted to provide further advice on this defect and to perform rectification works at client discretion.

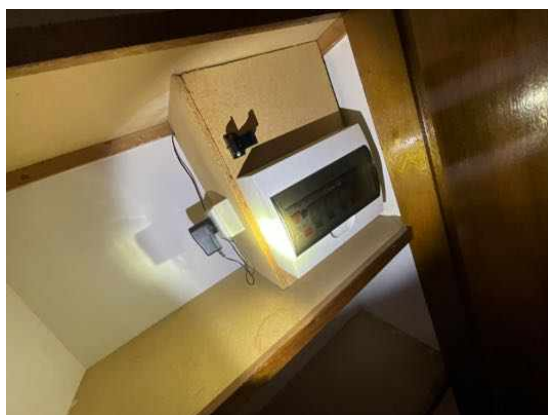
Building:	Main Building
Location:	Cabinetry upstairs
Finding:	No Evidence of Termite Management System - Durable notice / Legible Sticker
Information:	The application of a pre & post-construction chemical termite barrier is highly recommended for all properties. Such barriers are highly effective in preventing termite attack on any timber building elements throughout the property.

A durable notice was not placed in the switchboard unit to indicate current termite barriers is legible at the time of inspection.

Client must seek further information from the vendor or real estate agent if the conditions of termite management systems were maintained.

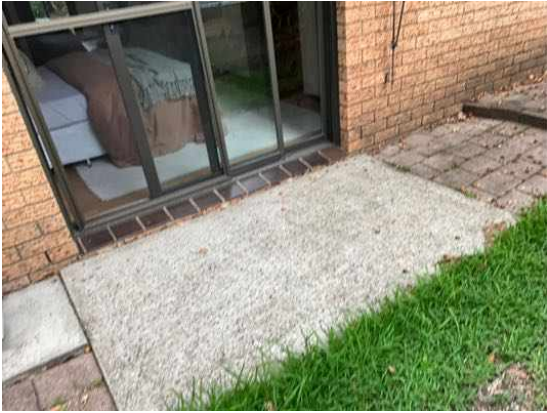
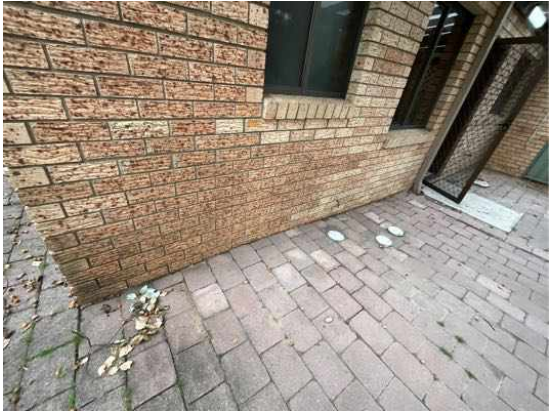
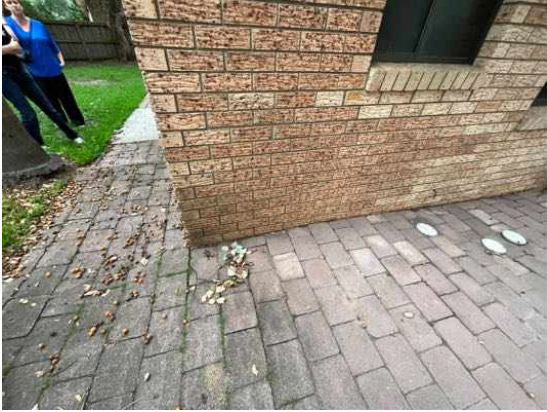
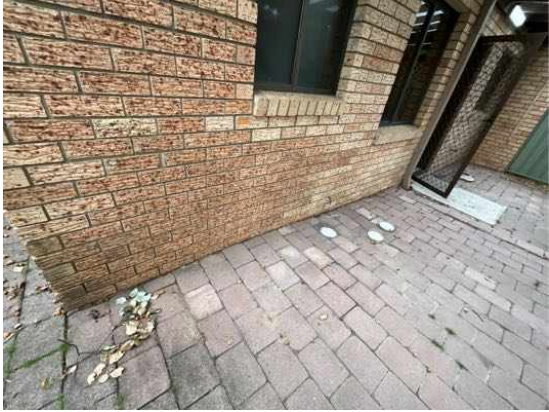
### Finding 6.02

Building:	Main Building
Location:	All Areas
Finding:	Slab Edge - Exposure
Information:	An inspection zone of at least 75mm in relation to the exposed slab edge, between the bottom brick and the perimeter pavement, is required. This inspection zone should be maintained in order to force termites into the open where they can be detected more readily during regular inspections. The slab edge should not be concealed by anything that may prevent inspection of the area, including render, landscaping, soil, turf, paving, concrete cladding or other structures.

Where the slab edge cannot be properly inspected, it is highly recommended that

termite or timber pest inspections be carried out every 6-12 months to aid protection of the property against infestation.

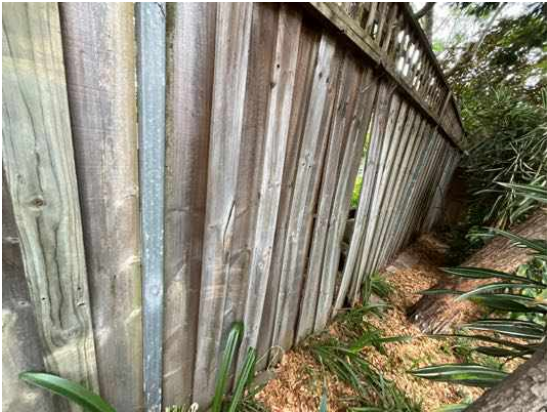
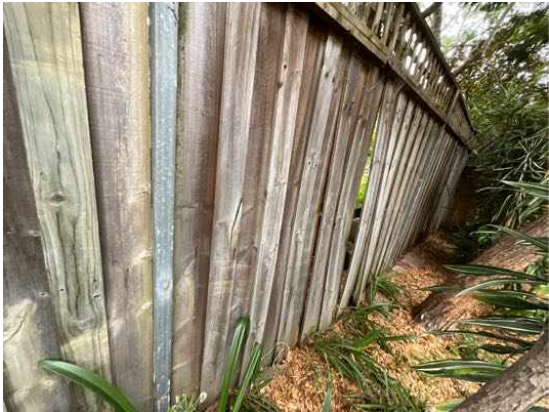
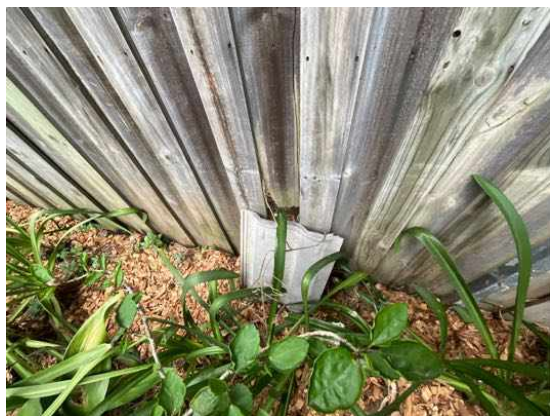
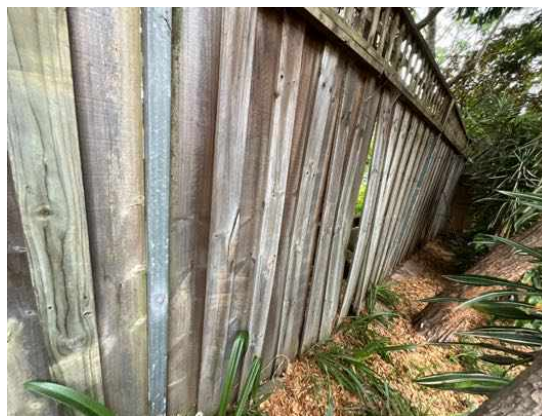
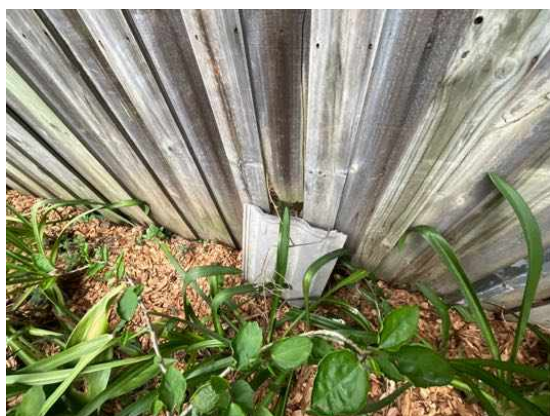
**Finding 6.04**

Building: Main Building  
 Location: All Areas  
 Finding: Timber on ground / conducive conditions to termite damage  
 Information: Timber on the ground is indeed conducive to termite damage. Termites are known to thrive in moist environments, and wood in contact with soil or moisture is more susceptible to infestation.

To prevent this, it's important to keep timber elevated and away from direct ground contact. Regular inspections and proper termite control measures are also essential to protect your wooden structures from termite damage.

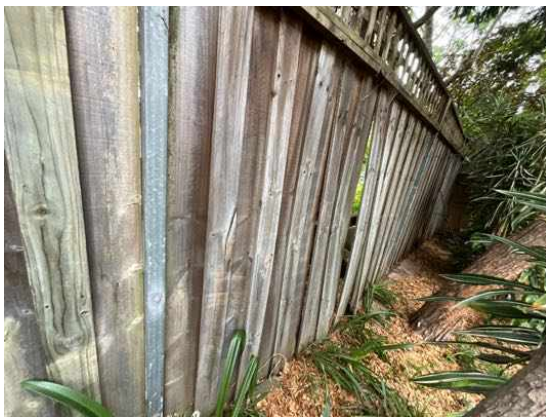
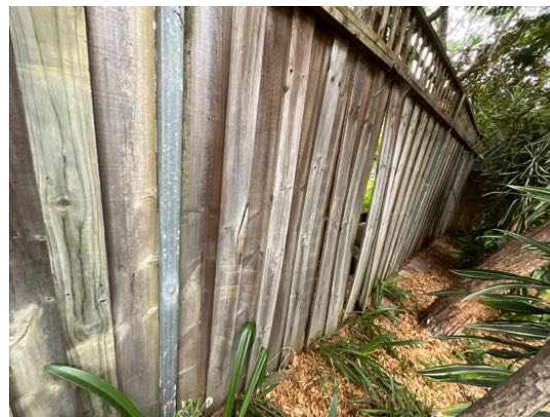
cause of the moisture that has created the visible wood rot should be identified and addressed in a suitable manner. Replacement of affected timbers may then be a necessary step in protecting surrounding building elements from such deterioration.

A qualified plumber may be appointed to assess the cause of excessive moisture and to provide advice on any remedial works as required. A qualified carpenter or registered builder may also be required to replace affected building materials.

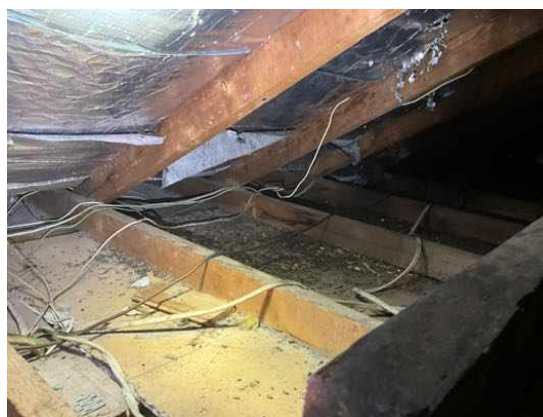
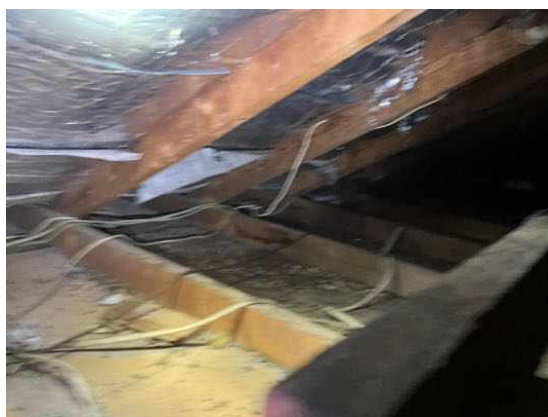
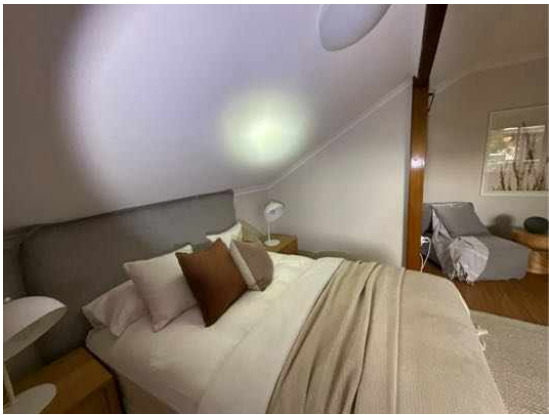
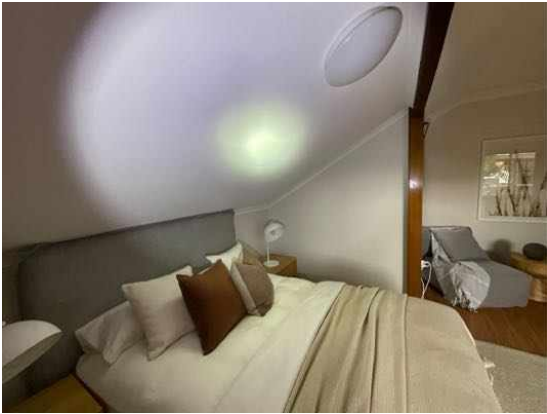
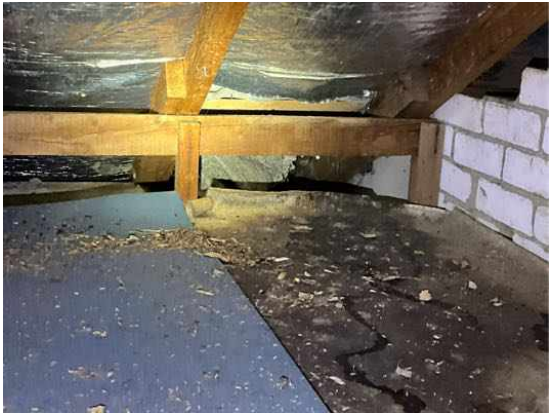
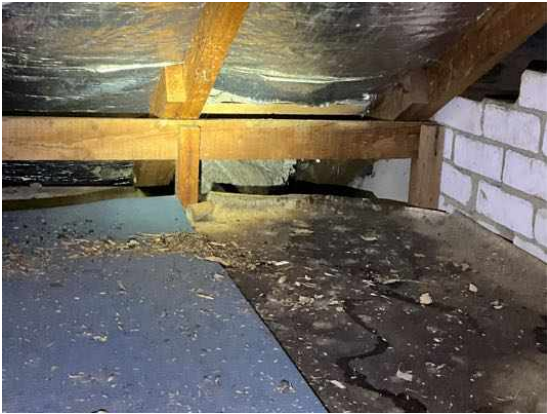
Building: Main Building  
Location: All Areas  
Finding: Additional Photos - Obstructions and Limitations  
Information: These photographs are an indication of the obstructions and limitations which impeded full inspection of the property at the time of inspection. These obstructions can hide an array of defects and should be removed to allow full inspection to be carried out. A re-inspection is recommended once the areas are made accessible.
