Building and Timber Pest Inspection Report

Inspection Date: Fri, 16 Jan 2026

Property Address: 2/105 Lowanna Dr, Buddina QLD 4575,
Australia

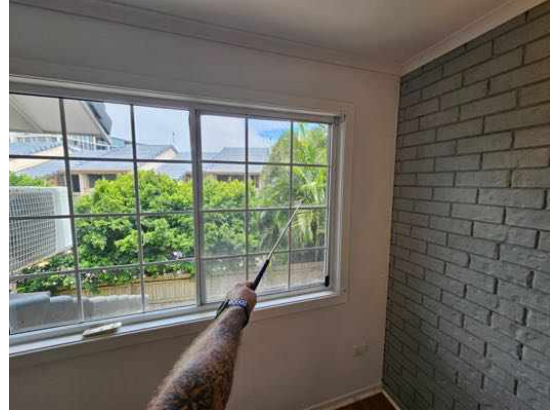
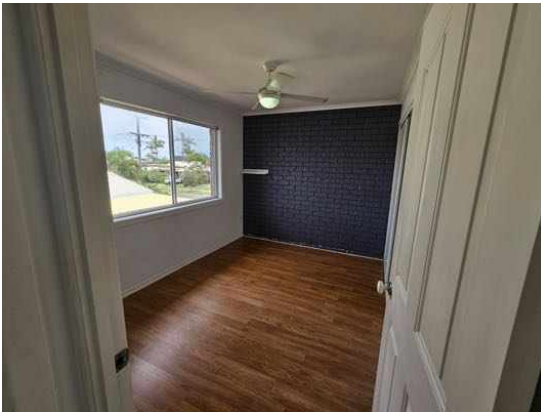
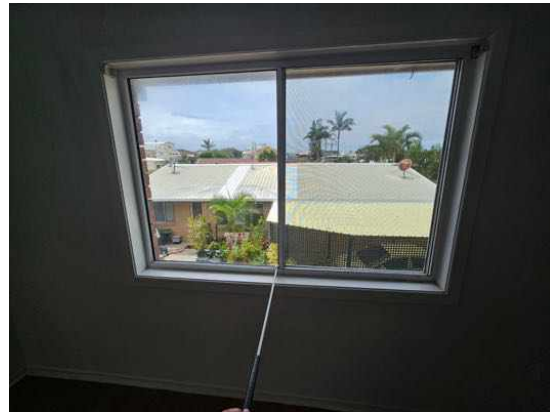
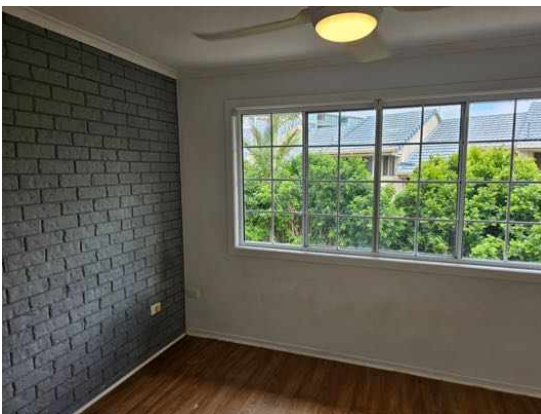
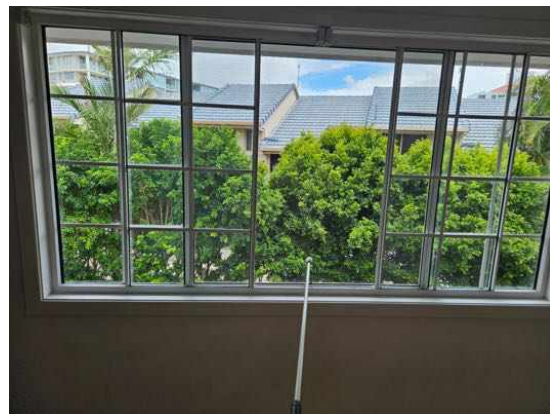
Windows to be protected Windows are defective if they do not comply with provision 3.9.2.6 of Volume 2 of the BCA that requires that a window opening must have protection if the floor below the window in a bedroom is 2m or more above the ground surface beneath.

Type of protection Windows requiring protection are defective if they are not fitted with a device to restrict the window opening or a screen, with secure fittings. The device or screen, where required, is defective if it permits a 125mm sphere to pass through the window or screen or is unable to resist an outward horizontal action of 250 N.

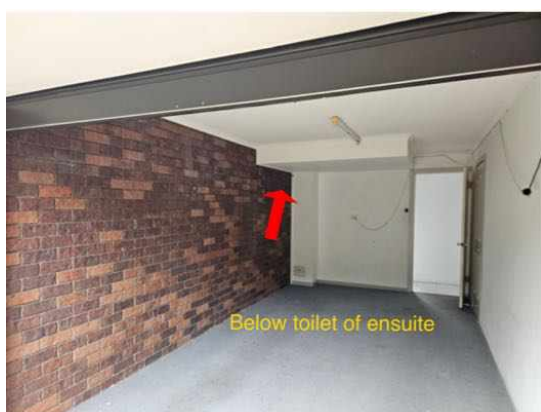
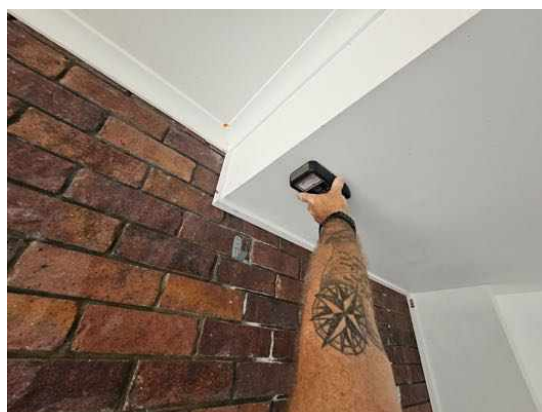
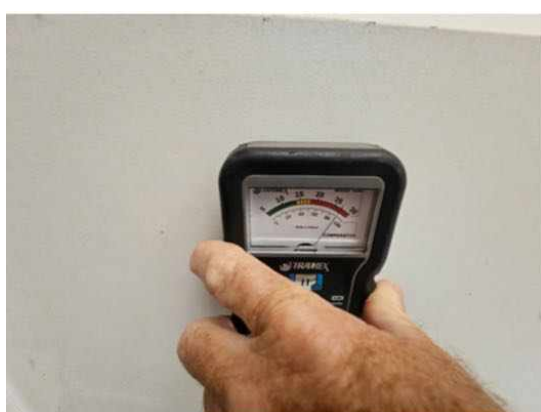
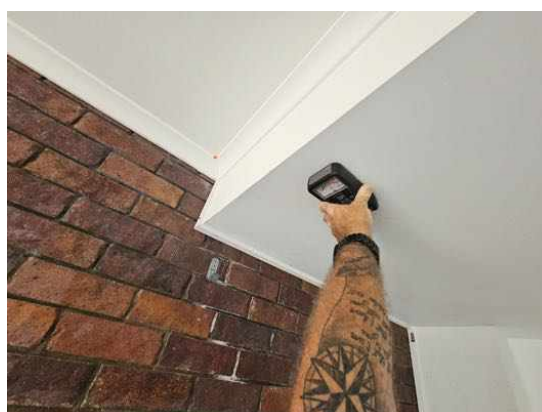
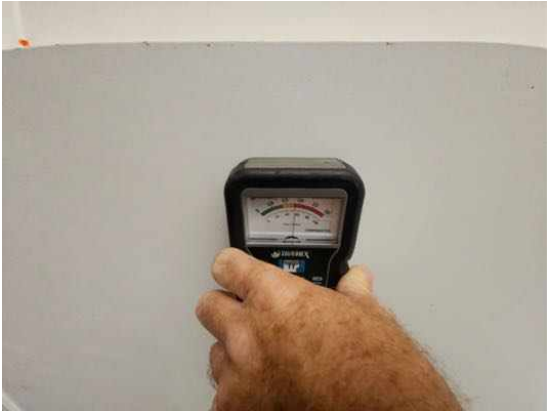
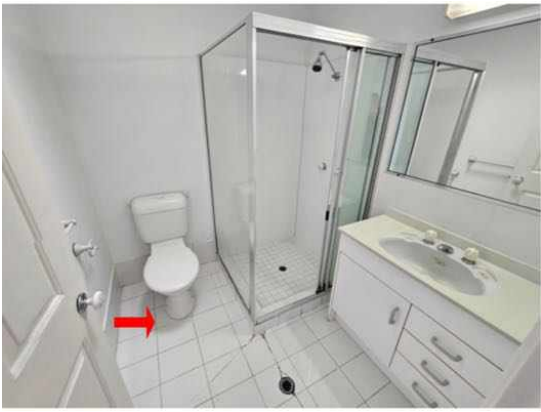
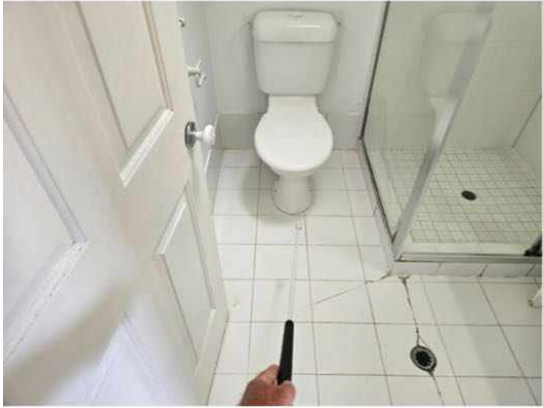
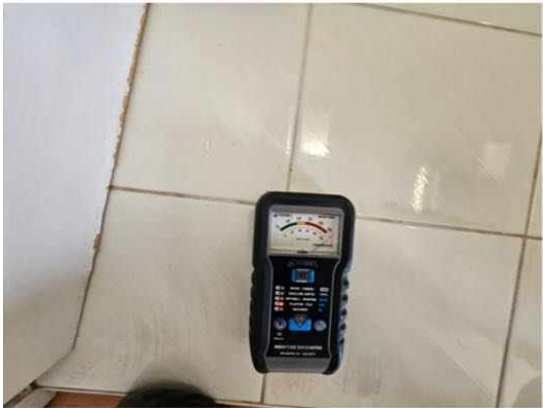
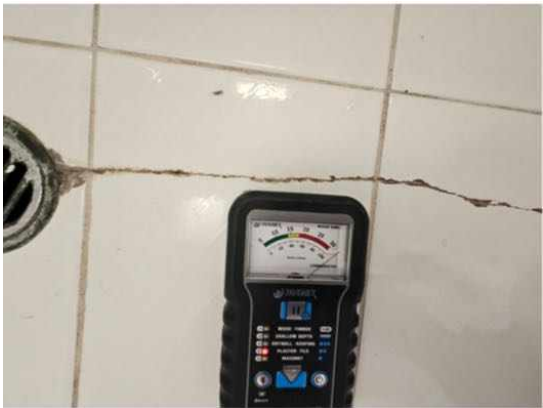
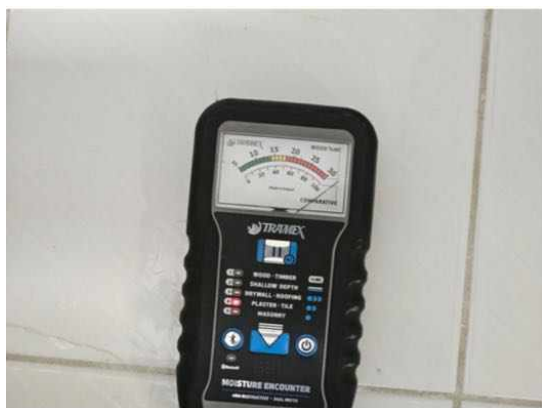
Finding 2.01

Finding: Elevated moisture in ensuite - floor

Information: Elevated moisture was noted in the tiled floor of the ensuite and is reflected in the ceiling of the garage directly below the toilet. The moisture levels were elevated throughout the floor. This could possibly be due to excess water from showering and regular bathing activities within the room entering via the large cracking in the floor.

The moisture reflected below may be entering via the plumbing services penetrating the floor, or through a failure in the floor / shower membrane, or from the plumbing service housed in the floor cavity. A definitive cause will most probably only be found through testing of the plumbing service and / or by conducting an invasive inspection of the floor cavity from the garage ceiling below.

Elevated moisture can attract timber pests and vermin, and produce conditions that promote timber pest attack, fungal growth and wood decay.

It is recommended that this be investigated further. Flood testing the shower may provide more insight; however, invasive inspections may be required via the ground floor ceiling. Engaging a leak testing specialist may also be prudent.

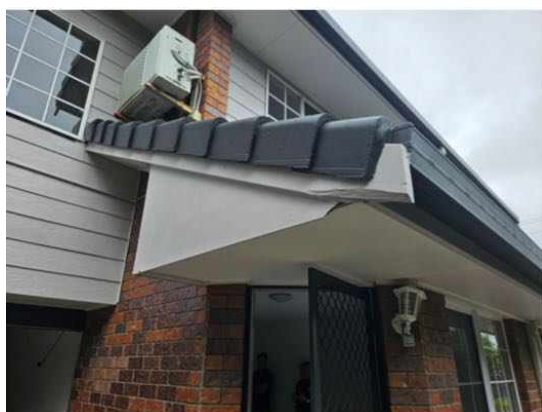
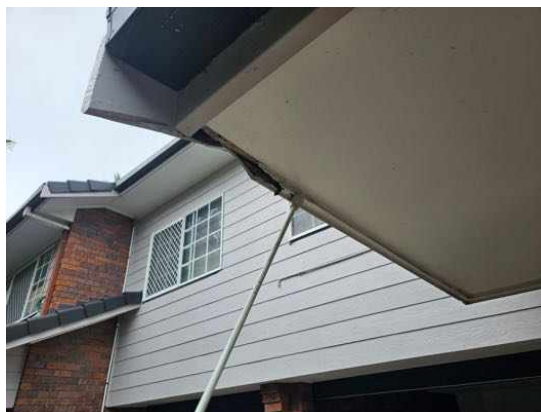
Finding 3.01

Building:	Main Building
Location:	As shown
Finding:	Wood rot / fungal decay
Information:	The timber beading shows evidence of wood rot in sections of the timber.

Wood rot, also known as Fungal Decay, occurs when timbers and other cellulose building materials are exposed to damp conditions on an ongoing basis. This could be the result of exposure to weathering over a prolonged period of time, or the attraction of excessive moisture from other abutting building materials.

A licensed carpenter or licensed builder should be consulted to advise on a solution for the affected building materials.

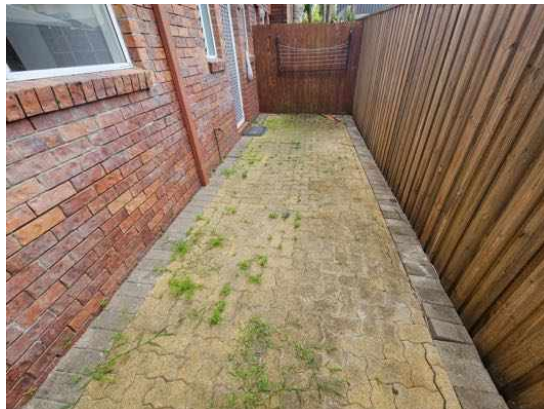
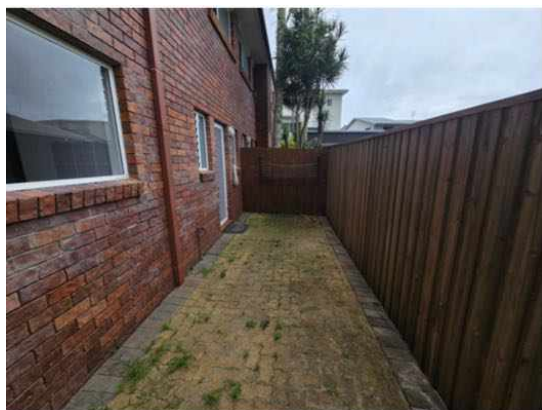
Building:	Yard
Location:	Rear
Finding:	Paving - Uneven
Information:	The external paved area is uneven, creating a potential trip hazard. It appears as though the area has been subject to poor installation, or that paving sections have lifted due to movements in the foundation of the property.

Where paving creates a trip hazard, personal injury may ensue if due caution is not taken by all persons within this area. Further consultation with a paving contractor or concreter is advised.

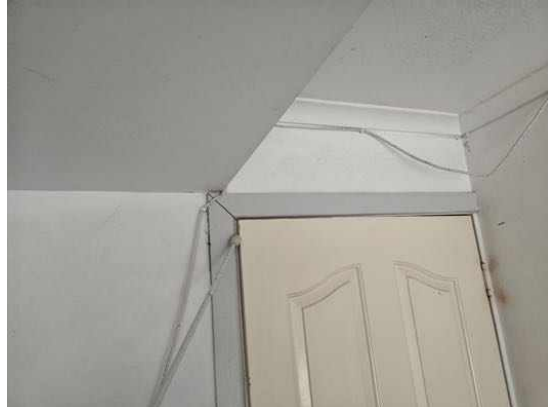
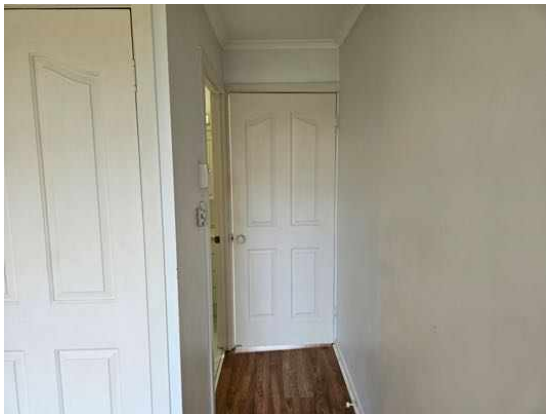
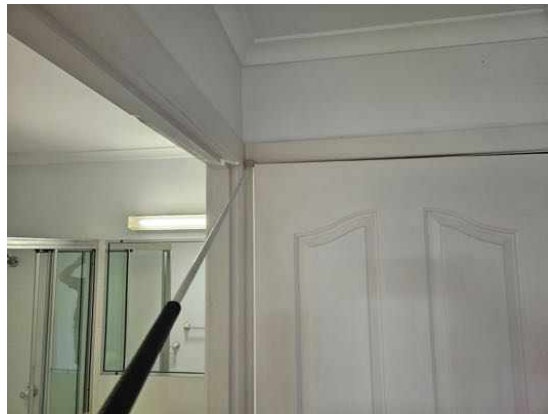
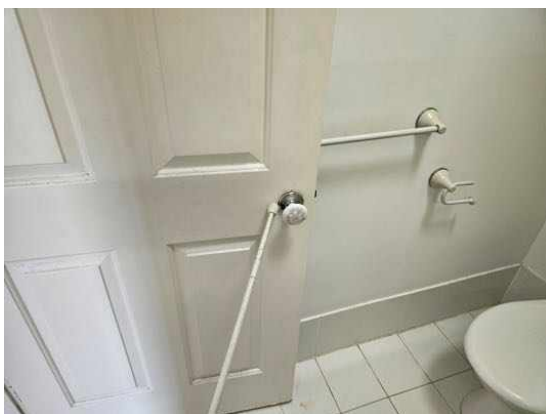
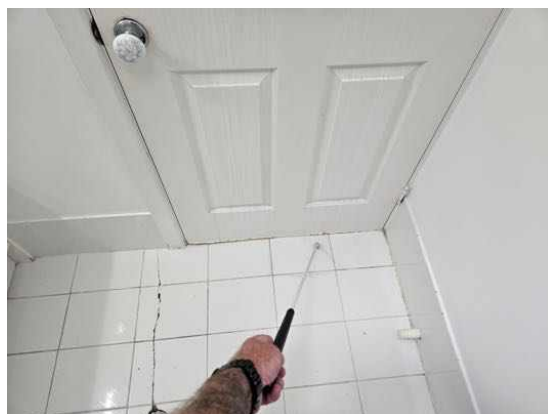
Finding 3.05

Building: Main Building
 Location: As shown
 Finding: Doors - Binding/Jamming
 Information: The doors to the rooms shown are binding / jamming in the openings.

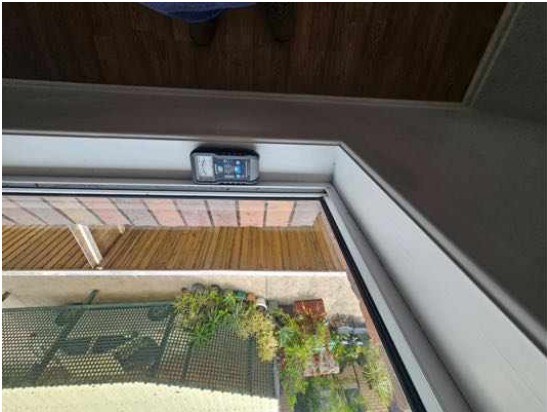
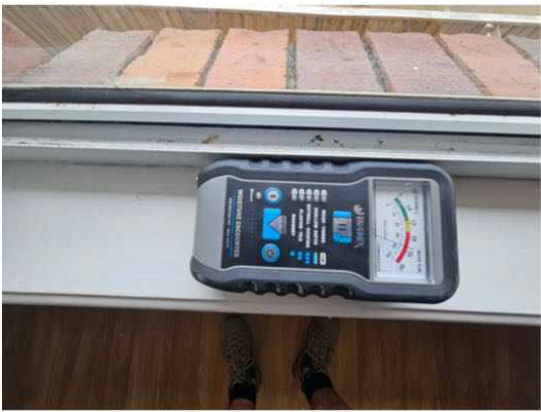
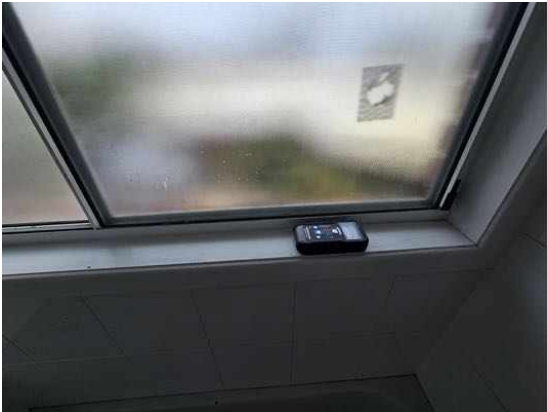
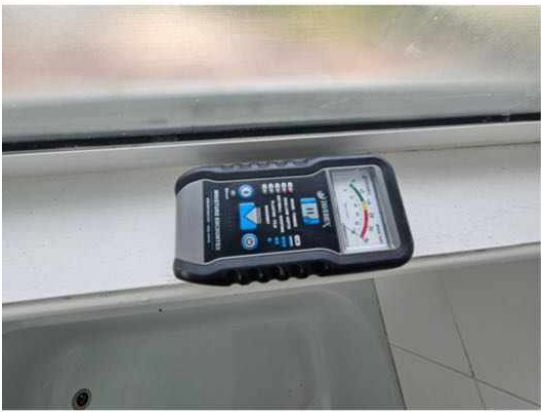
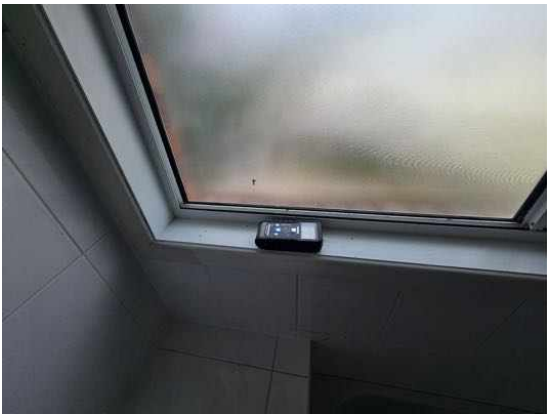
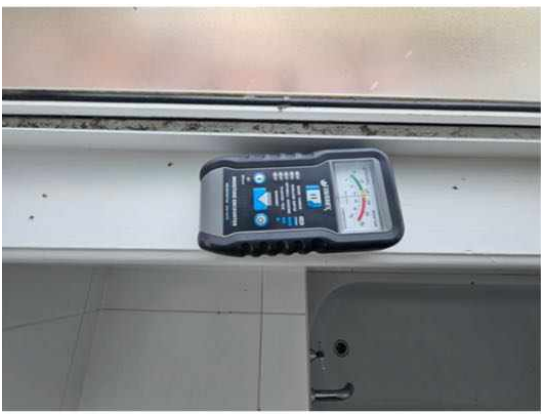
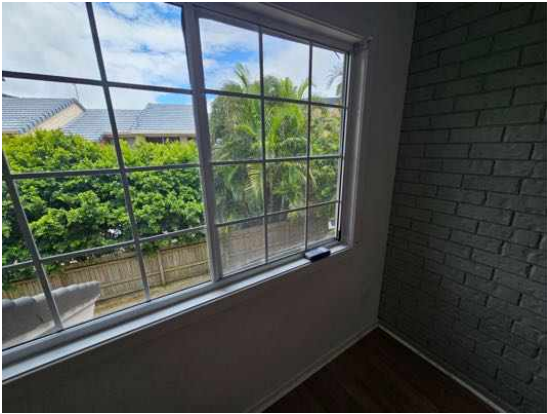
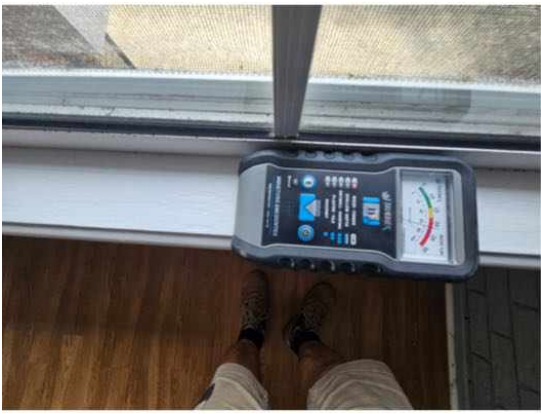
Finding 3.06

Building: Main Building
 Location: As shown
 Finding: Timber window sill / reveal moisture
 Information: During the inspection elevated moisture readings were noted in the timber reveals of the windows shown. This may indicate that minor moisture may be entering through

the joint between the bottom aluminium profile and the brick sill or the lower side of the window opening. There does not appear to be any damage or physical moisture effects present.

This should be monitored and if there is a change in the reveal appearance, a licensed painter should be engaged to carry out the necessary repairs.

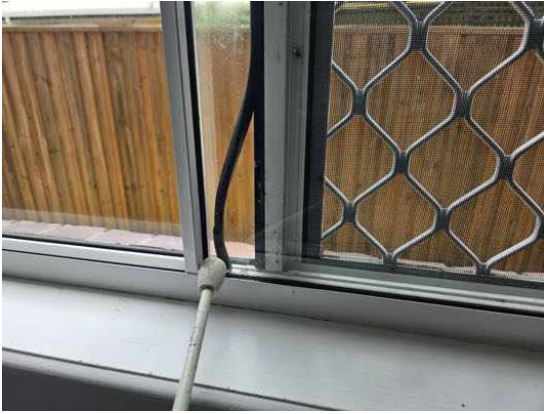
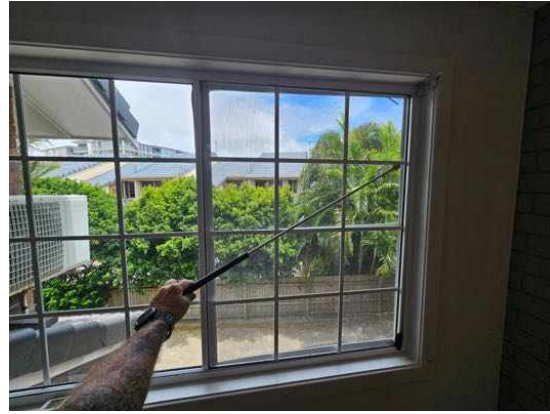
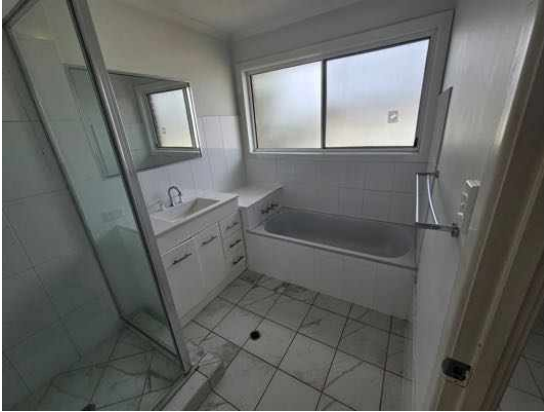
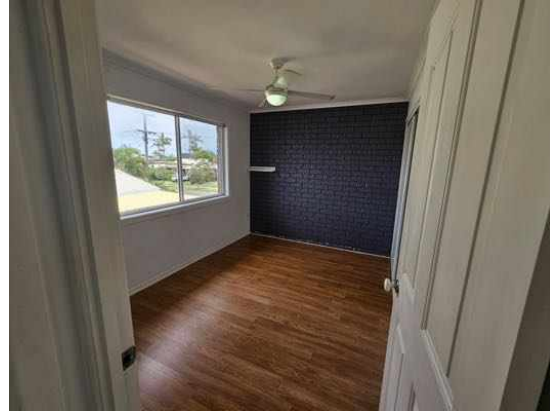
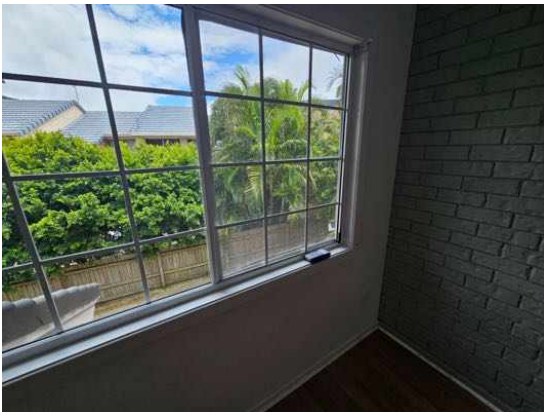
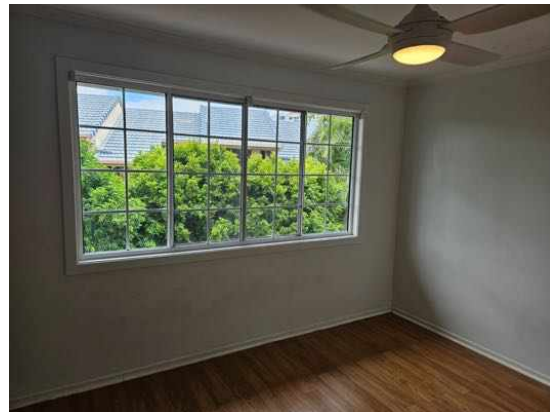
Finding 3.07

Building: Main Building
Location: All Internal Areas
Finding: Windows - operation
Information: During the inspection the windows are checked for functionality. Most of the aluminium windows are either stiff to slide, unable to be opened easily or jammed shut. Most do not have functioning latches.

A suitably qualified trade person should be engaged to service the windows.

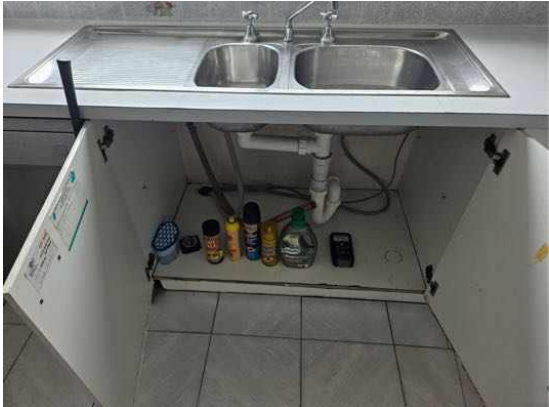
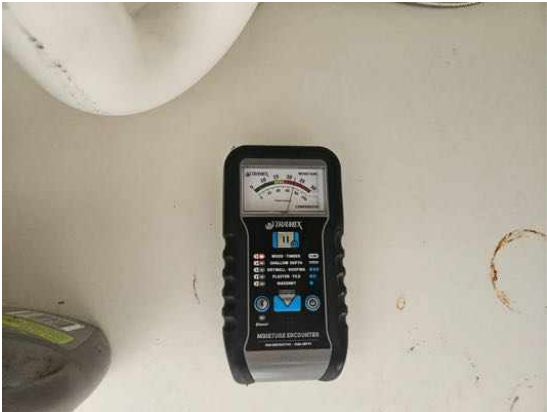
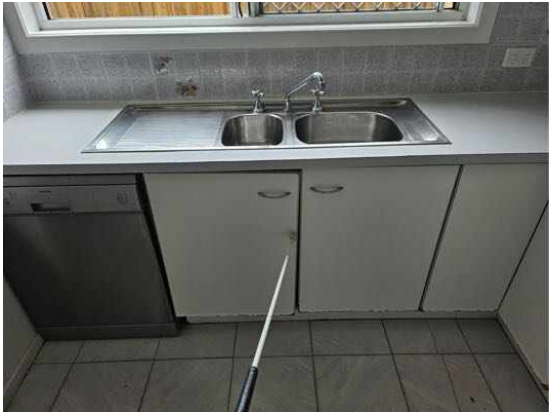
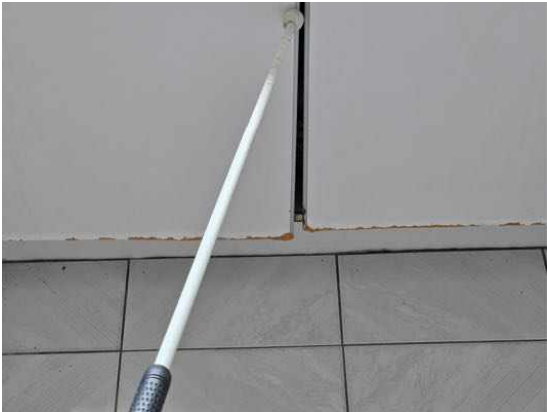
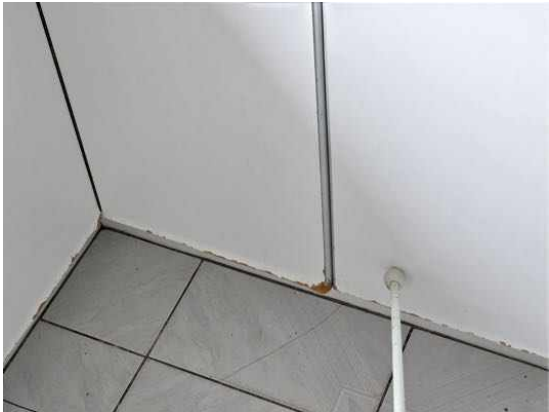
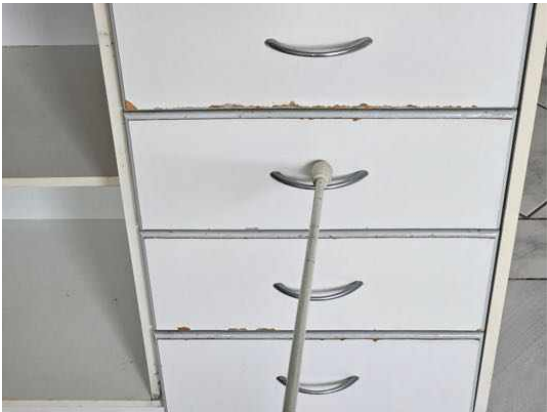
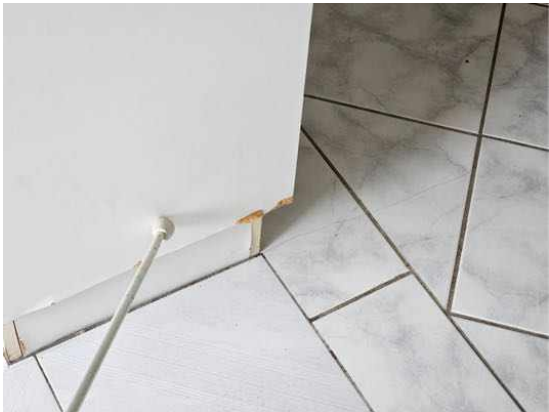
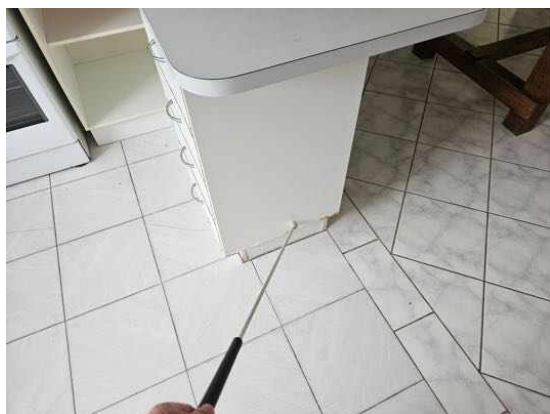
Finding 3.08

Building:	Main Building
Location:	Kitchen
Finding:	Moisture damage to cabinets - kitchen
Information:	During the inspection moisture damage was observed in the cabinet floor and cabinet surface edges in the kitchen. It is a consistent defect that is possible due to water spilling over the edge of benches and can also be an effect of poor materials used in construction and high humidity.

It would be of advantage to have the cabinetry assessed by a licensed cabinet maker.

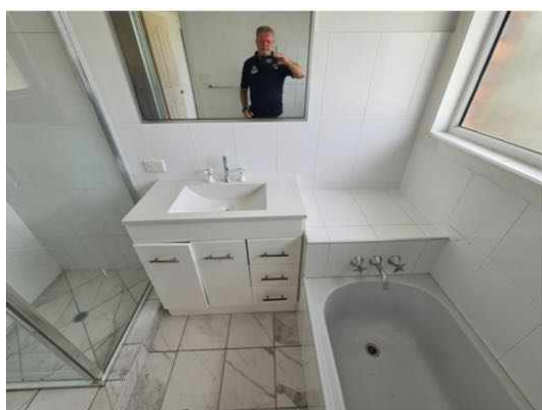
Finding 3.09

Building:	Main Building
Location:	Bathroom
Finding:	Evidence of elevated moisture - bathroom and ensuite vanity
Information:	Evidence of elevated moisture was detected during the inspection in the shelf and floor if the vanity cupboard of the bathroom and ensuite.

Excessive moisture can attract timber pests and produce conditions that promote timber pest attack, fungal growth and wood decay.

Excessive moisture in this areas is generally caused by deteriorated, inadequate or missing waterproofing membrane to the adjacent wet area, or leaking plumbing pipes, or penetration through external walls.

It is highly recommended that all plumbing and drainage fixtures and fittings be maintained regularly in order to prevent excessive moisture being present in the internal areas of the property.

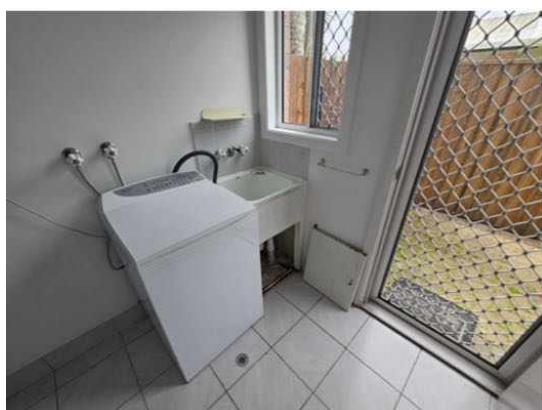
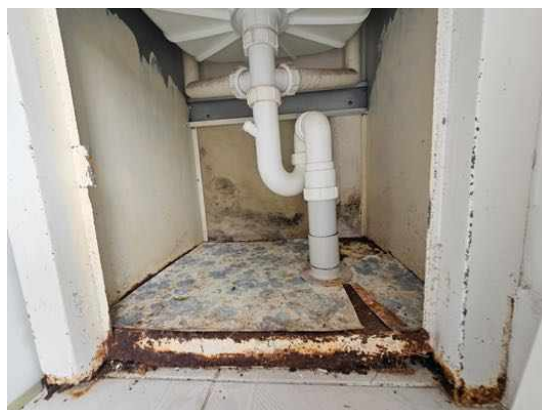
Building: Main Building
 Location: Laundry
 Finding: Laundry tub cabinet - rust
 Information: It was observed during the inspection that the laundry tub cabinet is severely rusted.

It would be advisable to have a licensed builder or carpenter assess the unit for replacement.

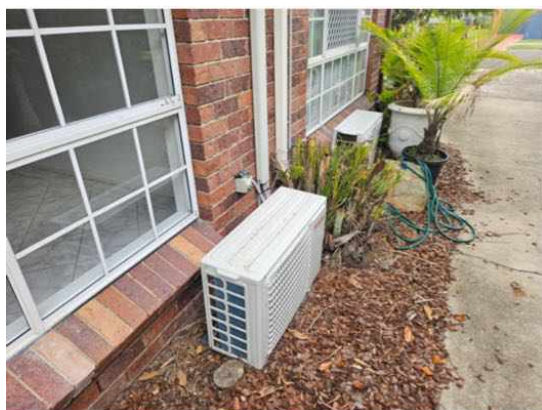
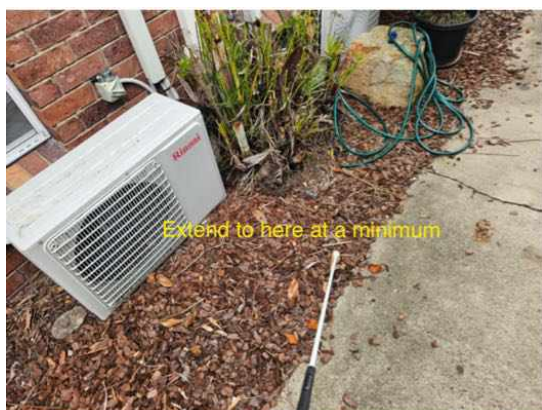
Building: Main Building
 Location: As shown
 Finding: Air conditioner - Disconnected drain
 Information: The Air Conditioner (A/C) overflow was found to be disconnected from storm water drainage and could create excessive moisture in the surrounding area.

Such leaking creates an environment which is conducive to an array of defects, including water damage to associated building elements and the attraction of termite or timber pest infestation.

It is recommended that a licensed plumber be appointed to connect the A/C overflow to a drainage source in order to prevent such an environment from being created. An alternative is to extend the overflow further into the garden away from the building perimeter.

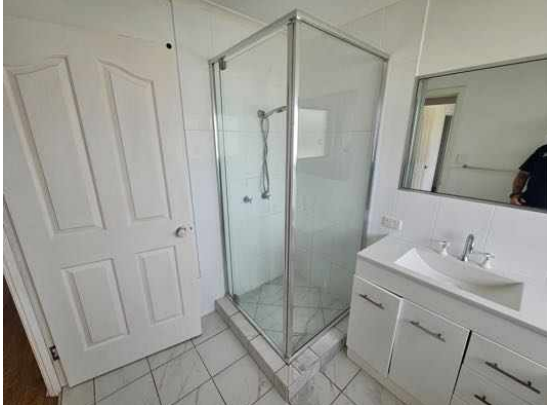
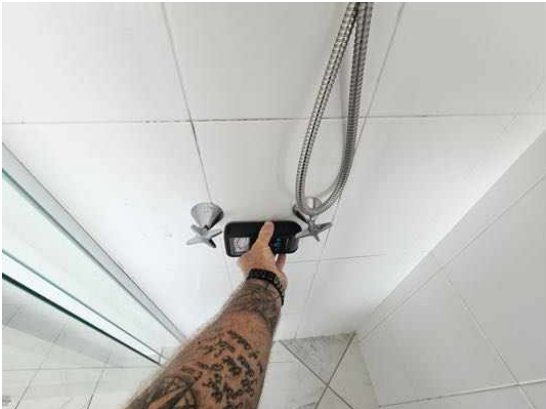
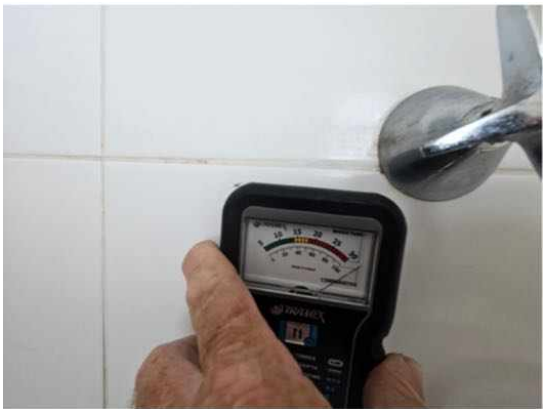
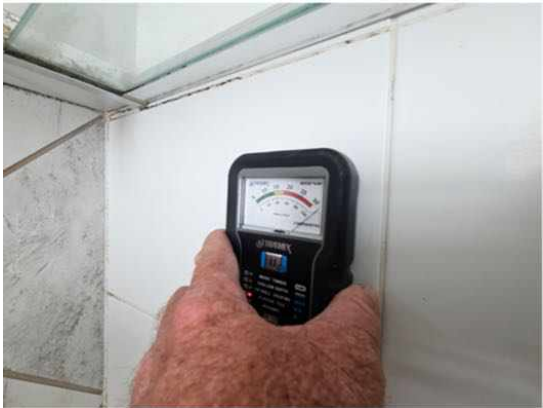
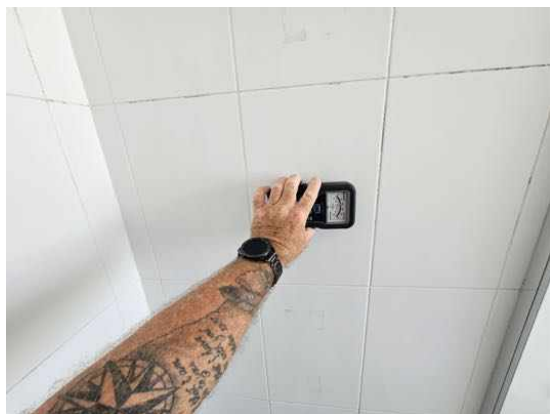
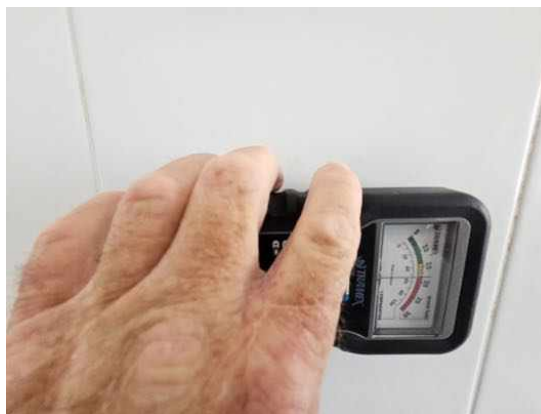
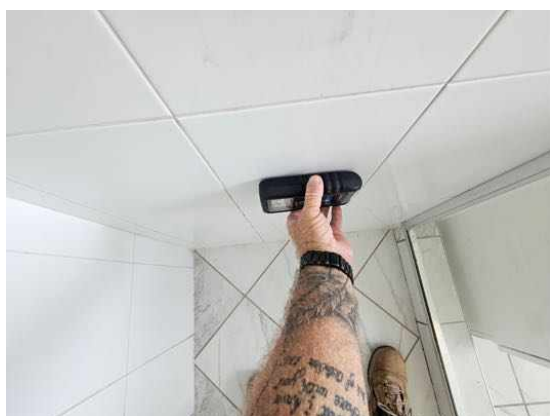
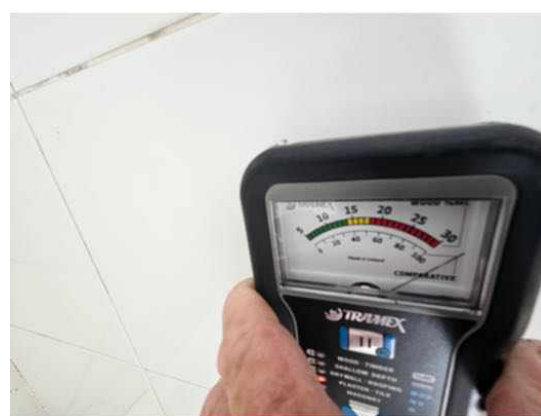
Finding 6.02

Building:	Main Building
Location:	Bathroom
Finding:	Elevated moisture present at the time of inspection - bathroom
Information:	Elevated moisture was noted in the tiled wall surfaces of the bathroom shower.

The levels varied at differing points throughout the recess. This could possibly be due to deteriorated grout and silicone sealants. These can break down over time and become porous, allowing moisture to enter the wall sheet surface behind the tiles.

Elevated moisture can attract timber pests and vermin, and produce conditions that promote timber pest attack, fungal growth and wood decay.

It is recommended that the moisture levels in these areas be minored over time and the grout and silicone could be renewed to possibly eliminate any further moisture penetration.

A licensed tiler and / or sealant specialist could be engaged to renew these elements.

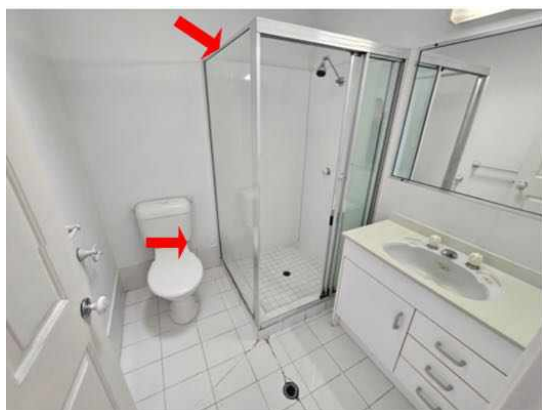
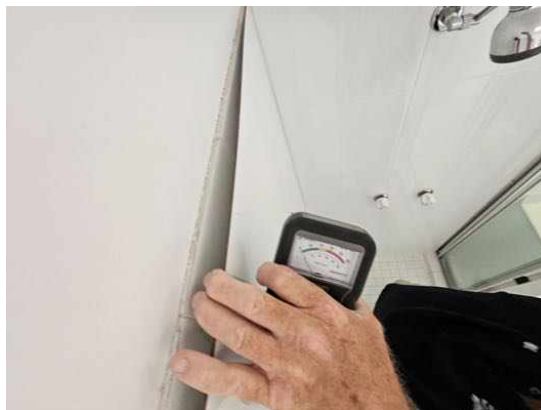
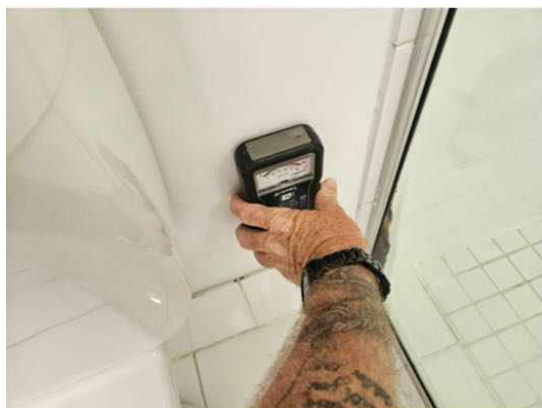
Finding 6.03

Building:	Main Building
Location:	Ensuite - Master
Finding:	Elevated moisture present at the time of inspection - ensuite
Information:	Elevated moisture was noted in the wall surface beside the shower screen of the ensuite shower.

This could possibly be due to deteriorated grout and silicone sealants. These can break down over time and become porous, allowing moisture to enter the wall sheet surface behind the tiles. It is difficult to assess this shower due to the laminated panels affixed to the original tiled wall. The sheets are loose the surface does not provide an adequate substrate to gain a definitive reading.

Elevated moisture can attract timber pests and vermin, and produce conditions that promote timber pest attack, fungal growth and wood decay.

It is recommended that the laminate sheet be re-fixed into position or removed and the shower surface remediated.

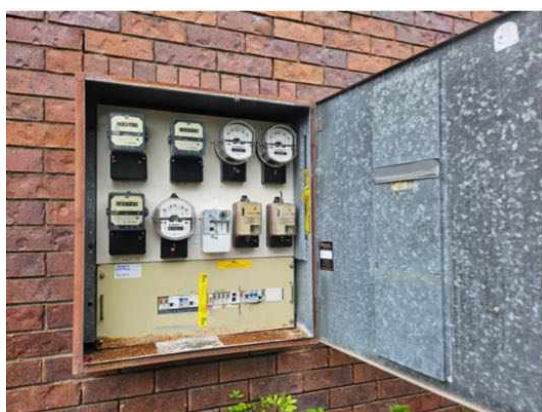
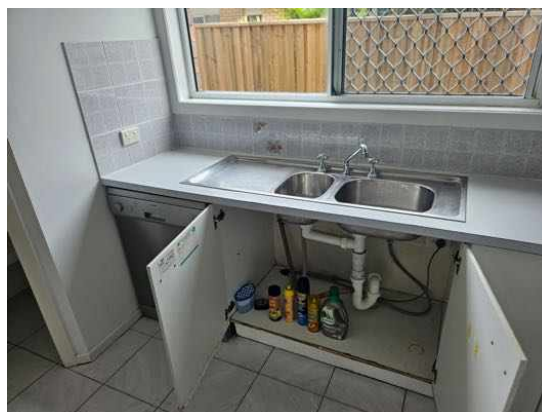
Building:	Main Building
Location:	Meter box, kitchen cupboard
Finding:	Durable pest inspection notice - not assessable
Information:	On the day of inspection it was noted that the durable timber pest inspection / treatment notice was missing, not visible or out of date. These notices / stickers are to verify the timber pest inspection dates, the inspector, the currency and type of timber pest system / barrier in place or being used in and around the property.

It is recommended that a licensed timber pest controller be contacted to assess the property's needs and provide costings for an annual inspection programme.
