## Building Inspection Report

Inspection Date: Thu, 2 Apr 2026

Property Address: 5/1025 Nepean Hwy, MOORABBIN, VIC,  
3189, Australia

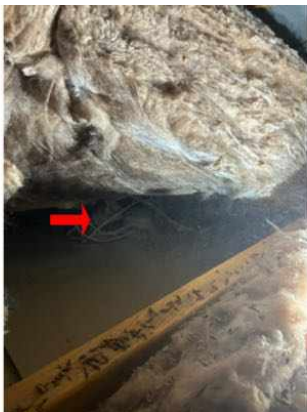
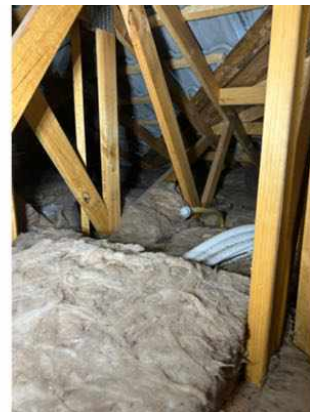
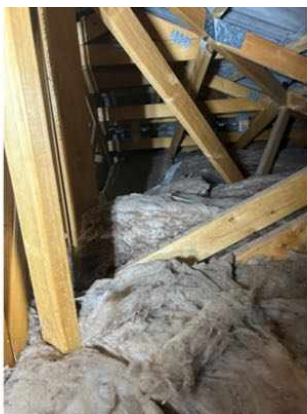
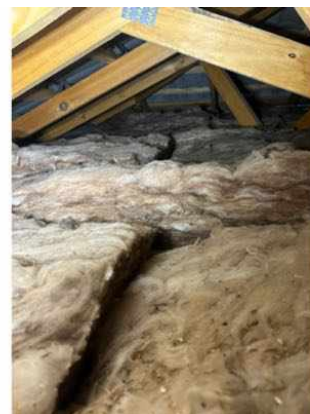
#### Defects 1.01

Building: Main Building  
Location: All Areas  
Finding: Insulation - Covering downlights  
Information: Sections of insulation in the roof void have been poorly installed or moved from their original position and are covering down light fittings. While the down lights have been fitted with appropriate protective covers, the presence of this insulation creates a potential fire hazard.

Insulation covering the downlighting can be a safety hazard unless the manufacturer of the lights allows installation to be covering the entire lighting fixture.

Any insulation within the vicinity of down light fixtures should be moved and re-applied to more appropriate sections of the roof void, thus ensuring the area is fire-safe. An insulation contractor should be appointed as soon as possible to perform any necessary works as required.

Unless the lighting manufacturer has approved that insulation can be installed over their lighting fixtures.

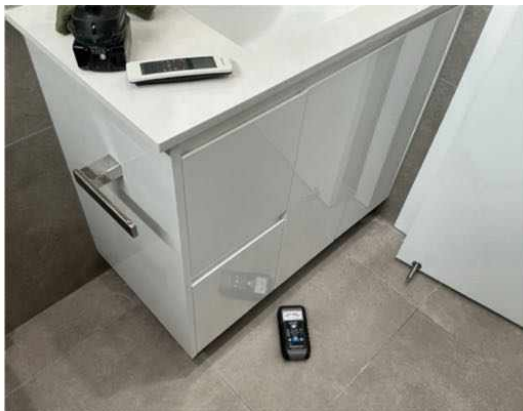
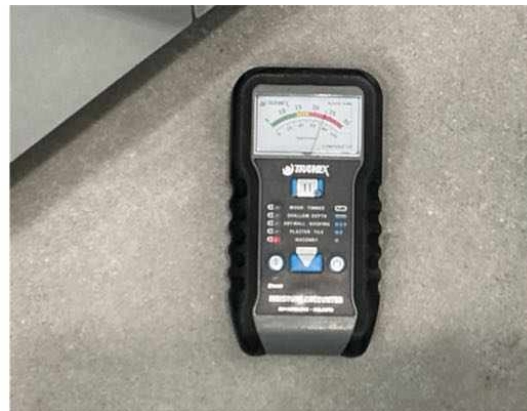
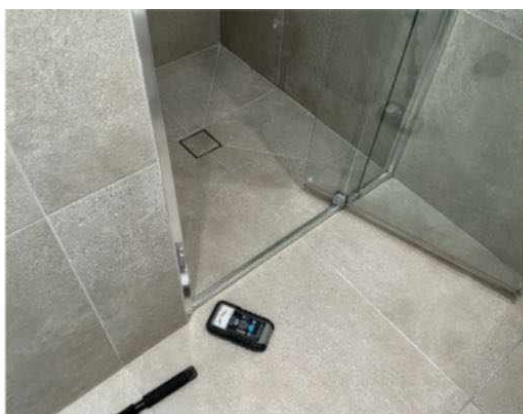
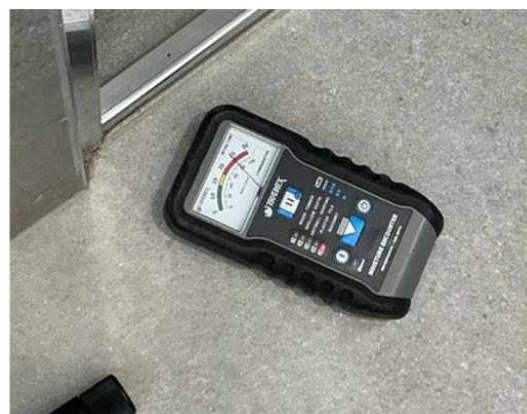
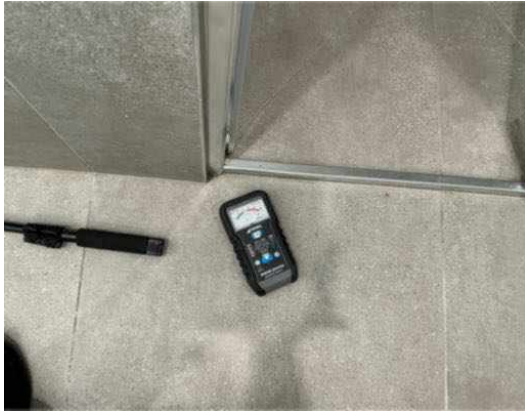
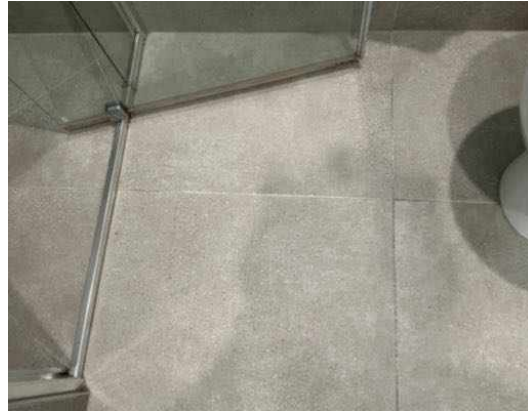
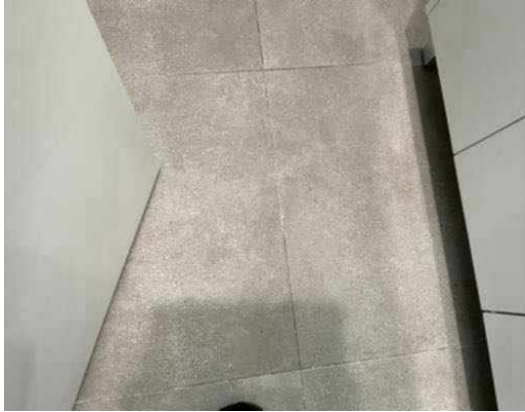
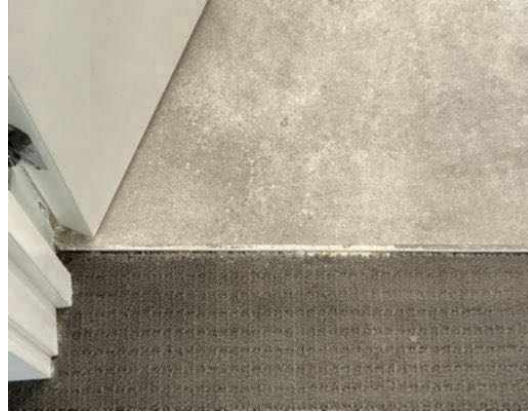
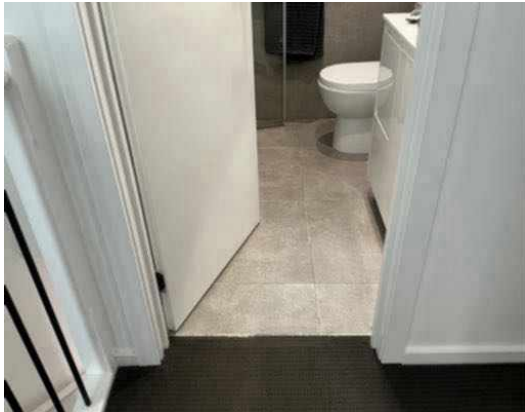
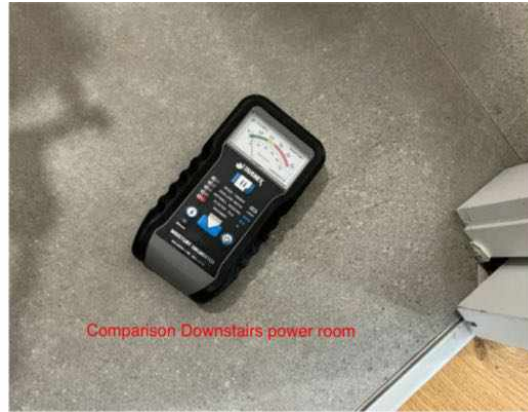
### Defects 2.01

Building:	Main Building
Location:	Bathroom
Finding:	Evidence of excessive moisture in Bathroom
Information:	Excessive moisture can encourage damp and mould growth as well as deteriorating associated building materials.

Excessive moisture is generally caused by deteriorated inadequate waterproofing, leaking plumbing pipes or fixtures, poorly sealed shower screens, broken or deteriorated grouting.

Excess moisture along with swollen doorframes and efflorescence in the bathroom area is considered a major defect for rectification. Further investigation will be required in order to determine the cause and recommend repairs. A registered builder and qualified tiler should be engaged in order to conduct these works.

It is highly recommended that all plumbing and drainage fixtures, grout, silicone and fittings be maintained regularly in order to prevent excessive moisture being present in the external / internal property, a registered builder and qualified plumber should be engaged to investigate further.

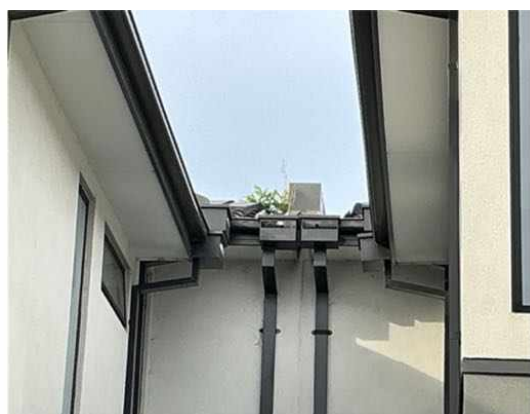
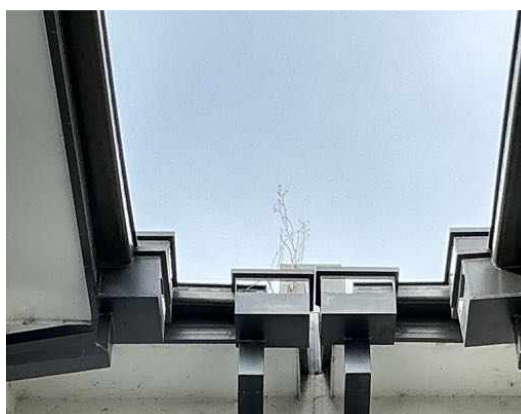
### Defects 3.01

Building:	Main Building
Location:	Roof Exterior
Finding:	Gutters - Blocked
Information:	Roof plumbing structures, such as guttering and downpipes, should be free of all debris to prevent blockages. Blockages of the guttering and downpipes will lead to pooling and accumulated water overflows, which is likely to subsequently flood eaves and exterior walls.

Blocked gutters are likely to lead to high levels of moisture in the affected areas. Such moisture will not only cause rust and decay of the associated building materials, but can also provide conditions that are conducive to termite and timber pest activity. Blockages in gutters should therefore be removed immediately to ensure dry conditions are maintained.

Where gutter guard is installed regular maintenance should include cleaning out any debris which may rest on top of or filter through the gutter guard.

Consult a Licensed Plumber for further specific advice on remedial works that may be required. In the interim, it is highly advised that blocked gutters be removed by the homeowner or a general handyperson as a matter of urgency.

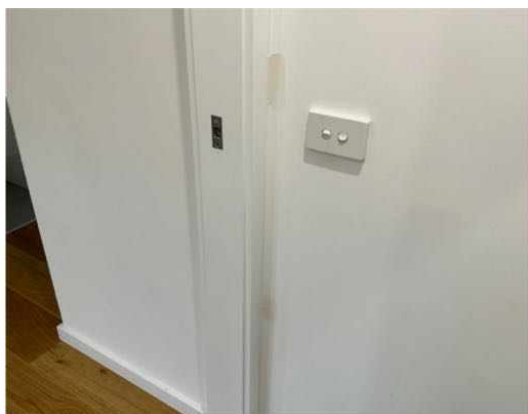
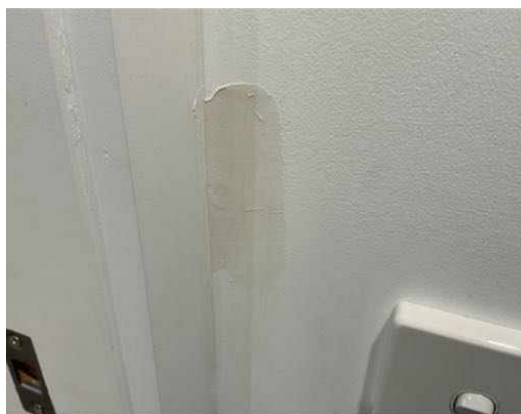
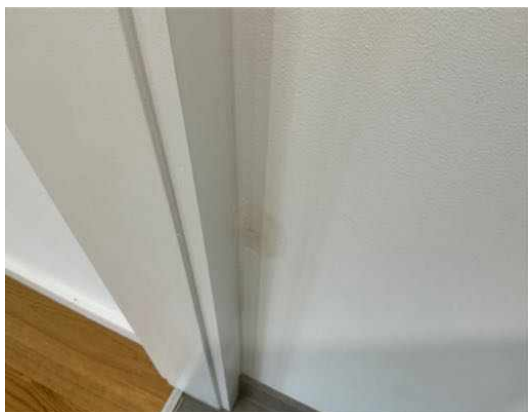
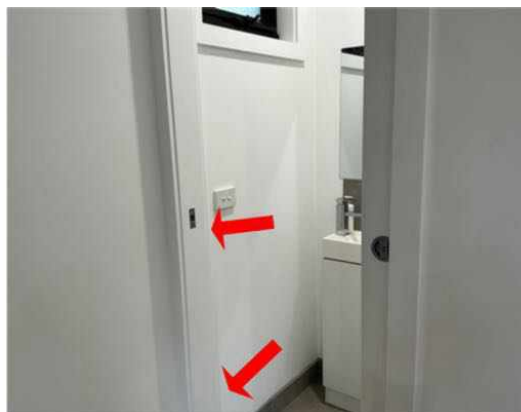
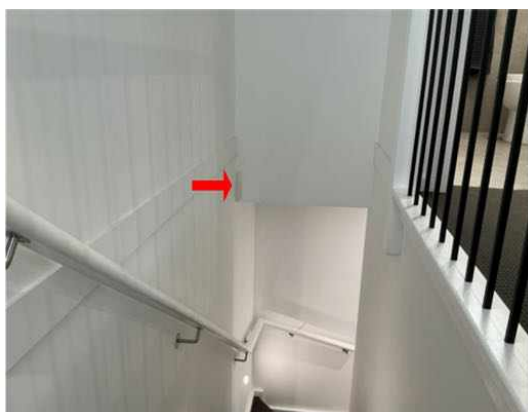
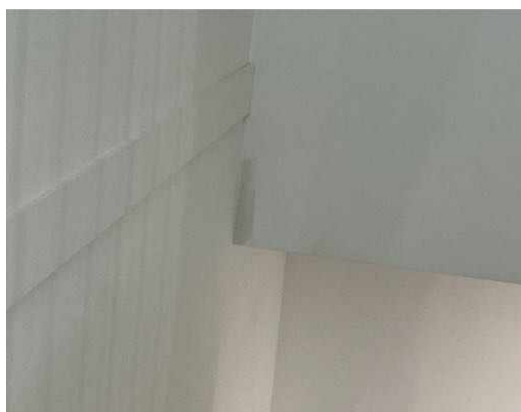
### Defects 3.02

Building:	Main Building
Location:	Powder Room
Finding:	Painting - Unfinished (AS2311)
Information:	The paint finish in this area was found to be incomplete at the time of inspection. Whilst incomplete or missing paint finish is generally an appearance defect, it can also lead to the development of secondary building defects over time.

Incomplete areas of paint finish exposes the area to moisture which could lead to deterioration of underlying building materials.

The incomplete painted areas have been marked for the painting contractor to touch up. These works are required to meet Australian Standards prior to final handover.

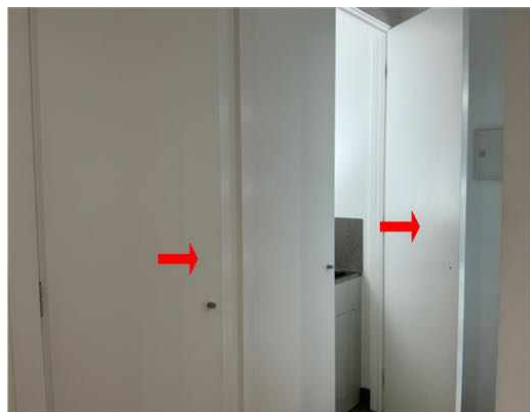
### Defects 3.03

Building: Main Building  
 Location: Storage Cupboard and laundry  
 Finding: Sticking or jamming  
 Information: Building elements which are sticking or jamming are difficult to operate and don't function as intended. There are a variety of causes for sticking and jamming.

The most usual causes are swelling of timbers due to moisture, bulging or bowing of metal frames, or general material deterioration. Generally, sticking and jamming building elements indicate that their frames are uneven or out of level, generally as result of movement to surrounding walls and floors.

Easement will be required, which usually depends on the building materials used. This may involve some sanding and/or application of a lubricant. It will almost always include ensuring the areas are cleaned and free of any debris that may be detrimental to their operational state.

Appointment of a carpenter or general handyman is recommended to rectify any sticking/jamming building elements.

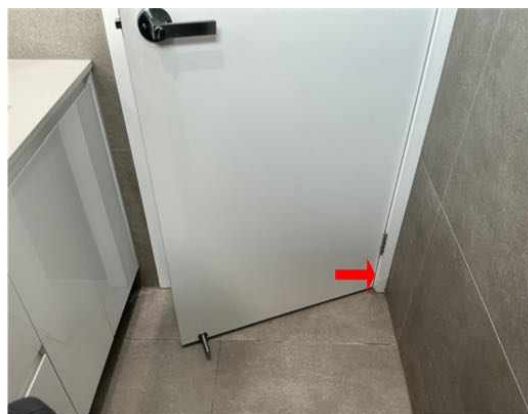
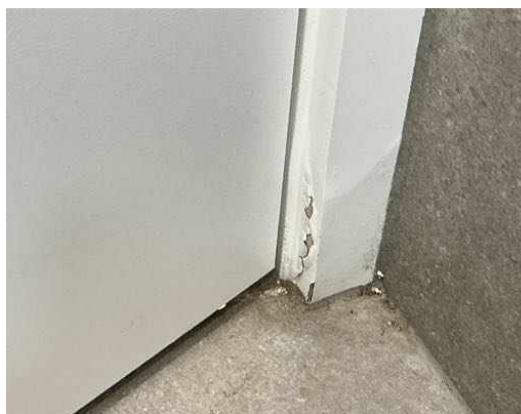
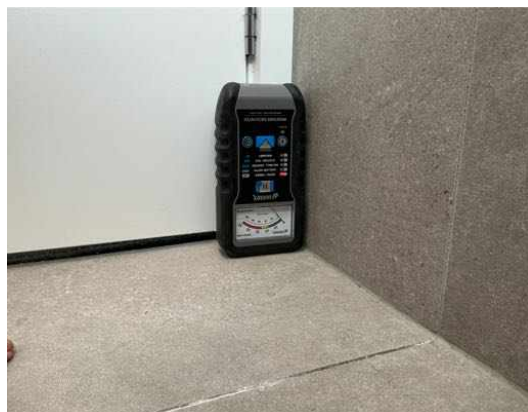
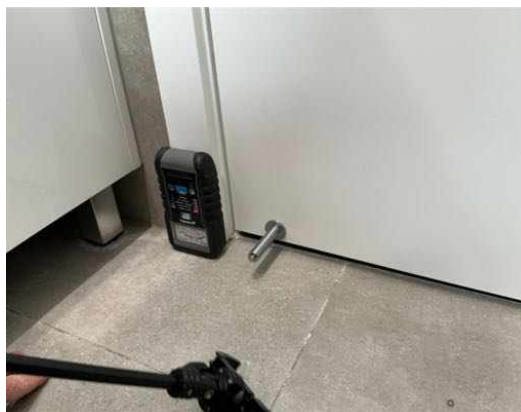
### Defects 3.04

Building:	Main Building
Location:	Bathroom
Finding:	Building element - Swollen
Information:	Swollen building elements generally indicate that the building materials have been affected by excessive moisture over a prolonged period of time, and have swollen as a result. The formation and development of mould/fungi or mildew is also a likely consequence of excessive moisture, which may pose major respiratory issues for occupants, particularly the elderly, the very young and those with existing illnesses and could be potential health safety hazards. In these cases an appropriately qualified inspector/tester should also be contacted for advice and/or technical assistance.

The structural integrity of swollen building elements can not be guaranteed, and further damage is likely to develop if left unmanaged. Excessive moisture is likely to lead to the development of secondary damage to any associated building elements, which may necessitate major reparation works if prolonged.

Rectification of the cause of the water leak should be addressed prior to any remedial works to the swollen building elements. A licensed plumber should be appointed immediately to identify the cause of the leak and provide advice on remedial works as necessary. Repair and/or replacement of swollen building elements should be conducted as a matter of urgency by a registered builder or qualified carpenter.

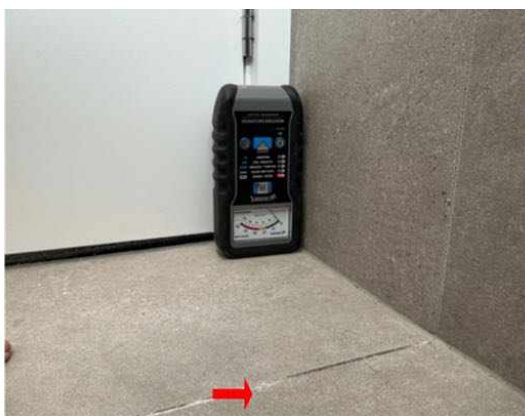
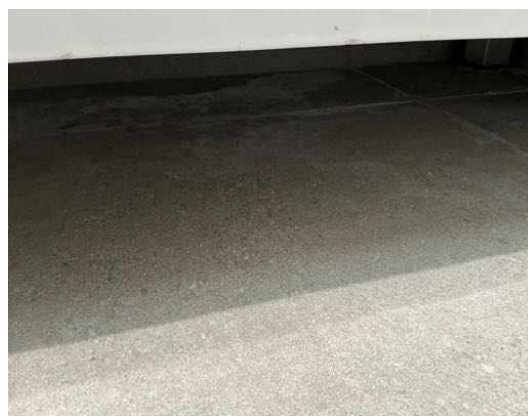
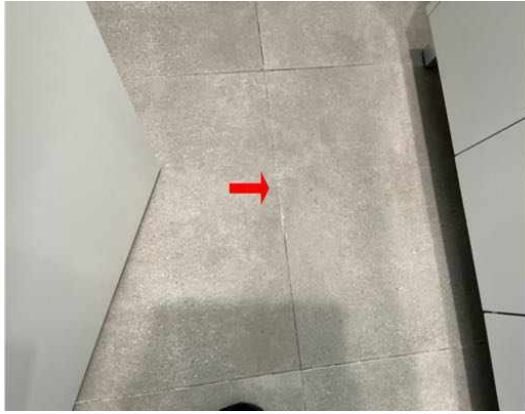
### Defects 3.06

Building:	Main Building
Location:	Bathroom
Finding:	Tiling - Efflorescence
Information:	Efflorescence appears to be affecting the brickwork, concrete or tiles in this area. Efflorescence typically occurs when excess salts within the concrete or cement mortar is leached to the surface due to water transfer.

It is typically seen as white salt deposits on the surfaces of concrete pavement or mortar between bricks or tiles. While detracting from the overall appearance of the affected area, efflorescence is not likely to develop into secondary damage if left unmanaged.

Generally, soluble salt deposits can be removed by dry brushing with a stiff-bristled brush. Repeated dry brushing is an ideal treatment for eliminating this forming of efflorescence. A cleaning contractor or general handyperson may be appointed to perform these works at the discretion of the client.

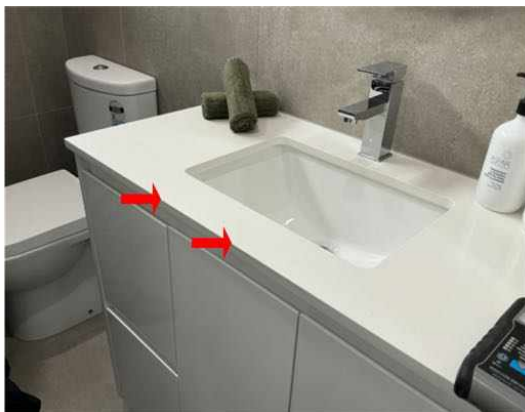
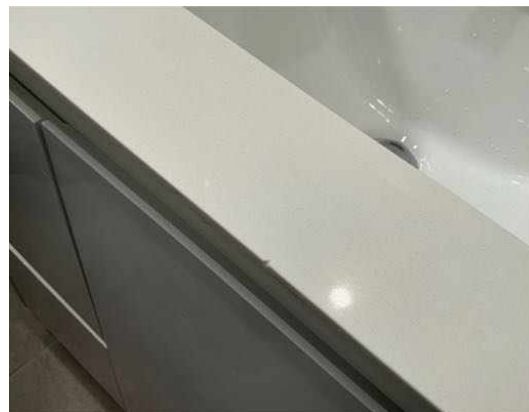
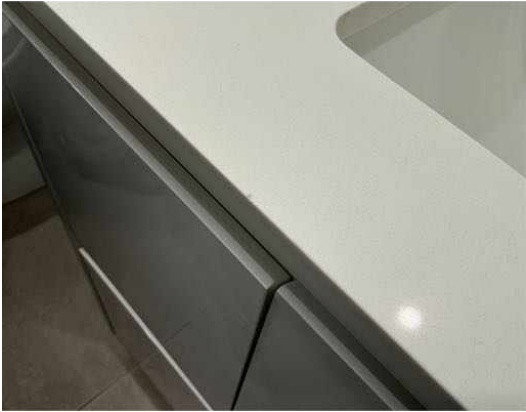
### Defects 3.07

Finding: Surface - Chipped

Information: The surface of this building element appears to have chipped as a result of general wear and tear. While being an appearance defect, such damage is expected of a property of this age and condition.

Chipped surfaces rarely impede on the structure or functionality of the affected building element and generally only create a blemish on its appearance. Chipped surfaces may be left in situ at client discretion, as no repairs or replacement are necessarily required. However, the client may wish to seek quotations for the cost of refurbishment or replacement of the identified building element.

A qualified carpenter or cabinet maker should be appointed to repair chipped surfaces and replace building elements where major damage has occurred.

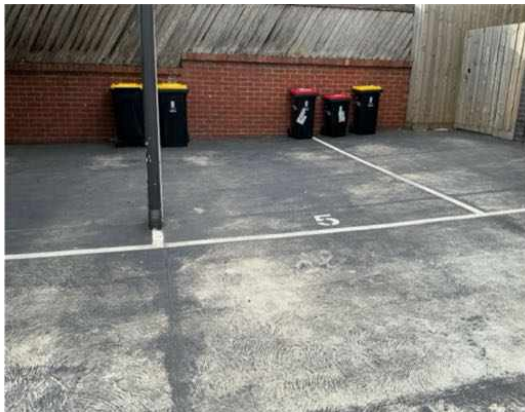
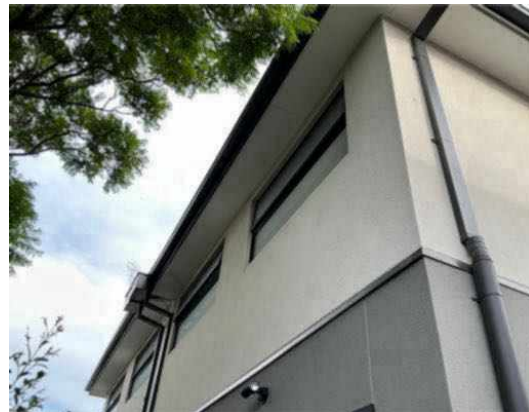
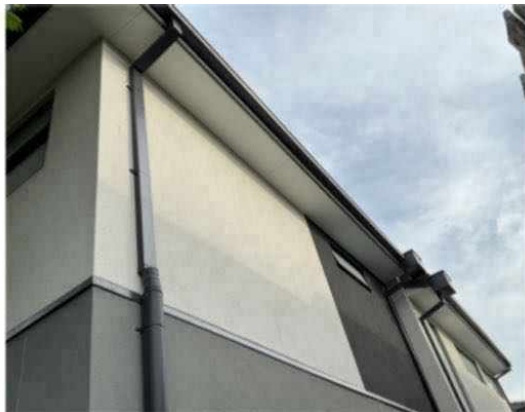
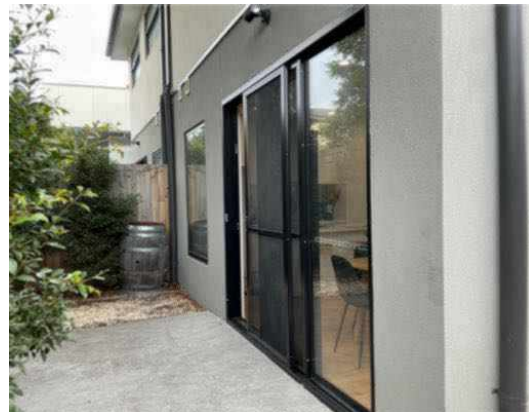
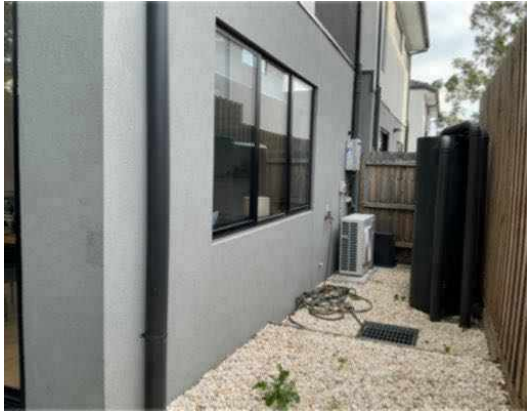
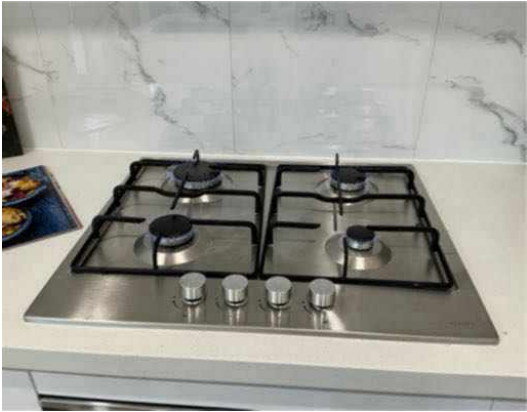
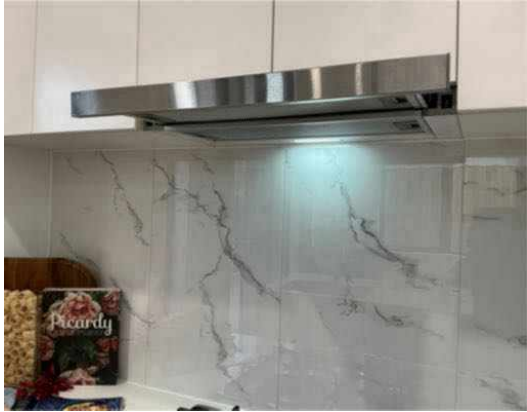
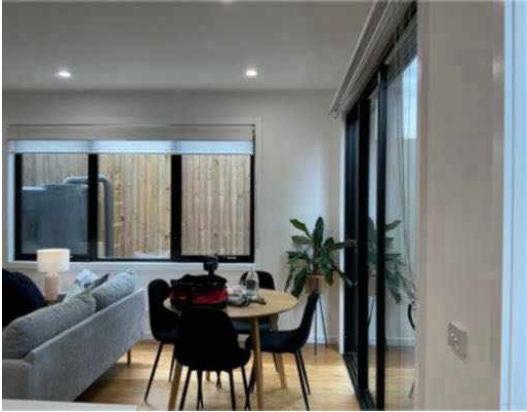
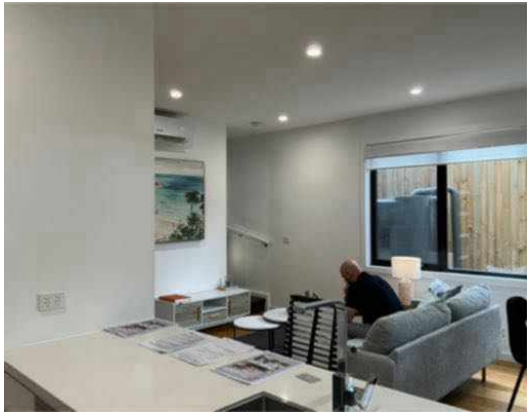
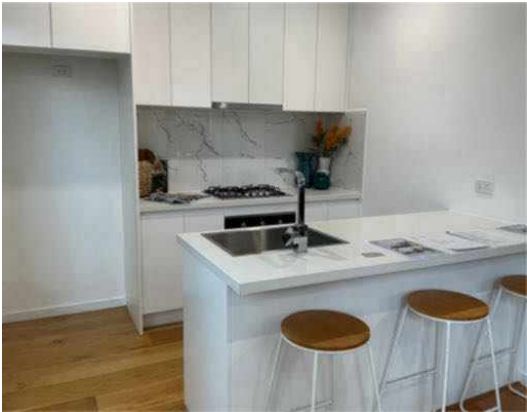
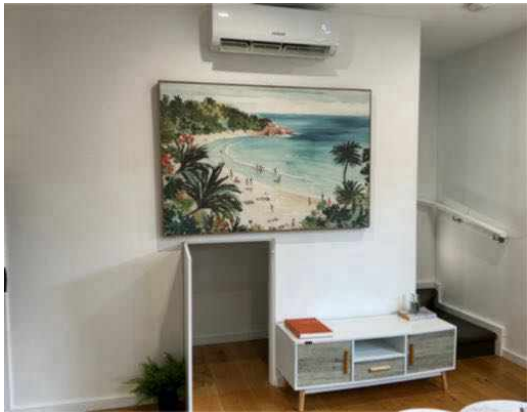
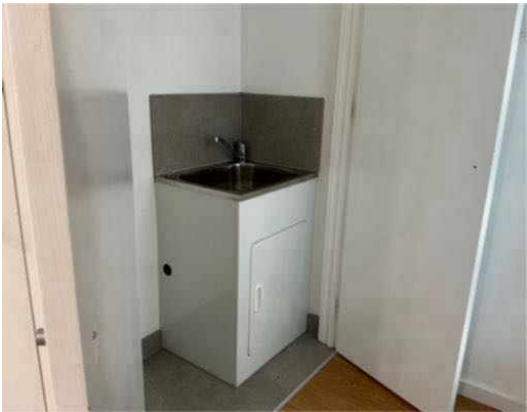
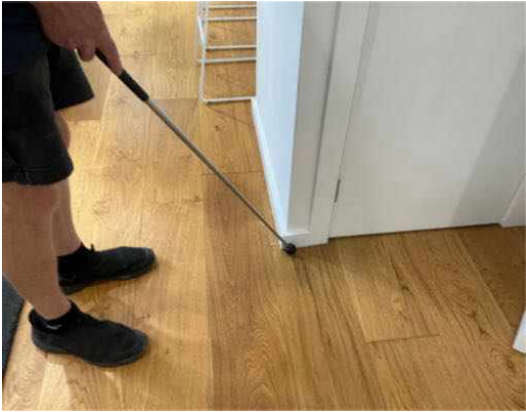
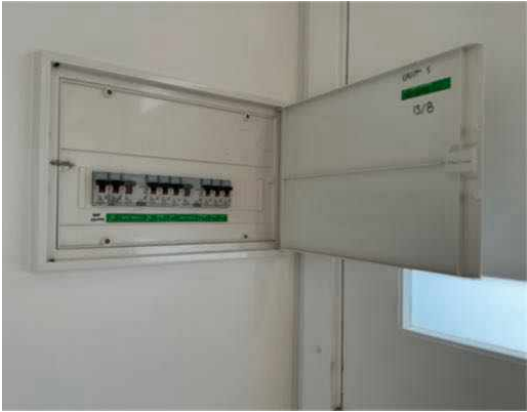
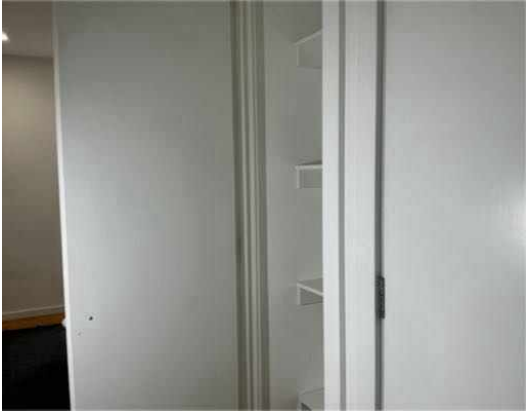
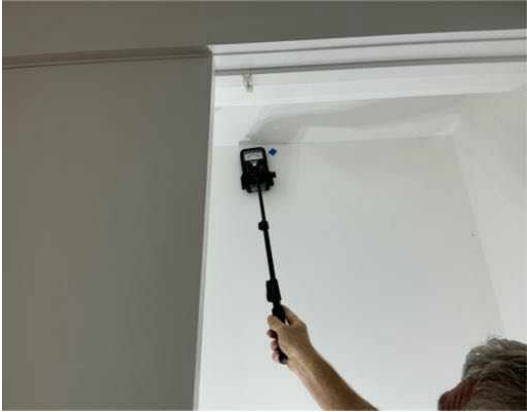
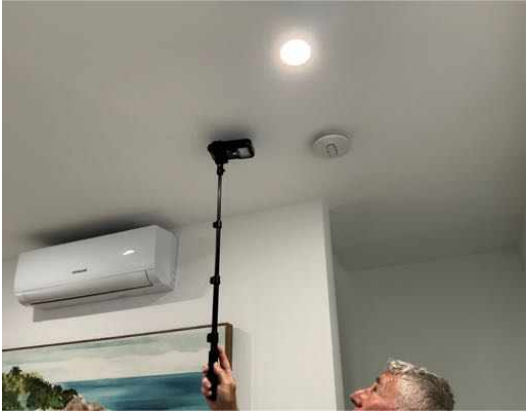
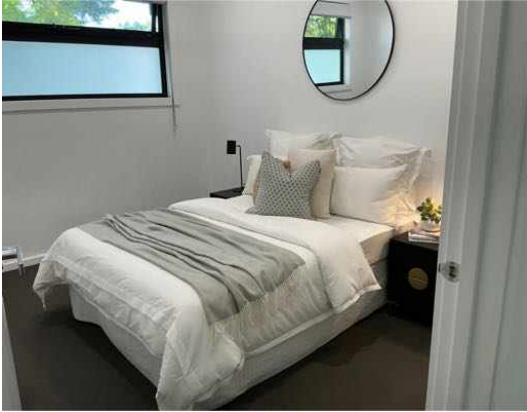
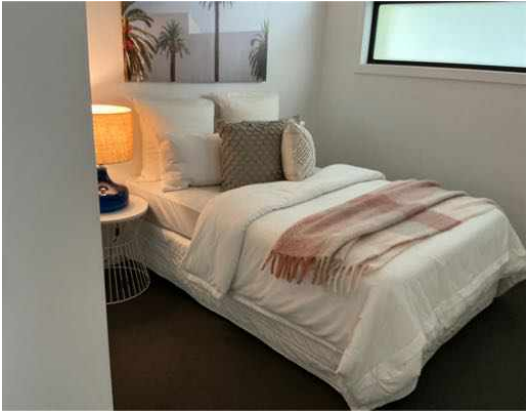
### Noted Item

Building: Main Building  
Location: All Areas  
Finding: Additional Photos - Obstructions and Limitations  
Information: These photographs are an indication of the obstructions and limitations which impeded full inspection of the property at the time of inspection. These obstructions can hide an array of defects and should be removed to allow full inspection to be carried out. A re-inspection is recommended once the areas are made accessible.
