# Building and Timber Pest Inspection Report

Inspection Date: Thu, 29 Jan 2026

Property Address: 85 Iola Ave, Farmborough Heights NSW  
2526, Australia

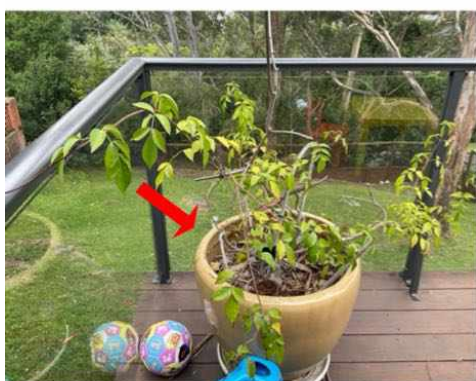
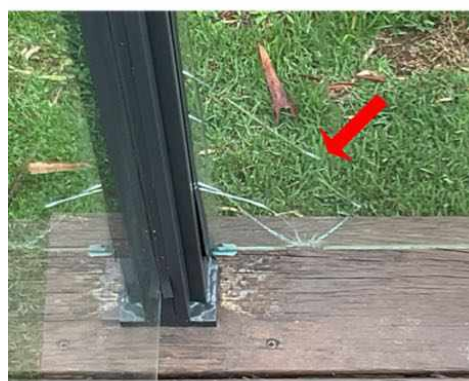
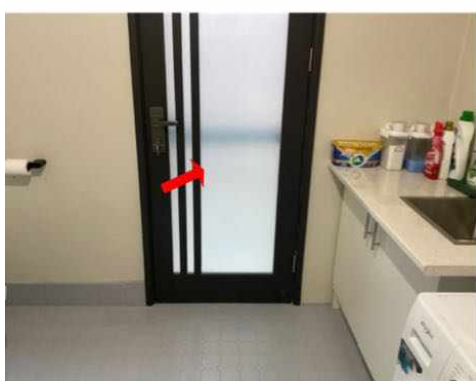
| Finding: | Door and balcony glass - Cracked |
| Information: | Cracks were identified in the laundry door glass and verandah railing glass window. Cracks in glass is generally the result of impact damage, and is likely to develop further when left unmanaged. |

The likelihood of this glass further cracking and shattering is increased exponentially, providing a safety hazard in the area. The cracked glass also impairs the weather tightness of the laundry, creating potential for minor water leaks.

A qualified glazier is required to repair these areas as soon as possible. Depending on the extent of the cracking, replacement may be required. Please be advised that any persons coming into contact with the cracked glass should do so with due caution to avoid any personal injury that may ensue.

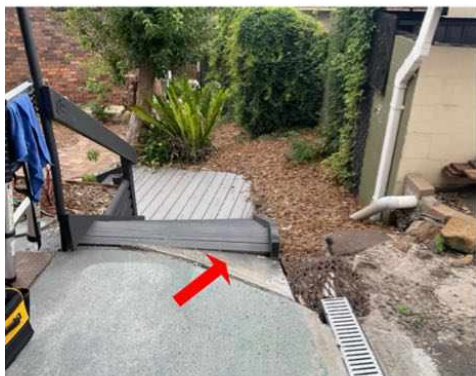
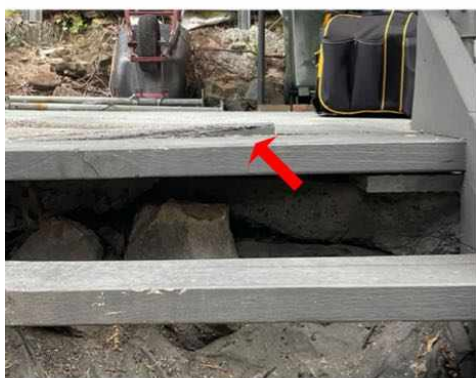
### Finding 1.03

| Finding: | Trip safety hazard |
| Information: | A raised section of concrete has created a trip hazard on the pedestrian footpath. The uneven surface poses a risk to pedestrians, particularly the elderly, children, and |

individuals with mobility impairments. This requires urgent repair by a concreting contractor.

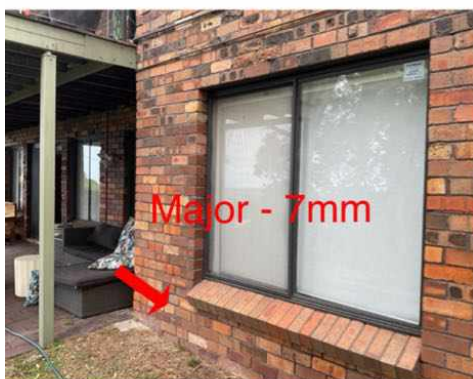
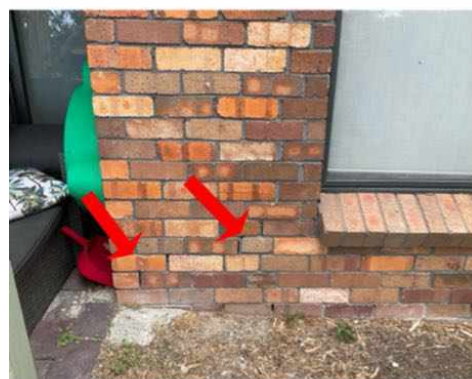
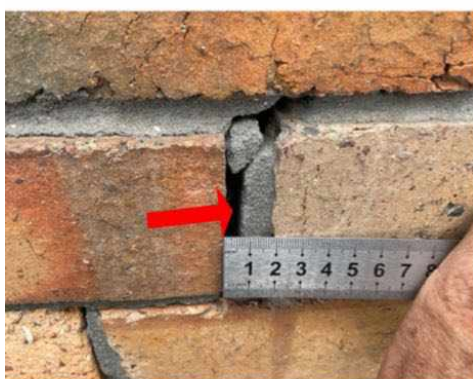
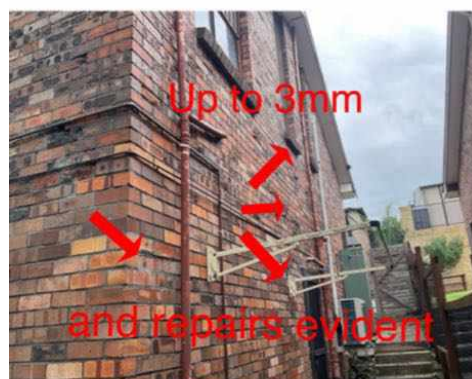
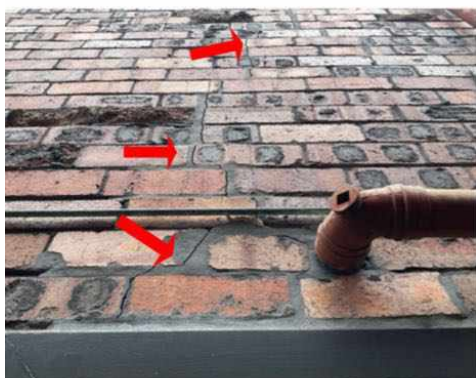
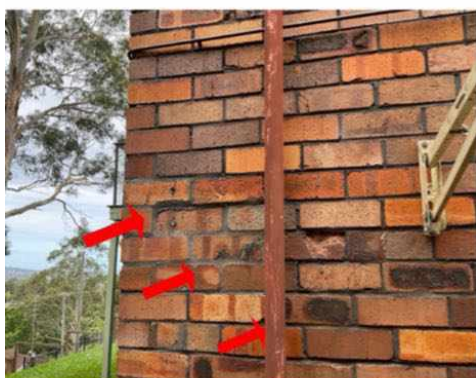
| Finding: | Step cracking to brickwork major |
| Information: | Step cracking was identified to the brickwork in the left and rear external wall areas at the time of inspection. The rear wall showed 7mm of cracking (pictured 1-3) which is a |

major defect. The NSW Standards and Tolerances 2017 states cracks over 5mm in width are a major defect requiring rectification work.

The following photos show minor cracking which should be monitored annually. Note- some areas have been repaired and have cracked again.

Step cracking, which is similar to other forms of cracking, has a variety of possible causes. However, the most common is the subsidence of adjacent footings.

Step cracking is a relatively common defect, and is most likely to occur adjacent to windows, doors and other openings. Mortar failure in the gaps between affected bricks indicates the stresses and tensions affecting the wall.

Where step cracking is extensive or severe in the rear wall, the client is advised to consult a structural engineer. Minor step cracking can be used as a warning sign to address factors causing stress to the wall, which can include the effect of surrounding trees, water leaks, soil erosion, or even the presence of reactive soils in the surrounding area.

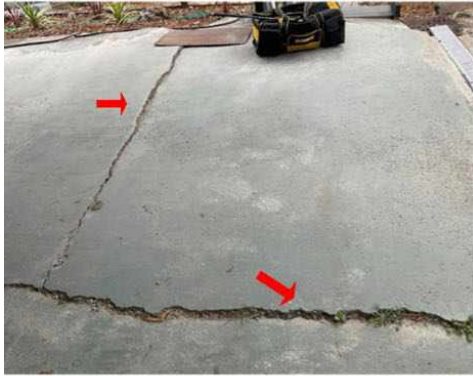
### Finding 2.03

| Finding: | Crack in concrete slab - Category 4 |
| Information: | Cracks coded as Category 4 was identified in the driveway slab of up to 30mm. A Category 4 crack is described as a crack that appears as a gap in the slab, with disturbing curvature or change in level affecting the slab. |

The approximate width of these cracks or gap is over 4mm or a change in offset of greater than 25mm when a 3m straight edge is placed over the defect.

Category 4 cracking to slabs exceeds allowable Standards and Tolerances, and are therefore considered as major defects that require rectification.

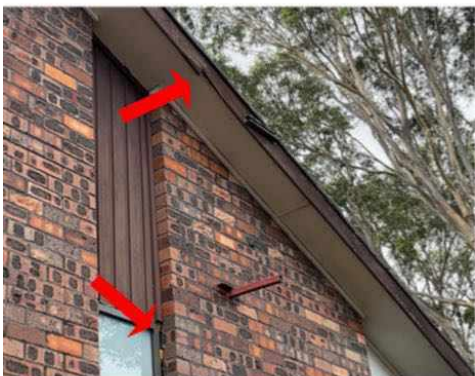
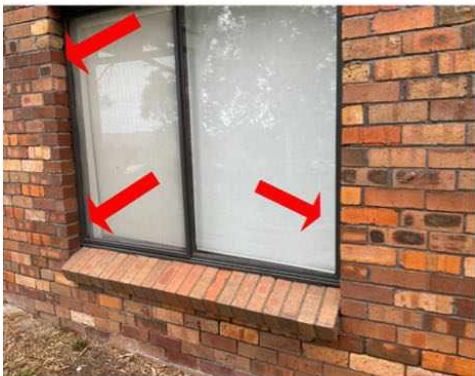
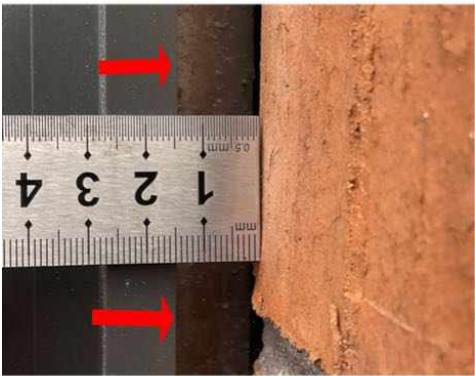
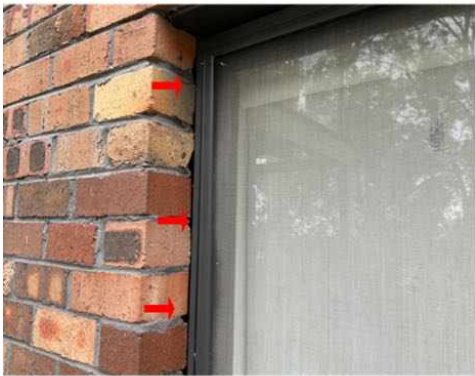
### Finding 2.04

| Finding: | Sealant (external) - Missing. |
| Information: | It was noted on inspection that many areas of external sealant was missing the external walls. Large gaps in the cladding were also evident. |

Flexible sealants should be applied to these affected areas to prevent any subsequent water damage that is likely to occur.

A sealant specialist or carpenter should be appointed to complete these works as soon as possible

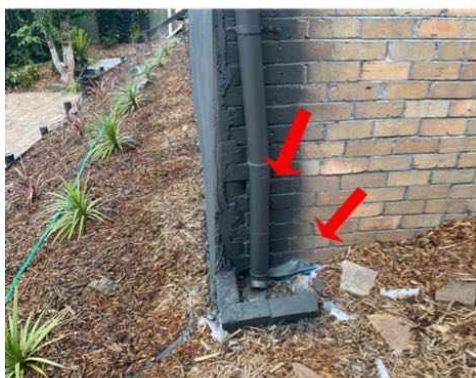
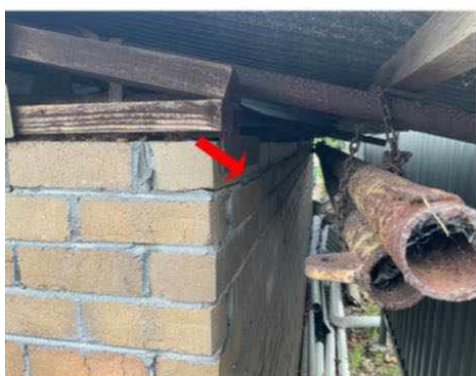
Building: Building 2  
Location: Exterior garage walls  
Finding: Step cracking to brickwork  
Information: Step cracking in the garage was identified to the brickwork at the time of inspection. See step cracking defect description previously in this report.

This minor step cracking can be used as a warning sign to address factors causing stress to the wall, which can include the effect of surrounding trees, water leaks, soil erosion, or even the presence of reactive soils in the surrounding area.

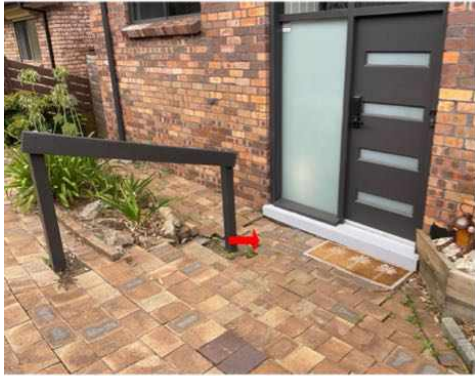
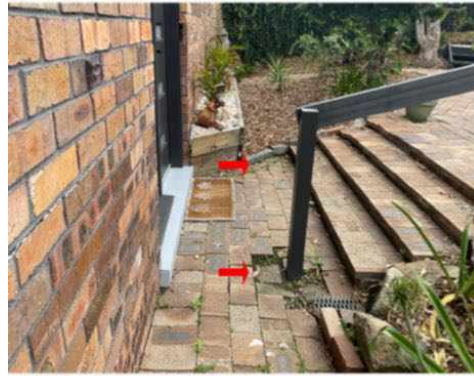
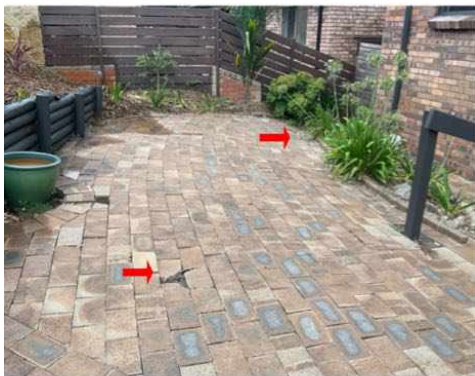
| Information: | It appears that this some paved areas has been affected by movement, often referred to as sinking or subsidence. General subsidence is usually initiated by changes in soil moisture content. The most critical factor is identifying the specific causes, and identifying if this is a recurring or ongoing problem, or one that has been resolved by previous works in the past. |

At this point it is recommended to contain storm water flows, ensure pavements flow away from buildings to lessen any excessive wetting and drying effects.

A landscaping contractor can repair this area when convenient.

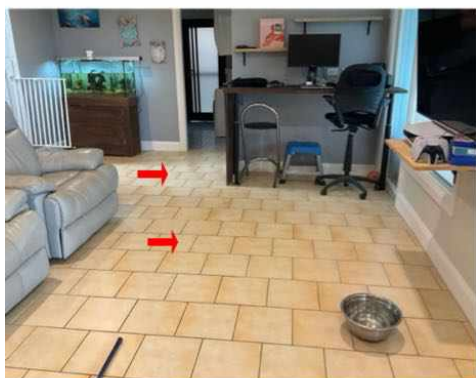
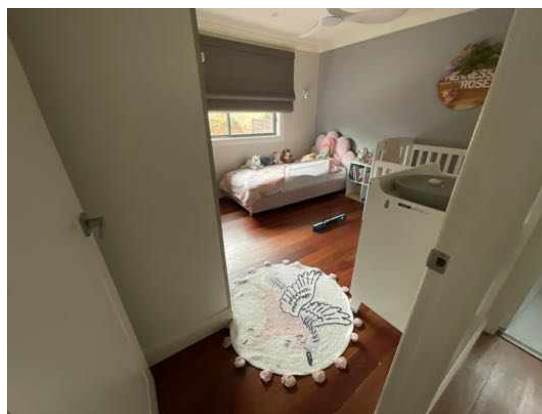
### Finding 3.05

Information: The internal flooring in some areas is out of level and uneven. Uneven flooring is likely to indicate minor defects such as expected movement of the foundations of the property.

It is advised that the flooring be closely monitored to identify any further movement. Where flooring remains relatively unchanged for an extended period of time (i.e. several months), it is likely that this defect has been caused by movement of the foundations of the property.

However, where flooring is uneven further, a structural engineer should be consulted.

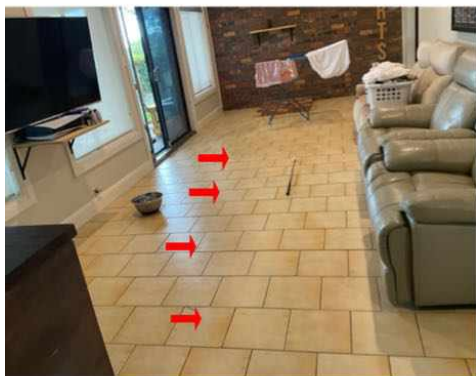
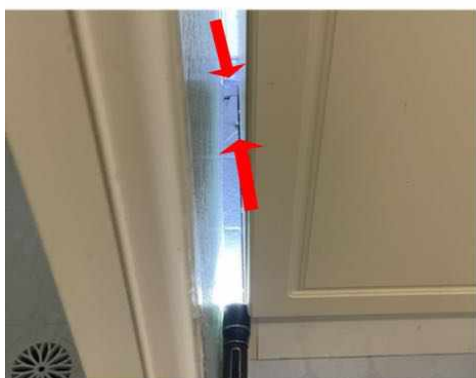
### Finding 3.06

| Finding: | Tiles cracked |
| Information: | Cracked tiles were evident in these pictured areas at the time of inspection. It is suspected that this cracking has occurred as a result of house settlement. |

Cracked tiles throughout the household detract from the overall appearance of the affected areas. In wet areas of kitchens and bathrooms, it can lead to water damage of adjoining walls and floors.

Replacement of cracked tiles is recommended as soon as possible. A tiling contractor may be appointed to perform these works. Where cracks become more numerous, contact a licensed building inspector for further investigation.

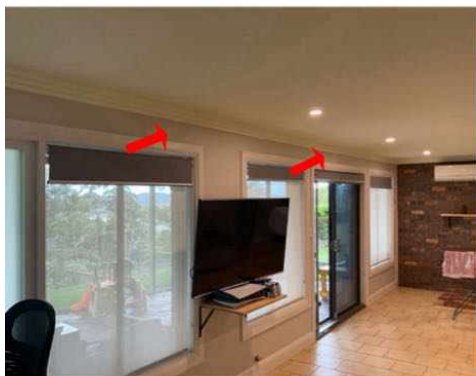
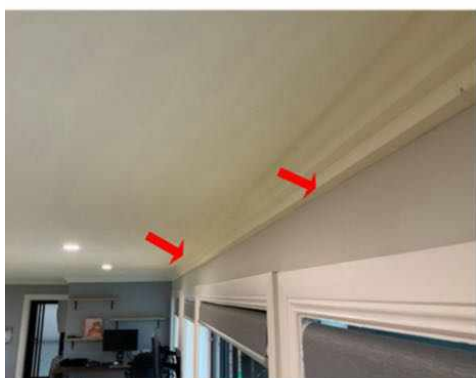
### Finding 3.07

| Information: | The ceilings/cornice in the kitchen, loungeroom and lower bedroom were found to be sagging/ wavy at the time of the inspection. Sagging to the fixed ceiling structure generally indicates that the building materials have swollen, due to contact with water, or that fixings (e.g. nails or glue) have become loose and require reattachment. |

In some cases, sagging ceiling linings may also indicate that there are structural issues, causing surfaces to warp, twist or sag, or that structural timber elements have been weakened from termite activity. Where sagging appears to be major, appointment of a structural engineer is advised to further inspect the property and identify the cause of the damage and determine the rectification works required.

Where minor sagging is evident, comparatively minor works, such as re-gluing of ceiling sheets, may be required. Such works may be performed by relevant tradespeople, such as plasterers and painters. Where excessive moisture has caused the roofing structure to swell and sag, the source of the water leak should primarily be identified prior to any remedial works being performed.

The appropriate action should be taken by the client as soon as possible to ensure that any potential further damage is limited.

An invasive inspection is required to remove timber and/or plaster in these areas to check this area for the cause.

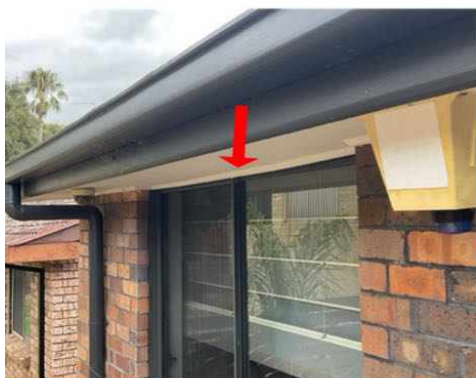
| Information: | Sagging to the eaves was evident in this area at the time of inspection. This type of defect is generally consistent with older properties, where the eave sheeting has worn over time. |

Eaves are important in preventing water ingress to associated walls by promoting adequate water run-off from roofing structures. Their secondary function is to prevent shelter to adjoining structures from excessive moisture and hence prevent water damage to these areas.

Sagging eaves are susceptible to the attraction of excessive moisture, and are therefore considered non-functional. This defect also detracts from the overall appearance and condition of the roofing structure and any associated structures.

A roofing plumbing or general handyman is recommended to perform rectification works as soon as possible. Subsequent water damage is likely to result over time if left unattended.

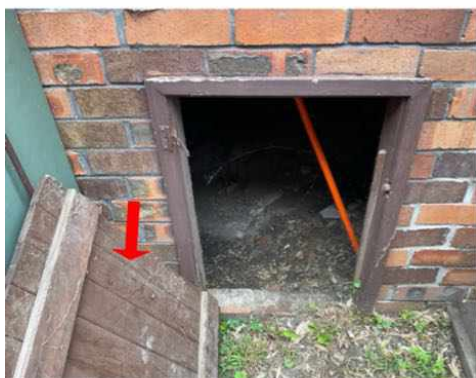
### Finding 3.11

| Finding: | Door - Damaged |
| Information: | Evidence of minor damaged areas was identified when subfloor door fell off when opened. |

A carpenter would be the trade responsible for rectification of this door when convenient.

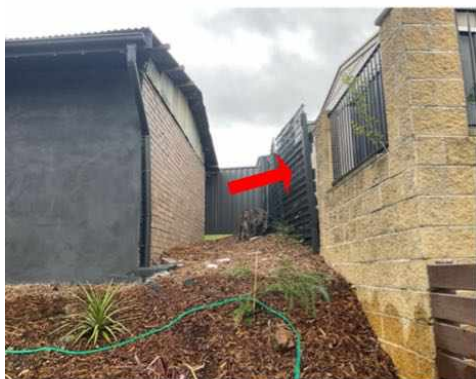
### Finding 3.12

| Finding: | Fences damaged - leaning and loose |
| Information: | Evidence of damage to the many fences was identified at the time of the inspection. The likely cause of these fences leaning is not enough concrete used in the post footings. The left rear fence top plate has snapped in half. The right rear fence post is loose. If left unmanaged this fence may deteriorate further. It is suggest a fencing contractor be engaged for rectification when convenient. |

The cost of repairing some fences is often shared between neighbours.

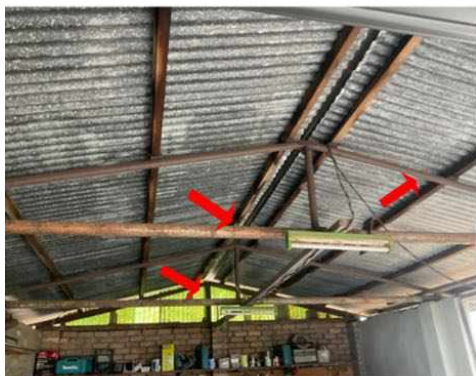
### Finding 3.13

| Finding: | Building element - Rusted or corroded |

Where possible, the use of galvanized (treated) metals or aluminium coated metals aid in rust prevention, as does regular general maintenance. Rust formation can be controlled with coatings, such as paint, that isolate the iron from the environment.

Rusting and corrosion should be managed by ideally removing or limiting the affected surface from exposure to moisture. A registered builder may be appointed to replace any building elements that have been severely affected by rust or water damage.

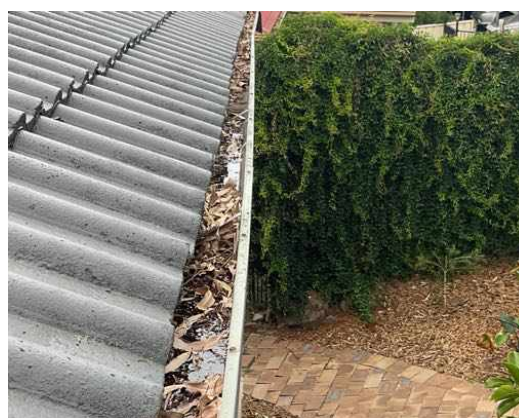
Blocked gutters are likely to lead to high levels of moisture in the affected areas which can cause rust and decay of the gutters and downpipes and wood rot to adjoining timber areas. Blockages in gutters should therefore be removed immediately to ensure dry conditions are maintained.

It is highly advised that gutters be cleaned by the homeowner or a general handyperson as a matter of urgency.

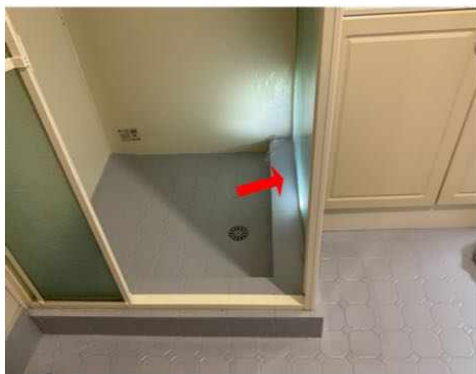
Building: Building 1  
 Location: Laundry  
 Finding: Shower screen - Leaking  
 Information: Leaking and cracked tiles was evident to the lower shower at the time of inspection. It is suspected that the leaking has occurred as a result missing sealant. Leaking from the shower , where left unattended, is likely to lead to water damage to adjoining flooring and walls. Such damage can lead to water damage and necessitate extensive remedial works being required. Active water leaks may also create an environment that is susceptible to the formation and development of mould.

Appointment of a sealant expert is required to repair or replace this missing sealant. Such works should be performed as soon as possible to ensure that no further damage occurs.

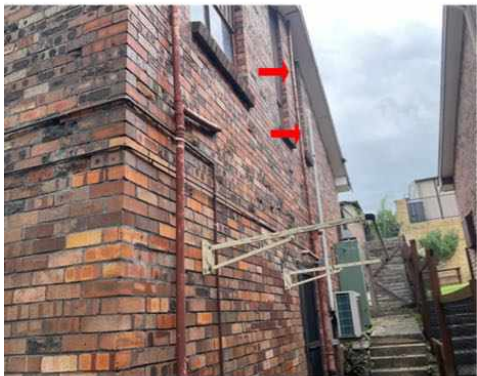
Note - see all photos in Sealant external (missing) in the above building report defects.

A sealant specialist or skilled handy person should be appointed to complete these works as soon as possible.

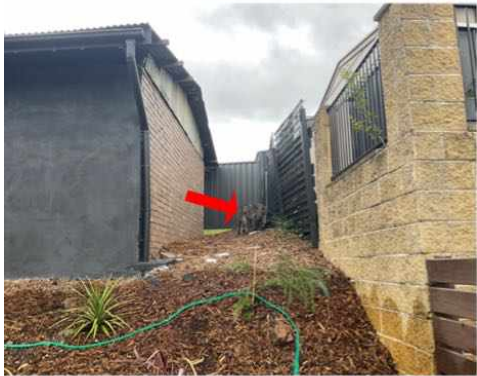
**Finding 6.03**

Building: Building 1  
 Location: Front yard  
 Finding: Tree stumps - left in ground  
 Information: Tree stumps left in ground provide opportunity for termite attack as they are likely to be subject to rot and decay providing an attractive food source. Treatment and/or Removal of the stump is highly recommended. A pest controller and tree removalist should be engaged to perform such works.

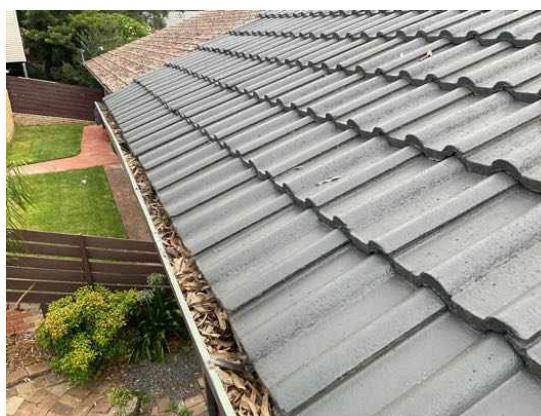
Blocked gutters are likely to lead to high levels of moisture in the affected areas. Such moisture will not only cause rust and decay of the associated building materials, but can also provide conditions that are conducive to termite and timber pest activity. Blockages in gutters should therefore be removed immediately to ensure dry conditions are maintained.

It is highly advised that gutters be cleaned by the homeowner or a general handyman as a matter of urgency.

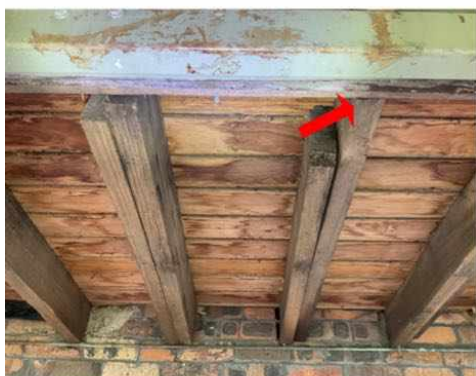
### Finding 7.01

Note - See ALL wood rot photos, all these show fungal decay.

In this case, some of the affected timber elements are in a decaying state and will need replacement by a carpenter or licensed builder.

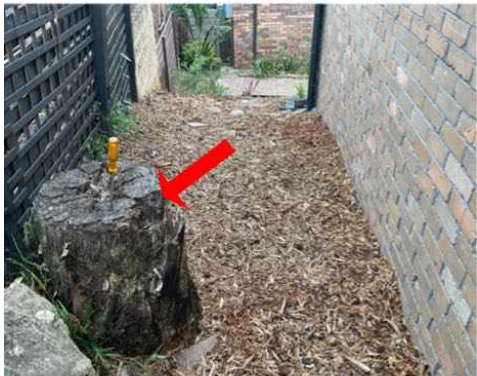
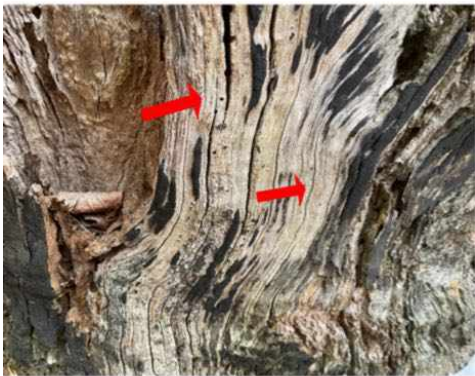
### Finding 8.01

As no live wood borer activity was identified treatment is not required at this time. Replacement of affected timbers may be considered by the client for superficial
