Building and Timber Pest Inspection Report

Inspection Date: Thu, 26 Feb 2026

Property Address: g6/6A Atkinson St, Liverpool NSW 2170,
Australia

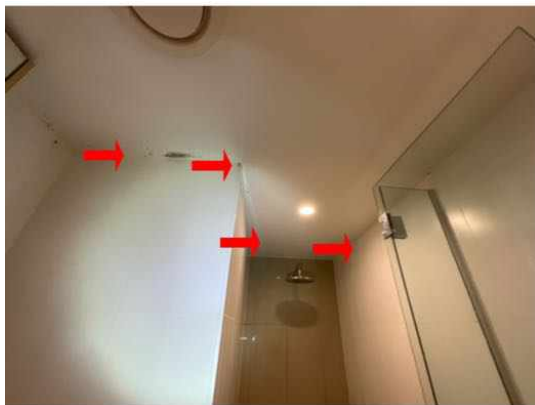
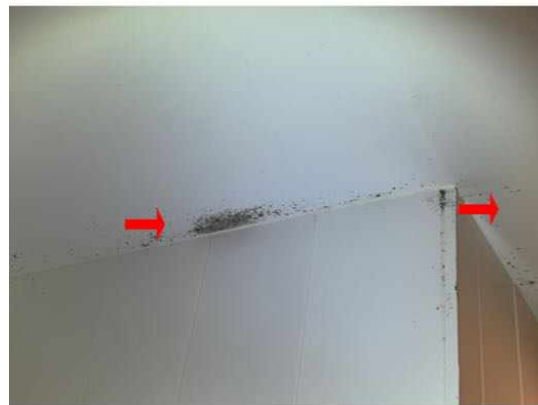
Finding 1.01

Building:	Main Building
Location:	Bathroom
Finding:	Mould present - Ventilation
Information:	Evidence of mould growth was noted, which is believed to have grown due to lack of ventilation to the area.

A safety hazard is due to mould. A mould remediation contractor is required to treat this mould urgently.

Generally, the client is advised to ensure that the general environment is free of moisture and humidity to aid in the prevention of mould formation and development. Any mould found during the inspection should be cleaned immediately by a cleaning contractor or the homeowner as applicable.

Although the exhaust fan was found to be working at the time of inspection, however a licensed electrician May be appointed to ensure the full exhaust fan operation.

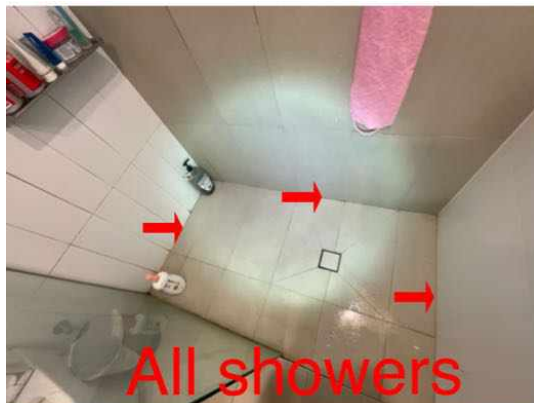
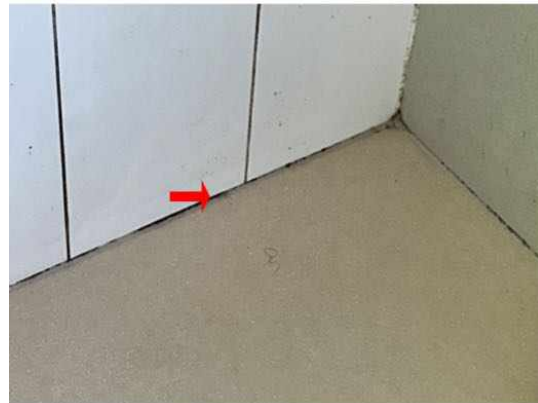
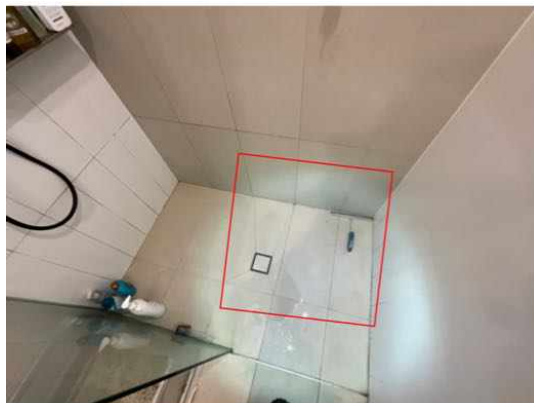
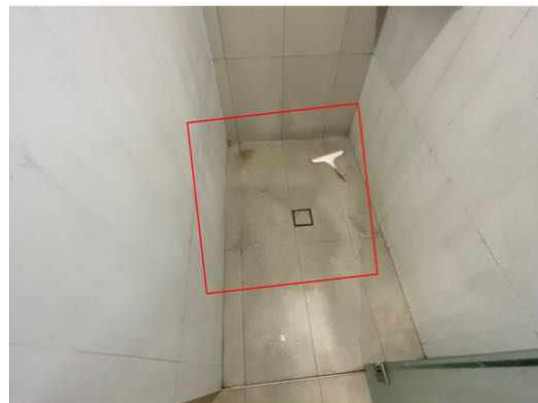
Finding 3.01

Building:	Main Building
Location:	All Wet Areas
Finding:	Sealant and grouting - Missing or damaged
Information:	It was noted on inspection that sealant or grout is degraded to this area.

Different materials and floor areas move at different rates, generally causing cracking to grout or sealant at this point. A flexible sealant is required to allow for expected expansion and contraction, while keeping the joint water tight and protective of all associated building materials.

Flexible and mould resistant materials should be applied to affected areas to prevent any subsequent water damage that is likely to occur. Regular maintenance and replacement of damage or missing or damaged sealant and grout is highly recommended to the wet areas, as this is a regular wear and tear defect. Sealant and grouting in areas that come into regular contact with water should be maintained for the long term care of your property.

A sealant specialist should be appointed to complete these works as soon as possible.

- Ensure wet area sealant and grouting is in serviceable condition

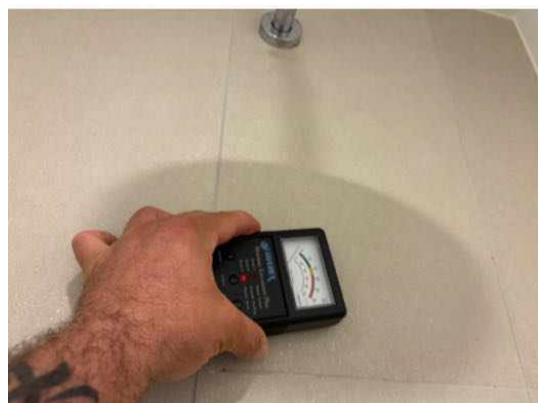
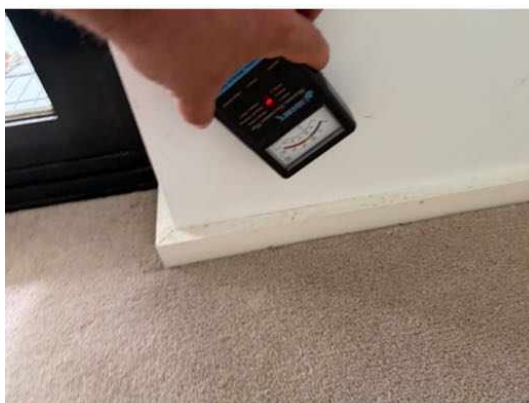
Building: Main Building
 Location: All Areas
 Finding: Moisture metre
 Information: During the inspection the property was checked for moisture using a moisture metre.

This is for information only.

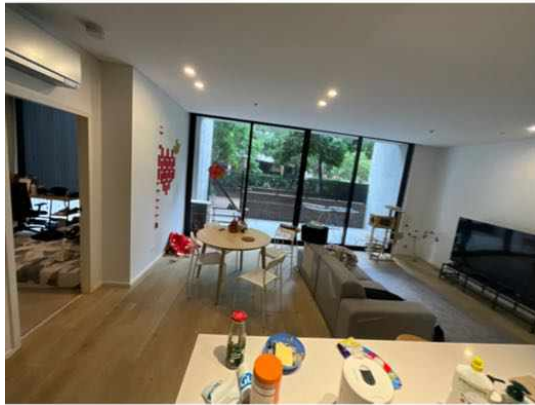
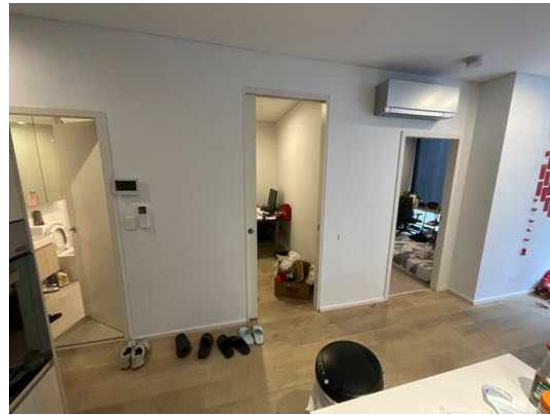
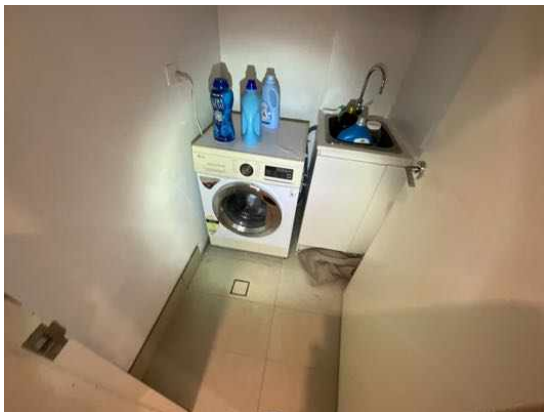
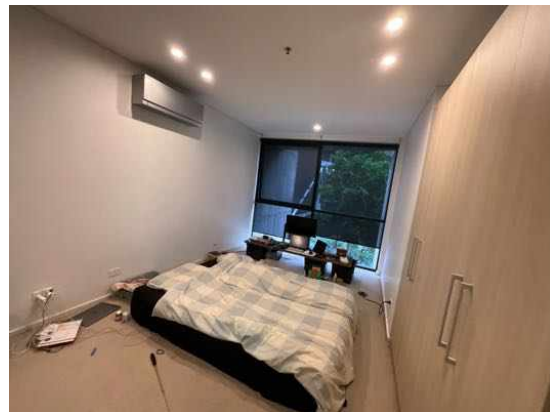
Building: Main Building
Location: All Areas
Finding: Additional Photos - Obstructions and Limitations
Information:

These photographs are an indication of the obstructions and limitations which impeded full inspection of the property at the time of inspection. These obstructions can hide an array of defects and should be removed to allow full inspection to be carried out. A re-inspection is recommended once the areas are made accessible.
