Building and Timber Pest Inspection Report

Inspection Date: Mon, 19 Jan 2026

Property Address: Unit 9/300 Jersey Rd, PLUMPTON, NSW,
2761, Australia

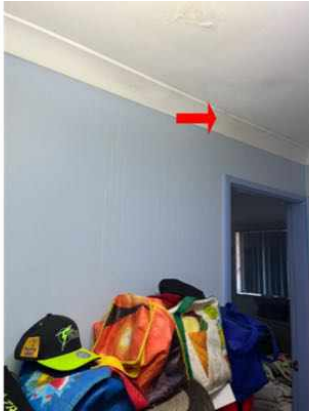
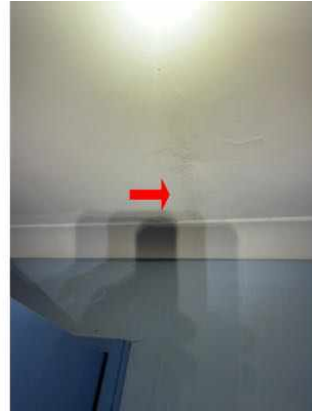
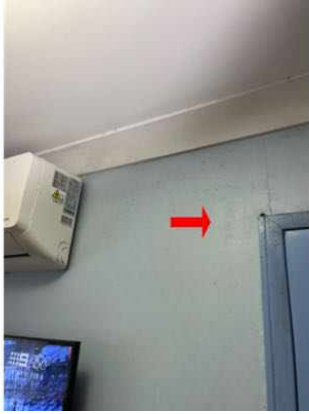
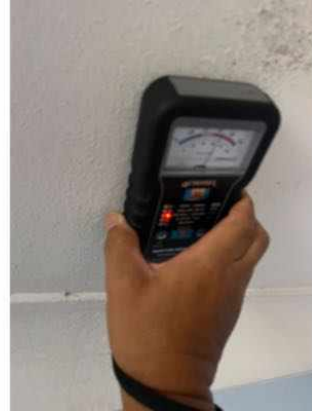
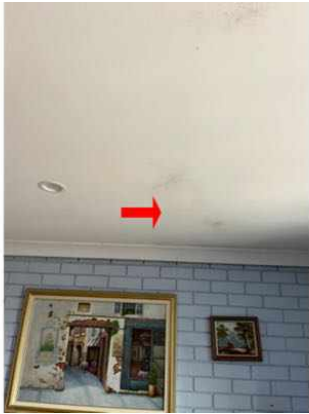
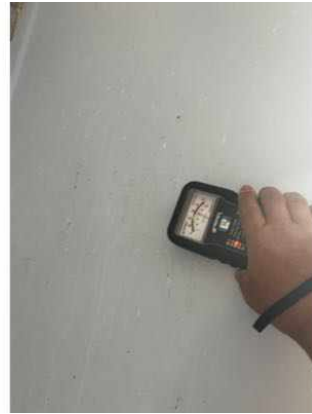
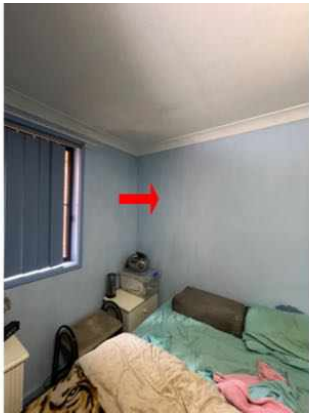
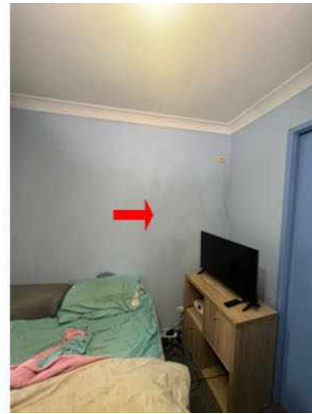
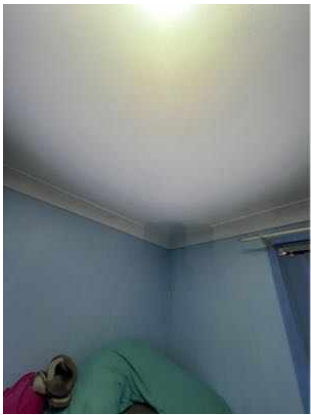
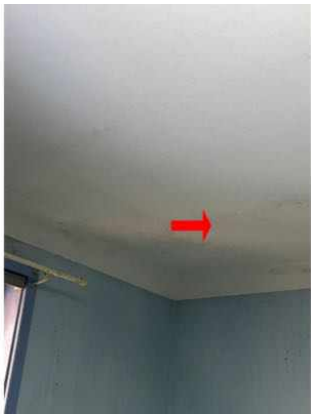
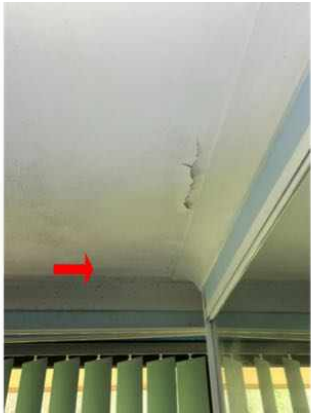
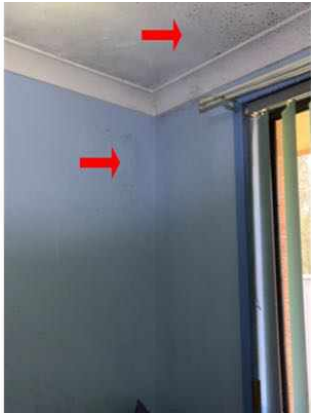
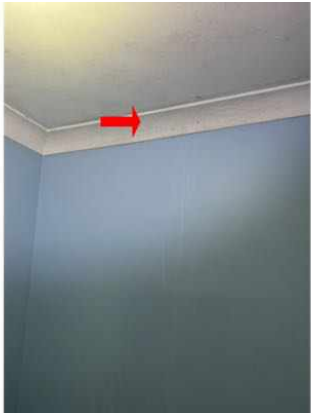
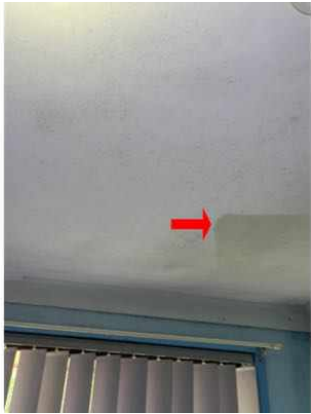
| Information: | Noticeable mould growth was observed throughout multiple rooms of the dwelling. The affected areas include ceiling surfaces, cornices, and upper wall sections, with visible black spotting, discolouration, and widespread staining. There is also clear evidence of previous damp penetration, including water stain marks on the walls, streaking, bubbled and delaminating paint to cornices and ceiling linings, and deterioration consistent with prolonged moisture exposure. Moisture metre readings taken during the inspection indicated high moisture levels in both the walls and ceilings, confirming the presence of elevated damp conditions at the time of assessment. |

The dwelling appears to have very limited ventilation, which is a significant contributing factor to mould formation and ongoing damp retention. Restricted air movement, combined with moisture ingress and high humidity, creates conditions favourable for mould growth and prevents drying of internal finishes.

Where mould growth of this extent is present, there may be associated environmental, biological, or health risks. A specialist inspection by a suitably qualified environmental health professional is recommended, particularly where questions regarding indoor air quality, spore levels, or occupant health concerns exist.

To assist in preventing further mould development, the client is advised to improve ventilation, eliminate sources of moisture, and maintain the internal environment in a dry condition. Any mould present should be cleaned promptly by a suitably qualified mould remediation contractor or by the homeowner where safe and appropriate. Severely affected building elements—including plasterboard linings, cornices, and paint finishes—may require repair or full replacement by a registered builder or qualified tradesperson once the underlying moisture issues have been rectified.

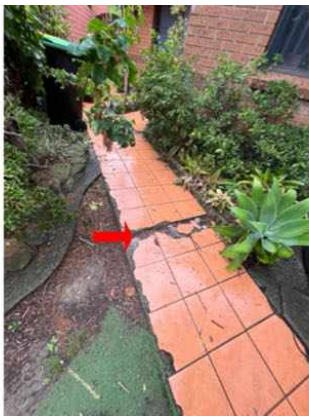
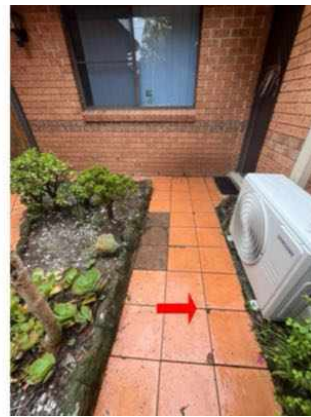
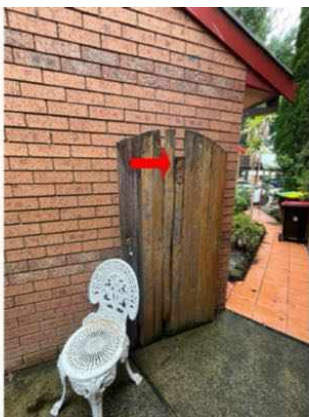
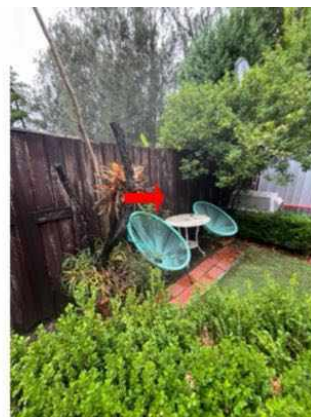
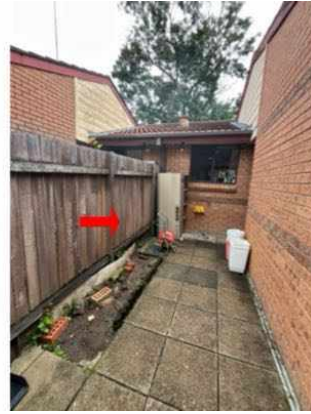
Building: Main Building
Location: All Areas
Finding: Deterioration caused by Fair and Wear and Tear

Information: Certain forms of deterioration commonly associated with fair wear and tear may not be specifically identified or itemised within this report. The external areas of the property display several age-related conditions typical for a dwelling of this era, including cracking and breakage to pathway tiles, displacement of pavers, general deterioration to timber boundary fencing, ageing and weathering to timber gates, and surface deterioration to fascia boards. These forms of degradation commonly occur over time due to ongoing weather exposure, ground movement, moisture cycles, and general usage, and they do not necessarily indicate defective workmanship or structural failure.

In accordance with the pre-inspection agreement, such minor and cosmetic conditions are generally excluded from detailed reporting unless they constitute a major defect, safety concern, or significant structural issue. Therefore, the absence of specific reference to these items should not be interpreted as confirmation that they are not present; rather, they fall within the scope of fair wear and tear and normal ageing typically expected for external elements such as tiled walkways, boundary fences, gates, landscaping interfaces, and fascia timbers.

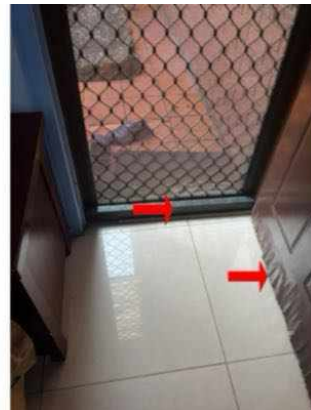
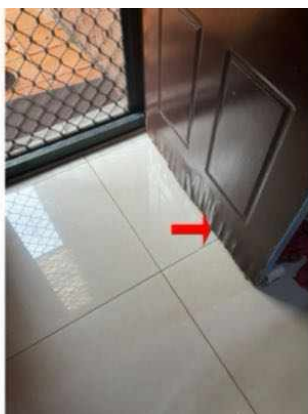
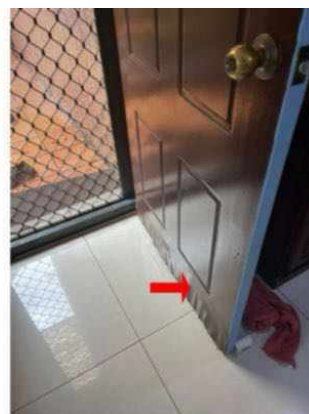
Finding 3.02

Information: The bottom section of the entry door shows visible swelling and distortion. This type of deterioration is typically caused by moisture absorption into the door substrate, resulting in expansion, delamination, or softening of the lower panel. The affected area displays warping and deformation, consistent with prolonged contact with moisture, poor weather protection, inadequate sealing, or past water ingress near the threshold. If left unmanaged, the condition may worsen over time, potentially affecting door operation, security, and overall durability.

Repair or replacement of the door, along with ensuring adequate weatherproofing around the doorway, is recommended to prevent further moisture-related deterioration.

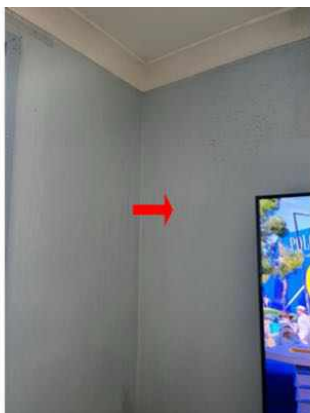
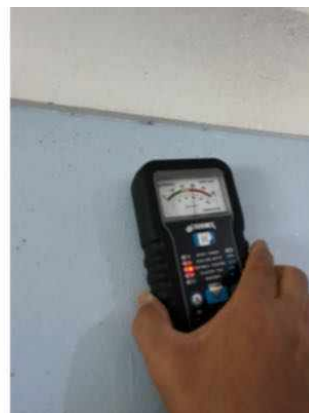
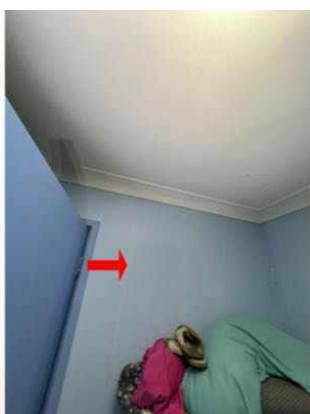
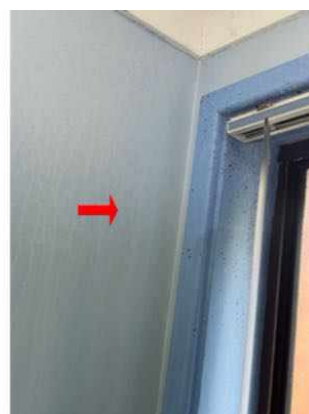
Finding 3.03

Finding: Walls - Water stained

Information: Water staining was evident to multiple wall and ceiling sections throughout the property at the time of inspection. The staining patterns, streaking marks, and discolouration observed on the internal linings indicate that these surfaces have been exposed to excessive moisture for an extended period. Associated deterioration such as bubbled paint, delamination of ceiling coatings, and darkened patches around cornices was also visible, consistent with ongoing or previous damp penetration. Moisture metre readings taken at various locations recorded high moisture levels in both walls and ceilings, confirming active moisture conditions within the internal building fabric.

These elevated moisture levels are of concern not only due to the deterioration of finishes but also because persistently damp environments are conducive to termite activity, particularly where moisture is retained within concealed wall cavities. Invasive inspection may therefore be required to determine whether hidden structural timber elements have been affected or remain at risk.

While water staining can sometimes be superficial, in this instance the widespread pattern across several rooms—together with mould growth, peeling ceiling finishes, and continuous damp streaking—suggests more significant underlying moisture issues that may be concealed behind wall linings. Where water staining is active, a licensed plumber or building professional should be engaged to identify the source of moisture ingress and provide recommendations for rectification works. Further evaluation of potential roof leaks, plumbing failures, inadequate ventilation, or external moisture entry is recommended.

Where building elements have been severely affected or have lost integrity, repairs or replacement by a qualified builder will be required once the moisture source has been rectified. Conversely, where staining is confirmed to be old and inactive, cosmetic repair or repainting may be undertaken at the client's discretion.

Given the extent of moisture and mould observed throughout the property, improving ventilation, identifying all sources of moisture, and undertaking a more invasive inspection are strongly recommended to prevent further deterioration and to assess any potential timber pest risk.

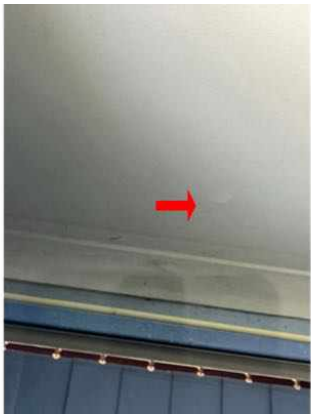
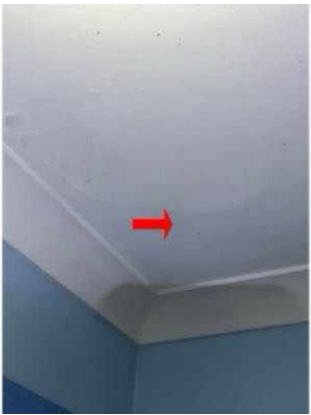
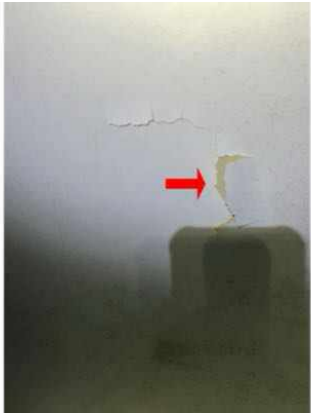
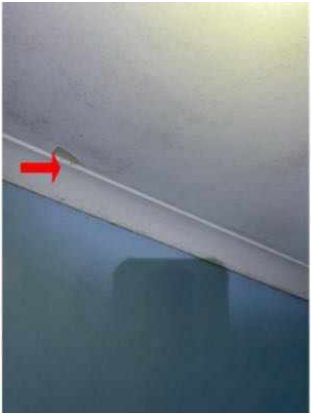
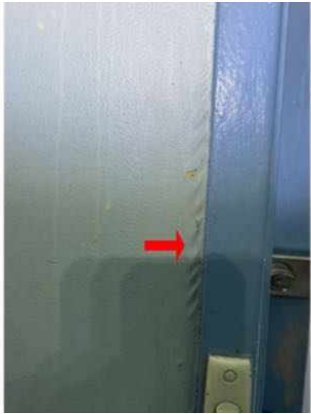
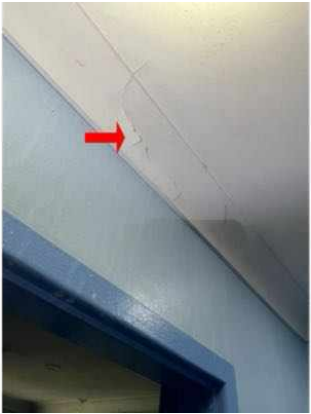
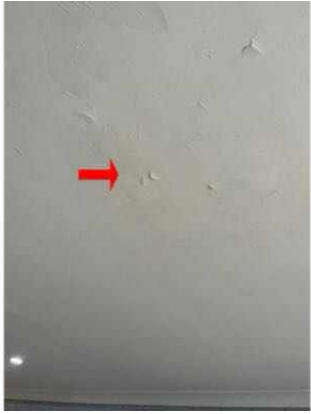
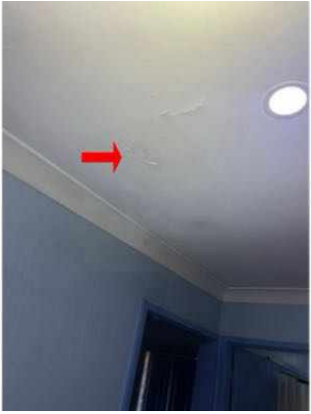
Finding 3.04

| Information: | Sections of paint in this area was found to have bubbled and deteriorated. Paint bubbling is generally an indication of excessive moisture in the area, that is currently hidden by the painted surface. |

The presence of excessive moisture can have major implications on associated building elements if left unattended. While only seemingly minor at this stage, the damage cannot be determined due to the paint obstructing any further inspection of the damage.

It is highly advised that the affected paint be cleaned to allow a further, more invasive inspection by a licensed plumber. Failure to act on this defect may necessitate major works in the future.

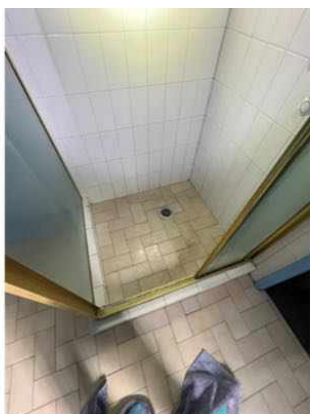
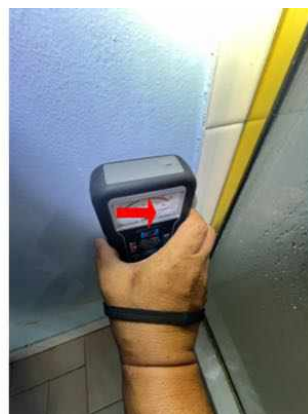
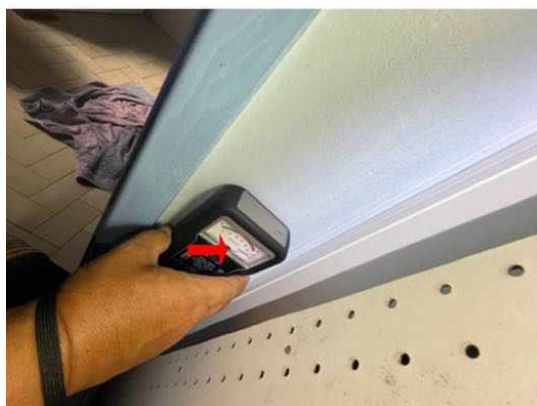
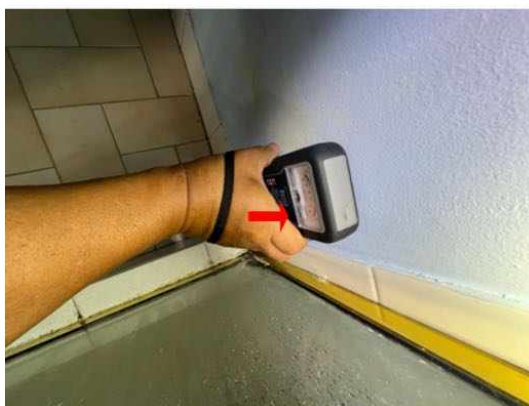
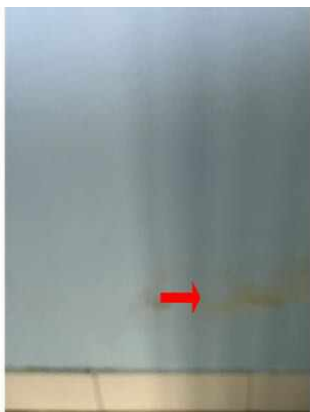
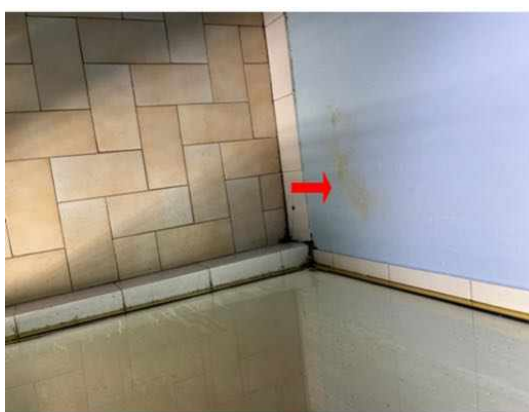
Finding 3.05

| Finding: | High Moisture Metre Readings - inadequate waterproofing is suspected |
| Information: | High moisture metre readings were recorded to the wall surfaces adjacent to the shower recess at the time of inspection, as shown in the supplied photographs. Elevated moisture levels in these locations strongly suggest that the waterproofing system to the wet area may not be performing as required under the relevant Australian Standards. Visible defects—including staining to lower wall sections, deteriorated tile junctions, cracking to skirting tiles, and gaps around the shower frame—further indicate that moisture has penetrated beyond the tiled surface and into non-water-resistant building materials. |

Incorrect or substandard waterproofing application is a common minor defect but can lead to significant deterioration when moisture is allowed to migrate behind wall linings. Ongoing exposure to moisture in these concealed areas may result in rot, mould growth, damage to adjoining rooms, and potential structural deterioration if left unaddressed.

Although widespread water damage was not visually evident externally at the time of inspection, the consistently high moisture readings must be treated as evidence of probable leakage. It is recommended that the area be considered as leaking until proven otherwise. Repair of the waterproofing membrane, or a targeted invasive inspection by a qualified waterproofing contractor or plumber, is strongly advised to determine the extent of concealed moisture and to prevent further deterioration.

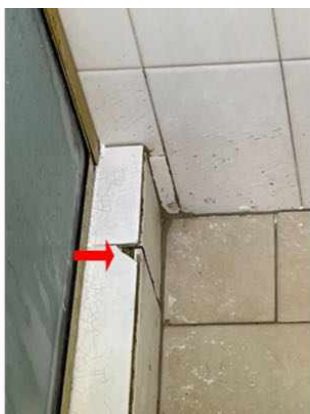
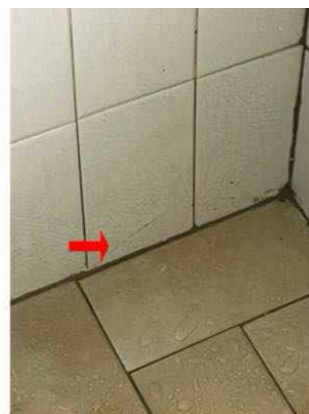
Finding 3.06

| Finding: | Cracked tiles in shower recess |
| Information: | Cracking was evident to the tiling in the shower recess at the time of inspection. While the cracking appears to be minor, this area is wet area it's frequently exposed to water, allowing potential for water penetration into adjoining sections of walls or flooring. If left unmanaged, water penetration to these areas may lead to subsequent water damage, which is likely necessitate repair work to affected building elements. A tiling contractor should be appointed urgently to ensure that no further water damage occurs. The re-application of silicone and grouting throughout remaining tile work is also advised, to further protect the area against water penetration. Where water penetration has led to water damage, appointment of a relevant tradesperson may be required to repair damaged building elements. |

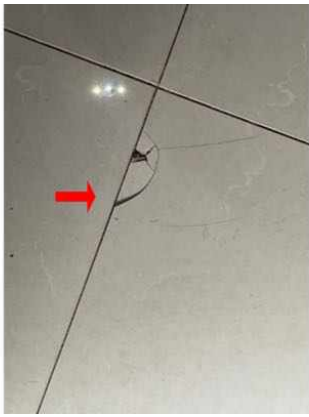
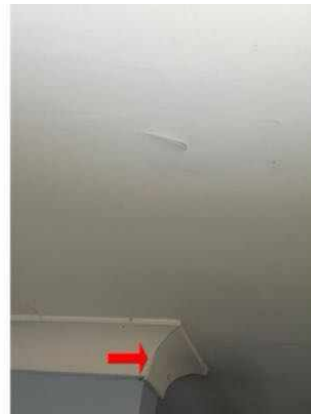
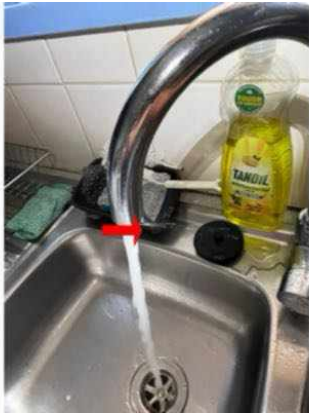
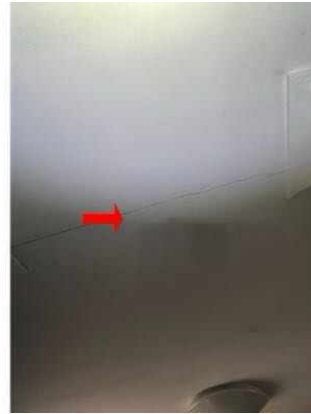
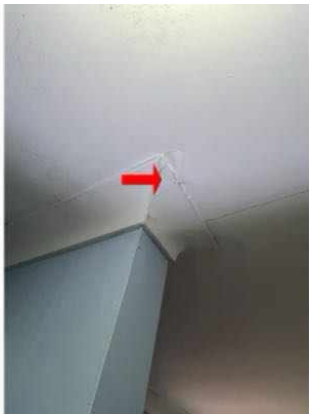
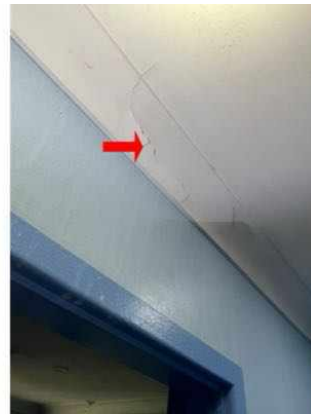
Finding 3.07

| Finding: | Deterioration caused by Fair and Wear and Tear |
| Information: | Certain forms of deterioration commonly associated with fair wear and tear were observed throughout the property. Conditions such as cracked floor tiles, deteriorated or loose tiles around the shower hob, minor displacement of wall tiles in wet areas, surface cracking to plaster linings, discolouration to wall surfaces, and age-related wear to junctions and trims are typical of older dwellings and do not necessarily indicate defective workmanship or structural failure. Localised impact damage and surface cracks to tiles are also evident in some areas, consistent with long-term use and general ageing. |

In accordance with the pre-inspection agreement, these minor and cosmetic conditions are generally excluded from reporting unless they constitute a major defect, safety risk, or significant structural concern. Their presence should therefore be considered part of normal wear and tear for a property of this type and era. The absence of specific reference to every instance of cracking, minor tile damage, grout deterioration, or plaster imperfections should not be taken to imply that such conditions do not exist; rather, they fall within the expected scope of ongoing ageing and general usage over time.

Where cracked or significantly deteriorated tiles occur in wet areas, periodic maintenance is recommended to prevent moisture entry into underlying surfaces. Repair or replacement may be undertaken at the client's discretion to improve appearance and function.

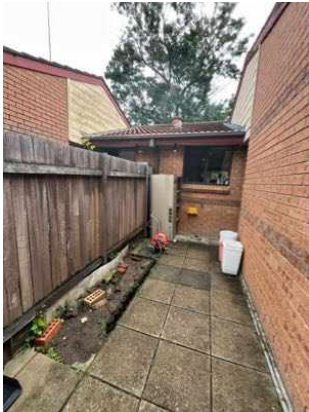
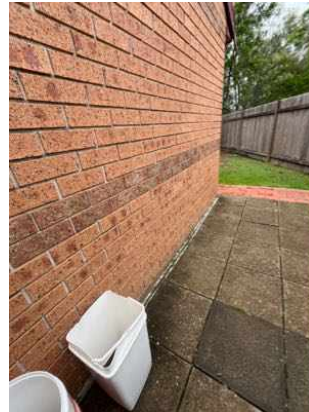
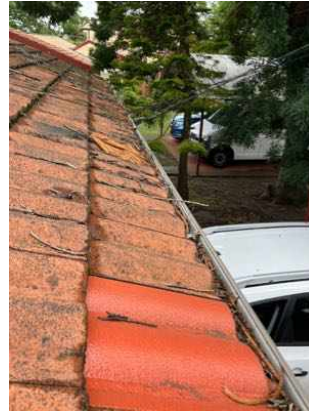
Building: Main Building
Location: All Areas
Finding: Conditions Conducive to Termite Activity
Information: The following areas and environmental conditions were identified as conducive to termite activity. These conditions increase the risk of concealed termite entry and should be addressed through appropriate maintenance, repairs, improved drainage, additional monitoring, or the installation of a compliant termite management system.

Inadequate Hot Water System (HWS) Overflow

The HWS overflow discharges directly to ground, resulting in constant moisture at the building perimeter. Excess moisture provides conditions favourable to termite activity.

Inadequate Air Conditioner Overflow Drainage

Air conditioner condensation lines discharging near walls can cause damp soil conditions, attracting termites.

Blocked gutters were noted to cause overflow, directing water onto walls and foundations. Excess moisture increases termite attractivity.

Elevated Moisture Meter Readings

Higher-than-normal moisture readings in wall or timber elements indicate hidden moisture sources and increased susceptibility.

Recommendation: Where no system exists, install a compliant termite management system and retain all documentation for future reference.

Recommendation: Connect the overflow to suitable stormwater drainage to divert water away from all structural elements.

Recommendation: Ensure AC overflow pipes are connected to appropriate stormwater drainage.

Recommendation: Clean and maintain gutters and downpipes regularly.

Recommendation: Investigate all sources of moisture and undertake immediate rectification.

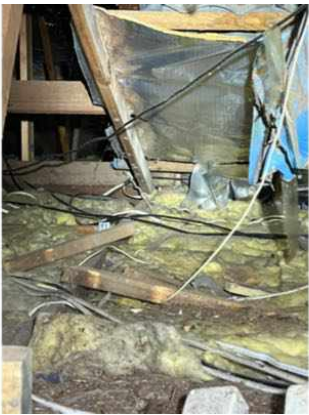
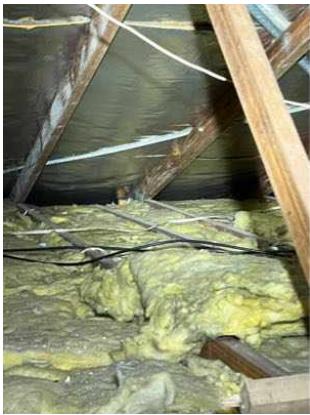
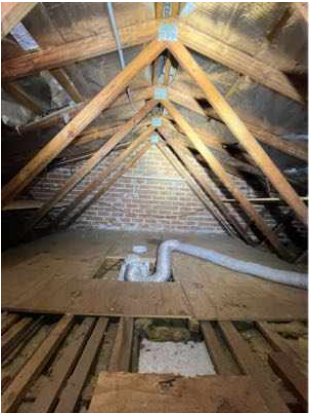
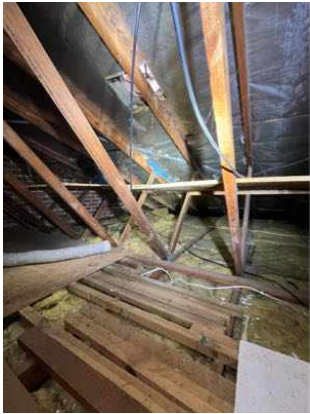
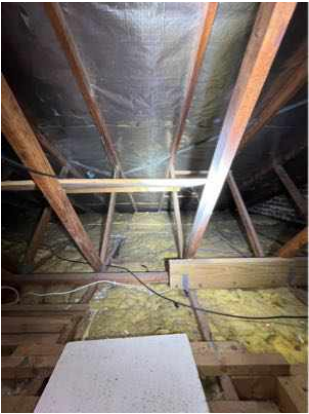
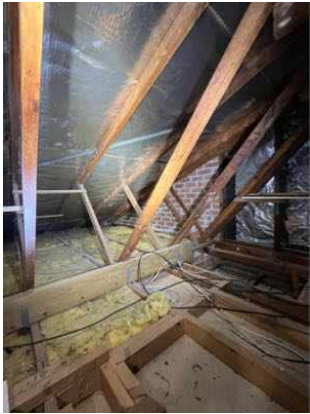
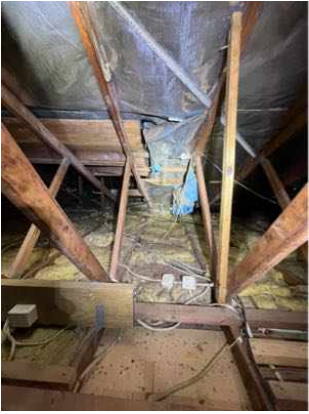
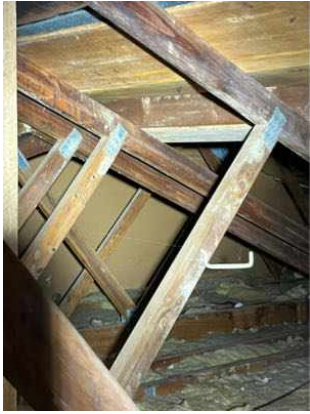
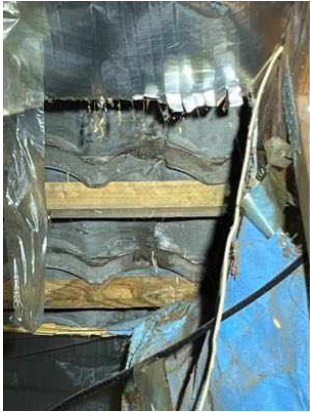
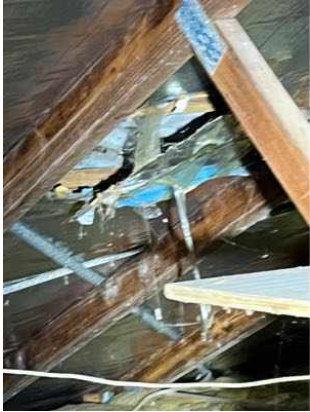
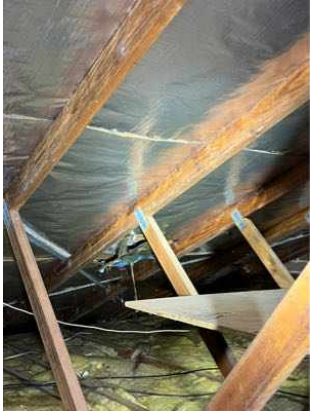
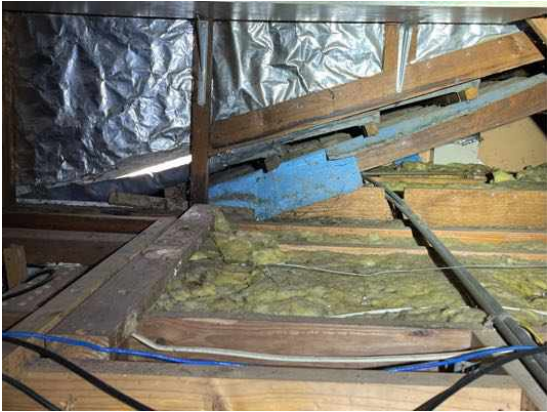
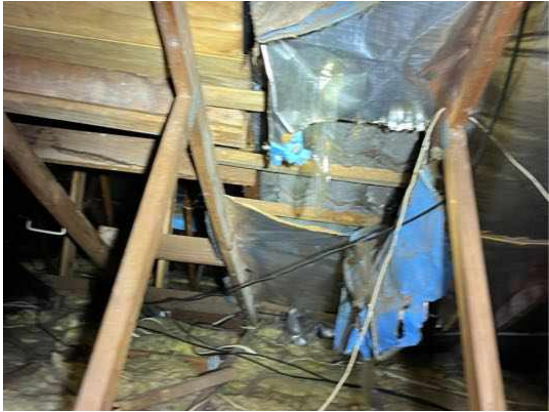
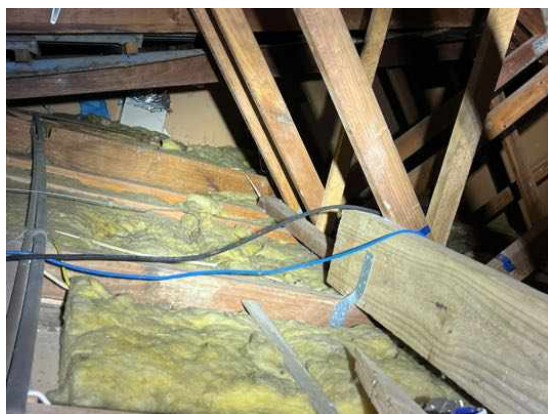
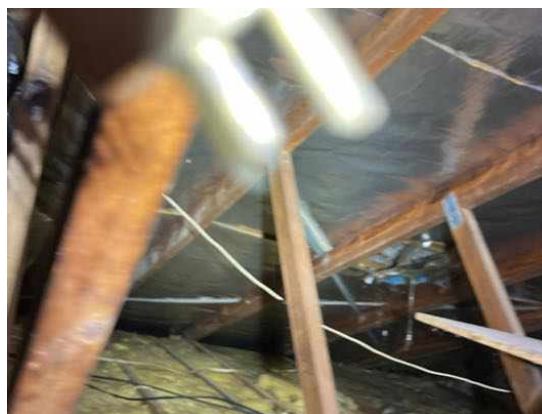
Building: Main Building
 Location: Roof Void
 Finding: Condition of Building Elements in the Roof Void
 Information: During the inspection of the roof void, numerous building elements were found to be in poor and deteriorated condition. Significant sections of the ceiling insulation were displaced, compressed, and contaminated with debris, reducing its thermal effectiveness. Several roof timbers exhibited moisture staining and darkened areas consistent with past or ongoing water ingress, particularly around sections of damaged sarking and torn reflective membrane.

The roof sarking was found to be extensively deteriorated in multiple locations, with large breaches, sagging sections, and delaminated areas exposing the underside of the roof sheeting. This deterioration increases the risk of roof leaks, reduces condensation control, and compromises the overall performance of the roof system.

Loose and unsecured electrical cabling was also noted across the joists, with cables draped haphazardly over framing members and insulation, representing a potential safety concern and not meeting best-practice installation standards. Numerous loose timbers, old construction offcuts, and accumulated debris were present throughout the roof void, contributing to restricted access and limiting safe inspection of concealed areas.

Some framing elements showed signs of past movement, with visible distortion and moisture-affected surfaces in the vicinity of older roof penetrations and repair patches. Vent ducting was also poorly supported in areas, with sections of flexible ducting resting on the insulation rather than being adequately suspended.

Overall, the roof void displayed a combination of aged materials, inadequate maintenance, moisture impact, and substandard service installation, and further assessment by appropriate licensed trades is recommended to identify required repairs and reinstate safe and compliant conditions within the space.

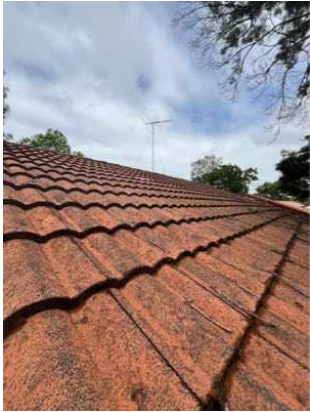
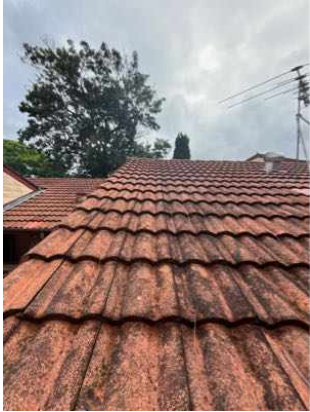
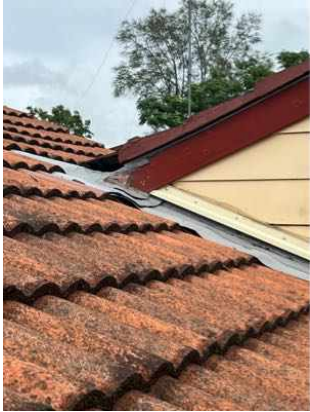
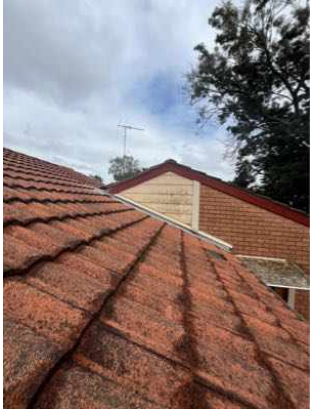
Building: Main Building
 Location: Roof Exterior
 Finding: Condition of Building Elements in the External Roof
 Information: Upon completion of the inspection, the tiled roof surface was found to exhibit general age-related wear, including widespread moss and lichen growth, organic debris accumulation and discolouration consistent with a roof of this vintage. Numerous roof tiles displayed minor chipping and surface erosion, and a small number were identified as displaced or poorly seated, which may reduce the roof's weatherproofing capability during periods of heavy rainfall.

Gutters in several sections were obstructed with leaf litter and debris, preventing effective drainage and increasing the risk of overflow into eaves and wall cavities if left unmaintained. Flashings around roof junctions and penetrations showed signs of previous patching and weathering and may not be providing optimal moisture protection.

While no active leaks were noted at the time of inspection, the overall condition indicates that routine maintenance is necessary, including cleaning of gutters, reinstating displaced tiles, and sealing or upgrading junction flashings to ensure the roof continues to perform as intended. Periodic monitoring is recommended, and a roofing contractor should be engaged to address these maintenance items.
