# Building and Timber Pest Inspection Report VR

Inspection Date: Tue, 3 Mar 2026

Property Address: 11 Woodford St, Brushgrove NSW 2460,  
Australia

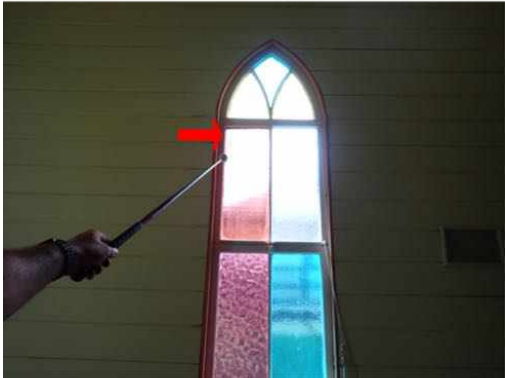
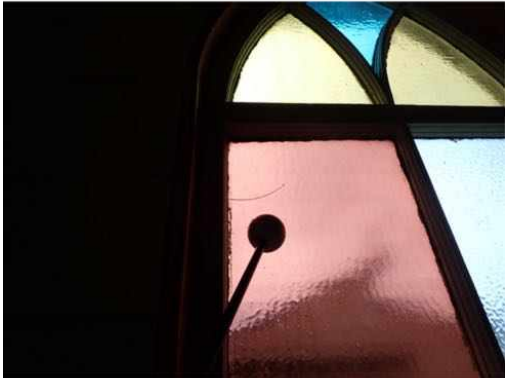
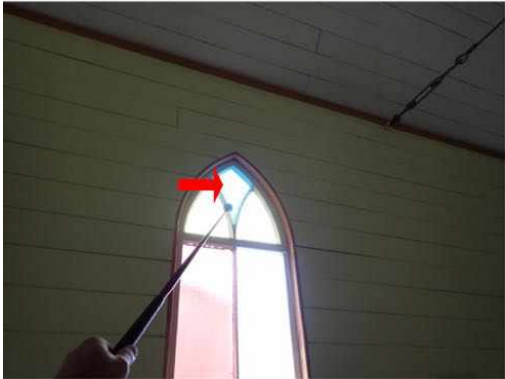
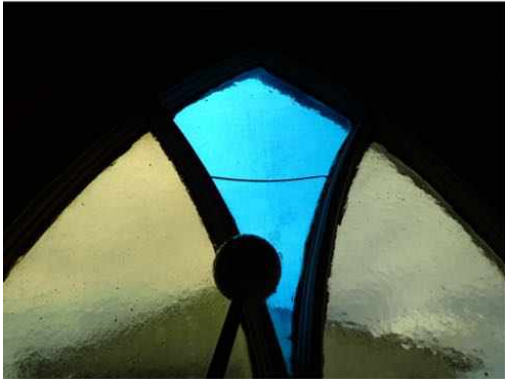
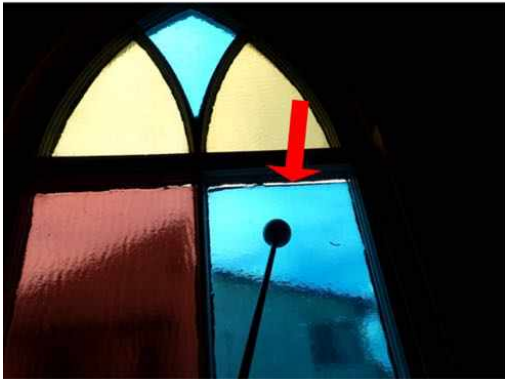
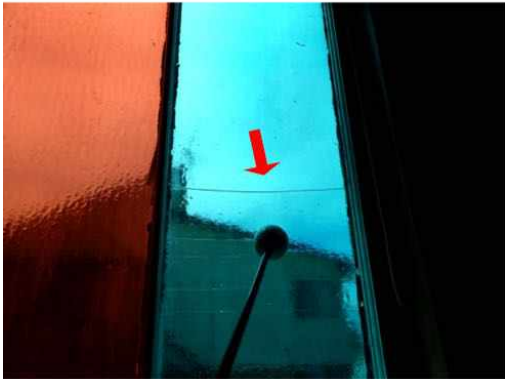
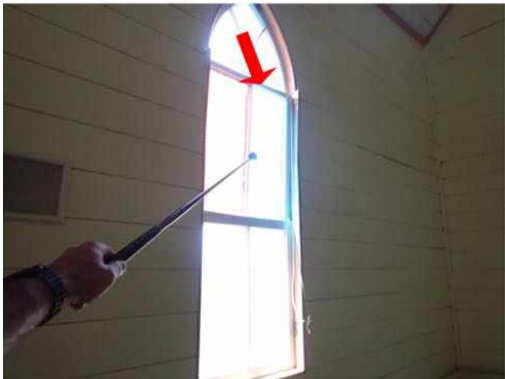
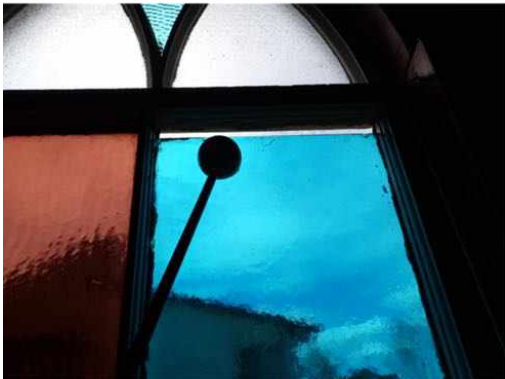
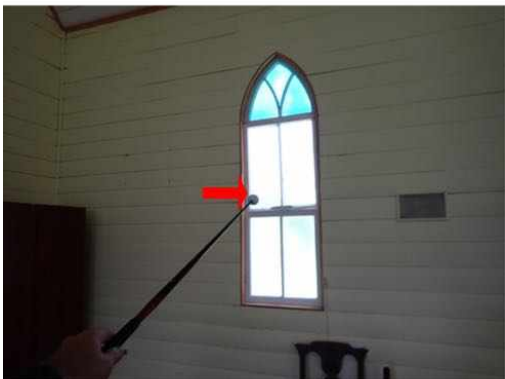
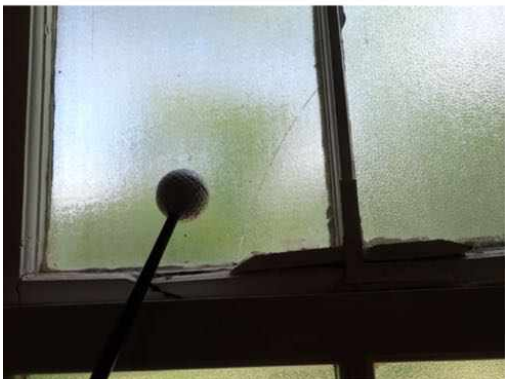
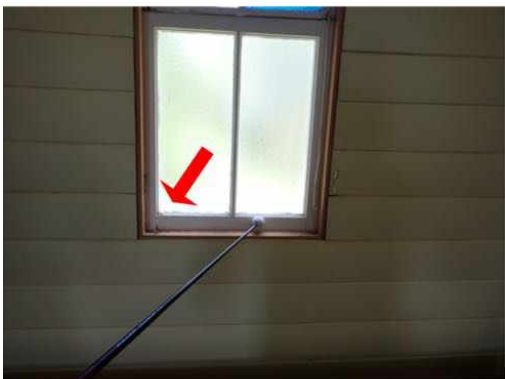
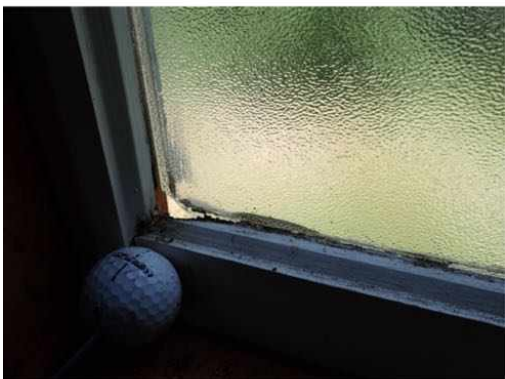
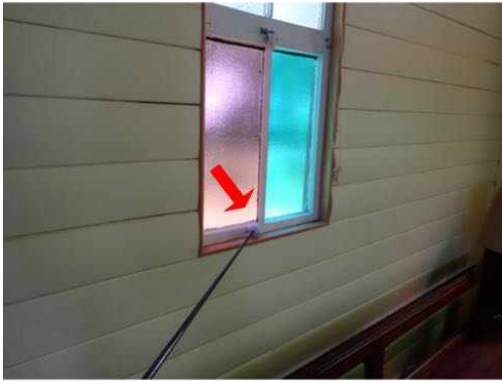
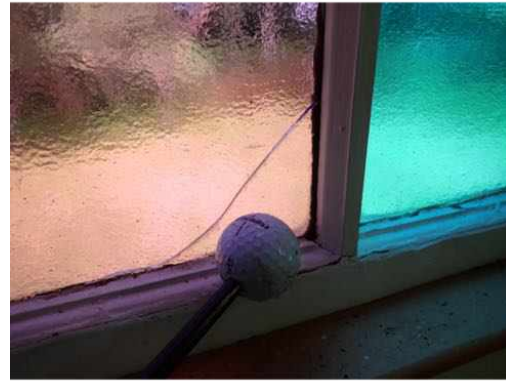
#### Finding 1.01

Building: Main Building  
Location: Windows  
Finding: Cracked Window Panes Throughout the Building  
Information: Several cracks were identified to window panes at multiple locations throughout the building. Cracked glass may worsen over time and may affect the weatherproofing and safety of the windows if left unaddressed. Replacement of the damaged panes is recommended. Repairs should be carried out by a licensed glazier or suitably qualified tradesperson.

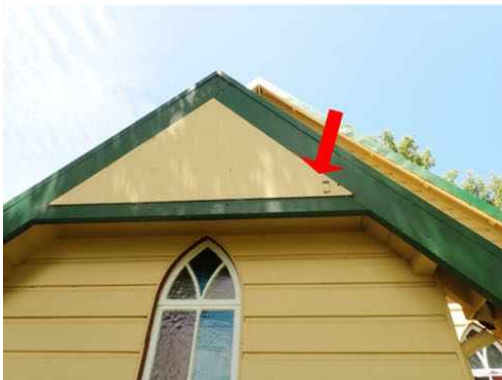
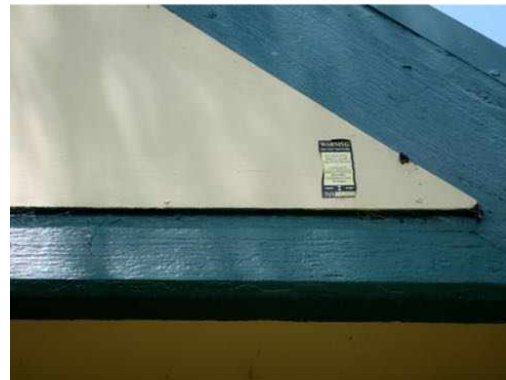
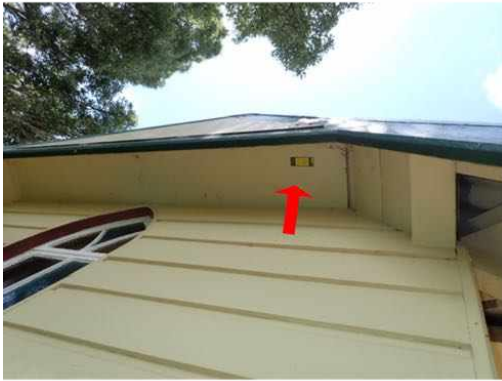
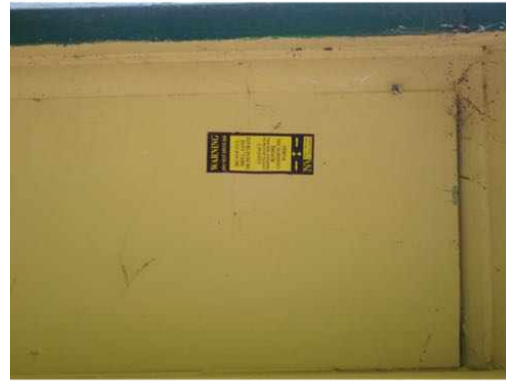
### Finding 1.02

Building:	Main Building
Location:	Front cladding and eave sheets
Finding:	Suspected Asbestos Containing Material Identified
Information:	Materials suspected to contain asbestos were identified at the property. Asbestos-containing materials were commonly used in buildings of this age and may be present in various building components. Disturbance or deterioration of asbestos-containing materials may pose a health risk if fibres become airborne. Confirmation of the material type can only be determined through laboratory testing. Any handling, removal, or disturbance of suspected asbestos materials should be carried out by a licensed asbestos contractor or suitably qualified professional in accordance with relevant safety regulations.

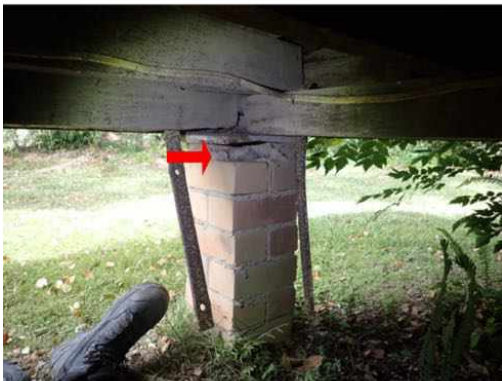
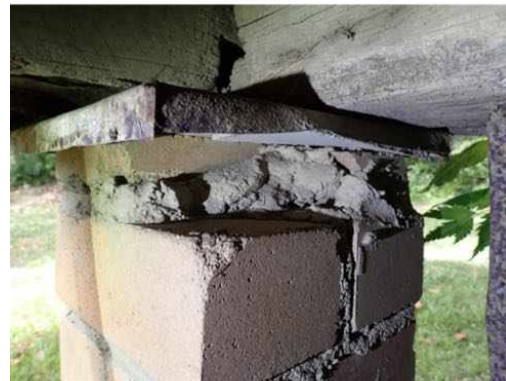
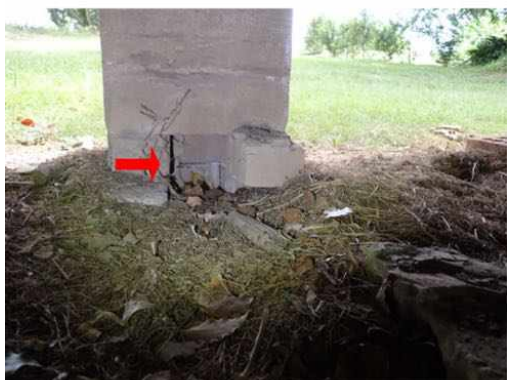
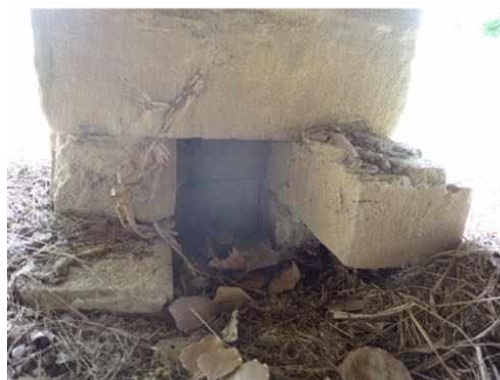
### Finding 2.01

Building:	Main Building
Location:	Subfloor
Finding:	Missing Bricks to Brick Piers
Information:	Missing bricks were identified to two brick piers. The absence of bricks may affect the stability and load distribution of the piers and may lead to further structural deterioration if left unaddressed. Repair is recommended including reinstatement of the missing bricks and making good to the affected piers. Repairs should be carried out by a licensed builder, bricklayer, or suitably qualified tradesperson.

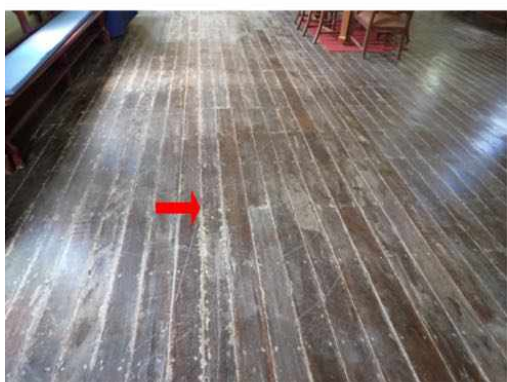
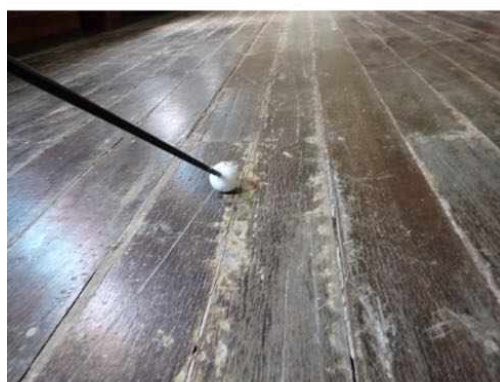
### Finding 2.02

Building:	Main Building
Location:	Flooring
Finding:	Timber Flooring – Average Condition
Information:	The timber flooring was found to be in average overall condition at the time of inspection. General wear and age-related deterioration were noted, which are commonly associated with a property of this age. Ongoing maintenance may be required over time to maintain the condition and serviceability of the flooring. Repairs or refinishing, should be carried out by a licensed builder, carpenter, flooring contractor, or suitably qualified tradesperson.

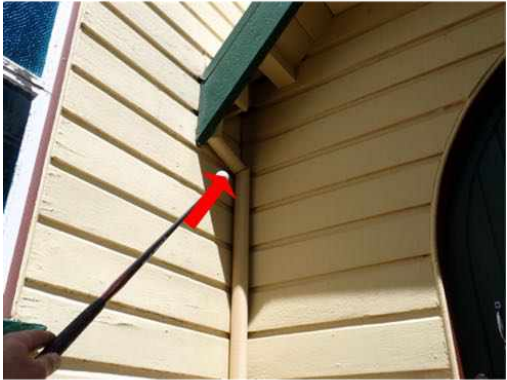
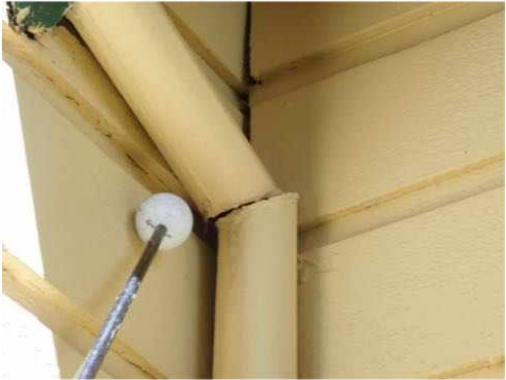
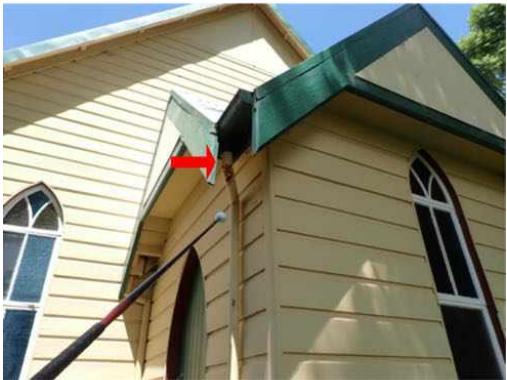
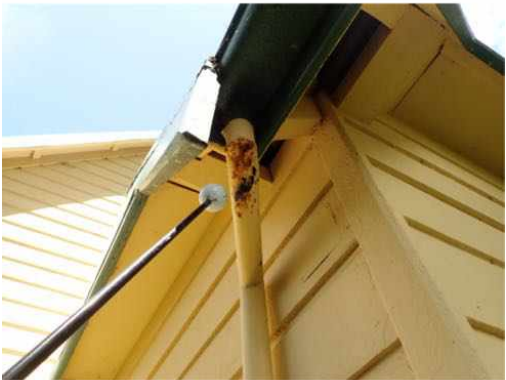
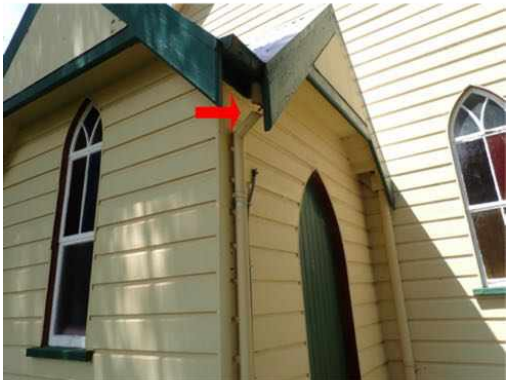
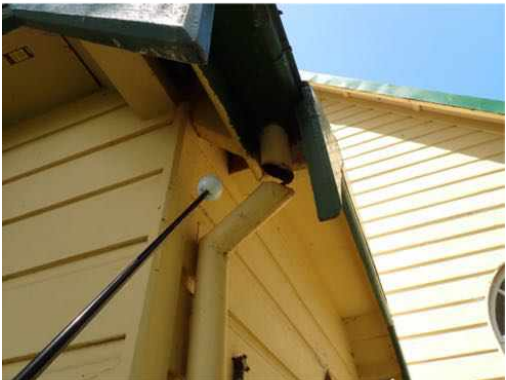
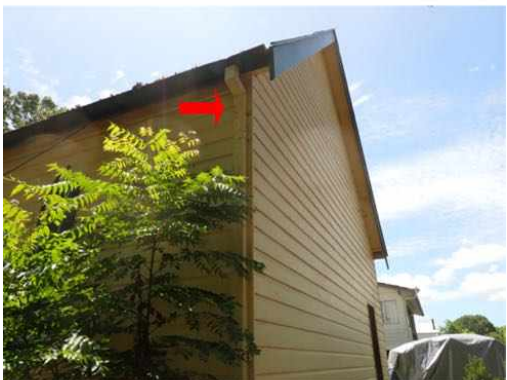
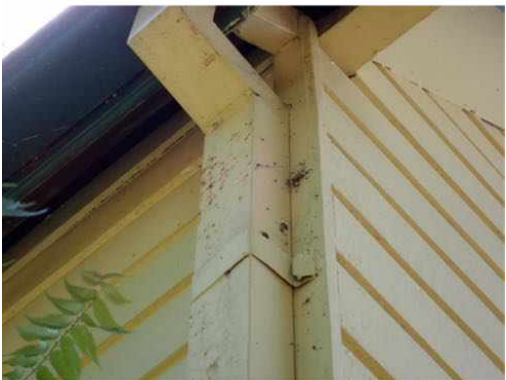
### Finding 2.03

Building:	Main Building
Location:	Down pipes
Finding:	Rust and Damage to Downpipes
Information:	Rust and physical damage were identified to sections of the downpipes. Deterioration of metal downpipes is commonly associated with prolonged exposure to weather and moisture and is a common defect with a property of this age. If left unaddressed, corrosion and damage may worsen over time and affect the effectiveness of the stormwater drainage system. Repair or replacement of the affected sections is recommended. Works should be carried out by a licensed plumber or suitably

qualified tradesperson.

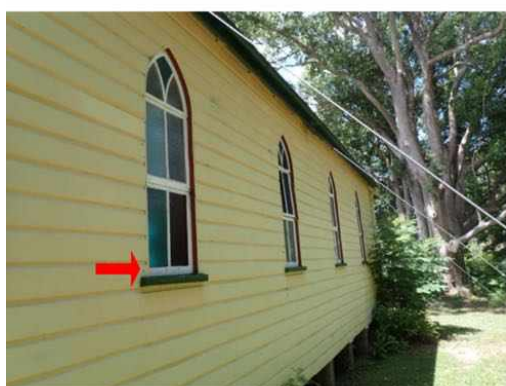
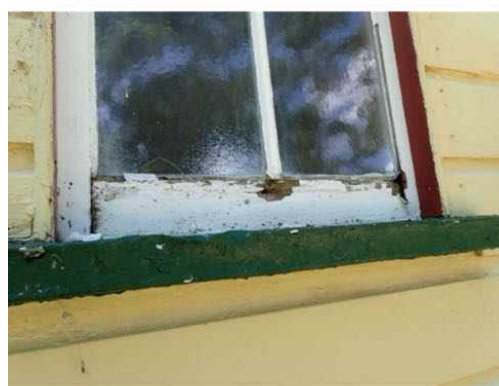
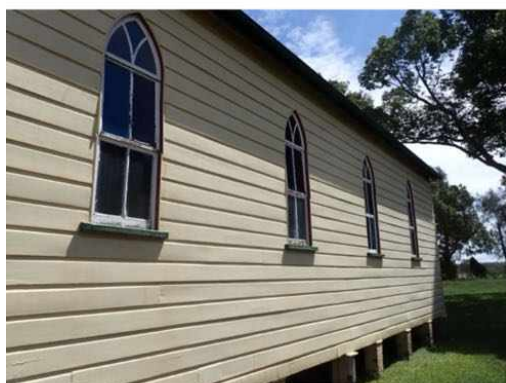
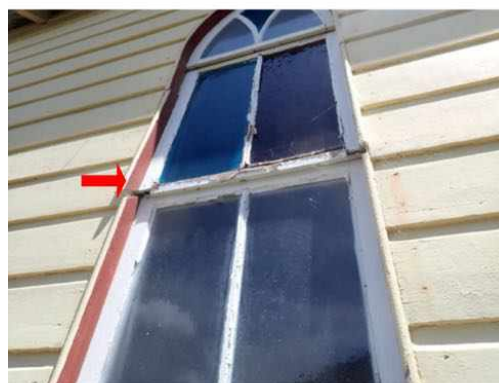
## Finding 2.04

Building:	Main Building
Location:	Windows
Finding:	Wood Rot and Deterioration to Windows
Information:	Wood rot and general deterioration were identified to timber components of the majority of the windows. Timber decay is commonly associated with prolonged exposure to moisture and weathering and is a common defect with a property of this age. If left unaddressed, the deterioration may worsen over time and affect the operation and integrity of the window frames. Repair or replacement of the affected timber components is recommended. Works should be carried out by a licensed builder, carpenter, or suitably qualified tradesperson.

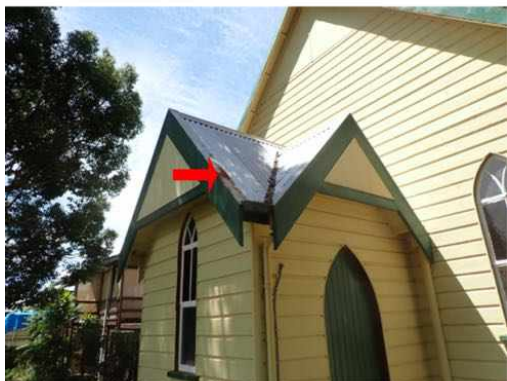
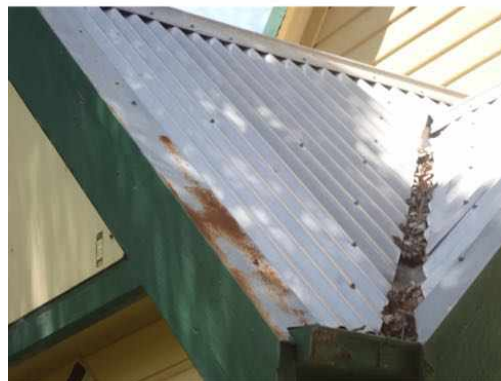
### Finding 3.01

Building:	Main Building
Location:	Roof
Finding:	Rust to Front Roof Flashings
Information:	Rust was identified to the roof flashings at the front of the building. Corrosion to metal

flashings is commonly associated with prolonged exposure to weather and moisture and is a common defect with a property of this age. If left unaddressed, the deterioration may worsen over time and may allow moisture ingress around the roof junctions. Maintenance including treatment, sealing, or replacement of affected flashings as required is recommended. Repairs should be carried out by a licensed roofer or suitably qualified tradesperson.

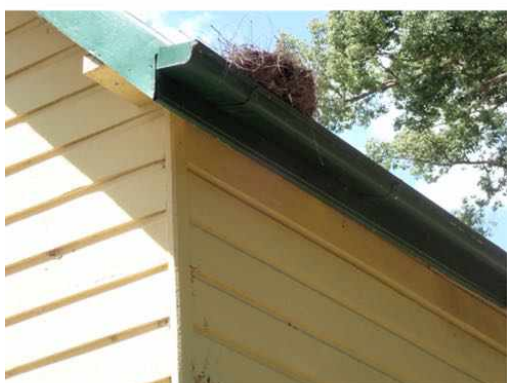
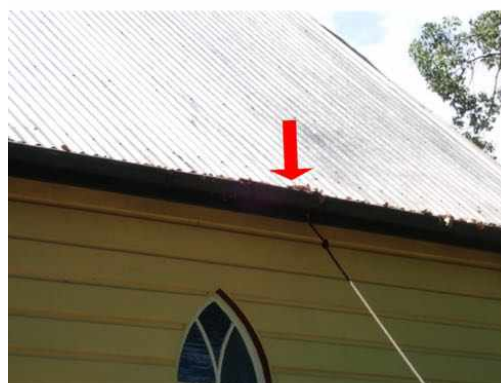
### Finding 3.02

Building: Main Building

Location: Gutters

Finding: Blocked Gutters

Information: Gutters were found to be blocked with debris at the time of inspection. Blocked gutters may restrict the flow of rainwater and can lead to overflow, which may contribute to moisture damage to the building over time. Regular cleaning and maintenance of the guttering system is recommended to ensure effective drainage. Works should be carried out by a licensed roof plumber, gutter contractor, or suitably qualified tradesperson.

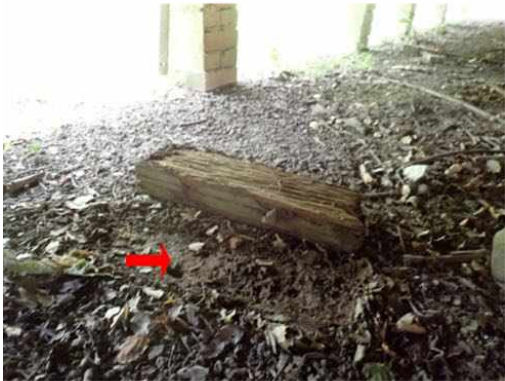
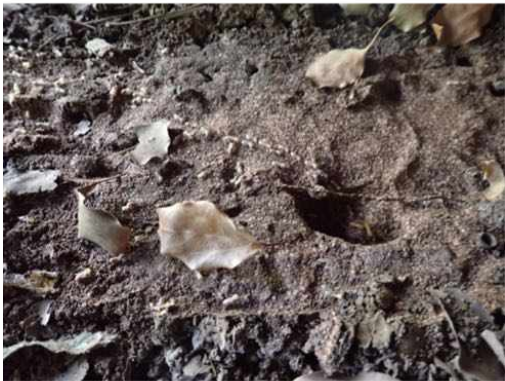
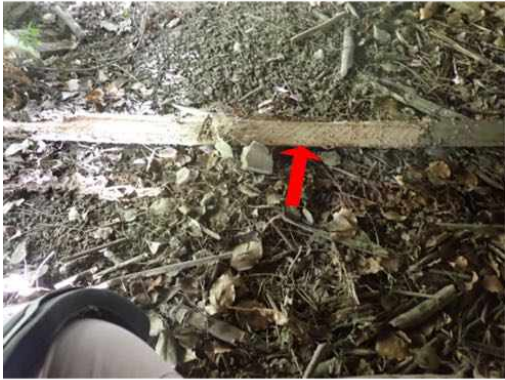
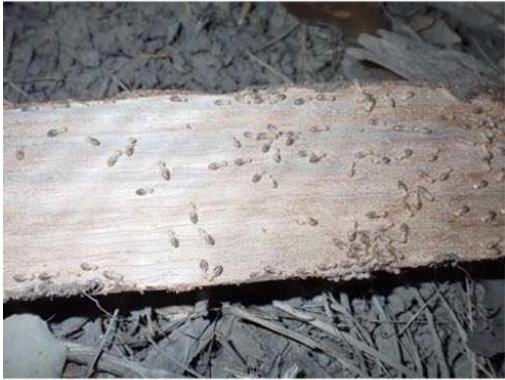
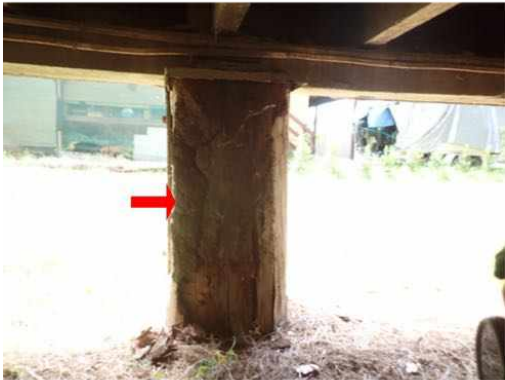
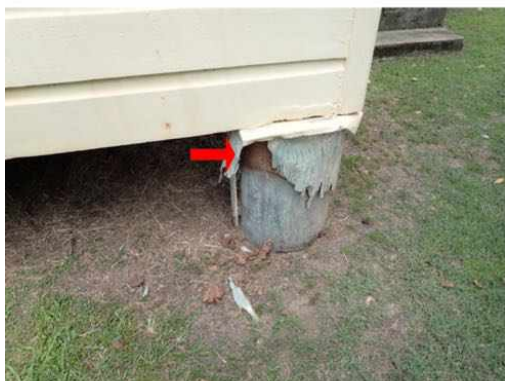
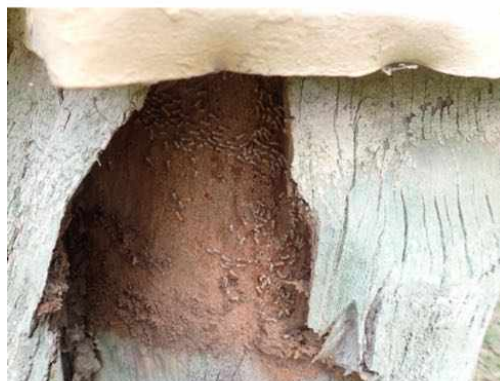
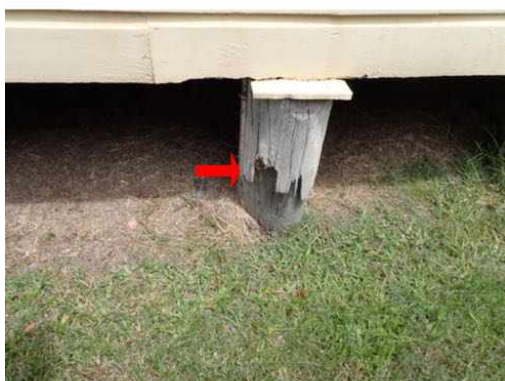
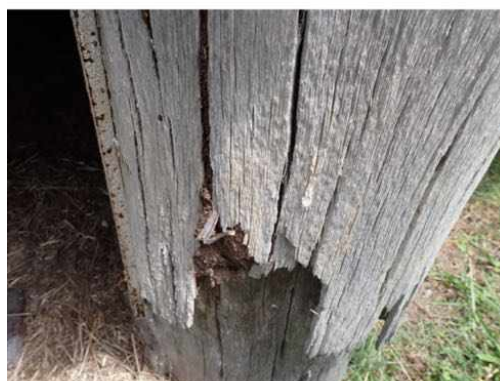
### Finding 4.01

Building: Main Building  
Location: Subfloor  
Finding: Termite Activity Identified to Loose Timbers and Timber Stumps in Subfloor  
Information: Termites were identified to several loose timbers located on the ground within the subfloor area and to all three timber stumps. Active termite presence indicates a risk of damage to structural timber elements within the building if left untreated. Further invasive inspection of concealed areas of the building is recommended to gain a better understanding of the extent of termite activity and any associated damage that may not be visible at the time of inspection. Treatment and further assessment should be carried out by a licensed timber pest specialist, with repairs to any damaged structural elements undertaken by a licensed builder or suitably qualified tradesperson.

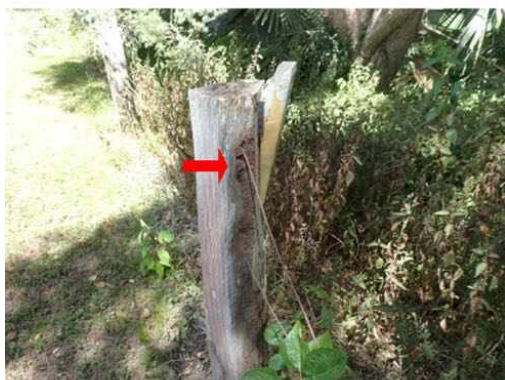
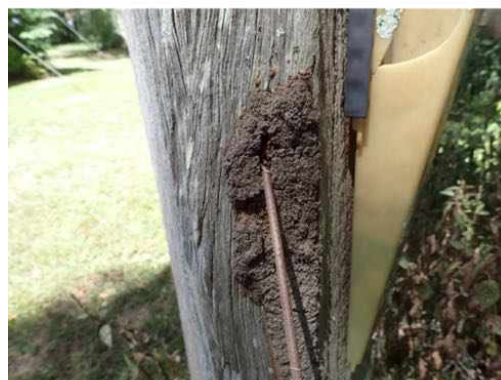
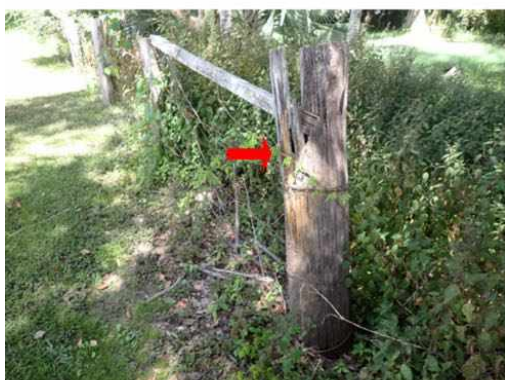
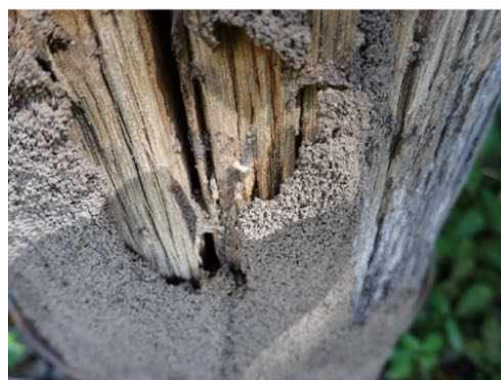
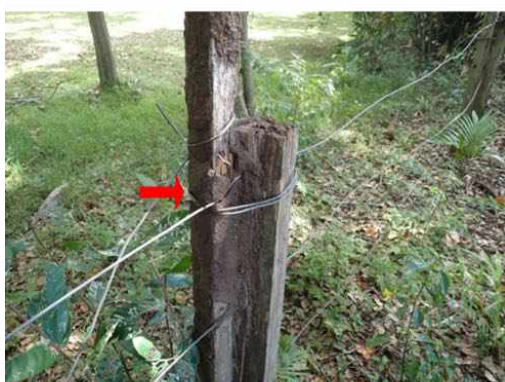
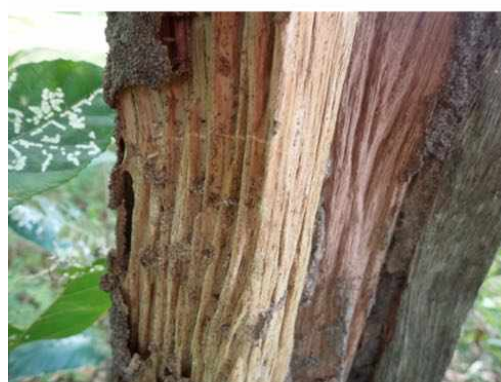
### Finding 4.02

Building:	Yard
Location:	Boundary fences
Finding:	Termite Damage to Timber Fence Post
Information:	Termite damage was identified to several timber fence posts at multiple locations around the property. Timber fence posts in ground contact are particularly susceptible to termite attack and deterioration over time. The affected posts may continue to weaken and deteriorate if left unaddressed. Repair or replacement of the damaged fence posts is recommended. Works should be carried out by a fencing contractor, carpenter, or suitably qualified tradesperson in conjunction with advice from a licensed timber pest specialist.

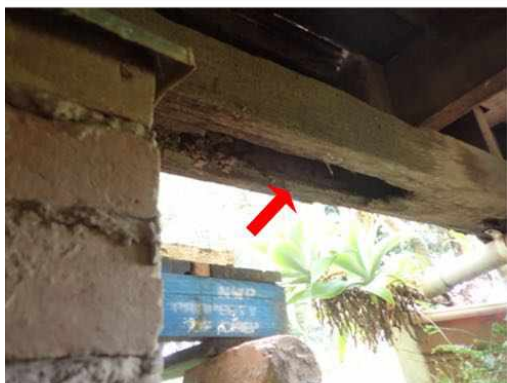
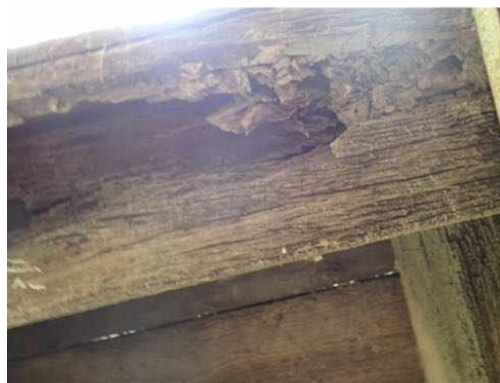
### Finding 5.01

Building:	Main Building
Location:	Subfloor
Finding:	Timber Pest Damage and Wood Rot to Subfloor Area at Front of Building
Information:	Timber pest damage and wood rot were identified to timber elements within the subfloor area at the front of the building. The deterioration of timber may affect the structural integrity of the affected components if left unaddressed. Timber decay and pest damage can occur over time due to moisture exposure and termite activity.

Further assessment including invasive inspection of concealed areas is recommended to determine the full extent of the damage. Treatment and repairs should be carried out by a licensed timber pest specialist and licensed builder or suitably qualified tradesperson.

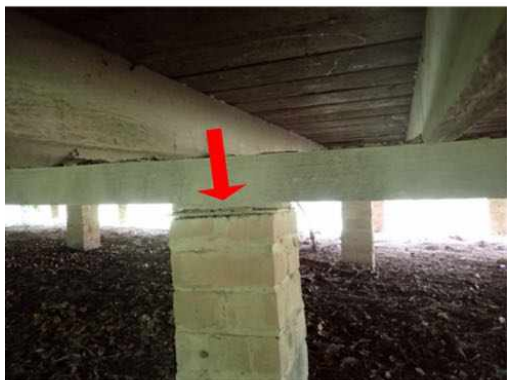
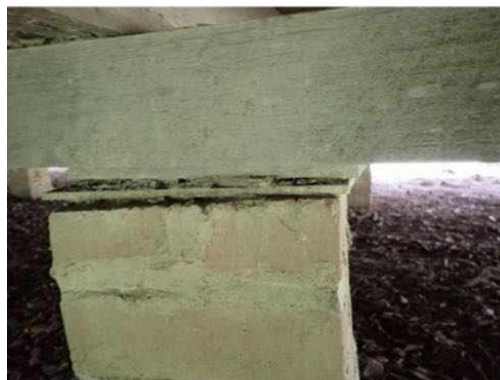
#### Finding 6.01

Building: Main Building  
 Location: Subfloor  
 Finding: Missing or Insufficient Ant Caps to Brick Piers and Timber Stumps  
 Information: Several missing and/or insufficient ant caps were identified to the brick piers and timber stumps. Ant caps are designed to assist in the detection and deterrence of termite activity by forcing termites to the outside of the structure where they can be more easily identified. Missing or inadequate ant caps may allow concealed termite entry to the subfloor structure. Installation or replacement of appropriate ant caps is recommended to improve termite management and detection. Works should be carried out by a licensed builder or suitably qualified tradesperson in conjunction with advice from a qualified timber pest specialist.

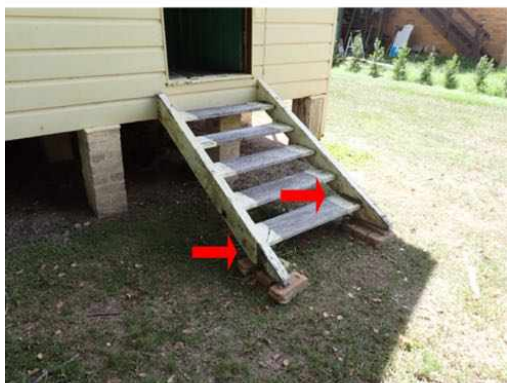
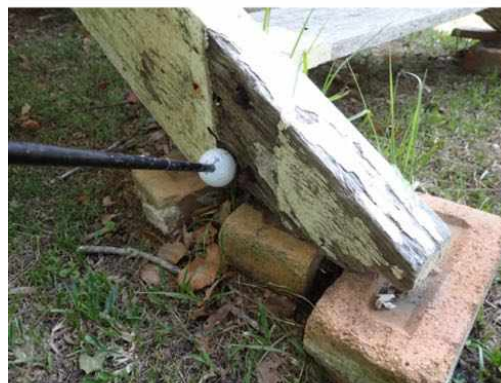
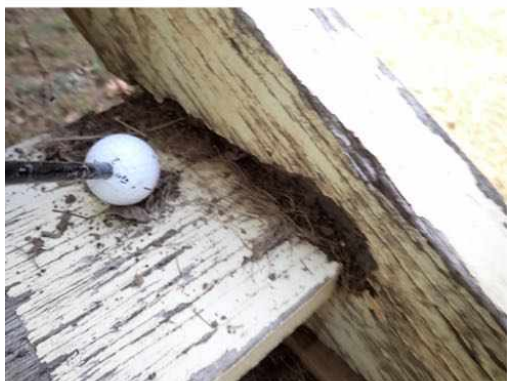
### Finding 7.01

Building:	Main Building
Location:	Rear stairs
Finding:	Wood Rot to Rear Stairs
Information:	Wood rot was identified to timber components of the rear stairs. Timber decay is commonly associated with prolonged exposure to moisture and weathering and may worsen over time if left unaddressed. Deteriorated timber may affect the structural integrity and safety of the stairs. Repair or replacement of the affected timber components is recommended. Works should be carried out by a licensed builder, carpenter, or suitably qualified tradesperson.

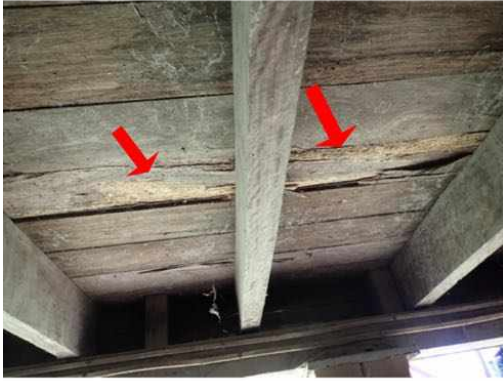
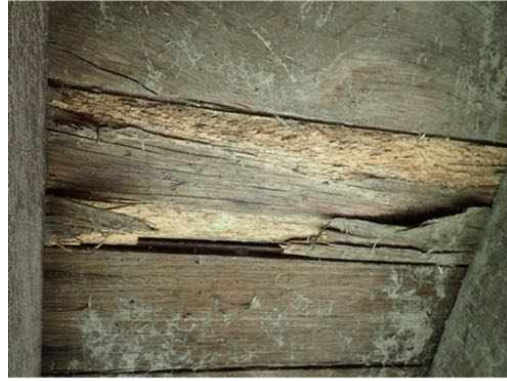
### Finding 8.01

Building:	Main Building
Location:	Subfloor
Finding:	Isolated Wood Borer Damage to Subfloor and Flooring Timbers

Information: Isolated wood borer damage was identified to some of the subfloor and flooring timbers. Wood borer activity can lead to deterioration of timber elements over time if conditions conducive to timber pest activity remain present. The damage appeared isolated at the time of inspection; however, continued monitoring and maintenance is recommended. Assessment and treatment, if required, should be carried out by a licensed timber pest specialist, with any repairs to affected structural timbers undertaken by a licensed builder, carpenter, or suitably qualified tradesperson.

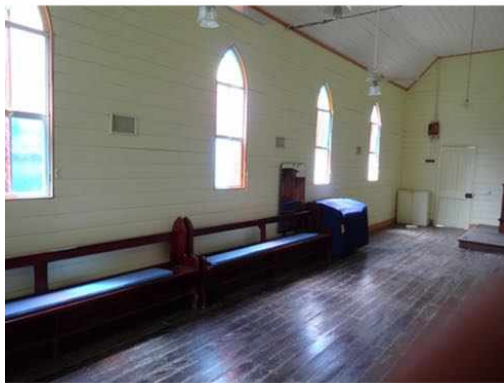
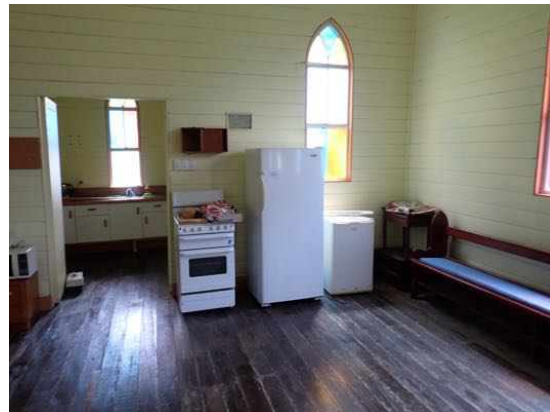
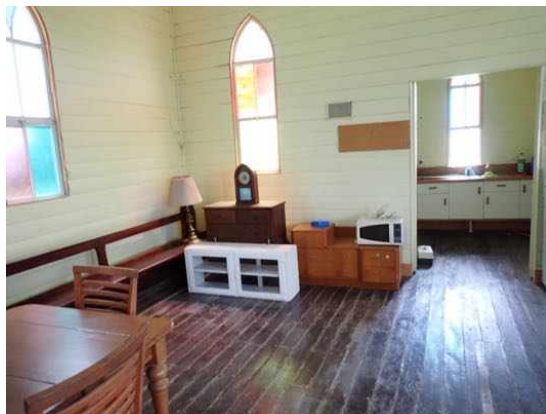
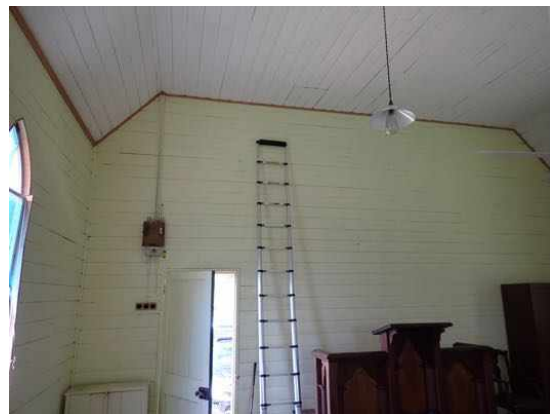
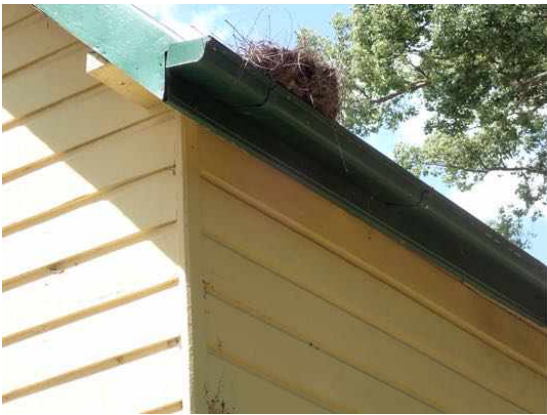
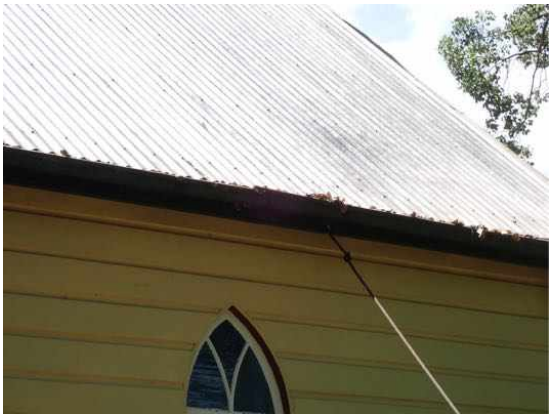
#### Noted Item

Building: Main Building  
Location: All Areas  
Finding: Additional Photos - Obstructions and Limitations  
Information: These photographs are an indication of the obstructions and limitations which impeded full inspection of the area at the time of inspection. These obstructions can hide an array of defects and should be removed to allow full inspection to be carried out. A re-inspection is recommended once the areas are made accessible.
