Building and Timber Pest Inspection Report

Inspection Date: Sat, 31 Jan 2026

Property Address: Unit 7/59 Essington St,
WENTWORTHVILLE, NSW, 2145, Australia

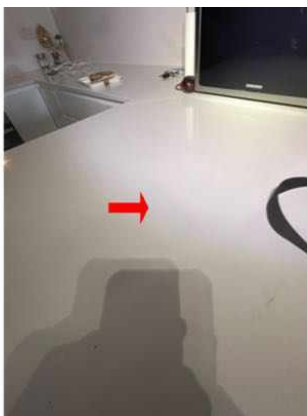
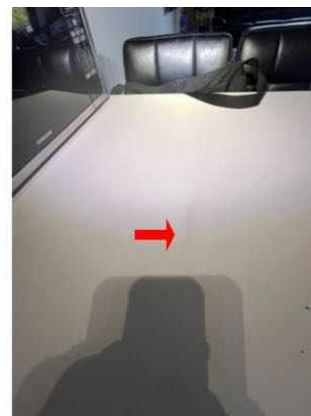
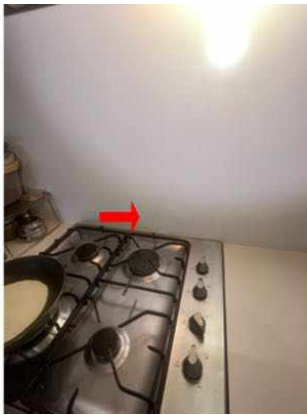
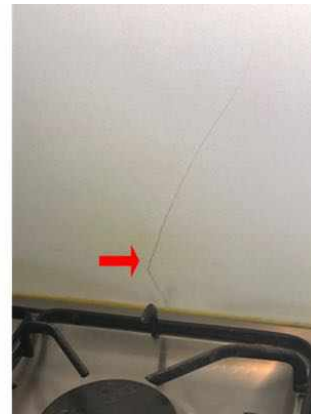
Finding 3.01

Finding: Cracks to the Caesarstone

Information: A crack to the Caesarstone kitchen benchtop was noted, extending across the surface and continuing in the vicinity of the cooktop area. The crack appears as a hairline fracture but is continuous and visible under normal lighting conditions. Such cracking is not typical of normal wear and may be associated with thermal stress, substrate movement, inadequate support beneath the stone, or localised impact. The location adjacent to the stove increases the likelihood of heat-related expansion and contraction contributing to the defect.

Cracks in engineered stone surfaces can permit the ingress of moisture and contaminants over time and may progressively widen if the underlying cause is not addressed. Rectification of stone cracks is generally considered a specialist repair, and in many cases replacement of the affected section may be required to achieve a durable outcome. Assessment by a qualified stone mason is recommended to determine the extent of the defect and appropriate remedial options.

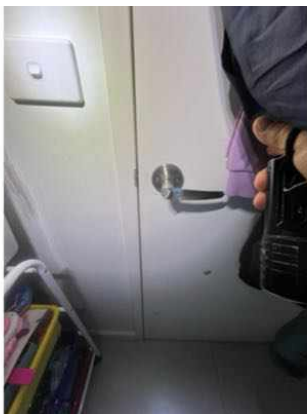
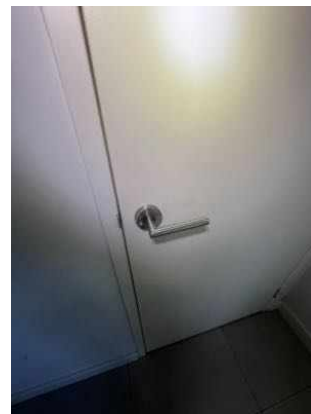
Finding 3.02

Building:	Main Building
Location:	Bedrooms
Finding:	Doors Rattles - Striker plate misaligned
Information:	The striker plate to this door appears to have become misaligned and has consequently resulted in the door's operation being compromised.

This is a common defect and is expected in a property of this age, whether being due to substandard installation or general deterioration of the door hardware.

Readjustment of the striker plate is recommended at client discretion. Works such as these can be completed by a general handyman or qualified carpenter.

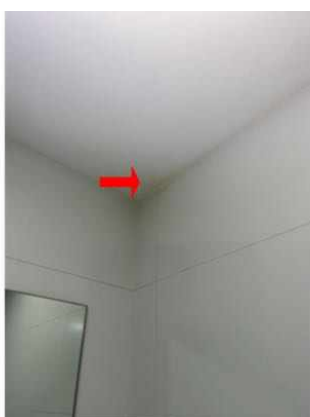
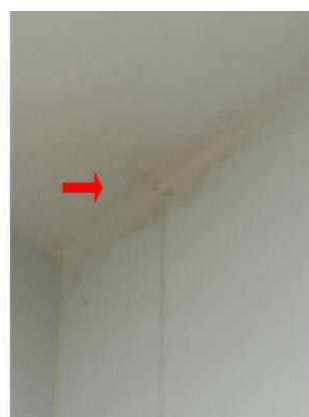
Finding 3.03

Building:	Main Building
Location:	Bathroom
Finding:	Stain on the Corner Junction
Information:	Discolouration was noted to the ceiling and upper wall junction at the bathroom corner. The staining presents as light brown/yellowish marks concentrated along the ceiling line and corner junction, with a faint vertical run mark down the wall surface. The pattern is consistent with moisture-related surface staining rather than structural

cracking or material failure.

At the time of inspection, no active moisture, dripping, or wet surfaces were observed, and there was no evidence indicating an active leak from the level above. The condition is more consistent with intermittent condensation build-up, high humidity typical of bathroom environments, or possible inadequacies in paint finish or sealant application at the junctions.

While the staining appears minor and superficial at present, continued moisture exposure can contribute to mould growth or further deterioration of finishes over time. Improving ventilation, ensuring adequate exhaust fan use, and maintaining appropriate paint and sealant finishes are recommended. Ongoing monitoring is advised to confirm that no concealed leak develops.

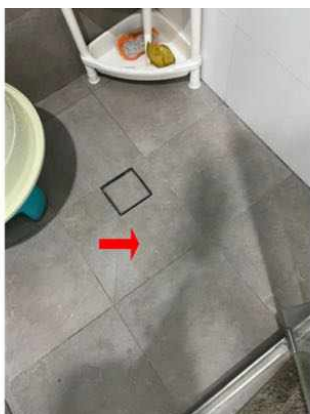
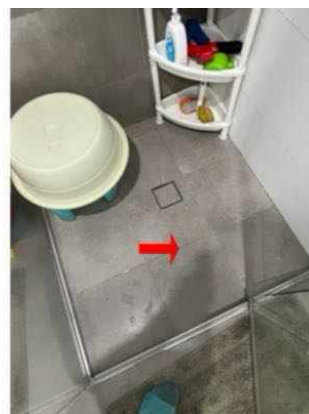
Finding 3.04

Building:	Main Building
Location:	Bathroom
Finding:	Shower base - Water pooling
Information:	Evidence of water pooling around the floor waste in the shower recess was noticed at the time of inspection. It is suspected that this excessive moisture is attributed to insufficient fall in the shower floor tiles.

This pooling is minor overall but is still considered unsatisfactory, as standard tiling practices would not permit this situation to occur. Pooling water around floor wastes can create a slip hazard in extreme cases and create conditions that are conducive to mould growth over time. Where left unmanaged, the degradation of sealant and grouting is also likely to occur, possibly necessitating further repair works.

Remedial works may involve some sections of tiling and flooring repair and replacement. A tiling contractor or bathroom specialist should be appointed to provide further advice on reparation options and to perform works as necessary.

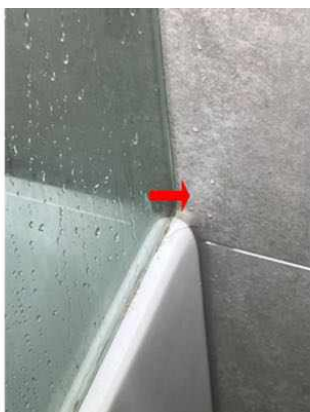
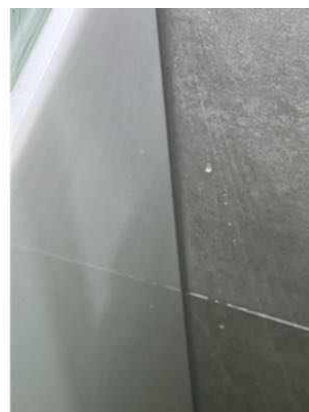
Finding 3.05

Building:	Main Building
Location:	Bathroom 2
Finding:	Leaking Shower Screen
Information:	A minor leak through the shower screen was noted during the inspection, likely caused by deteriorated sealant. Reapplying sealant to the affected area is recommended to resolve the defect.

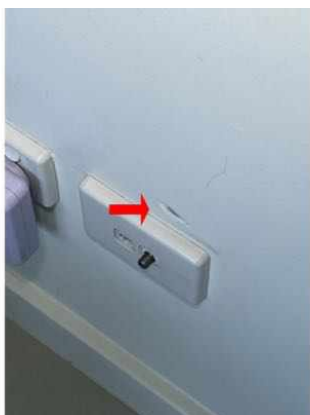
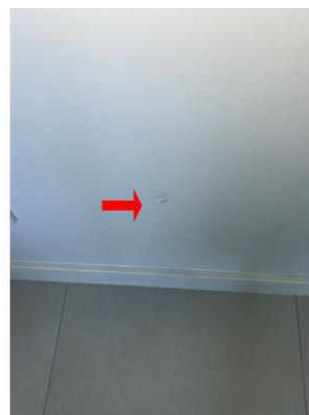
Finding 3.06

Building:	Main Building
Location:	Bedroom
Finding:	Localized Impact Damages
Information:	Localised impact damage was noted to the wall lining at low level. The damage presents as a small indentation and surface break to the plasterboard, with minor paint delamination and exposure of the underlying substrate. The shape and location are consistent with mechanical impact, such as contact from furniture, appliances, or similar hard objects.

The defect is cosmetic in nature and does not indicate structural concerns. However, the damaged surface may be more susceptible to further deterioration if left unrepaired. Rectification would typically involve patching, sanding, and repainting by a

general handyman or painter to restore the finish.

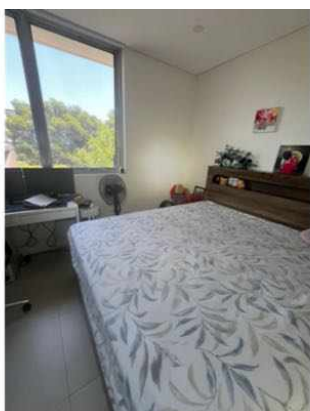
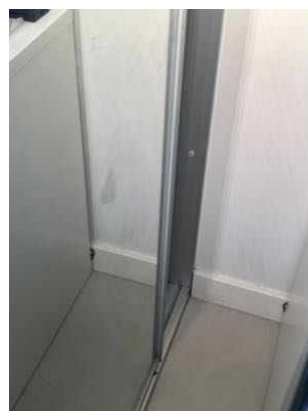
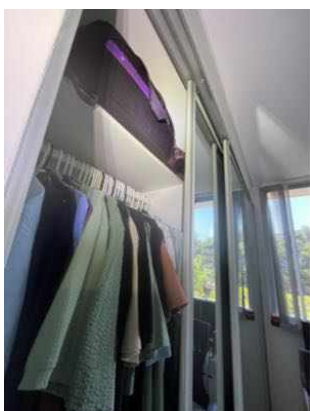
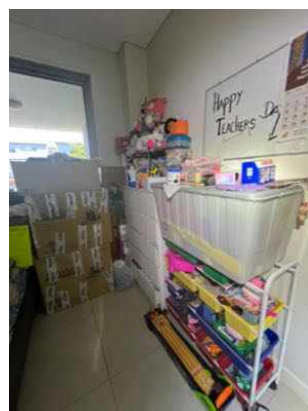
Building: Main Building
 Location: All Areas
 Finding: Note Regarding Mould and Staining
 Information: It should be noted that the presence of furniture or stored items within the dwelling may restrict airflow and ventilation, particularly behind such items, creating conditions conducive to condensation and subsequent mould or staining.

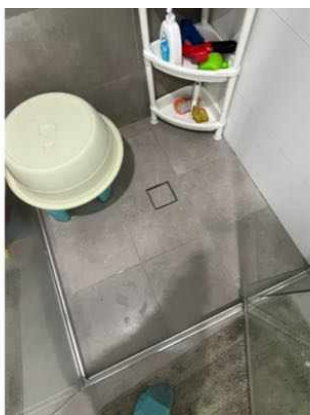
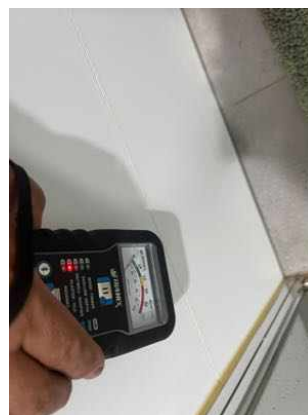
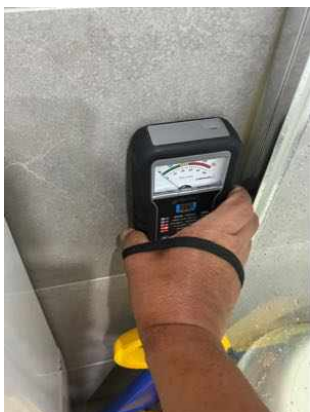
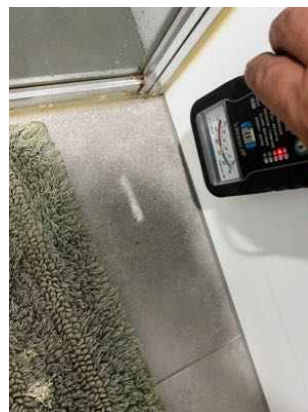
Building: Main Building
Location: Bathrooms
Finding: Minimal Moisture Metre Readings
Information: After conducting an assessment of the shower recess, the moisture content of the walls in and around the shower was examined. The results indicated that there was no significant difference in moisture readings between the walls behind the wet area and other walls, and there were no visible signs of recent water damage on the surrounding walls that could be inspected.

Based on these observations, it can be assumed that the waterproofing of the shower is sound and there is currently no evidence of any leakage. However, it is important to note that if the shower has not been used recently, moisture readings may not be a reliable indicator of any leaks.
