## Building Inspection Report

Inspection Date: Mon, 23 Feb 2026

Property Address: a104/38 B Manchester Dr, Schofields NSW  
2762, Australia

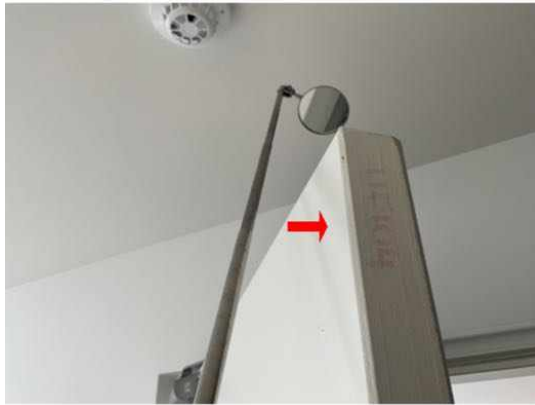
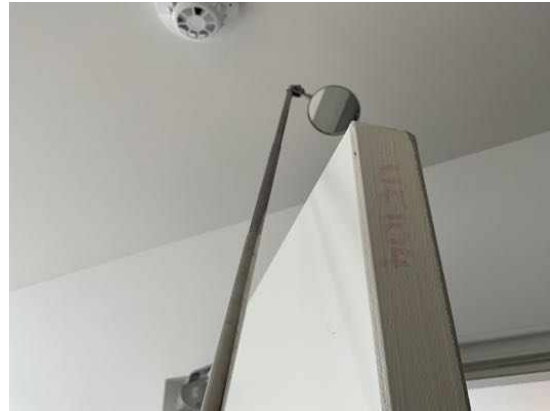
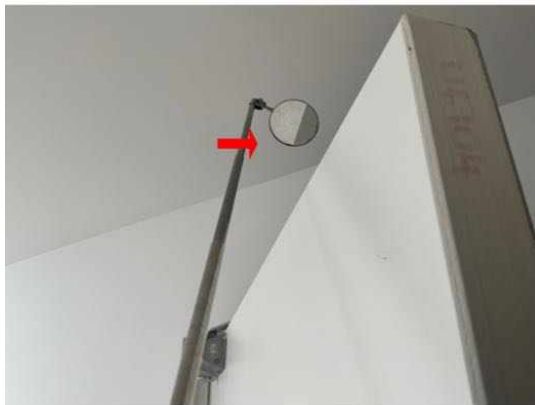
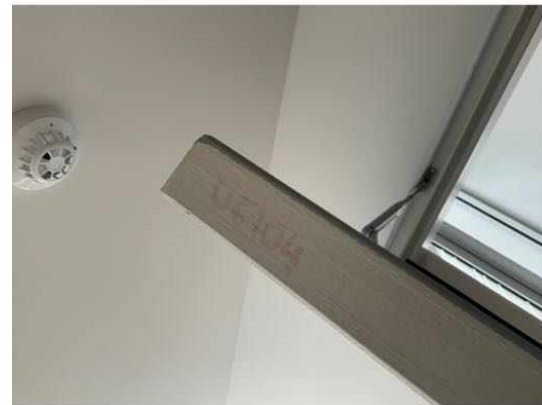
#### Defects 3.01

Building:	Main Building
Location:	All Areas
Finding:	Incomplete Painting of Doors
Information:	The paintwork on the doors throughout the building is incomplete, failing to meet the requirements specified by Australian Guides and Tolerances.

- **\*\*Coverage:\*\*** Incomplete paint coverage on the doors, with visible areas left unpainted or thinly coated.
- **\*\*Edges and Corners:\*\*** Edges and corners of the doors are inadequately painted, showing bare or poorly covered areas.

- Reduced durability and protection of the door surfaces against wear and environmental factors.
- Compromised aesthetic quality and overall visual appeal of the building.
- Increased maintenance costs due to the need for early repainting or repairs.

The doors must be repainted to meet the standards outlined in the Guide to Standards and Tolerances. This includes:

- Ensuring complete and consistent paint coverage on all surfaces of the doors.
- Achieving a smooth and even finish without visible defects such as brush marks,

drips, or streaks.

- Proper surface preparation to ensure good paint adhesion and prevent peeling or flaking.

- Thoroughly painting edges and corners to achieve a uniform appearance.

A detailed inspection should be conducted post-repainting to confirm compliance with the required standards.

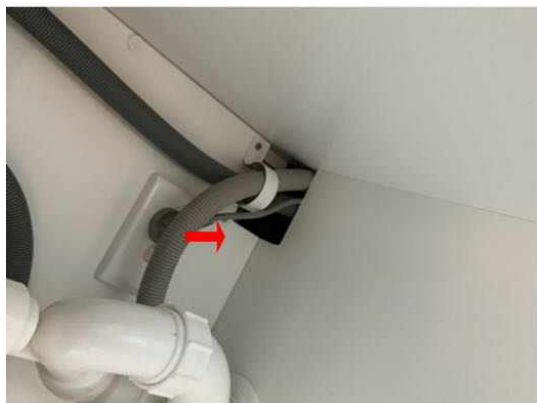
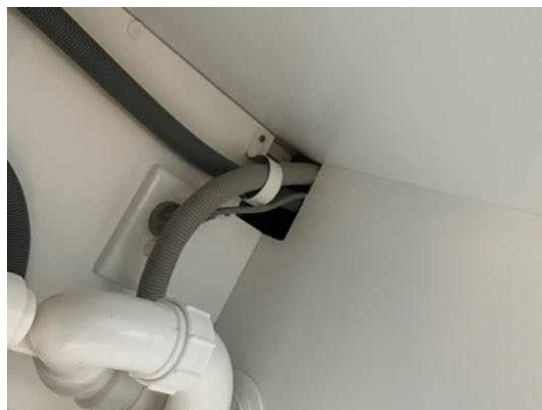
### Defects 3.02

Building: Main Building  
 Location: Kitchen  
 Finding: Pipe Penetrations not capped  
 Information: There is an open hole around the pipes under the cabinetry that hasn't been sealed or capped.

- Pests like mice or cockroaches can enter through the gap.
- Water can get in and cause mould or damage to the cabinet.

- It looks untidy and is hard to keep clean.

A plumber or handyman can seal the hole using a cover plate, grommet, or suitable sealant.

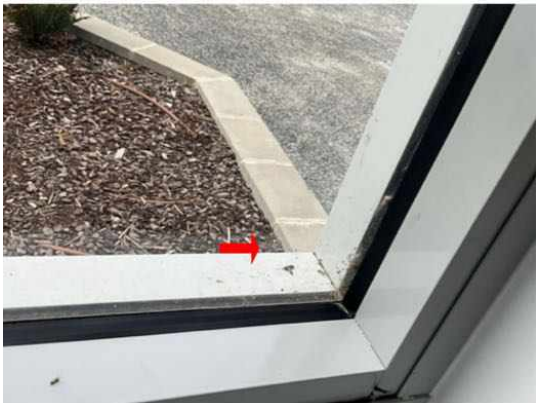
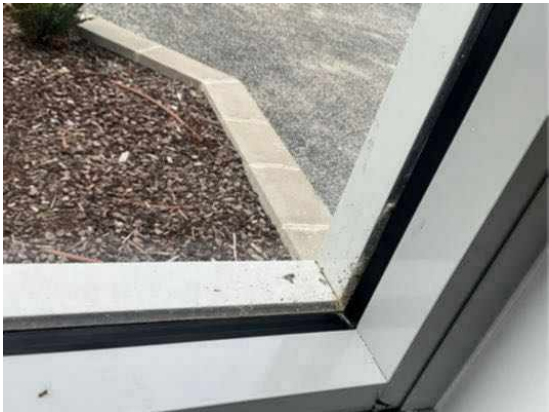
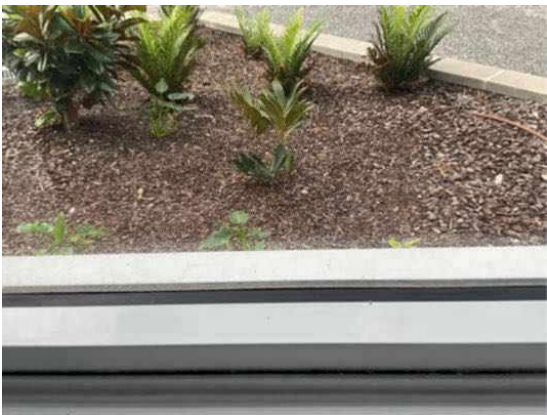
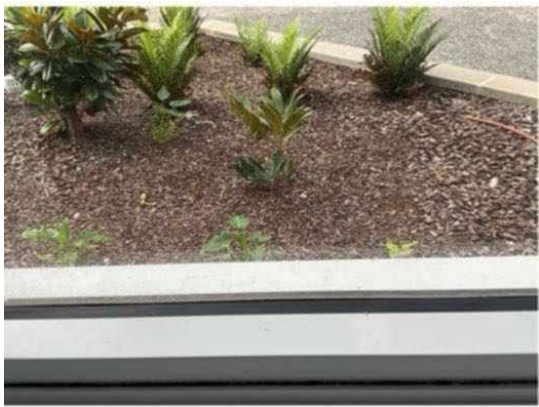
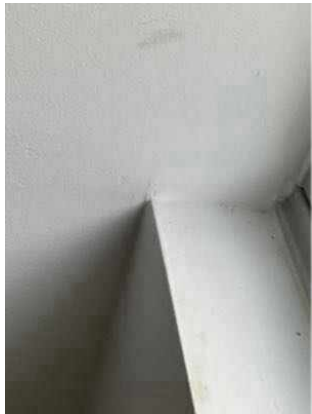
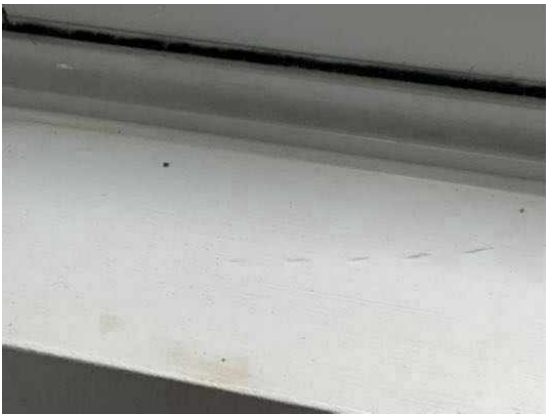
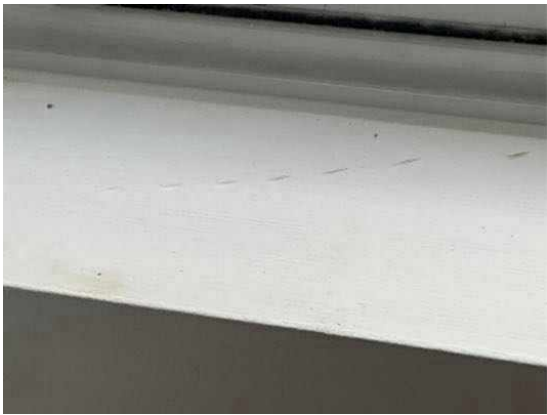
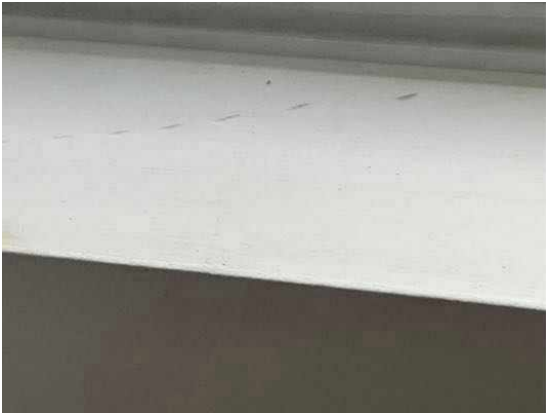
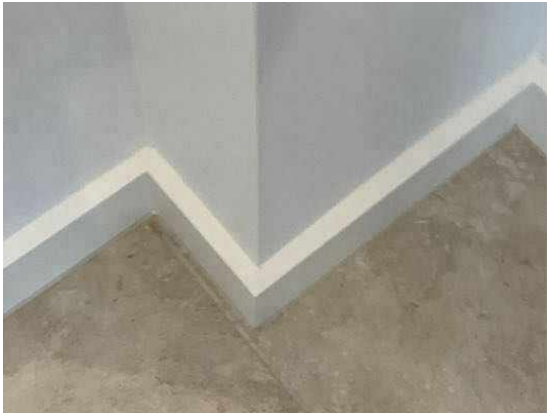
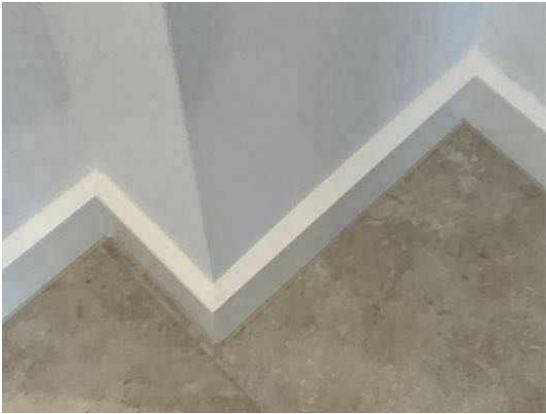
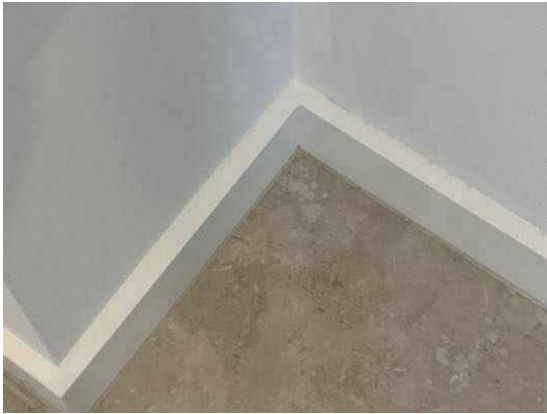
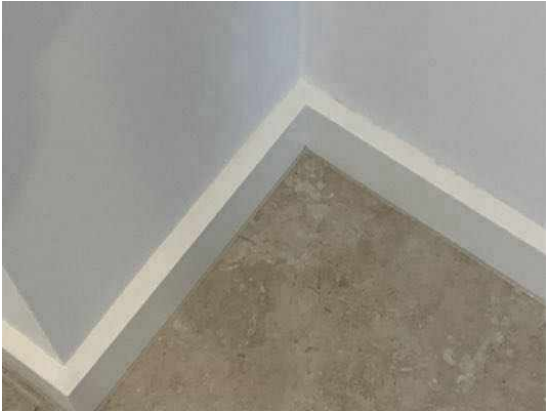
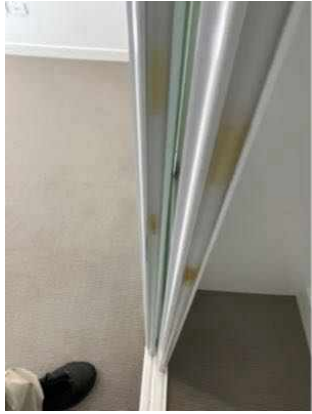
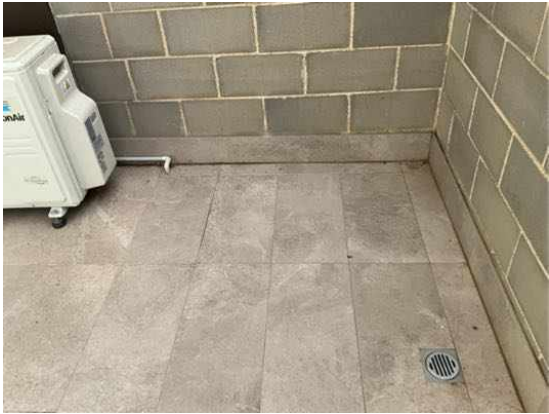
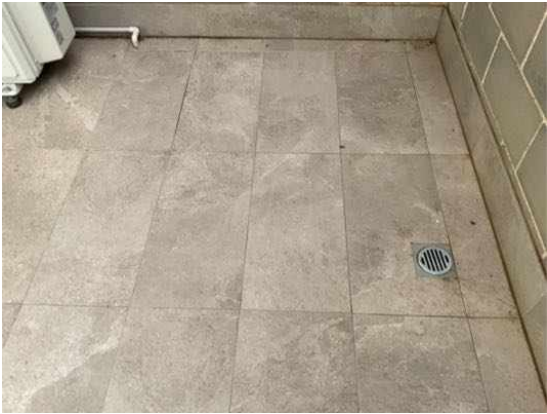
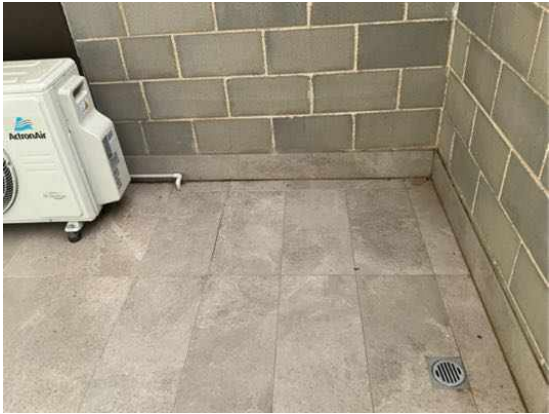
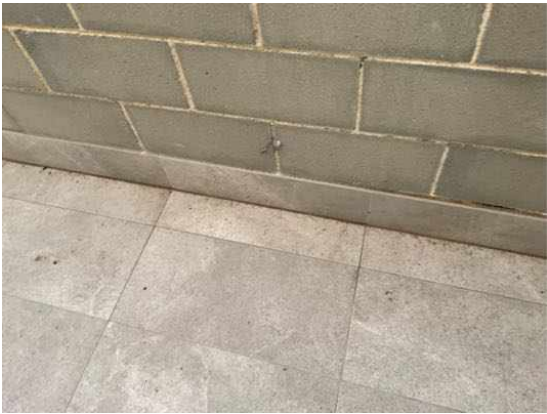
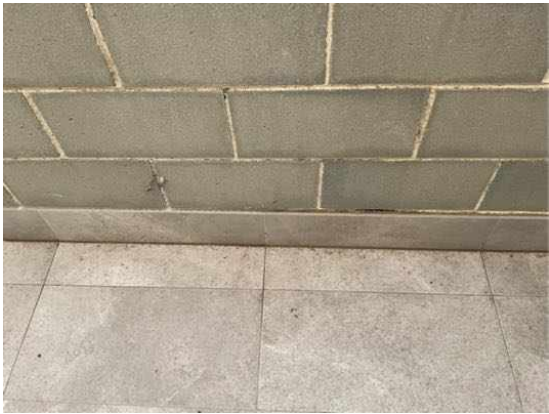
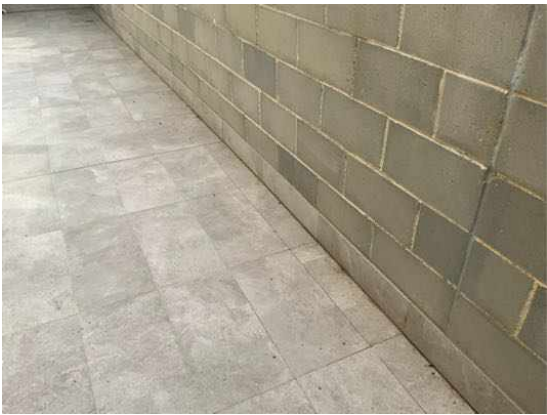
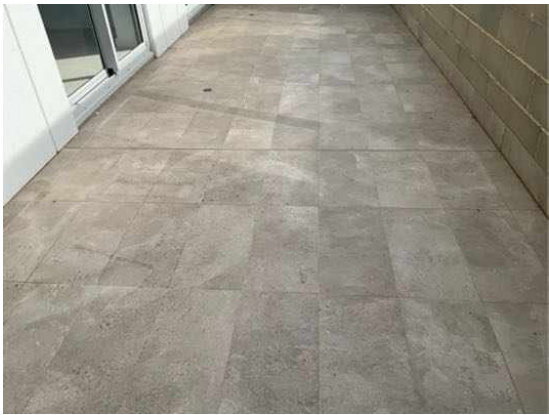
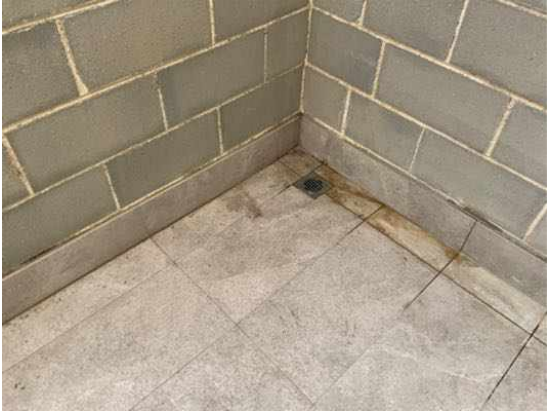
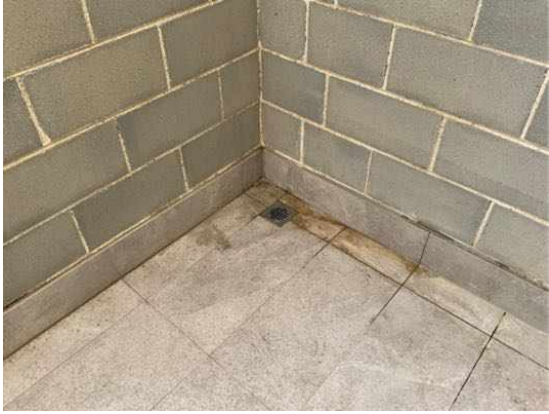
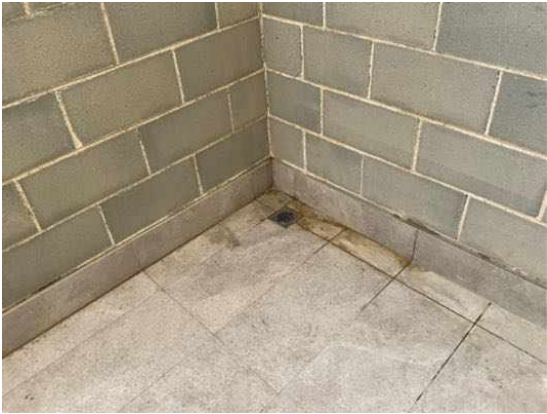
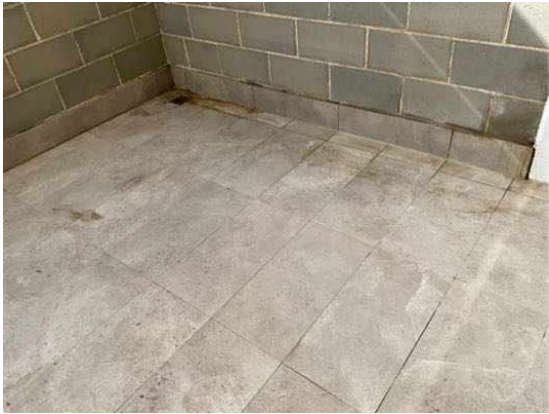
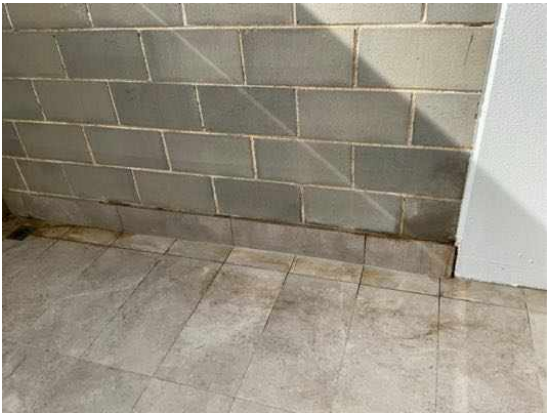
### Defects 3.03

Building:	Main Building
Location:	All Areas
Finding:	Cleaning required
Information:	It was observed that the house requires cleaning.

Works are defective where windows are not clean, floors are not swept, mopped or vacuumed as appropriate, tiles, sinks, basins, baths, windows or any other area throughout the property are not cleaned, and shelving, drawers and cupboards are not ready for use not cleaned and ready for use at handover.

This is to be referenced against the Australian Standards & Tolerances clause 19.8 Cleaning.

This is to be addressed prior to handover.

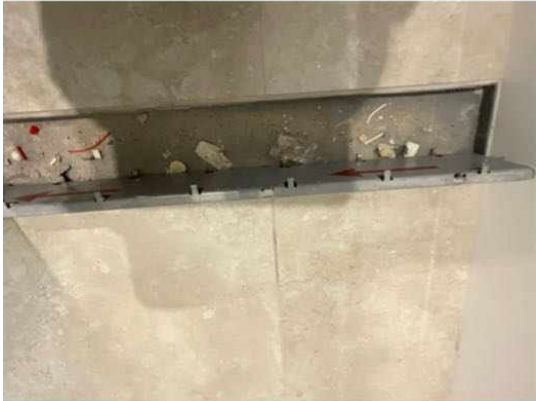
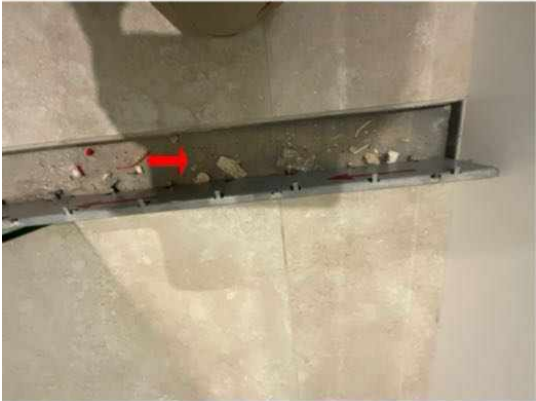
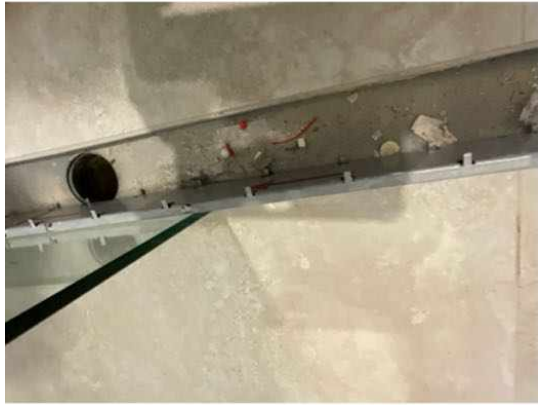
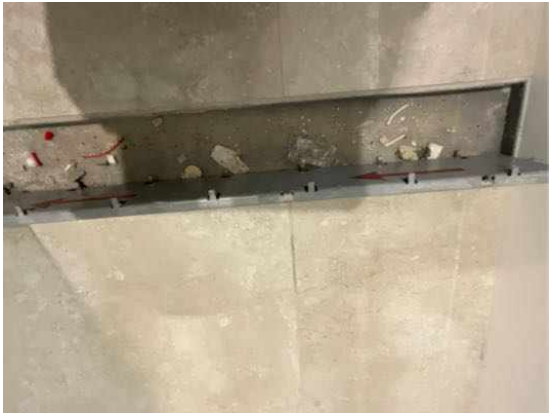
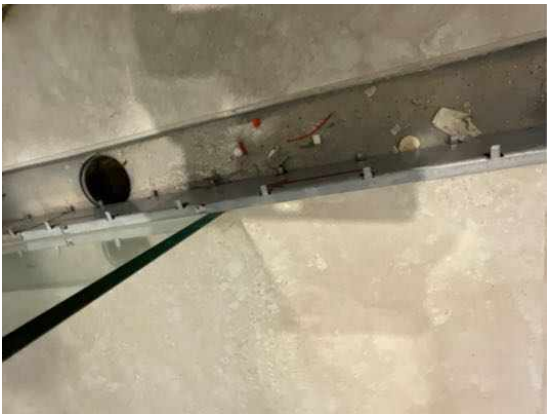
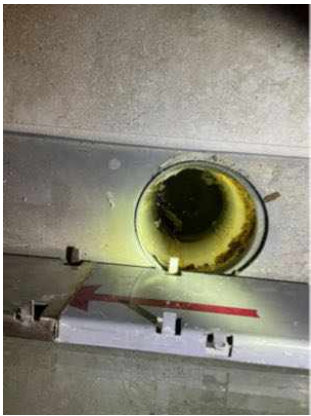
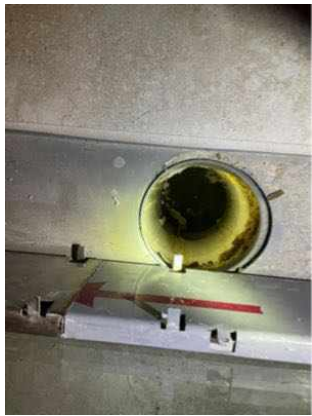
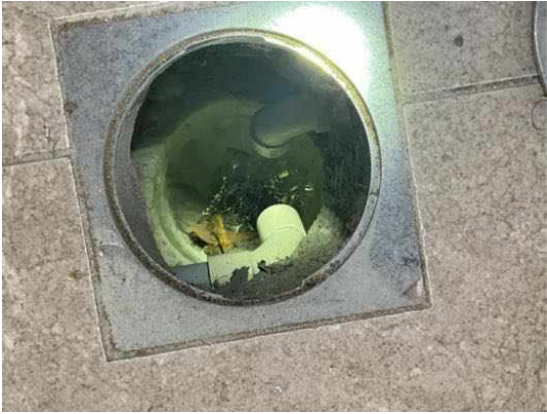
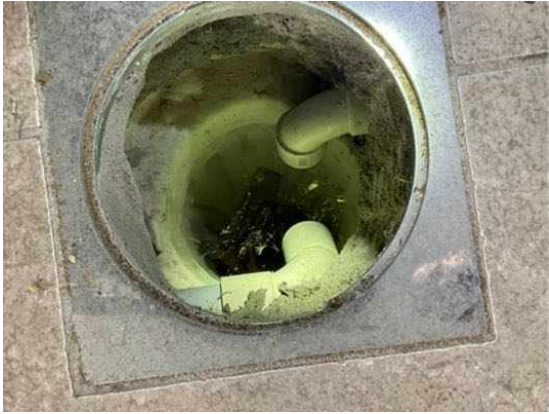
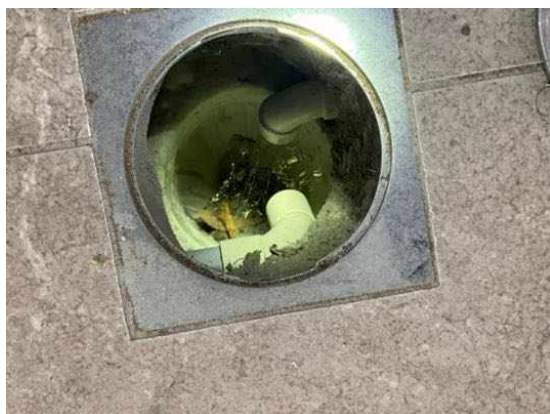
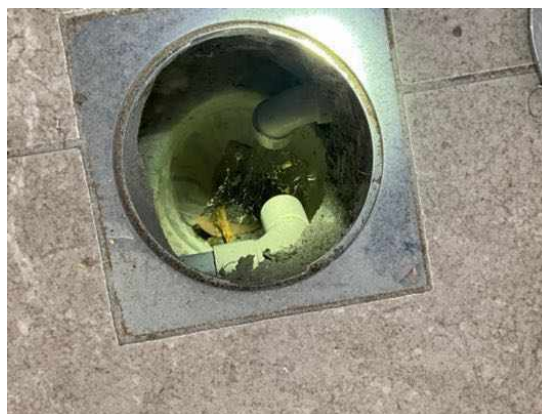
Defects 3.04

Building: Main Building  
Location: All Areas  
Finding: Floor waste Debris  
Information: It was noted that there is builder debris in the floor waste drainage. Debris in the plumbing system may lead to blockages in the future.

This is referenced against the Australian Standards and Tolerances clause 19.8 Cleaning - Owners are entitled to expect that the building site and works are clean and tidy on completion.

Building sites are defective if they are not clear of building debris. All floor wastes need to be checked and cleared prior to handover.

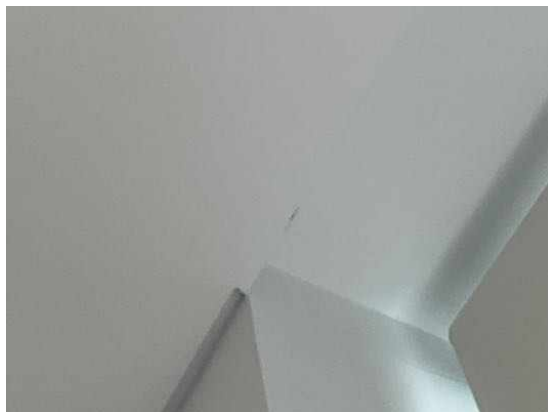
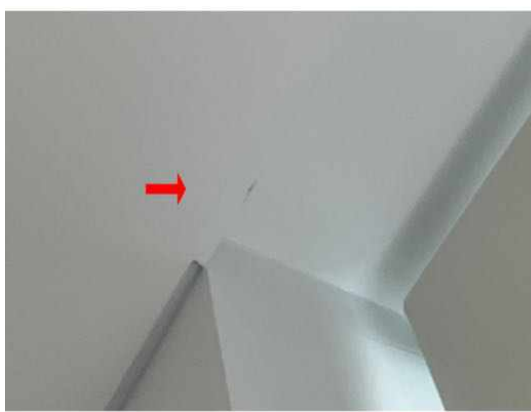
### Defects 3.06

Building: Main Building  
 Location: Bedroom - Master  
 Finding: Paint - Substandard  
 Information: Areas were identified where the surface finish of the painting is substandard and this is considered a defect.

Any irregularity in the surface which is visible from a normal viewing position is considered a defect. Marks may also be a result of fault by other tradespeople throughout the construction process.

Defective surface finish of paintwork is marked with an arrow to the below photos in the following locations.

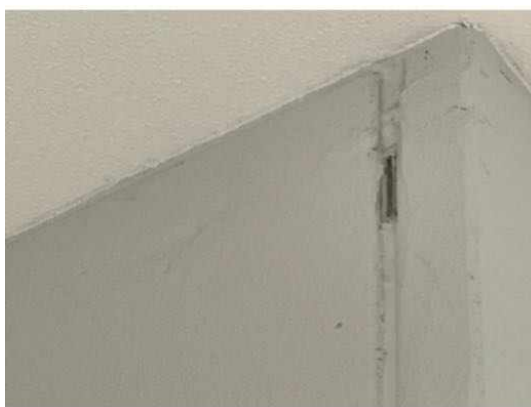
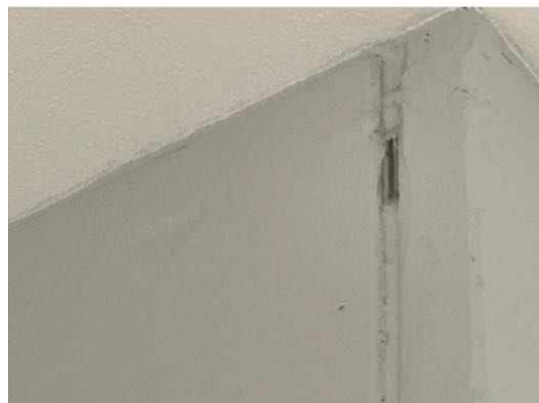
### Defects 3.07

Building:	Main Building
Location:	Yard
Finding:	Weep Hole to External Cladding- suspected non compliance
Information:	A weep hole has been observed to the external wall cladding system. The installation appears inconsistent and may not comply with the manufacturer's installation requirements.

Incorrectly installed or non-compliant weep provisions may allow moisture ingress behind the cladding system or restrict adequate drainage and ventilation, potentially leading to concealed moisture damage over time.

It is recommended that the cladding manufacturer's installation manual and system specifications be reviewed to confirm compliance. A suitably qualified builder or façade specialist should assess and rectify as required.

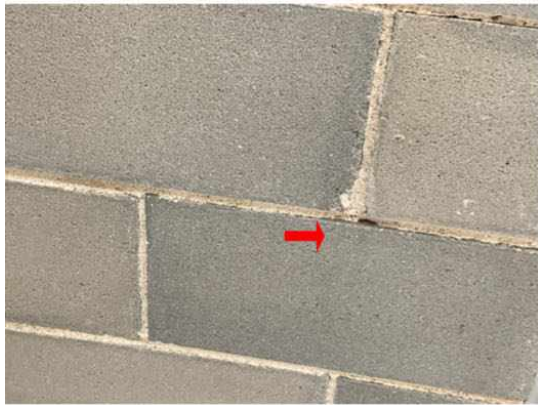
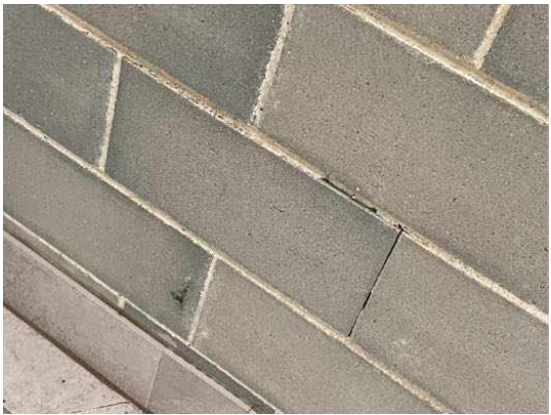
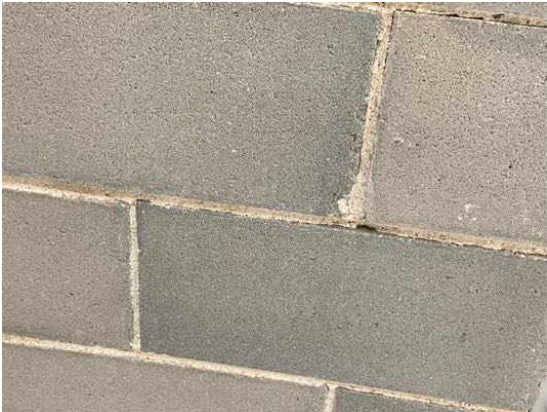
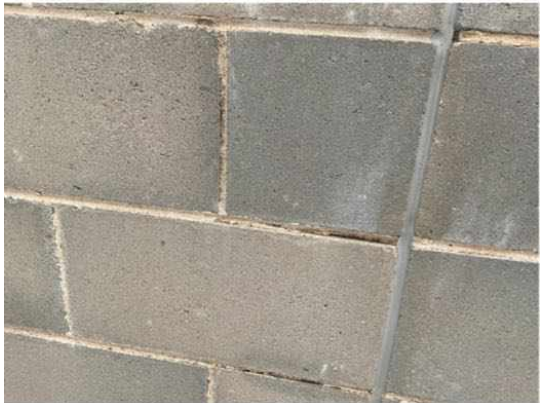
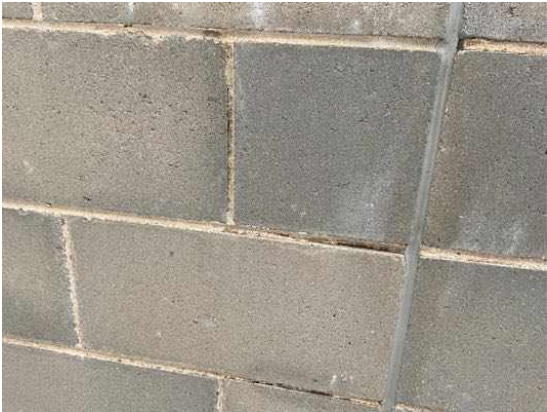
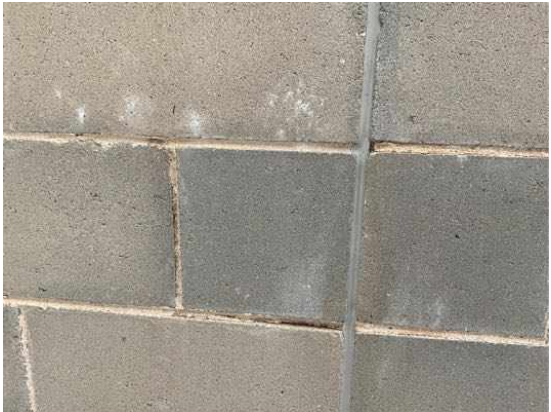
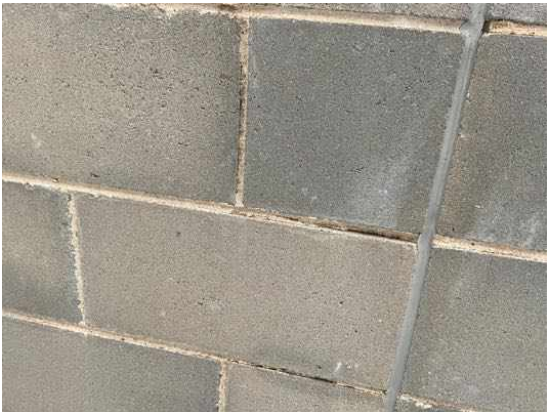
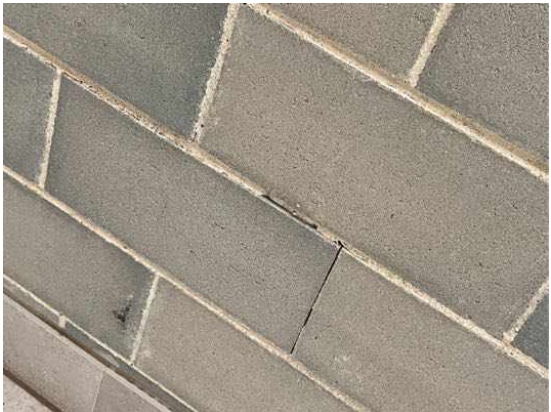
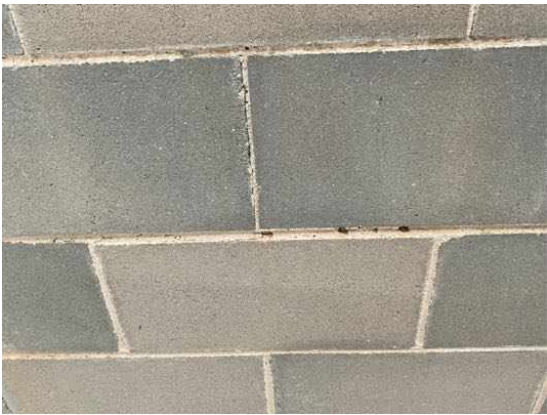
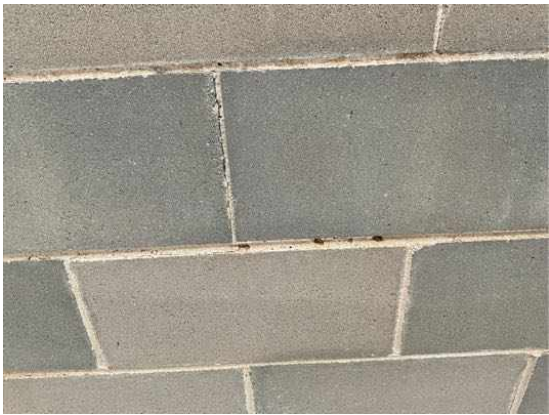
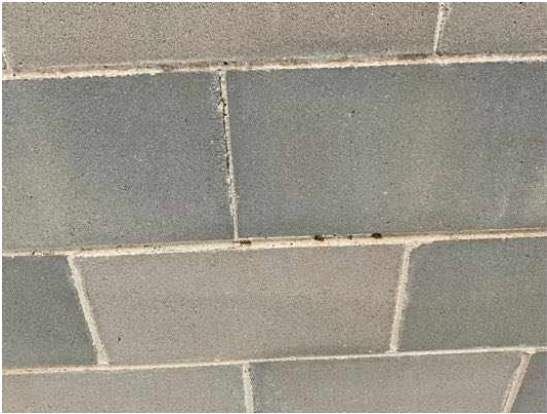
### Defects 3.08

Building:	Main Building
Location:	Yard
Finding:	Mortar joints - Filling required
Information:	Instances of voids and holes affecting the masonry mortar have been identified. Excepting weep holes and vents voids and holes are defects if they are visible from a normal viewing position.

Where a building element is installed in such a way that it fails to achieve the required minimum standard or level of finish at the time of the inspection, the builder needs to rectify the defect as soon as possible and complete works to the required standard prior to handover.

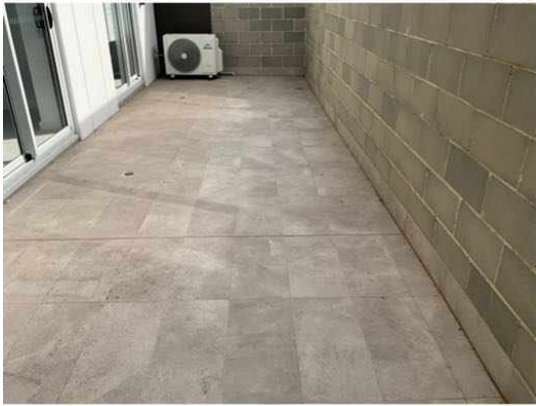
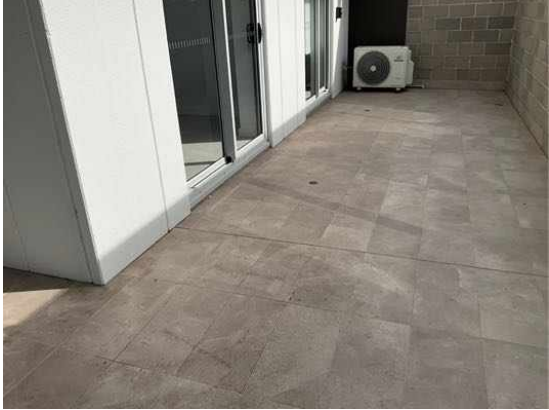
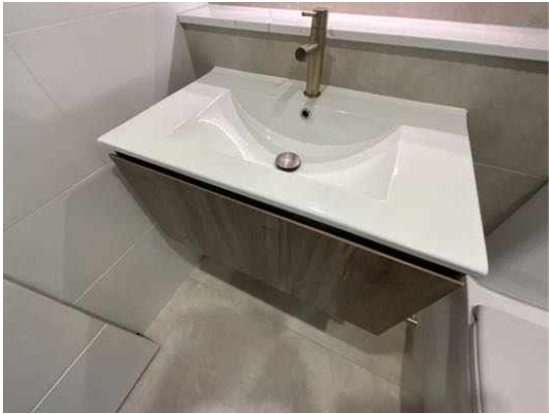
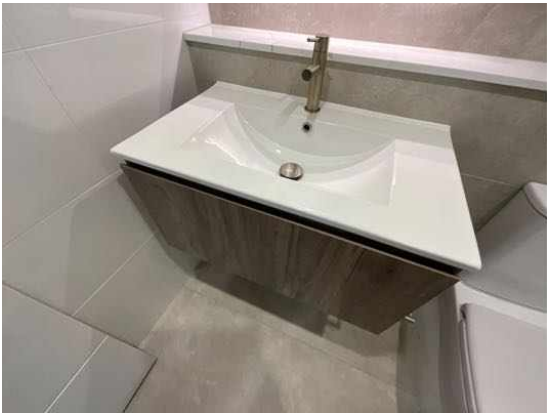
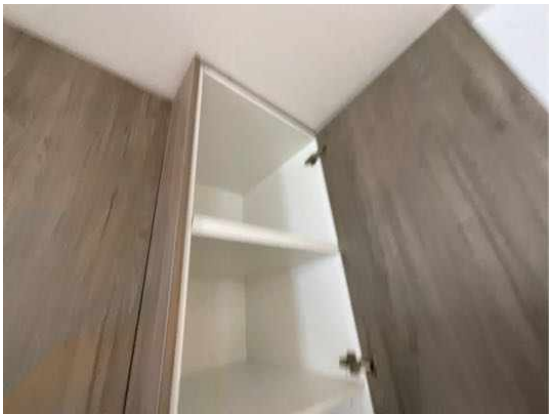
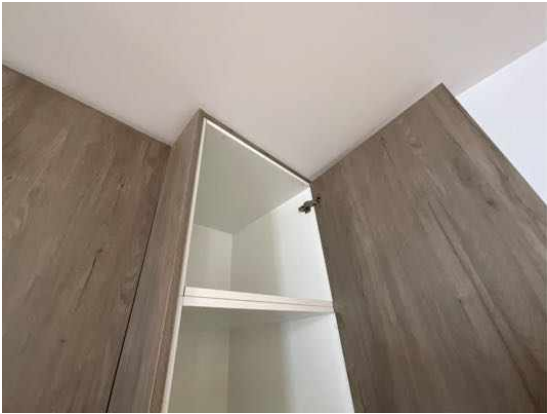
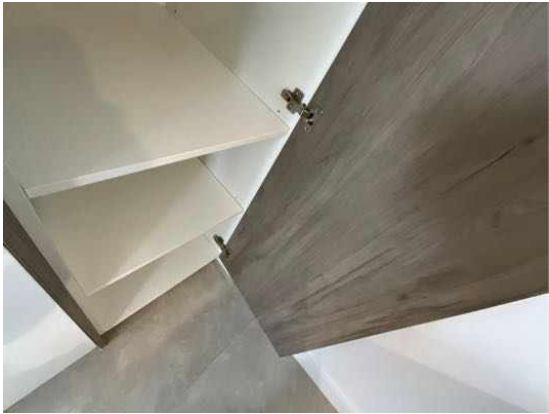
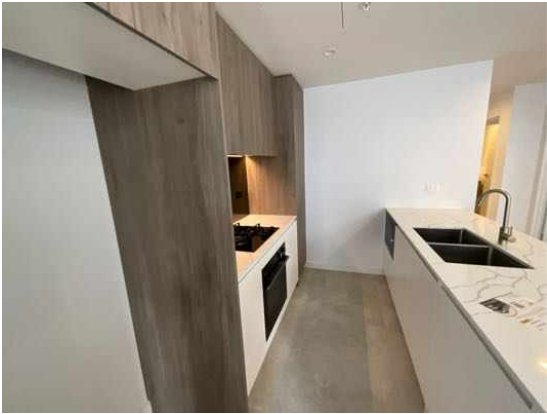
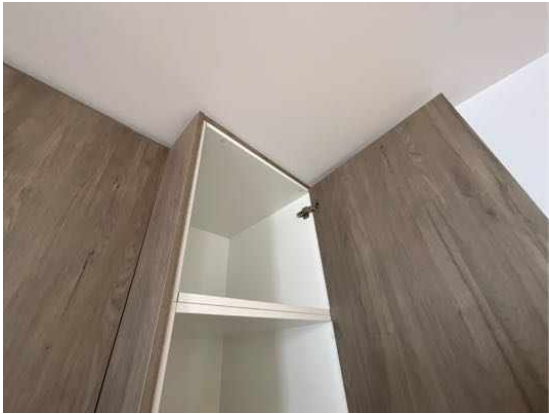
#### Noted Item

Building: Main Building  
Location: All Areas  
Finding: Additional Photos - Obstructions and Limitations  
Information: These photographs are an indication of the obstructions and limitations which impeded full inspection of the property at the time of inspection. These obstructions can hide an array of defects and should be removed to allow full inspection to be carried out. A re-inspection is recommended once the areas are made accessible.
