Building and Timber Pest Inspection Report

Inspection Date: Tue, 3 Mar 2026

Property Address: 2 Cloud Cl, Redan VIC 3350, Australia

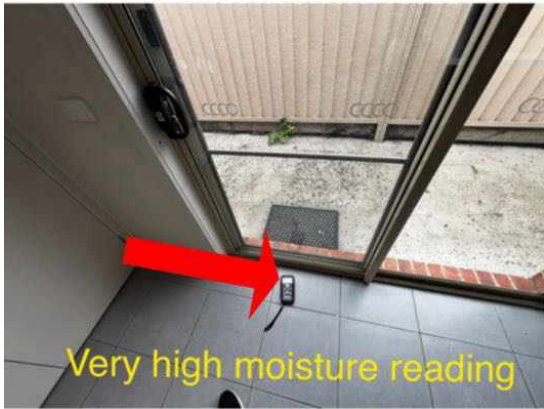
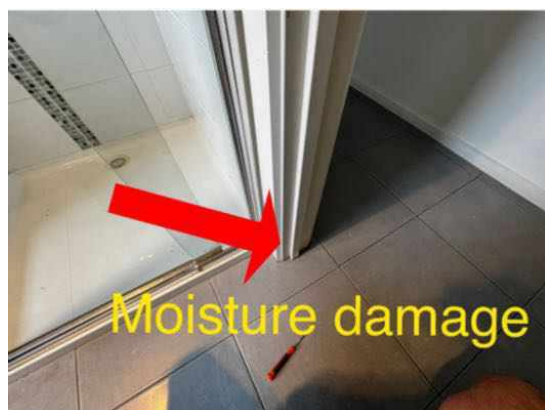
Building: Main Building
Location: All Tiled Areas > All Areas
Finding: Elevated Moisture Levels – Floor Tiled Areas (Major Defect)
Information: Elevated moisture readings ranging from approximately 60% to 100% were detected using a moisture meter to all floor tiled areas within the dwelling. The elevated readings were consistent across the tiled areas. Minor moisture-related swelling was observed to the bathroom door jamb, which is consistent with prolonged exposure to moisture.

No active water leaks were identified during the inspection. It should be noted that running water was not available at the time of inspection, which limited the ability to fully test plumbing fixtures and wet areas. Moisture testing of adjoining carpeted areas did not reveal elevated readings, suggesting that the moisture appears to be largely confined to the tiled areas.

The source of the elevated moisture readings could not be determined at the time of inspection. Possible causes may include historical water leaks, a concealed plumbing leak beneath the slab or within wall cavities, failure of waterproofing in wet areas, or excessive wet mopping practices. Regardless of the cause, the presence of widespread elevated moisture readings indicates a potential underlying issue.

In accordance with the principles of AS 4349.1–2007, widespread elevated moisture affecting multiple floor areas and having the potential to cause deterioration of building elements is considered a Major Defect, as it may lead to concealed damage to floor substrates, wall framing, skirting boards and other structural or finish elements if left unaddressed.

It is recommended that further investigation be undertaken by a licensed plumber or leak detection specialist to determine the source of the moisture. This may involve pressure testing of plumbing systems and potential invasive inspection. Once the source is identified, appropriate rectification should be undertaken and affected building elements repaired as required.

Further investigation recommended in the short term due to the extent of elevated moisture readings and potential risk of concealed damage.

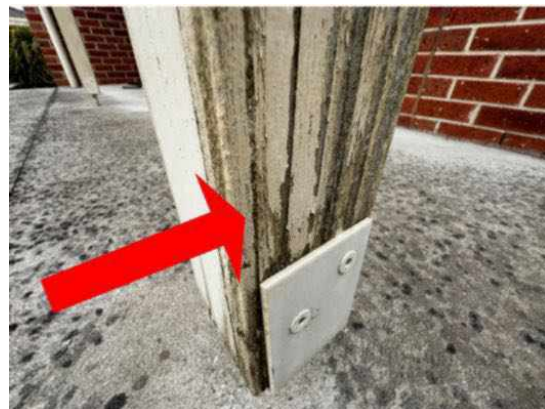
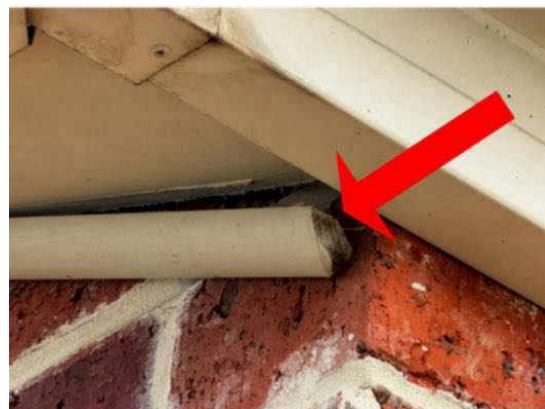
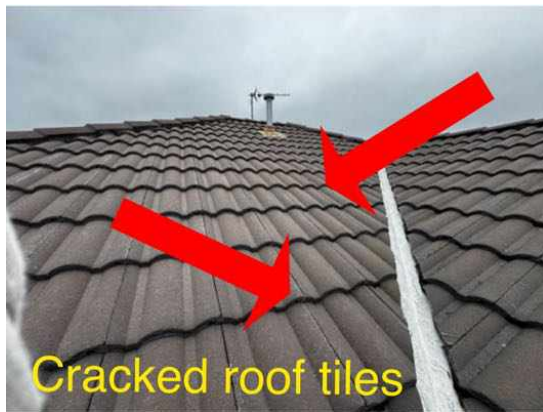
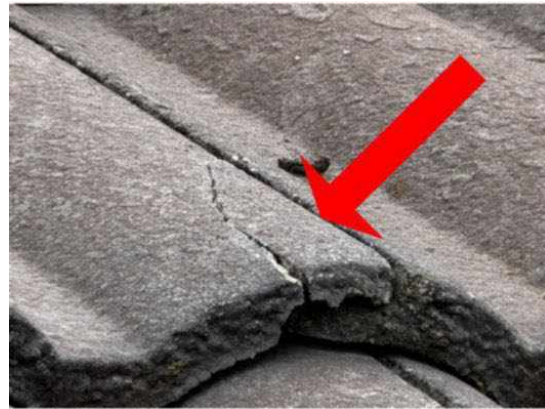
Finding 3.01

Building:	Main Building
Location:	All Areas > All Areas
Finding:	External Defects – Porch Posts, Eaves, Roof Tiles and Roof Plumbing
Information:	The following external defects were observed during the inspection:

Weathered and deteriorating timber posts were noted to the front porch area. Prolonged exposure to weather without adequate maintenance may lead to further deterioration and potential loss of structural integrity over time.

Loose quad mouldings were observed beneath sections of the eave lining. Loose trim elements may allow minor gaps where moisture, insects or debris can enter.

Minor cracking was observed to roof tiles in several locations. No evidence of active water leaks was detected internally at the time of inspection. Cracked roof tiles, however, may allow moisture ingress during heavy rain if deterioration progresses.

A downpipe and spreader from the main roof was observed discharging onto the porch roof flashing. Direct discharge of concentrated water flow onto flashing components is considered poor roof plumbing practice and increases the risk of water

It is recommended that the front porch timber posts be assessed and repaired or replaced as required, and that appropriate sealing or protective coating be applied. Loose quad mouldings should be refixed. Cracked roof tiles should be replaced to maintain roof integrity. A licensed roofing plumber should assess the downpipe discharge arrangement and redirect the flow to an appropriate drainage point that does not rely on flashing to manage concentrated water discharge.

Rectification recommended in the short to medium term to prevent further deterioration and reduce risk of moisture ingress.

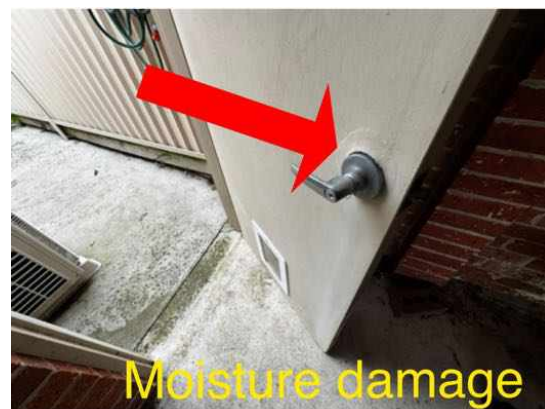
Finding 3.02

Building:	Main Building
Location:	All Areas > All Areas
Finding:	Minor Internal Defects – Garage, Doors, Flooring and Joinery
Information:	The following minor internal defects were observed during the inspection:

Staining was observed to the garage concrete floor, suspected to be oil stains likely associated with vehicle parking. Moisture-related damage was noted around the external garage door handle area. Scuffs, marks and minor damage were observed to the plaster walls within the garage.

In the main bathroom, the tile skirting was observed to be partially separating from the

wall. Minor crack damage was observed to the front bedroom door.

The timber door seal to the main entry door was weathered. The entry door was also observed to be binding during operation, making it difficult to open and close. Minor cosmetic damage was observed to the edge of the entry door.

Additional minor cosmetic defects included paint damage to the hallway sliding door and a damaged door catch to the cupboard door located across from the kitchen.

It is recommended that damaged or worn flooring be repaired or replaced as required. The tile skirting in the bathroom should be re-secured. The entry door should be adjusted to allow smooth operation and the weather seal replaced if necessary. Minor plaster and paint defects may be repaired as part of general maintenance.

Maintenance recommended in the short to medium term.

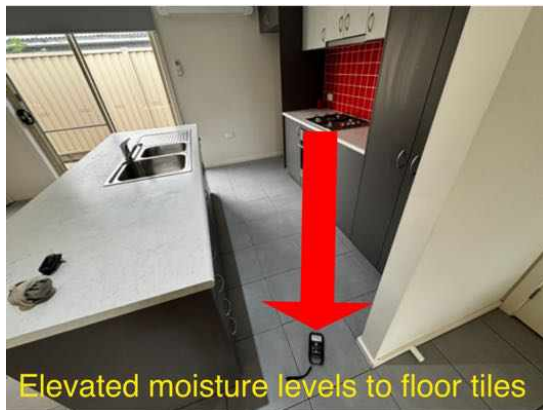
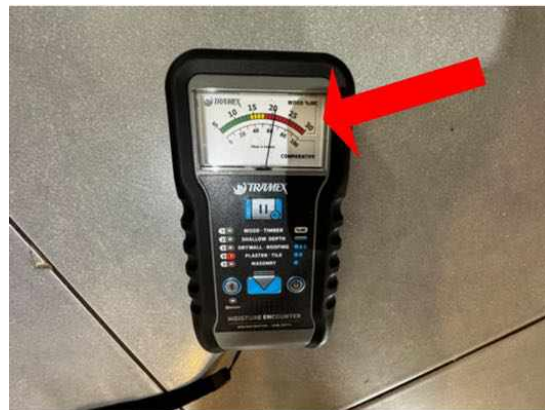
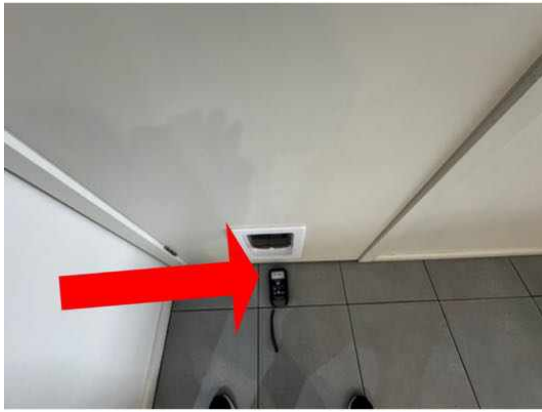
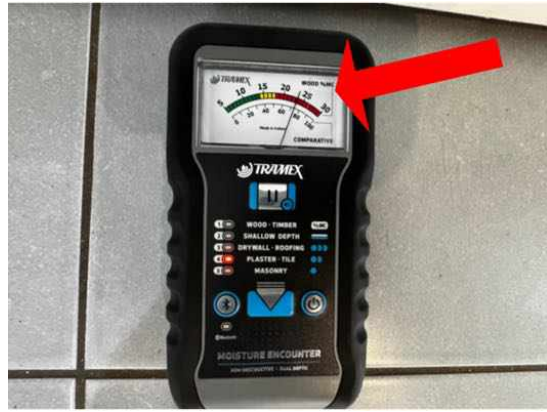
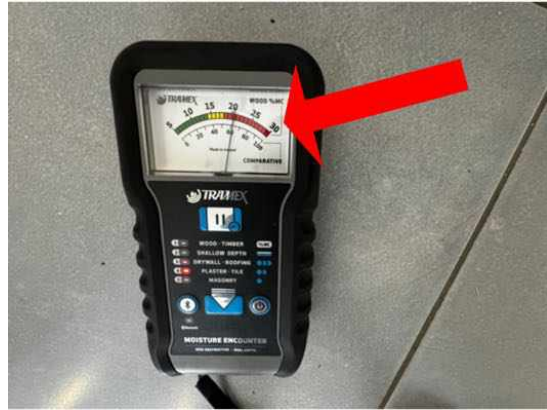
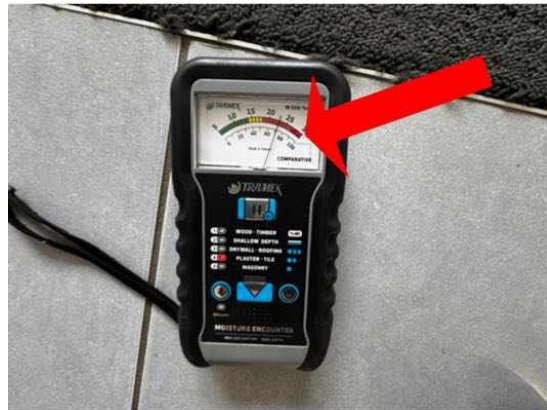
Building:	Main Building
Location:	All tiled areas > All Areas
Finding:	Elevated moisture levels to kitchen, bathroom, hallway, entry, laundry & toilet floor tiles (TP)
Information:	At the time of inspection, elevated moisture readings were detected using a moisture meter in the kitchen, bathroom, hallway, entry, laundry & toilet floor tiles. Levels of moisture ranged from 60% to 100% in some areas. No active water leaks were observed during the inspection. It is important to note that no running water was available during the inspection. Moisture readings in adjoining rooms were normal. It appears that the moisture is contained to these tiled areas only. Some moisture

damage was found to the bathroom door jamb suggesting moisture is affecting surrounding building elements in this area however no other moisture damage was observed to skirting boards, door jambs, architraves or joinery. It is suspected that the moisture may be from conditions such as excessive wet mopping, spills, or historic overflows or leakages from appliances or plumbing fixtures.

In accordance with AS 3660.2, wet areas and plumbing-related moisture issues are recognised as increasing termite risk, as persistent dampness within building elements can create conditions conducive to termite activity and concealed access. Ongoing moisture exposure may also lead to deterioration of surrounding materials, further elevating termite susceptibility.

As a result, the moisture issues identified within these areas are considered to increase the risk of termite activity and material deterioration. It is recommended that these areas are periodically monitored for ongoing moisture issues. Assessment is recommended by a licensed termite management or pest control contractor where elevated termite risk is identified.

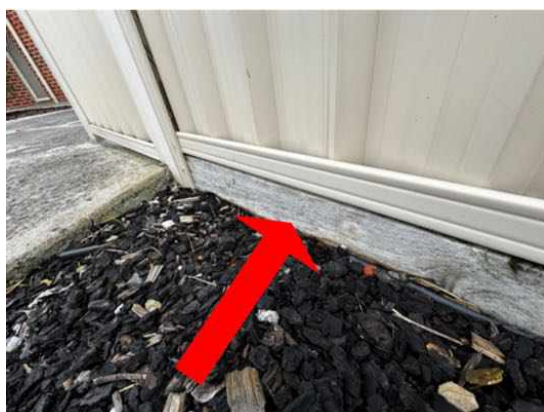
Finding 6.02

Building:	Main Building
Location:	All Areas > All Areas
Finding:	Inground timber contact (TP)
Information:	At the time of inspection, in-ground timber contact was observed to the front and rear yards, including timber garden edging under fence panels all in direct contact with the ground. There was also a dead tree stump next to the water tank. These timber elements are positioned within the soil zone and in close proximity to the building and associated structures.

In accordance with AS 3660.2, conditions that facilitate termite access or provide a direct food source are recognised as increasing the risk of termite activity to existing buildings. Timber elements in direct contact with the ground are particularly vulnerable, as they can attract subterranean termites and support concealed foraging activity, potentially allowing termite colonies to establish and migrate toward nearby structures without early detection.

As a result, the presence of in-ground timber elements is considered to increase the risk of termite activity to the property. It is recommended that a licensed termite management or pest control contractor be engaged to assess these conditions and provide advice on appropriate risk mitigation measures, which may include removal or replacement of timber elements with non-susceptible materials, isolation of timber from soil contact, and integration of suitable termite management measures to suit the

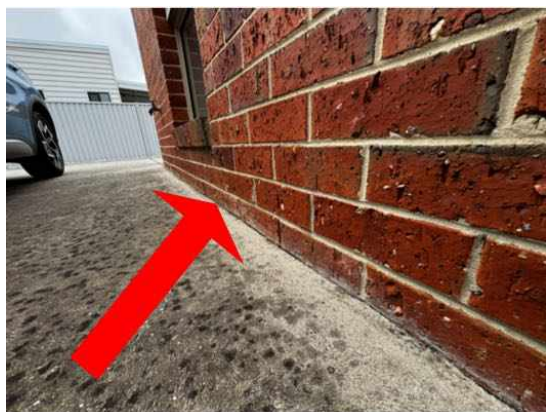
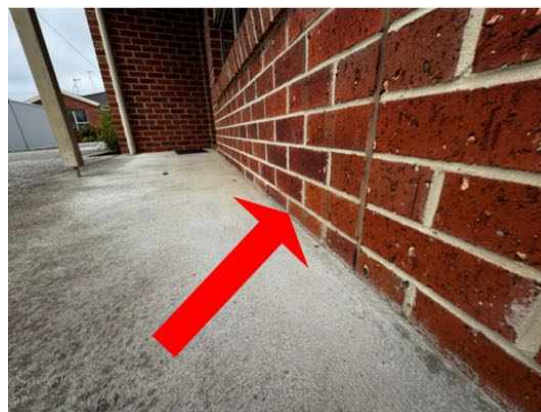
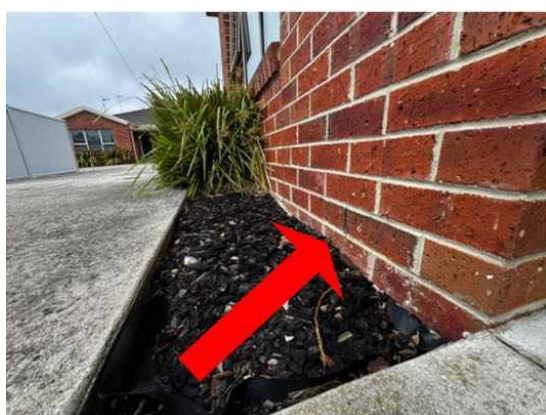
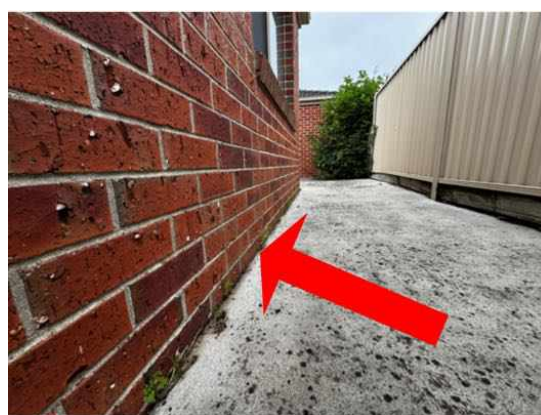
Finding 6.03

Building:	Main Building
Location:	All Areas > All Areas
Finding:	Slab edge - concealed (TP)
Information:	At the time of inspection, the slab edge to most areas of the building was observed to be concealed behind concrete paving and landscaping. This condition restricts clear visibility of the slab perimeter and limits the ability to visually inspect critical inspection zones intended for the early detection of termite activity.

Where slab edges and inspection zones are concealed, concealed termite entry paths may develop without early warning. In accordance with AS 3660.2, existing buildings are required to maintain conditions that allow for effective inspection and management of termite risk, noting that obstructions such as paving, paths, or landscaping can compromise the effectiveness of termite management measures. Where inspection zones are obstructed, the likelihood of undetected termite activity is increased.

As a result, the current configuration is considered to increase the risk of concealed termite entry to the building. It is recommended that a licensed termite management or pest control contractor be engaged to assess the extent of the concealed slab edges and provide advice on rectification options, which may include modifying paving or

landscaping to reinstate suitable inspection access and integrating appropriate termite management measures to suit the existing conditions.

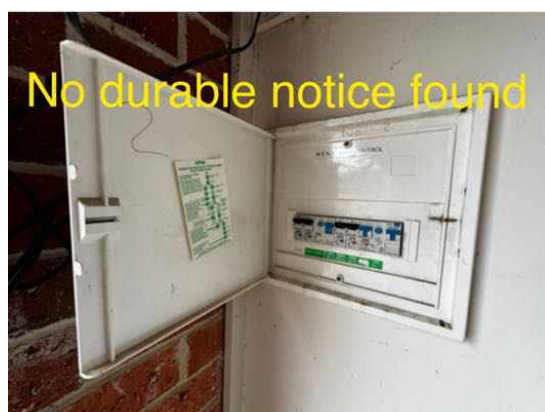
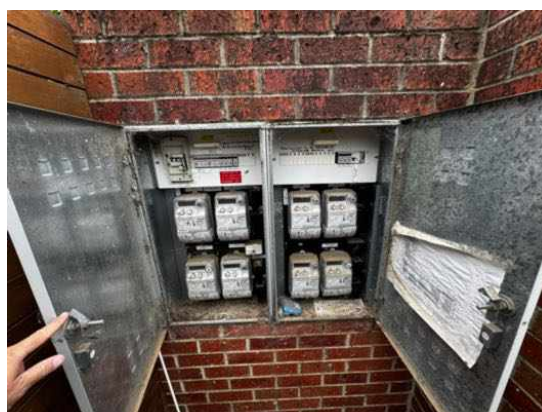
Building:	Main Building
Location:	Meter Box > All Areas
Finding:	Termite management system - no evidence of chemical installation (TP)
Information:	At the time of inspection, there was no visible evidence to suggest that a chemical termite management system has been installed or remains effective. In addition, no durable notice was observed within the electrical switchboard to identify the presence, type, or date of any termite protection measures.

For this reason, the installation of a post-construction chemical termite management system is highly recommended to reduce the risk of termite activity. A durable notice should also be installed within the electrical switchboard to clearly identify the treatment provided and support ongoing inspection and maintenance.

Engagement of a licensed termite management or pest control contractor is recommended as a matter of priority to assess the site conditions, consider local termite risk, and determine the most appropriate treatment method and procedures for this property.
