Building and Timber Pest Inspection Report

Inspection Date: Tue, 10 Feb 2026

Property Address: 154 Kennedy St, Howlong NSW 2643,
Australia

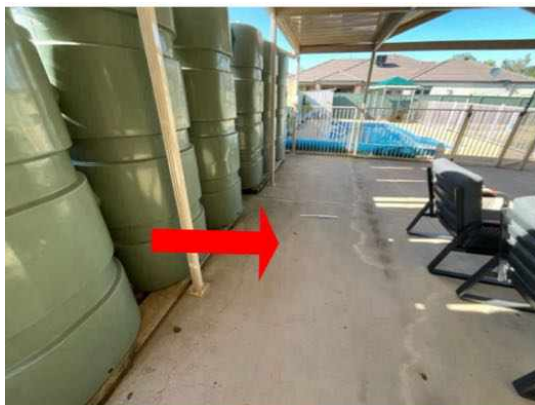
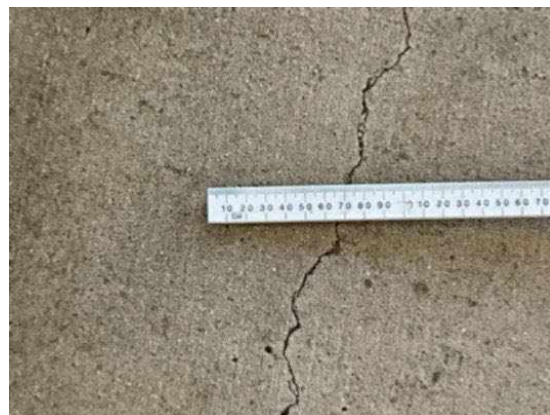
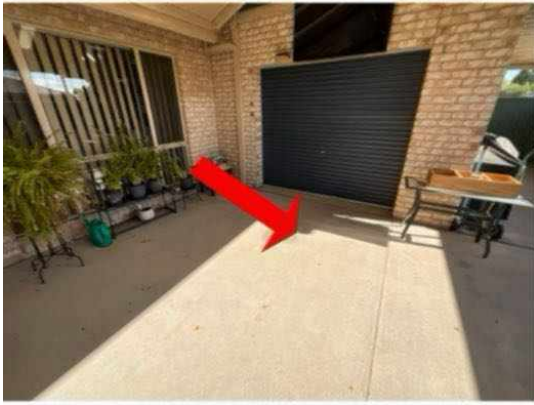
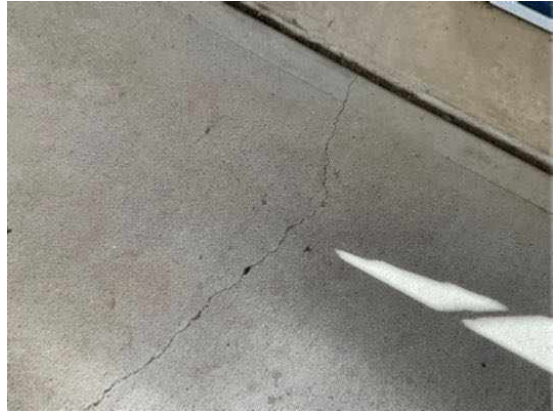
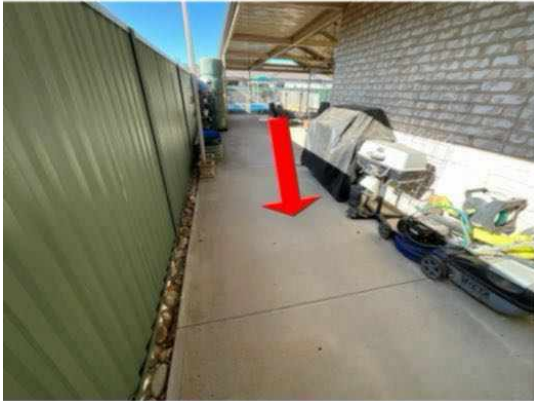
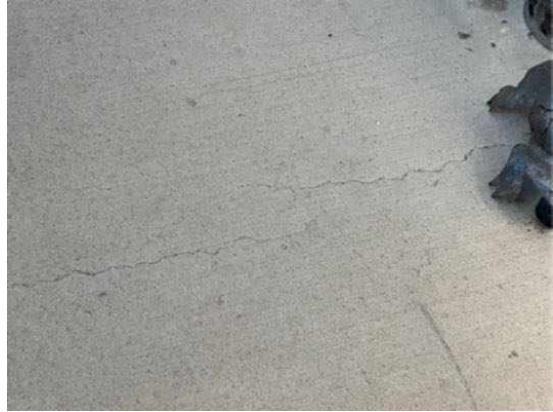
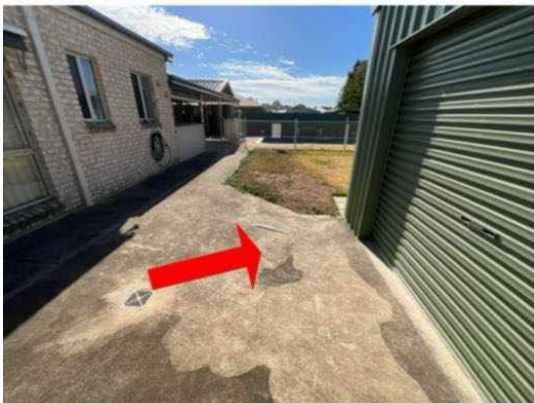
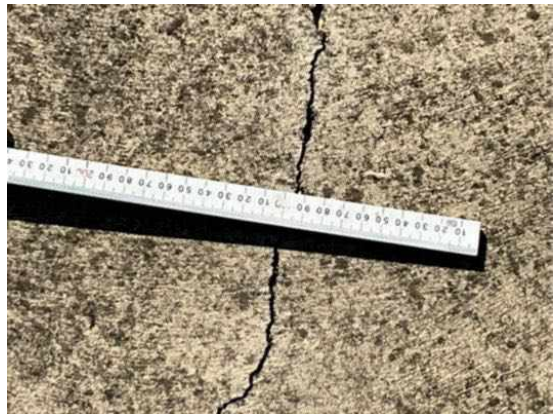
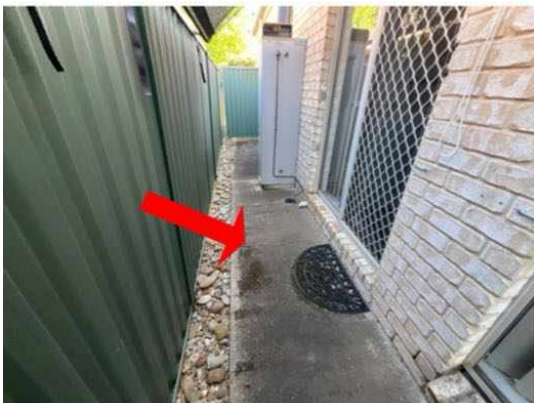
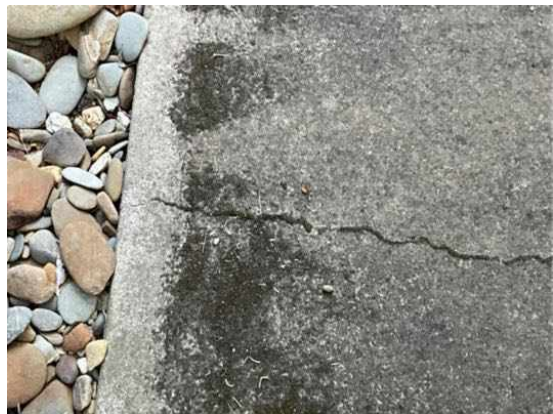
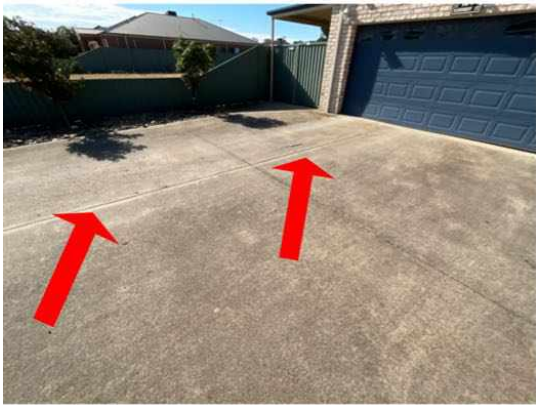
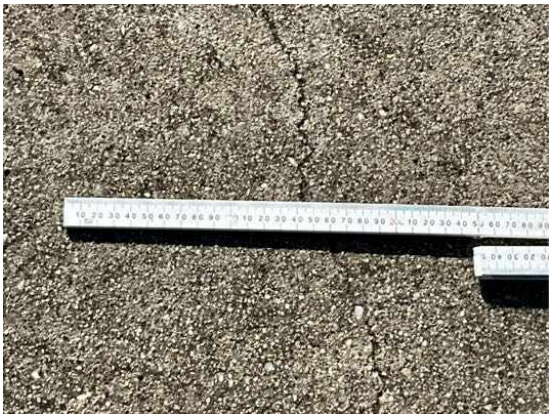
Finding 3.01

Building: Building 1
 Location: Alfresco area, shed, side yard, driveway
 Finding: Cracking - External Concrete Paving Damage Category 1 - Fine (less than 2mm)
 Information: Fine cracks were identified in external concrete paving. Although fine cracks are quite noticeable, they are often only considered to be an appearance defect, and usually do not indicate any structural damage. To be considered a Category 1 or fine crack, the crack is found to be less than 2mm in width.

Generally the cause of a hairline crack in existing concrete paving such as driveways and pathways is indicative of the expansion and contraction of the concrete. Such causes are generally due to environmental factors, such as moisture levels, weather conditions, root systems of nearby trees or the soil types on which they are laid.

Fine cracks may also be due to poor original installation of the concrete. Factors such as poor compaction of the sub surface and/or inadequate reinforcing of the slab may create cracking and other secondary defects.

Monitoring of all cracking should be conducted frequently. Always contact a building inspector should cracks widen, lengthen, or become more numerous.

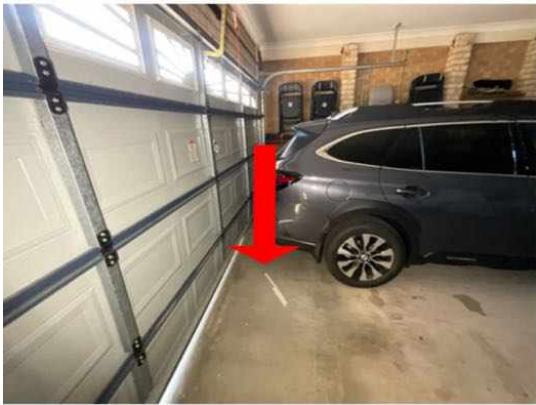
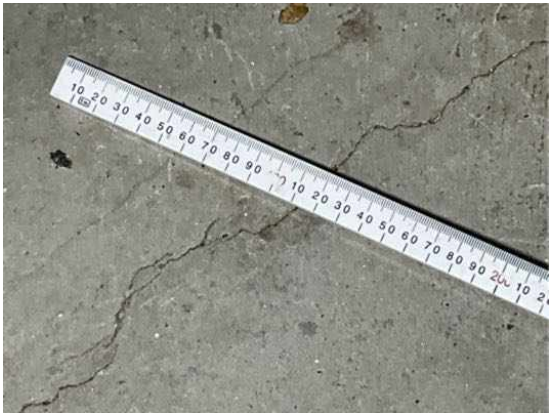
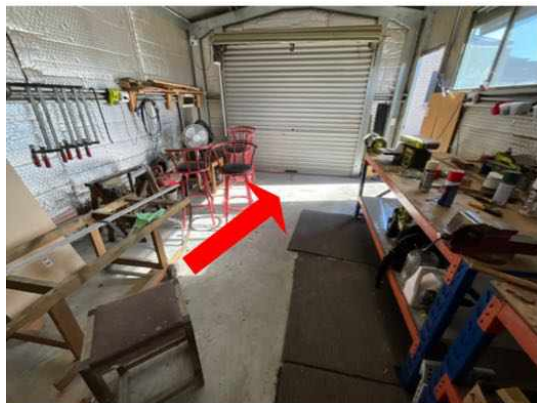
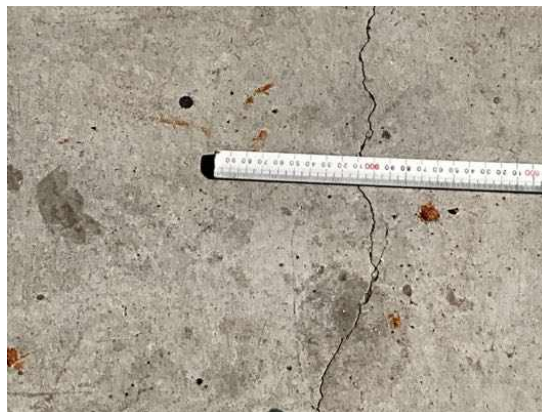
Finding 3.02

Building: Building 1
Location: Garage, shed
Finding: Crack in concrete slab - Category 1
Information: A crack coded as Category 1 was identified in the slab. A Category 1 crack is described as a fine but noticeable crack, with the slab at an otherwise reasonable level.

To be considered Category 1, the approximate width of the crack is less than 1.0mm, or a less than 10mm change in offset when a 3m straight edge is placed over the defect.

Category 1 cracks should be monitored for a period of 12 months. At the end of the monitoring period, identified cracks that are rated greater than Category 2 are considered defects, and require rectification.

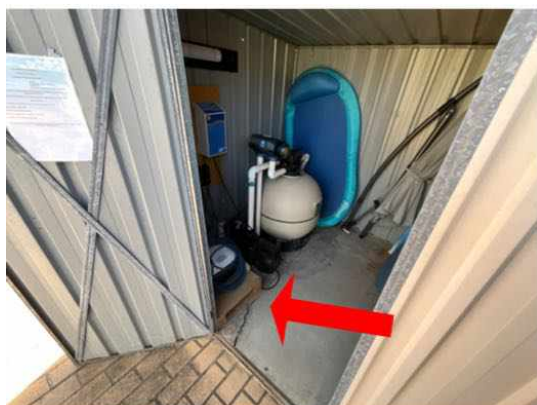
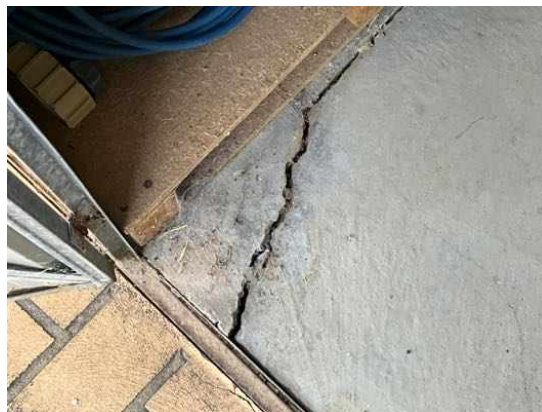
Finding 3.03

Building:	Building 1
Location:	Pump shed
Finding:	Cracking - External Concrete Paving Cracks (2mm - 4mm)
Information:	cracks were identified in external concrete paving Wide cracks are significant and are likely to lead to secondary defects if left unmanaged.

General age and expected deterioration of the paved areas is a common cause of this type of cracking. However, expansion and contraction of the slab may also have occurred due to environmental factors. Such factors include variable moisture and weather conditions, the presence of trees and their roots having a settling or lifting affect on the soil, or the effect of load bearing, e.g. heavy vehicles over a sustained period of time.

Cracking to this degree may also be due to poor original installation of the concrete. Factors such as poor compaction of the sub surface and/or inadequate reinforcing of the slab may create cracking and other secondary defects. Wide cracks may also have a more significant structural cause, such as subsidence of soils.

A concreter or handyman should be contacted to restore the area if cracking becomes significantly wider.

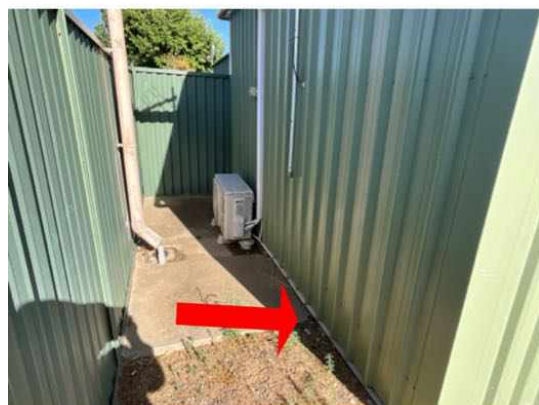
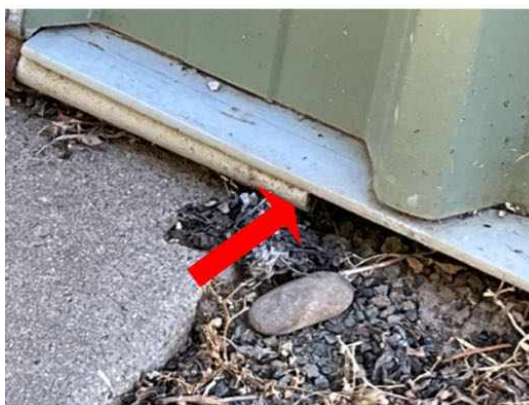
Finding 6.01

Building: Building 1
 Location: Shed
 Finding: Air conditioner - Disconnected overflow
 Information: The Air Conditioner (A/C) overflow was found to be disconnected from storm water drainage and is creating excessive moisture in the surrounding area.

Such leaking creates an environment which is conducive to an array of defects, including water damage to associated building elements and the attraction of termite or timber pest infestation.

It is highly recommended that a licensed plumber be appointed to connect the A/C overflow in order to prevent such an environment from being created. These minor works should be carried out as soon as possible.

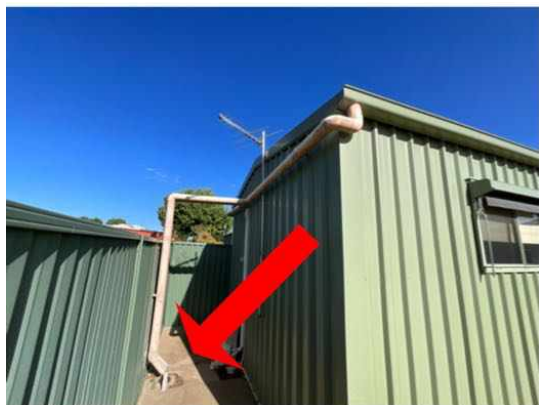
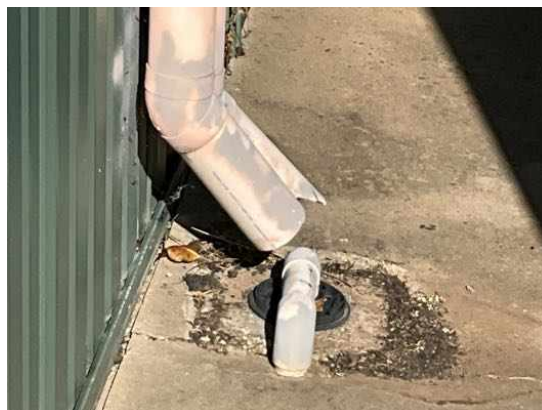
Finding 6.02

Building: Building 1
 Location: Shed
 Finding: Stormwater drain - Not connected
 Information: The roof plumbing is not adequately connected to stormwater drainage on the site. This disconnection negatively impacts the functional capacity of the roof plumbing.

Where roof plumbing doesn't drain adequately, the area at the base perimeter can become excessively damp, potentially creating an environment that is susceptible to rust and corrosion of surrounding building elements, as well as attracting termites and other pests.

It is highly recommended that a plumber be appointed to further inspect the area and to install adequate drainage equipment where necessary.

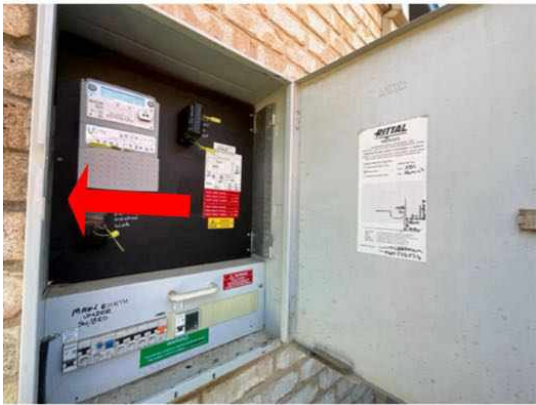
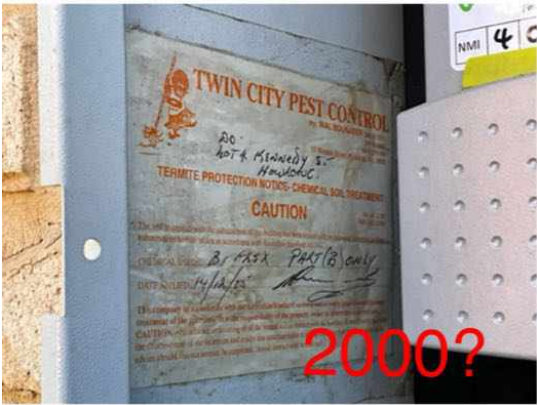
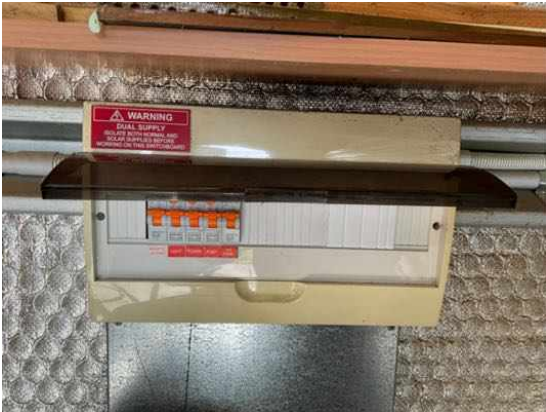
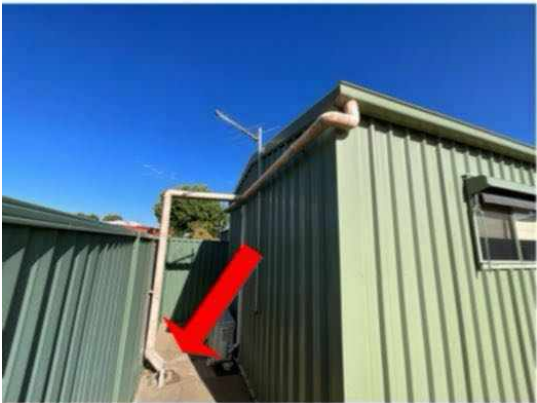
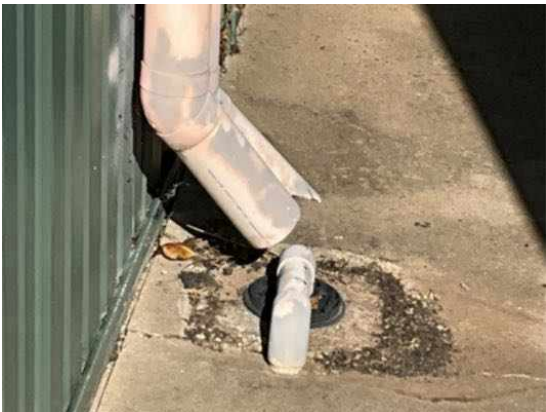
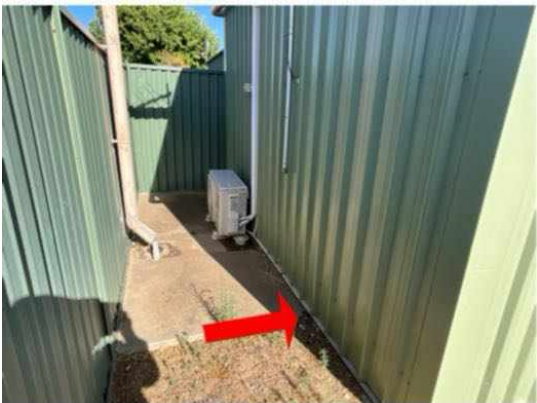
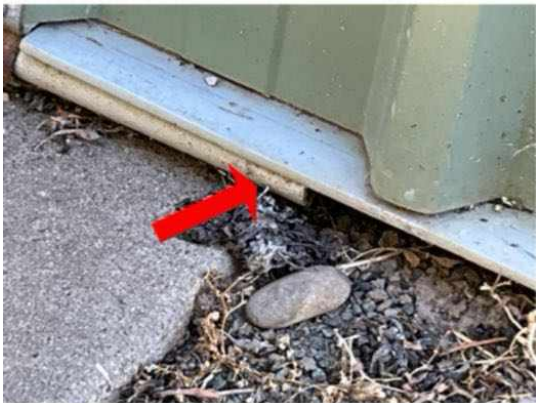
Finding 6.03

Building:	Building 1
Location:	All External Areas
Finding:	Termite Management System- evidence of a chemical installation
Information:	The application of a post-construction chemical termite barrier is highly recommended for all properties, particularly if live termite activity has been found on the site previously. Such barriers are highly effective in preventing termite attack on any timber building elements throughout the property.

A durable notice has been placed in the switchboard unit to indicate current termite barriers. At the time of inspection, it appeared as though a termite management system has been installed. The recency of any treatment cannot be determined.

The client may consider gaining further advice from a pest controller as to the costs and procedures involved with this application. It is recommended that obtaining such advice be a short-term priority.

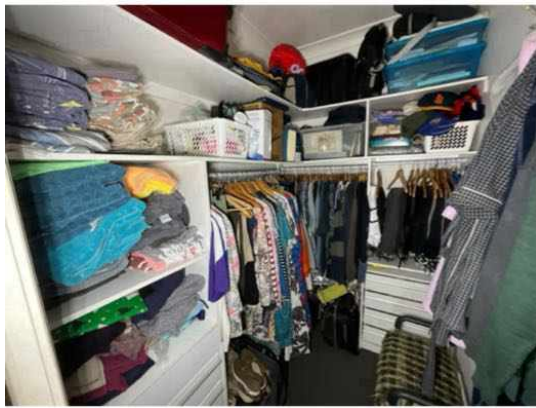
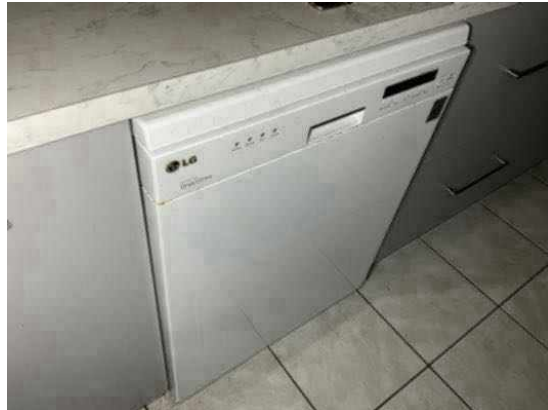
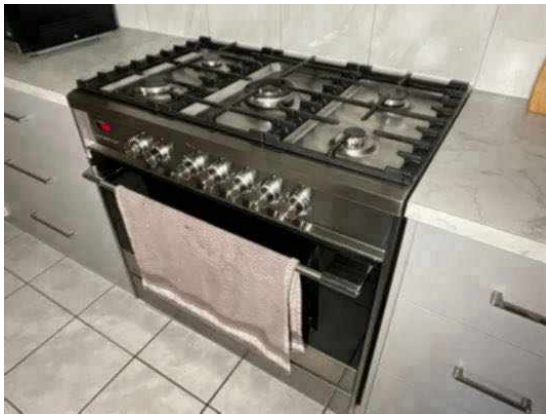
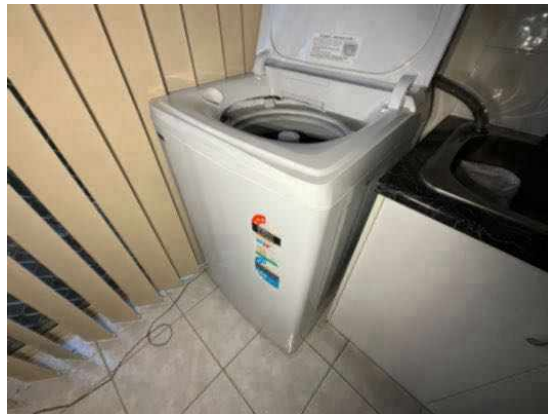
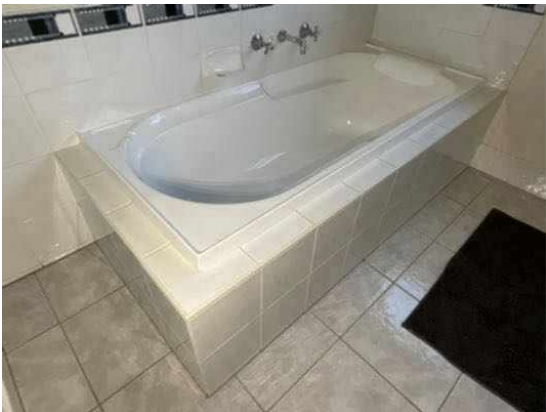
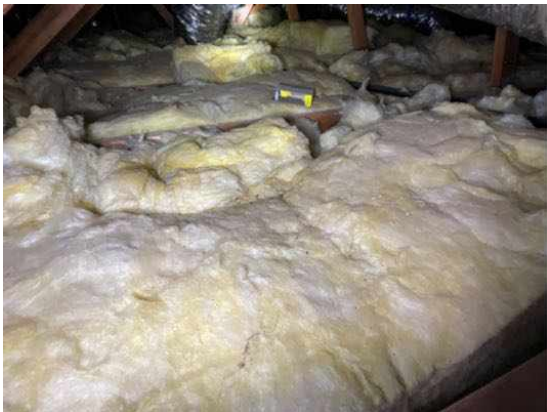
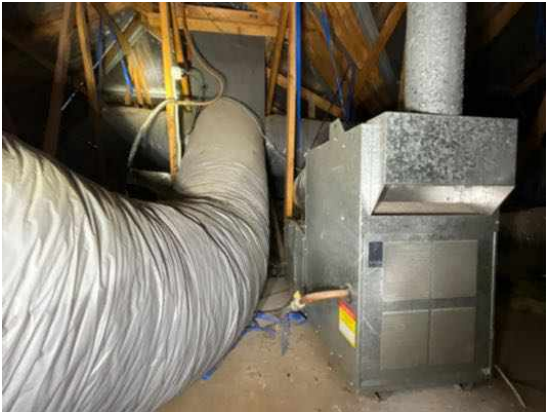
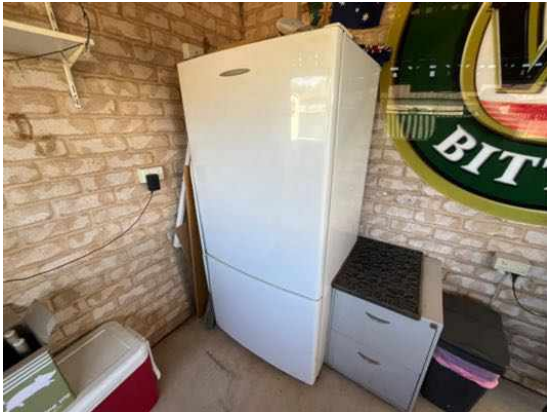
Noted Item

Building: Building 1
Location: All Areas
Finding: Additional Photos - Obstructions and Limitations
Information: These photographs are an indication of the obstructions and limitations which impeded full inspection of the property at the time of inspection. These obstructions can hide an array of defects and should be removed to allow full inspection to be carried out. A re-inspection is recommended once the areas are made accessible.
