Building and Timber Pest Inspection Report

Inspection Date: Thu, 26 Mar 2026

Property Address: 4 Alwyn Avenue, Wallacia NSW 2745

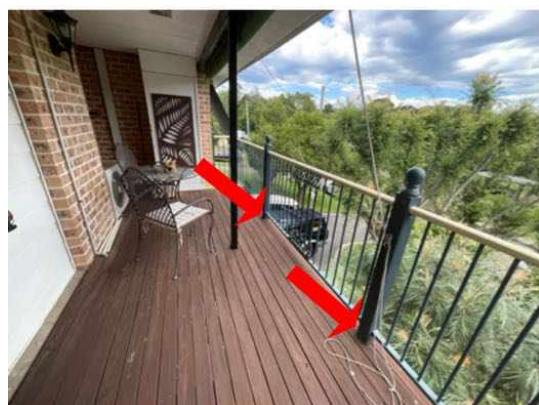
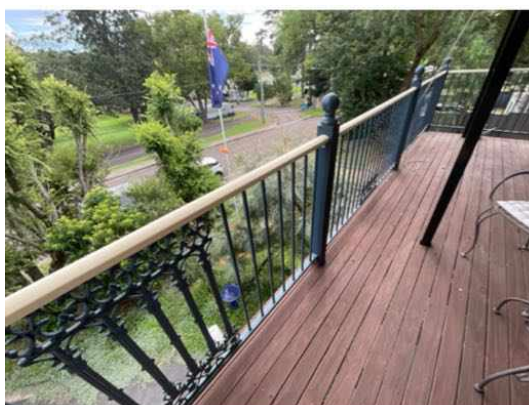
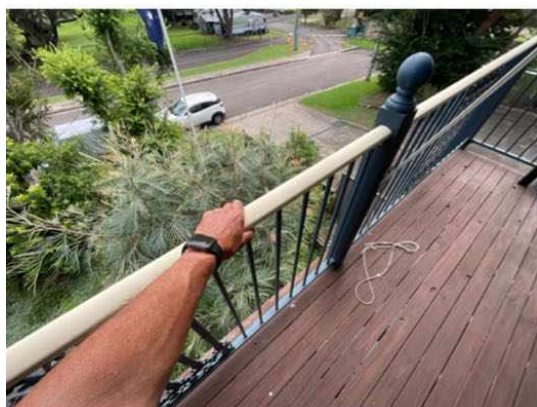
| Finding: | Safety Hazard – Defective Balustrade. |

At the time of inspection, the balustrade posts were found to be loose and unstable, with noticeable movement under minimal applied pressure. The posts do not appear to be adequately secured to the supporting floor joists, indicating a failure or inadequacy in the fixing system. This condition was observed in accessible areas only.

Loose or inadequately fixed balustrade components present a significant safety hazard. There is an increased risk of sudden failure or collapse when lateral force is applied, such as when a person leans against the barrier. This creates a risk of serious injury due to falling from height. While this report does not assess regulatory compliance, it is noted that barriers are generally required where there is a potential fall of 1 metre or greater, and the current condition would not be considered safe for normal use.

- The balustrade posts were found to be loose and inadequately secured, with noticeable movement indicating a risk of failure. This condition presents a safety hazard due to the potential for collapse and fall from height. Urgent repair by a licensed builder or carpenter is recommended, and the balustrade should not be relied upon until rectified.

It is recommended that a suitably qualified and licensed builder or carpenter be engaged as a matter of urgency to assess the extent of the defect and carry out necessary repairs. Works should include securely fixing the balustrade posts to the structural framing in accordance with accepted building practices to ensure the barrier is stable and fit for purpose. The balustrade should not be relied upon until repairs have been completed.

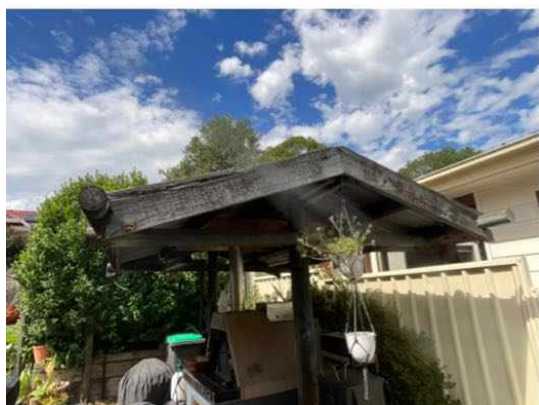
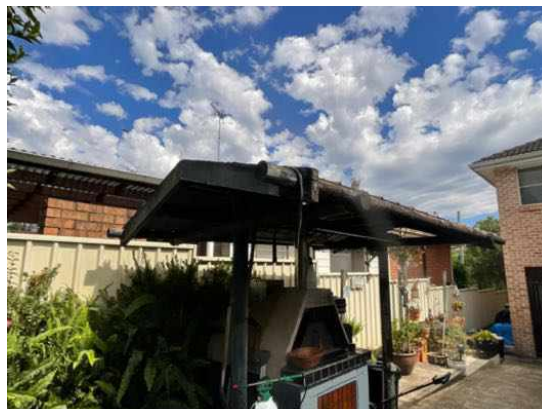
Building: Main Building
 Location: External Areas
 Finding: External Timber Building Elements.
 Information: External Timber Elements – Weather Exposure and Condition

External timber elements were observed in various locations around the property. Some of these timbers appear to lack adequate protective treatment (e.g., paint or sealant), leaving them exposed to the effects of weathering.

Untreated or poorly protected external timbers are susceptible to accelerated deterioration due to exposure to moisture, UV radiation, and general weathering. If left unattended, ongoing deterioration may occur, potentially resulting in the need for premature replacement of affected timbers.

It is recommended that exposed and untreated timber elements be sealed or painted by a suitably qualified painting contractor or handyman as soon as practicable to

prevent further deterioration.

Where timber components have already deteriorated beyond practical repair, a licensed carpenter should be engaged to carry out necessary repairs or replacement.

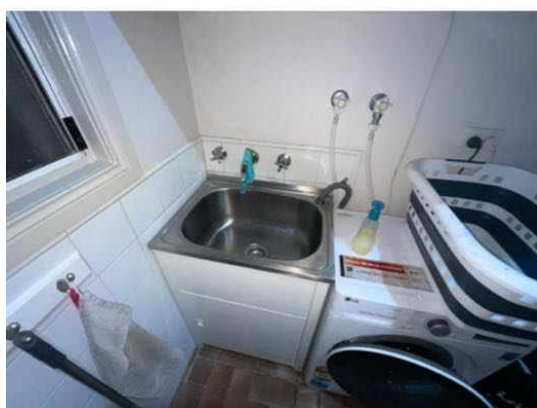
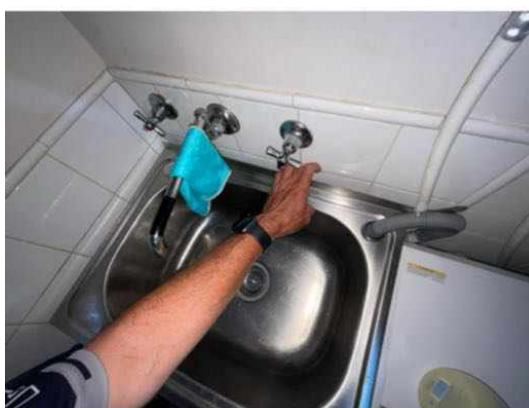
Finding 3.02

Building: Main Building
 Location: Laundry
 Finding: Laundry Tub Unit – Installation and Sealing Issues.
 Information: Findings:

- The laundry tub unit is not securely fixed to the wall, which presents a potential risk of movement.
- If left unattended, this movement could dislodge or strain the plumbing connections, potentially leading to leaks or water damage.
- Additionally, sealant is missing at the wall junctions around the unit, leaving gaps that may allow moisture ingress, promoting mould growth and damage to surrounding cabinetry or wall surfaces.

- Unsecured fixtures can compromise the integrity of plumbing connections, potentially resulting in leaks or costly water damage.
- Lack of sealant may lead to ongoing moisture exposure, which can deteriorate cabinetry materials and create an environment conducive to mould and mildew.

The laundry tub unit requires immediate attention to secure its position and prevent further plumbing or moisture-related issues. Rectification by a suitably qualified tradesperson will help maintain the longevity and functionality of the laundry area.

- Secure the laundry tub unit firmly to the wall to prevent movement and ensure plumbing stability.
- Apply appropriate waterproof sealant to all wall junctions and gaps around the unit to prevent moisture ingress.

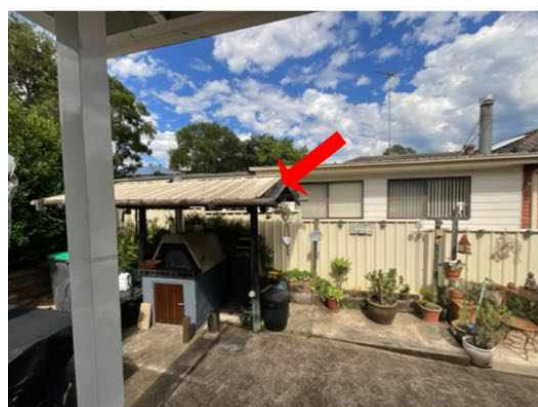
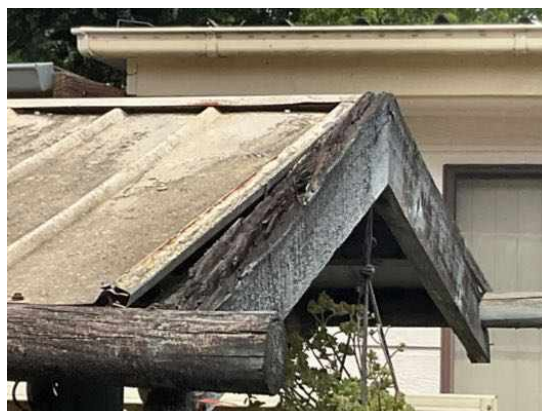
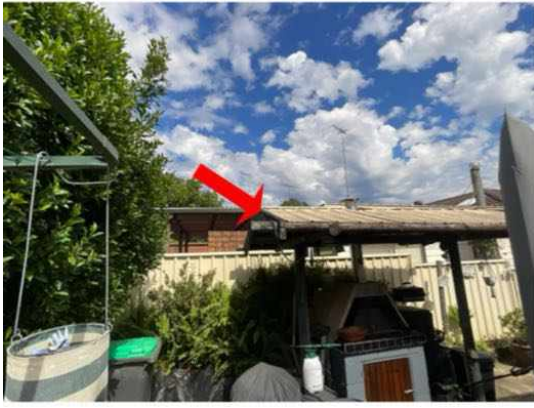
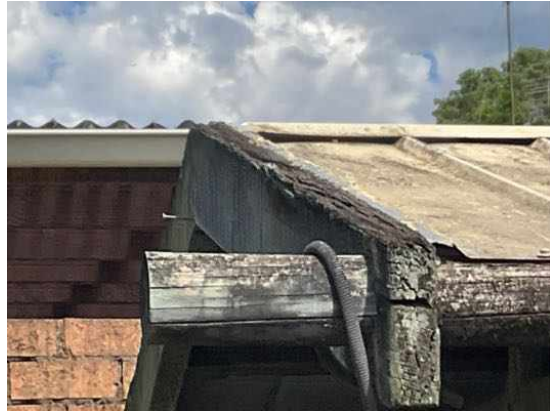
Building: Main Building
 Location: Yard
 Finding: Fungal Decay (Wood Rot) – Conducive Conditions for Timber Pests..
 Information: Findings:

- Wood rot not only compromises the structural integrity of affected timbers but also creates ideal conditions for termite activity and other timber pests.
- Damp and decaying timber is particularly attractive to subterranean termites, which prefer moist environments and can use rotting timber as a bridge into the structure.

- Wood rot observed in the BBQ roof structure
- Continued exposure to moisture could worsen the decay and increase pest risk.
- All affected timbers should be removed and replaced with treated or non-susceptible materials.
- Wood Rot is conducive to termite activity and should be addressed urgently by removing and replacing affected timbers with treated or non-susceptible materials.

- Prompt removal of decayed or untreated timber is recommended to eliminate conducive conditions.
- Where necessary, replace susceptible materials with non-susceptible or treated timber suitable for external use.

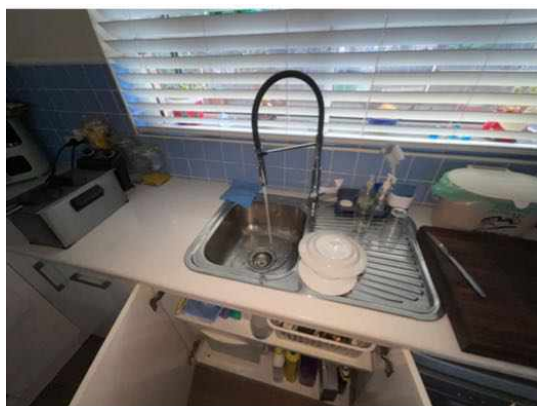
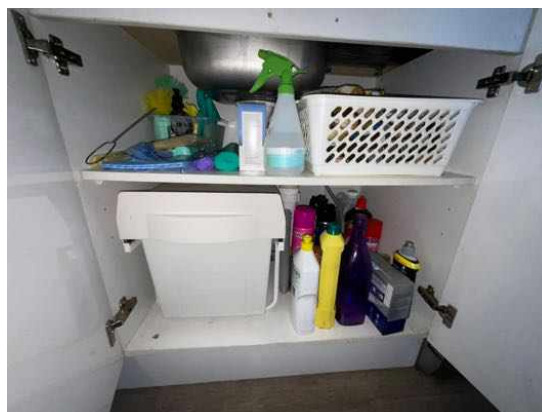
Building: Main Building
 Location: Kitchen
 Finding: Kitchen Sink – Overall Condition & Recommendations.
 Information: Observations:

- Further monitoring and testing are recommended once the tap(s) are in constant use, to identify any drainage issues or signs of slow leaks not evident during the limited inspection.
- For long-term property care, it is advised that sealant and grouting in water-exposed areas be regularly inspected and maintained.
- It is recommended that the stored items beneath the sink be removed to allow for a full re-inspection of the plumbing and cabinetry, ensuring no concealed defects are present.

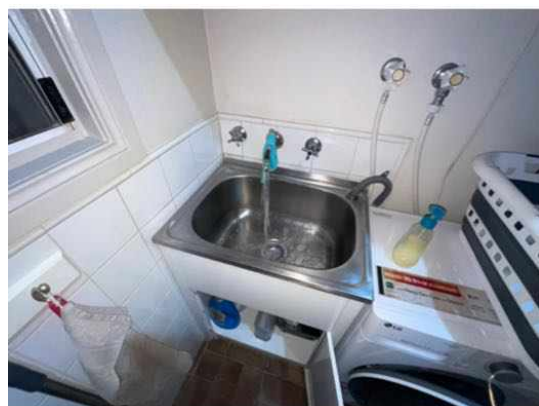
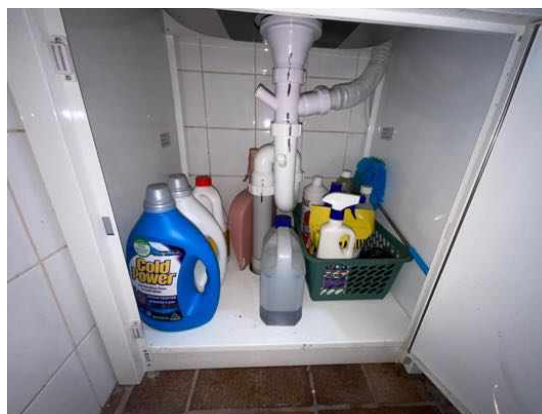
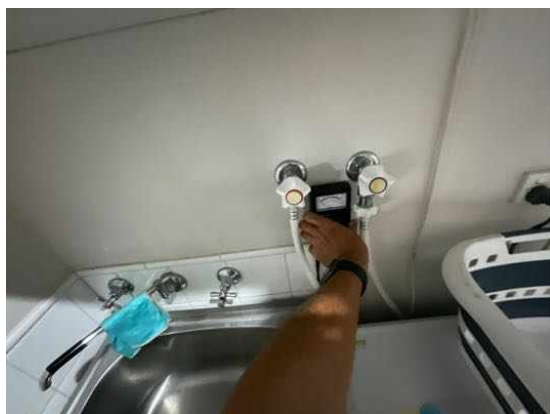
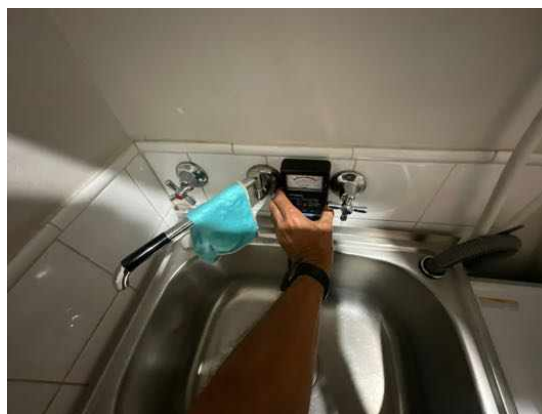
Building: Main Building
 Location: Laundry
 Finding: Laundry - Taps/Plumbing/Drainage.
 Information: Observation: Laundry Tub – Taps, Plumbing, and Cabinetry

- Further monitoring or testing is recommended once the taps are placed into regular use, to ensure no leaks develop over time and that the drainage system continues to perform adequately.
- Flexible and mould-resistant sealant should be applied to junctions between the basin and the wall to prevent water ingress that may lead to damage.
- Regular maintenance and prompt replacement of missing or deteriorated sealant is highly recommended, as this is a common wear-and-tear issue.
- Sealant and grouting in wet areas should be maintained as part of the long-term care and upkeep of the property.
- Where required, a sealant specialist or qualified tiling contractor should be appointed to carry out remedial sealing works.

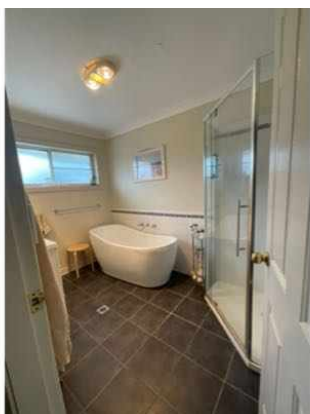
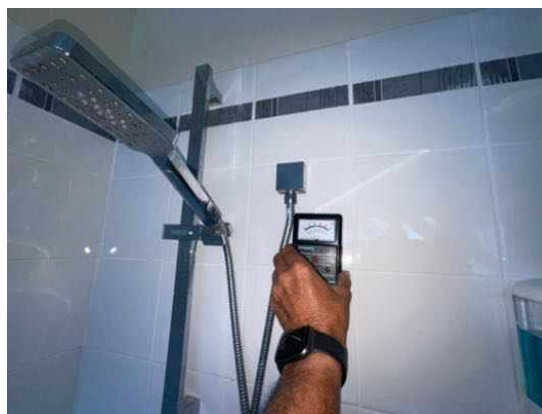
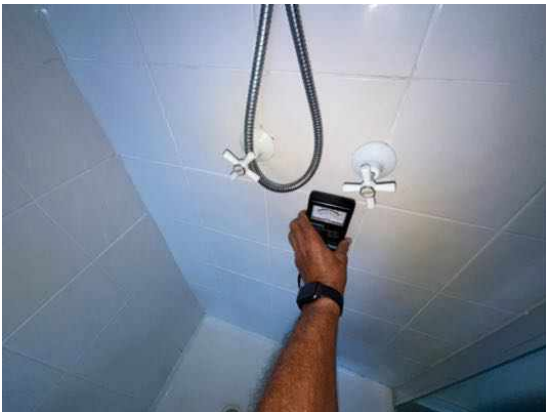
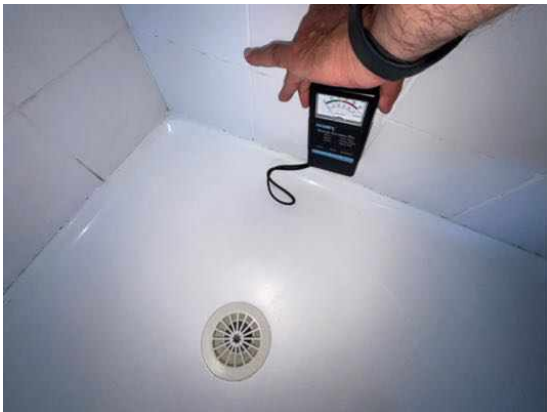
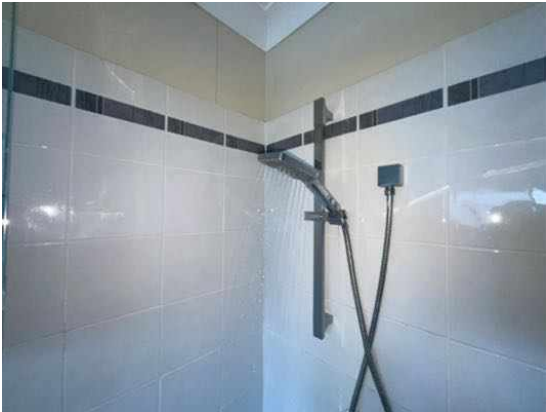
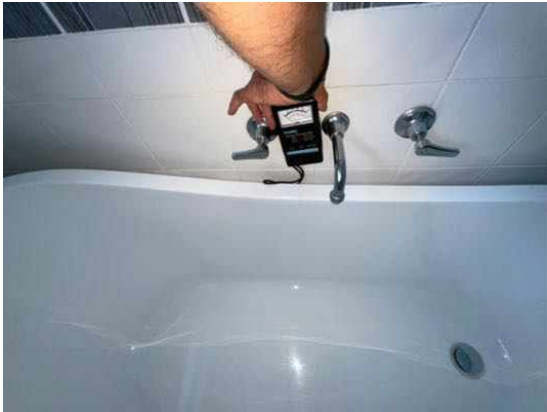
Building: Main Building
 Location: Bathroom
 Finding: Wet Areas - Bathroom(s) - Overall Condition & Recommendations.
 Information: Overall Condition & Recommendations

Recommend replacing sealant
