Building and Timber Pest Inspection Report

Inspection Date: Mon, 09 Mar 2026

Property Address: 601 Pacific Hwy, Wyoming NSW 2250,
Australia

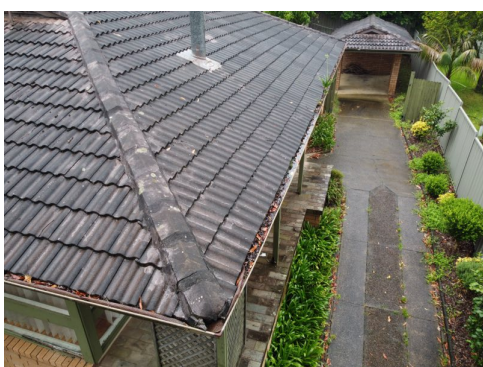
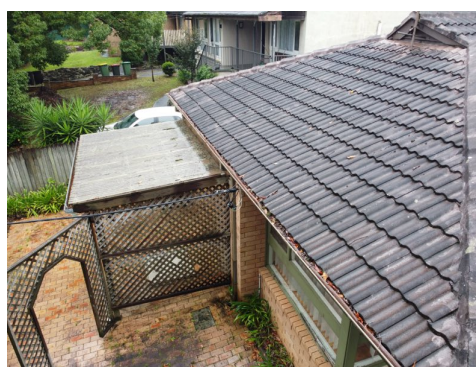
Finding: Roof Drainage System Defects – Gutters, Downpipes and Associated Deterioration

Information: Multiple defects were observed to the roof drainage system. Several downpipes were disconnected or improperly connected, allowing roof water to discharge directly onto the ground adjacent to the building. Gutters were heavily filled with debris and appeared blocked, and a section along the driveway side had sagged, allowing water to accumulate and overflow during rainfall. The gutter attached to the front pergola was also heavily corroded with sections rusted through. Deterioration to fascia boards was noted at external corners, which may be associated with prolonged moisture exposure.

Where roof drainage systems do not function correctly, uncontrolled roof water discharge can occur and ongoing moisture exposure to surrounding building elements may result. A roofing plumber should be engaged to assess and rectify the guttering and downpipe system as required, and a builder should address any associated building deterioration. This should be done as a matter of urgency to prevent further moisture exposure and deterioration.

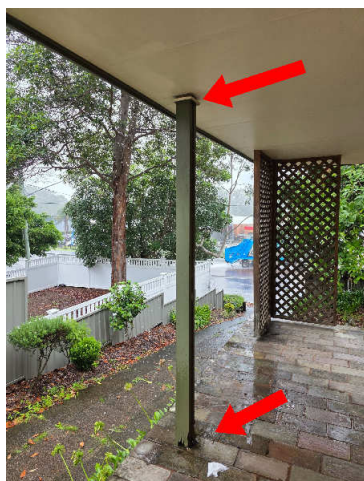
Finding: Severely Decayed Veranda Post – Driveway Side

Information: A veranda support post located below the affected gutter section on the driveway side was observed to be severely decayed at its base due to fungal decay. The lower portion of the post has deteriorated and the post has dropped, meaning it no longer appears to be providing effective support to the veranda structure. Continued deterioration may affect the stability of the supported structure.

A builder should be engaged to assess and rectify as required. This should be done as a matter of urgency.

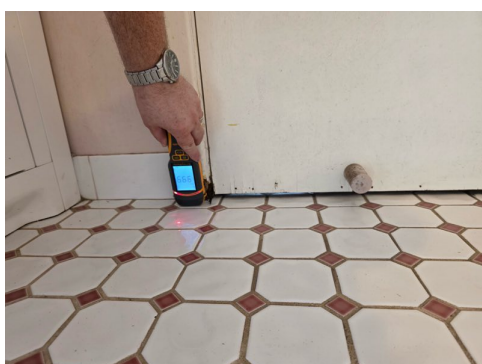
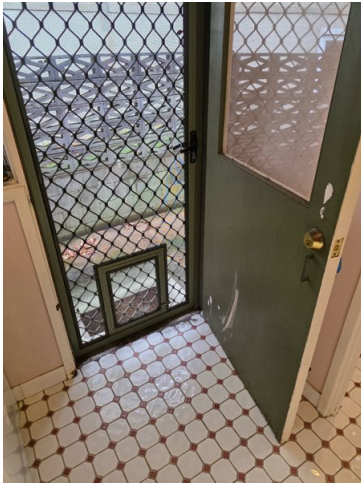
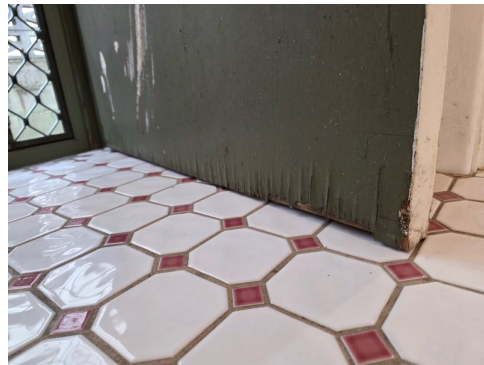
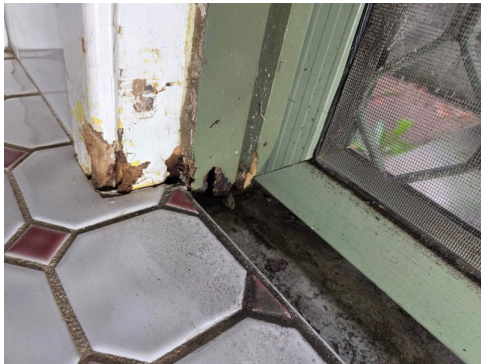
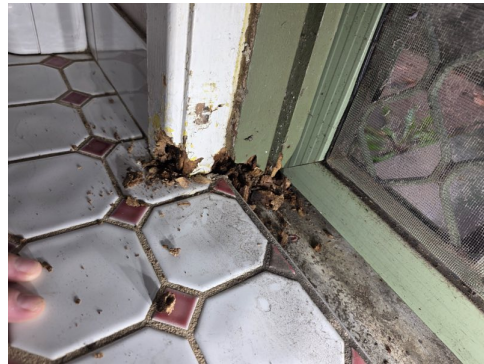
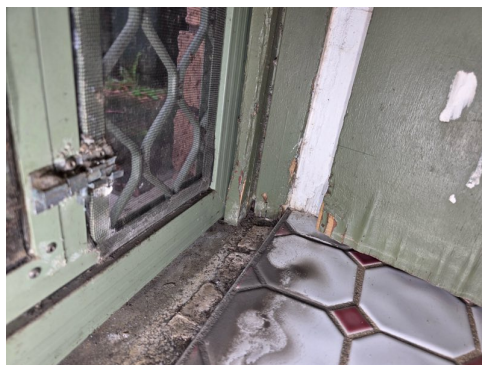
Finding 2.03

Finding: Severe Timber Decay – Laundry External Door Frame and Door

Information: The lower sections of the external laundry door jamb and architrave were observed to be heavily deteriorated due to fungal decay. The bottom of the laundry door is also delaminating and shows clear signs of prolonged moisture exposure and moisture damage. Continued deterioration may affect the function of the door and allow ongoing moisture exposure to surrounding building elements. Concealed damage could not be ruled out during a non-invasive inspection.

A builder should be engaged to assess, carry out a further investigation to determine the extent of any concealed damage, if any, and to rectify as required. This should be done without delay.

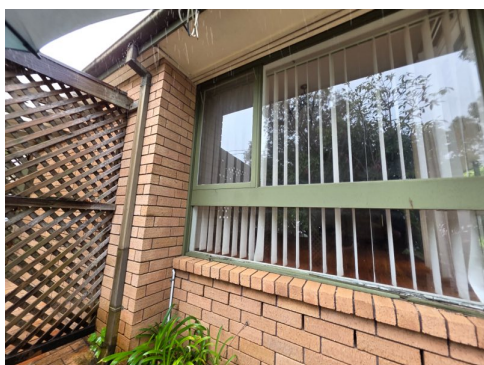
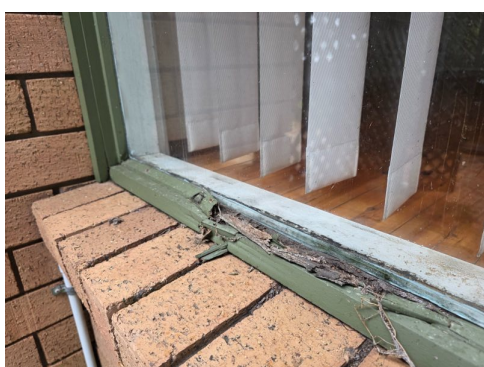
Finding: Timber Decay to Window Bottom Rail – Living Room Corner Window

Information: The external bottom rail of the corner window in the living room was observed to be deteriorated due to fungal decay. The timber shows clear signs of moisture-related breakdown and no longer appears to be providing full weather protection to the window assembly. Slightly elevated moisture readings were also recorded to the internal window framing and concealed deterioration within the surrounding wall structure cannot be ruled out.

A builder should be engaged to assess and repair or replace the affected timber components as required. This should be carried out as soon as practicable to prevent further deterioration.

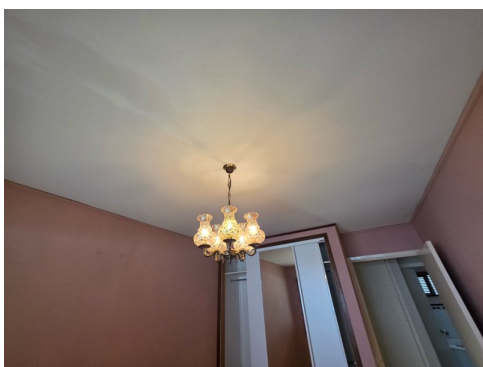
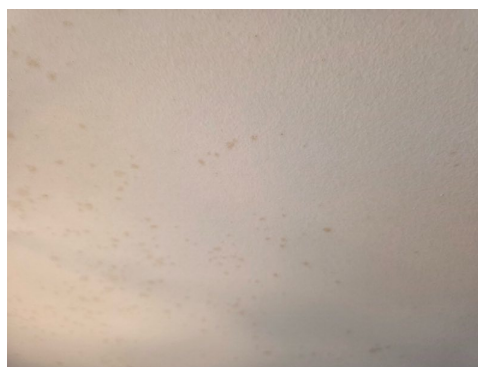
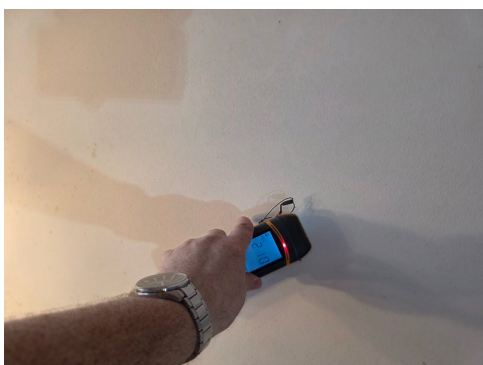
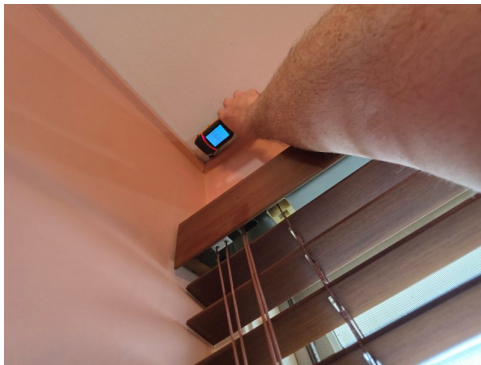
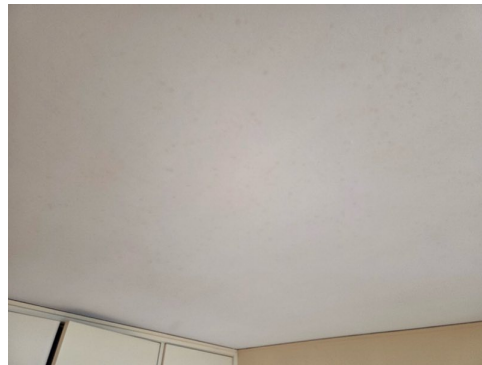
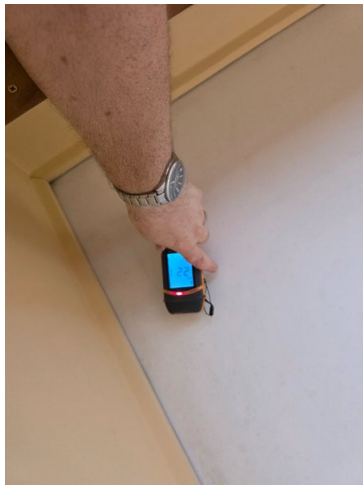
Finding 3.02

Finding: Ceiling Staining and Suspected Mould Growth

Information: Yellow spot-like staining was observed to sections of the ceiling linings in Bedrooms 1 and 2. In addition, small spot-like marks consistent with suspected mould growth were noted to the ceiling corners, particularly to the external wall corner of Bedroom 2 where elevated moisture readings were recorded. A similar condition was observed in the living room corner above the window as well. These conditions indicate ongoing moisture presence and may be associated with condensation, humidity, or possible moisture ingress.

Concealed deterioration within ceiling materials cannot be ruled out during a visual inspection. A licensed builder should investigate the source of moisture and carry out rectification as required. This should be addressed without delay to prevent further deterioration.

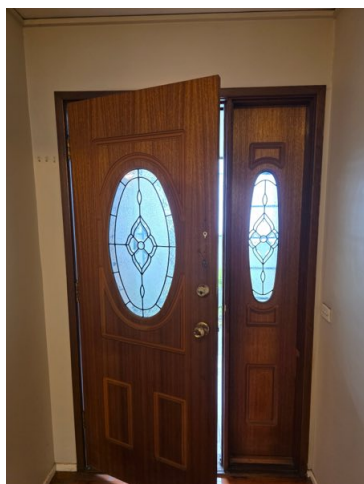
Finding 3.03

Finding: Cracked Leadlight Glass – Front Entry Door

Information: Cracking was observed in the leadlight glass panel in the front entry door. Cracked glass may deteriorate further over time and can present a breakage hazard if the panel becomes unstable.

A glazier should be engaged to assess and rectify as required. This should be done at the owner's discretion.

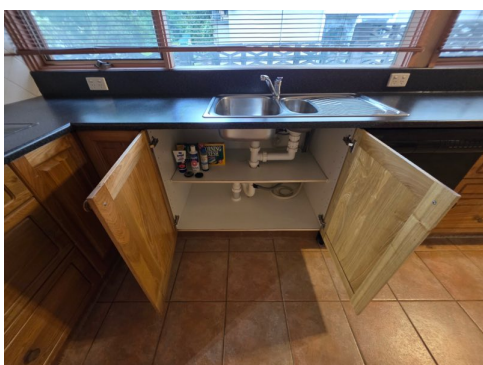
Finding: Elevated Moisture and Minor Water Damage – Kitchen Sink Cabinet

Information: Elevated moisture readings were recorded to the cabinet carcass beneath the kitchen sink. Minor deterioration was observed to the cabinet base along with water staining to the shelf above. This indicates ongoing or previous moisture exposure in the cabinet area and concealed deterioration in surrounding cabinetry cannot be ruled out.

A licensed plumber should be engaged to carry out further investigation and rectify as required. This should be done as soon as practicable.

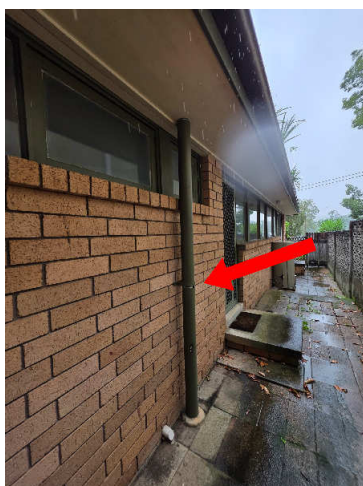
Finding: Corroded Sewer Vent Pipe

Information: The metal sewer vent pipe was observed to have a rusted hole through its face approximately halfway up its height. Corrosion holes can allow sewer gases to escape and may allow continued deterioration of the pipe.

A licensed plumber should be engaged to assess and rectify as required. This should be done as soon as practicable.

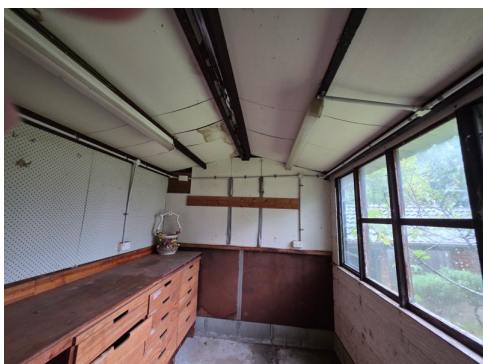
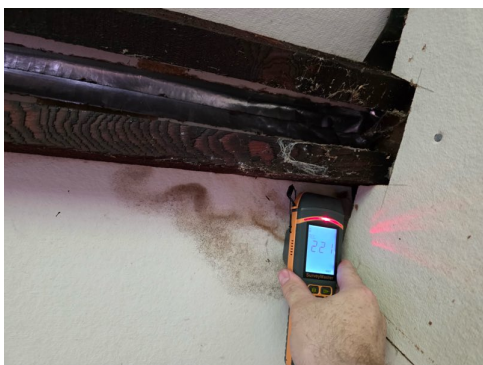
Finding 3.08

Finding: Water Staining and Elevated Moisture – Shed Ceiling Linings

Information: The shed ceiling linings appear to be a chipboard-type material and multiple sheets displayed visible water staining. Elevated moisture readings were also recorded in several areas, indicating ongoing or recent moisture exposure. Continued moisture exposure may lead to progressive deterioration of these sheet materials.

A builder should be engaged to carry out further investigation and rectify as required. This should be done as soon as practicable.

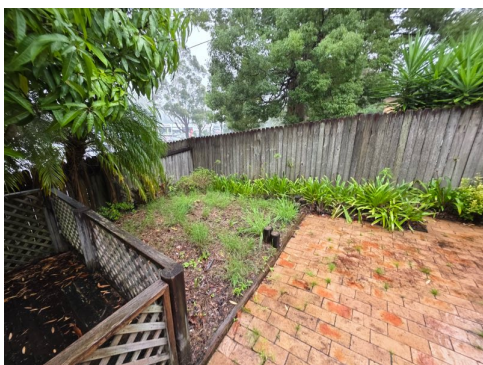
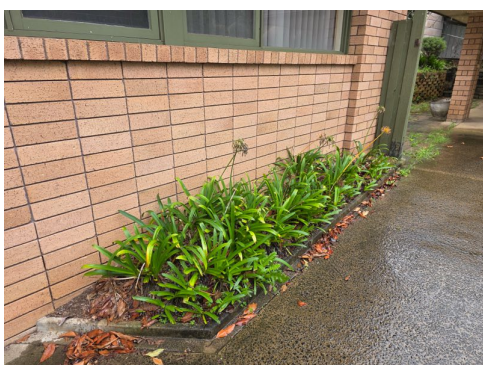
Finding: Garden Beds - Conditions Conducive to Termites

Information: Garden beds, particularly those constructed from untreated timber, were noted adjacent to the dwelling. These create a highly conducive environment for termite activity due to the combination of retained soil moisture from watering, direct soil contact, and the organic material in the soil and timber edging. Such conditions increase the risk of concealed termite ingress into the property, as termites can travel through the garden beds and enter the structure undetected.

Where practical, garden beds should be removed, relocated, or modified so that they do not abut the dwelling. Where this is impractical or undesirable, the risk of concealed termite activity remains. In these cases, a licensed pest controller should establish an ongoing termite management plan, and regular timber pest inspections should be carried out every 6–12 months to assist in protecting the property against infestation.

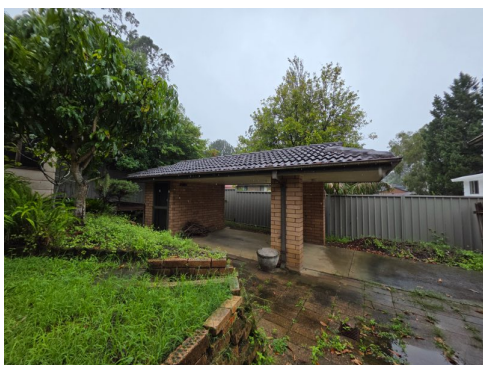
Finding 6.03

Finding: Stored Timber – Termite Conducive Condition

Information: Stored timber was observed in the storage room at the rear of the carport. Timber stored against or close to structures can create conditions conducive to termite activity and may attract termites to the vicinity of the building.

A licensed pest controller should be engaged to assess and advise as required. Ongoing termite management is recommended, including timber pest inspections every 6–12 months. This should be done at the owner's discretion.

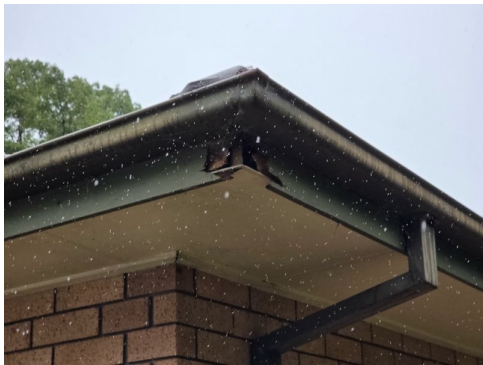
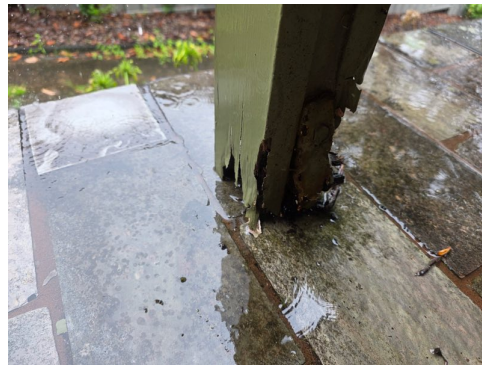
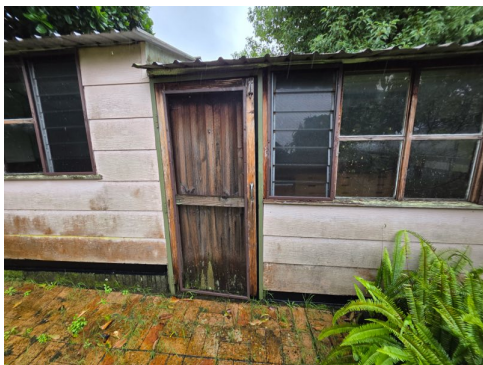
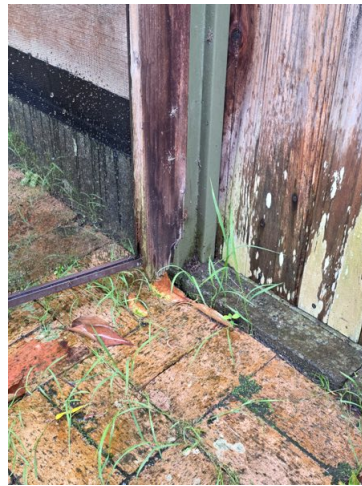
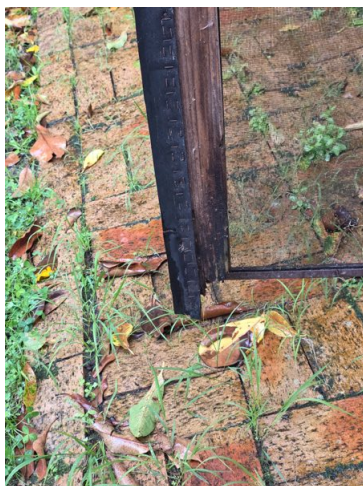
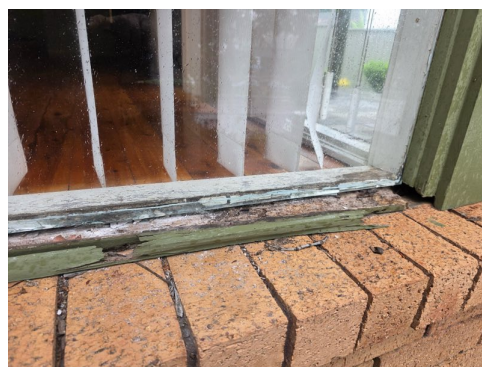
Finding 7.01

Finding: Fungal - Fungal decay observed in timber elements

Information: Fungal decay was observed in timber elements in the fascia boards, window frame, verandah post, laundry door jamb and shed fly screen frame. Fungal decay (commonly referred to as wood rot) occurs when timber remains damp for extended periods, allowing fungal spores to colonise and break down the wood fibres. This process reduces the strength, durability, and integrity of the timber.

Decay is typically caused by poor drainage, regular wetting, or direct contact with soil or saturated surfaces.

Recommend a licensed builder or pest manager assess the extent of deterioration and replace or treat affected timbers as necessary. Regular timber pest inspections should be carried out every 6–12 months. Rectify without delay.

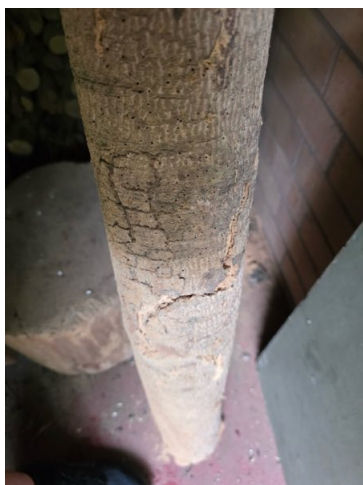
Finding 8.01

Information: Evidence consistent with wood borer activity was observed in a piece of stored firewood in the shed area. Numerous small round exit holes were visible in the timber, which is typical of wood borer infestation. The affected timber does not form part of the building structure.

Infested firewood can act as a harbourage for timber pests and may introduce or sustain pest activity on the property if stored close to the dwelling. The affected timber should be removed from the site or stored well away from the building. Regular timber pest inspections should continue at intervals of approximately 6–12 months to monitor conditions.

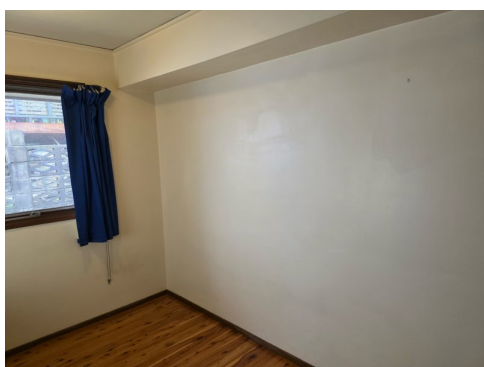
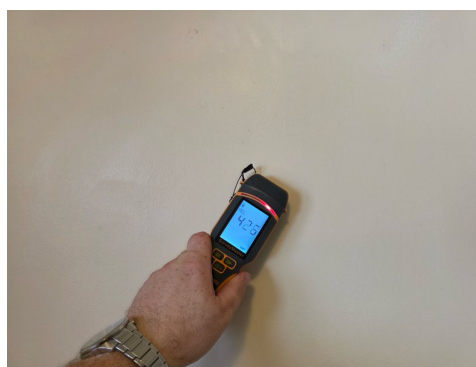
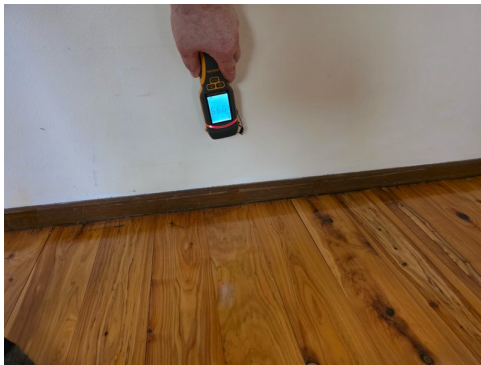
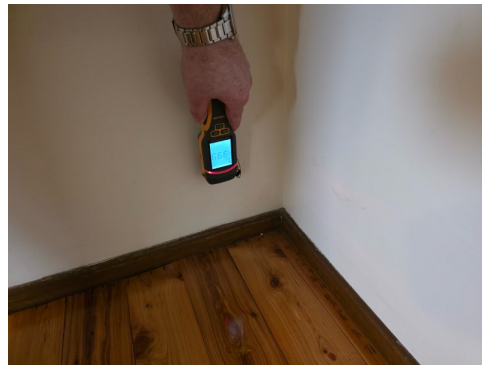
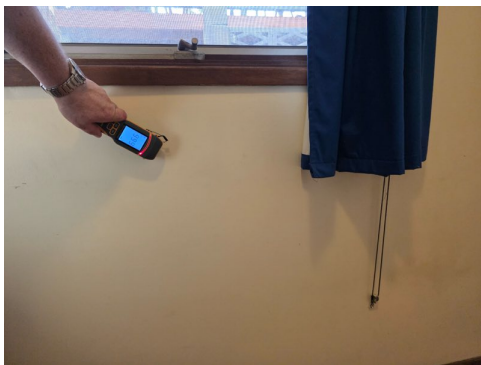
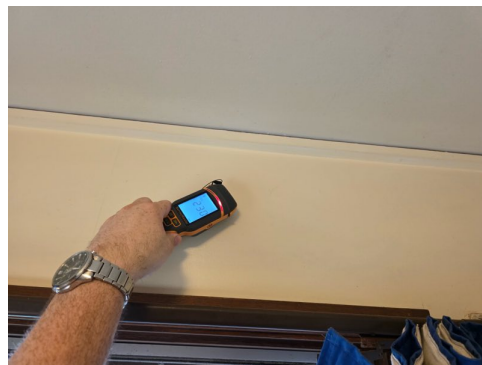
Finding: Elevated Moisture Readings – Multiple Internal Walls

Information: Elevated moisture readings were recorded along several internal perimeter walls, including beneath windows in Bedrooms 1, 2 and 3 and along the rear wall of Bedroom 3. No visible deterioration, swelling, or material breakdown was observed in these areas at the time of inspection. The inspection occurred during wet and humid conditions following recent rainfall, which may influence moisture meter readings in wall linings.

Although no damage was evident, concealed moisture sources or deterioration cannot be ruled out in a visual, non-invasive inspection. It is recommended that the affected areas be monitored and, if moisture levels persist or deterioration becomes evident, a licensed builder should investigate and rectify as required.

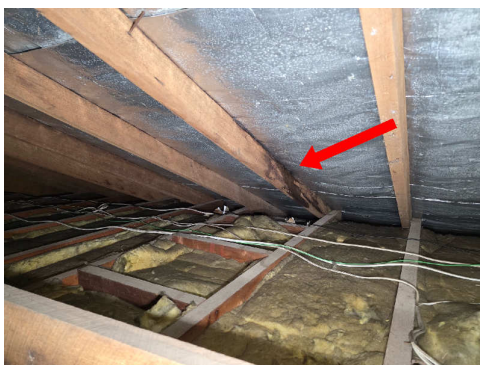
Finding: Water Staining to Roof Framing – Roof Void Access Area

Information: Water staining was observed on a rafter adjacent to the roof void access opening. Due to access limitations the surrounding area could not be safely inspected and moisture readings were not obtained. It could not be determined during the visual inspection whether the staining represents a historic condition or a current moisture entry point.

If moisture ingress is ongoing, deterioration of roof framing or ceiling materials may occur over time. A roofing plumber should investigate and rectify if required. This should be addressed as soon as practicable.

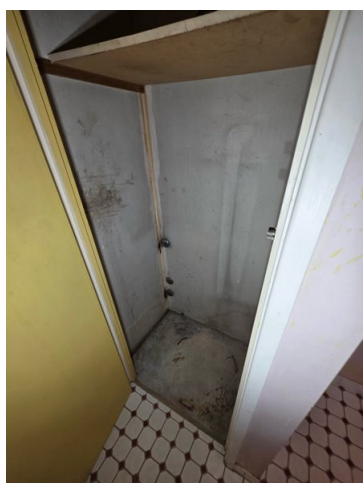
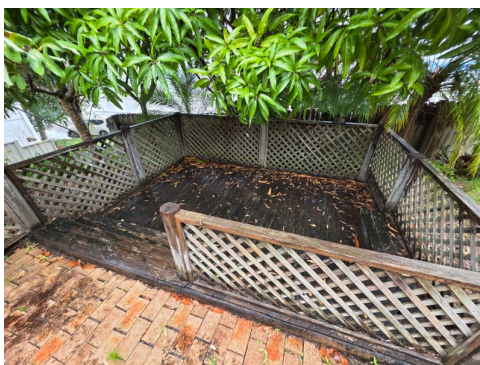
Information: Reporting on asbestos is outside the scope of this inspection. Suspected asbestos-containing material (ACM) was observed in the bathroom, laundry, eave and meter box. Based on our experience in the building industry, there is a higher risk that the identified building elements contain asbestos, particularly given that any home constructed prior to 1990 may contain asbestos in various forms.

No sample testing has been undertaken to confirm the presence of asbestos. We strongly recommend a separate Asbestos Inspection and Condition Audit be carried out by a licensed assessor, which may include laboratory testing for definitive confirmation.

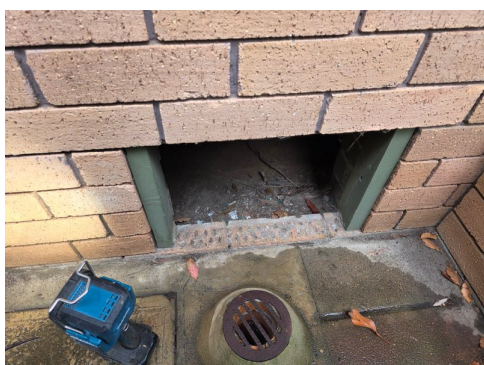
Information: The subfloor area could not be accessed due to restricted opening size, preventing inspection of the subfloor structure and conditions. A visual inspection was conducted from the opening to the subfloor area. Defects or timber pest activity may exist in areas that were not accessible for inspection.

A builder should be engaged to carry out further investigation as required. This should be done at the owner's discretion.
