Building and Timber Pest Inspection Report

Inspection Date: Thu, 12 Feb 2026

Property Address: 37/12 Yeates Cres, Meadowbrook QLD
4131, Australia

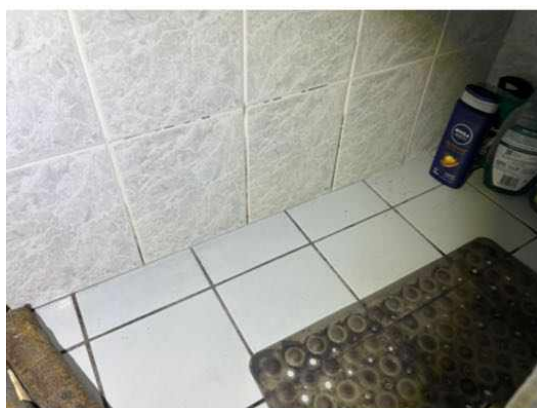
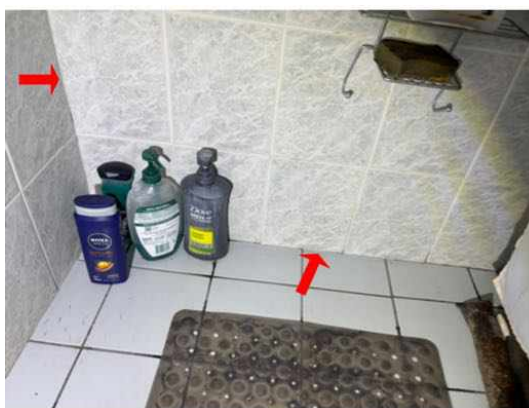
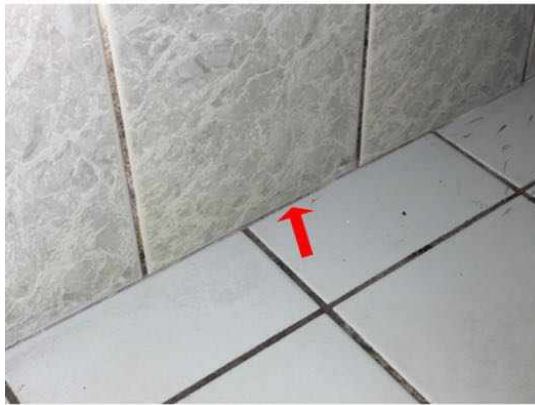
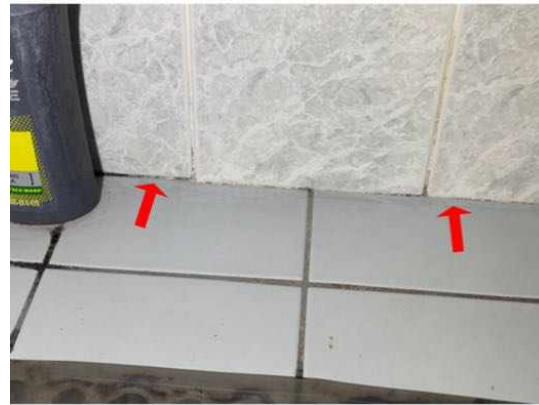
Finding 3.01

Building: Main Building
Location: Bathroom
Finding: Sealant deteriorating
Information: At the time of the inspection it was noticed that the sealant in the bathroom was deteriorating.

Sealant is used in tiled areas to prevent moisture from entering the wall cavity and causing damage to the building elements. A moist environment in the wall cavity may also be a conducive condition for termite activity.

If it is not addressed, damage to building elements will occur and would require invasive works to rectify any damage.

A building maintenance professional or sealant applicator should be appointed to replace all sealant as a matter of urgency.

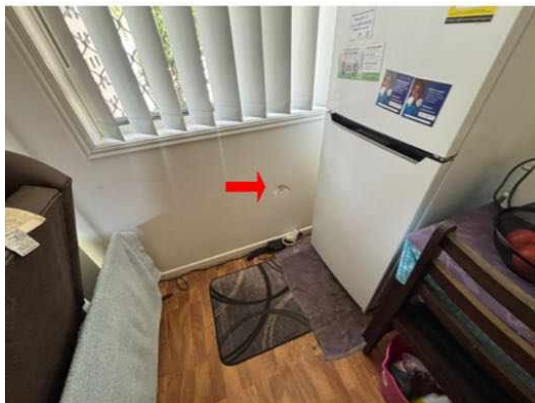
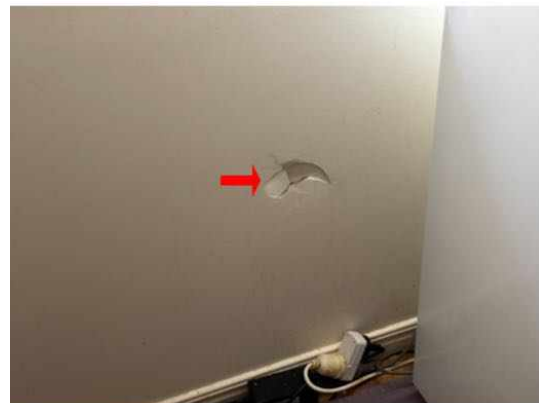
Finding 3.02

Finding: Living/dining - wall lining damaged

Information: At the time of the inspection, it was noted that there was some damage to a section of the wall lining in the living/dining area. This appears to be impact damage.

A building maintenance professional or painting contractor could be engaged to carry out this minor repair. This can be done at the clients discretion.

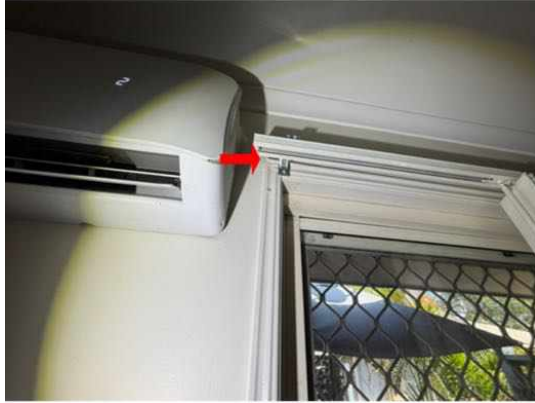
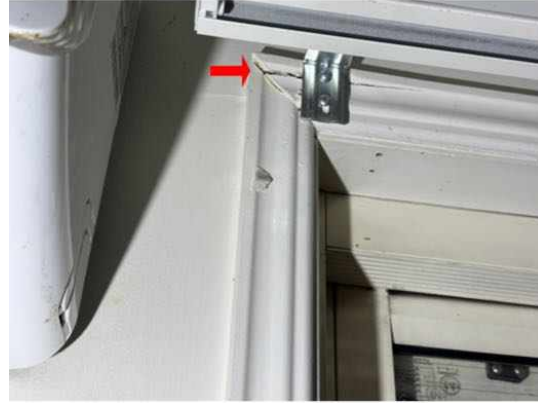
Finding 3.03

Finding: Lounge - curtain rail loose

Information: At the time of the inspection, it was noted that the curtain rail in the lounge was pulling away from the wall. The curtain rail is only attached to the architrave which is not strong enough to support it. Longer screws are required to ensure that the curtain rail is securely attached to the wall.

A building maintenance professional could be engaged to re-install the curtain rail. This can be done at the clients discretion.

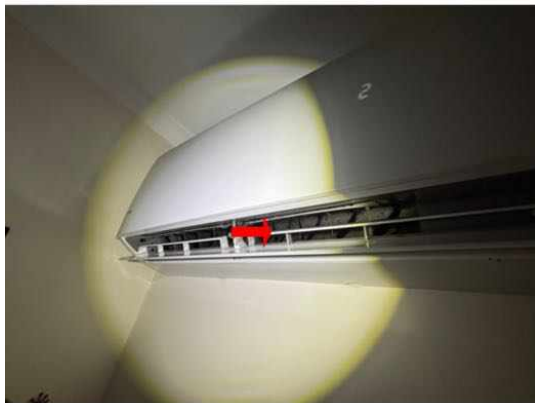
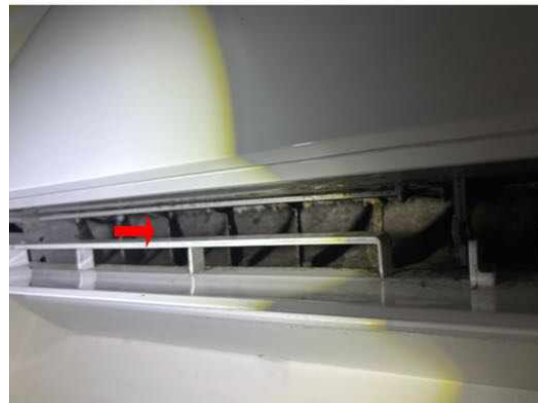
Finding 3.04

Finding: Mould in air conditioning unit

Information: At the time of the inspection, it was noted that there is mould to the wall mounted air conditioning unit in the lounge. Lack of maintenance may be a contributing factor.

The air conditioner should not be used until it is cleaned. It is understood that the unit is scheduled for cleaning, information received from the tenant.

A specialist air conditioning cleaning company should be engaged to carry out a full clean to all the units in the dwelling. This should be done as a matter of urgency.

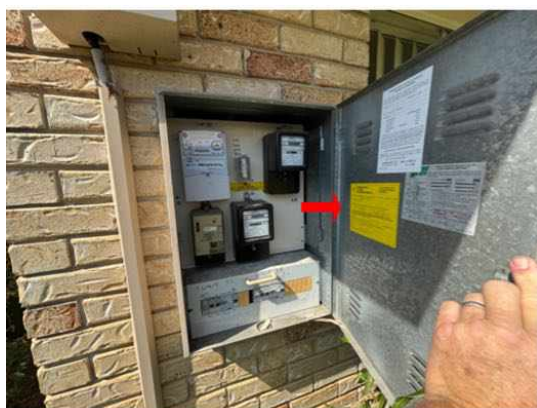
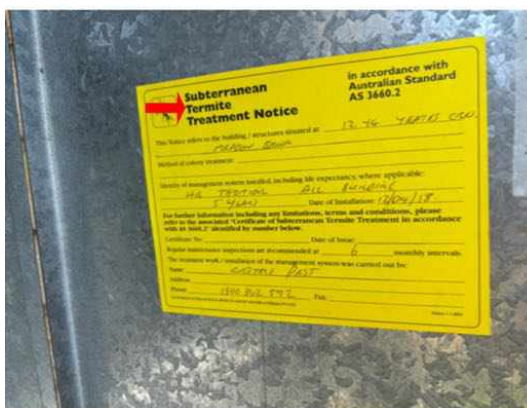
Finding 6.01

Building:	Main Building
Location:	All External Areas
Finding:	Evidence of a previous chemical termite management system was identified.
Information:	At the time of the inspection, evidence of a previous chemical termite management system was found by way of a durable notice in the electricity meter box on the wall of unit 38.

A chemical soil treatment was carried out on the 12/04/2018 with an expected life span of 5 years. This treatment may no longer be effective.

The client should enquire of the body corporate if this chemical treatment has been updated. The client should enquired of the body corporate as to the nature of the termite management plan for the complex and the individual units. Also, are annual termite inspections being carried out and up to date.

A termite and timber pest technician should be engaged to carry out annual termite inspections as per AS 3660 in order to further protect the dwelling. Annual termite inspections must be carried out in partnership with any termite treatment system, physical or chemical, as no termite treatment system can be expected 100% effective.

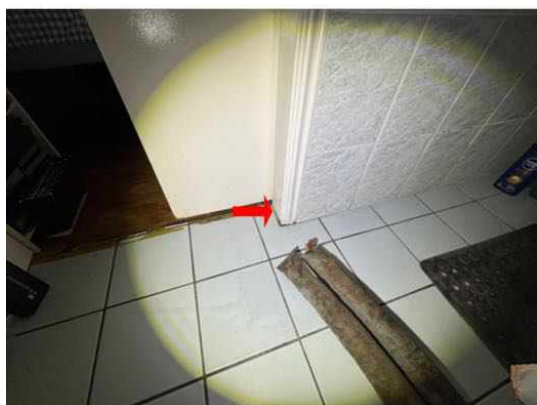
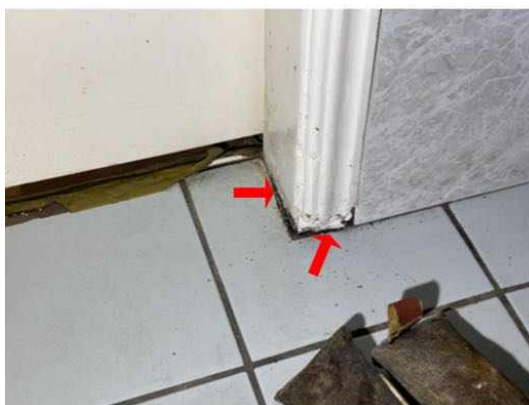
Finding 7.01

Location: Bathroom
Finding: Bathroom - wood rot
Information: At the time of the inspection, it was noted that there was evidence of wood rot to the bottom of the timber door frame and architrave for the bathroom door. There is no shower screen or lip in the tiled floor to stop moisture escaping from the shower cubicle area. The sealant in the shower area is also deteriorating. This may be allowing moisture from the shower to affect the timber door frame.

This building element shows evidence of wood rot. Wood rot, also known as Fungal Decay, occurs when timbers and other cellulose building materials are exposed to damp conditions on an ongoing basis.

Wood rot is often associated with general damp problems and is evidenced by a 'musty' smell or mould and mildew occurring on surfaces. If left unmanaged, damp conditions can lead to further health problems and the decay of timbers will continue.

Early intervention and regular maintenance, particularly of exterior timbers, will prolong the useful life of these building elements. Prior to any works being performed, the cause of the moisture that has created the visible wood rot should be identified and addressed in a suitable manner. Replacement of affected timbers may then be a necessary step in protecting surrounding building elements from such deterioration.

A qualified carpenter or registered builder may also be required to replace affected building materials.

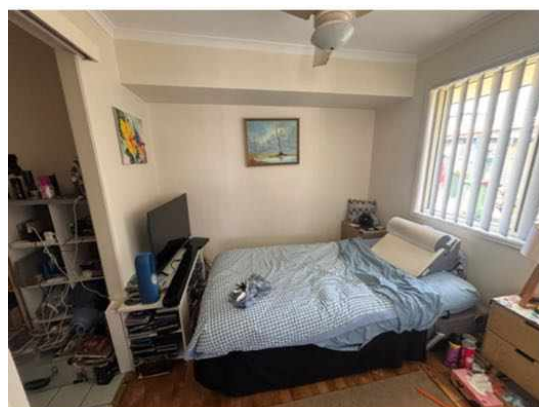
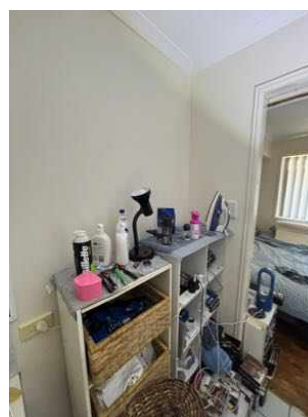
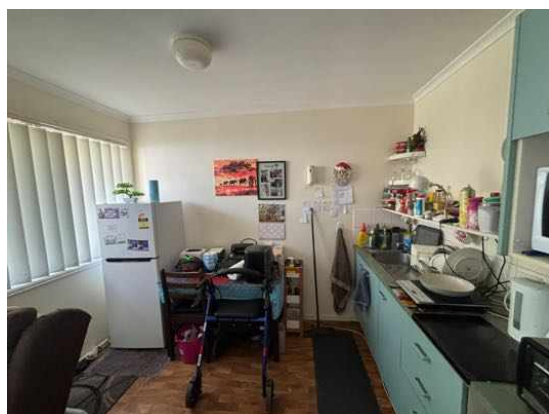
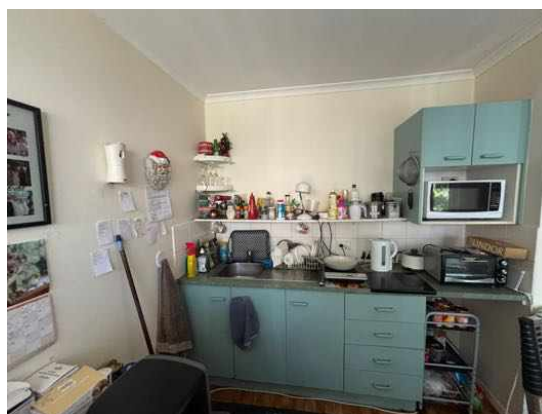
Building: Main Building
 Location: All Internal Areas
 Finding: Obstructions and Limitations - Internal areas
 Information: These photographs are an indication of the obstructions and limitations which impeded full inspection of the property of the internal areas at the time of inspection. These obstructions can hide an array of defects and should be removed to allow full inspection to be carried out. A re-inspection is recommended once the areas are made accessible.

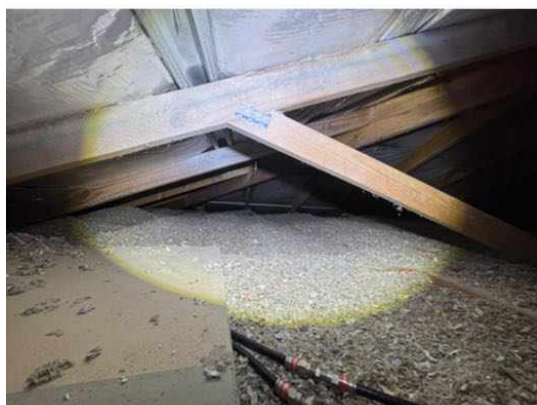
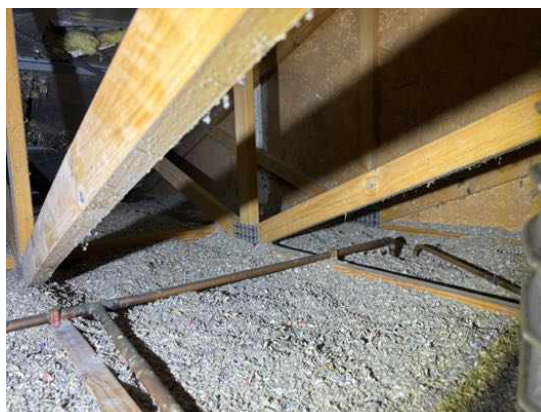
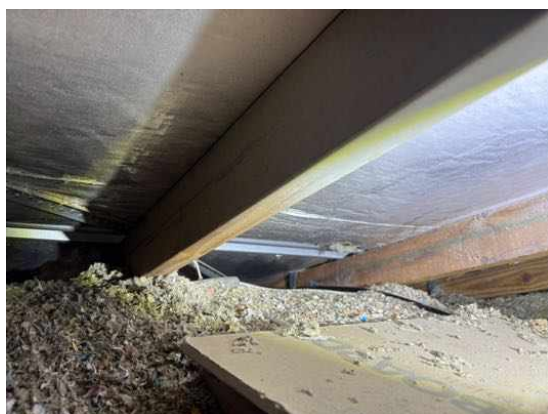
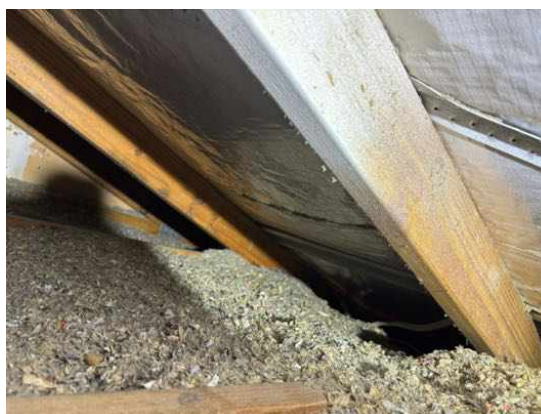
Building: Main Building
 Location: Roof Void
 Finding: Obstructions and Limitations - Roof cavity
 Information: These photographs are an indication of the obstructions and limitations which impeded full inspection of the property of the roof cavity

at the time of inspection. These obstructions can hide an array of defects and should be removed to allow full inspection to be carried out. A re-inspection is recommended once the areas are made accessible.

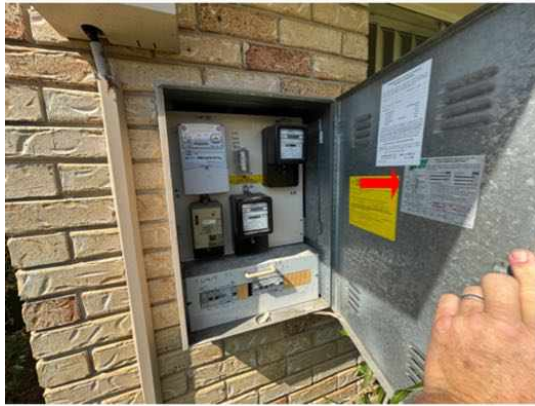
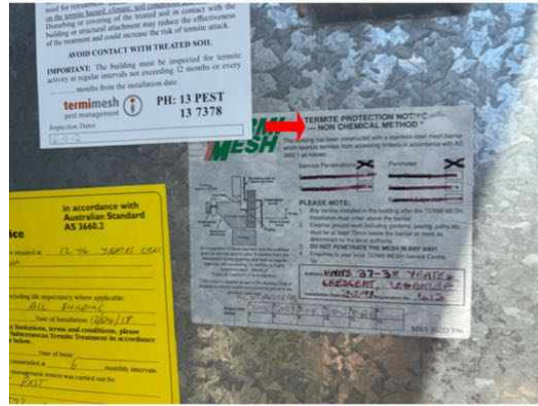
Building:	Main Building
Location:	All External Areas
Finding:	Evidence of a physical termite management system was identified.
Information:	At the time of the inspection, evidence of a physical termite management system was found by way of a durable notice in the electricity meter box on the wall of unit 38.

A physical termite barrier was installed to the slab penetrations and perimeter during construction. The product used was Termimesh. The durable notice is dated the 21/02/1997. Physical termite barriers do not stop or eliminate termites. Physical termite barriers are designed to expose concealed termite activity.

The client should enquire of the body corporate as to the nature of the termite management plan for the complex and the individual units. Also, are annual termite

inspections being carried out and up to date.

A termite and timber pest technician should be engaged to carry out annual termite inspections as per AS 3660 in order to further protect the dwelling. Annual termite inspections must be carried out in partnership with any termite treatment system, physical or chemical, as no termite treatment system can be expected to be 100% effective.
