# Building and Timber Pest Inspection Report

Inspection Date: Fri, 6 Feb 2026

Property Address: 75 Read St, Bronte NSW 2024, Australia

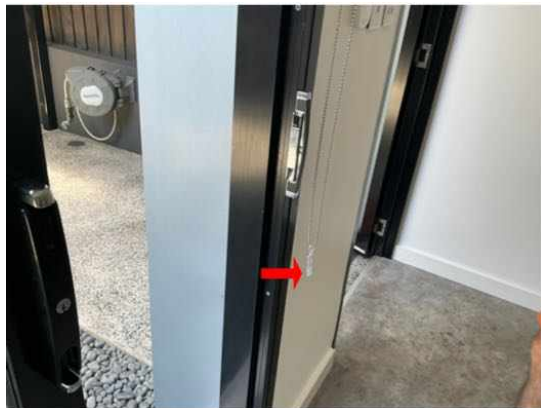
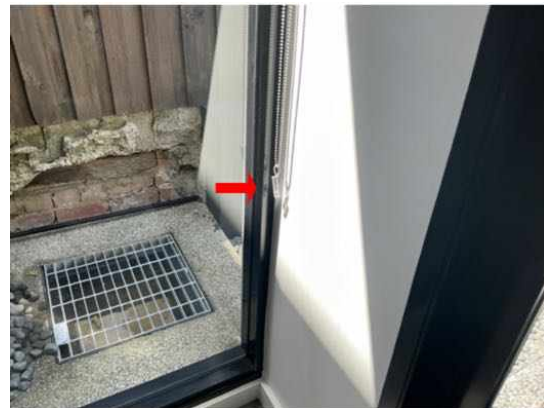
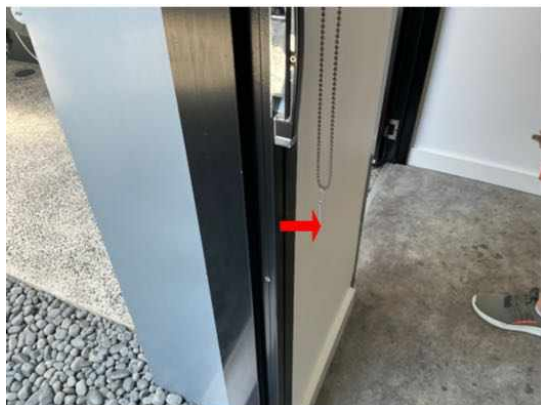
#### Finding 1.01

| Finding: | Blind chain not secured |
| Information: | The chain of the blind is not secured to the window frame. This can cause the chain to dangle freely and potentially become tangled, posing a safety hazard. Additionally, an unsecured chain can make it difficult to operate the blind properly and can affect its overall functionality. It is important to secure the chain to the window frame to prevent these issues and ensure the safe and proper operation of the blind. A blind installer can help secure the chain and ensure that the blind is properly installed and functioning correctly. |

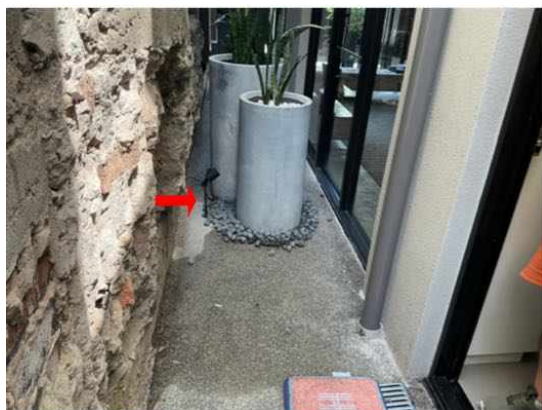
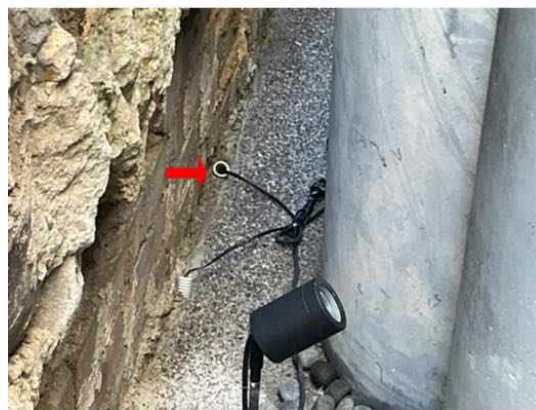
#### Finding 1.02

| Finding: | Conduit - Missing |

**Information:** A conduit has not been installed to exterior wires in this area. This is a safety measure that is aimed at protecting the wires and preventing any personal injury that may result if wires are squashed or damaged.

Without a conduit providing adequate protection, external wiring is likely to become damaged and deteriorated over time, creating an electrical safety hazard. Damage to the wiring is also likely to result in the associated elements losing function.

A qualified electrician should be contacted immediately to install a conduit around the wires and provide any further advice on additional works that may be required to increase the safety of the wiring and its surrounding area.

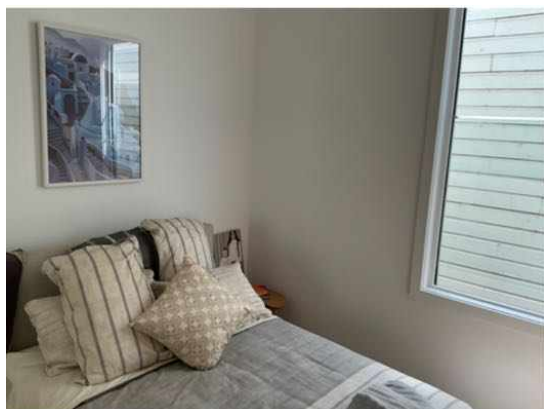
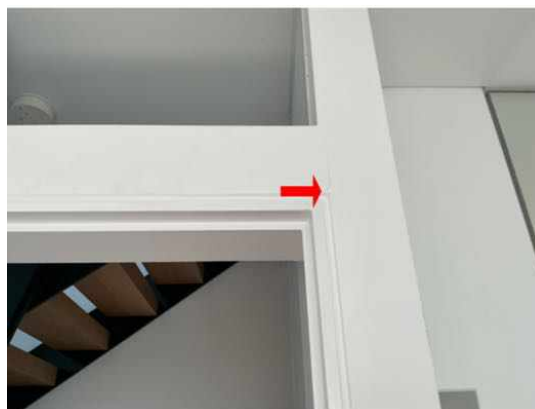
### Finding 3.01

**Finding:** Cracking - Damage Category 0 - Hairline (less than 1mm)

**Information:** Hairline cracks are very minor in nature and generally are only ever an appearance defect. While such cracking may be noticeable in some cases, it is quite common and does not indicate any structural damage.

Cracking of this nature can generally be repaired with minor sanding, filling and/or repainting. Such works should be performed by a qualified painter or a general handyman.

Monitoring of all cracking should be conducted frequently. Always contact a building inspector should cracks widen, lengthen, or become more numerous.

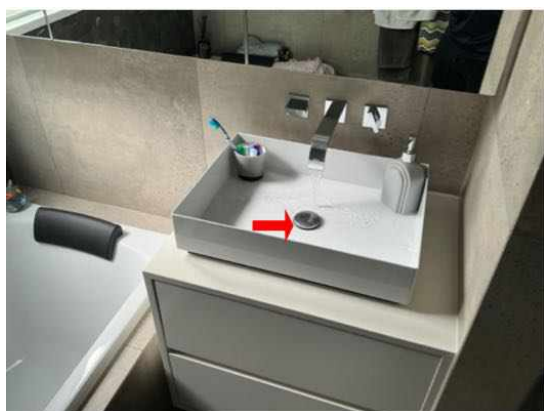
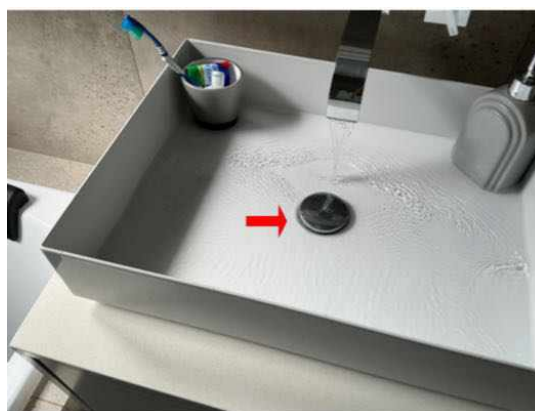
### Finding 3.02

Building: Main Building  
 Location: Bathroom  
 Finding: Bathroom Basin – Pop-Up Waste Not Functioning  
 Information: During the inspection, it was noted that the pop-up waste to the bathroom basin was not functioning correctly and appeared to be stuck. As a result, the basin may not drain properly, which can lead to water pooling and inconvenience during normal use.

Rectification by a licensed plumber is recommended to repair or replace the pop-up waste and restore proper operation.

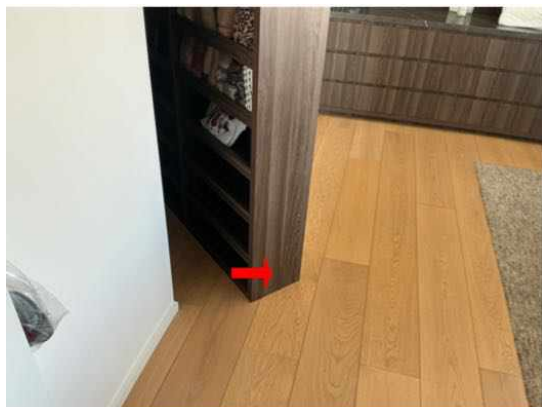
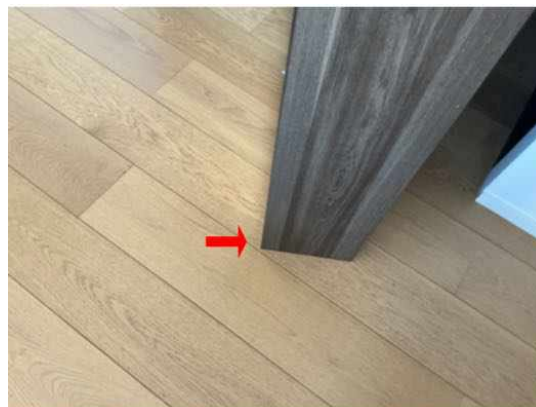
### Finding 3.03

Building: Main Building  
 Location: Bedroom - Master  
 Finding: Doors - Binding/Jamming  
 Information: Binding and/or jamming of several doors throughout the property were evident during standard operation. This defect inhibits the functionality of affected doors as well as creating potential for secondary defects to associated building elements, such as damage to the floor covering.

A door that binds to flooring or to the associated door frame may have several

causes, ranging from minor defects, such as poor installation of the door or deteriorated hinges, through to major structural issues, such as damage to subfloor structures.

Where door binding/jamming appears to indicate major structural issues, a registered builder specialising in re-stumping should be appointed to provide an estimate on the cost of rectification.

For minor causes, a qualified carpenter or general handyperson should be appointed to perform minor rectification works at client discretion.

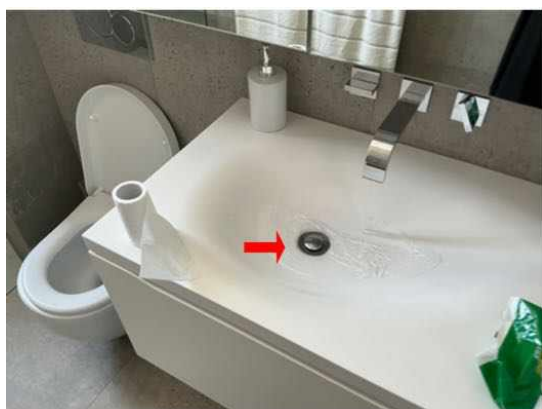
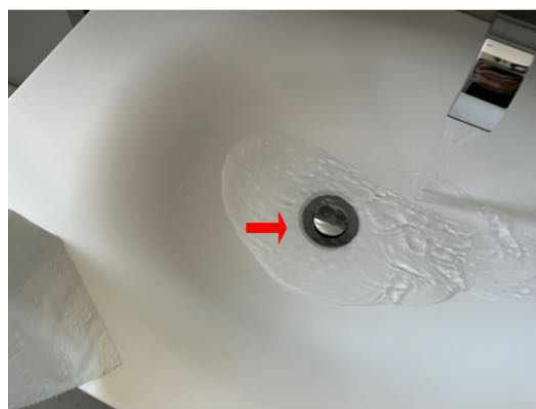
### Finding 3.04

| Finding: | Bathroom Basin – Pop-Up Waste Not Functioning |
| Information: | During the inspection, it was noted that the pop-up waste to the bathroom basin was not functioning correctly and appeared to be stuck. As a result, the basin may not drain properly, which can lead to water pooling and inconvenience during normal use. |

Rectification by a licensed plumber is recommended to repair or replace the pop-up waste and restore proper operation.

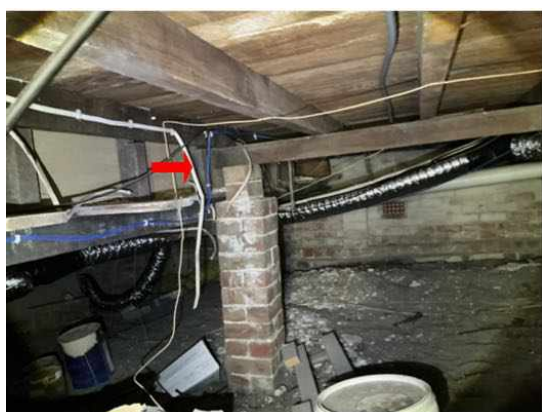
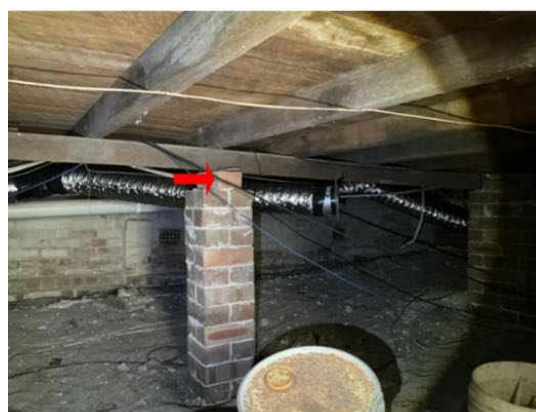
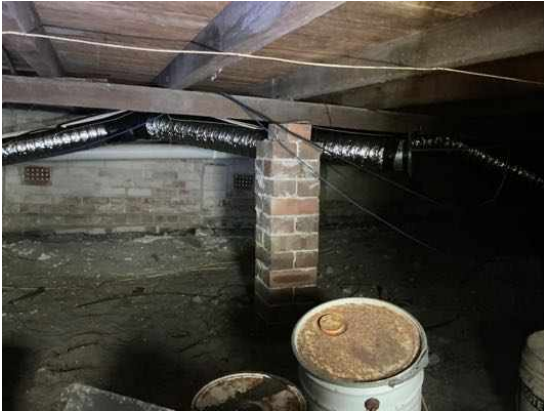
### Finding 6.01

Building: Main Building  
Location: Subfloor  
Finding: Ant caps - Not installed  
Information: Ant caps have not been installed to the subfloor structure at the time of inspection. Generally, ant caps are installed to the intersection between the top of the stumps (or piers) and the subfloor structures.

Installed during the construction process, ant caps are designed to easily identify termite or pest ingress from stumps to the adjoining bearers.

Where ant caps have not been installed, frequent monitoring of these areas should be carried out in order to identify any signs of termite or timber pest workings.

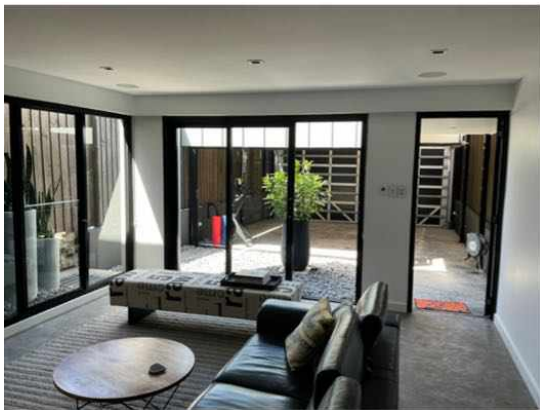
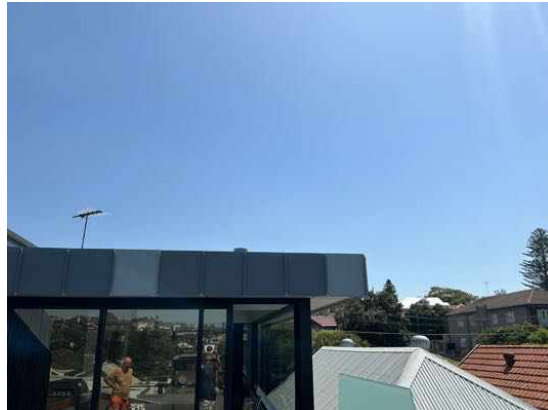
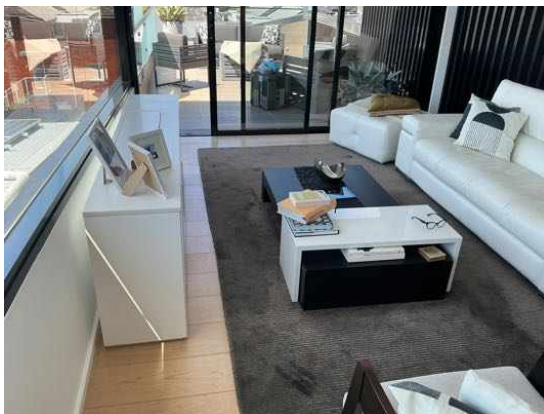
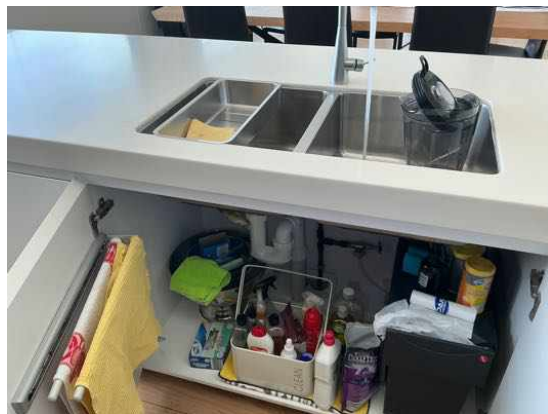
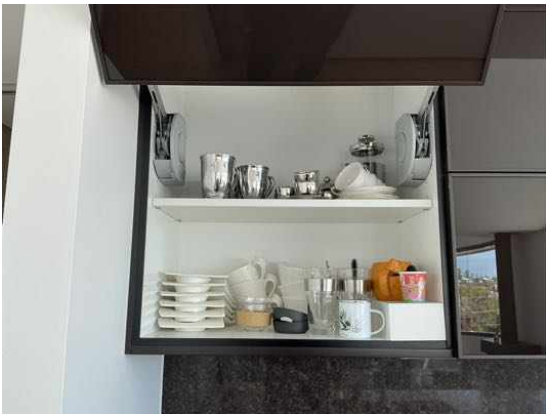
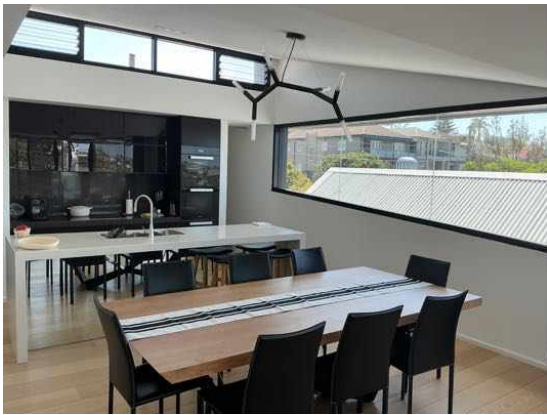
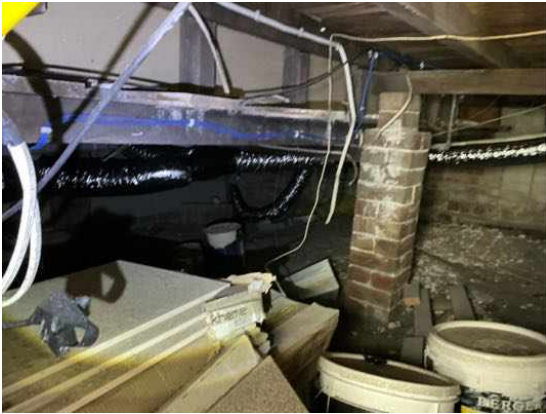
Finding: Additional Photos - Obstructions and Limitations

Information: These photographs are an indication of the obstructions and limitations which impeded full inspection of the property at the time of inspection. These obstructions can hide an array of defects and should be removed to allow full inspection to be carried out. A re-inspection is recommended once the areas are made accessible.

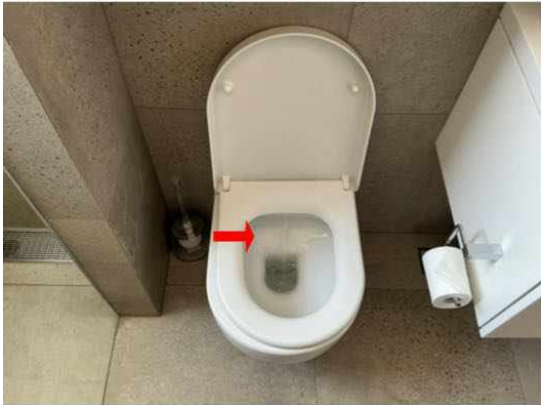
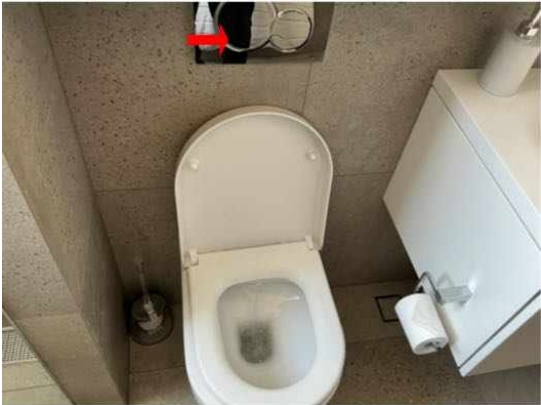
Building: Main Building  
Location: Bedroom - Master  
Finding: Toilet Flush Mechanism Intermittent Operation  
Information: During the inspection, it was noted that after the toilet was flushed, the water continued to run. However, on the second test, it operated normally. This may be due to ageing or wear of internal components. It is recommended to monitor the situation.

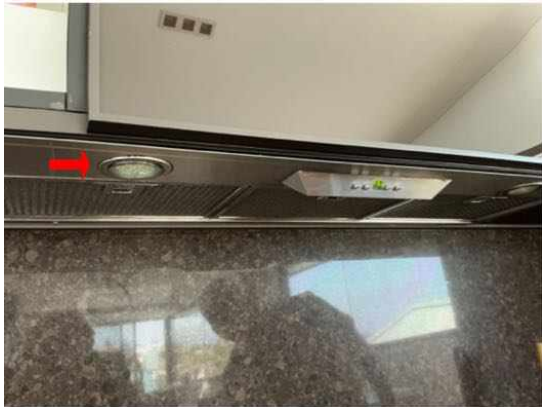
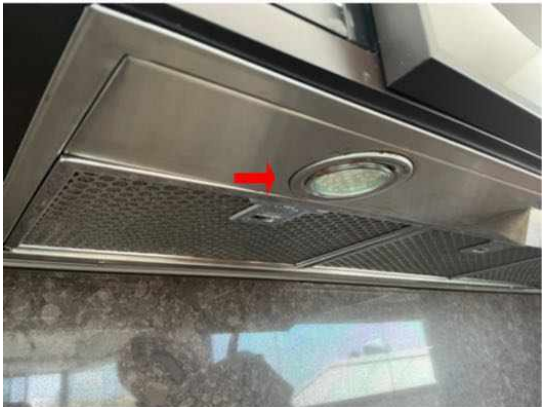
Location: Kitchen  
Finding: Range Hood Light Operation Issue  
Information: During the inspection, it was noted that the range hood light only turns on after the button is held for more than 10 seconds. It is unclear whether this is due to a specific setting or a manufacturer-related characteristic. It is recommended to check whether this operation is normal.

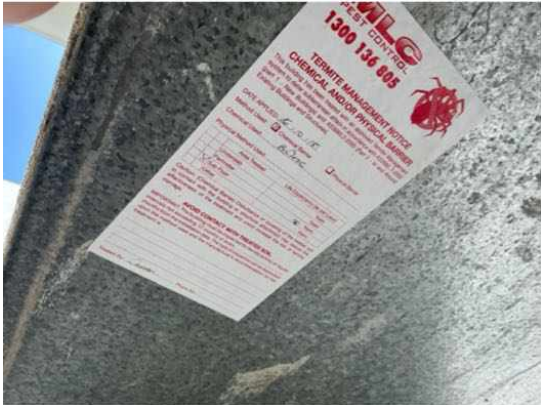
| Information: | Chemical treated barriers deteriorate over time necessitating the need for re-application of a barrier every 6-10 years depending on the product type environment etc. Due to this deterioration chemical barriers decline in their effectiveness exponentially if not replenished. |

Consult the record of installation to identify the type of chemical and date of application. It is then advised to consult a licensed pest controller regarding reapplication intervals. Annual inspections are almost always required for all system types.
