BEFORE YOU BUY
BEFORE YOU BUILD

Building and Timber Pest Inspection Report

Inspection Date: Wed, 18 Mar 2026

Property Address: 25 Kaylaur Cres, Albion Park Rail NSW
2527, Australia

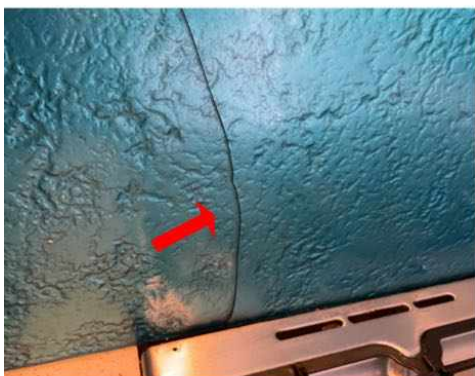
Building:	Building 1
Location:	Windows
Finding:	Windows and splashback - Cracked
Information:	Cracks were identified in these areas. Cracking in windows is generally the result of impact damage, and is likely to develop further when left unmanaged.

The likelihood of this windowpanes further cracking and shattering is increased exponentially, providing a safety hazard in the area. The cracked windows also impairs the weather tightness of the building, creating potential for minor water leaks.

Most of the shutters around the house walls did not work, all,requiring repair.

A qualified glazier is required to repair the window as soon as possible. Depending on the extent of the cracking, replacement of the window may be required. Please be advised that any persons coming into contact with the cracked window should do so with due caution to avoid any personal injury that may ensue.

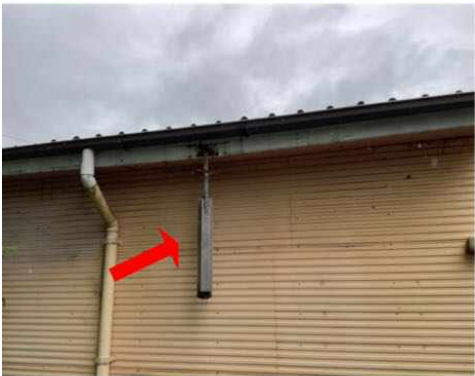
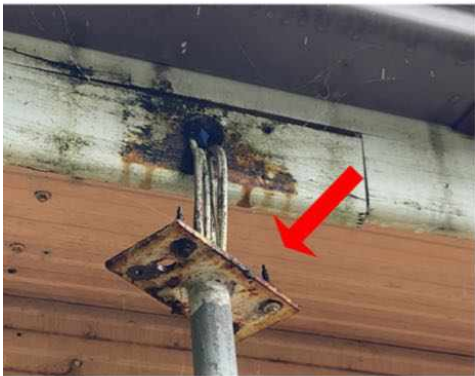
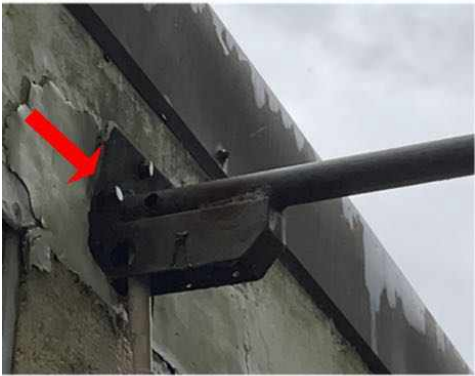
Finding 1.02

Building: Building 1
Location: Pictured areas
Finding: Fitting or fixture - Loose
Information: The lights in this rear area are loose and require removal to stop potential injury.

If left unmanaged, the fittings may further deteriorate, causing potential for the development of injury.

An electrician should be appointed to perform these rectification works immediately.

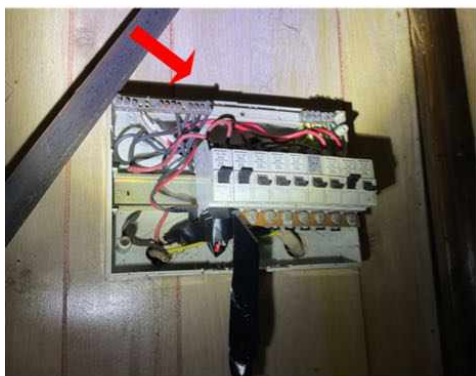
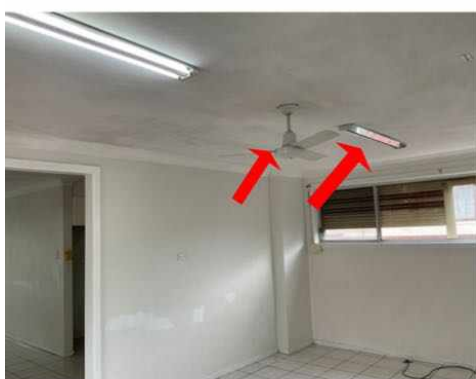
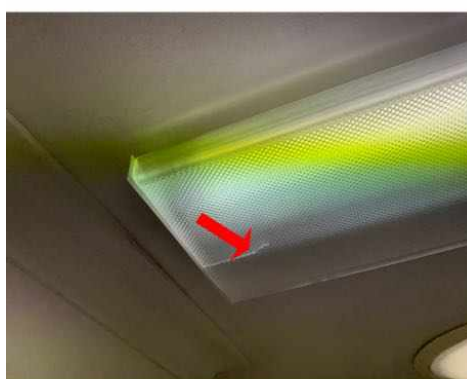
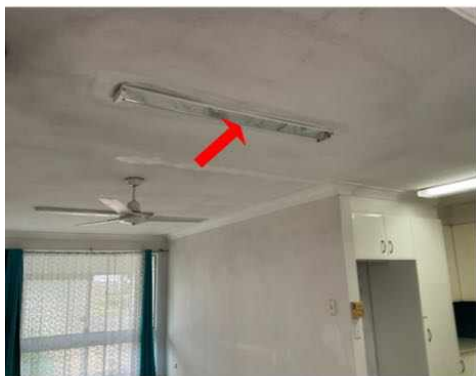
Finding 1.03

Building: Building 1
Location: Pictured areas
Finding: Electrical fittings - Broken or missing
Information: Many lights did not work or were missing bulbs. The rear fuse box was unprotected. Breakage occurs generally when the building materials have aged and decayed, but may also be indicative of impact damage to the building element (accidental or deliberate).

Left unmanaged, these fittings may cause further damage to surrounding building elements. Some broken fitting does expose electrical works, and may create a safety hazard if there is potential contact with persons in the area.

Repair and/or replacement of all lighting is advised. A Licensed electrician should be appointed to check all electrical wiring in the property. All fuses were turned off by the inspector on leaving to prevent any further damage.

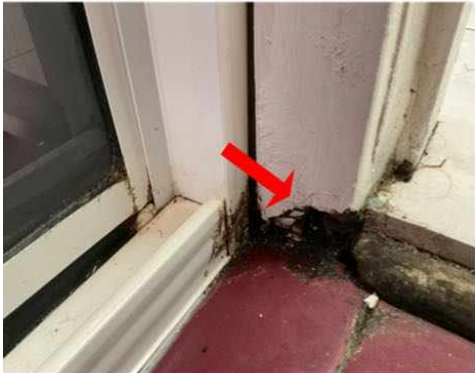
Finding 2.01

Building:	Building 1
Location:	Pictured areas
Finding:	Subfloor structure - Wood rot
Information:	The subfloor structures are showing signs of deterioration and wood rot (fungal decay) of the timbers. It is suspected that this defect has developed as a result of damp conditions from many bathroom leaks. Here the flooring and some supportive timbers have suffered water damage.

The presence of wood rot to the subfloor structure is also conducive to termite infestation. As timber stumps are in direct contact with the ground, concealed termite is made possible. Such entry is made easier if the timbers become non-durable due to even slight wood rot.

Where wood rot is present to any structural timber, rectification or replacement of the affected timber building element is required. The adequate timeframe for such works are dependent on the severity of the rot. Where rot has developed to become widespread, replacement of sections of the subfloor structure may be required. Consultation with a registered builder specialising in re-stumping is highly advised as soon as possible.

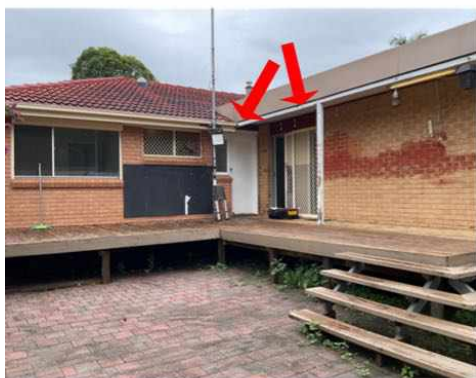
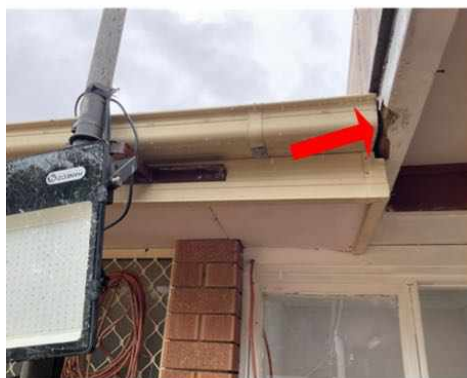
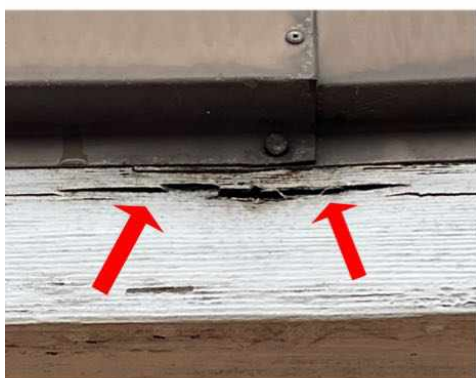
Building:	Building 1
Location:	Pictured deck areas
Finding:	Fascias - Wood rot
Information:	Wood rot was found to be affecting fascias in this area. Wood rot, also known as Fungal Decay, occurs when timbers and other cellulose building materials are exposed to damp conditions on an ongoing basis.

It is likely that this wood rot has developed as a result of faults in the roof plumbing, creating excessive moisture in this areas. Frequent exposure to rain and other weather conditions also make fascias and barges susceptible to accelerated deterioration.

Early intervention and regular maintenance will prolong the useful life of these building elements. Prior to any works being performed, the cause of the moisture that has created the visible wood rot should be identified and addressed in a suitable manner.

It is advised that a roof plumber be appointed to inspect all roof plumbing and subsequently identify the cause of the wood rot. Replacement of affected fascias and barges may then be a necessary step in protecting surrounding building elements from such deterioration.

A qualified plumber may be appointed to assess the cause of excessive moisture and to provide advice on any remedial works as required. A qualified carpenter or registered builder may also be required to replace affected building materials.

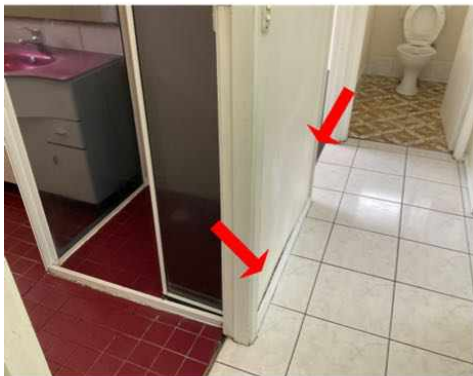
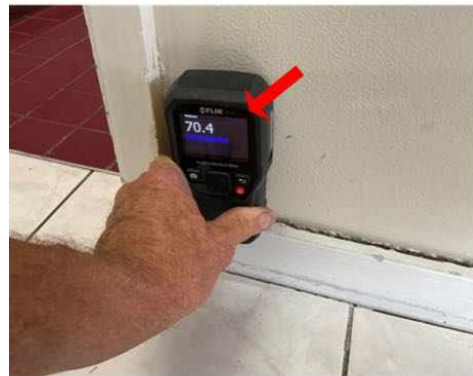
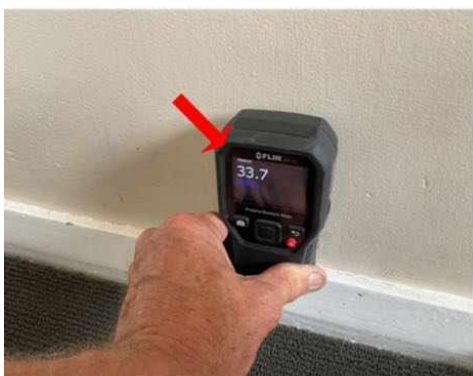
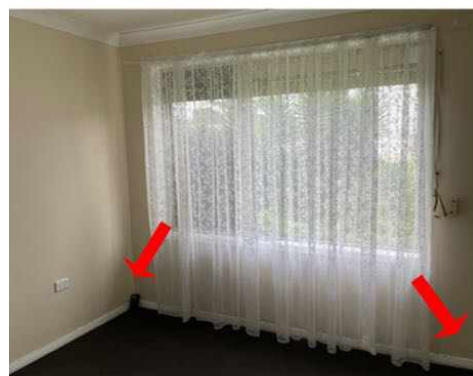
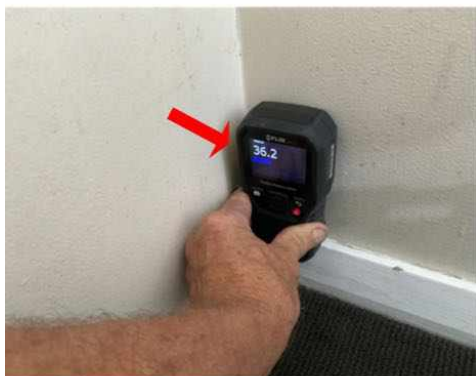
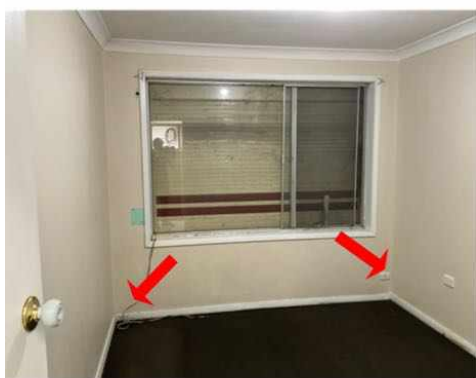
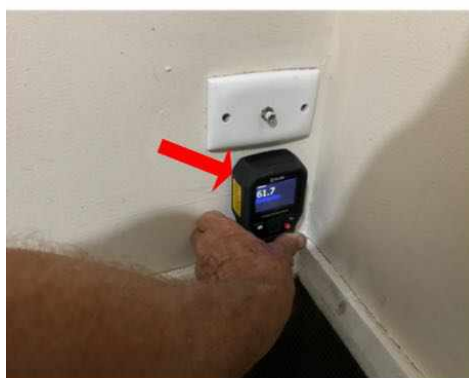
Finding 3.03

Building:	Building 1
Location:	Walls surrounding bathroom and front bedroom walls
Finding:	Evidence of excessive moisture was present at the time of inspection
Information:	Excessive moisture was found in the hall and rear bedroom walls from bathroom leaks. High moisture was also found in the front bedroom walls.

Excessive moisture can attract termites and produce conditions that promote termite attack, fungal growth and wood decay.

Excessive moisture is generally caused by deteriorated, inadequate or missing roof drainage, damaged waterproofing membranes and sealant, leaking plumbing pipes or fixtures, poorly plumbed HWS overflows or condenser units and poor site drainage.

It is highly recommended that all plumbing and drainage fixtures and fittings be maintained regularly in order to prevent excessive moisture being present in the internal property.

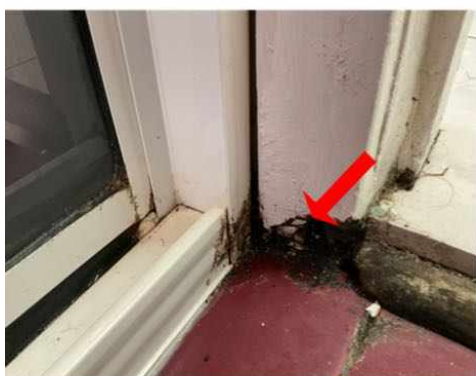
Finding 3.04

Building:	Building 1
Location:	Bathroom & laundry
Finding:	Sealant and grouting - Missing or damaged
Information:	It was noted on inspection that sealant or grout is degraded to these pictured areas.

Different materials and floor areas move at different rates, generally causing cracking to grout or sealant at this point. A flexible sealant is required to allow for expected expansion and contraction, while keeping the joint water tight and protective of all associated building materials.

Flexible and mould resistant materials should be applied to affected areas to prevent any subsequent water damage that is likely to occur. Regular maintenance and replacement of damage or missing or damaged sealant and grout is highly recommended to the wet areas, as this is a regular wear and tear defect. Sealant and grouting in areas that come into regular contact with water should be maintained for the long term care of your property.

A sealant specialist or tiling contractor should be appointed to complete these works as soon as possible

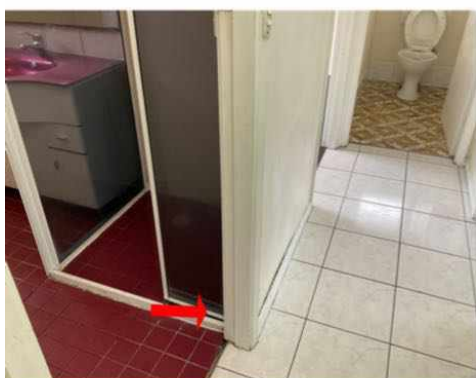
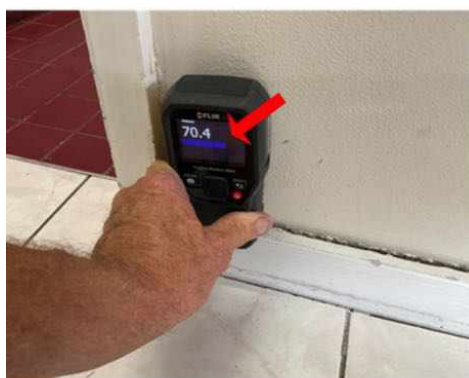
Finding 3.05

Building:	Building 1
Location:	Bathroom
Finding:	Shower screen - Leaking
Information:	Leaking was evident to the shower screening in two corners at the time of inspection. It is suspected that the leaking has occurred as a result missing sealant. Leaking from the shower , where left unattended, is likely to lead to water damage to adjoining flooring and walls. Such damage can lead to water damage and necessitate extensive remedial works being required. Active water leaks may also create an environment that is susceptible to the formation and development of mould.

Appointment of a sealant expert is required to repair or replace this missing sealant. Such works should be performed as soon as possible to ensure that no further damage occurs.

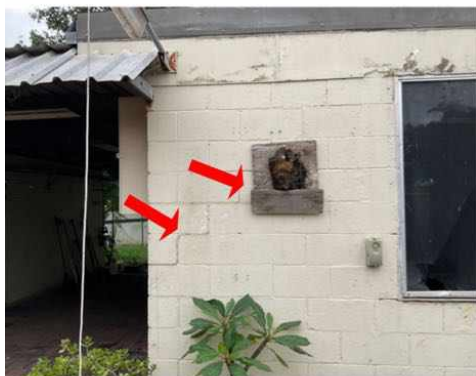
Finding 3.06

Building:	Building 2
Location:	Exterior front and rear walls of rear building
Finding:	Step cracking to brickwork (minor)
Information:	Step cracking was identified to the brickwork in this area at the time of inspection. Step cracking, which is similar to other forms of cracking, has a variety of possible causes. However, the most common is the subsidence of adjacent footings.

Step cracking is a relatively common defect, and is most likely to occur adjacent to windows, doors and other openings. Mortar failure in the gaps between affected bricks indicates the stresses and tensions affecting the wall.

Where step cracking is extensive or severe, the client is advised to consult a structural engineer. This minor step cracking can be used as a warning sign to address factors causing stress to the wall, which can include the effect of surrounding trees, water leaks, soil erosion, or even the presence of reactive soils in the surrounding area.

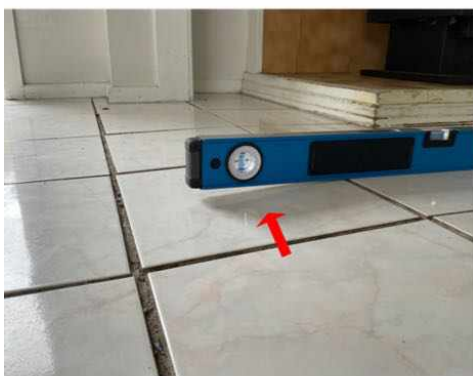
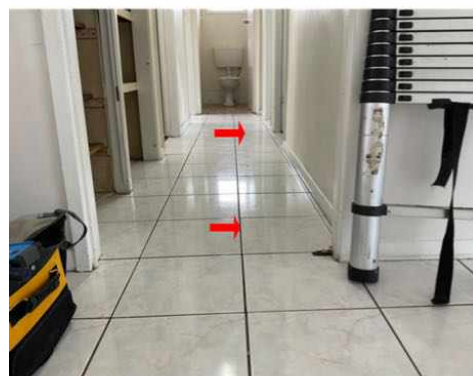
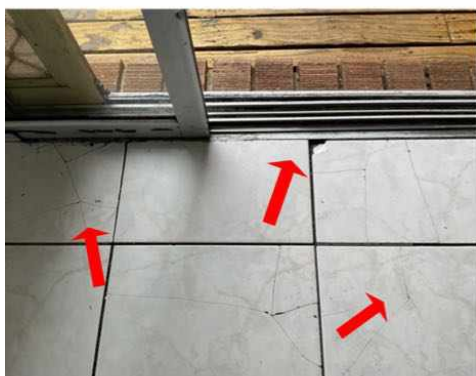
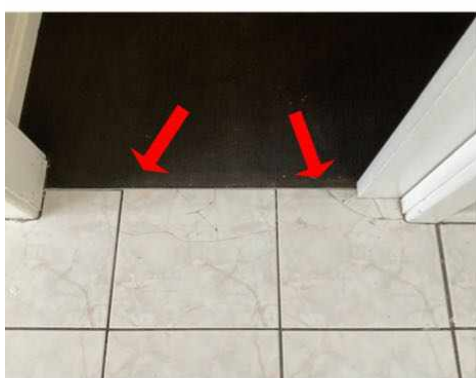
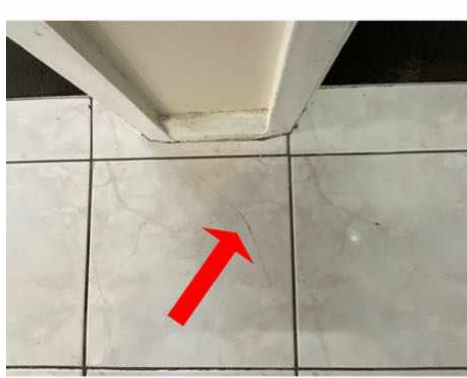
Building:	Building 1
Location:	Many areas
Finding:	Cracked floor tiles and uneven flooring
Information:	Cracking in the floor tiles was evident in many areas at the time of inspection. Many areas of flooring were found to be uneven, some of these areas contributing to cracking in floor tiles. It is suspected that this cracking has occurred as a result of minor settlement.

Cracked tiles throughout the household detract from the overall appearance of the affected areas however it is unlikely to create or lead to any secondary defects.

While not considered a matter of urgency, replacement of cracked floor tiles is recommended at the clients discretion. A tiling contractor may be appointed to perform these works. Where cracks become more numerous, contact a licensed building inspector for further investigation.

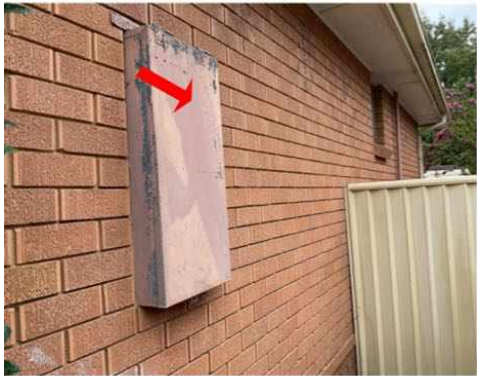
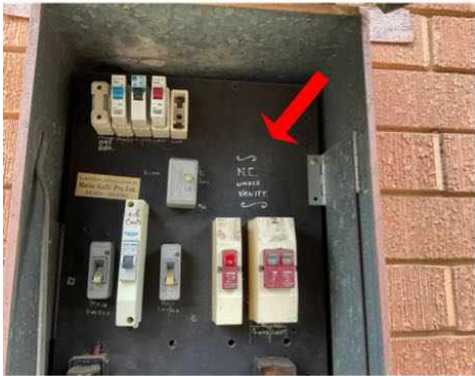
Building:	Building 1
Location:	Meter Box
Finding:	Termite Management System - no evidence of a chemical installation
Information:	The application of a post-construction chemical termite barrier is highly recommended for all properties. Such barriers are highly effective in preventing termite attack on any timber building elements throughout the property.

A durable notice should be placed in the switchboard unit to indicate current termite barriers. At the time of inspection, no durable notice was evident and it appeared as though no chemical termite management system has been installed, with no evidence to suggest preventative works taking place since the property was built.

The client may consider gaining further advice from a pest controller as to the costs and procedures involved with a 'chemical' application. It is recommended that obtaining such advice be a short-term priority.

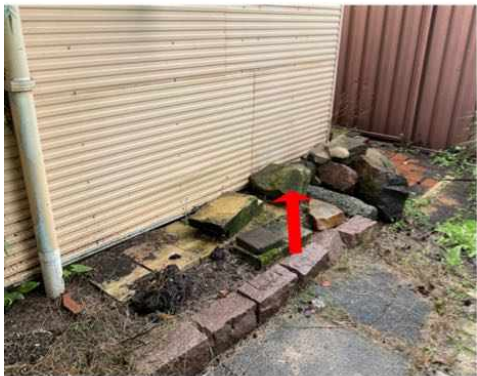
Finding 6.02

Building: Building 1
Location: Exterior walls
Finding: Bridging - decking
Information: Where decking obstructs inspection of building elements, also known as bridging as it provides a bridging point for the access of termites, full inspection can not be achieved. Consequently moisture or dampness may be present and the areas becomes conducive to termite activity. Decks against or very close to buildings provide cover, shade and can provide an environment that is attractive to termite infestation.

The removal of any such stored building materials that may be conducive to termite activity should be carried out as soon as possible and arrange re inspection to minimize the risk of termite attack.

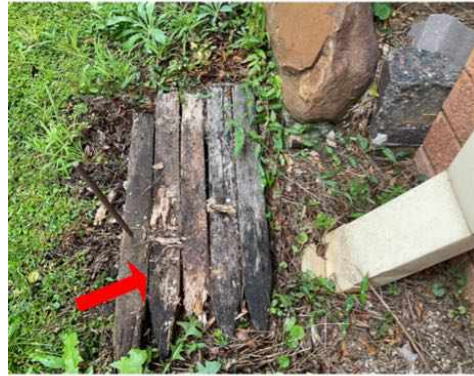
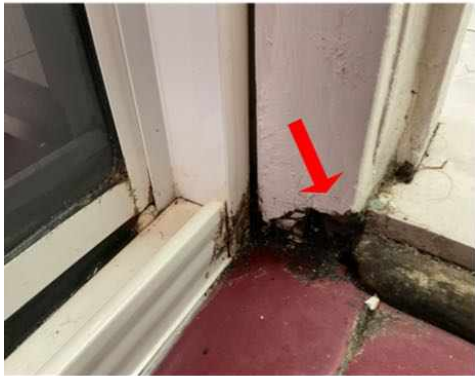
Building:	Building 1
Location:	Pictured areas
Finding:	Fungal decay - present (localised)
Information:	Fungal decay also known as wood decay or wood rot generally refers to the deterioration of timber elements when in contact with excessive levels of moisture for a prolonged period of time.

The development of fungal decay is accelerated by temperatures from 5degreeC to 40degreeC as well as the presence of oxygen. Generally fungal decay develops on timber elements that are in use in an external environment which are exposed to rain penetration.

Note - See ALL wood rot photos in building defects above, all these show fungal decay.

In this case, the affected timber element is in a decaying state and will need replacement by a carpenter or licensed builder.

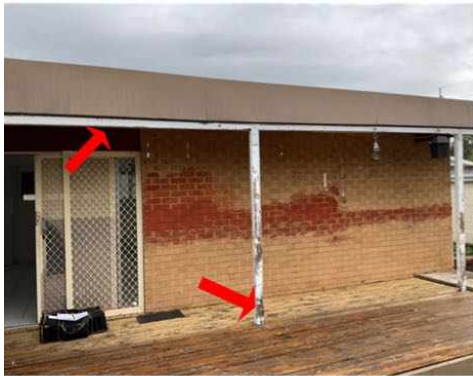
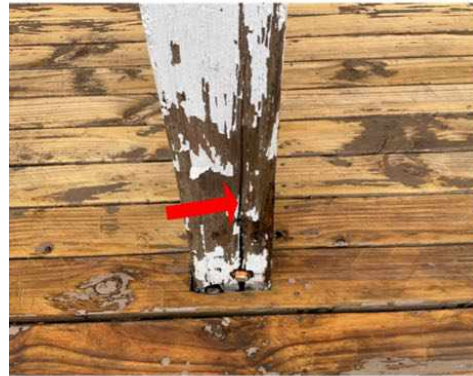
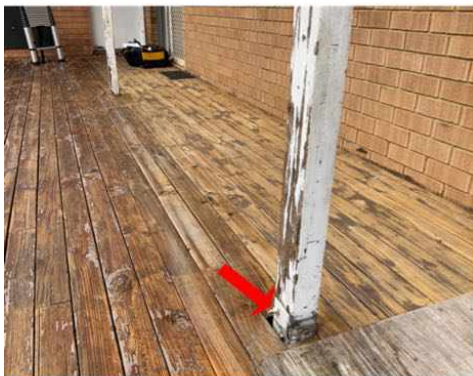
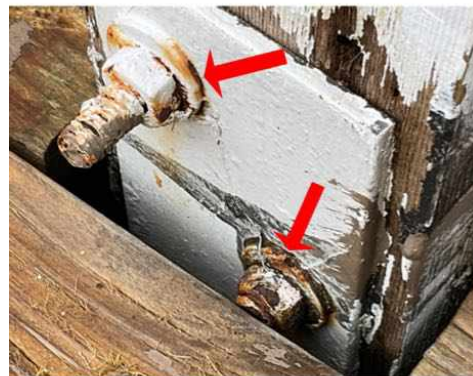
people or purpose. This can only be done by a qualified engineer. For the purpose of this report, the Structure includes the elevated rear deck and stairs that show wood rot and a split timber post.
