# Building and Timber Pest Inspection Report

Inspection Date: Wed, 14 Jan 2026

Property Address: 27 Hamilton Ave, Earlwood NSW 2206,  
Australia

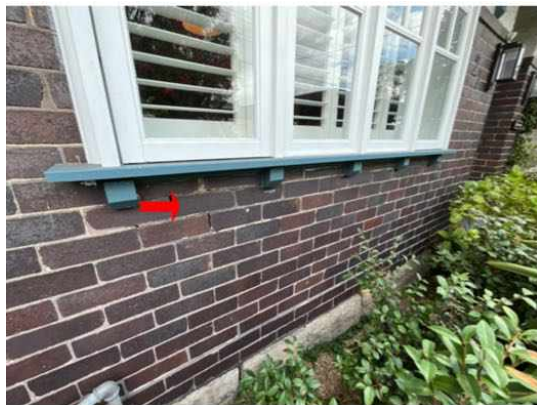
#### Finding 3.01

Building: Main Building  
Location: Exterior walls  
Finding: Brickwork - Deteriorated mortar  
Information: Mortar, or 'bedding', is the material which fills joints and intersections between bricks in masonry walls and structures. Sections of mortar in this brickwork were identified as having deteriorated.

Mortar deterioration can be addressed by a bricklayer.

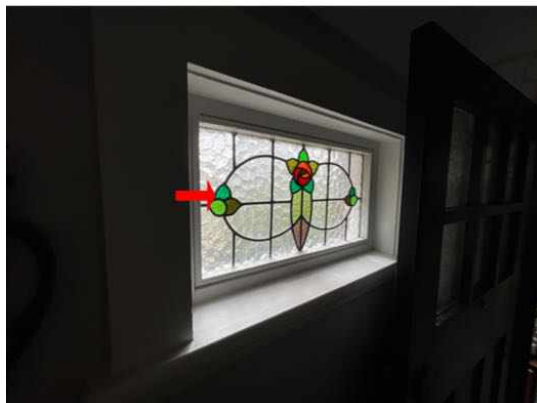
#### Finding 3.02

Building: Main Building  
Location: Window  
Finding: Glass - Cracked  
Information: Cracks were identified in the glass in this area. Cracking in glass is generally the result of impact damage, and is likely to develop further when left unmanaged.

A qualified glazier is required to repair the glass.

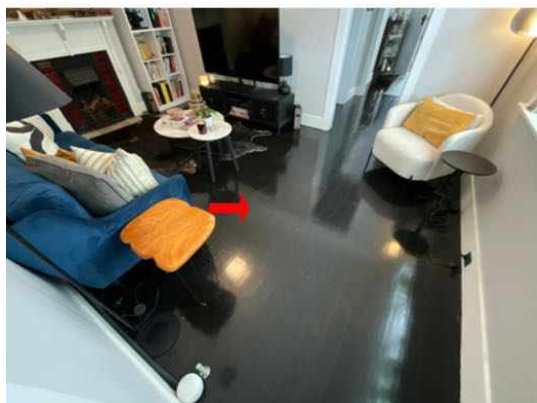
### Finding 3.03

Building:	Main Building
Location:	Lounge Room
Finding:	Floors - bouncy
Information:	The internal flooring in this area was identified as being bouncy at the time of inspection. A bouncy floor surface generally presents as a discernible change in level as they are walked across, in noisy or creaking flooring, or in consequent movement of surrounding furniture and fixtures.

Bouncy floors generally indicate that the floorboards or the subfloor structures are coming loose from the joists that they are installed on. Bouncy flooring may also be the result of gaps between flooring and joist structures, which require packing.

The client is advised to seek quotations for required repairs from a Registered Builder.

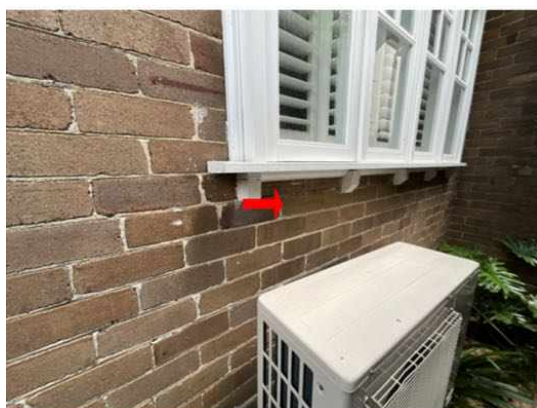
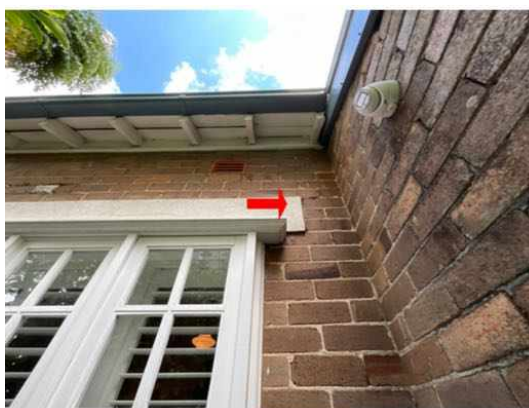
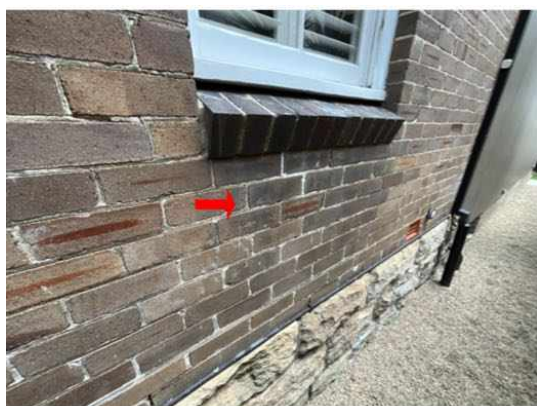
### Finding 3.04

Building:	Main Building
Location:	Exterior walls
Finding:	Brickwork - Cracking noticeable
Information:	There were several cracks and or crack repairs evident to external brickwork.

Noticeable cracks are a common occurrence in external brickwork and are a likely

result of age expected building movement, general expansion, and/or contraction of building materials in different weather conditions.

It is highly advised that a qualified bricklayer be appointed to provide necessary works to cracked brickwork to prevent any further damage.

Always monitor these cracks and contact a building inspector should cracks widen, lengthen, or become more numerous.

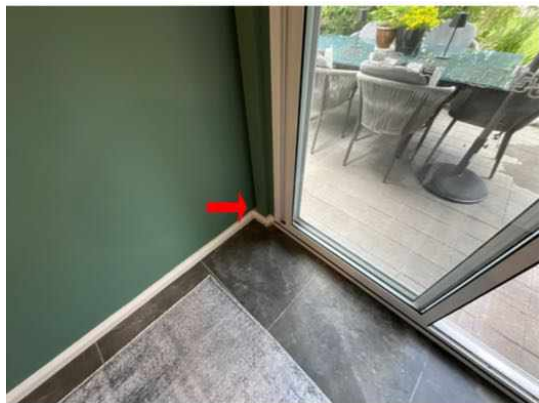
### Finding 3.05

Building:	Building 2
Location:	Internal Area
Finding:	Water staining
Information:	Water staining was evident in this area at the time of inspection. Water staining indicates that surfaces have been exposed to excessive moisture over time. The minerals and other elements in the water lead to staining, which may graduate to corrosion and deterioration if left unmanaged.

Although there was no moisture detected I would recommend monitoring and acting on the following.

Where water staining is active, a builder must be consulted to identify the cause of the staining and to provide advice on any reparation works that may be required.

Replacement of any broken or damaged structures is advised.

Conversely, where water staining is old and inactive, affected building materials may be repaired or replaced at client discretion. A qualified carpenter or registered builder may be appointed to perform these works.

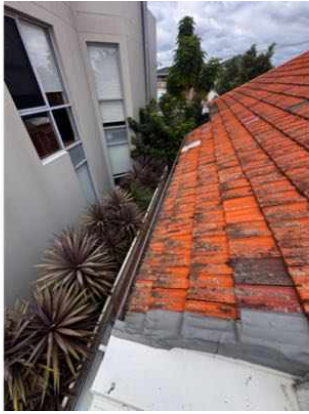
### Finding 3.06

Finding: Gutters - Blocked

Information: Roof plumbing structures, such as guttering and downpipes, should be free of all debris to prevent blockages. Blockages of the guttering and downpipes will lead to pooling and accumulated water overflows, which is likely to subsequently flood eaves and exterior walls.

Blocked gutters are likely to lead to high levels of moisture in the affected areas. Such moisture will not only cause rust and decay of the associated building materials, but can also provide conditions that are conducive to termite and timber pest activity. Blockages in gutters should therefore be removed to ensure dry conditions are maintained.

Consult a Licensed Plumber for further specific advice on remedial works that may be required. In the interim, it is highly advised that blocked gutters be removed by the homeowner or a general handyperson as a matter of urgency.

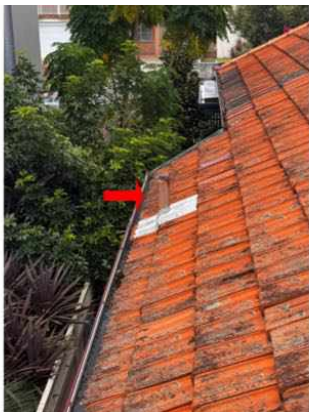
### Finding 3.07

Building:	Main Building
Location:	Roof Exterior
Finding:	Building element - Rusted or corroded
Information:	This building element shows evidence of rusting and corrosion, which is likely to have developed as a result of excessive exposure to moisture and or inadequate coatings.

As surface rust provides no protection to the underlying iron, the deteriorating condition is likely to worsen if not addressed in the short-term future.

Where possible, the use of galvanized (treated) metals or aluminium coated metals aid in rust prevention, as does regular general maintenance. Rust formation can be controlled with coatings, such as paint, that isolate the iron from the environment.

Rusting and corrosion should be managed by ideally removing or limiting the affected surface from exposure to moisture.

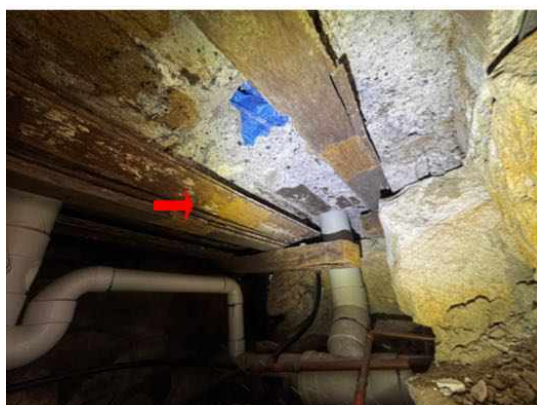
## Finding 5.01

Building:	Main Building
Location:	Subfloor
Finding:	Termite - damage identified
Information:	Despite no live termite or timbered pest activity being indicated, termite damage was found to have affected this area.

A building contractor should be appointed to provide a further invasive inspection and to see what necessary works are required.

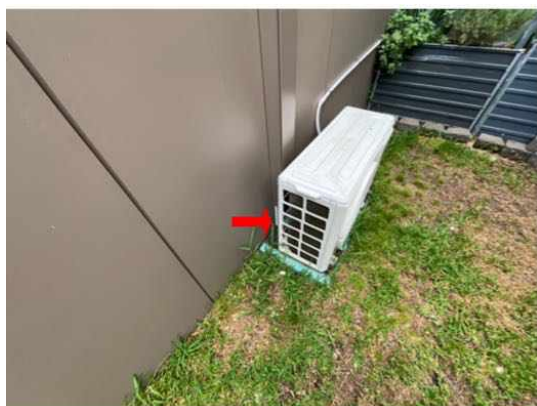
### Finding 6.01

Building:	Building 2
Location:	Exterior walls
Finding:	Air conditioner - Disconnected overflow
Information:	The Air Conditioner (A/C) overflow was found to be disconnected from storm water drainage and is creating excessive moisture in the surrounding area.

Such leaking creates an environment which is conducive to an array of defects, including water damage to associated building elements and the attraction of termite or timber pest infestation.

It is highly recommended that a licensed plumber be appointed to connect the A/C overflow in order to prevent such an environment from being created. These minor works should be carried out as soon as possible.

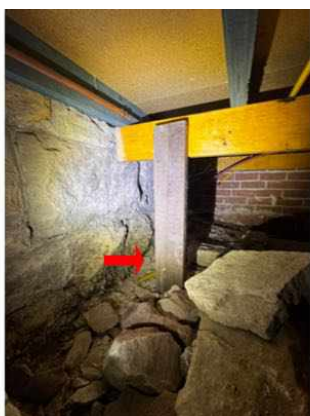
### Finding 6.02

Building:	Main Building
Location:	Subfloor
Finding:	In ground contact
Information:	Any timbers in direct ground contact provide opportunity for concealed termite entry and are likely to be subject to premature rot and decay as the soil retains moisture or damp conditions against the timbers.

Remove untreated timber that is in direct contact with external grounds. Consider replacement with more durable materials i.e. treated timber or non timber elements. Frequent pest inspections are advised to readily identify any termite activity in these areas.

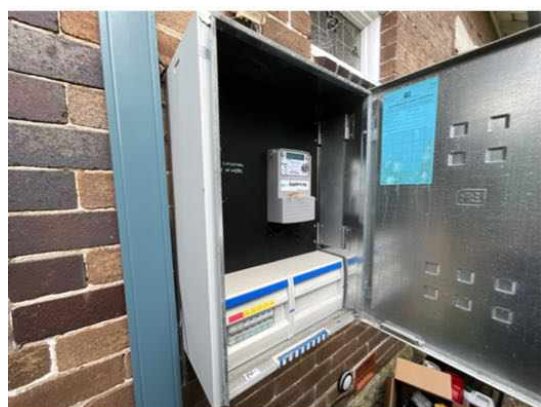
### Finding 7.01

Building:	Main Building
Location:	All Areas
Finding:	Termite Management System - no evidence of a chemical installation
Information:	The application of a post-construction chemical termite barrier is highly recommended

for all properties, particularly if live termite activity has been found on the site previously. Such barriers are highly effective in preventing termite attack on any timber building elements throughout the property.

A durable notice should be placed in the switchboard unit to indicate current termite barriers. At the time of inspection, it appeared as though no termite management system has been installed, with no evidence to suggest preventative works taking place.

The client may consider gaining further advice from a pest controller as to the costs and procedures involved with this application. It is recommended that obtaining such advice be a short-term priority.

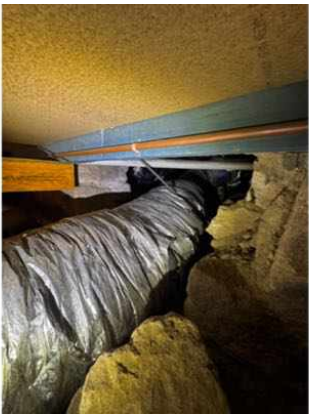
Building: Main Building  
Location: Subfloor  
Finding: Additional Photos - Obstructions and Limitations  
Information: These photographs are an indication of the obstructions and limitations which impeded full inspection of the property at the time of inspection. These obstructions can hide an array of defects and should be removed to allow full inspection to be carried out. A re-inspection is recommended once the areas are made accessible.
