Building Inspection Report

Inspection Date: Thu, 29 Jan 2026

Property Address: 4 Edwin Pl, Austins Ferry TAS 7011,
Australia

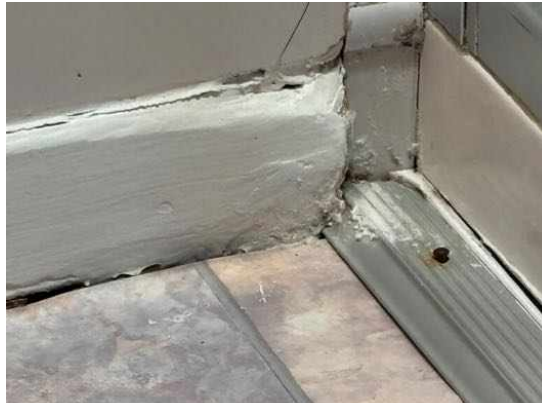
Defects 2.01

Building: Main Building
 Location: Shower room
 Finding: Shower active water leak
 Information: In the subfloor there is active water underneath the shower taps area. It was wet after running the shower just a couple of minutes. The subfloor timbers are wet and are water stained. There is also some damaged chipboard and pine framing, that looks to have been a previous renovation/repair, however these have also become water damaged.

In the shower room, there were elevated moisture readings low down on the shower wall panelling. This usually indicates water is behind this area, which is not uncommon.

On the wall next to the shower, there is some previous water damage visible. There is also a cracked tile. Additionally the floor boards are cupped from water damage.

If not rectified, water will continue to ingress and may lead to water damage and deterioration of the surrounding building elements if the water proofing membrane is not intact or absent. However our non invasive inspections is unable to determine the adequacy of the water proofing membrane.

It is most likely that this shower will need to be demolished and reconstructed. Only once the door, panelling, tray and flooring is removed will the full extent of the damage be visible.

Recommend client engage a Lic Plumber to inspect and rectify the leak, as soon as possible.

Recommend client engage a Lic Builder who specialises in bathroom renovation, to carry out a more invasive inspection, advise and rectify as soon as possible.

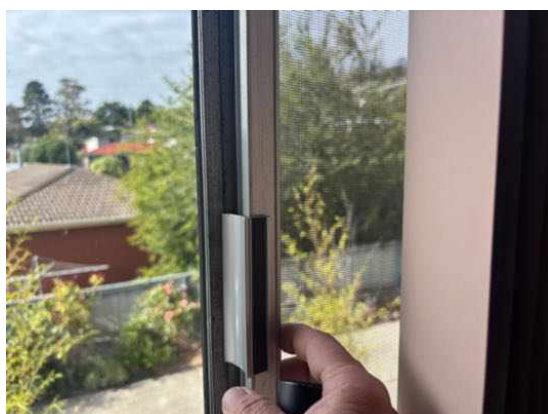
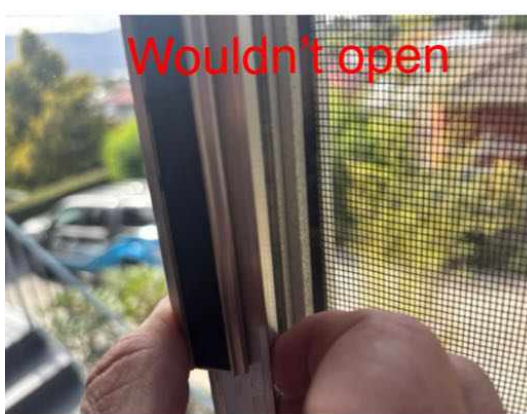
Defects 3.01

Building:	Main Building
Location:	Multiple locations
Finding:	Windows - cleaning and maintenance required
Information:	In multiple locations throughout the property, the windows would benefit from cleaning and maintenance. One window would not open and was missing some rubber and other windows had wheels dragging on the tracks instead of spinning.

Generally, factors such as general age of the building element and a lack of maintenance are the usual causes for this type of defect.

Windows provide ventilation to the adjoining area and should be at a fully operational level to ensure user comfort. Restricted function of the window may also pose as a potential safety hazard if required for emergency egress from the building.

Recommend client engage a Handy Person to rectify as soon as practicable.

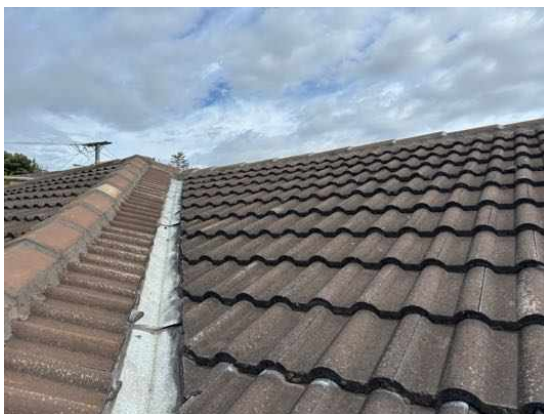
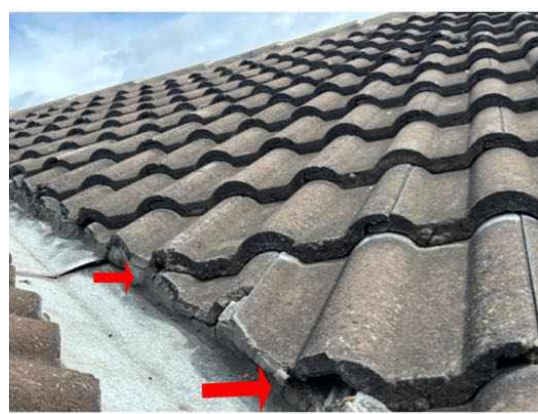
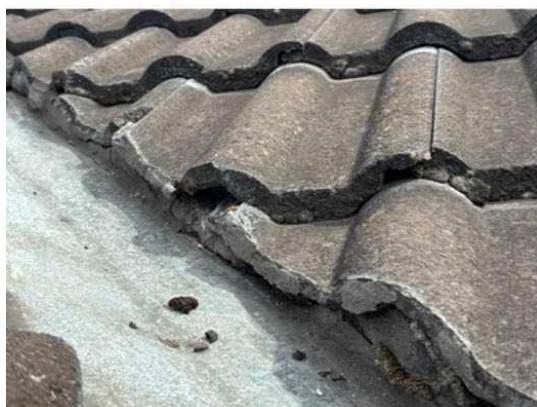
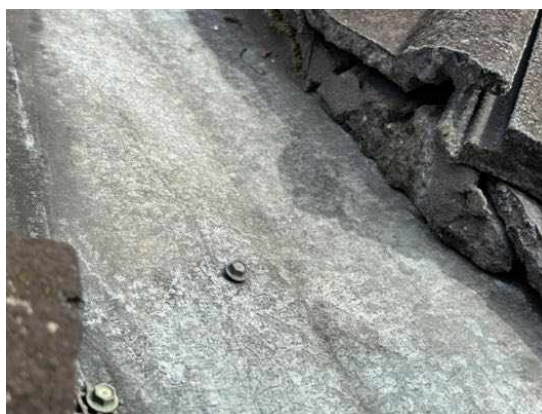
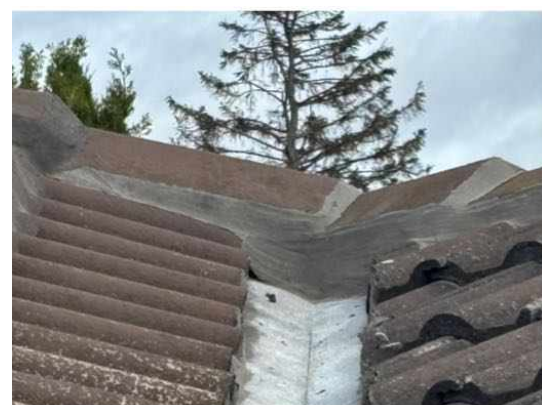
Defects 3.06

Building: Main Building
 Location: Roof void
 Finding: Corrosion to valley metal

In the roof void there is some corrosion to the roof valley metal, at the front of the house. This pointing has deteriorated to this valley. This is most likely allow water in and causing the corrosion.

Rusting and corrosion, which is likely to have developed as a result of excessive exposure to moisture and or inadequate coatings.

As surface rust provides no protection to the underlying iron, the deteriorating condition is likely to worsen if not addressed in the short-term future.

Recommend client engage a Tiled Roof Contractor to rectify as soon as possible, to prevent further deterioration.

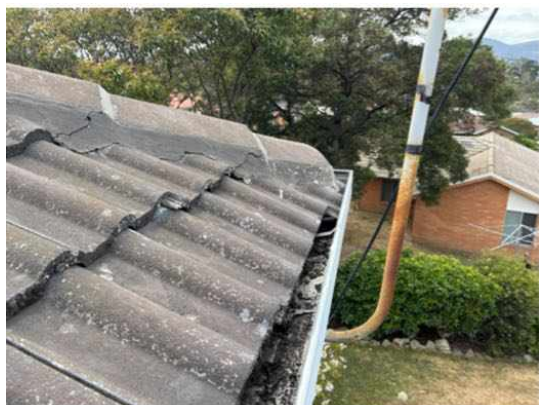
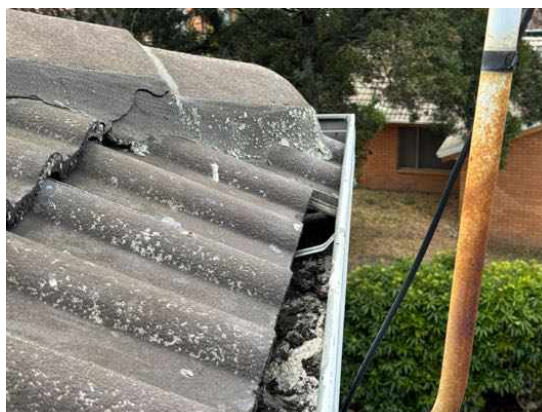
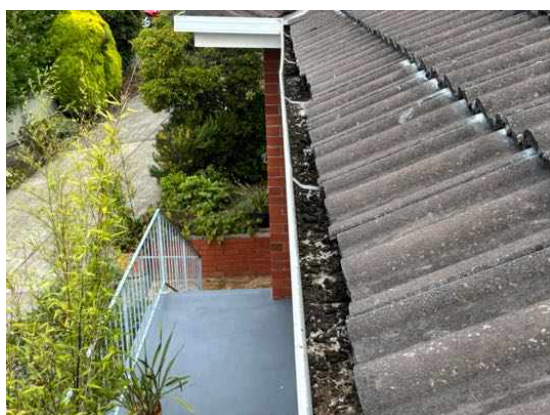
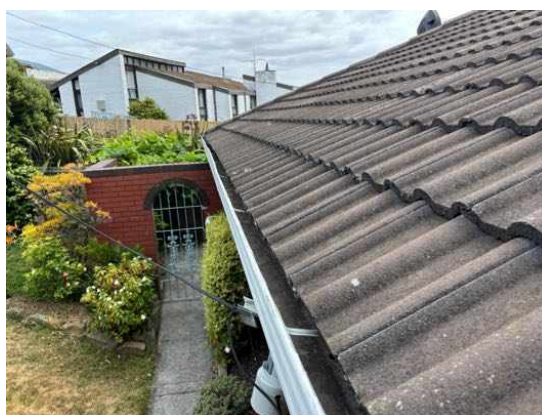
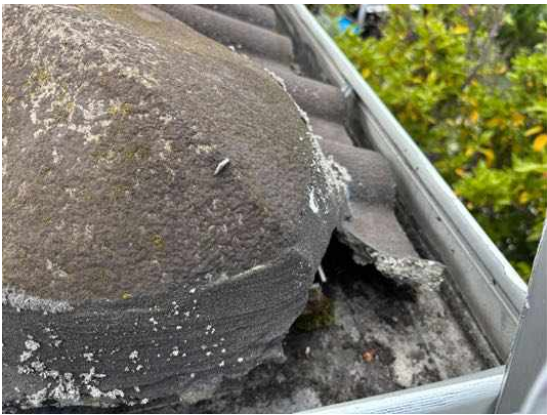
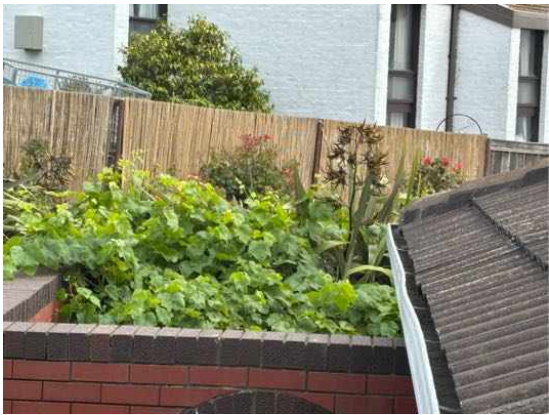
Defects 3.07

Building:	Main Building
Location:	Roof
Finding:	Tiled roof - maintenance required
Information:	The roof is in fair condition for its age. Concrete tiles such as these get brittle with age and cracks can occur. It is good that there has been some repointing and repairs done and most of that is looking good from the ladder. It is unusual that the slipped tiles were not put back in place prior to repointing. But some of that pointing has cracked again and there are a few cracked tiles and some silicone repairs. As these roof age they do need regular inspections and maintenance.

Broken and friable roof tiles are generally the result of ageing and weathering of what is essentially a porous material.

If left to further deteriorate, broken and brittle roof tiles are likely to lead to water penetration via the roof into the ceiling space, causing secondary damage to ceiling linings, insulation and roof structures. Broken roof tiles are also likely to detract from the effectiveness of the roof drainage system, creating potential for secondary damage to the exterior roof covering and roof plumbing.

Recommend client engage a Tiled Roof Contractor to rectify as soon as possible.

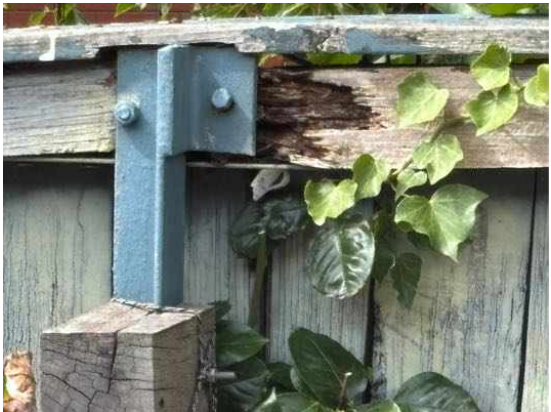
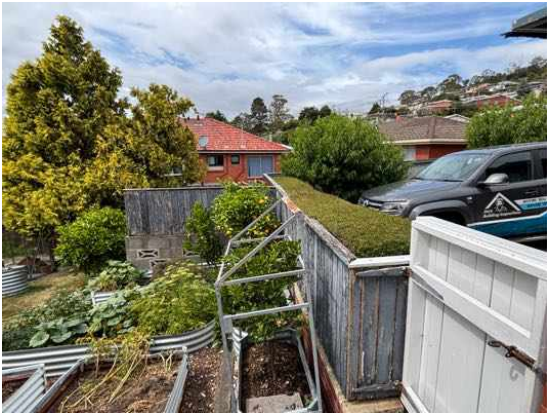
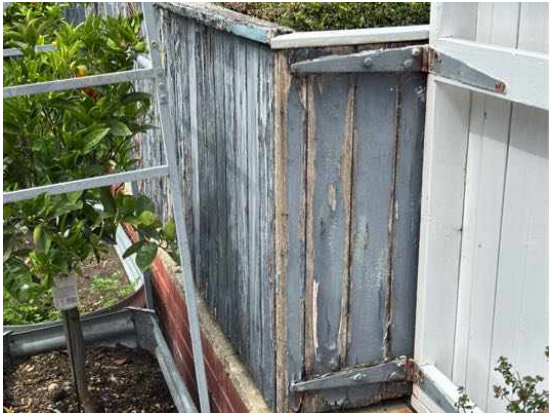
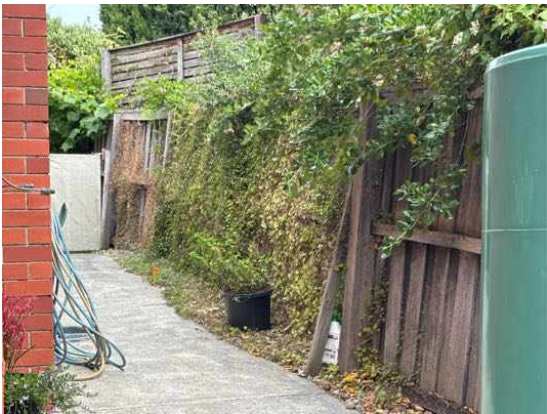
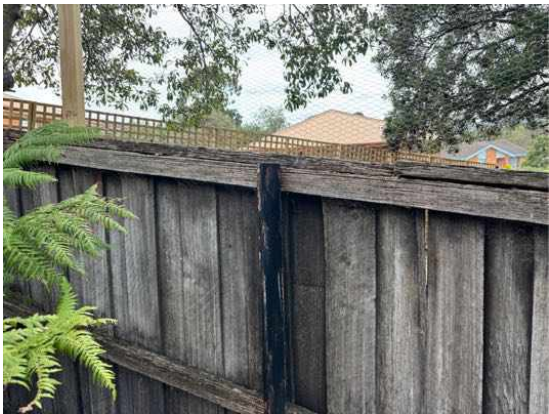
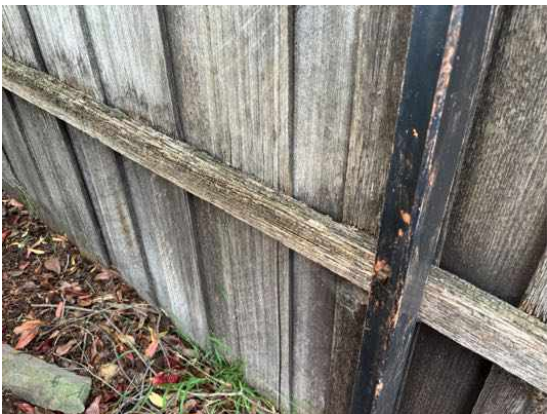
Defects 3.11

Building: Main Building
 Location: Multiple locations
 Finding: Fences deteriorated
 Information: The fences on the both sides of the house and the rear of the house are badly deteriorated. These will need replacing in the near future.

Failure to rectify will lead to further deterioration.

Recommend client engage a Handy Person or Fencing Contractor to rectify at clients convenience.

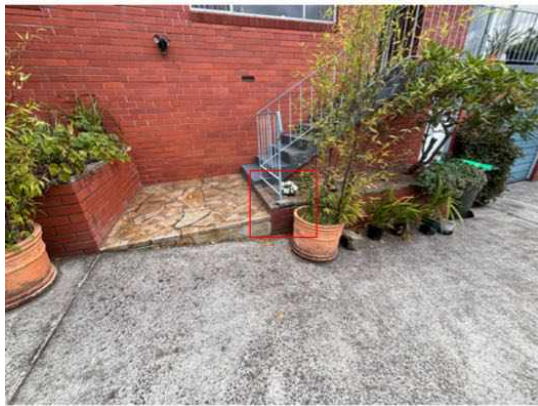
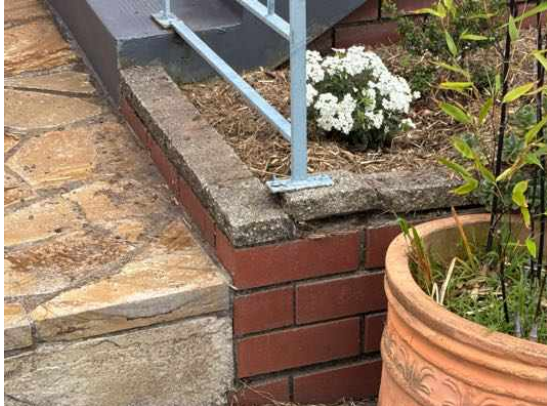
Defects 3.12

Building: Main Building
 Location: Front balustrade
 Finding: Balustrade hand rail loose
 Information: The hand rail to the balustrade at the front of the house is loose. The paver it is secured to is floating.

If not rectified this could become a hazard.

Recommend client engage a Handy Person to rectify as soon as possible.

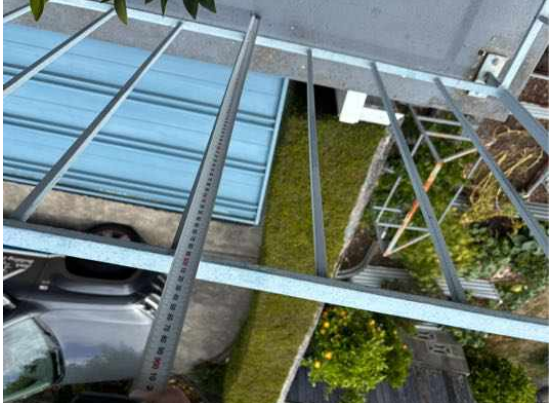
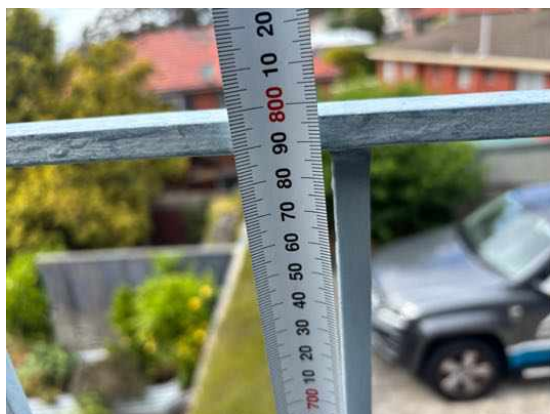
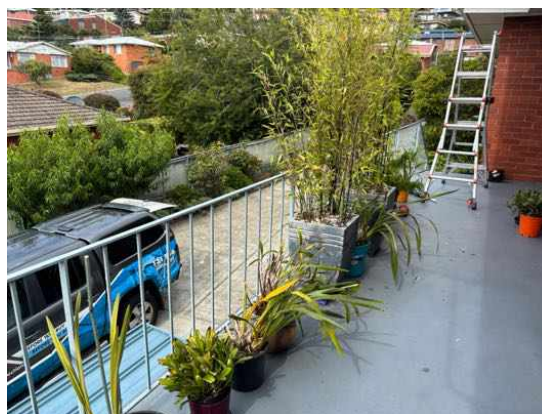
Building: Main Building
 Location: Balustrade to rear deck
 Finding: Balustrade - low
 Information: FYI the balustrade was measured and found to less than the present building regulation requirement of 1000mm high.

????Additionally the gaps between the balustrade cladding were found to be greater than the present building regulation requirement of 125mm.

Some changes to the building regulations are made to ensure the safety of all inhabitants and balustrades are definitely one of those crucial regulations.

I strongly recommend client contact a Lic Builder to discuss possible rectification solutions, as soon as possible.

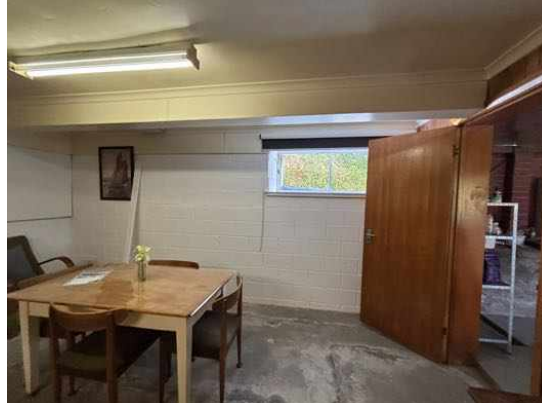
There is some efflorescence to the floor of the rumpus room (which generally indicates moisture). This rumpus area is below ground level. Recommend client does not carpet this area. Recommend that if the client wishes to utilise this area they should engage a Water Proofing Contractor to install a waterproofing system to the walls and floors. Once a system has been installed then tiles/vinyl would be more suitable for the flooring.

Efflorescence typically occurs when excess salts within the concrete or cement mortar is leached to the surface due to water transfer.

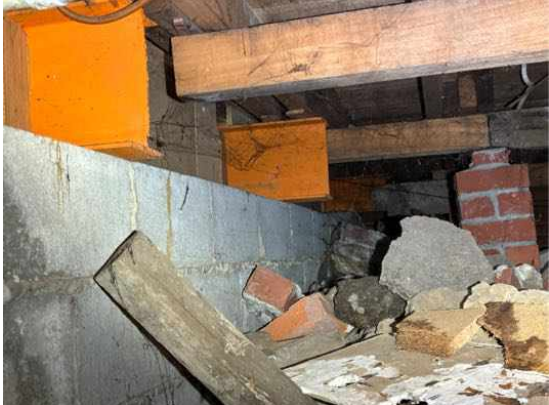
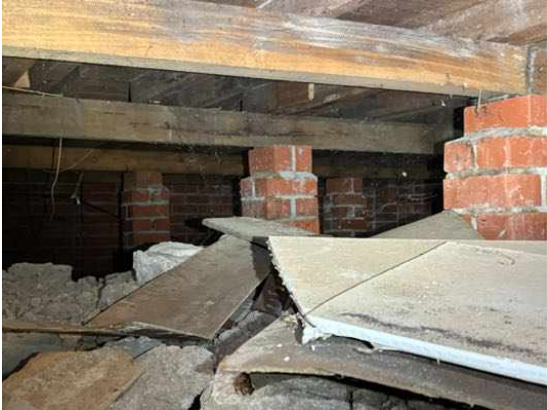
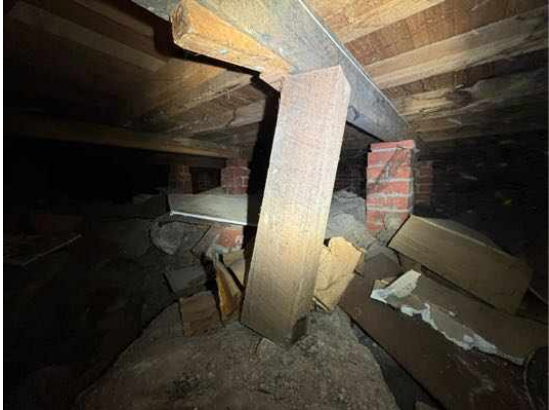
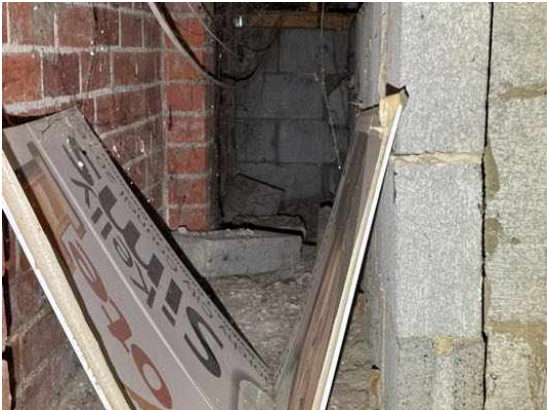
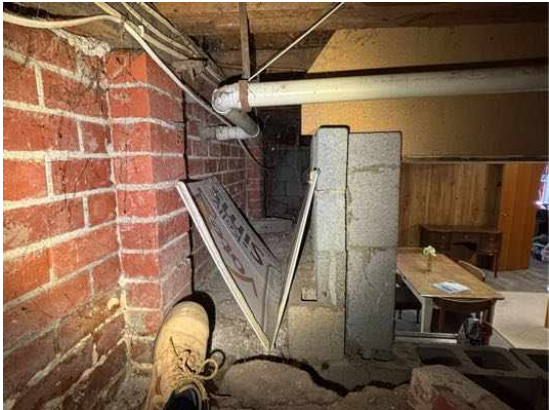
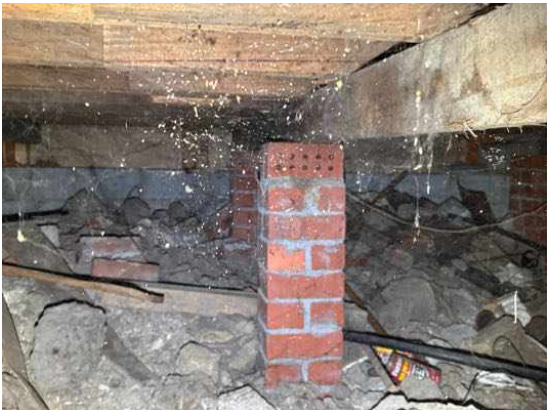
Information: An array of debris was found in the subfloor at the time of inspection. Debris in this area restricts ventilation and creates potential for concealed pest entry. Stored timbers and other materials may also make the area susceptible to wood rot.

A clear and empty subfloor will be better ventilated and easier to maintain in a dry condition.

Debris in the subfloor should be removed as soon as practicable.

Recommend client engage Rubbish Removal Contractor to rectify at clients convenience.
