Building and Timber Pest Inspection Report

Inspection Date: Wed, 18 Mar 2026

Property Address: 6 Middleton Avenue, Cranebrook NSW
2749

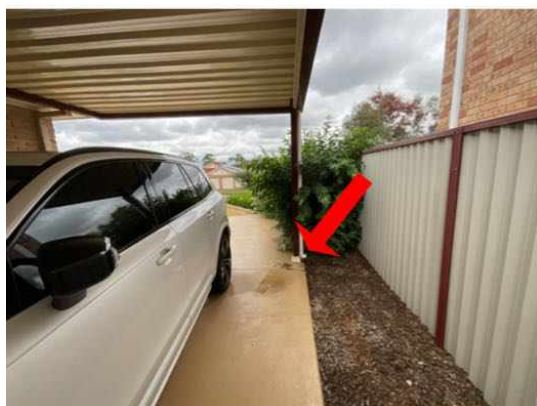
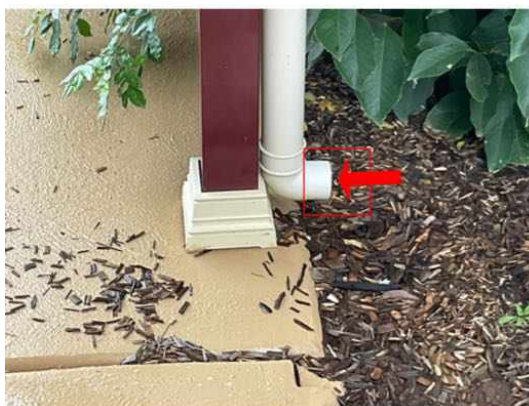
A section of roof plumbing was found where the downpipe is not connected to the stormwater drainage system.

Excessive moisture from uncontrolled roof runoff can create conditions that promote termite activity and timber decay.

It is advised that a licensed plumber be engaged to:

- Inspect the affected roof plumbing area, and
- Connect the downpipe to a compliant stormwater drainage system, or alternatively, install appropriate drainage measures to manage water flow and mitigate potential property damage or pest risks.

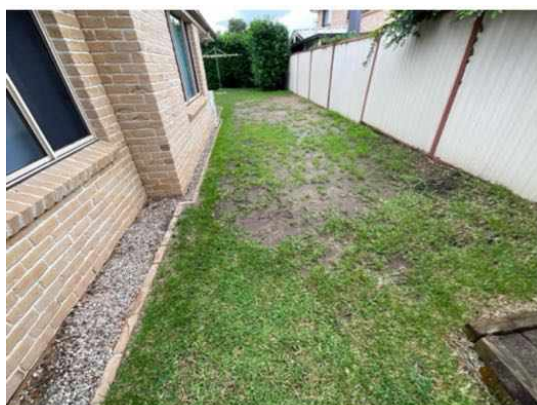
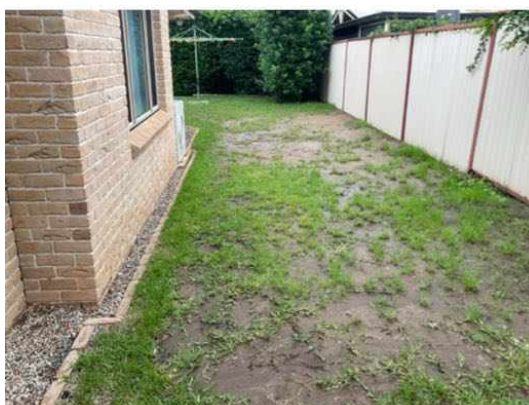
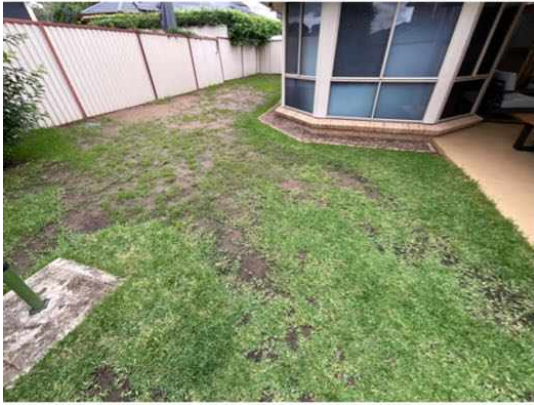
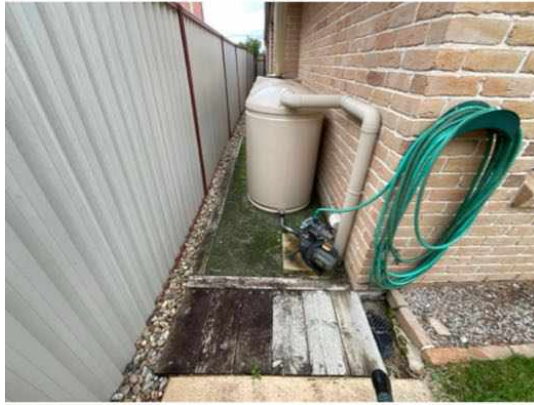
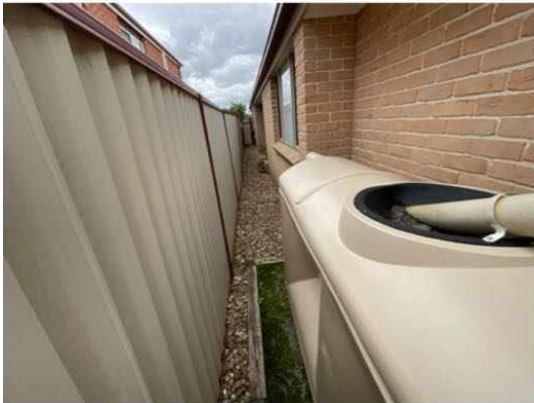
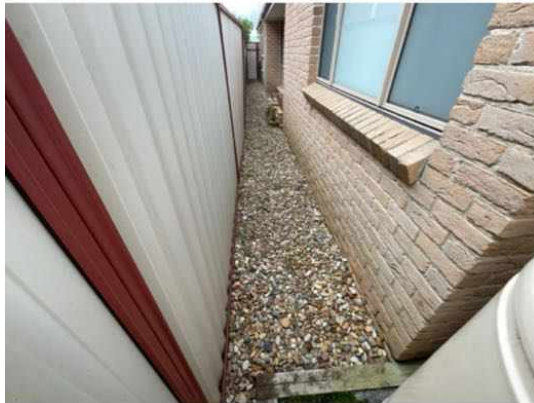
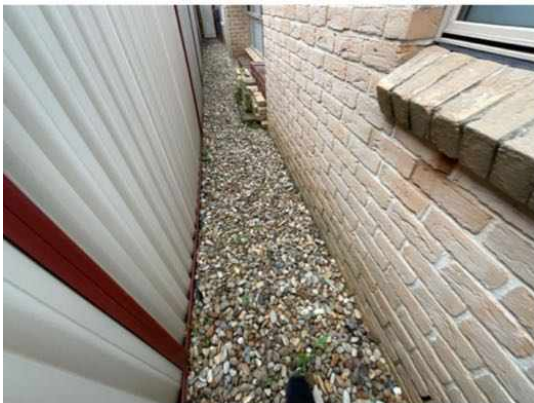
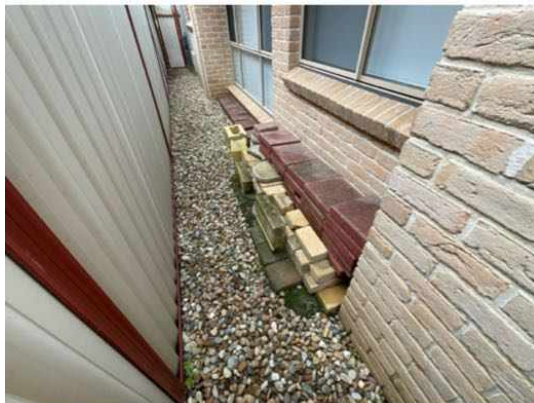
Finding 3.02

Building: Main Building
 Location: Exterior - Rear & Right side
 Finding: Site/Yard Drainage – Below Average.
 Information: Defect – Below Average Site Drainage

Site drainage in the inspected areas appears to be below average, with no surface drains observed at the time of inspection. Ground surfaces and paved areas adjacent to the building do not appear to be adequately graded to facilitate effective surface water runoff.

- Water should not be allowed to accumulate against the base of external walls or around the perimeter of the dwelling.
- Prolonged moisture exposure can contribute to:
- Dampness and structural deterioration

- Movement of footings or erosion of subsoils
- Conditions that are conducive to timber pest activity, including termites, which are attracted to moist environments
- Best practice site drainage includes:
 - Paved surfaces falling away from the building by at least 25mm over the first metre
 - Bare ground sloping away by at least 50mm over the first metre

Failure to meet these minimum drainage falls increases the risk of water ingress, foundation issues, and secondary building defects.

- A licensed plumber and/or landscaping contractor should be engaged to:
 - Evaluate the current site grading and surface runoff conditions
 - Install or upgrade surface water drainage (e.g. strip drains, spoon drains, grated channels) as required
 - Improve grading around the building to ensure water flows away from the structure

Addressing these issues proactively will assist in protecting the structural integrity of the building, while also reducing environmental conditions favourable to termite activity.

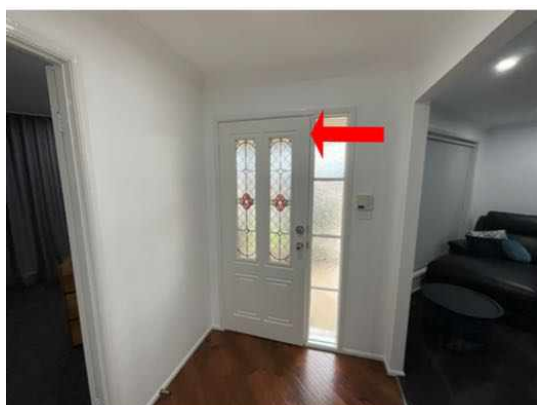
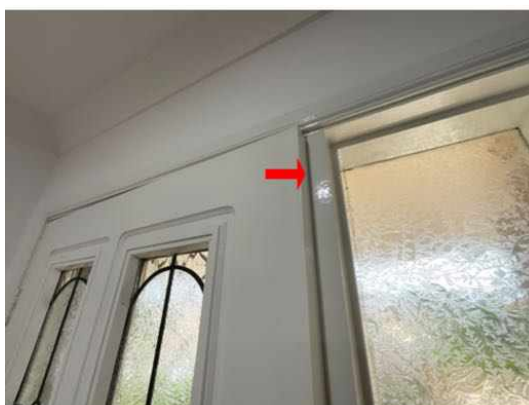
Finding 3.03

Building: Main Building
 Location: Entry
 Finding: Door - Binding and/or Jamming.
 Information: Functional Defect Identified

Binding and/or jamming of this door was observed during standard operation and appeared to be rubbing or binding. This issue impairs the normal functionality of the door and may lead to secondary damage to adjacent building elements, such as scuffing or tearing of floor coverings, or stress to door hardware and framing.

- Poor door installation
- Worn, damaged, or misaligned hinges
- Swelling or warping of materials

- The issue is minor in nature, a qualified carpenter or general handyperson may be appointed to carry out corrective works at the client's discretion.

Prompt assessment and remediation are advised to prevent further deterioration or related damage.

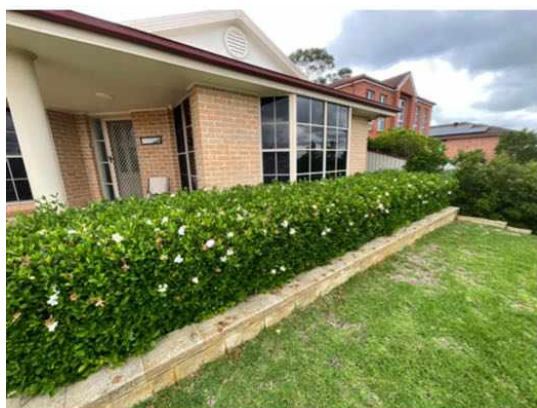
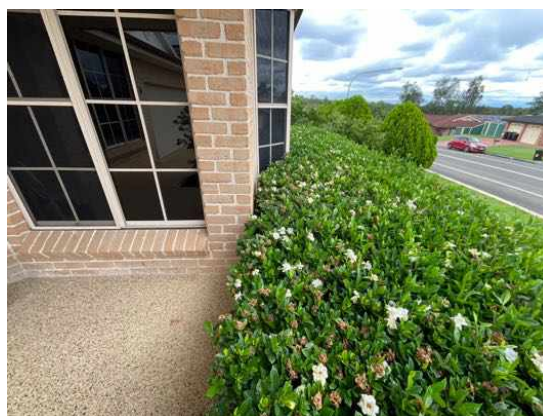
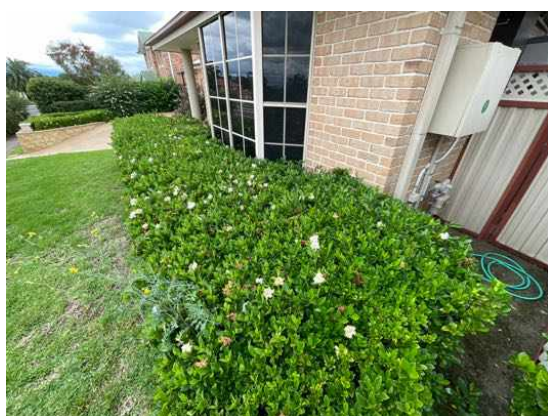
Building:	Main Building
Location:	Exterior walls
Finding:	Plumbing and/or yard drainage - Conducive conditions..
Information:	Observation: Drainage Issues Around Property

noted to have drainage problems, resulting in water pooling, ponding, or stagnation. These conditions are considered highly conducive to timber pest activity.

Garden beds were observed directly against the perimeter of the building. This condition can result in water pooling or retention during rainfall or from regular watering/hosing, which may lead to moisture ingress beneath the structure.

- Persistent moisture buildup around the base of the building creates an environment that is conducive to termite activity and timber decay.
- Plants and vegetation close to or in contact with external walls can provide shade and cover, further increasing the likelihood of termite infestation.
- Garden beds may also conceal weep holes, slab edges, or termite barriers, reducing visibility during inspections and allowing for undetected termite entry.

It is important that appropriate drainage improvements be undertaken to prevent moisture build-up around the building. This may include plumbing repairs, grading adjustments, or installation of drainage systems.

It is strongly recommended that garden beds be removed or relocated away from the building perimeter. Maintaining a clear inspection zone around the structure helps reduce moisture retention and improves visibility during regular pest inspections. This preventative measure significantly lowers the risk of termite ingress and related structural damage.

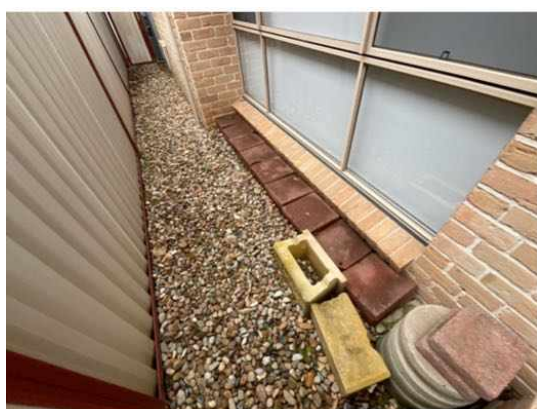
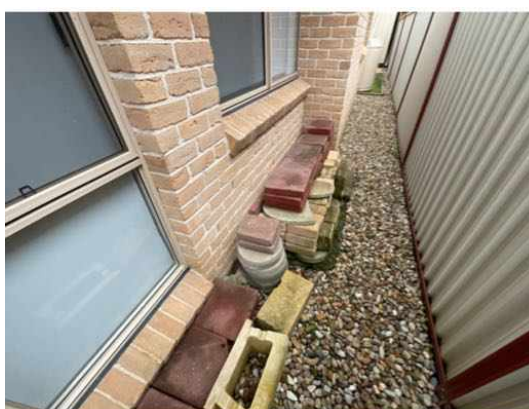
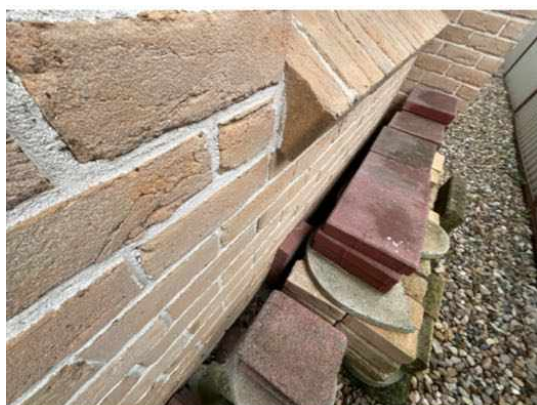
Finding 6.03

Building:	Main Building
Location:	Exterior walls - right side
Finding:	Bridging or Obstruction - Stored items against wall..
Information:	Obstructions – Stored Items

Such areas are also more likely to retain moisture or dampness, creating conducive conditions for termite activity. Obstructions against or very close to the building can provide cover, shade, and a favourable environment for infestation.

- Remove all obstructions and stored materials located against or near the building.
- Arrange a follow-up inspection to assess previously inaccessible areas and reduce the risk of undetected termite activity.

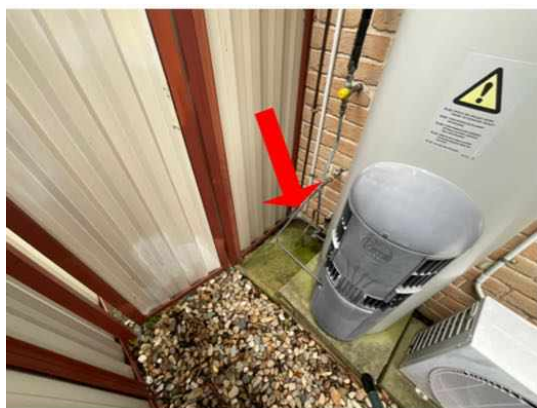
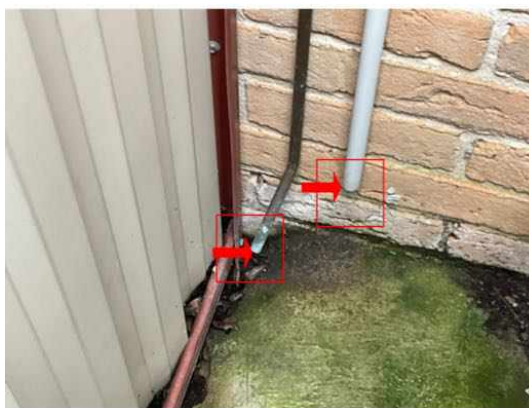
Finding 6.04

Building:	Main Building
Location:	All External Areas
Finding:	Overflow Management – Risk of Termite Activity..
Information:	Observation: Water Pooling from HWS and Air Conditioning Overflows

Water discharge from the Hot Water System (HWS) pressure relief valve and air conditioning unit overflows was observed discharging close to the base of the

Persistent moisture near the foundation or subfloor area significantly increases the likelihood of termite activity. Termites are highly attracted to damp environments, and stagnant water near structural elements provides ideal conditions for foraging and infestation.

- Moisture Conducive to Infestation: Termites require moisture for survival, and pooled water can soften timber materials, making them more accessible.
- Structural Risk: Prolonged dampness may also contribute to timber decay, further increasing vulnerability.

It is highly recommended that all overflows from the HWS and air conditioning units be redirected away from the building, preferably via fixed drainage or extension piping, to prevent water accumulation near the structure.

These minor corrective works should be undertaken promptly to minimise the risk of both termite ingress and potential structural damage due to ongoing moisture exposure.
