Building and Timber Pest Inspection Report

Inspection Date: Thu, 29 Jan 2026

Property Address: 2/9 Boobook Ct, Buderim QLD 4556,
Australia

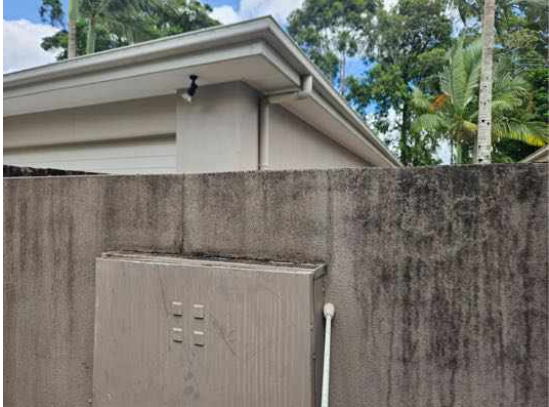
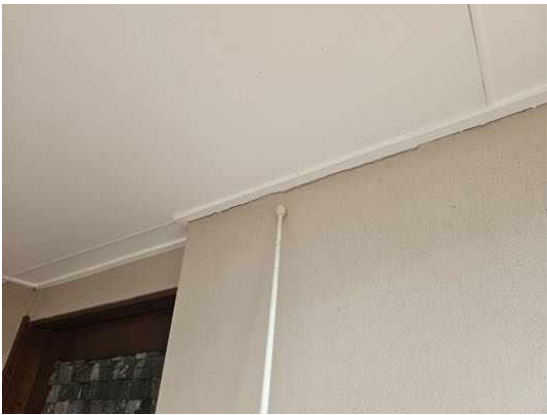
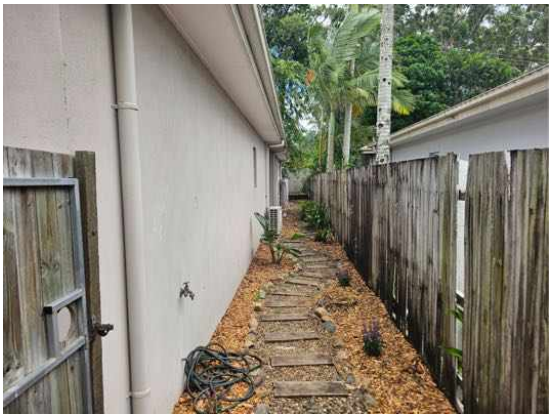
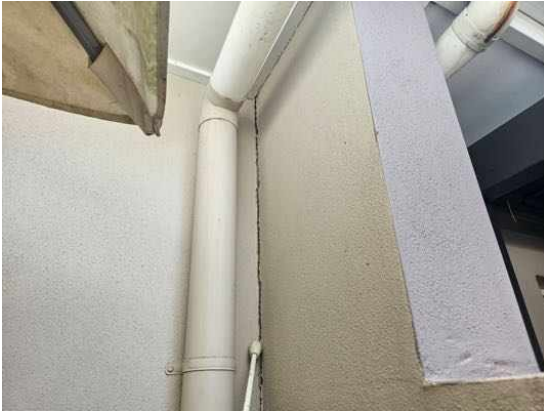
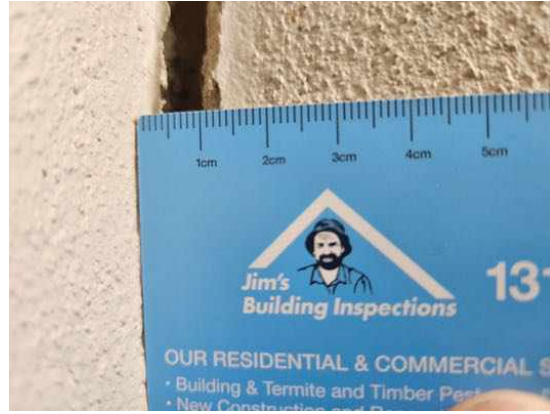
Building:	Main Building
Location:	All External Areas
Finding:	Brickwork - Step & shear cracking, general building movement
Information:	Step and shear cracking was identified to the brickwork throughout the exterior of the property at the time of inspection. Step cracking, which is similar to other forms of cracking, has a variety of possible causes, including the lack of control joints provided at construction. However, minor subsidence and movement of adjacent footings could be the cause.

Step cracking is a relatively common defect, and is most likely to occur adjacent to windows, doors and other openings. Mortar failure in the gaps between affected bricks indicates the stresses and tensions affecting the wall. A large movement gap was noted in the dividing wall at the rear of the property, showing significant movement in this area.

Minor step cracking and exterior movement can be used as a warning sign to address factors causing stress to the wall, which can include the effect of surrounding trees, water leaks, soil erosion, or even the presence of reactive soils in the surrounding area. Large trees are located in the rear yard area and excessive moisture from leak roof plumbing could also be a contributing factor.

This has been given a minor defect rating at this time; however, this has the potential to become a major defect issue if not addressed when any change is noted.

Where step cracking is extensive or severe, the client is advised to consult a structural engineer. These should be monitored and if any increase is noted, seek professional advice.

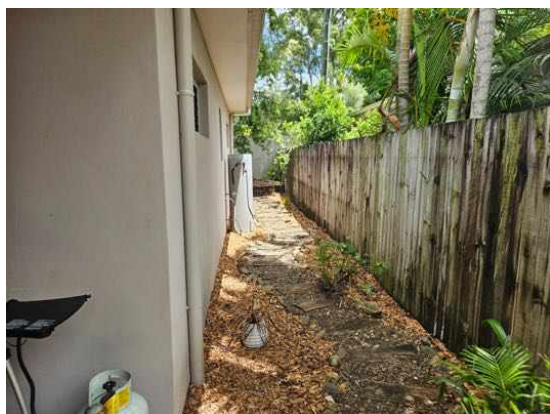
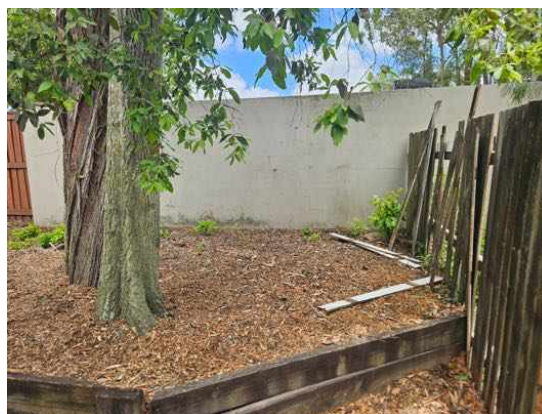
Finding 3.02

Building:	Yard
Location:	Boundary fencing
Finding:	Fencing - Deteriorated
Information:	It was noted at the time of inspection that sections of the fencing throughout the property have deteriorated. Typically fencing deteriorates due to age and or wear, rot and or rust which is generally expected for a structure of this age, due to prolonged exposure to weather conditions. Sometimes inadequate installation or maintenance can be to blame.

If left unattended, it is likely that further damage will occur. It is suspected that repair of several elements of the fencing may be required however replacement may be a consideration of the client also.

A licensed fencing contractor should be appointed to provide further advice and perform rectification works as necessary.

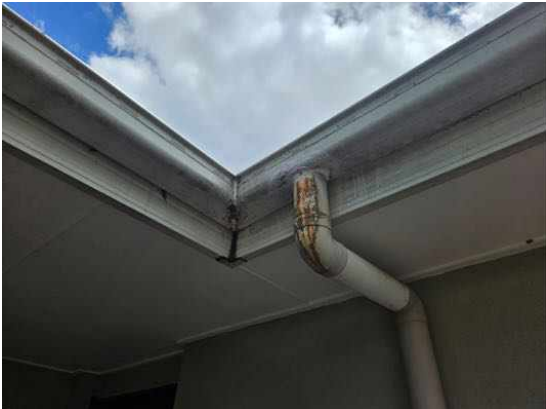
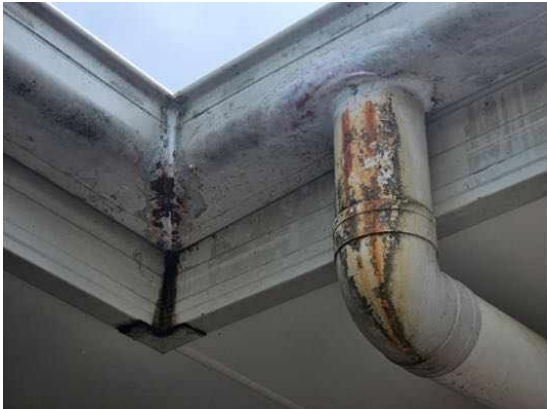
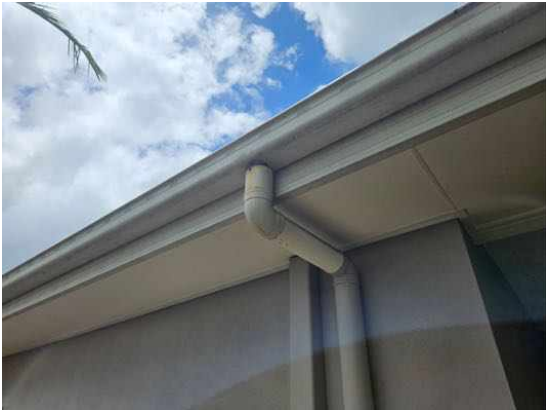
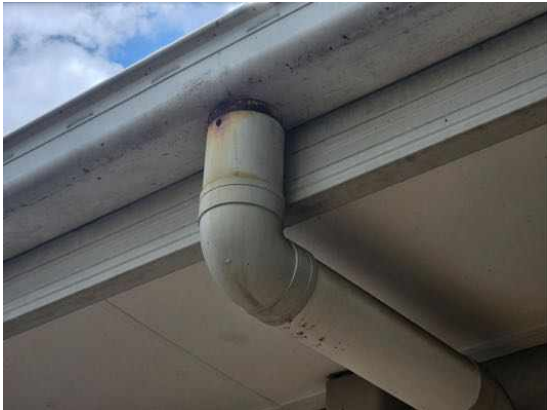
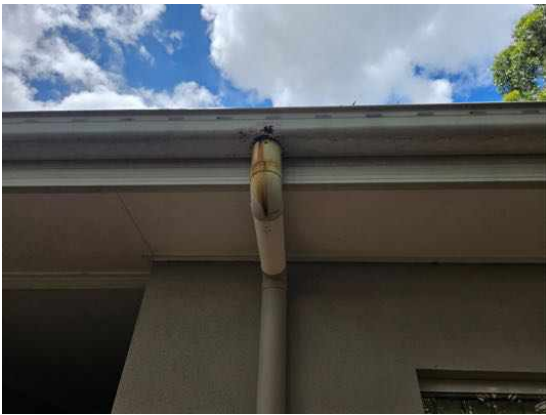
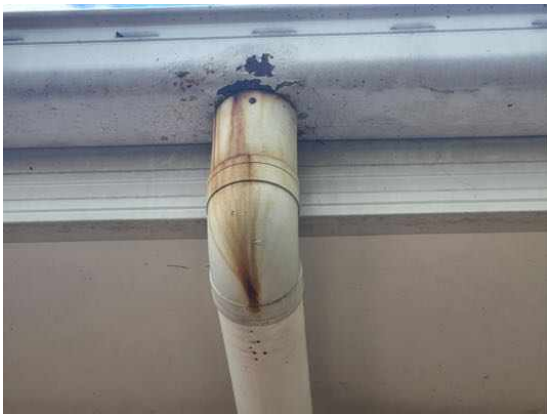
Building:	Main Building
Location:	All External Areas
Finding:	Downpipe dropper and gutter - rusting
Information:	On the day of inspection it was noted that the downpipe droppers around the perimeter of the property were rusted and functioning effectively. Some rust was

noted in the gutter itself.

This should be repaired without delay to reduce further damage to the roof plumbing, reduce the moisture around the foundations, and to reduce the possibility of increased timber pest activity.

The attendance of a roofing contractor or plumber with roofing experience is strongly recommended.

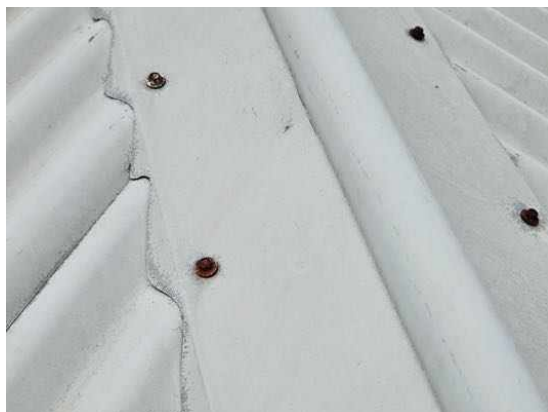
Finding 3.05

Building:	Main Building
Location:	Entry portico
Finding:	Roof screws - rusting
Information:	It was noted during inspection, that throughout the roof surface of the entry portico the majority of roof screws are showing signs of rust at varying degrees ranging from minor to moderate.

This should be monitored over time, and should the condition worsen, consider replacement of the screws. As roof screws deteriorate they can have an effect on the adjoining roof materials.

A roofing plumber could be appointed at the clients discretion to replace the screws in question.

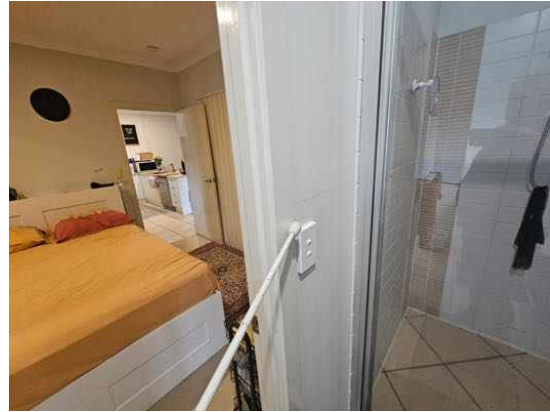
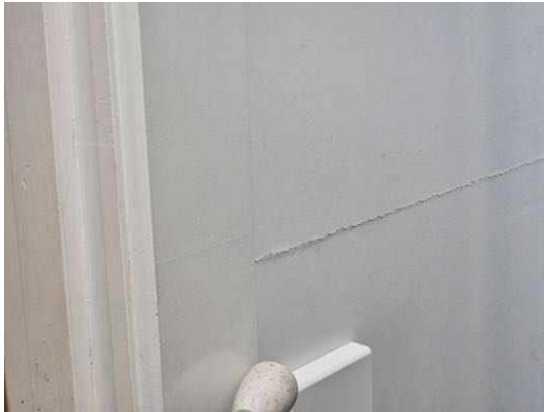
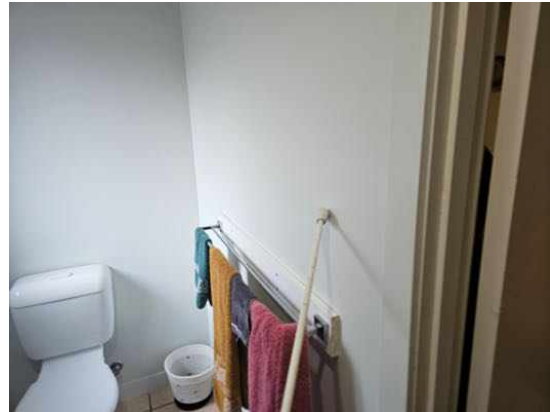
Finding 3.06

Building:	Main Building
Location:	Ensuite - Master
Finding:	Minor movement cracking
Information:	Minor movement cracking and repairs to the ensuite walls, were observed at the time of the inspection.

Cracking of this nature is expected in this type of building and it appears to be associated with movement of the building elements. Should there be further greater movement, always contact a structural engineer or a licensed builder.

The fine but visible cracks can be patched and painted over by an experienced painter or handyman at the clients discretion.

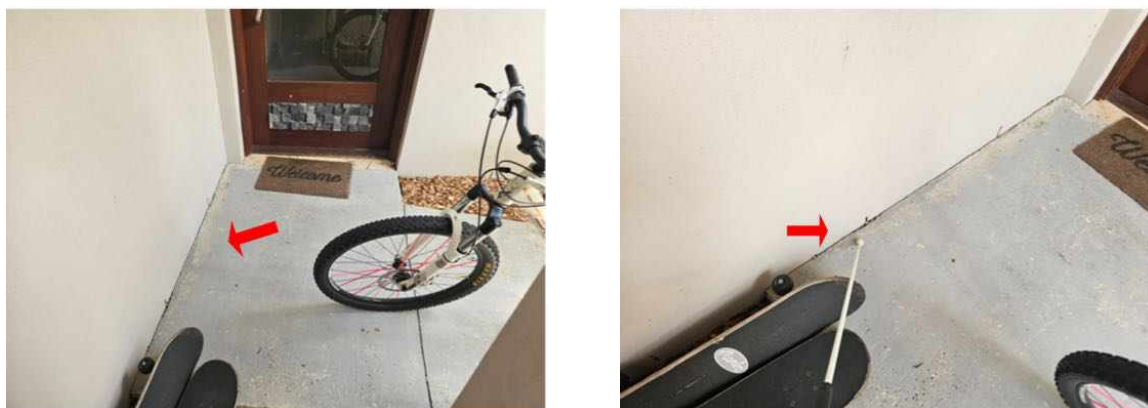
Building: Main Building
 Location: Front entry
 Finding: Weep holes - Blocked by path
 Information: It was noted during the time of inspection that the weep holes to the brickwork at the front entry were partially blocked by the entry path. Weep holes are designed to allow water from leaks or seepages in brickwork to be directed to the external environment, prior to entering the wall cavity or associated building materials. Weep holes should therefore be kept clean and free of debris or blockages.

Blocked weep holes are likely to result in the presence of excessive moisture within the brickwork and associated structures, creating potential for water damage and moisture problems.

may be able to undertake remedial works to remove blockages.

Preventative works are necessary in ensuring the structural integrity of the affected brickwork and prevention of pest entry should be performed as soon as possible.

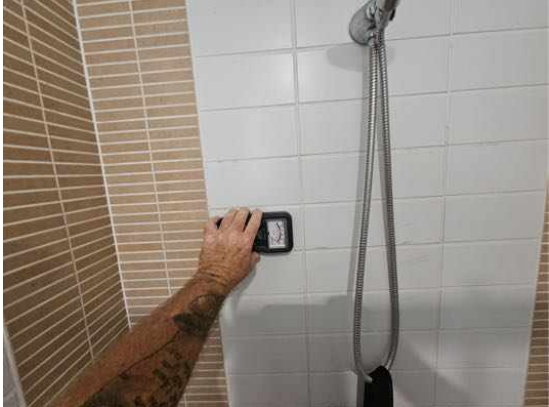
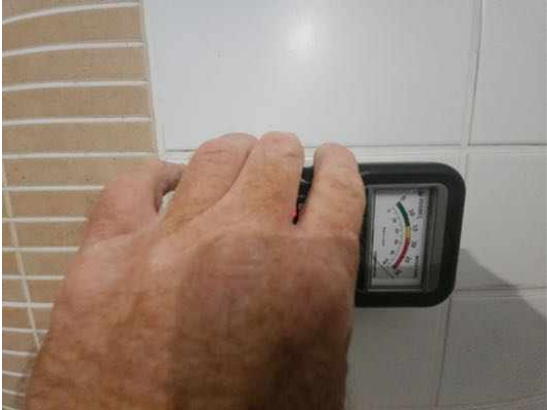
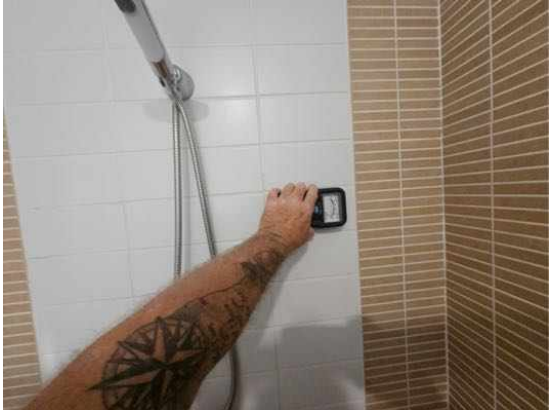
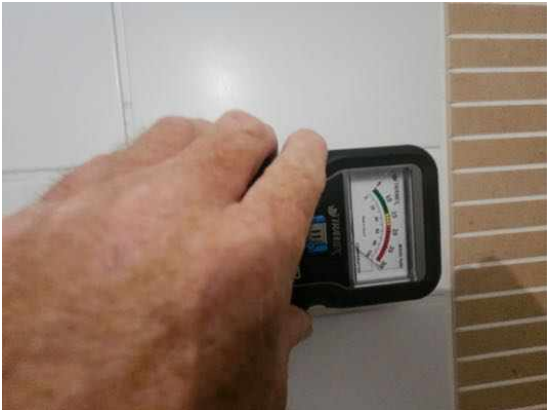
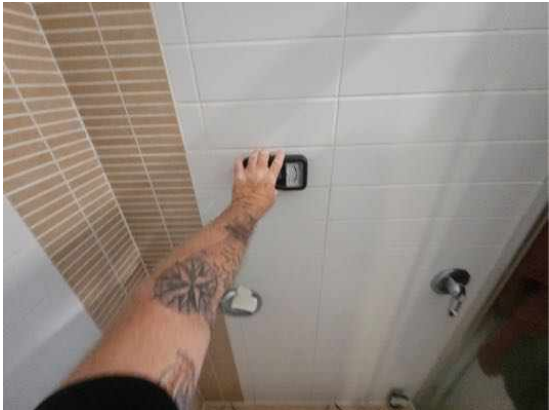
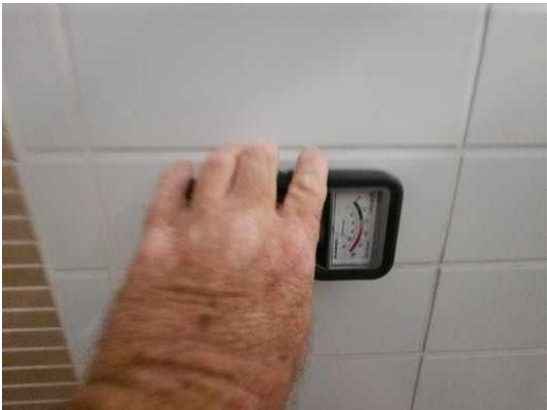
Finding 6.03

Building:	Main Building
Location:	Ensuite - Master
Finding:	Elevated moisture present at the time of inspection - ensuite
Information:	Elevated moisture was noted in the tiled wall surfaces of the ensuite shower.

The levels varied at differing points throughout the recess. This could possibly be due to deteriorated grout and silicone sealants. These can break down over time and become porous, allowing moisture to enter the wall sheet surface behind the tiles. Moisture was also found around the penetration for shower rose, this should be checked for integrity.

Elevated moisture can attract timber pests and vermin, and produce conditions that promote timber pest attack, fungal growth and wood decay.

The moisture readings in the ensuite shower recess are contained in the tiles to approximately 2/3 the height of the tiled walls, which can usually indicate grout and silicone degradation. The bathroom is mainly concentrated around and below the mixer tap.

It is recommended that the moisture levels in these areas be minored over time and the grout and silicone be renewed to possibly eliminate any further moisture penetration. No moisture was detected on the reverse side of the wall.

A licensed tiler and / or sealant specialist could be engaged to renew these elements.

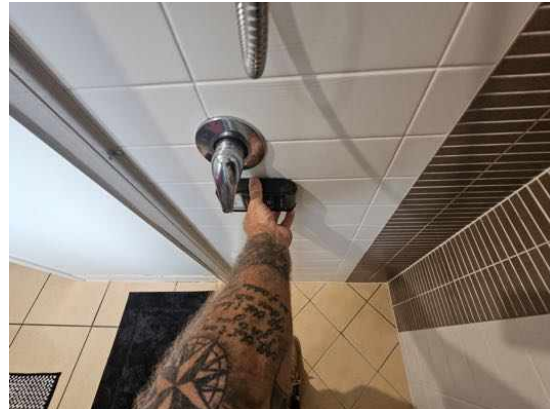
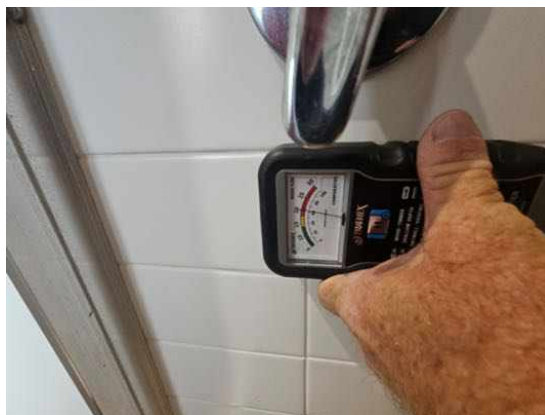
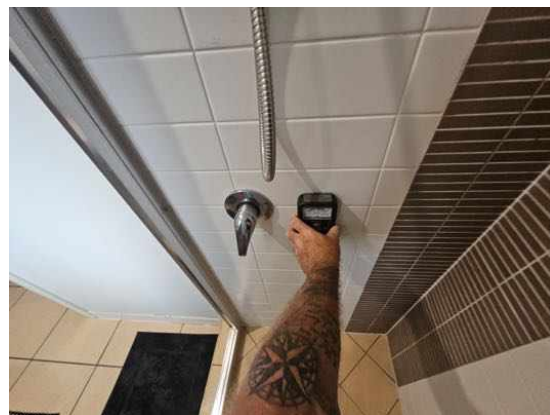
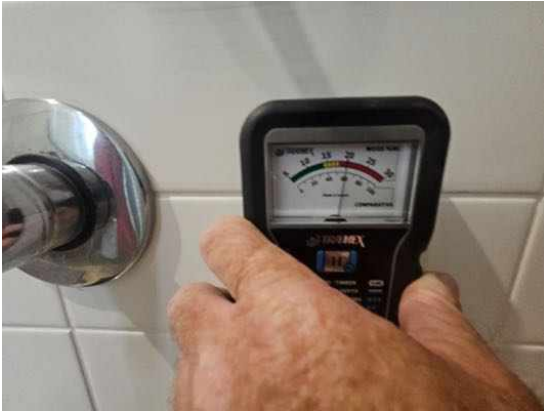
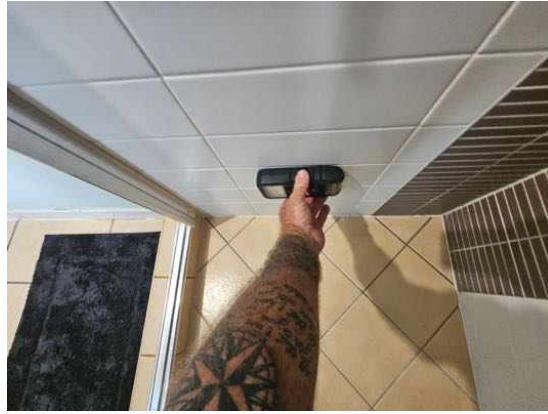
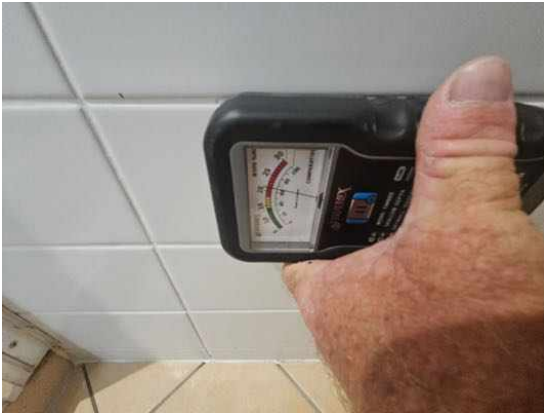
Finding 6.04

Building: Main Building
Location: Bathroom
Finding: Elevated moisture present at the time of inspection - bathroom
Information: Elevated moisture was noted in the tiled wall surfaces of the bathroom shower around and below the mixer tap.

The levels appeared to be isolated in the zone shown in the photographs. This could possibly be due to deteriorated grout and silicone sealants. These can break down over time and become porous, allowing moisture to enter the wall sheet surface behind the tiles. It is most likely that there is some ingress at the tap penetration or from the fitting itself.

Elevated moisture can attract timber pests and vermin, and produce conditions that promote timber pest attack, fungal growth and wood decay.

It is recommended that the plumbing service be assessed for integrity.

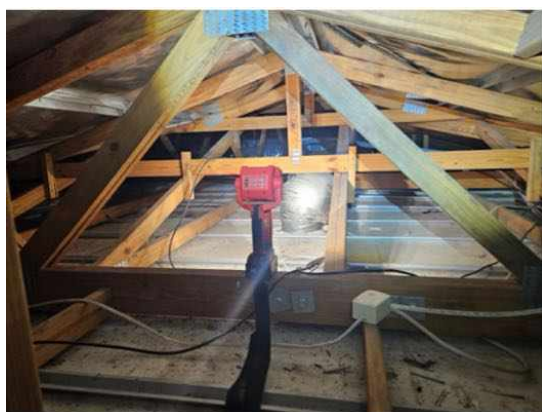
Building: Main Building
Location: Garage
Finding: Unable to access ceiling space - congested framing
Information: On the day of inspection the ceiling space was not able to be inspected due to the congested and narrow roof framing from the garage access hatch to main areas of the home. An alternative access hatch location is recommended to facilitate better access to the ceiling void.
