Building and Timber Pest Inspection Report

Inspection Date: Wed, 18 Feb 2026

Property Address: 121 Burrumbuttock Brocklesby Rd,
Burrumbuttock NSW 2642, Australia

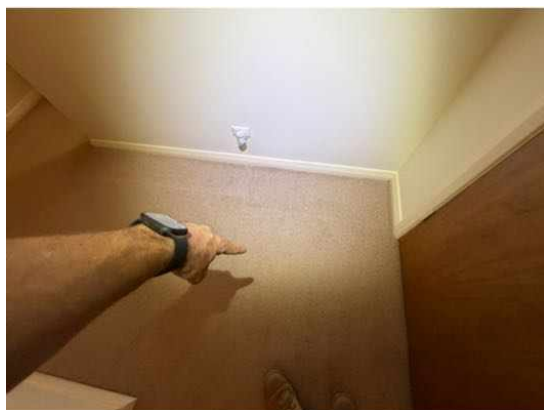
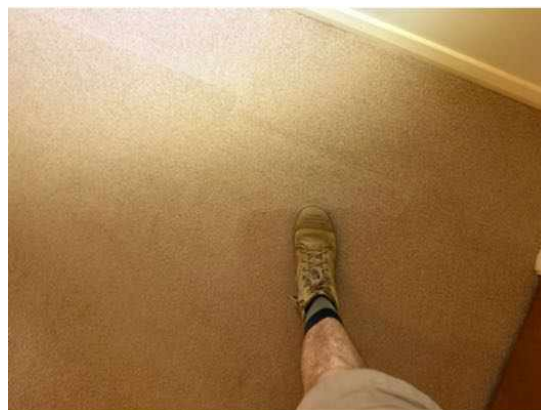
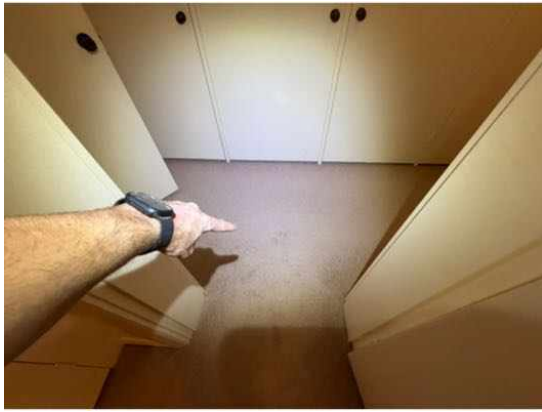
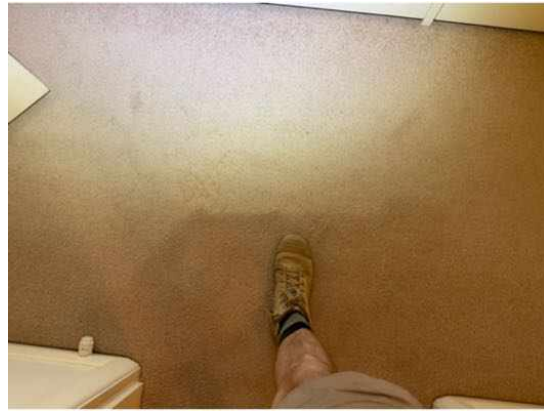
Finding 3.01

Building: Main Building

Location: All Areas

Finding: Flooring - Uneven

Information: It appears some areas of the flooring throughout the building appear to be slightly uneven. It is advised that the client monitor the flooring to identify any further movement. Where flooring remains relatively unchanged for an extended period of time, it is likely that this defect has been caused by expected movement of the foundations of the property.

Should further movement and unevenness occur, a structural engineer should be engaged for further evaluation.

All areas of cracking as well as areas of uneven flooring should be closely monitored. Should cracking widen, lengthen or become more numerous, or the flooring become further uneven, a structural engineer should be engaged promptly, for further evaluation.

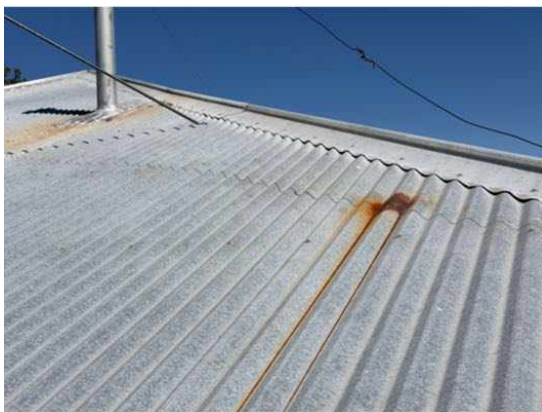
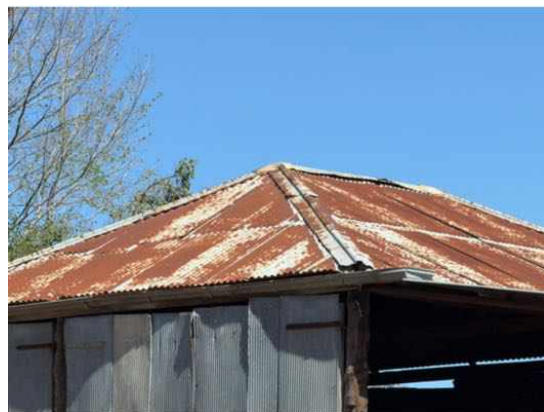
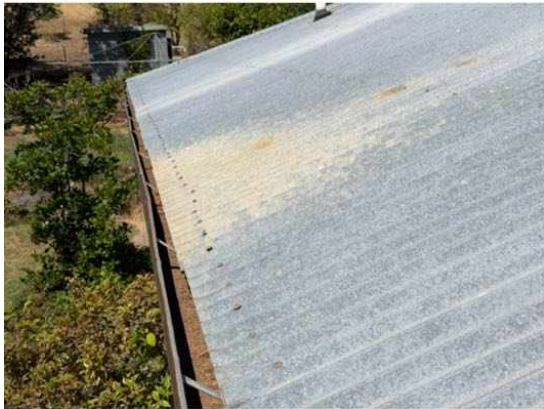
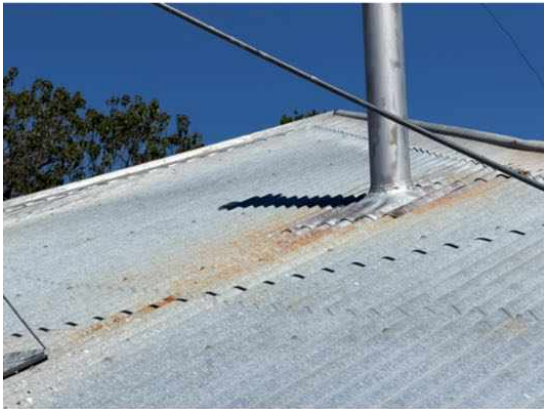
Finding 3.02

Building:	Main Building
Location:	Roof Exterior
Finding:	Roof Exterior - Weathered, Rust
Information:	Areas of the roof exterior were found to be weathered and had areas of rust. While weathering of the roof exterior is consistent with the age of the property, maintenance works are advised.

Where left unmanaged, deteriorating roof sheeting and plumbing is likely to lead to secondary defects, including water leaks. It is advised that the client consult with a licensed roofing contractor in the short term, to provide further advice on maintenance works needed.

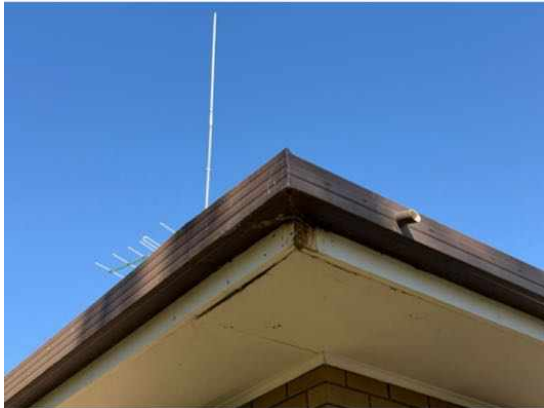
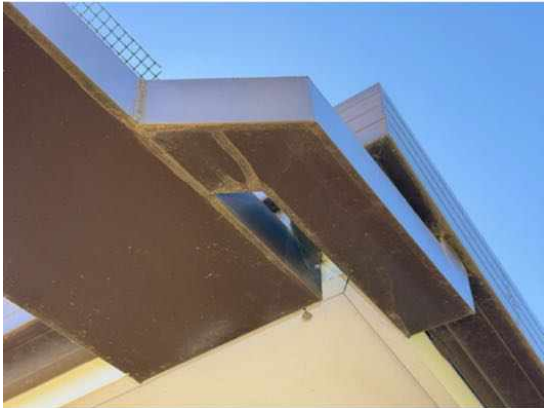
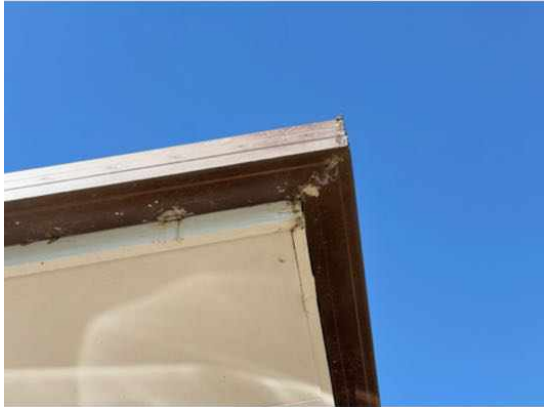
Finding 3.03

Building: Main Building
 Location: Gutters, Down-pipes
 Finding: Roof Plumbing - Rust & Leaking
 Information: It appears that areas of the roof plumbing were leaking & had areas of rust. Rusted & leaking roof plumbing could eventually develop holes overtime that can affect other building elements, and create water pooling in the area, creating an environment conducive to termite activity, if neglected.

Recommend consulting with a licensed roof plumber in the short term, to provide further advice & maintenance works where necessary.

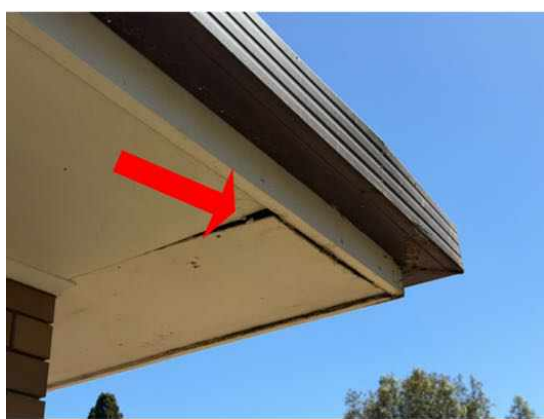
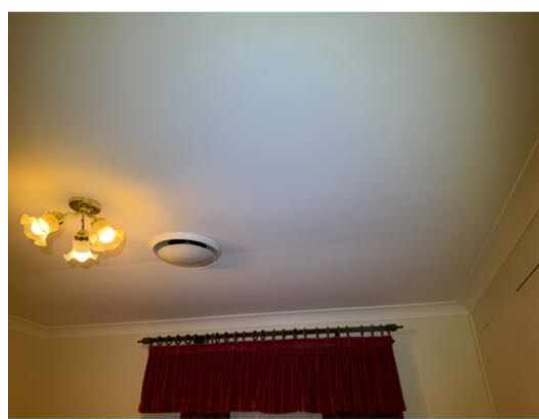
Finding 3.04

Building:	Main Building
Location:	Eaves, Bedroom
Finding:	Ceiling & Eaves - Sagging
Information:	Sections of the ceiling & eaves at but not limited to the bedroom were found to be slightly sagging at the time of inspection. Causes of ceiling and eaves sagging include fixings (e.g. nails or glue) that have become loose and require re-fixing.

Where minor sagging has occurred, it is advised that the client monitor these areas. Should further sagging occur, a licensed tradesperson such as a plaster should be engaged to provide maintenance works.

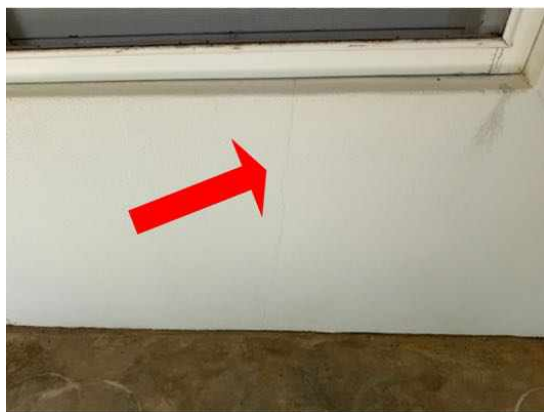
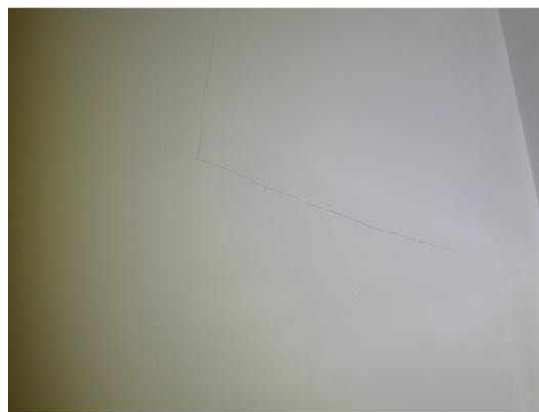
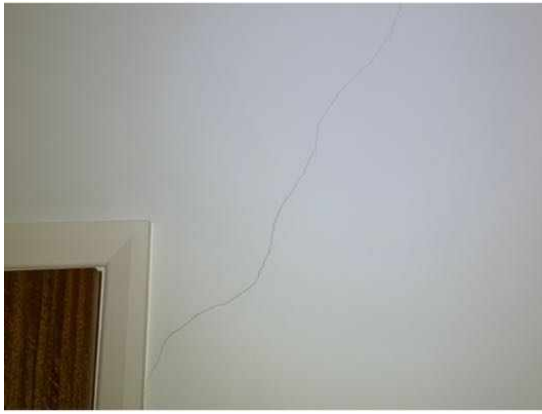
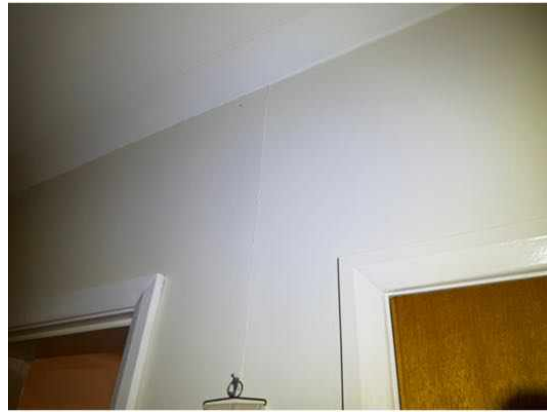
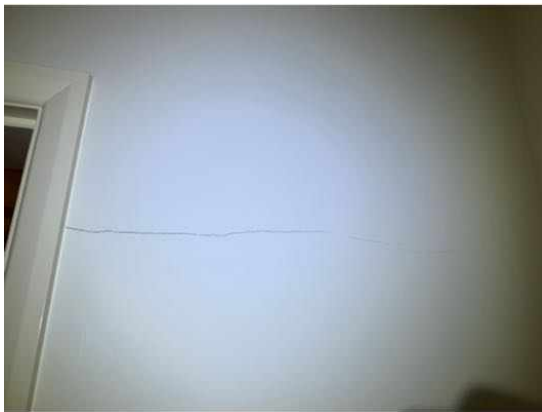
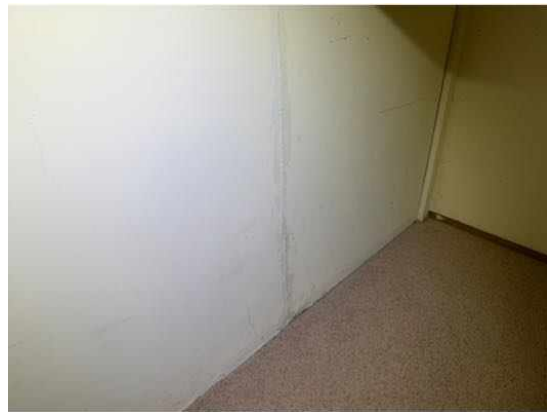
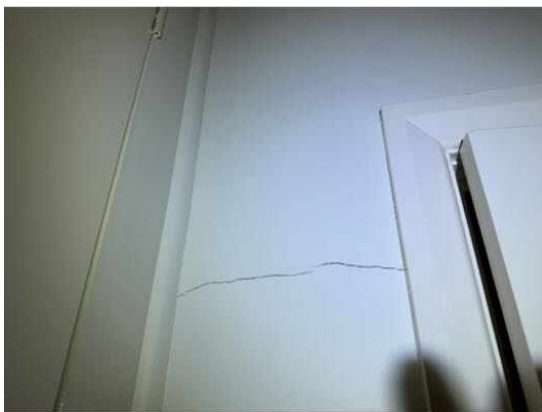
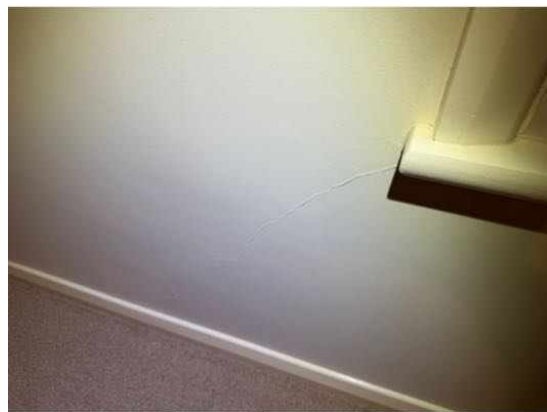
Finding 3.05

Building:	Main Building
Location:	Internal Areas
Finding:	Walls - Cracking
Information:	There appears to be cracking in some areas throughout the building, a common finding in buildings of a similar age and condition. The client should monitor the cracking. Should cracking widen, lengthen, or become more numerous, a structural engineer should be engaged promptly, for further evaluation.

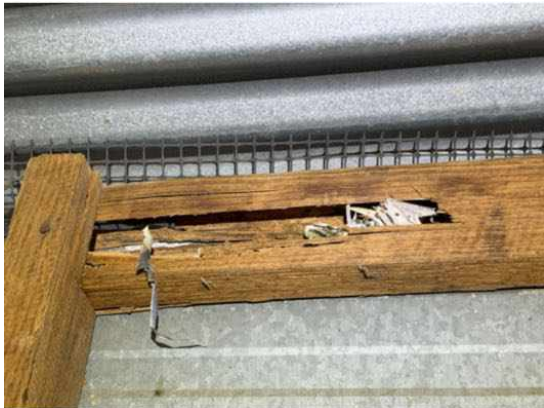
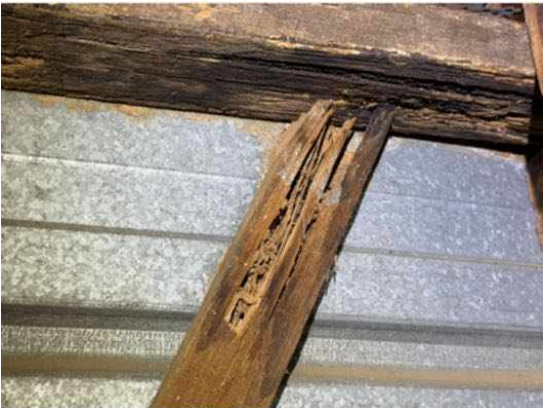
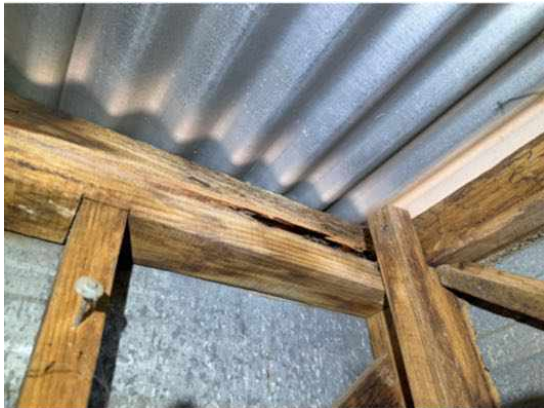
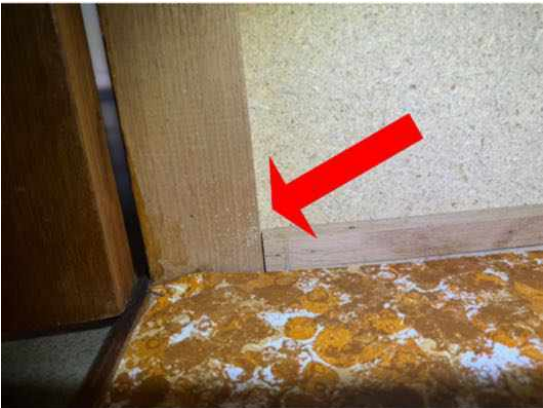
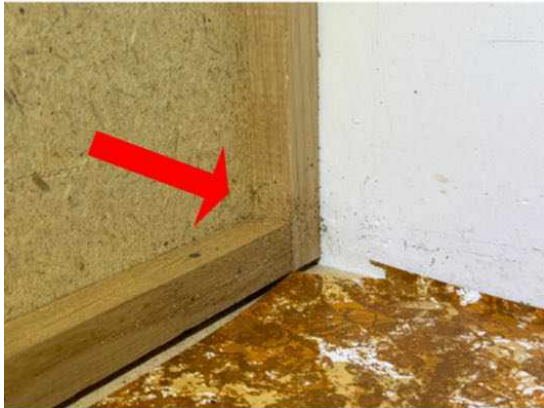
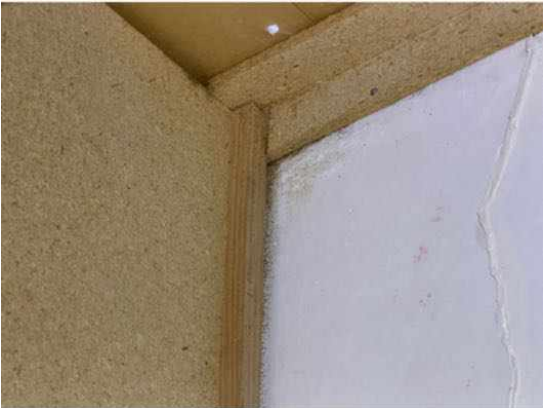
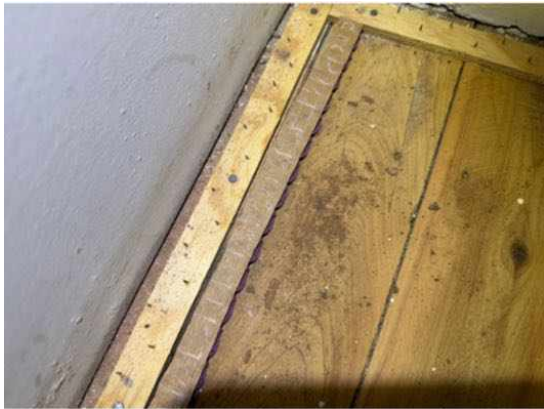
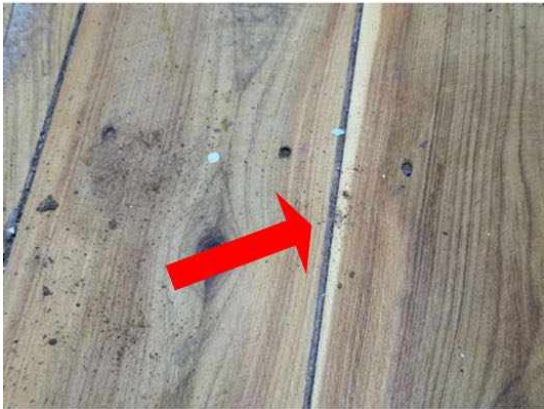
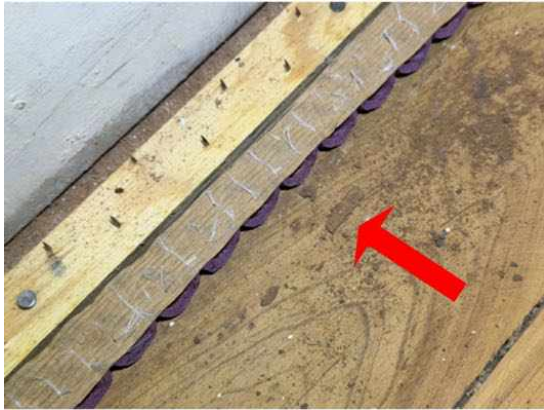
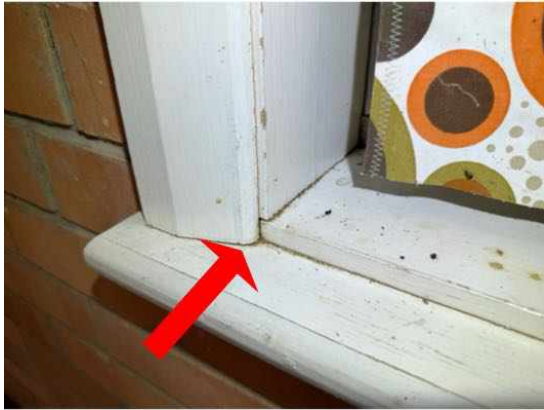
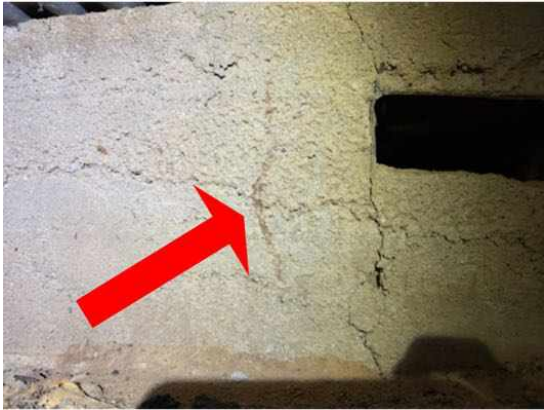
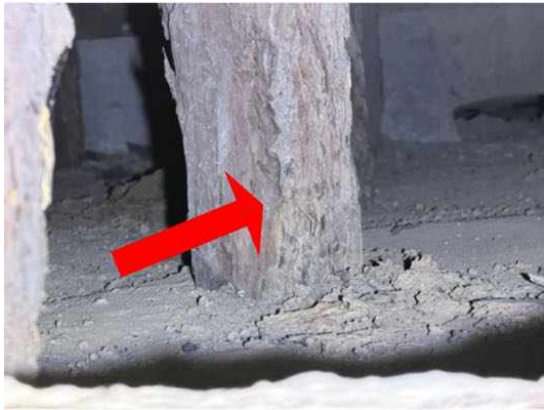
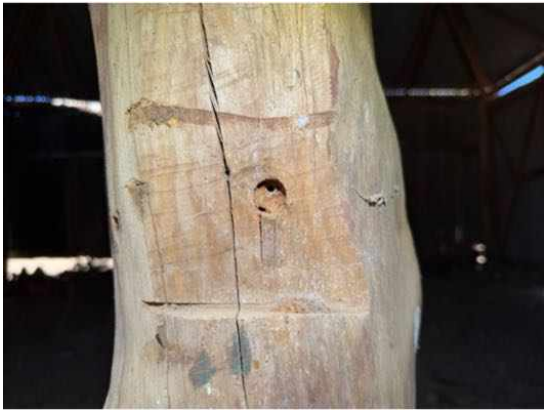
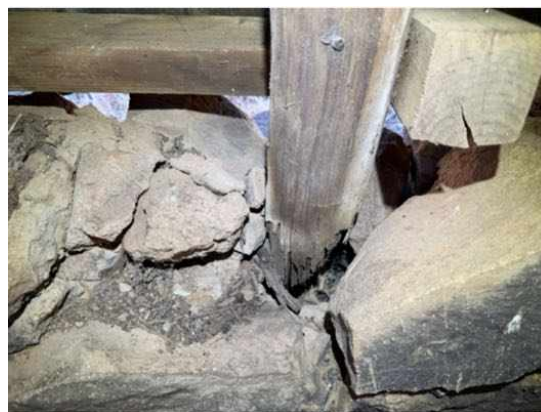
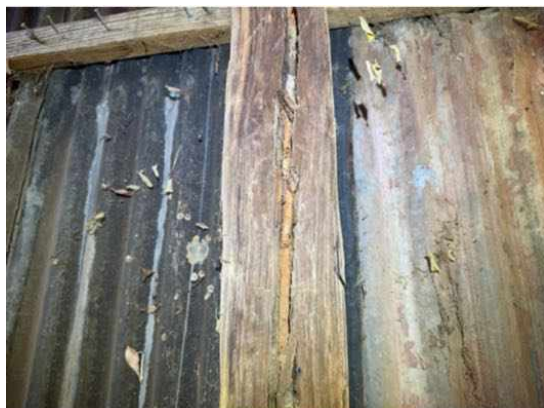
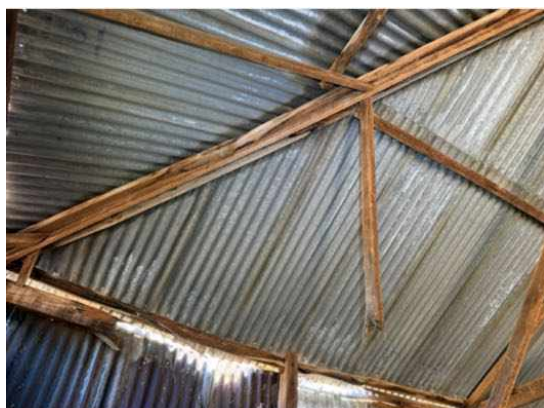
Finding 5.01

Building: Main Building
Location: Subfloor, Outside Sheds, Cupboards, Garage Window
Finding: Evidence of termite workings & damage

Although no live termite activity was identified at the time of inspection, previous termite damage & workings were identified at, but not limited to, areas of the subfloor, outside sheds, cupboards & garage window. Damaged materials such as the shed framing should be replaced promptly, to avoid further deterioration, and ensure the shed is secure.

Evidence of previous termite damage and workings were identified at, but not limited to the outside sheds timber framing, garage window frame, areas of the subfloor, and some internal cupboards. Affected and damaged materials such as the shed framing should be replaced promptly by a registered builder to ensure the structure is secure. It appears termite damage was also present to the original subfloor timber piers, however this area was unable to be inspected due to no access hole installed. It is advised that access be gained to this area, and a re-inspection be conducted, to confirm & identify the extent of the damage.

A more invasive inspection is also advised to identify the extent of the damage. 6 monthly ongoing termite inspections, conducted by a qualified termite inspector, are also recommended

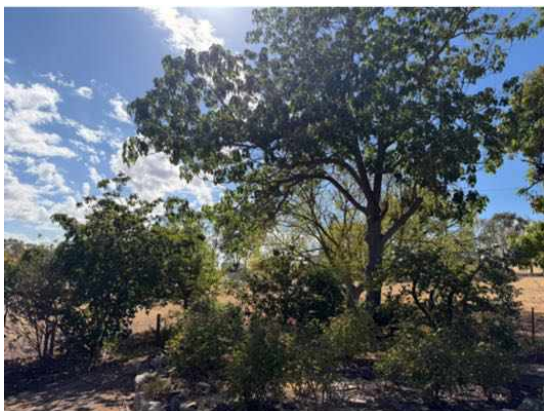
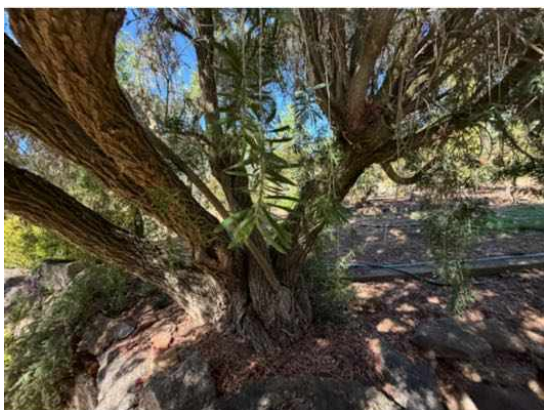
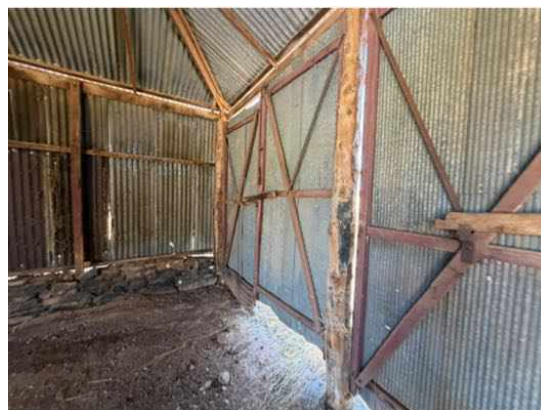
Finding 6.01

Building:	Main Building
Location:	All External Areas, Shed Framing
Finding:	Timber in direct ground contact & trees - conducive to termites
Information:	Where timber materials are in direct contact with the ground and consequently moisture, they become conducive to termite activity. The tree stumps, shed framing, and trees surrounding the building create an environment conducive to termite infestation.

Where feasible, any timbers in direct contact with the ground should be removed and any trees in close proximity to the building should be removed or test drilled (inspected) at least annually to reduce the risk of termite infestation & detect any early signs of termite activity.

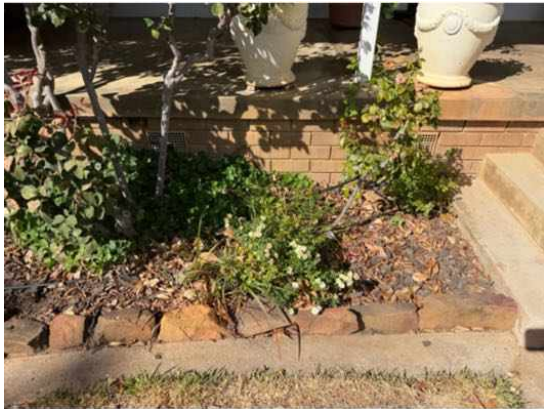
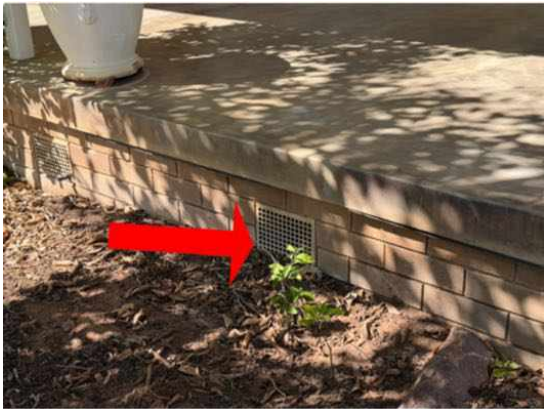
Finding 6.02

Building:	Main Building
Location:	All External Areas
Finding:	Potential Water pooling - against property
Information:	It appears that there are potential areas around the perimeter of the property that could be susceptible to water pooling.

Where insufficient site drainage and garden beds against the house are present, water pooling is likely to occur, and can create areas conducive to timber pests and potential damage to the subfloor structure overtime, if neglected. Recommend consulting with a licensed plumber and/or landscaping contractor in the short term to further assess and provide remedial advice.

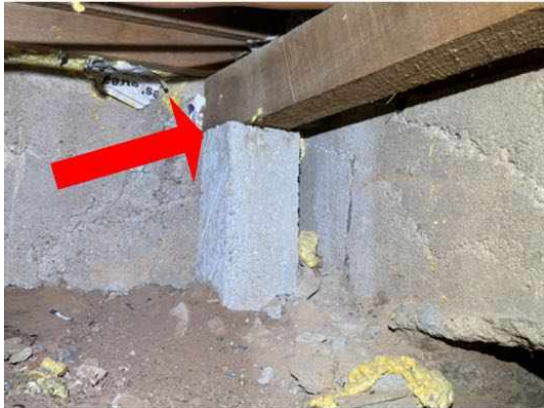
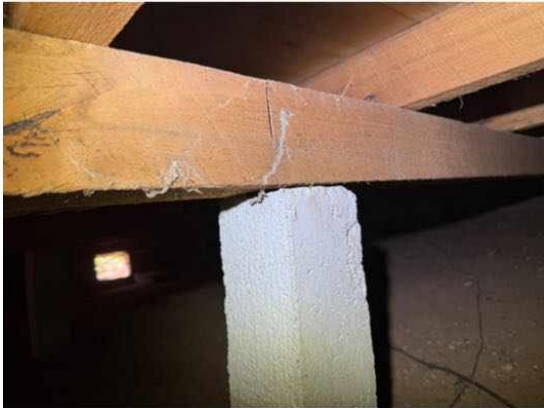
Finding 6.03

Building: Main Building
 Location: Subfloor
 Finding: Ant caps - Not Installed
 Information: It was found that ant caps have not been installed to the piers. Ant caps are designed to easily identify termite ingress from piers to the adjoining bearers. Where ant caps have not been installed, this creates an obstruction for inspection and frequent monitoring of these areas should be carried out in order to identify any signs of termite workings. It is advised that sufficient ant caps be installed to the piers by a licensed carpenter.

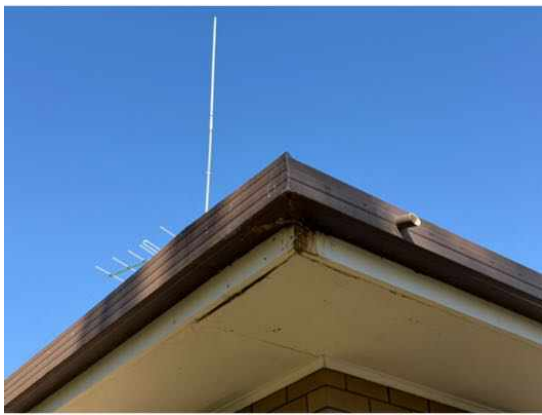
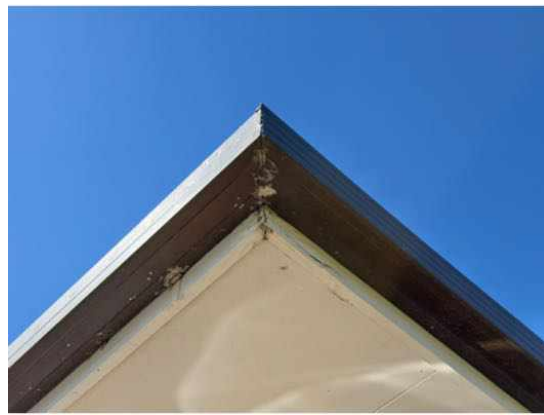
Finding 7.01

Building:	Main Building
Location:	Fascia's
Finding:	Fungal decay & weathering
Information:	Areas of fungal decay (wood rot) & weathering were identified at but not limited to the fascia boards. The client can engage a licensed carpenter at their discretion to provide maintenance and remedial works where necessary. A licensed painter can also be engaged to provide protective coatings to areas of weathered external timbers.

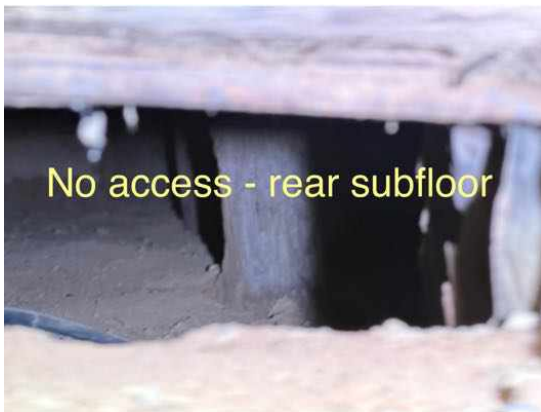
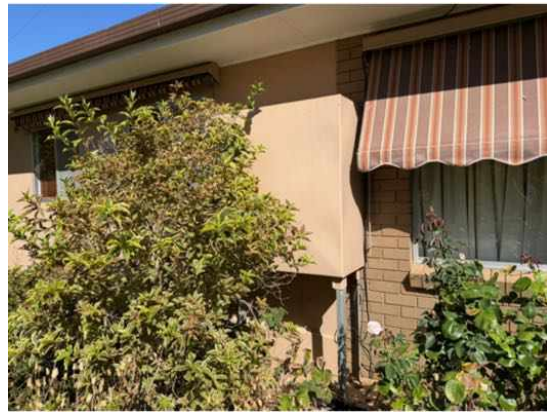
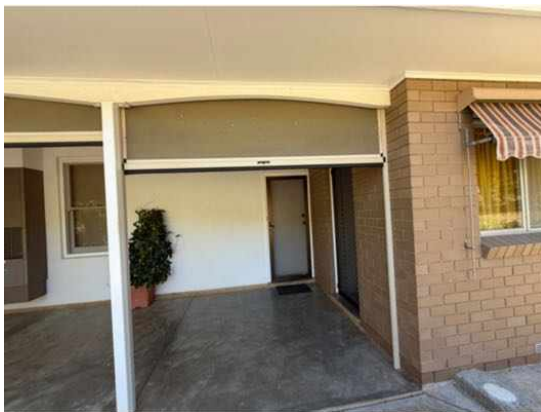
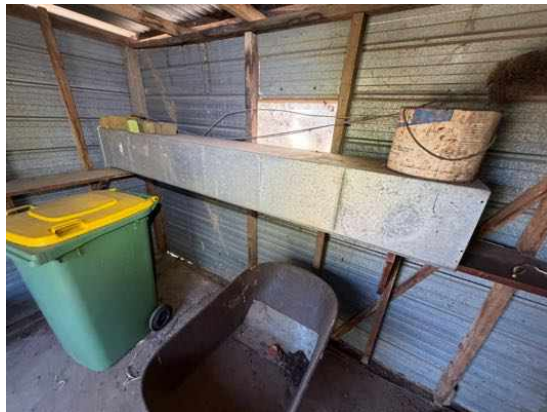
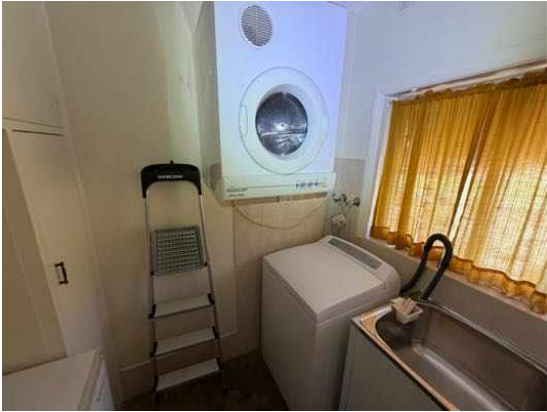
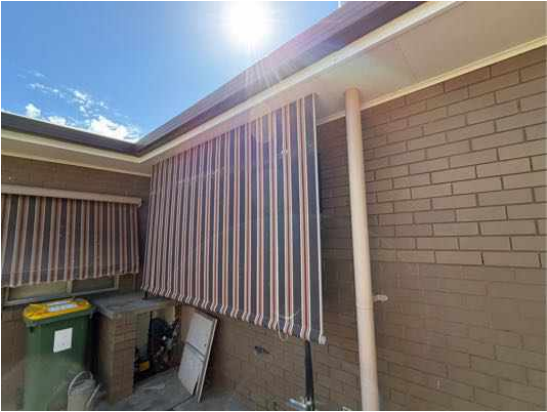
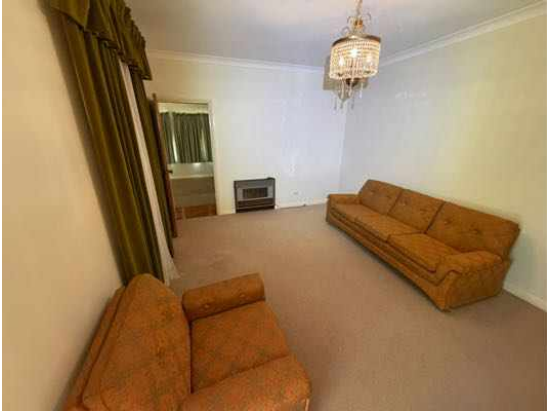
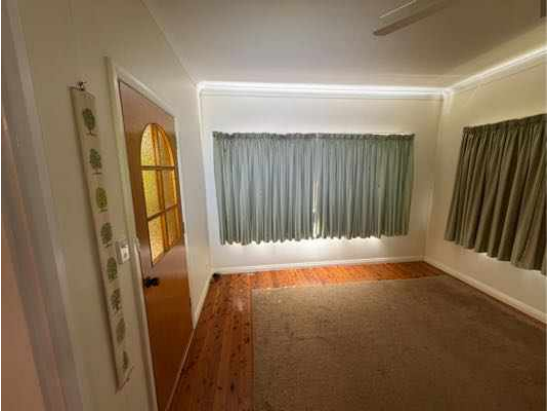
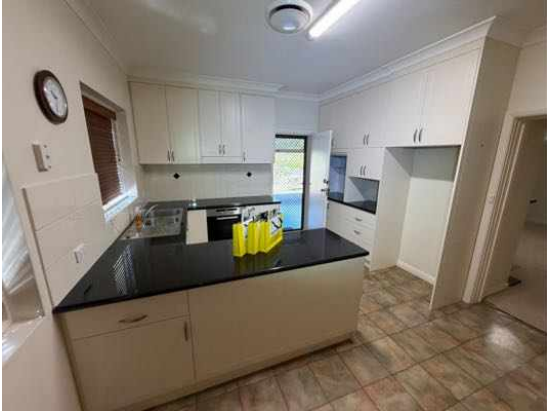
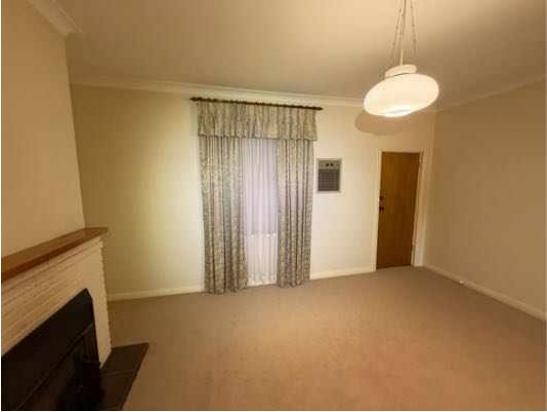
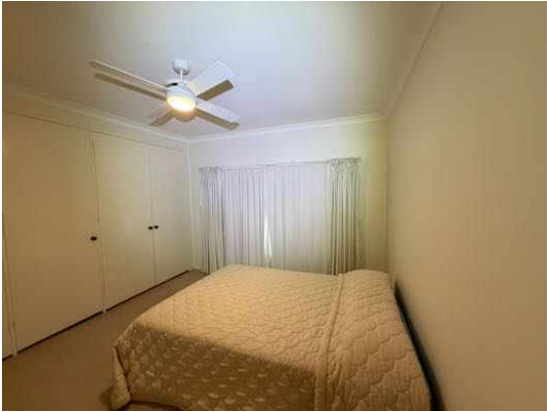
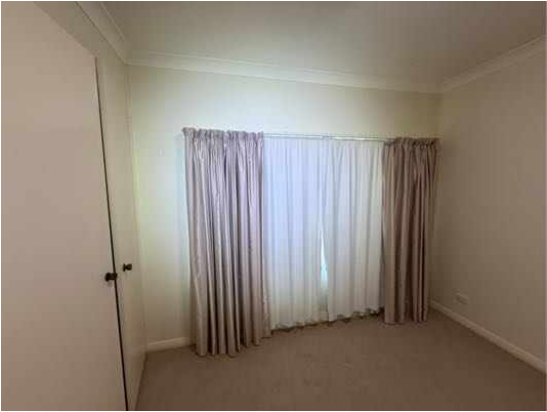
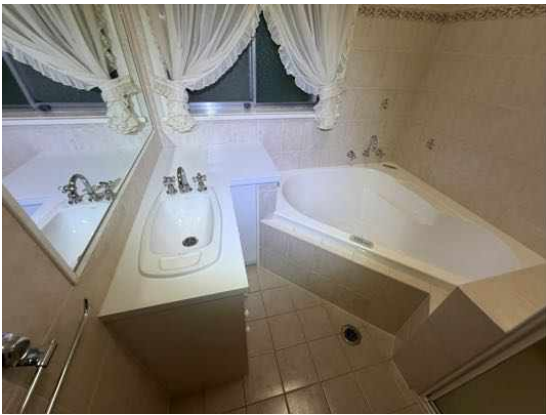
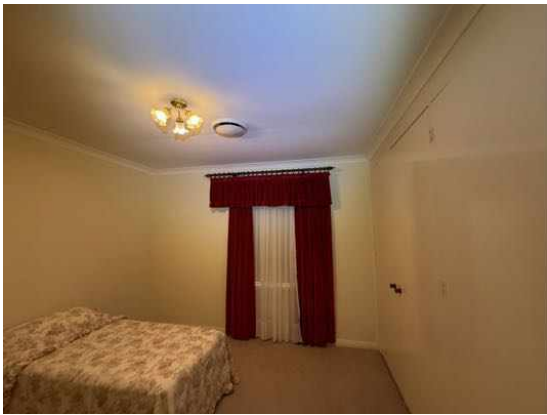
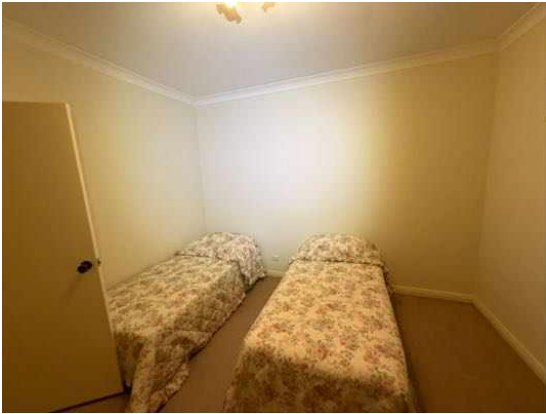
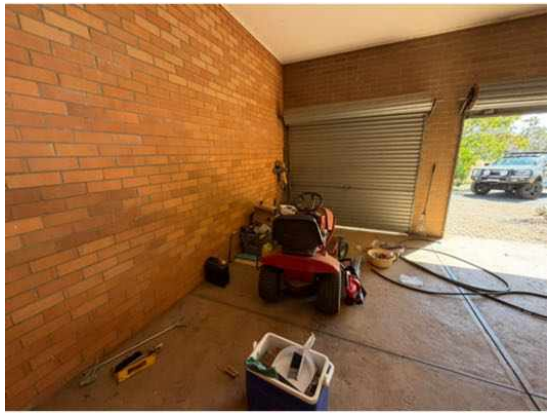
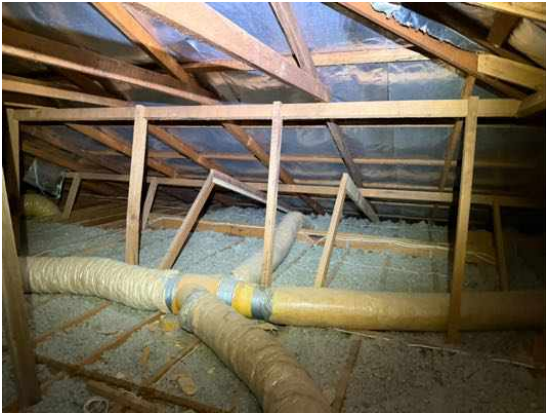
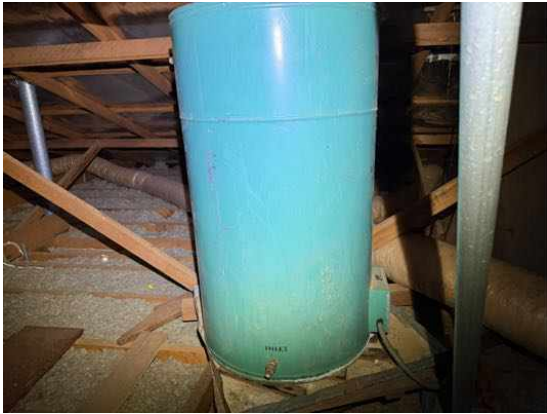
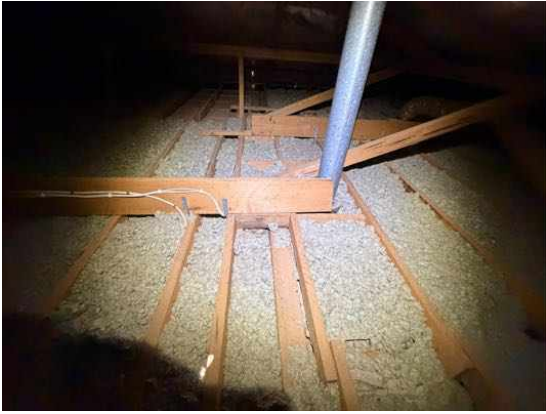
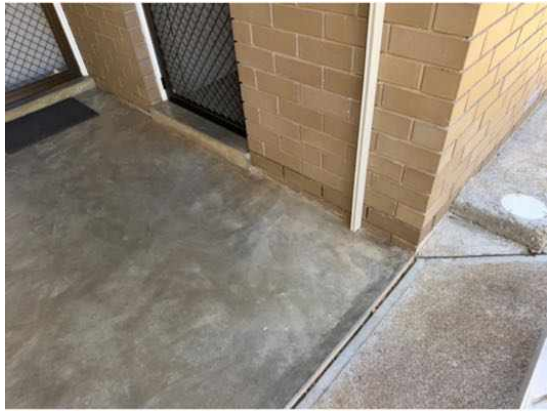
Several limitations and obstructions impeded the inspection and, if feasible, should be removed, and a further inspection should be performed. The rear, original section of the subfloor was not able to be inspected due to no access hole installed. Recommend that access be gained to this area and a reinspection be conducted, prior to clients completion of due diligence. Indicative images below depict some of the obstructions encountered.

Building: Main Building
Location: All Areas
Finding: Additional Photos - Obstructions and Limitations
Information: These photographs are an indication of the obstructions and limitations which impeded full inspection of the property at the time of inspection. These obstructions can hide an array of defects and should be removed to allow full inspection to be carried out. A re-inspection is recommended once the areas are made accessible.

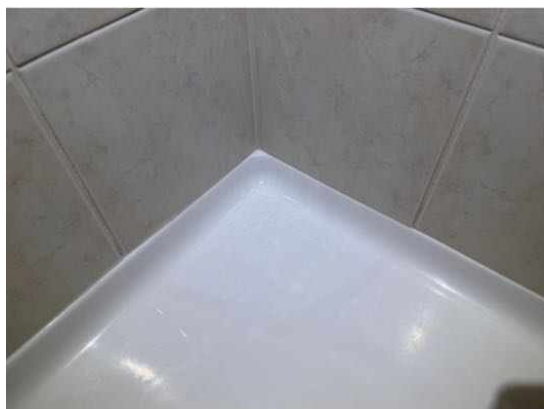
Building: Main Building
 Location: Tiled Areas
 Finding: Sealant and grouting - Monitor & General Maintenance
 Information: It appears that the sealant and grouting in the tiled areas are slightly weathered, a common defect in houses of a similar age.

It is noted for the clients information that sealant and grouting in areas that come into regular contact with water should be maintained.

Should the sealant deteriorate further, a tiling contractor should be engaged to provide maintenance works where necessary to ensure all wet areas are sufficiently sealed.

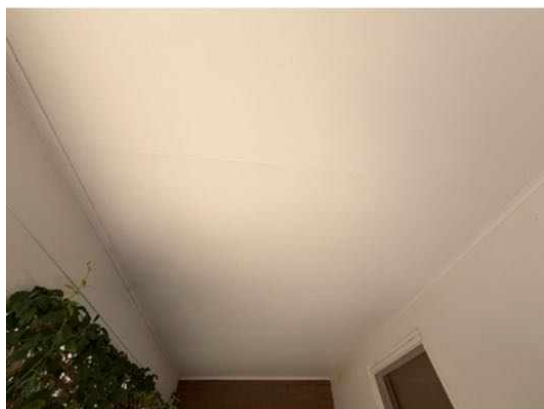
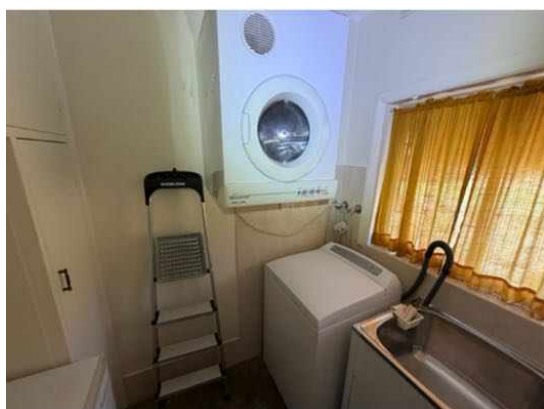
Building: Main Building
 Location: Laundry, Garage, Eaves
 Finding: Asbestos - Suspected ACM Identified on Site
 Information: This suspected defect is highlighted as a caution only as reporting on asbestos is outside the scope of this report. It is suspected that the materials including but not limited to the eave sheets, laundry wall & ceiling lining and garage ceiling may be ACM's (Asbestos containing materials)

It is advised that the client consider a separate Asbestos Inspection and Condition Audit, which can include the taking of samples for definitive confirmation of the presence of Asbestos, carried out by a licensed Asbestos Inspector.

In the interim, no works should be conducted to these areas without further specialist advice.

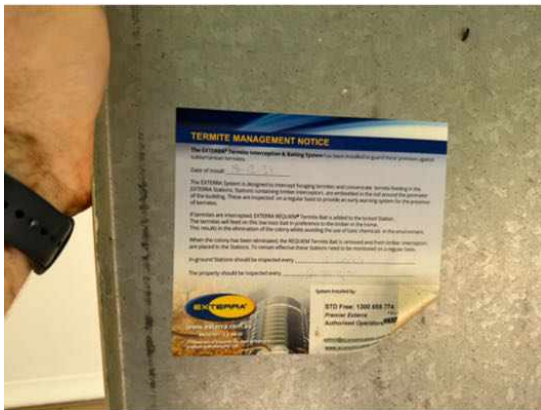
Building: Main Building
Location: Switchboard
Finding: Evidence of a previous termite management system
Information: A durable notice has been installed in the meter box, indicating that a termite management system has been installed in 2021. It is recommended that the client contact the company that installed the treatment to inspect the bait boxes with the appropriate tools and provide further information regarding the treatment & future management plan.

Termite management systems expire and require replenishment once expired.
