# Building and Timber Pest Inspection Report

Inspection Date: Tue, 24 Feb 2026

Property Address: 6/65 Pommel Cres, Epping VIC 3076,  
Australia

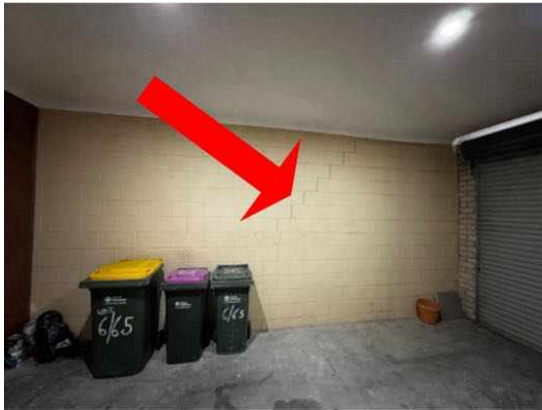
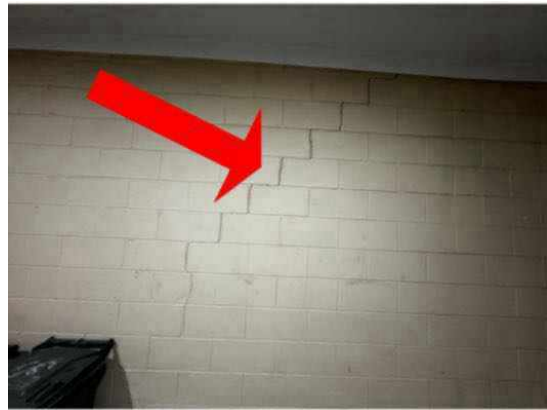
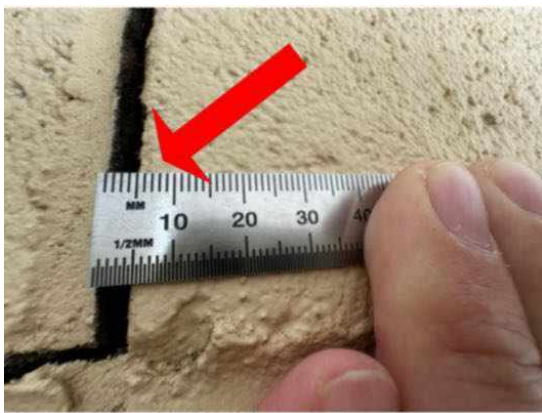
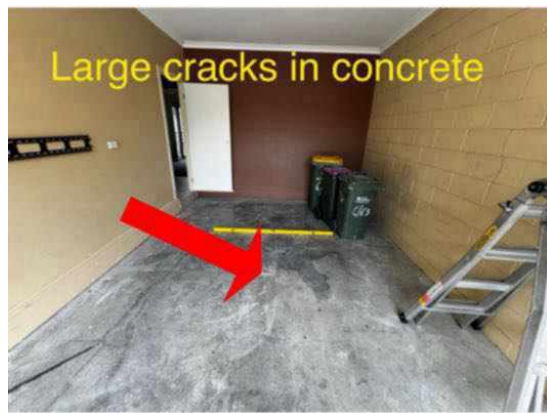
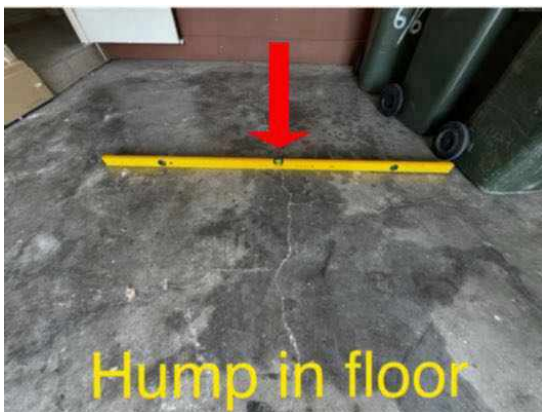
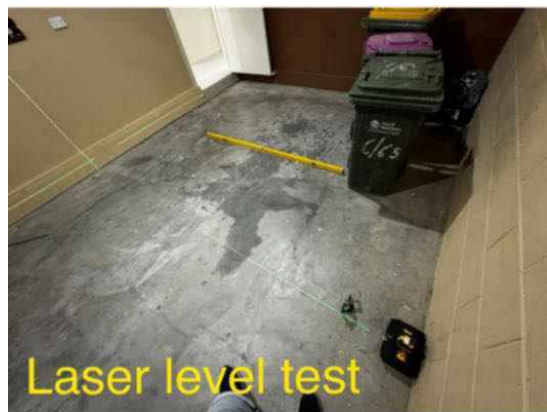
Building: Main Building  
 Location: Boundary wall, garage floor, front elevation > Front,Front Right,Level 1,Rear Right  
 Finding: Suspected Structural Movement – Step Cracking and Garage Floor Heave  
 Information: Step cracking to boundary blockwork was observed within the garage and was also visible in the first-floor storage room off the balcony. The cracks measured up to approximately 5mm in width. The step cracking to the first-floor area was clearly visible and consistent with structural movement.

A substantial crack was observed to the centre of the garage concrete floor slab. Laser level measurements indicated that the centre of the garage floor was raised by approximately 12mm. This level of heave over a relatively short span is indicative of slab movement, likely associated with reactive soil conditions, moisture variation, or foundation-related movement.

The internal garage door was also observed to be binding and difficult to operate, which is consistent with distortion of the surrounding structure due to movement.

There was evidence of previous repair to the brickwork above the garage door to the front elevation. Fresh, uncleaned mortar was visible in this area, suggesting that cracking has previously occurred and that the front façade has been affected by structural movement.

The combination of blockwork step cracking, slab heave, door binding, and evidence of prior façade repairs indicates ongoing or historical building movement. Given the elevated moisture conditions previously noted and the property being vacant for an extended period, moisture variation within reactive soils may be a contributing factor.

It is recommended that a qualified structural engineer be engaged to assess the extent and cause of the movement and determine whether the movement is ongoing or historical. Further monitoring of cracks, including crack gauges, may be required. Any contributing moisture issues should be identified and rectified to stabilise soil conditions.

Further structural assessment recommended in the short term due to measurable slab heave and visible structural cracking.

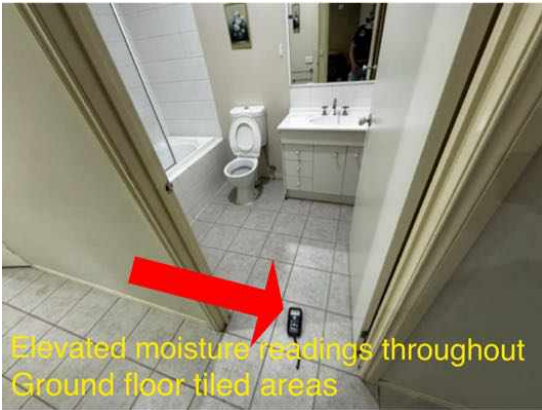
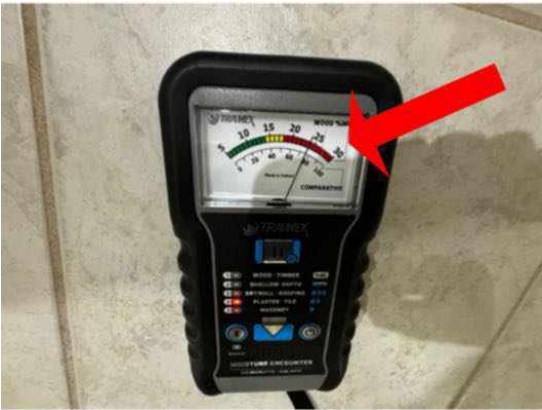
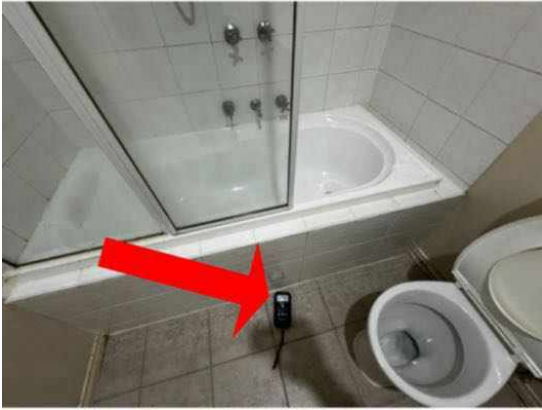
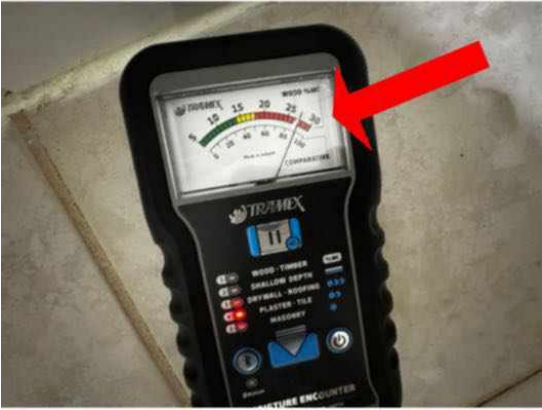
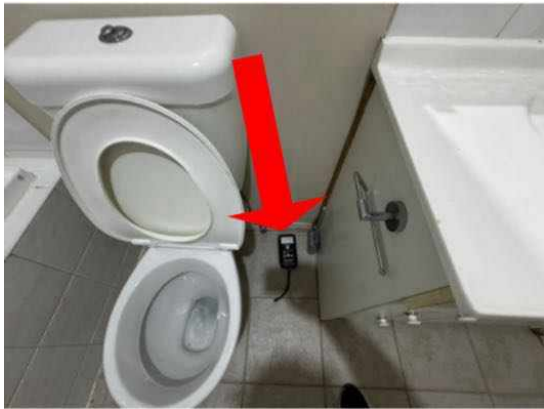
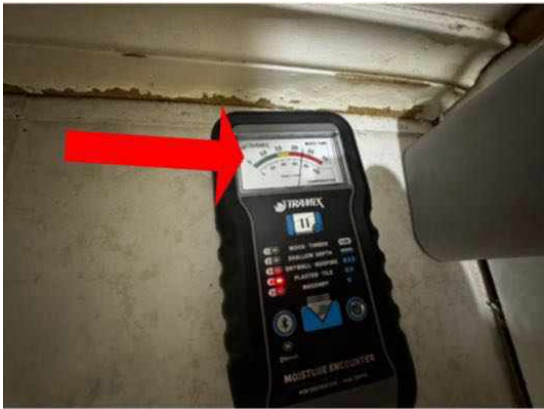
## Finding 2.02

Building:	Main Building
Location:	Tiled areas > Ground Level
Finding:	Widespread Elevated Moisture – Ground Floor (Suspected Concealed Leak)
Information:	Elevated moisture readings were detected to the entire tiled area on the ground floor, including the bathroom, hallway, laundry, and entry. Moisture testing confirmed consistent elevated readings across these areas.

There were visible signs of moisture damage to surrounding building elements, including skirting boards, architraves, and door jambs, which exhibited swelling, deterioration, and distortion consistent with prolonged moisture exposure. Moisture damage was also observed to the rear bedroom directly adjacent to the bathroom, with skirting boards inside the robe clearly affected. Cracking to floor tiles was noted within these moisture-affected areas.

Given that the property has reportedly been vacant for over twelve months, it is suspected that an ongoing concealed water leak may be present, potentially from plumbing or waterproofing failure. However, no active water leaks were detected during the inspection.

The extent and distribution of moisture damage indicate a high risk of concealed structural deterioration, mould growth, and conducive conditions for termite and timber pest activity.

It is recommended that a licensed plumber be engaged to conduct pressure testing and leak detection to identify any concealed plumbing leaks. Further invasive investigation may be required to determine the full extent of moisture migration. Consultation with the body corporate and adjoining property owners may also be necessary to determine whether the source of moisture originates from neighbouring properties. Damaged skirting boards and affected materials should be repaired or replaced once the source has been identified and rectified.

Immediate. Further investigation recommended immediately to due to widespread elevated moisture readings and high risk of concealed structural damage.

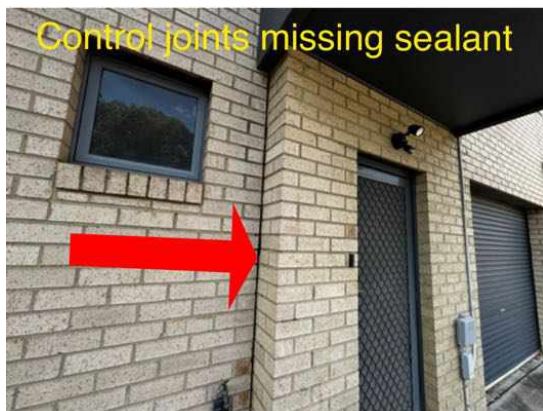
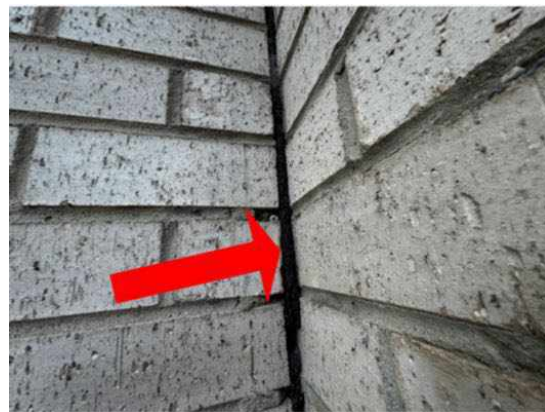
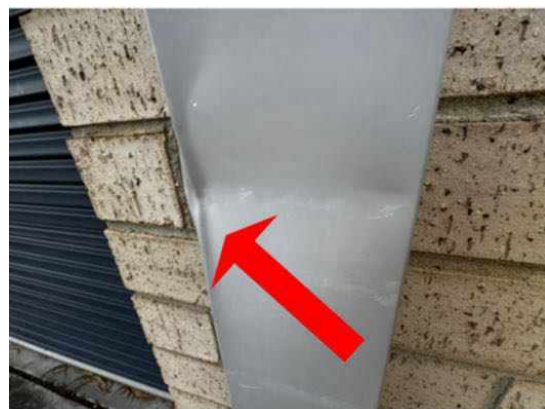
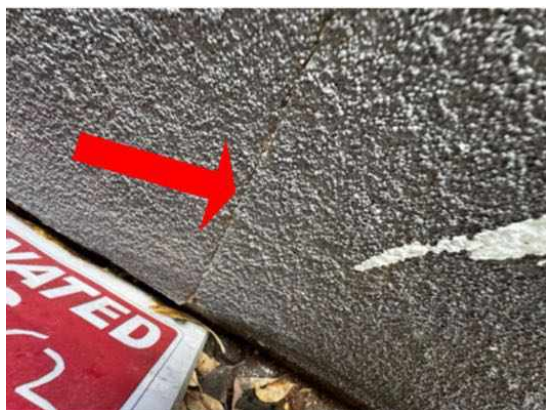
### Finding 3.01

Building:	Main Building
Location:	All Areas > All Areas
Finding:	External Minor Defects – Brickwork, Drainage and Joinery
Information:	The following minor external defects were observed during the inspection:

Control joints to the external brickwork were observed without sealant/caulking. Unsealed control joints may allow moisture ingress into the wall cavity and reduce the effectiveness of movement joints designed to accommodate thermal and structural movement.

A damaged downpipe was observed adjacent to the garage opening. Damaged stormwater components may reduce effective water discharge and contribute to moisture accumulation near the foundations.

A large stain was observed to the rear balcony wall. The staining may be associated with moisture exposure or inadequate drainage; however, no active water ingress was confirmed at the time of inspection.

Weathering was noted to the external timber doors and door sills, indicating the need

for maintenance to preserve the timber and prevent deterioration.

The front balcony wall was observed to be cracked and separating at a corner junction. Gaps at this location will require re-caulking to prevent moisture penetration into the building envelope.

It is recommended that control joints be properly sealed with suitable flexible sealant, the damaged downpipe be repaired or replaced, and the stained balcony wall be monitored and investigated if staining worsens. Weathered timber doors and sills should be sanded and sealed. Cracked and separating balcony junctions should be cleaned and re-caulked to prevent moisture ingress.

Maintenance recommended in the short to medium term to prevent further deterioration and moisture-related issues.

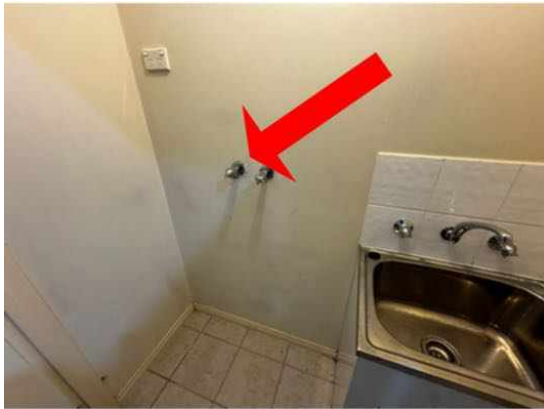
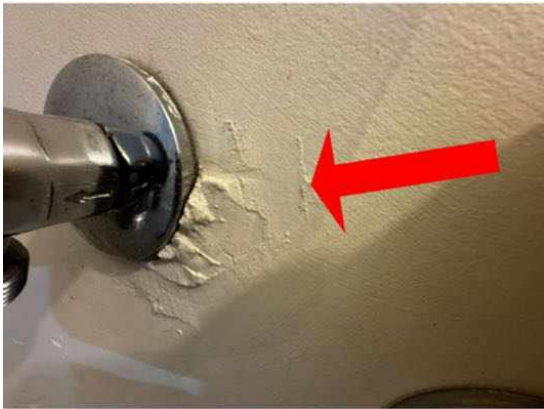
### Finding 3.02

Building:	Main Building
Location:	All Areas > All Areas
Finding:	Internal Defects – Poor Workmanship and General Deterioration
Information:	The following internal defects were observed during the inspection:

Substandard caulking/sealant was applied to the bathtub junctions and grout lines. The finish was inconsistent and may not provide adequate waterproofing protection. Plaster above the bathtub exhibited signs of deformation and cracking, which may be associated with moisture exposure or building movement.

Substandard plaster repairs were evident to walls and ceilings throughout the property. General cosmetic damage was noted, including marks, scratches and damage to walls, ceilings, doors, architraves, staircase components, skirting boards and door jambs.

Cracked floor tiles were observed to the first-floor toilet area, and the toilet roll holder was damaged. Damage to kitchen joinery and cracked kitchen benchtops were also noted. Creaking floors were observed to the first-floor dining area, which may indicate movement in the subfloor structure or floor sheeting.

The rear bedroom fly door was damaged. The garage door was binding during operation, and the step-down transition from the hallway into the garage was found to be out of alignment and out of level. The overall standard of workmanship observed throughout the unit was poor, with multiple defects indicative of substandard installation and repairs.

These defects are largely maintenance-related and workmanship issues; however, when considered alongside previously noted structural movement and moisture concerns, they may also be symptomatic of broader building performance issues.

It is recommended that a qualified tradesperson rectify defective caulking, plaster repairs, cracked tiles, damaged joinery and other cosmetic defects. The garage door

alignment and step-down level difference should be assessed and corrected. Creaking floors should be further investigated if movement worsens. Any areas affected by moisture should be monitored and repaired once the moisture source is identified and rectified.

Rectification recommended in the short to medium term, with moisture-affected areas addressed as a priority.

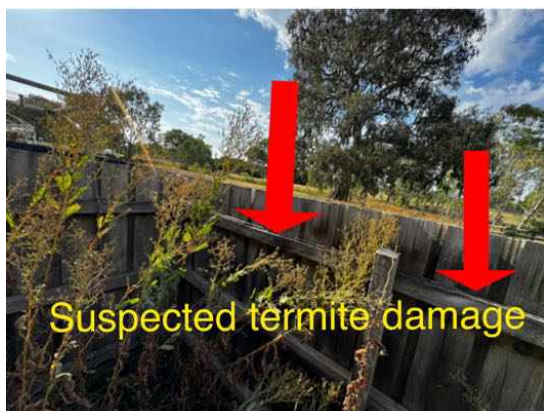
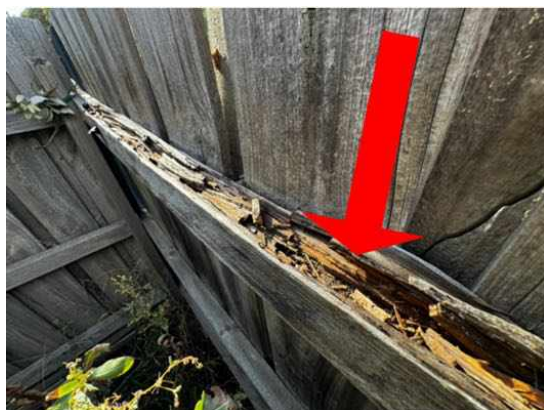
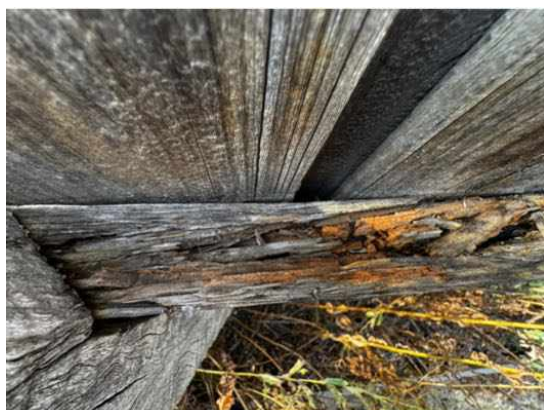
Building: Main Building  
Location: Yard - Front > Front Right  
Finding: Suspected Termite-Damaged Timber – Front Yard  
Information: Suspected termite damage was observed to a length of timber located on the ground beneath the boundary fence in the front yard. The damage is consistent with past termite activity, however no live termite activity was detected at the time of inspection.

Given the property is a double-storey townhouse approximately 20+ years old, with no visible termite management system or durable notice, and is located adjacent to a reserve and public park with mature trees, the overall termite risk profile of the site is considered elevated. The presence of timber in direct ground contact in the front yard constitutes a conducive condition for termite activity.

Remove all timber debris from the ground, eliminate any timber in direct soil contact, and reduce vegetation against the building perimeter. It is strongly recommended that a licensed termite management specialist be engaged to assess the property and implement an appropriate termite management system.

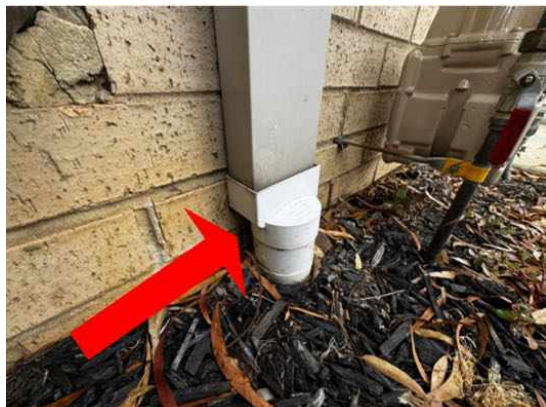
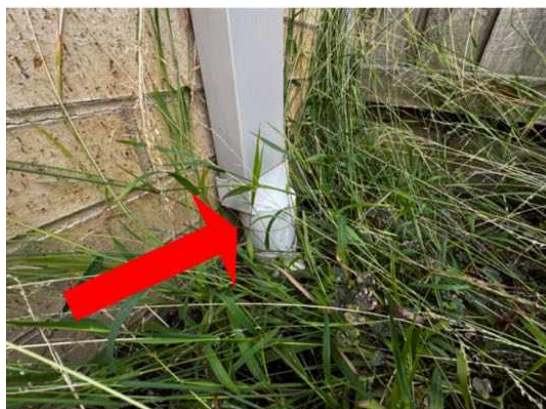
### Finding 6.01

Building:	Main Building
Location:	Walls > Front,Rear
Finding:	Downpipes hard against brickwork concealing inspection zones (TP)
Information:	At the time of inspection, several downpipes were observed to be installed hard against the external brick walls. This configuration restricts visual access to the wall surface and slab edge behind the downpipes, making it difficult to identify early signs of termite activity.

Effective termite risk management relies on maintaining clear and accessible inspection zones to allow early detection of termite activity. Where services such as downpipes are installed directly against masonry walls, concealed termite entry paths may develop behind these elements without being readily visible, increasing the likelihood of undetected termite ingress.

As a result, the positioning of downpipes hard against the brickwork is considered to increase the risk of concealed termite entry. It is recommended that a licensed termite management or pest control contractor be engaged to assess these locations and provide advice on improving inspection access or implementing supplementary termite management measures to address the increased risk.

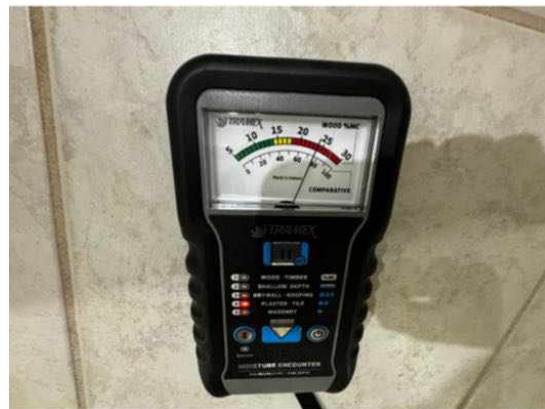
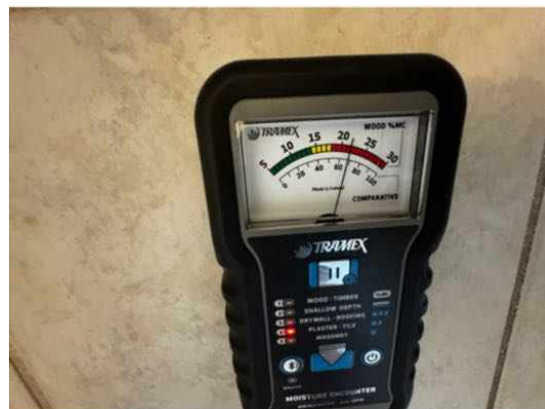
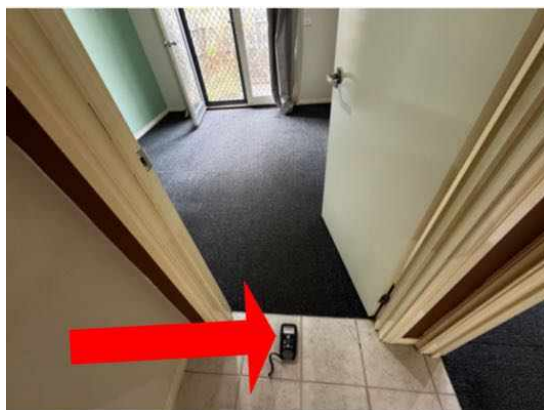
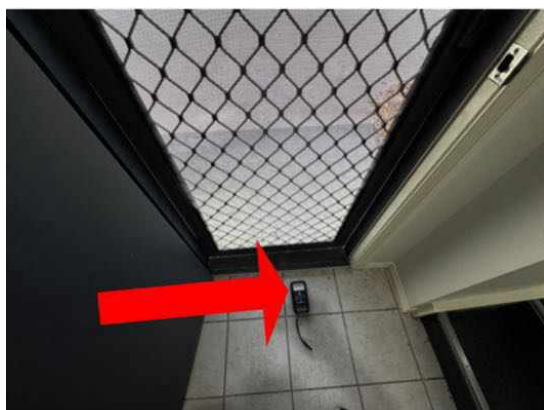
### Finding 6.02

Building:	Main Building
Location:	Kitchen, laundry, toilet > Ground Level
Finding:	Elevated moisture levels to ground floor tiled areas (TP)
Information:	At the time of inspection, elevated moisture readings were detected using a moisture meter to the ground floor tiled areas, including the bathroom, hallway, entry, and laundry areas. No active water leaks were observed during the inspection. Moisture readings to adjoining rooms were within normal range, indicating that the elevated moisture appears to be largely contained to the tiled areas.

Moisture-related damage was observed to adjacent building elements, including skirting boards, door jambs, architraves and sections of joinery. This suggests that moisture may be migrating from the tiled surfaces into surrounding materials.

Given that the property has reportedly been vacant for over twelve months, it is suspected that the elevated moisture may be associated with an ongoing concealed leak, potentially from plumbing or waterproofing failure, rather than day-to-day occupant use. Long-term vacancy can also allow minor leaks to persist undetected, increasing the risk of deterioration.

Prolonged elevated moisture levels create conducive conditions for termite and timber

pest activity and increase the likelihood of concealed structural damage, fungal decay, and mould growth.

It is recommended that a licensed plumber be engaged to investigate for concealed plumbing leaks and that further invasive investigation be undertaken if necessary to determine the source of moisture. A waterproofing assessment of wet areas may also be required. Damaged skirting boards, door jambs, and other affected materials should be repaired or replaced once the source of moisture has been rectified.

Further investigation recommended in the short term due to high moisture readings and increased risk of concealed structural and timber pest damage.

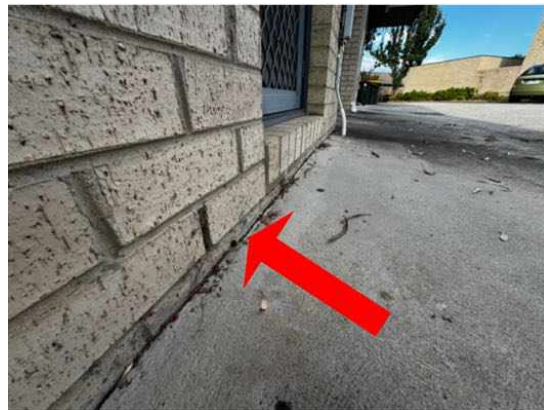
Building: Main Building  
 Location: All Areas > All Areas  
 Finding: Slab edge - concealed (TP)  
 Information: At the time of inspection, the slab edge to most areas of the building was observed to be concealed behind concrete paving and landscaping. This condition restricts clear visibility of the slab perimeter and limits the ability to visually inspect critical inspection zones intended for the early detection of termite activity.

Where slab edges and inspection zones are concealed, concealed termite entry paths may develop without early warning. In accordance with AS 3660.2, existing buildings are required to maintain conditions that allow for effective inspection and management of termite risk, noting that obstructions such as paving, paths, or landscaping can compromise the effectiveness of termite management measures. Where inspection zones are obstructed, the likelihood of undetected termite activity is increased.

As a result, the current configuration is considered to increase the risk of concealed termite entry to the building. It is recommended that a licensed termite management or pest control contractor be engaged to assess the extent of the concealed slab edges and provide advice on rectification options, which may include modifying paving or landscaping to reinstate suitable inspection access and integrating appropriate termite management measures to suit the existing conditions.

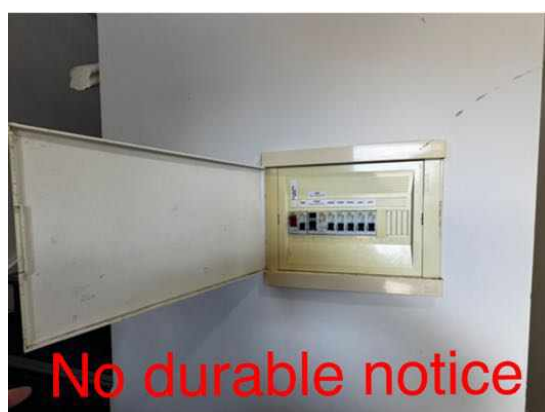
## Finding 6.05

Building:	Main Building
Location:	Meter Box > Front Left
Finding:	Termite management system - no evidence of chemical installation (TP)
Information:	At the time of inspection, there was no visible evidence to suggest that a chemical termite management system has been installed or remains effective. In addition, no durable notice was observed within the electrical switchboard to identify the presence, type, or date of any termite protection measures.

For this reason, the installation of a post-construction chemical termite management system is highly recommended to reduce the risk of termite activity. A durable notice should also be installed within the electrical switchboard to clearly identify the treatment provided and support ongoing inspection and maintenance.

Engagement of a licensed termite management or pest control contractor is recommended as a matter of priority to assess the site conditions, consider local termite risk, and determine the most appropriate treatment method and procedures for this property.
