Building and Timber Pest Inspection Report

Inspection Date: Wed, 11 Mar 2026

Property Address: 48A Napoli St, Padstow NSW 2211,
Australia

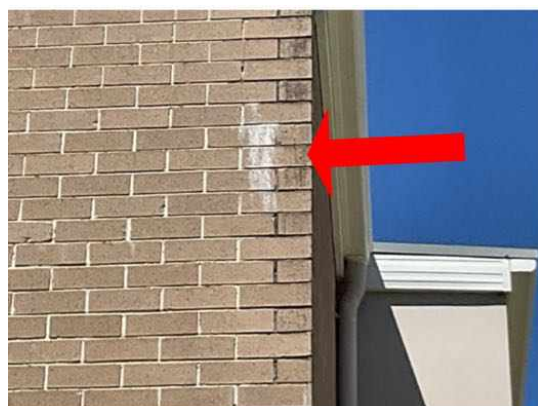
It is typically seen as white salt deposits on the surfaces of concrete pavement or mortar between bricks or tiles. While detracting from the overall appearance of the affected area, efflorescence is not likely to develop into secondary damage if left unmanaged.

Generally, soluble salt deposits can be removed by dry brushing with a stiff-bristled brush. Repeated dry brushing is an ideal treatment for eliminating this forming of efflorescence. A cleaning contractor or general handyperson may be appointed to perform these works at the discretion of the client.

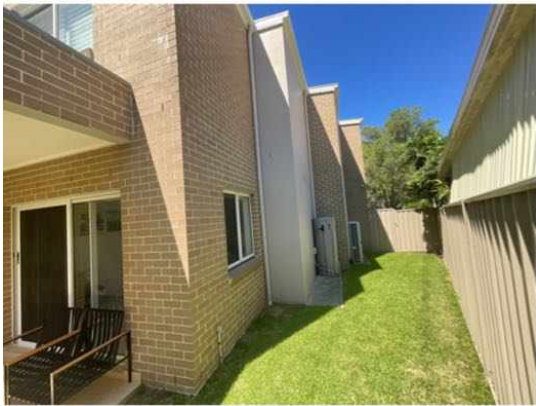
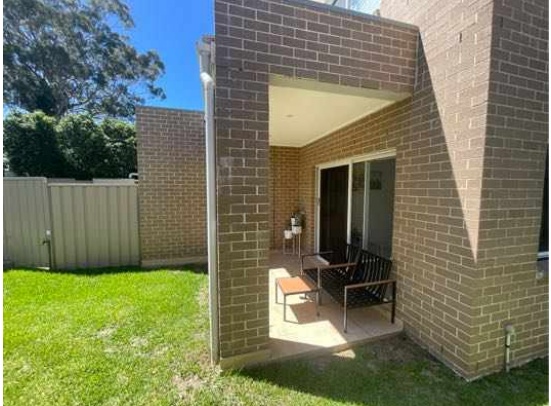
Finding 6.01

Building: Main Building
Location: All Areas
Finding: Garden Beds - Conditions Conducive to Termites
Information: Garden beds were found to be evident in the garden area. These garden beds can include untreated timber, and with a combination of moisture from watering hosing can make conditions conducive to termite activity and termite ingress.

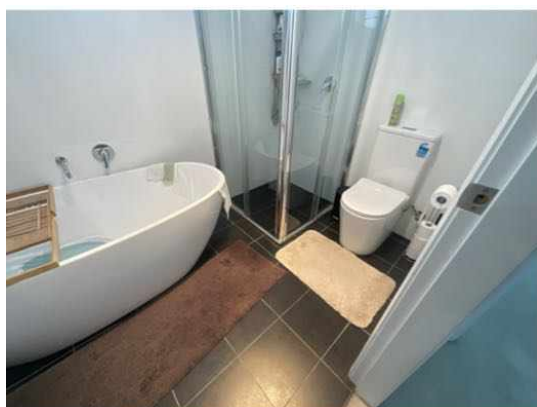
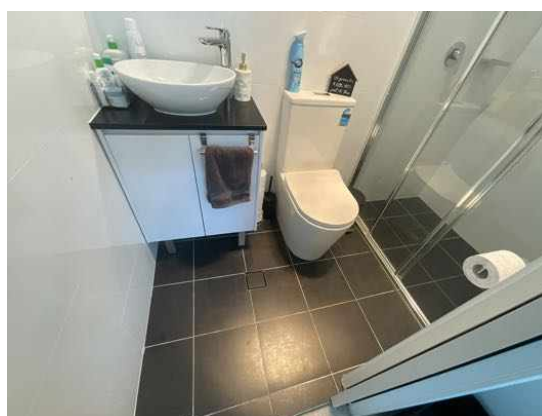
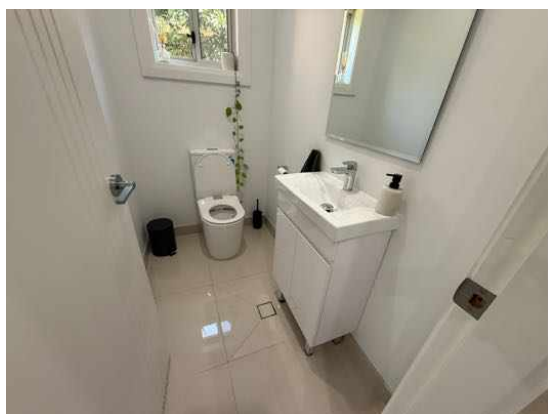
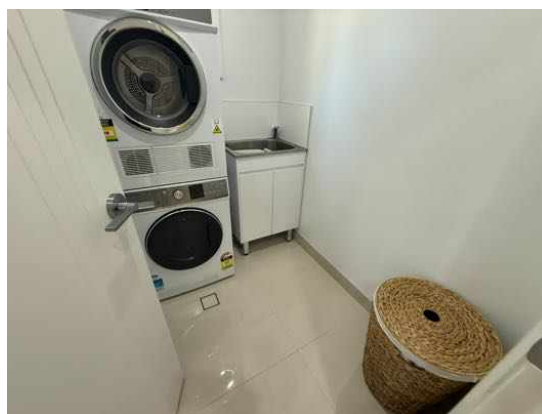
Building: Main Building
 Location: All Areas
 Finding: Water Proofing Membranes - Information Only
 Information: Internal Water Proofing Membranes, are crucial in preventing water ingress into the property is important to know that the Membrane System used is to Australian Standards and has been installed correctly. Please refer to the original Building Documents or Maintenance Schedule for the relevant information including; - Membrane used and Manufacturers Specifications. - The Installer and Installation Certification. Especially with older property's where this information is unavailable, all wet areas should be monitored. Generally new waterproofing with a certificate may only have a guarantee of 8yrs. If any leaks, water staining, peeling or bubbling of the paint become evident to any adjacent walls or ceilings below a licensed builder or waterproofing specialist is recommended to investigate further.

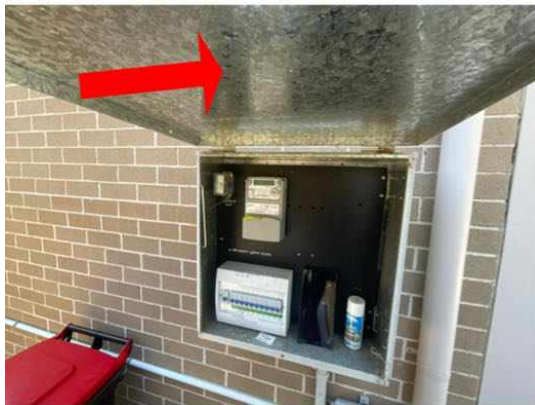
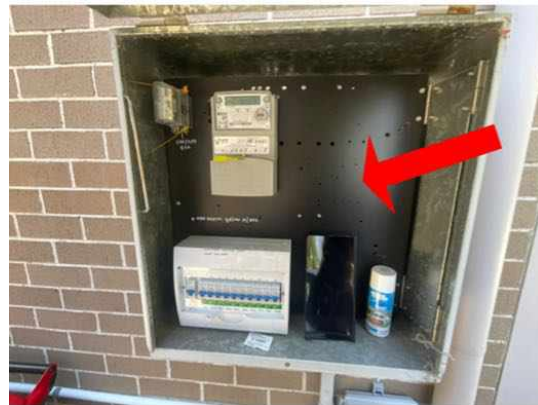
Building: Main Building
 Location: All Areas
 Finding: Durable Notice - missing
 Information: The house should have a Durable Notice, which is usually a sticker inside your electrical meter box. Durable notice was not found during the inspection.

- the product or system used to protect the house,
 - the life expectancy of that product or system as per the manufactures register label
 - the company's name and date of Installation.
- If there is no durable notice or certificate, the best thing would be to get a reputable Pest Management contractor to install system that is protecting your property.

Make sure they explain the system that is protecting your home, and what you need to do to maintain it.
