Building and Timber Pest Inspection Report VR

Inspection Date: Fri, 9 Jan 2026

Property Address: 139 Catherine St, Leichhardt NSW 2040,
Australia

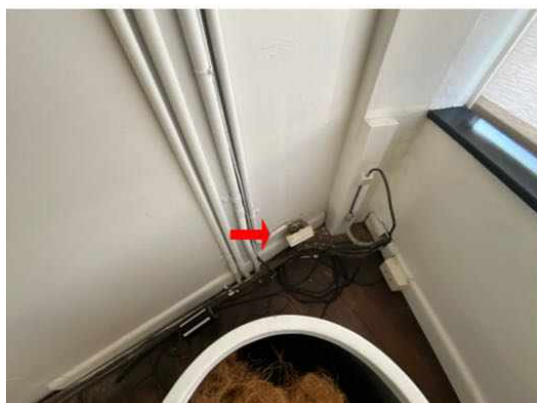
Building:	Main Building
Location:	Lounge Room
Finding:	Fitting or fixture - Loose (power point)
Information:	The fitting in this area is loose and requires adjustment to tighten.

If left unmanaged, the fitting may further deteriorate, causing potential for the development of other minor secondary defects.

A relevant tradesperson should be appointed to perform these rectification works at discretion of the client.

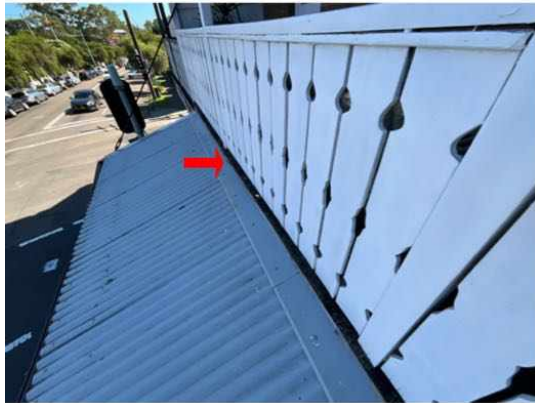
Building:	Main Building
Location:	External Areas
Finding:	Wood rot
Information:	This building element shows evidence of wood rot. Wood rot, also known as Fungal Decay, occurs when timbers and other cellulose building materials are exposed to damp conditions on an ongoing basis. This could be the result of exposure to weathering over a prolonged period of time, or the attraction of excessive moisture from other abutting building materials.

Early intervention and regular maintenance, particularly of exterior timbers, will prolong the useful life of these building elements. Prior to any works being performed, the cause of the moisture that has created the visible wood rot should be identified and addressed in a suitable manner. Replacement of affected timbers may then be a necessary step in protecting surrounding building elements from such deterioration.

A qualified carpenter or registered builder may also be required to replace affected building materials.

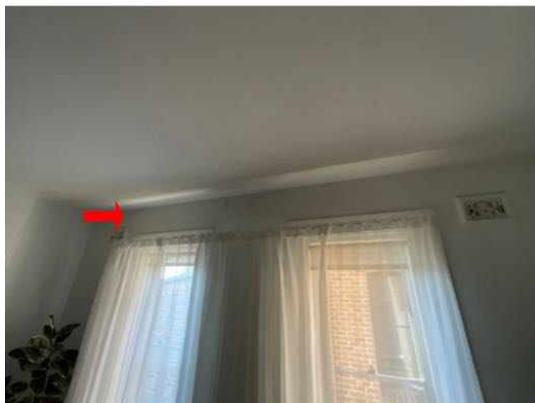
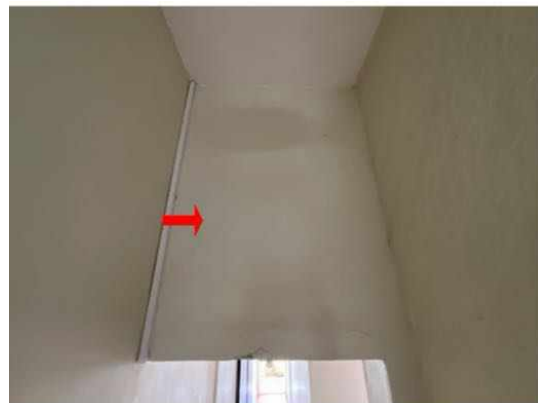
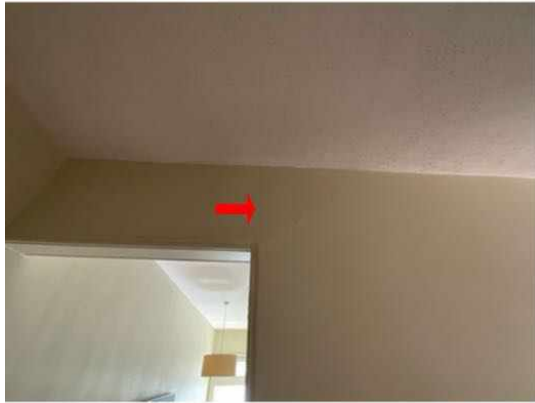
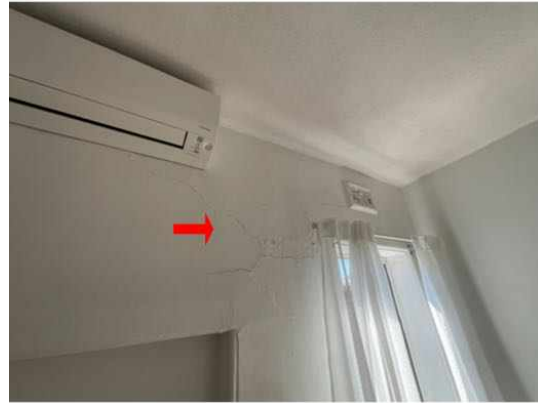
Finding 3.02

Building:	Main Building
Location:	Internal Areas
Finding:	Cracking - Damage Category 2 - Noticeable (up to 5mm)
Information:	Noticeable cracks are a common occurrence as a result of many primary defects. Such causes may include age, general wear and tear, expected building movement, general expansion/contraction of building materials in different weather conditions, and/or minor failings in the installation or application of building materials.

I recommend monitoring and if further cracking is evident appoint a bricklayer to see what works are required.

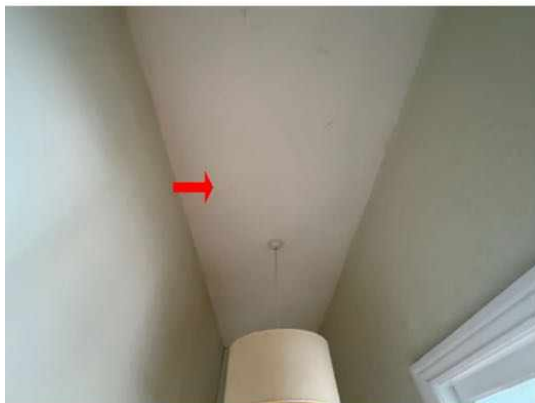
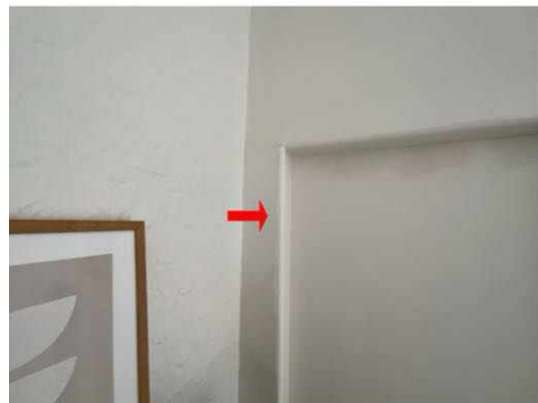
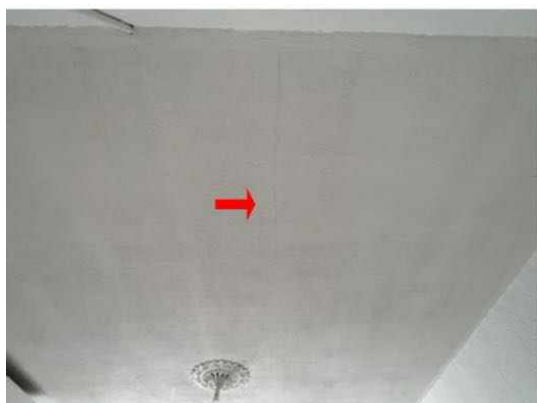
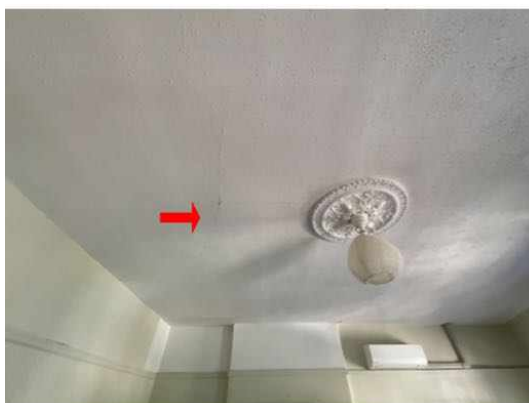
Finding 3.03

Finding: Cracking - Damage Category 1 - Fine (up to 1mm)

Information: Although fine cracks are quite noticeable, they are often only considered to be an appearance defect, and usually do not indicate any structural damage. Generally, the cause of a fine crack is indicative of a separation between building materials and finishes (e.g. paint, plaster, etc.) along joins.

Cracking of this nature can generally be repaired with minor sanding, filling and/or repainting. Such works should be performed by a qualified painter or a general handyman.

Monitoring of all cracking should be conducted frequently. Always contact a building inspector should cracks widen, lengthen, or become more numerous.

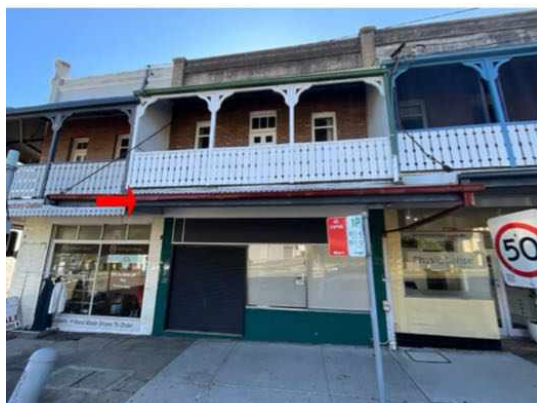
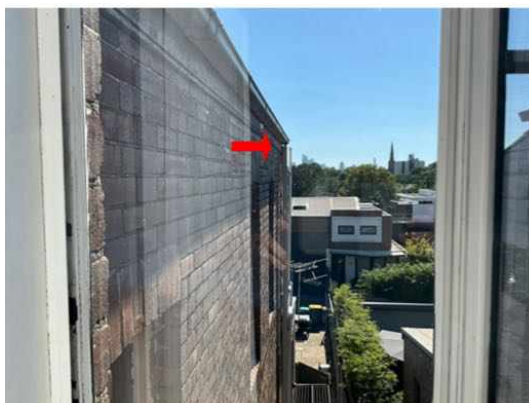
Finding 3.04

Building:	Main Building
Location:	Roof Exterior
Finding:	Roof plumbing - Insufficient fall
Information:	There is an insufficient fall in the roof drainage, which means that the angle is inadequate to facilitate movement of rainwater. This is resulting in pooling of water in the area, creating the potential for water damage to associated building elements.

Without adequate roof drainage, premature rust and decay of the roof plumbing structures is imminent. The development of such deterioration is likely to lead to the formation of secondary defects to adjoining wall sections and roofing elements.

Adjustment by a roofing plumber is required to prevent any further damage to the area.

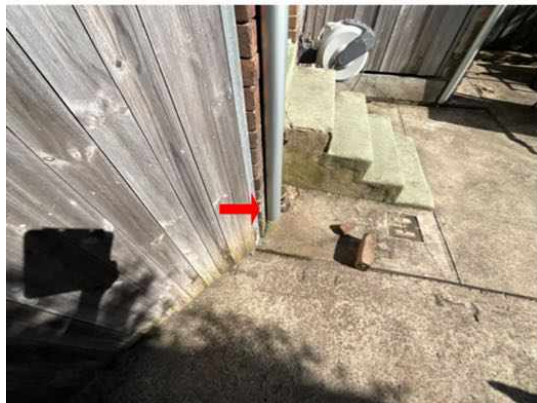
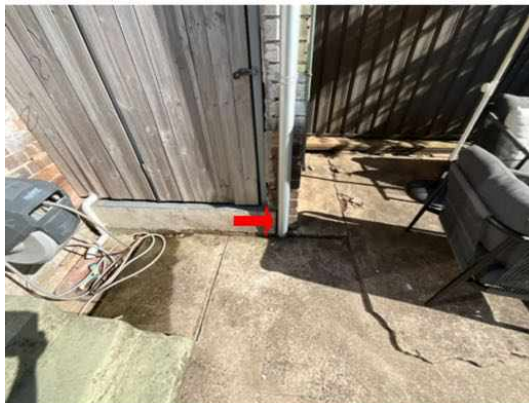
Finding 3.05

Building:	Main Building
Location:	Exterior walls
Finding:	Stormwater drain - Not connected
Information:	The roof plumbing is not adequately connected to stormwater drainage on the site. This disconnection negatively impacts the functional capacity of the roof plumbing.

Where roof plumbing doesn't drain adequately, the area at the base perimeter can become excessively damp, potentially creating an environment that is susceptible to rust and corrosion of surrounding building elements, as well as attracting termites and other pests. It is highly recommended that a plumber be appointed to further inspect the area and to install adequate drainage equipment where necessary.

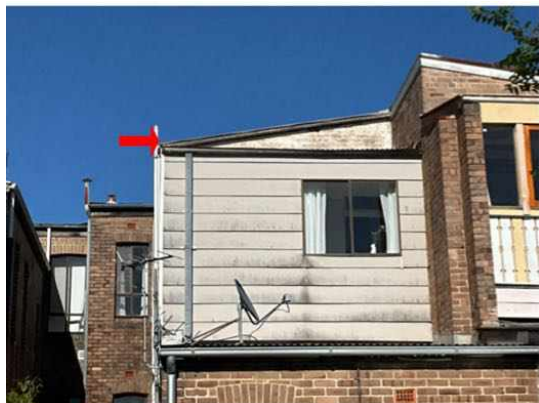
Finding 3.06

Building:	Main Building
Location:	Roof Exterior
Finding:	Roof plumbing - Rusted or corroded
Information:	The roof plumbing has areas of rust and corrosion. It is suspected that this has been caused by blockages, resulting in pooling or standing water, that have prematurely rusted elements of the roof plumbing.

Rusted roof plumbing will generally develop holes and leaks that can affect other building elements with poor drainage of storm water. Poorly drained roof areas will also lead to damp conditions surrounding the base perimeter of the building which, if left unmanaged, can lead to a range of secondary building defects.

Repair and/or replacement of rusted roof plumbing is highly required in order to reinstate the roof drainage system to a fully operational level. To further maintain these areas, gutters should be cleaned frequently, allowing the avoidance of any partial blockages.

A licensed plumber or specialist roof restoration company should be appointed to undertake these works.

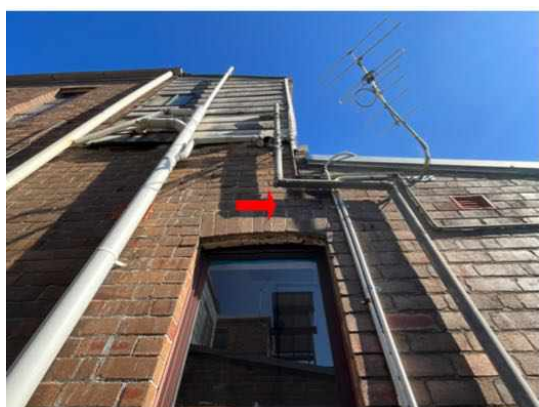
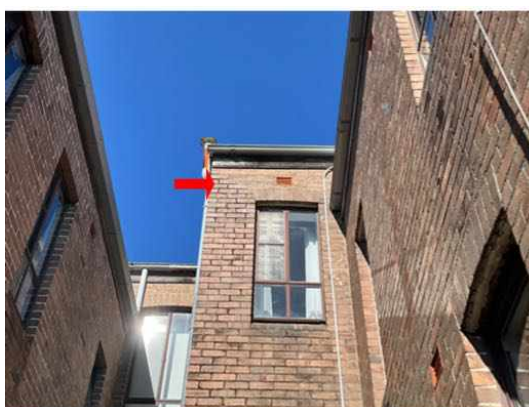
Finding 3.07

Building:	Main Building
Location:	Exterior walls
Finding:	Brickwork - Cracking noticeable
Information:	There were several cracks and or crack repairs evident to external brickwork.

Noticeable cracks are a common occurrence in external brickwork and are a likely result of age expected building movement, general expansion, and/or contraction of building materials in different weather conditions.

It is highly advised that a qualified bricklayer be appointed to provide necessary works to cracked brickwork to prevent any further damage.

Always monitor these cracks and contact a building inspector should cracks widen, lengthen, or become more numerous.

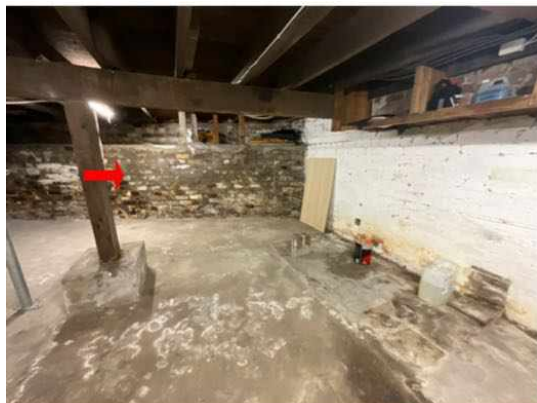
Finding 3.08

Building:	Main Building
Location:	Subfloor
Finding:	Interior walls - Lateral damp
Information:	Lateral penetrating damp refers to the sideways movement of moisture. The implications of unmanaged damp range from mould fungi growth, wood rot and

decaying building materials, to finishes including lifting, bubbling, peeling and staining of paint, plaster and wallpaper.

Structural waterproofing barriers or tanking barriers are often used to protect internal surfaces against the affects of lateral penetrating dampness. These types of work are generally undertaken where the source of the penetrating damp cannot be prevented.

Consultation with a damp proofing contractor is advised to address the cause of the damp and to perform remedial works as necessary.

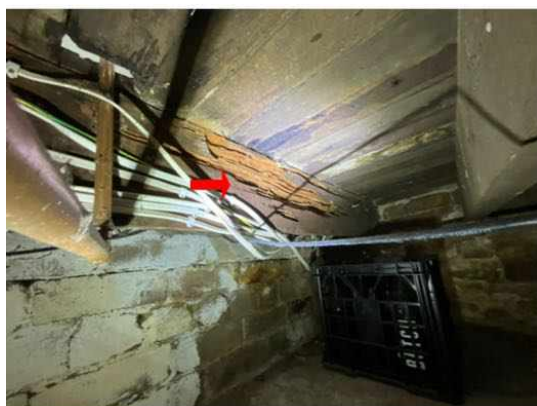
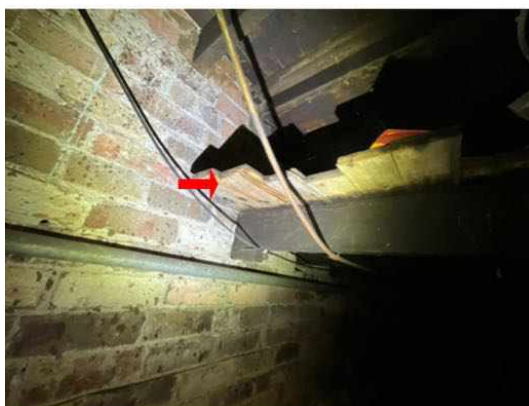
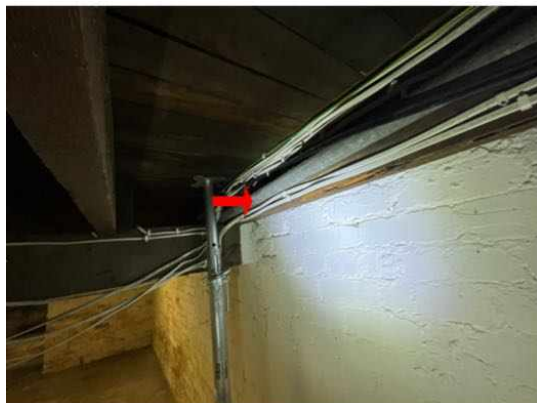
Finding 3.09

Building:	Main Building
Location:	Subfloor
Finding:	Termite - damage identified
Information:	Despite no live termite or timbered pest activity being indicated, termite damage was found to have affected this area.

A building contractor should be appointed to provide a further invasive inspection and to see what necessary works are required.

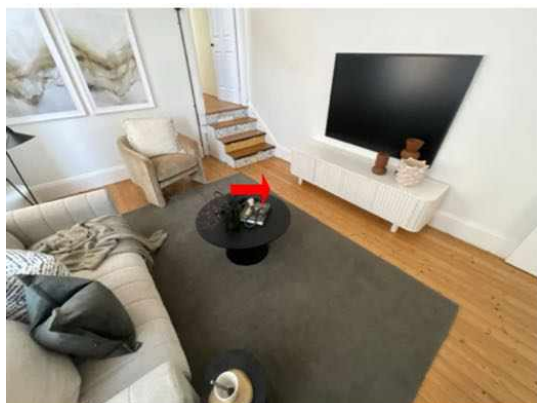
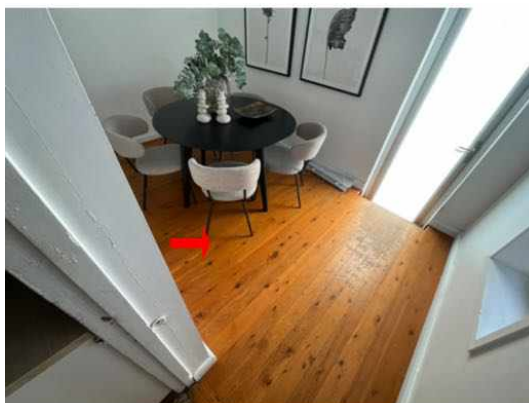
Finding 3.10

Building:	Main Building
Location:	Lounge Room & Dining Room
Finding:	Floors - bouncy
Information:	The internal flooring in this area was identified as being bouncy at the time of inspection. A bouncy floor surface generally presents as a discernible change in level as they are walked across, in noisy or creaking flooring, or in consequent movement of surrounding furniture and fixtures.

Bouncy floors generally indicate that the floorboards or the subfloor structures are coming loose from the joists that they are installed on. Bouncy flooring may also be the result of gaps between flooring and joist structures, which require packing.

The client is advised to seek quotations for required repairs from a Registered Builder.

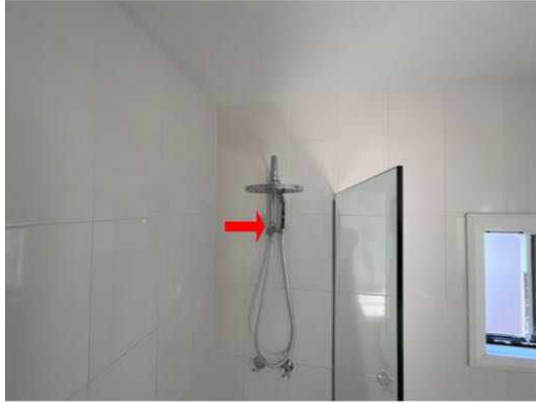
Finding 3.11

Building:	Main Building
Location:	Bathroom
Finding:	Fitting or fixture - Loose (Shower Head)
Information:	The fitting in this area is loose and requires adjustment to tighten.

If left unmanaged, the fitting may further deteriorate, causing potential for the

development of other minor secondary defects.

A relevant tradesperson should be appointed to perform these rectification works at discretion of the client.

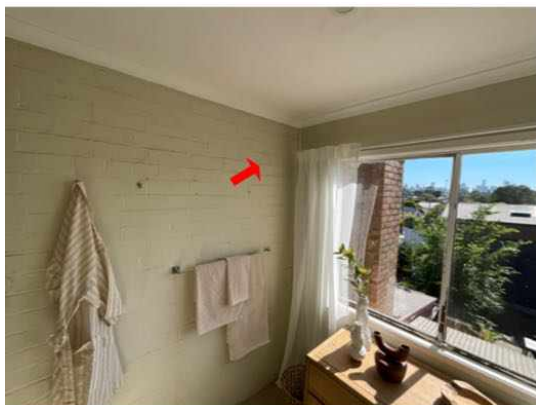
Finding 3.12

Information: Sections of paint in this area was found to have bubbled and deteriorated. Paint bubbling is generally an indication of excessive moisture in the area past or present.

Although there was no moisture detected in the wall I would recommend monitoring this area.

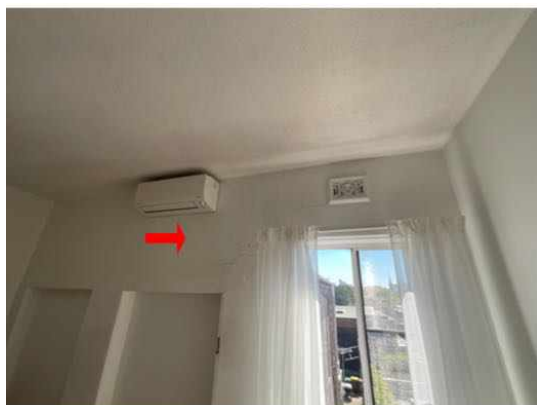
Finding 3.13

Information: Sections of paint in this area was found to have bubbled and deteriorated. Paint bubbling is generally an indication of excessive moisture in the area past or present.

Although there was no moisture detected in the wall I would recommend monitoring this area.

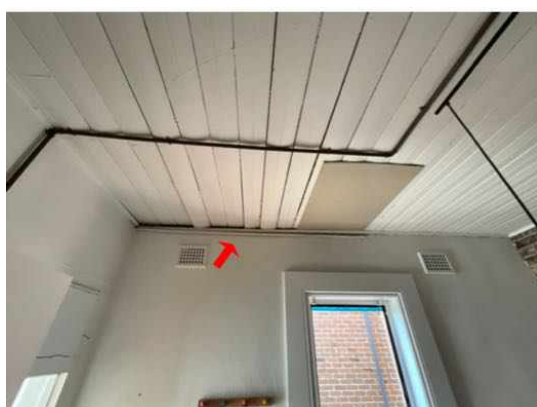
Finding 3.14

Building: Main Building
 Location: Kitchen
 Finding: Nails - Popping
 Information: Numerous popped nails were identified at the time of inspection. Nails and screws are held by the friction between them and the surface that they are applied to. Over time, the nails and screws can back out, which is often a result of general ageing and deterioration of the building structure.

On further inspection there was a bathroom above this area and therefore there may have been a leak. Although there was no moisture detected I would recommend monitoring this area and if further deterioration is evident appoint a builder to see what necessary works are required.

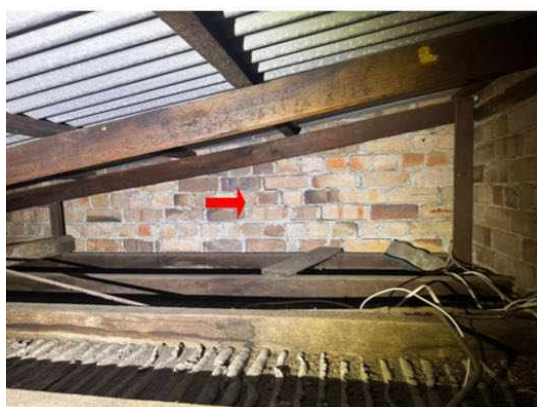
Finding 3.15

Building: Main Building
 Location: Roof Exterior
 Finding: Brickwork - Cracking noticeable

Information: There were several cracks and or crack repairs evident to external brickwork.

Noticeable cracks are a common occurrence in external brickwork and are a likely result of age expected building movement, general expansion, and/or contraction of building materials in different weather conditions.

It is highly advised that a qualified bricklayer be appointed to provide necessary works to cracked brickwork to prevent any further damage.

Always monitor these cracks and contact a building inspector should cracks widen, lengthen, or become more numerous.

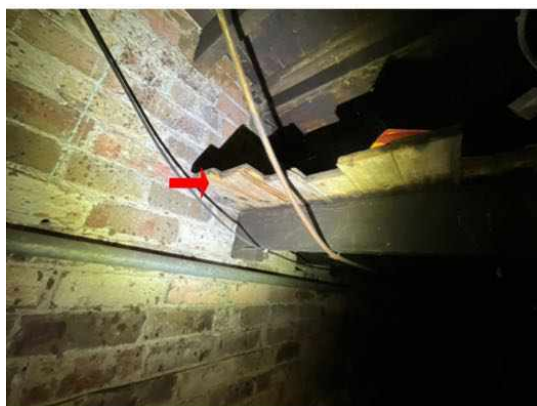
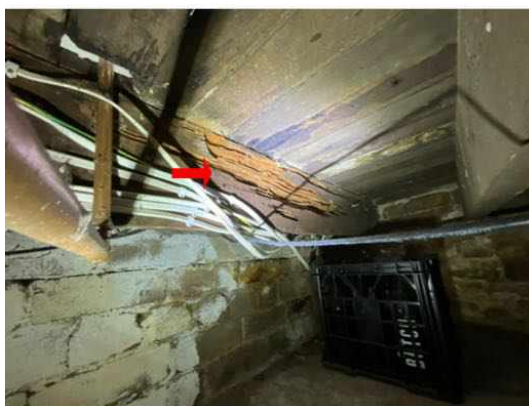
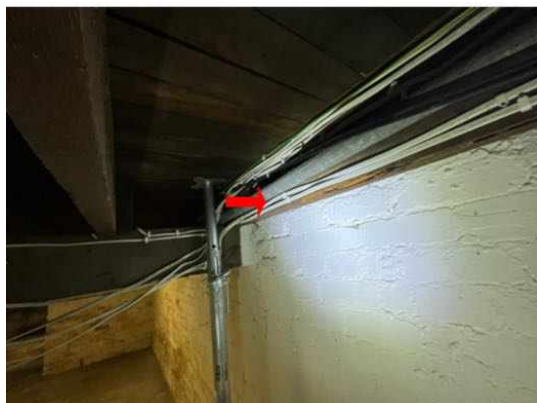
Finding: Termite - damage identified

Information: Despite no live termite or timbered pest activity being indicated, termite damage was found to have affected this area.

A building contractor should be appointed to provide a further invasive inspection and to see what necessary works are required.

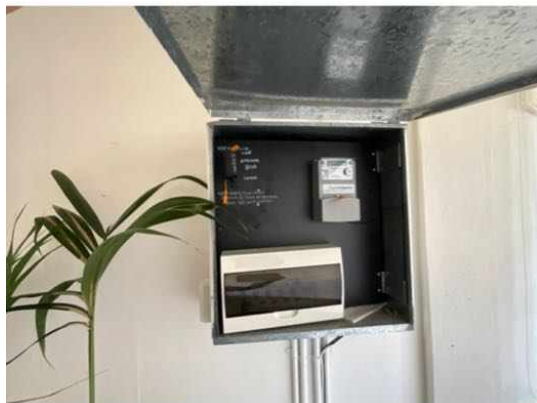
Finding 6.01

Building:	Main Building
Location:	All Areas
Finding:	Termite Management System - no evidence of a chemical installation
Information:	The application of a post-construction chemical termite barrier is highly recommended for all properties, particularly if live termite activity has been found on the site previously. Such barriers are highly effective in preventing termite attack on any timber building elements throughout the property.

A durable notice should be placed in the switchboard unit to indicate current termite barriers. At the time of inspection, it appeared as though no termite management system has been installed, with no evidence to suggest preventative works taking place.

The client may consider gaining further advice from a pest controller as to the costs and procedures involved with this application. It is recommended that obtaining such advice be a short-term priority.

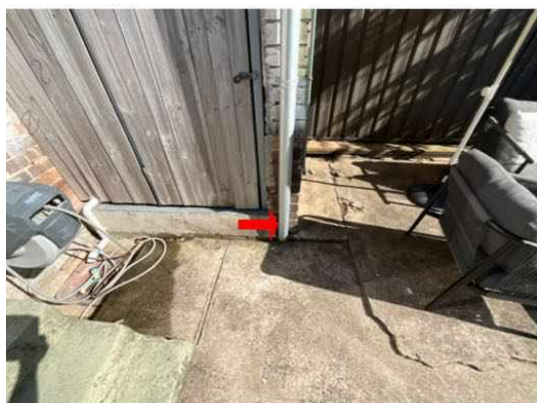
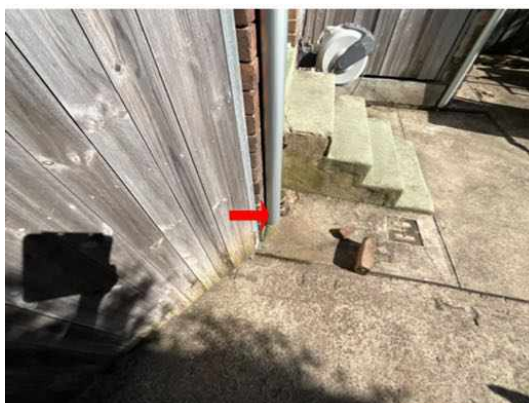
Finding 6.02

Building:	Main Building
Location:	Exterior walls
Finding:	Excessive moisture - identified
Information:	Excessive moisture can attract termites and produce conditions that promote fungal growth and wood decay.

Prior to any remedial works being performed a qualified plumber should be appointed to further inspect the property and to identify the cause of the excessive moisture.

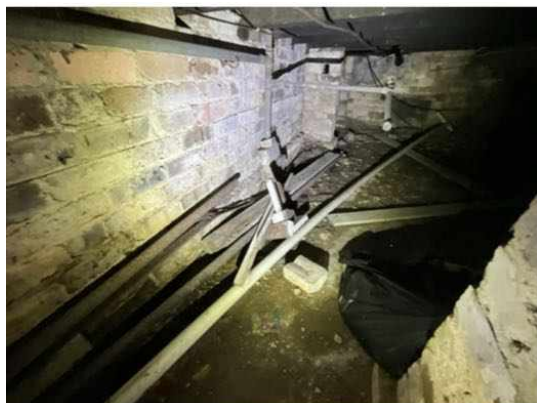
Finding 6.03

Building:	Main Building
Location:	Subfloor
Finding:	Subfloor - Debris
Information:	An array of debris was found in the subfloor area at the time of inspection. Debris in this area restricts subfloor ventilation and creates potential for concealed pest entry. Stored timbers and other materials may also make the area susceptible to termite activity and wood rot.

A clear and empty subfloor will be better ventilated and easier to maintain in a dry condition. The removal of any timber debris is vital in minimising the risk of termite or

wood borer activity.

Debris in the subfloor should be removed as soon as possible. Depending on the location and amount of debris and stored items, the homeowner may elect to undertake this task. Alternatively there are a large number of rubbish removal subcontractors that could undertake these works.

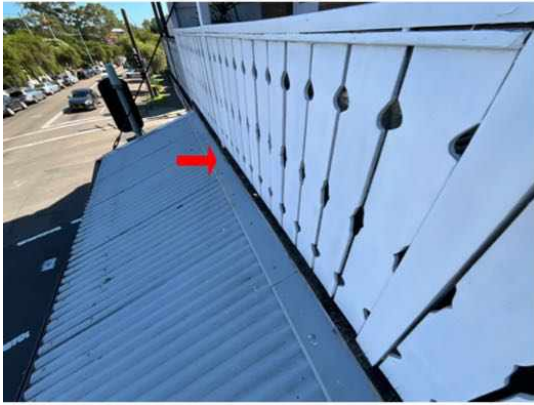
Finding 7.01

Building:	Main Building
Location:	External Areas
Finding:	Fungal decay - present (localised)
Information:	Fungal decay also known as wood decay or wood rot generally refers to the deterioration of timber elements when in contact with excessive levels of moisture for a prolonged period of time.

The development of fungal decay is accelerated by temperatures in the range of 5degreeC to 40degreeC as well as the presence of oxygen. Generally fungal decay develops on timber elements that are in use in an external environment which are exposed to rain penetration.

In this case although the affected timber element is in a decaying state the extent of any visible damage appears to be localised to a specific area and is yet to spread to other parts of the building element or affect adjoining structures. The fungal decay is therefore likely to be of a relatively superficial nature with minimal impact on the structural integrity or tensile strength of the timber element.

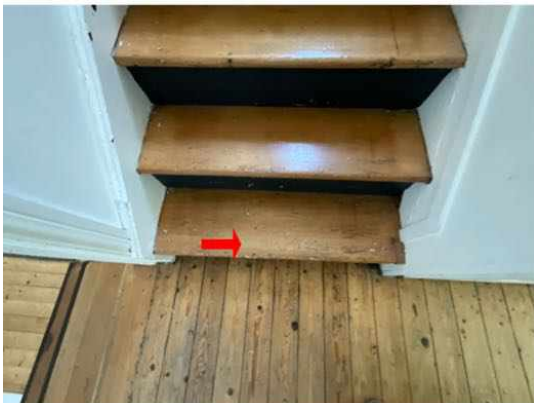
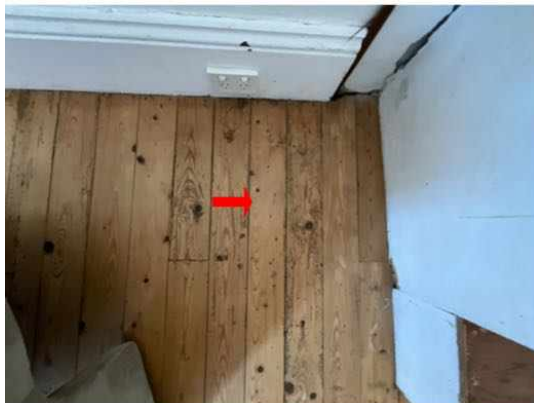
Finding 8.01

The Lyctid borer which generally attacks hardwoods such as subfloor and roofing structures is generally identified by a fine dust surrounding the affected timbers.

As no live wood borer activity was identified treatment is not required at this time.
