Building and Timber Pest Inspection Report

Inspection Date: Sat, 28 Feb 2026

Property Address: 1/510 Butson Ave, South Albury NSW 2640,
Australia

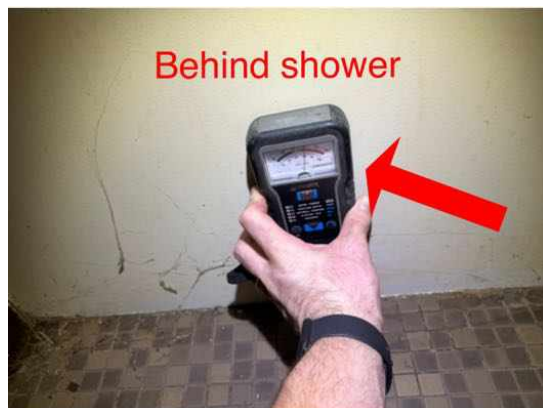
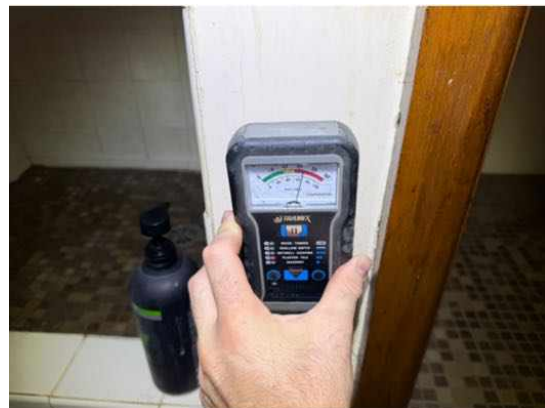
Finding 3.01

Building: Main Building
 Location: Shower
 Finding: Shower - High Moisture
 Information: It appears that high moisture is present at but not limited to, behind the shower wall and to the wall adjacent to the shower. Potential causes of leaking include but are not limited to loose or damaged plumbing fittings and fixtures, and/or deteriorated seals or waterproofing.

Areas of leaking and high moisture create an environment conducive to termite activity and therefore should not be neglected. Recommend engaging a licensed plumber promptly, to provide remedial works where necessary.

Evidence of high moisture was identified at, but not limited to behind the shower wall, and the adjacent shower wall. Recommend engaging a licensed plumber and/or tiling contractor promptly, to identify the cause of the moisture & provide remedial works where necessary.

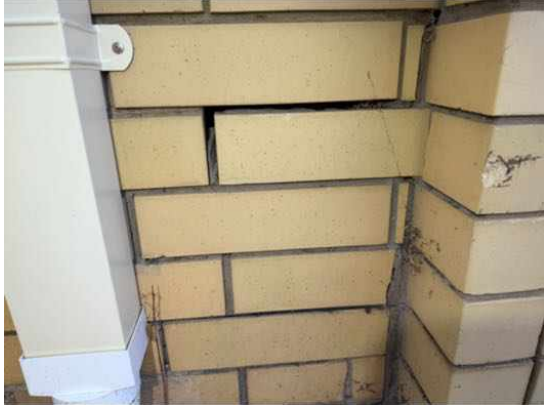
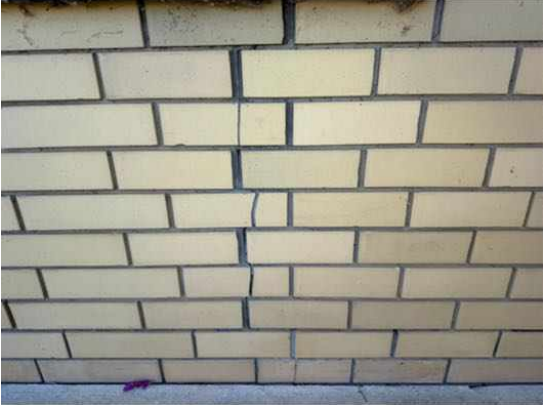
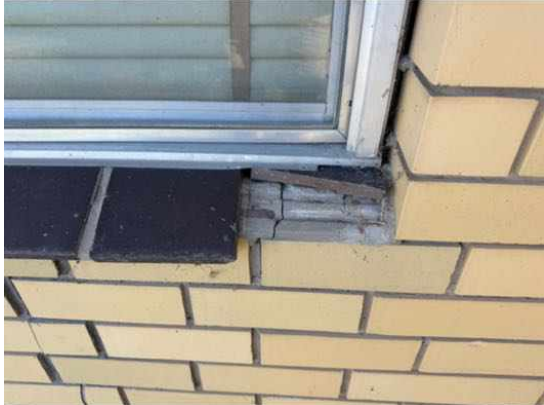
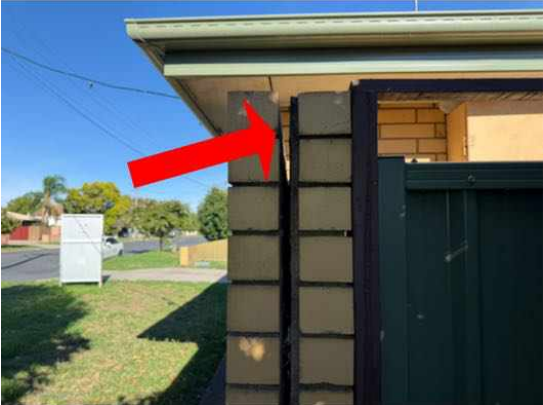
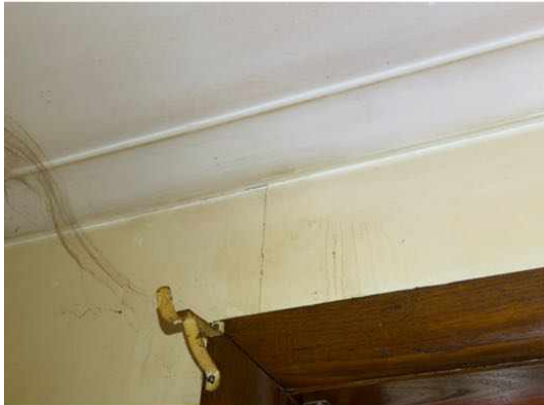
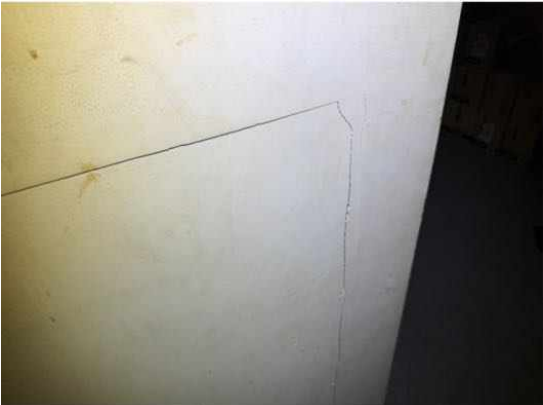
Finding 3.02

Building: Main Building
 Location: Internal Areas, Brickwork, Brick Fence
 Finding: Cracking & Movement - External & Internal
 Information: Cracking and evidence of movement was identified to some areas of the brickwork, front brick fence, and internal wall linings at the time of inspection. Cracking has a variety of possible causes, however, the most common is movement of adjacent

footings and/or expansion / contraction of building materials. Cracking is a relatively common defect, and is most likely to occur adjacent to windows, doors and other openings.

The client should monitor the cracking & movement. Should the cracking lengthen, widen or become more numerous, the client should consult with a structural engineer promptly to provide further advice.

All areas of internal and external cracking and areas where movement has occurred should be closely monitored to identify any further movement. Should cracking lengthen, widen, or become more numerous, a structural engineer should be engaged promptly, for further evaluation.

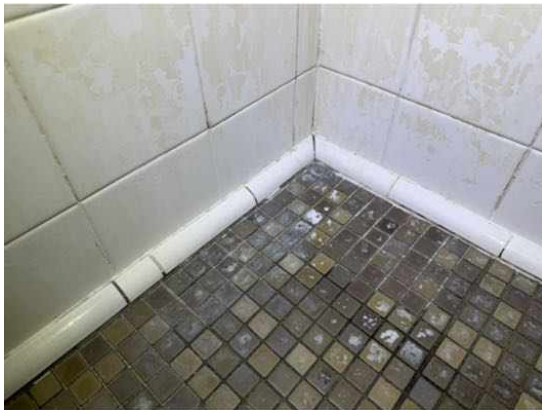
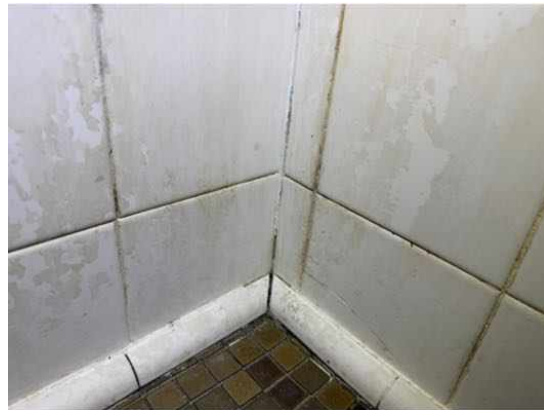
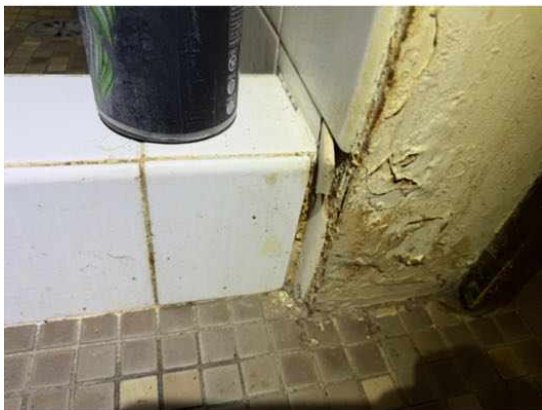
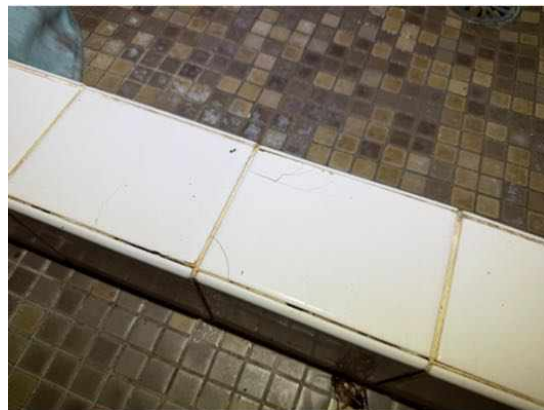
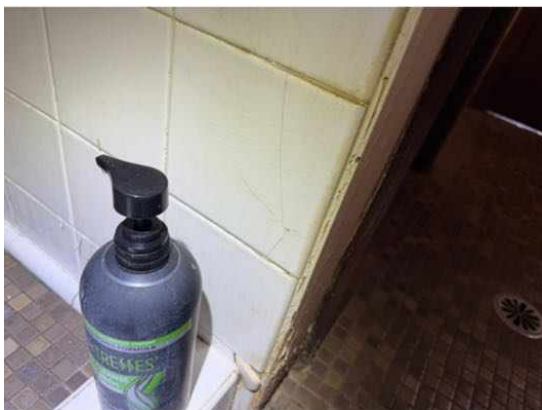
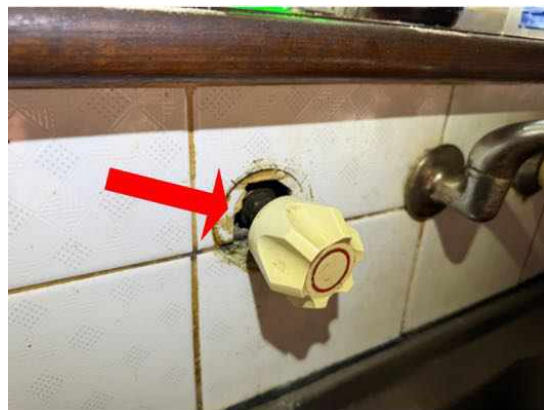
Finding 3.03

Building: Main Building
Location: Tiled Areas

Finding: Sealant / grouting - deteriorated or missing & Cracked Tiles

Information: It appears that the sealant and grout has deteriorated in some tiled areas, a common defect in buildings of a similar age. Areas of cracked tiles were also noted, which can allow for moisture ingress behind the tiles, if neglected.

Sealant and grouting in areas that come into regular contact with water should be maintained for the long term care of your property.

Recommend engaging a licensed tiling contractor in the short term, to provide maintenance works where necessary.

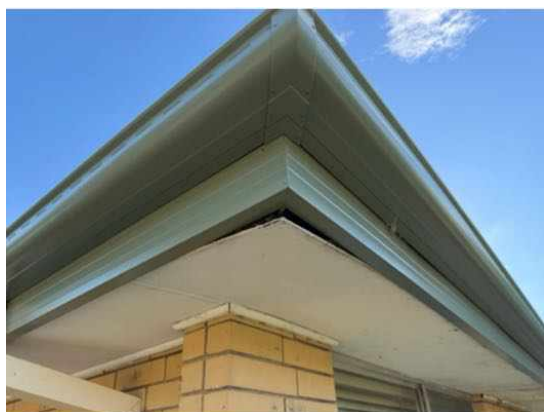
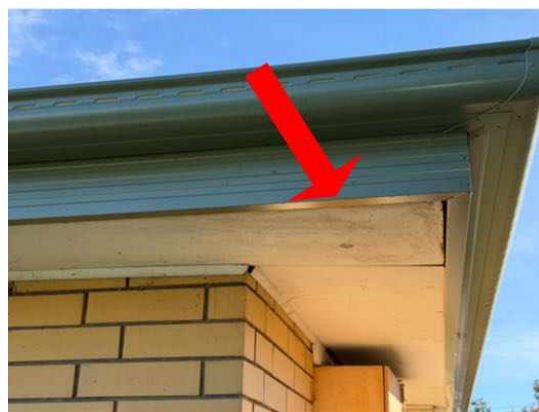
Finding 3.04

Building: Main Building
 Location: Front
 Finding: Eaves - Sagging
 Information: It appears that the eaves at but not limited to the front elevation, were found to be sagging at the time of inspection. Sagging of eaves generally indicates that the fixings (e.g. nails or glue) have become loose and require refixing.

Where minor sagging is evident, remedial works such as re-fixing of the eaves may be required. Such works could be performed by relevant tradespeople, such as a licensed carpenter or a general handyman at clients discretion.

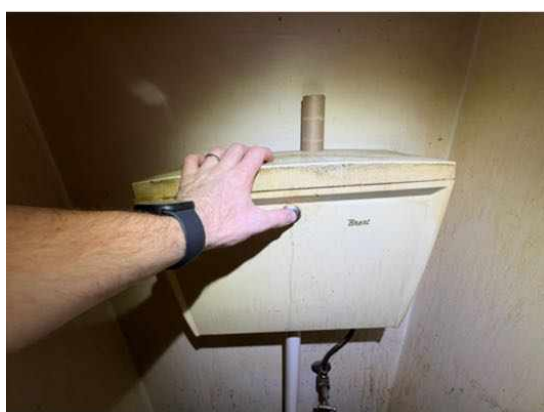
Finding 3.05

Building: Main Building
 Location: Toilet
 Finding: Toilet - Not Operating
 Information: It appears that the toilet was not operating/flushing at the time of inspection. Recommend engaging a licensed plumber to provide further advice and remedial works where necessary

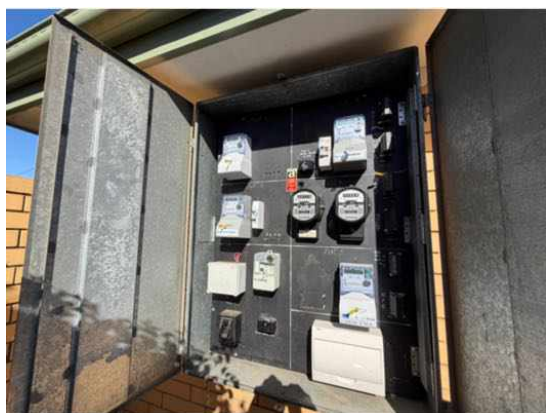
Finding 6.01

Building: Main Building
 Location: Switchboard
 Finding: Termite Management System - no evidence of a chemical installation
 Information: The application of a termite barrier is strongly recommended, as it appears no termite management system has been installed, with no evidence or durable notice to suggest works taking place. Generally, a durable notice is placed in the meter box to indicate current termite barriers.

Such barriers are highly effective in preventing termite attack on the building and therefore should be installed.

Recommend seeking further advice from a licensed pest controller.

Installation of a termite barrier is recommended as there was no evidence of installation of a previous termite management system. 12 monthly termite inspections, conducted by a qualified termite inspector are also advised. Recommend engaging a licensed pest controller, to provide further advice.

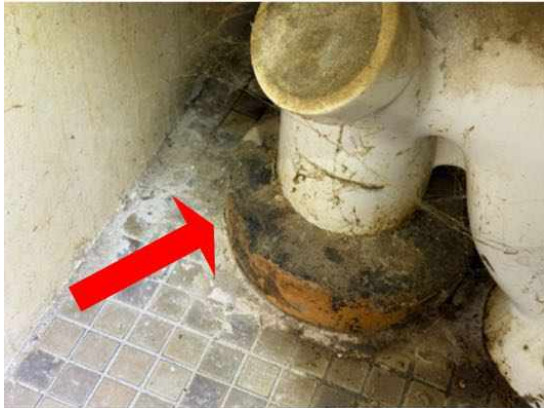
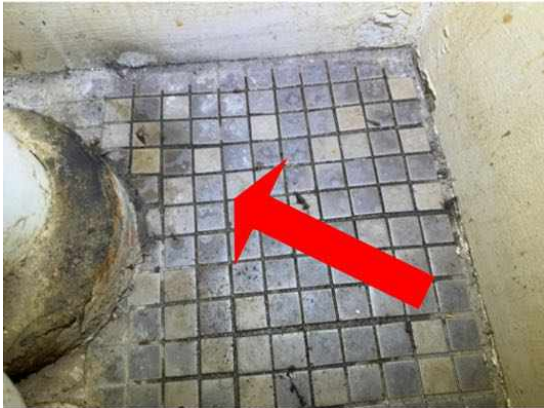
Finding 6.02

Building: Main Building
 Location: Toilet
 Finding: Toilet - Leaking
 Information: The toilet base appeared to be leaking at the time of inspection. Although fairly common, water leaks can lead to water damage of surrounding building elements if left unmanaged and create an environment conducive to termite activity.

Recommend engaging a licensed plumber promptly, to provide maintenance works where necessary.

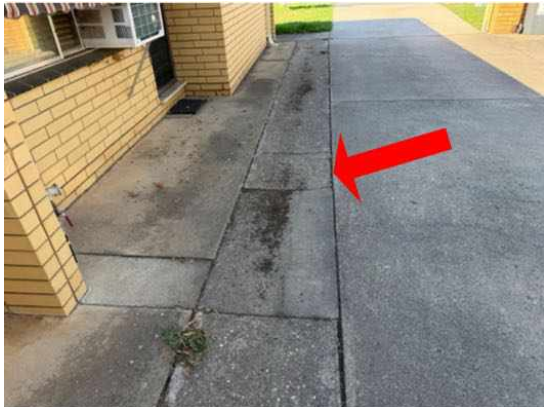
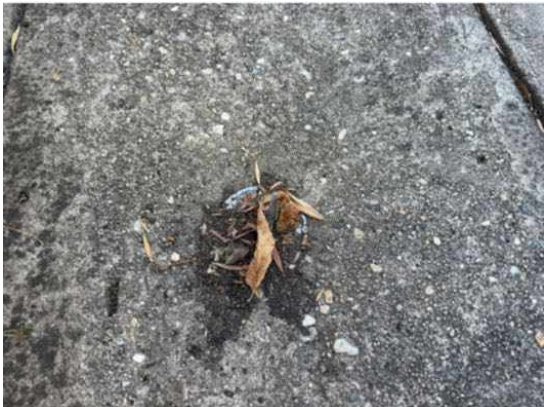
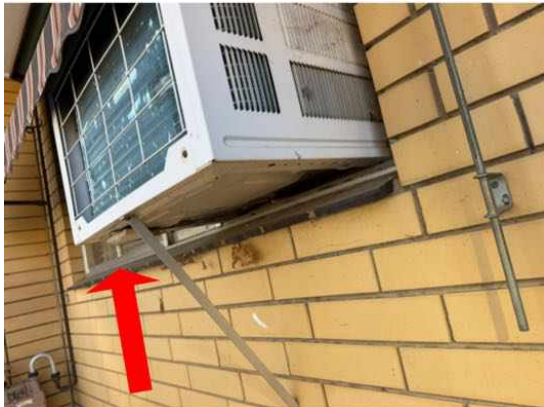
Finding 6.03

Building: Main Building
Location: All external areas
Finding: Potential Water pooling - against property
Information: Potential areas of water pooling around the perimeter of the property were identified. It appears that the drain that was present in front of the unit appeared to be blocked. Recommend consulting with a licensed plumber to provide further advice, to ensure sufficient stormwater drainage has been installed.

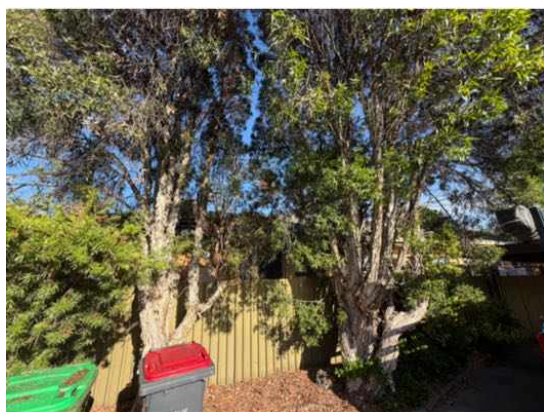
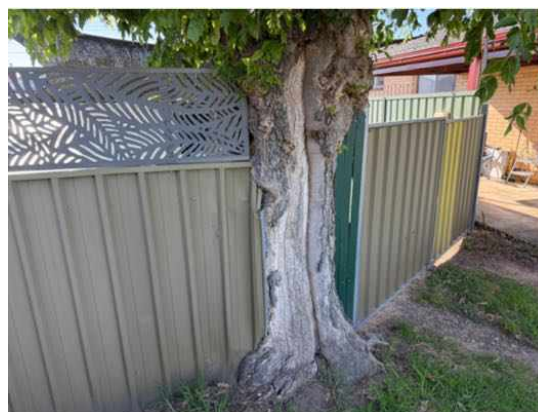
Finding 6.04

Building:	Main Building
Location:	All External Areas
Finding:	Timber in direct ground contact & trees - conducive to termites
Information:	Where timber materials are in direct contact with the ground and consequently moisture, they become conducive to termite activity. The trees surrounding the building create an environment conducive to termite infestation.

Where feasible, any trees in close proximity to the building should be removed or test drilled (inspected) at least annually to reduce the risk of termite infestation & detect any early signs of termite activity.

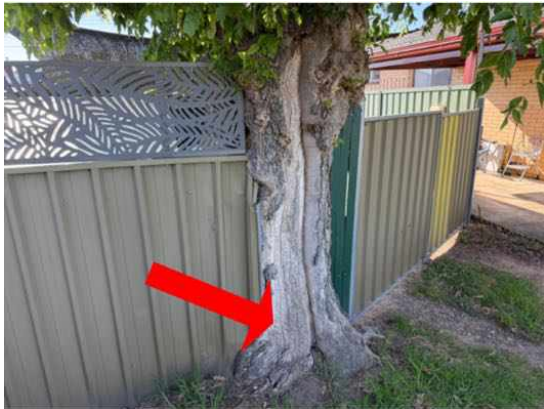
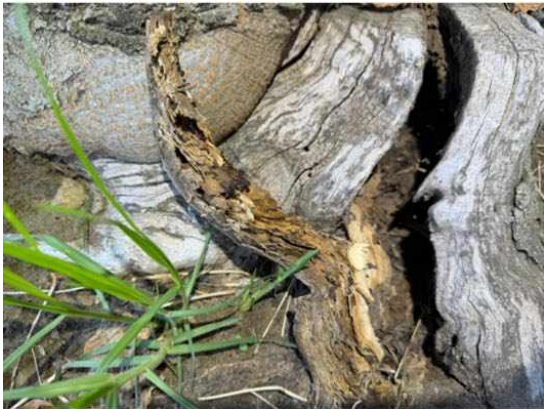
Finding 8.01

Building:	Main Building
Location:	Front Tree
Finding:	Evidence of wood borer damage identified (powder-post)
Information:	Evidence of previous Lyctus Borer (powder-post beetle) damage was identified in the roof void at but not limited to the edge of a timber batten. Wood borer damage is generally considered superficial damage to the affected timber.

As no live wood borer activity was identified treatment is not required.

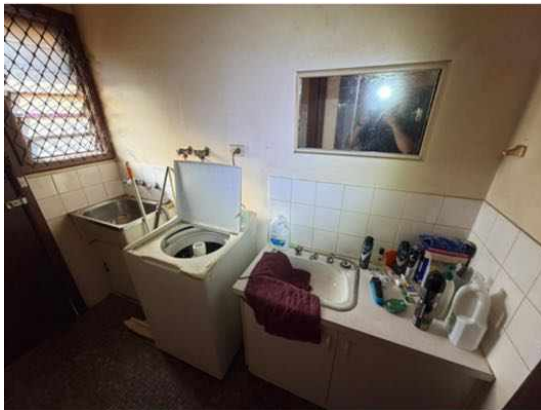
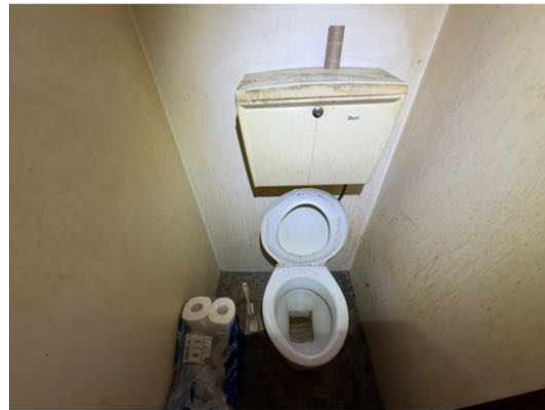
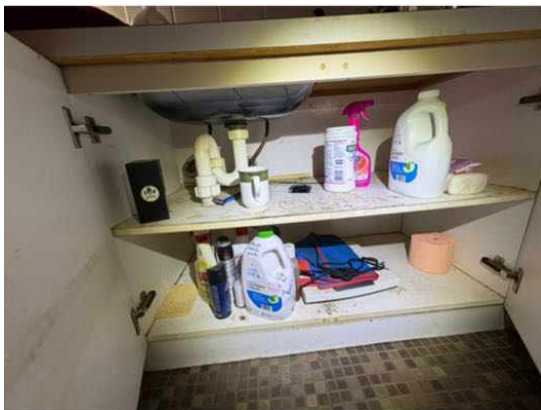
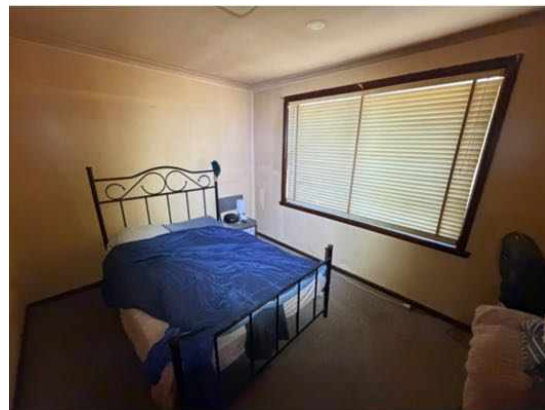
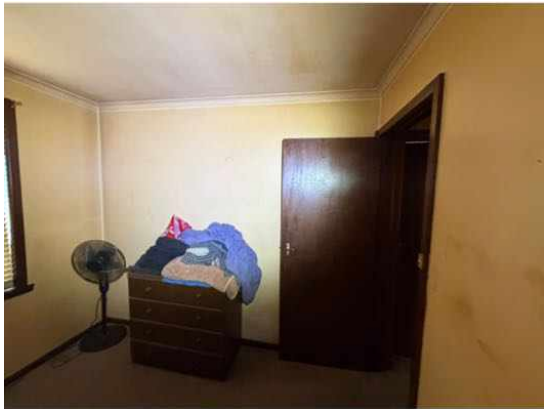
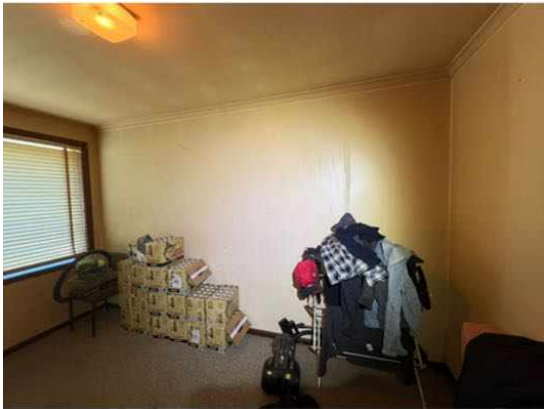
Building: Main Building
Location: All Areas
Finding: Additional Photos - Obstructions and Limitations
Information: These photographs are an indication of the obstructions and limitations which impeded full inspection of the property at the time of inspection. These obstructions can hide an array of defects and should be removed to allow full inspection to be carried out. A re-inspection is recommended once the areas are made accessible.

Several limitations and obstructions impeded the inspection and, if feasible, should be removed, and a further inspection should be performed. The roof void was unable to be fully inspected due to areas of low roof pitch, loose fill insulation, and pipework. Indicative images below depict some of the obstructions encountered.

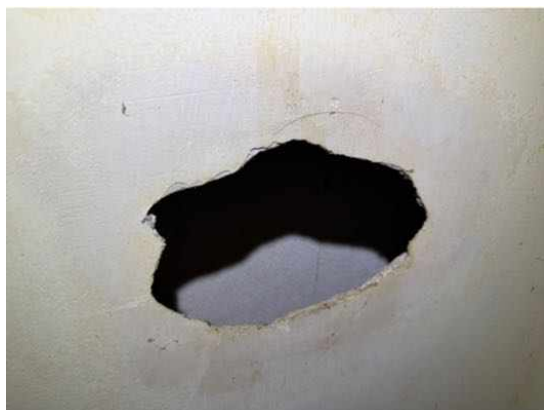
Building: Main Building
 Location: Toilet Wall
 Finding: Asbestos - Damaged Suspected ACM
 Information: This suspected defect is highlighted as a caution only as reporting on asbestos is outside the scope of this report. It appears that a damaged suspected ACM (asbestos containing material) sheet was identified at, but not limited to the toilet wall.

It is advised that the client consider a separate Asbestos Inspection and Condition Audit, which can include the taking of samples for definitive confirmation of the presence of Asbestos, carried out by a licensed Asbestos Inspector. In the interim, no works should be conducted to these areas without further specialist advice.

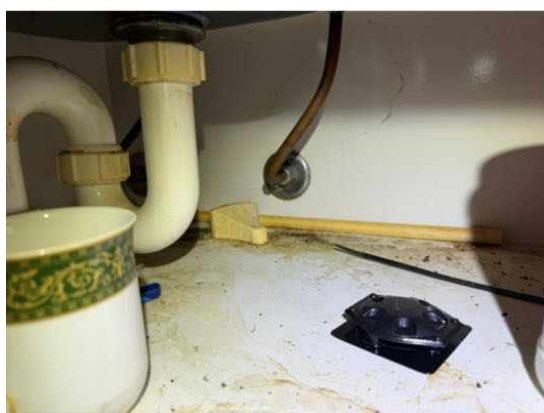
Building:	Main Building
Location:	Bathroom Vanity
Finding:	Water Staining Present
Information:	It appears that water staining was present at but not limited to, beneath the bathroom vanity. Potential causes of leaking include deteriorated or damaged plumbing fittings and fixtures. Recommend that the client monitor the area and engage a licensed plumber, should the leak persist or return.

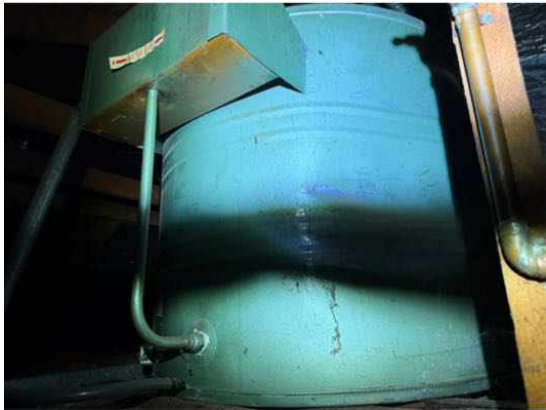
Building:	Main Building
Location:	Roof Void
Finding:	Gravity-Fed HWS in roof void
Information:	A gravity-fed hot water system (HWS) remains in the roof void. It is advised that the client consult with a licensed plumber to provide further advice regarding the hot water system, to see if an upgrade is needed if there isn't already one in place. If the system is unused, it may contain residual water & may need draining, to avoid rust and the potential for future leaks.
