# Building and Timber Pest Inspection Report

Inspection Date: Wed, 28 Jan 2026

Property Address: 29 Sweetgum St, Ashmore QLD 4214,  
Australia

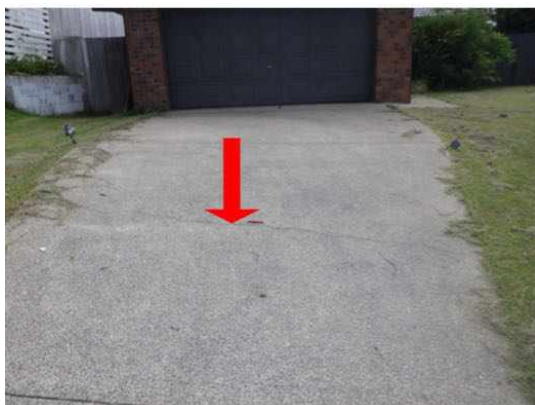
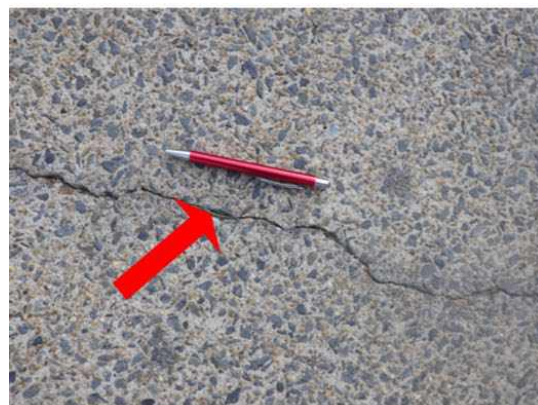
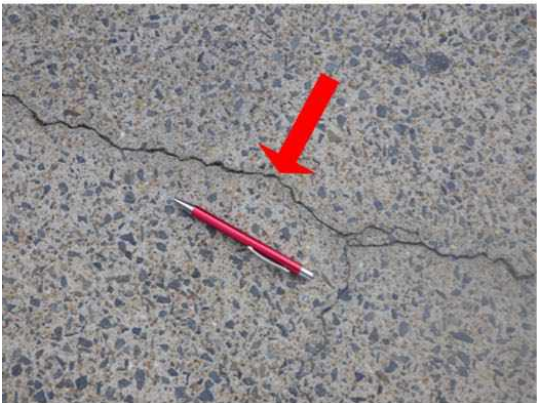
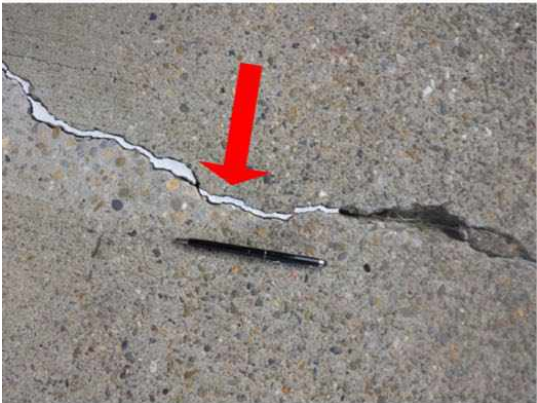
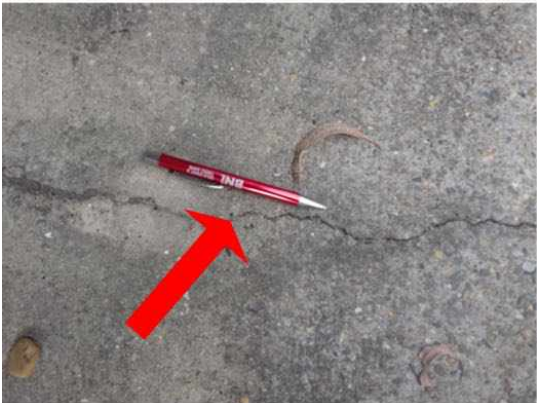
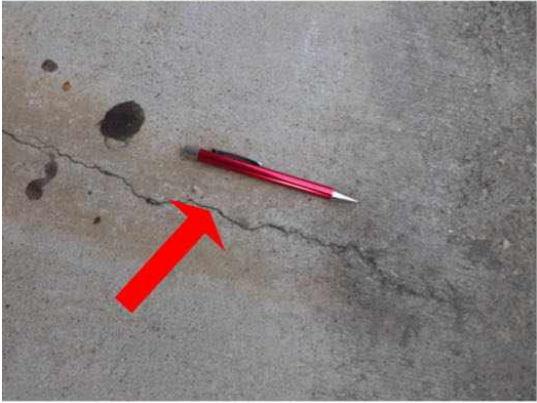
Building: Main Building  
Location: Driveway > Existing  
Finding: Cracking in concrete slab - Category 1  
Information: Cracking coded as Category 1 - 2 was identified in the driveway and footpaths concrete slabs (as per example photos). A Category 1 crack is described as a fine but noticeable crack, with the slab at an otherwise reasonable level.

To be considered Category 1, the approximate width of the crack is less than 1.0mm, or a less than 10mm change in offset when a 3m straight edge is placed over the defect.

Category 1 cracks should be monitored for a period of 12 months. At the end of the monitoring period, identified cracks that are rated greater than Cracking above category 2 is considered a defect which requires rectification.

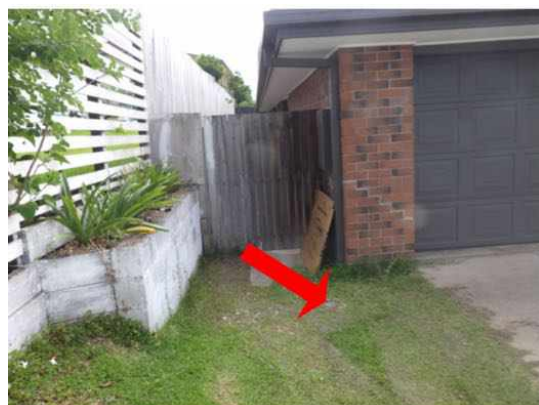
Finding 3.02

Building: Main Building  
Location: Yard - Front > Front Left  
Finding: Sewer line - Caps Missing  
Information: At the time of inspection it was noted the sewer or stormwater line on the left side of the property was missing the protective riser cap.

The missing sewer or stormwater line cap creates the potential for sewer line blockages.

A licensed plumber or general handyman should be engaged to replace the sewer line cap as soon as possible.

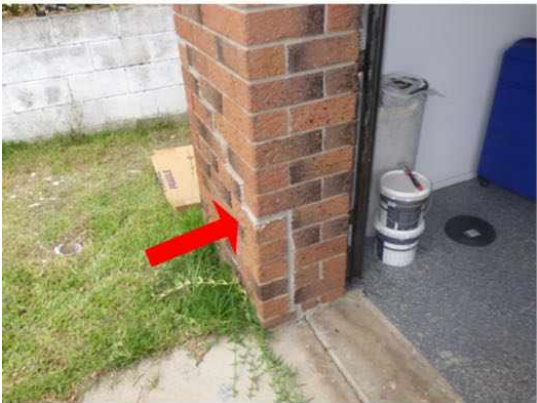
### Finding 3.03

Building: Main Building  
Location: Exterior walls - front > Front Left  
Finding: Evidence of previous repairs  
Information: At the time of inspection it was noted there appears to have been previous repair work to the brickwork on the front left side of the garage.

The cause or reason for the repair work is unknown but may be the result of impact damage.

The client is advised to monitor the area for any signs of change.

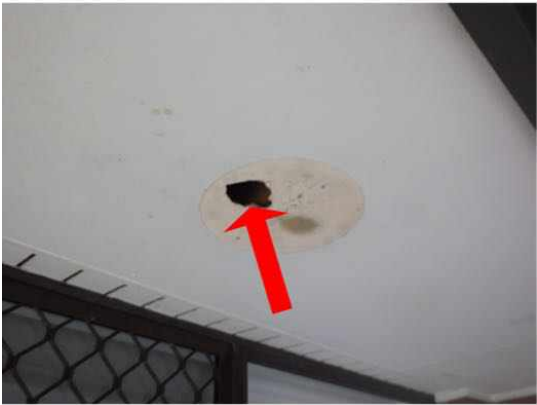
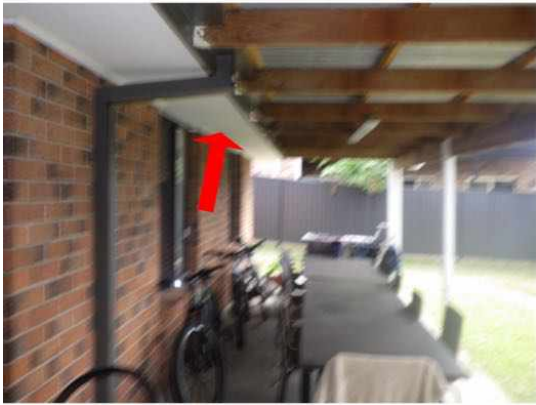
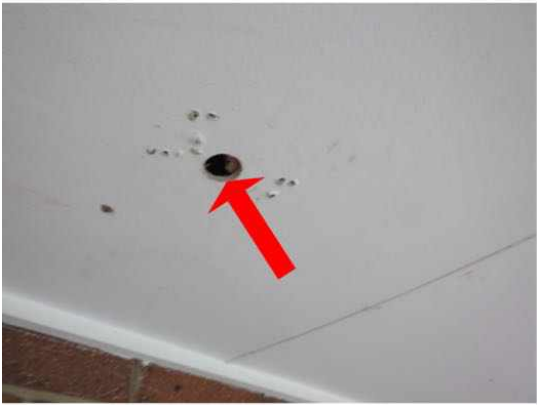
**Finding 3.04**

Building: Main Building  
 Location: Eaves > Centre Right  
 Finding: Eaves - Holes  
 Information: Holes were identified in the eaves linings in the alfresco area. It is suspected that the holes are from a previously removed fixture or fittings.

All excessive holes, gaps or cracks should be adequately filled by a suitable sealant or trimmings.

Such works may be conducted by a general handyman or licensed painter.

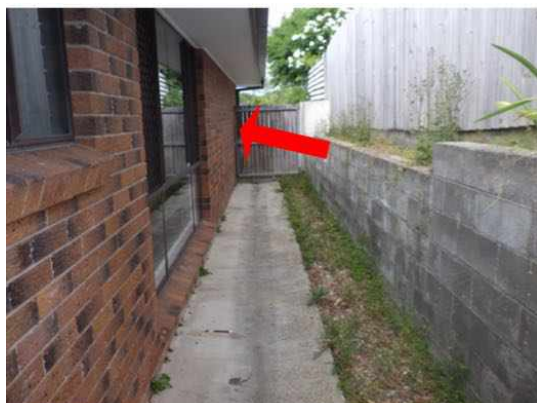
### Finding 3.05

Building: Main Building  
 Location: Exterior walls - left side > Front Left  
 Finding: Gate - Sticking/ jamming  
 Information: At the time of inspection the gate to the left side of the property was sticking or jamming on the exterior walls brickwork during standard operation.

A fencing contractor or general handyman could be engaged to adjust or repair the gate as required.

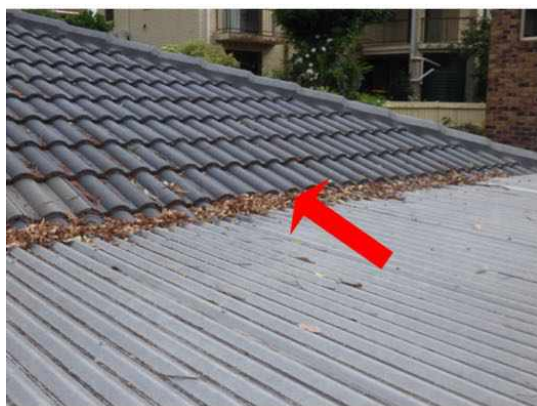
### Finding 3.06

Building: Main Building  
 Location: Roof Exterior > Rear Right  
 Finding: Debris  
 Information: At the time of inspection there was vegetation type debris on the exterior roof areas. Any debris on roof areas has the potential to restrict roof gutters or valley flashings effectiveness and creates the potential for stormwater line blockage.

A general handyman should be engaged to remove the roof debris.

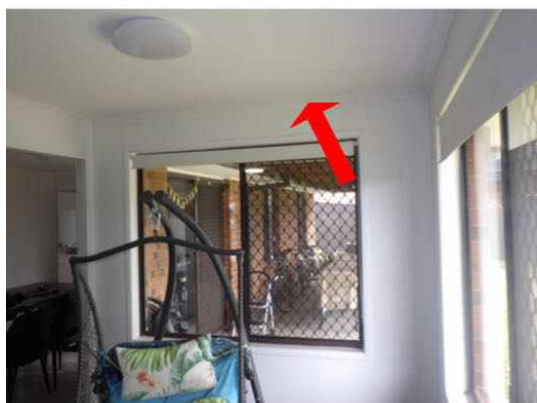
### Finding 3.07

Building: Main Building  
 Location: Living Room > Centre Right  
 Finding: Painted surface - Cornice  
 Information: At the time of inspection a section of paint to the living area ceiling cornice was found to have bubbled and deteriorated. Paint bubbling or deterioration is generally an indication of moisture exposure or substandard workmanship.

A licensed painter or general handyman could be engaged to undertake repair work..

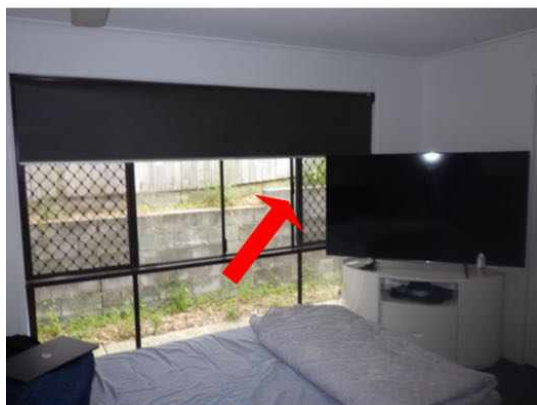
### Finding 3.08

Building: Main Building  
 Location: Bedroom - Master > Centre,Rear  
 Finding: Window - Broken latch  
 Information: The right side window latch to the main bedroom sliding window was found to be broken at the time of inspection. Breakage occurs generally when the building materials have aged and decayed, but may be indicative of impact damage (accidental or deliberate).

Repair and/or replacement of the broken window catch is advised to improve the operational state of the associated window.

An aluminium window service agent or general handyman should be appointed to repair/replace the window latch at the client's discretion.

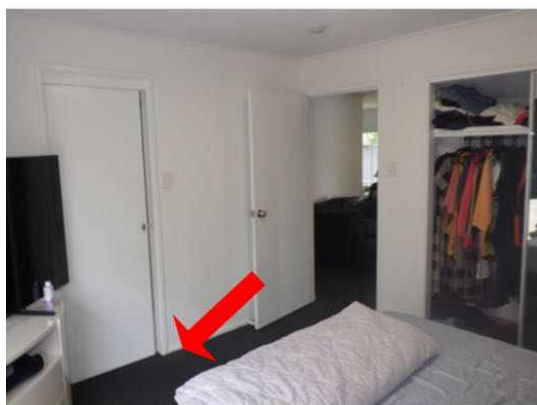
### Finding 3.09

Finding: Wood Rot

Information: At the time of inspection an area of the timber architrave and skirting board in the main bedroom area showed signs of wood rot. It is suspected the timber wall framing in the area may be affected also. Wood rot damage is generally caused from exposure to moisture at some time, possibly from water tracking or escaping from the shower area opposite. Monitoring of the area for any signs of further deterioration is advised.

The client could engage a qualified carpenter or general handyman to undertake repair work.

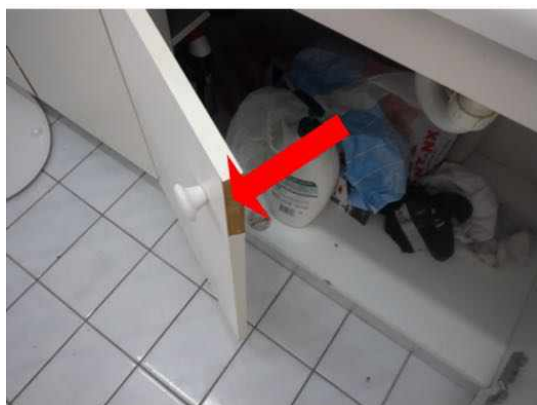
### Finding 3.10

Finding: Cabinetry - Deterioration

Information: At the time of inspection the bathroom cabinetry showed signs of minor deterioration.

The level of damage appears consistent with exposure to moisture or general wear and tear.

A qualified cabinet maker or general handyman could be engaged to undertake repair works at the clients discretion.

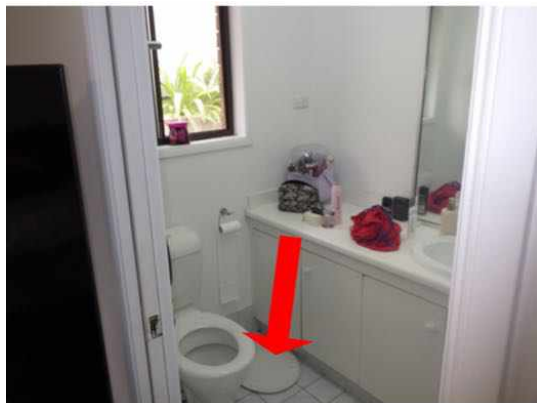
### Finding 3.11

Building: Main Building  
 Location: Ensuite > Centre Left  
 Finding: Toilet seat  
 Information: The toilet seat in the ensuite was found to be detached at the time of inspection. It is suspected that this defect has developed due to general wear and tear.

It is recommended that the seat be replaced by a licensed plumber or general handyman.

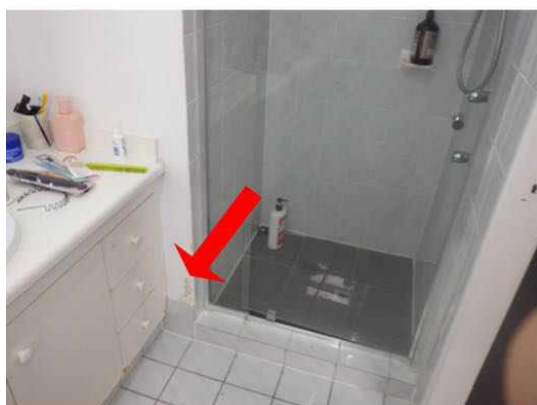
### Finding 3.12

Building:	Main Building
Location:	Ensuite > Centre Right
Finding:	Painted surface - Deteriorated
Information:	At the time of inspection a section of paint to the ensuite wall was found to have deteriorated. Deteriorated internal paint is generally an indication of excessive moisture exposure or poor workmanship.

The presence of excessive moisture can also have implications on associated building elements if left unattended. While only seemingly minor at this stage, the cause of the damage cannot be fully determined, but may be from water escaping the shower cubicle area.

It is advised that the affected paint work be rectified by a qualified painter.

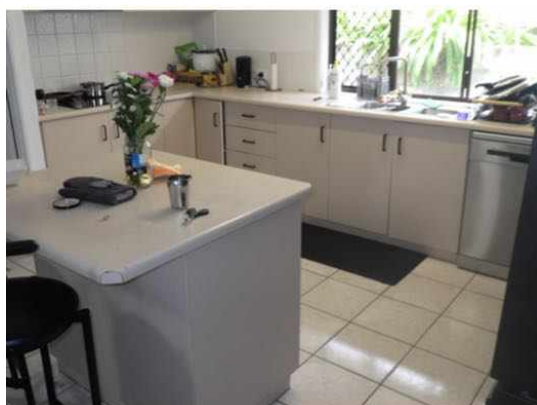
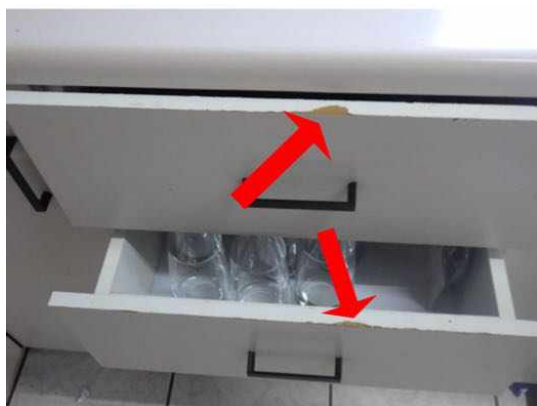
Building:	Main Building
Location:	Kitchen > Existing
Finding:	Cabinetry - Deterioration
Information:	At the time of inspection the kitchen cabinetry showed signs of minor deterioration (as per example photos). The level of damage appears consistent with exposure to moisture or general wear and tear.

A qualified cabinet maker or general handyman could be engaged to undertake repair works at the clients discretion.

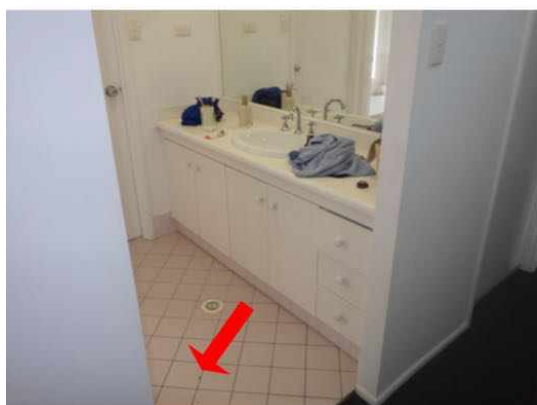
### Finding 3.15

Building: Main Building  
 Location: Powder Room > Centre  
 Finding: Tile - Chipped  
 Information: A chipped tile to the powder room floor area was identified at the time of inspection. Chipped tiles are generally caused by impact.

A tiling contractor could be appointed to perform repair works at the clients discretion.

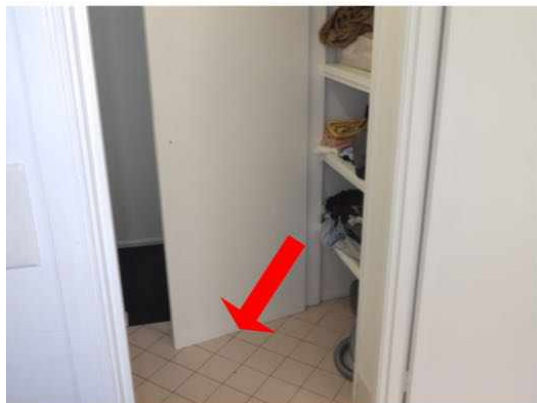
### Finding 3.16

Building: Main Building  
 Location: Linen Cupboard > Front  
 Finding: Door Rubbing  
 Information: It was noted that the bottom edge of the linen cupboard door is rubbing on the floor tiles making the door stiff to fully open at the time of inspection.

This is noted as a minor defect that you need to be aware of.

A licensed carpenter or general handyman could be engaged to ease the door at the clients discretion.

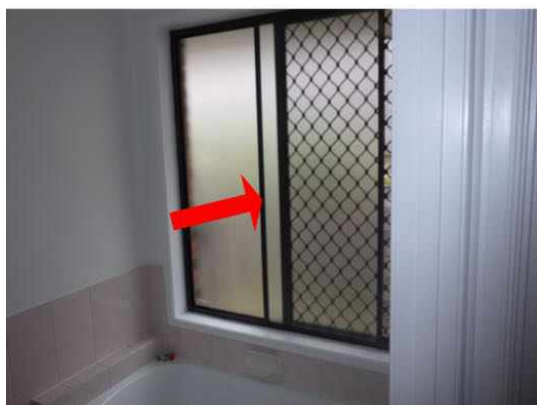
### Finding 3.17

Building: Main Building  
 Location: Bathroom > Centre Right  
 Finding: Window - missing latch  
 Information: The window latch to the bathroom area aluminium sliding window was found to be missing at the time of inspection. Breakage occurs generally when the building materials have aged and decayed.

Replacement of the missing window catch is advised to improve the operational state of the associated window.

An aluminium window service agent or general handyman should be appointed to replace the window latch at the client's discretion.

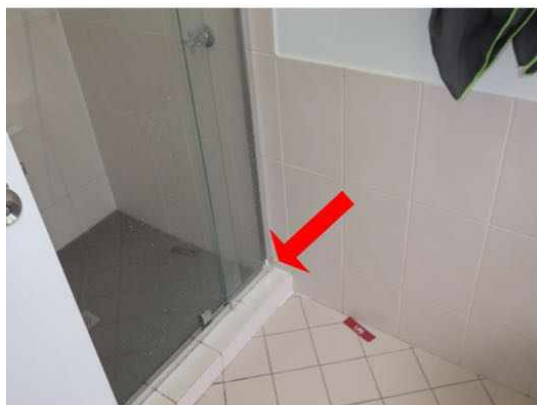
### Finding 3.18

Building: Main Building  
 Location: Bathroom > Rear Left  
 Finding: Shower - Cracked tile  
 Information: Cracking was evident to a wall tile in the bathroom shower cubicle at the time of inspection. The cracking is more than likely due to impact damage, but may have also been caused by general ageing and deterioration of associated building elements.

While the cracking appears to be minor, any additional impact may lead to further cracking.

As this area is frequently exposed to water, any cracking is likely to allow water penetration if left unmanaged.

Appointment of a tiling contractor is required to repair the cracked shower wall tile, so as to ensure no water damage occurs.

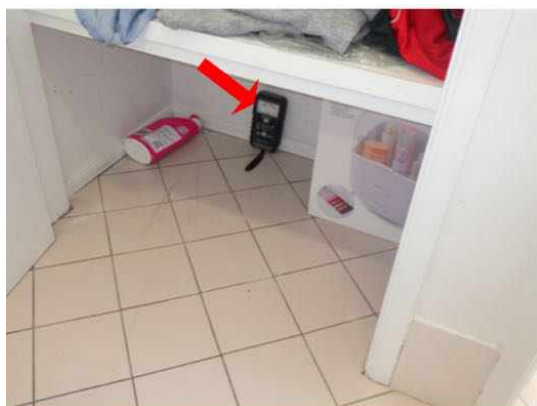
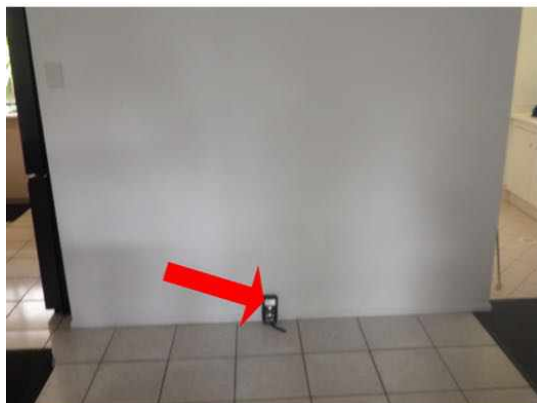
### Finding 3.19

Building:	Main Building
Location:	Bathroom > Rear Left
Finding:	Shower - Monitor
Information:	Elevated moisture level readings were recorded to the lower 200mm of wall to the bathroom shower alcove at the time of inspection. There was no elevated moisture level readings around the tap area, and no elevated readings transferring to the other side of the wall in the areas where moisture readings were able to be obtained. Both sealant and grout appear in fair condition at present.

This defect is quite common, and is suspected to have been caused by moisture permeating or leaching through the grouting and perhaps gaps in the sealant.

Monitoring the area is advised and if any visual signs of excessive moisture appear (peeling paint, mould) then consultation with a qualified plumber or bathroom specialist would be advised to identify the cause of damp and to perform remedial works as required.

Always ensure that sealant and grout is in good condition to prevent any moisture issues occurring in the future.

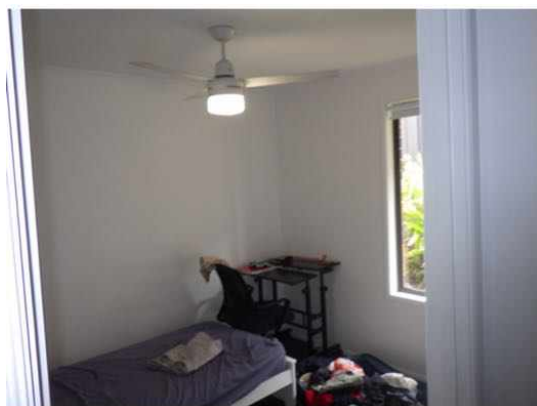
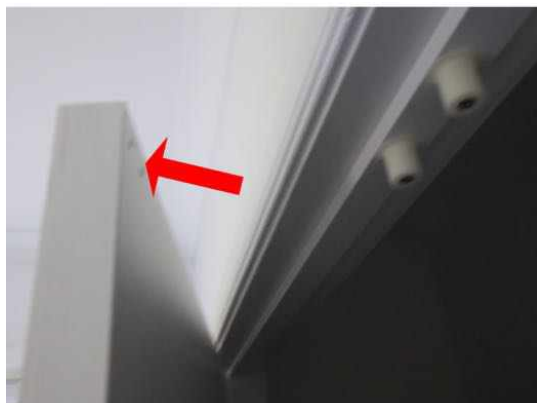
### Finding 3.20

Building: Main Building  
 Location: Bedroom 2 > Centre Right  
 Finding: Door - Broken latch  
 Information: The door latches to the bedroom 2 robe doors were found to be broken or missing at the time of inspection. Breakage occurs generally when the building materials have aged and decayed, but may be indicative of impact damage (accidental or deliberate).

Replacement of the broken door catches is advised to improve the operational state of the associated doors.

A general handyman could be appointed to replace the door latch at the client's discretion.

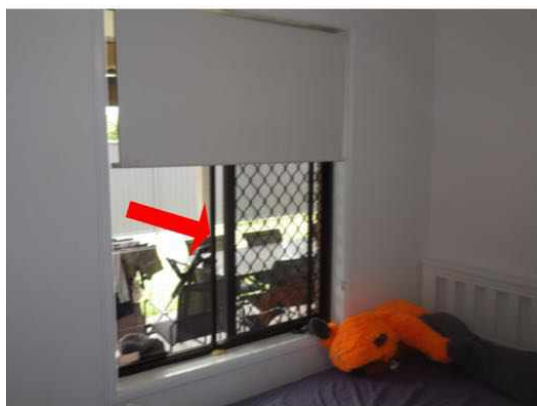
### Finding 3.21

Building: Main Building  
 Location: Bedroom 3 > Centre,Rear  
 Finding: Window - missing latch  
 Information: The window latch to the bedroom 3 area aluminium sliding window was found to be missing at the time of inspection. Breakage occurs generally when the building materials have aged and decayed.

Replacement of the missing window catch is advised to improve the operational state of the associated window.

An aluminium window service agent or general handyman should be appointed to replace the window latch at the client's discretion.

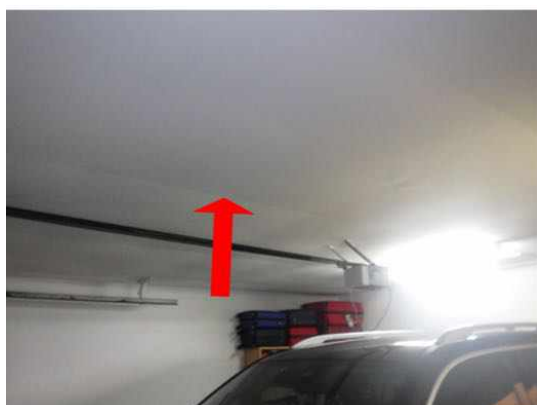
### Finding 3.22

Building:	Main Building
Location:	Garage > Existing
Finding:	Ceiling - Sagging
Information:	The ceiling linings in the garage showed signs of minor sagging at the time of inspection. Sagging to the fixed ceiling structure generally indicates that the building materials have swollen, due to exposure to moisture, or that fixings (e.g. nails or glue) have become loose and require reattachment.

Such works may be performed by relevant tradespeople, such as plasterers and painters.

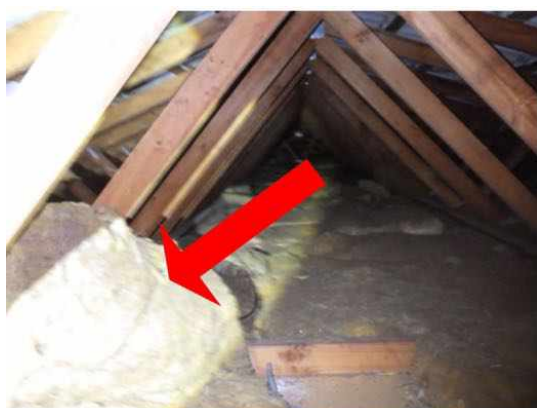
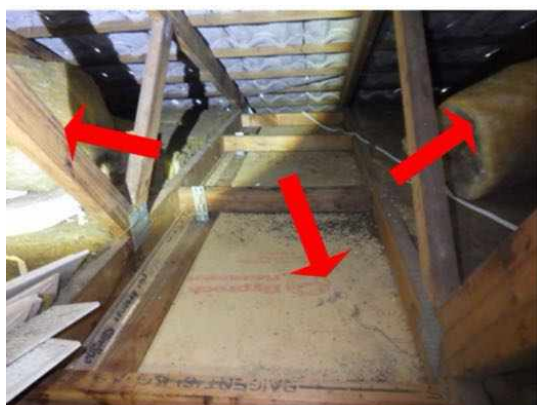
### Finding 3.23

Building:	Main Building
Location:	Attic > Existing
Finding:	Insulation - Poor Installation
Information:	Insulation has been installed in the roof void with some large gaps in the coverage found at the time of inspection. A number of insulation batts have been removed or

A general handyman could be engaged to undertake rectification work.

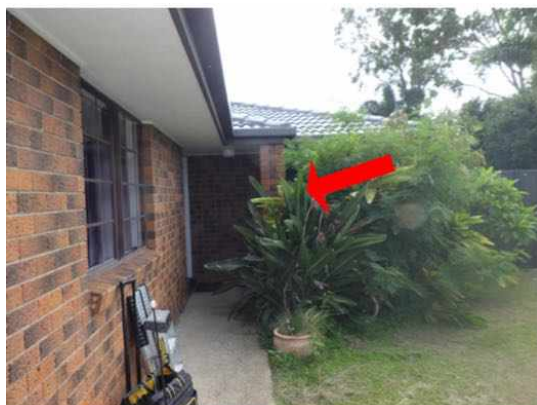
### Finding 6.02

Building: Main Building  
 Location: Exterior walls - front > Centre Right  
 Finding: Gardens  
 Information: At the time of inspection it was observed there is garden beds directly against external walls. Generally placing garden beds directly against a property walls should be avoided as it creates potential nesting sites for termites or rodents and/or moisture related issues.

surfaces. The grass and other vegetation heights should be maintained around the perimeter of the building to allow for an inspection zone around the building exterior.

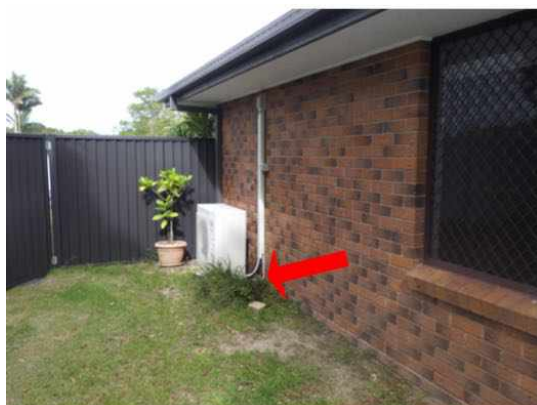
**Finding 6.04**

Building: Main Building  
 Location: Exterior walls - right side > Centre Right  
 Finding: Overflow - Not plumbed for drainage  
 Information: The air conditioning unit overflow is not plumbed or connected to suitable drainage, which can result in the surrounding area becoming excessively damp. These damp conditions can lead to secondary defects such as rot, rust or corrosion of associated building elements, the formation of fungal decay, or even the creation of potential slip hazards. When coupled with poor site drainage, pooling of water may also attract termite activity to this area. It is highly recommended that a qualified plumber be appointed to install adequate drainage to the overflow. These works will ensure that the area remains dry and free of any secondary defects.

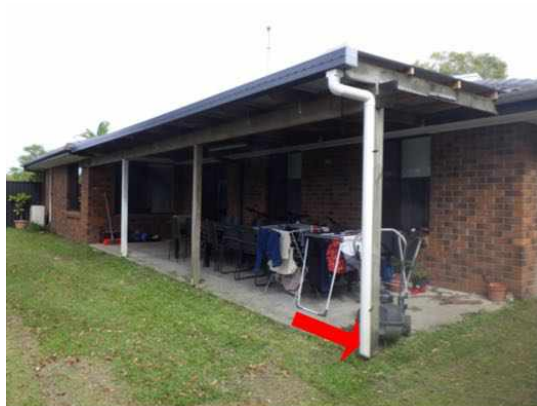
**Finding 6.05**

Building: Main Building  
 Location: Alfresco > Rear Right  
 Finding: Stormwater downpipes

Where roof plumbing doesn't drain as required, the area at the base perimeter can become excessively damp, potentially creating an environment that is susceptible to flooding and rust or corrosion of surrounding building elements, as well as attracting termites and other pests.

It is recommended that a licensed plumber be appointed to further inspect and to extend the down pipes to the properties stormwater line as necessary.

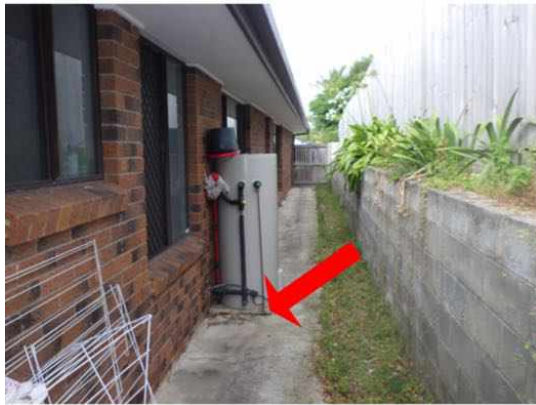
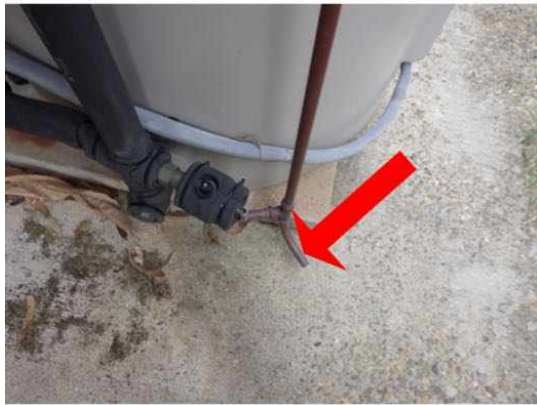
### Finding 6.06

Building: Main Building  
 Location: Exterior walls - left side > Centre Left  
 Finding: Overflow - Not plumbed for drainage  
 Information: The hot water service overflow is not plumbed or connected to suitable drainage, which can result in the surrounding area becoming excessively damp. These damp conditions can lead to secondary defects such as rot, rust or corrosion of associated building elements, the formation of fungal decay, or even the creation of potential slip hazards. When coupled with poor site drainage, pooling of water may also attract termite activity to this area. It is highly recommended that a qualified plumber be appointed to install adequate drainage to the overflow. These works will ensure that the area remains dry and free of any secondary defects.
