# Building and Timber Pest Inspection Report

Inspection Date: Tue, 24 Feb 2026

Property Address: 16 Debussy Place, Cranebrook NSW 2749

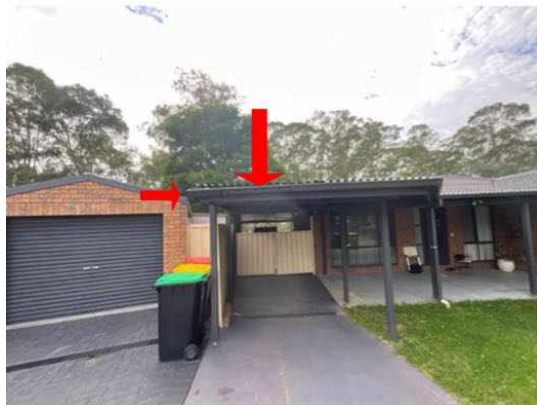
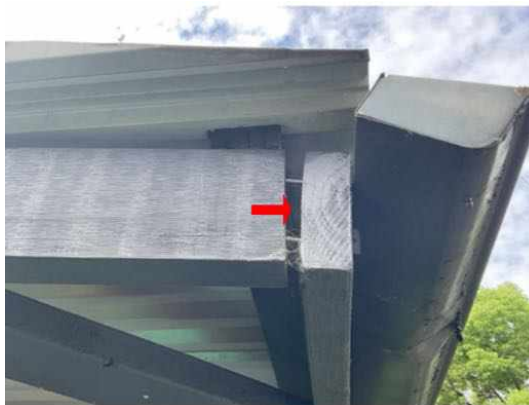
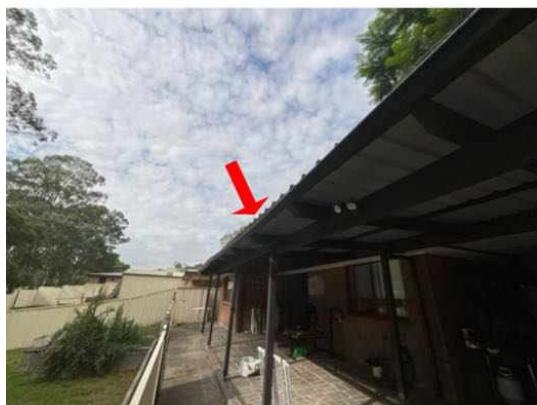
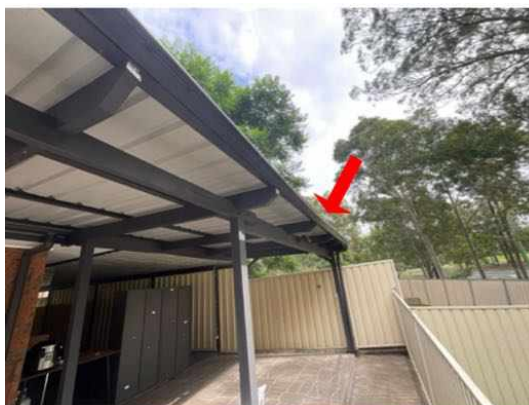
Building:	Main Building
Location:	Roof Exterior
Finding:	Minor Defect – Roof Guttering (Front Carport and Rear Pergola)
Information:	Observation:

At the time of inspection, the roof guttering servicing the front carport and rear pergola was observed to have insufficient fall and/or angle to facilitate effective drainage of rainwater toward the connected downpipes. Localised sagging was evident, resulting in ponding of water within sections of the gutter.

Additionally, minor separation to the roof framing was noted at the front left corner of the structure. The framing members appear to have loosened or shifted slightly, contributing to misalignment in this area.

Inadequate fall and sagging of roof guttering can result in ongoing water ponding. Over time, this may accelerate corrosion of metal components, deterioration of gutter brackets and fixings, and potential leakage into adjoining building elements. Persistent moisture retention may also contribute to conducive conditions for timber decay and, in some cases, increased risk of termite activity in adjacent structural elements.

Minor separation of roof framing, if left unattended, may lead to further movement, misalignment of roof drainage components, and potential progressive deterioration.

It is recommended that a licensed roofing plumber assess and reinstate the correct fall to the affected gutter sections, including repair or replacement of sagging brackets

It is further recommended that a suitably qualified handyman or carpenter carry out minor repairs to the separated roof framing at the front left corner to restore stability and alignment.

Rectification at this stage is considered minor maintenance; however, timely attention is advised to prevent further deterioration and associated costs.

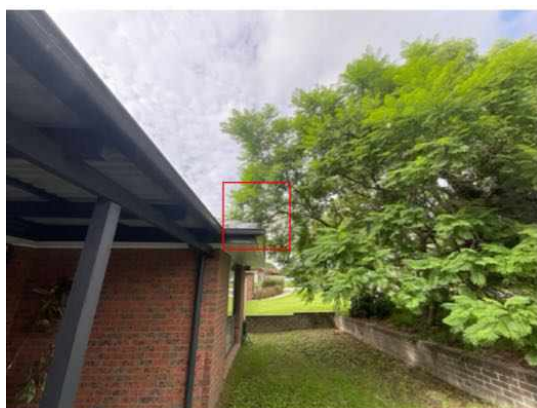
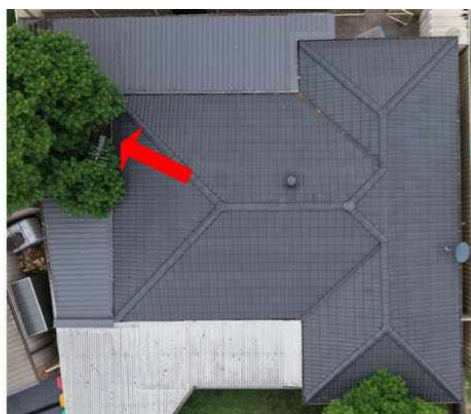
### Finding 3.02

Building: Main Building  
 Location: Roof Exterior  
 Finding: Overhanging Trees and Gutter Maintenance – Observations & Recommendations.  
 Information: Overhanging tree branches were observed above the roofline, contributing to the accumulation of leaf litter and debris within the gutters. This condition can adversely affect the performance of the roof plumbing system, particularly during periods of heavy rainfall.

Blocked or restricted gutters impede the effective discharge of stormwater, increasing the likelihood of water pooling or overflow. This may result in accelerated rusting and corrosion of gutters and downpipes, as well as the creation of damp conditions that

- Prune or remove overhanging tree branches to minimise debris accumulation.
- Clean all gutters and downpipes to restore full drainage capacity.
- Consider the installation of gutter guards as a preventative measure, particularly in heavily treed areas.

General gutter cleaning may be undertaken by the homeowner; however, pruning of larger branches should be carried out by a suitably qualified arborist or landscape contractor. A licensed roof plumber should be engaged to assess the condition of the guttering system and undertake any necessary remedial works. Regular maintenance will assist in preserving roof plumbing components, protecting the building envelope, and reducing the risk of moisture-related damage or pest activity.

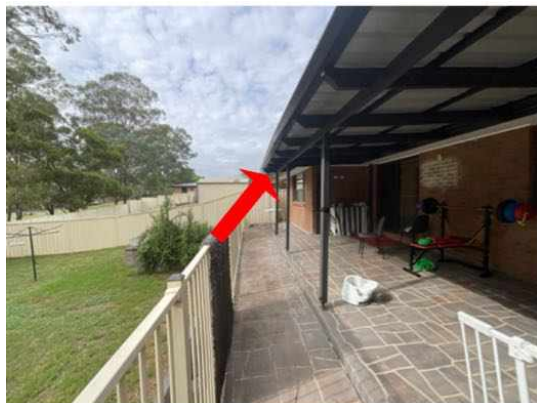
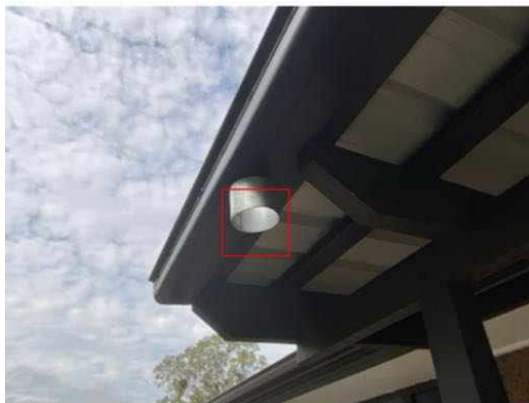
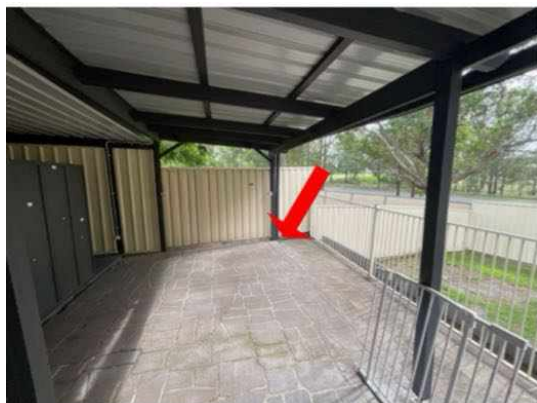
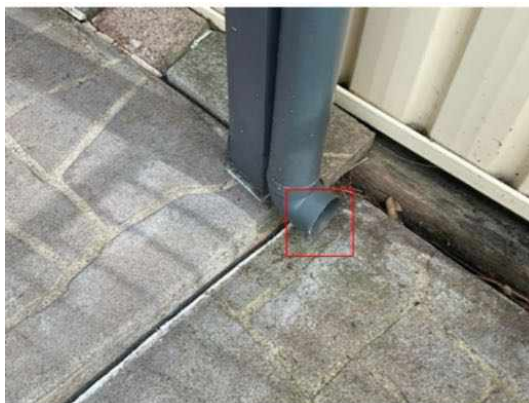
### Finding 3.03

Building: Main Building  
 Location: Roof Exterior  
 Finding: Downpipe – Unconnected.  
 Information: Findings:

Inadequate roof drainage can result in prolonged damp conditions around the foundations, potentially contributing to structural movement, subfloor moisture ingress, and long-term building degradation.

Persistently damp conditions near or under the structure can create an environment highly conducive to termite activity and other timber pests.

The current roof plumbing setup poses both compliance and moisture-management concerns, with the potential to contribute to structural or pest-related issues. Prompt rectification by a qualified professional is advised to ensure proper water management and protect the integrity of the building.

It is recommended that a licensed plumber be engaged to:

- Inspect all roof plumbing and stormwater discharge points
- Repair, replace, or install appropriate downpipes and drainage infrastructure to ensure all roof runoff is directed into a compliant stormwater system
- Assess for any secondary effects of prolonged moisture exposure near the building

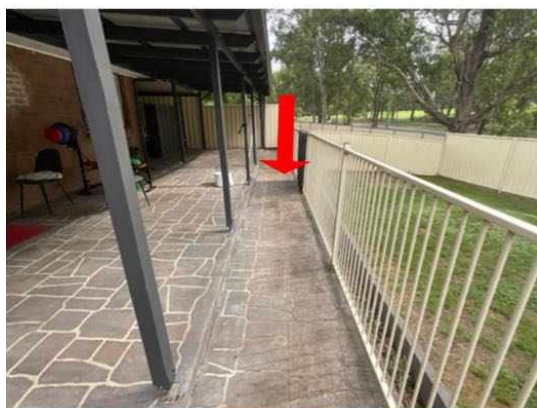
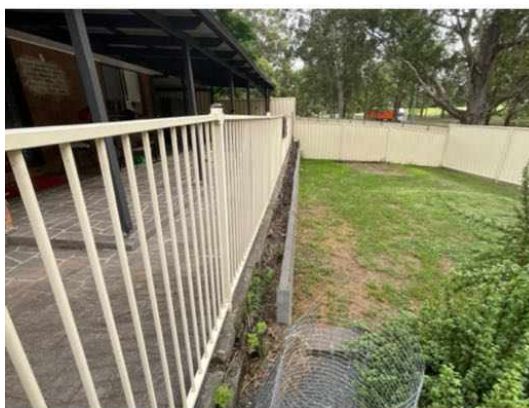
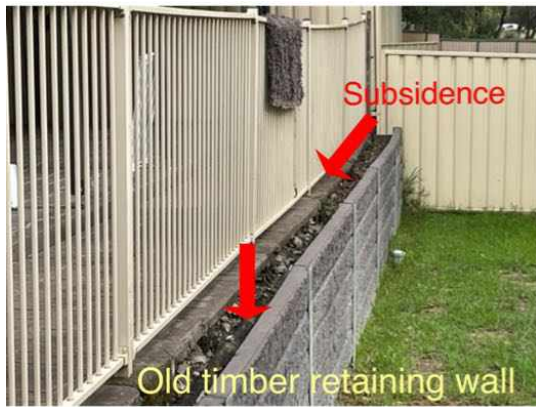
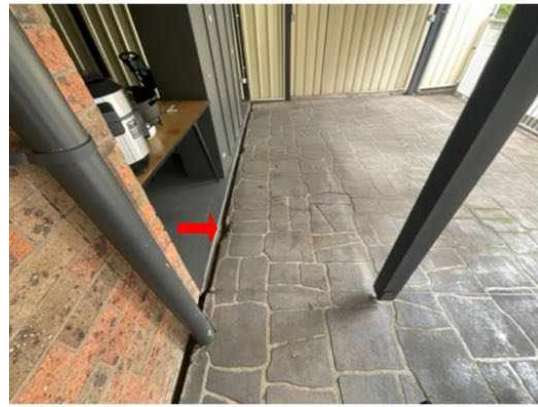
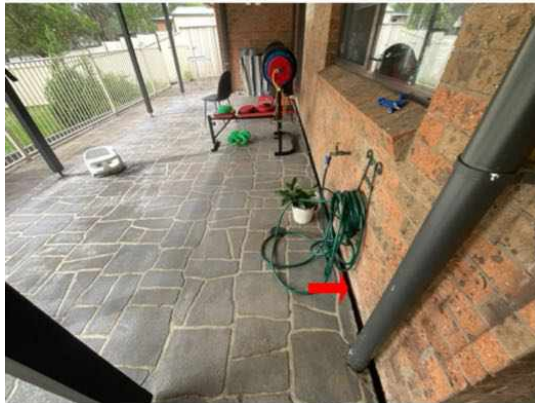
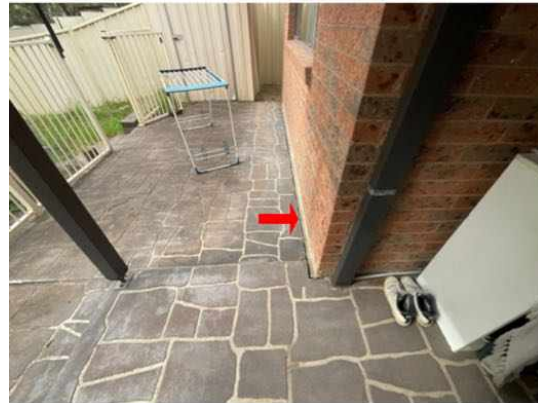
### Finding 3.04

Building:	Yard
Location:	Yard - Back
Finding:	Minor Defect – Movement to Rear Concrete Paving and Associated Retaining Walls
Information:	Observation:

Concrete paving at the rear of the dwelling was observed to have experienced movement consistent with localised subsidence or settlement. The paving has visibly moved away from the external wall of the house, with notable separation gaps evident at the interface. Differential levels across sections of the paving were also apparent.

An older timber log retaining wall was noted adjacent to the rear paving area. This wall appears to be partially buried and only partly visible at the time of inspection. A secondary retaining wall constructed of steel posts and concrete sleepers has been installed in front of the original wall, which appears to have been added at a later stage, possibly as a replacement or reinforcement measure.

The observed separation and displacement of the paving is consistent with ground movement, commonly referred to as sinking or subsidence. This may be associated with inadequate site preparation, insufficient compaction of fill material behind the retaining structures, deterioration of the original timber retaining wall, or changes in soil moisture content over time.

At present, the defect is considered minor as no structural damage to the dwelling was observed in this immediate area. However, if movement continues, it may lead to trip hazards, further separation, drainage issues, or potential impact on adjacent structures. General subsidence is often influenced by reactive soil conditions and fluctuations in moisture levels, and it is important to determine whether the movement is historic and stabilised or ongoing.

It is recommended that the affected area be monitored for signs of further movement, including widening gaps, additional settlement, or cracking. If movement appears progressive, further investigation by a suitably qualified contractor or geotechnical professional may be warranted to determine the underlying cause.

A landscaping contractor or retaining wall specialist may be engaged, at the client's discretion, to assess remediation options. Such works may include re-compaction of fill, drainage improvements, repair or replacement of retaining structures, and reinstatement of paving to restore alignment and reduce trip hazards.

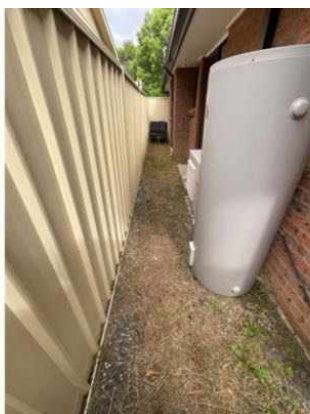
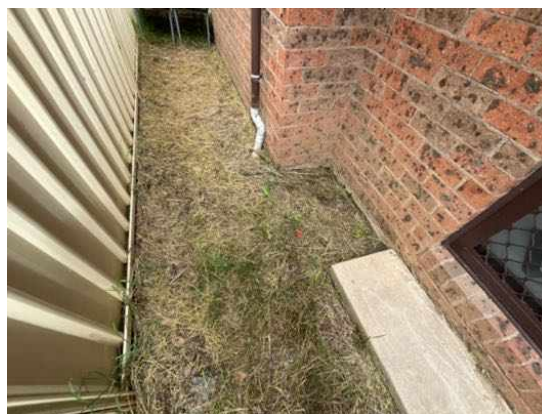
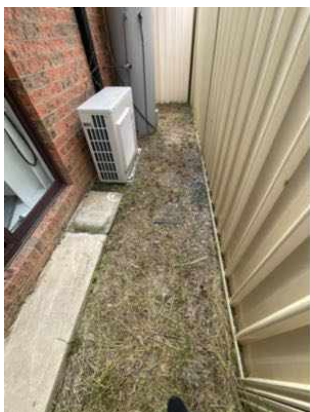
### Finding 3.05

Building: Yard  
 Location: Yard - Right side  
 Finding: Site/Yard Drainage – Below Average.  
 Information: Defect – Below Average Site Drainage

Site drainage in the inspected areas appears to be below average, with no surface drains observed at the time of inspection. Ground surface areas adjacent to the building do not appear to be adequately graded to facilitate effective surface water runoff.

Failure to meet these minimum drainage falls increases the risk of water ingress, foundation issues, and secondary building defects.

- A licensed plumber and/or landscaping contractor should be engaged to:
  - Evaluate the current site grading and surface runoff conditions
  - Install or upgrade surface water drainage (e.g. strip drains, spoon drains, grated channels) as required
  - Improve grading around the building to ensure water flows away from the structure

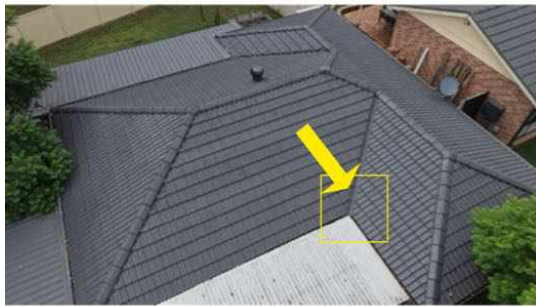
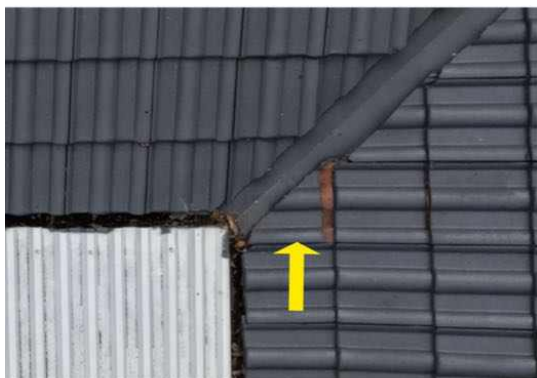
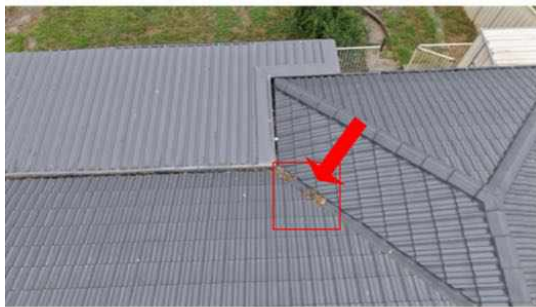
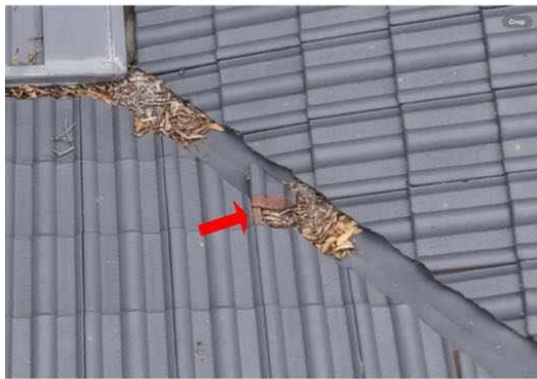
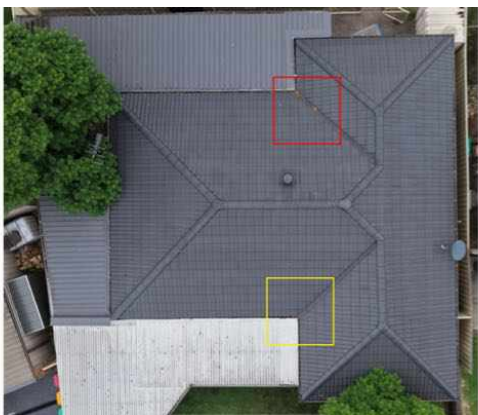
### Finding 3.06

Building:	Main Building
Location:	Roof Exterior
Finding:	Roof tiles - Slipped or Dislodged Tiles.
Information:	Observation:

During the external inspection of the roof covering, it was noted that some roof tiles have slipped or moved from their original position.

- Broken or cracked tiles,
- Failed or deteriorated fixings,
- Movement or degradation of supporting battens.

Immediate rectification is recommended. A licensed roofing contractor should be engaged to:

- Replace or refix any loose or missing tiles, and
- Inspect the roof for any related or underlying issues that may require further attention.

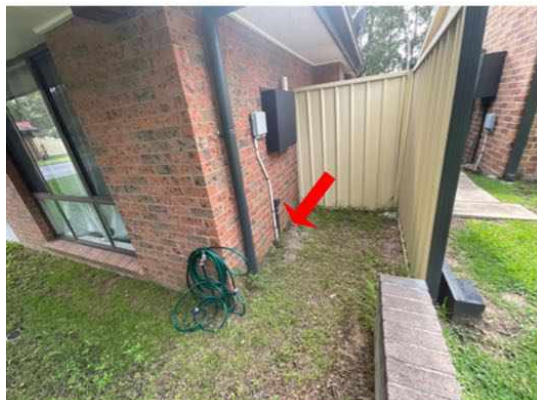
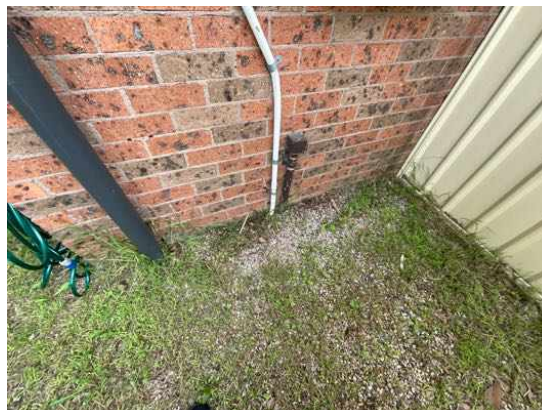
Building:	Main Building
Location:	Exterior walls
Finding:	Plumbing and/or yard drainage - Conducive conditions..
Information:	Observation: Drainage Issues Around Property

Areas of the property—both around the perimeter and within the external yard—were noted to have drainage problems, resulting in water pooling, ponding, or stagnation. These conditions are considered highly conducive to timber pest activity.

At the time of inspection, it was noted that the weep holes in the external brickwork of the property are concealed by adjacent ground level. This creates a bridging point for termites, allowing undetected access over or around the termite barrier system and into the structure. As a result, a full inspection of this area could not be achieved.

- Concealed termite entry becomes possible when weep holes are obstructed by ground levels, paving, concrete slabs, footpaths, garden beds, or built-up landscaping.
- These obstructions also provide moist, shaded environments that are attractive to termite activity.
- Moisture build-up due to covered weep holes further increases the risk of timber pest infestation and wood decay.

It is important that appropriate drainage improvements be undertaken to prevent moisture build-up around the building. This may include plumbing repairs, grading adjustments, or installation of drainage systems.

- Where removal of obstructions is not feasible, it is recommended that the area be inspected regularly, ideally every 3 to 6 months, to monitor for signs of termite activity or moisture-related damage.

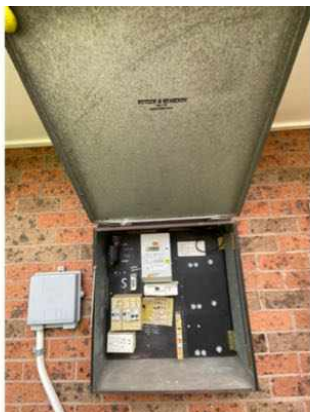
Building:	Main Building
Location:	All Areas
Finding:	Termite Management System - Missing Durable Notice..

Proper maintenance and documentation are essential to ensure continued protection. Without a visible durable notice, there is no clear indication of what system (if any) is in place, which may limit the effectiveness of future termite inspections and hinder warranty claims.
