Building and Timber Pest Inspection Report

Inspection Date: Wed, 25 Mar 2026

Property Address: 11 Pollard St, Wodonga VIC 3690, Australia

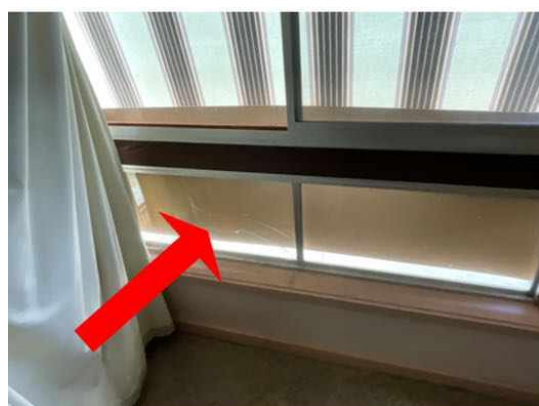
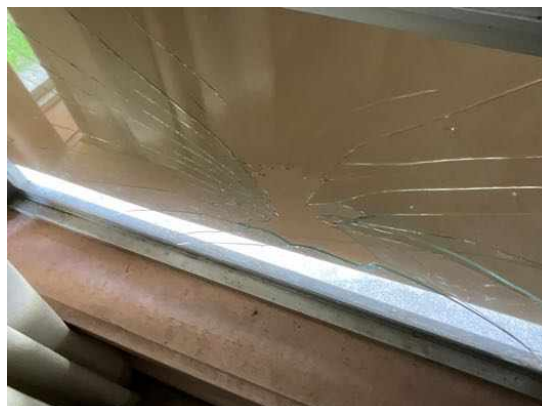
Building:	Building 1
Location:	Bedroom - Master
Finding:	Window - Cracked
Information:	Cracks were identified in the window in this area. Cracking in windows is generally the result of impact damage, and is likely to develop further when left unmanaged.

The likelihood of this windowpane further cracking and shattering is increased exponentially, providing a safety hazard in the area. The cracked window also impairs the weather tightness of the building, creating potential for minor water leaks.

A qualified glazier is required to repair the window as soon as possible. Depending on the extent of the cracking, replacement of the window may be required. Please be advised that any persons coming into contact with the cracked window should do so with due caution to avoid any personal injury that may ensue.

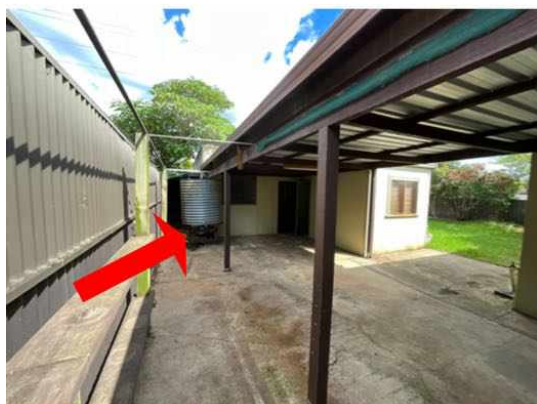
Building:	Building 1
Location:	Shed
Finding:	Tank leaning
Information:	The water tank in this area is poorly supported. This has caused the tank to lean over.

This instability could become dangerous if left unattended.

A builder or tank specialist should be contacted as soon as possible to improve the support and prevent potential damage.

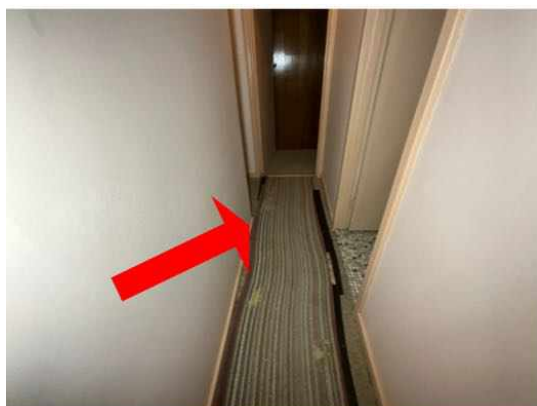
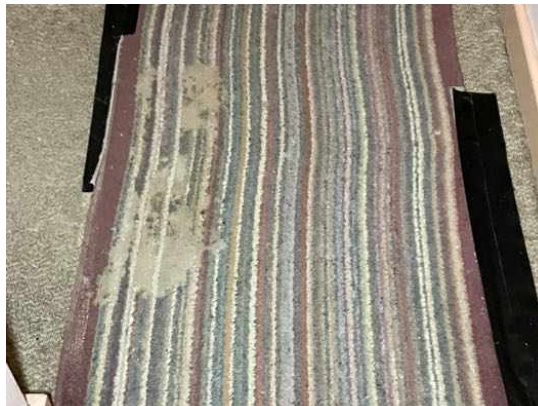
Finding 3.02

Bouncy floors generally indicate that the floorboards or the subfloor structures are coming loose from the joists that they are installed on. Bouncy flooring may also be the result of gaps between flooring and stumps or joist structures, which require packing.

The client is advised to seek quotations for required repairs from a Registered Builder specialising in re-stumping. The potential resolution may range from packing gaps in subfloor structures through to replacement of subfloors stumps and refixing of flooring.

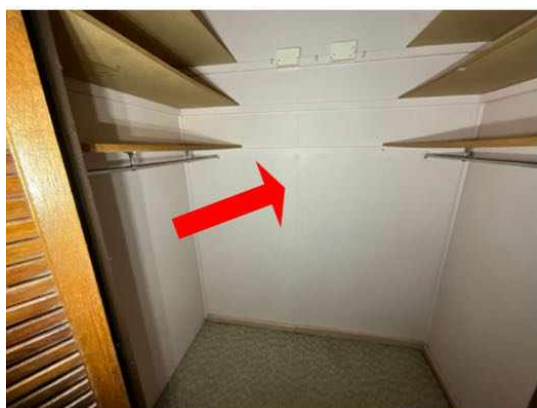
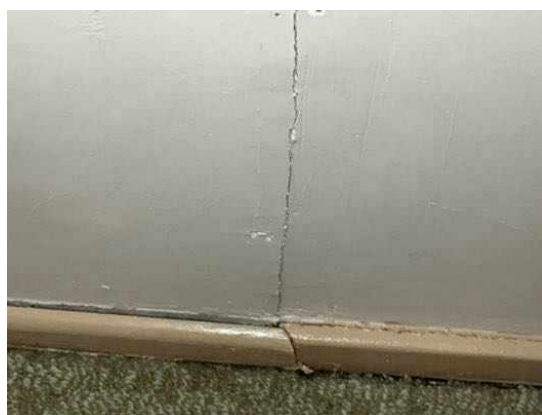
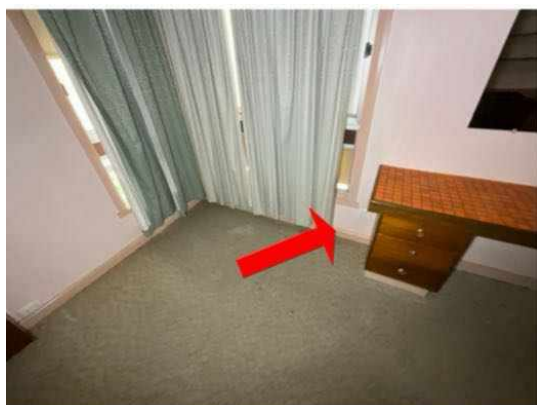
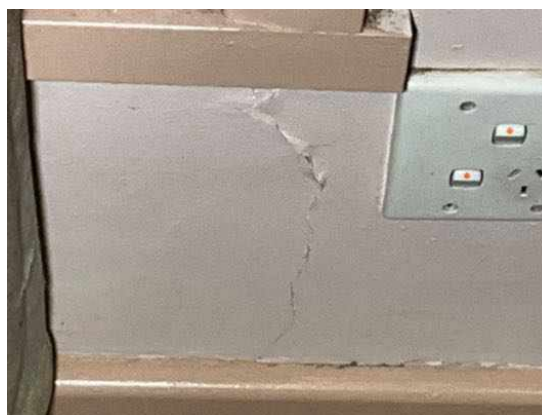
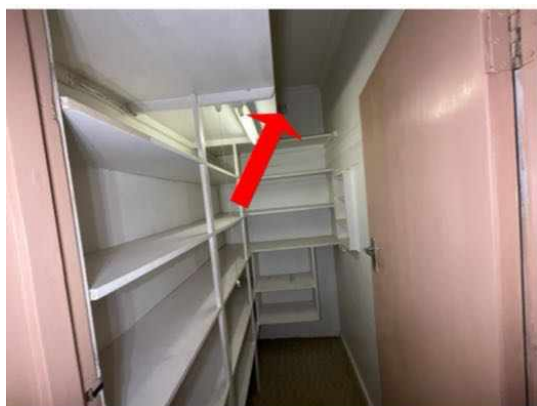
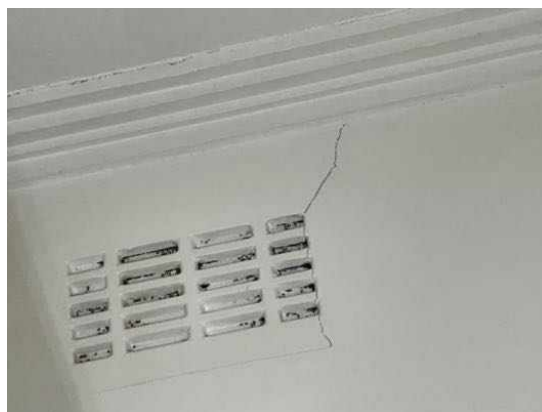
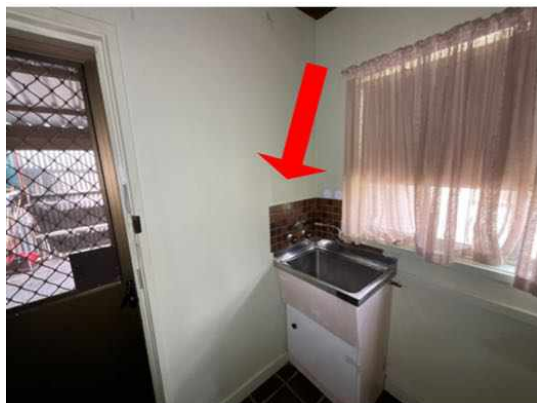
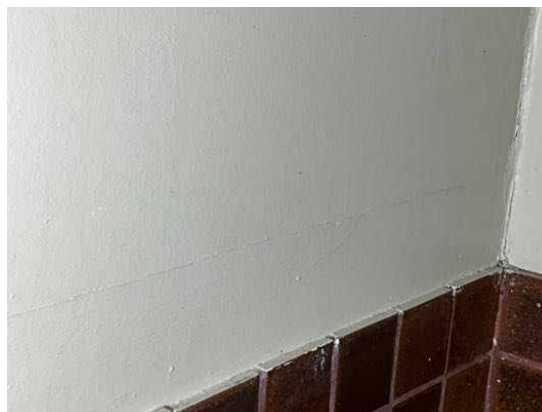
Finding 3.03

Building:	Building 1
Location:	Bedroom - Master, store, laundry
Finding:	Cracking - Damage Category 2 - Noticeable (up to 5mm)
Information:	Noticeable cracks are a common occurrence as a result of many primary defects. Such causes may include age, general wear and tear, expected building movement, general expansion/contraction of building materials in different weather conditions, and/or minor failings in the installation or application of building materials.

Noticeable cracks may result in minor sticking or jamming of associated doors and windows, which require easement. However, noticeable cracks are easily filled and repaired. A plasterer can be consulted to install an expansion joint at this point to allow for this movement during different weather conditions.

Monitoring of all cracking should be conducted frequently. Always contact a building inspector should cracks widen, lengthen, or become more numerous. Additionally, your building inspector should also be contacted if associated building elements such as doors and windows become more difficult to operate over time.

Relevant tradespeople, such as carpenters, painters and plasterers, should be appointed to perform remedial works, as deemed necessary.

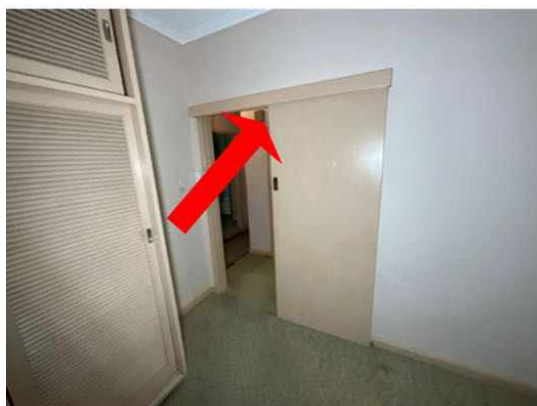
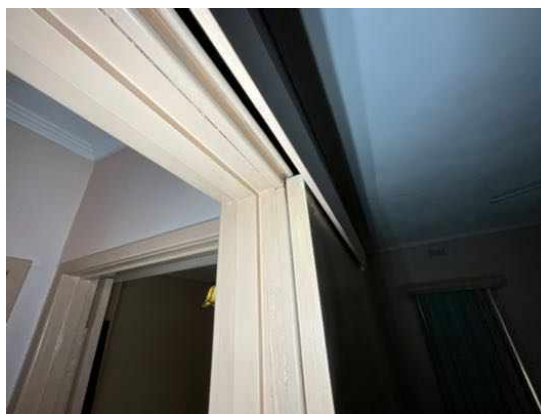
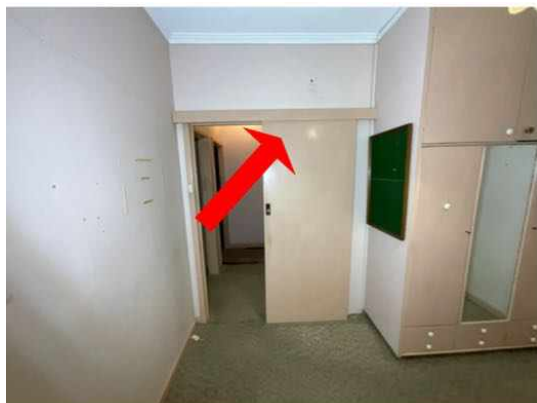
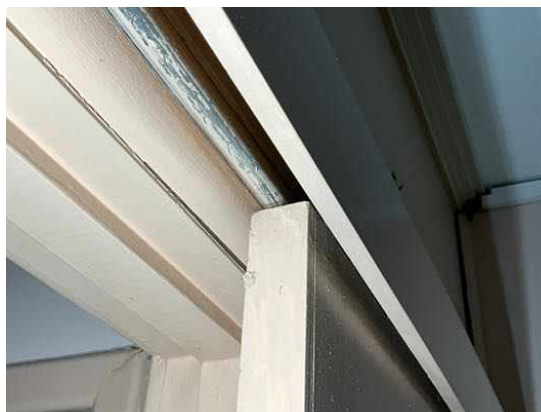
Finding 3.04

Building:	Building 1
Location:	Bedroom 2, 3
Finding:	Door- Stiff to slide
Information:	The door in this area was jammed and difficult to slide along the associated tracks at the time of the inspection. Restricted function of the affected door may pose as a potential safety hazard if required for emergency egress from the building.

Generally, factors such as general age of the building element and a lack of maintenance are the usual causes for this type of defect.

Replacement of door hardware or tracks may be required, as well as minor repairs and cleaning. A registered builder or general handy person will be required to repair the affected doors.

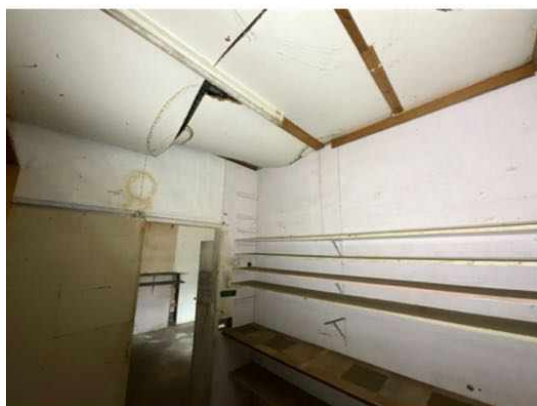
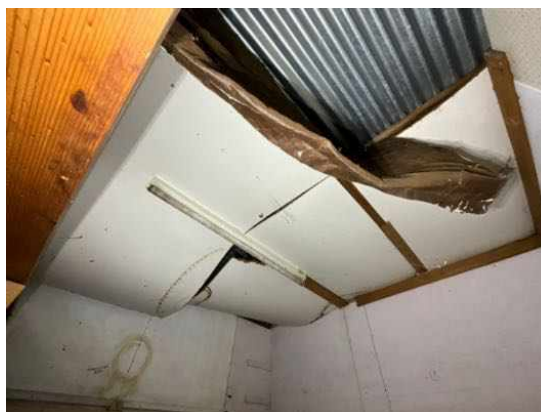
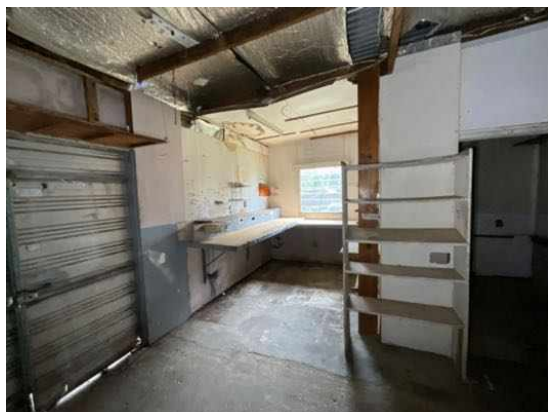
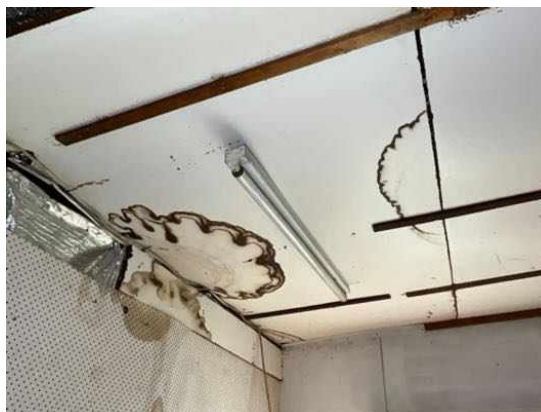
Finding 3.05

Building:	Building 1
Location:	Shed
Finding:	Ceiling - Water damaged
Information:	Water damage to the ceiling lining is generally an indication of excessive moisture being present in the roof void, usually via a leak to the roof covering.

Where water damage is evident to the ceiling, the primary requirement is to identify and rectify the source of the leak. A roofing plumber should be appointed as soon as possible to identify the leak and perform rectification works as necessary, ensuring the water damage is restricted.

Once the leak is repaired, consultation with relevant tradespeople, including plasterers and painters, is advised. Rectification works may include replacement of ceiling lining or minor repainting, depending on the extent of the damage.

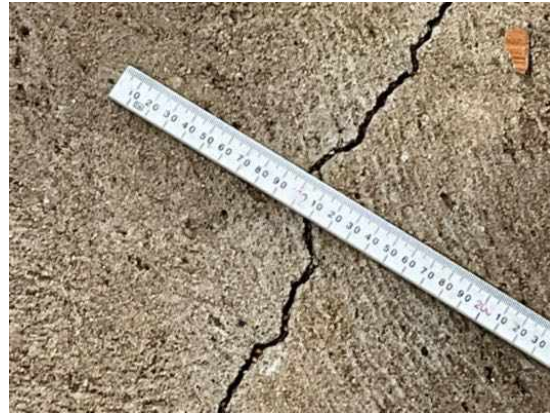
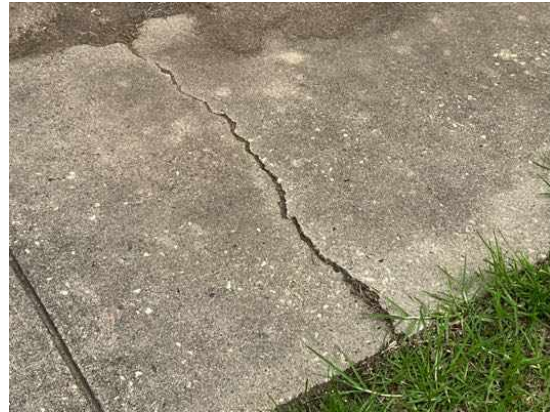
Finding 3.06

Building:	Building 1
Location:	Carport, yard- front
Finding:	Cracking - External Concrete Paving Damage Category 3 - Wide Cracks (2mm - 4mm)
Information:	Wide cracks were identified in external concrete paving Wide cracks are significant and are likely to lead to the development of safety hazards and secondary defects if left unmanaged.

General age and expected deterioration of the paved areas is a common cause of this type of cracking. However, expansion and contraction of the slab may also have occurred due to environmental factors. Such factors include variable moisture and weather conditions, the presence of trees and their roots having a settling or lifting affect on the soil, or the effect of load bearing, e.g. heavy vehicles over a sustained period of time.

Cracking to this degree may also be due to poor original installation of the concrete. Factors such as poor compaction of the sub surface and/or inadequate reinforcing of the slab may create cracking and other secondary defects. Wide cracks may also have a more significant structural cause, such as subsidence of soils.

Where the crack is located adjacent to structural elements of the building, the advice of a Structural Engineer is advisable before undertaking repairs. Significant repair and likely replacement of the concrete paving is probable.

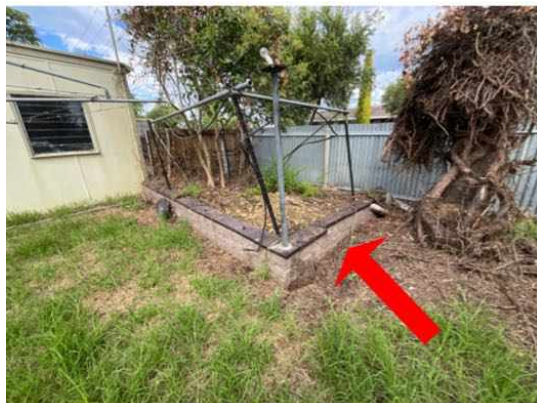
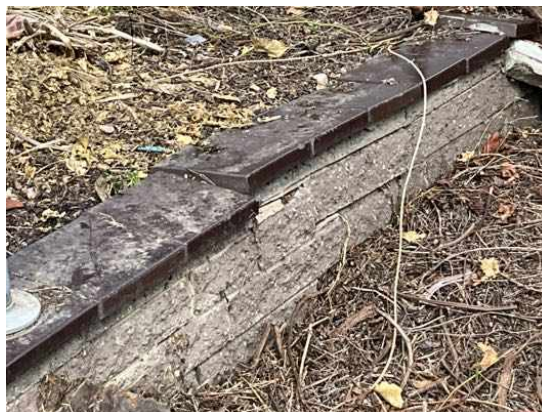
Finding 3.07

Building:	Building 1
Location:	Yard - Back
Finding:	Brickwork- Step cracking
Information:	Step cracking was identified to the brickwork in this area at the time of inspection. Step cracking, which is similar to other forms of cracking, has a variety of possible causes. However, the most common is the subsidence of adjacent footings.

Step cracking is a relatively common defect, and is most likely to occur adjacent to windows, doors and other openings. Mortar failure in the gaps between affected bricks indicates the stresses and tensions affecting the wall.

Minor step cracking can be used as a warning sign to address factors causing stress to the wall, which can include the effect of surrounding trees, water leaks, soil erosion, or even the presence of reactive soils in the surrounding area.

If cracks increase in size or number contact a Licensed builder immediately to make all needed repairs.

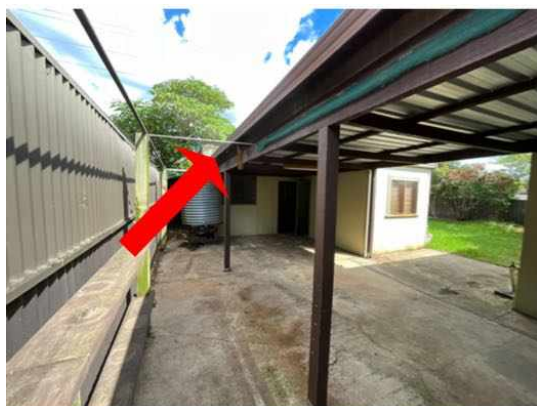
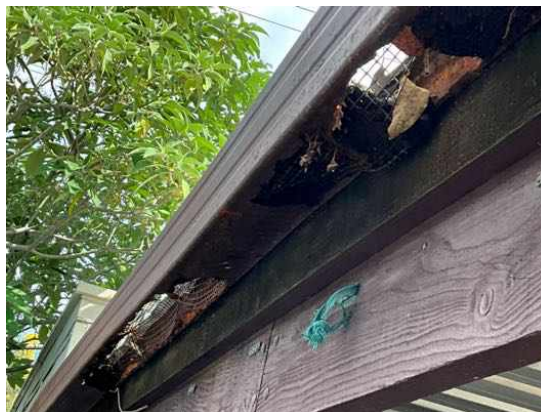
Building:	Building 1
Location:	Carport
Finding:	Gutters- Deteriorated
Information:	The guttering and some downpipes have deteriorated.

Although not a major problem now, they will deteriorate further if left for an extended period.

Sagging can be seen in the gutter.

A Licensed Plumber should be engaged as soon as possible to advise on any repairs or maintenance that may be required.

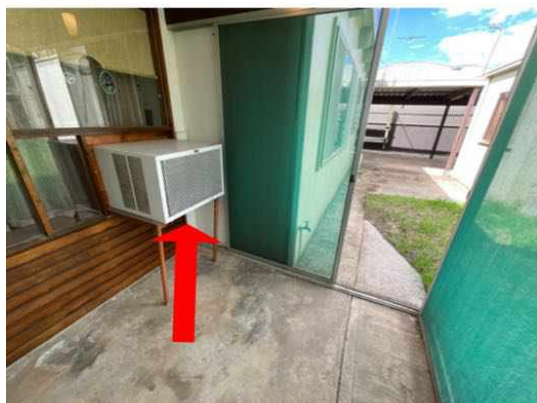
Finding 6.02

Building:	Building 1
Location:	Shade room
Finding:	Air conditioner - Disconnected overflow
Information:	The Air Conditioner (A/C) overflow was found to be disconnected from storm water drainage and is creating excessive moisture in the surrounding area.

Such leaking creates an environment which is conducive to an array of defects, including water damage to associated building elements and the attraction of termite or timber pest infestation.

It is highly recommended that a licensed plumber be appointed to connect the A/C overflow in order to prevent such an environment from being created. These minor works should be carried out as soon as possible.

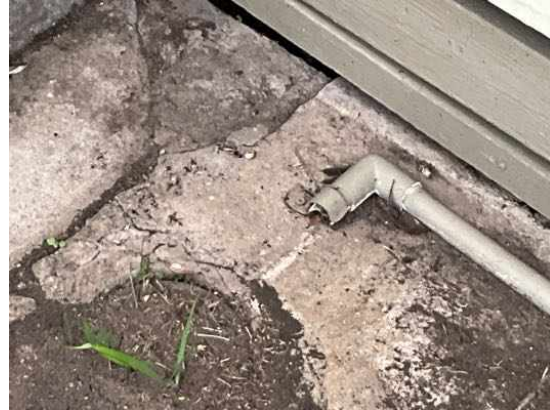
Finding 6.03

Building:	Building 1
Location:	Driveway
Finding:	Air conditioner - Disconnected overflow
Information:	The Air Conditioner (A/C) overflow was found to be disconnected from storm water drainage and is creating excessive moisture in the surrounding area.

Such leaking creates an environment which is conducive to an array of defects, including water damage to associated building elements and the attraction of termite or timber pest infestation.

It is highly recommended that a licensed plumber be appointed to connect the A/C overflow in order to prevent such an environment from being created. These minor works should be carried out as soon as possible.

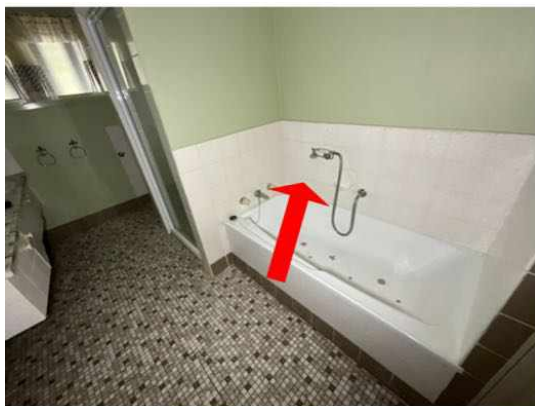
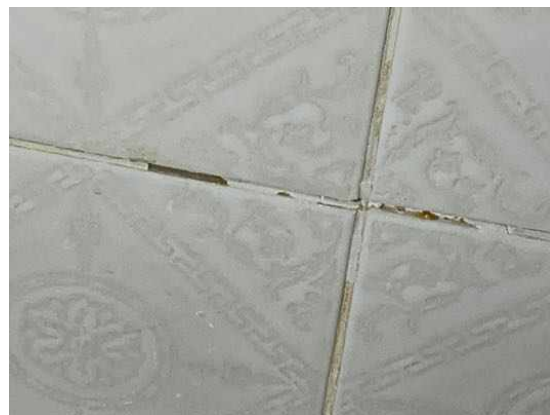
Finding 6.04

Building: Building 1
 Location: Bathroom
 Finding: Inadequate sealant or Grout
 Information: This area has a lack of effective Sealant or Grout. This is allowing the ingress of water to the structure inside the wall.

The presence of water encourages Termite attack, Mould and Fungal Decay.

A Tiler or General Handy person must be contacted as soon as possible to effect repairs and prevent further deterioration.

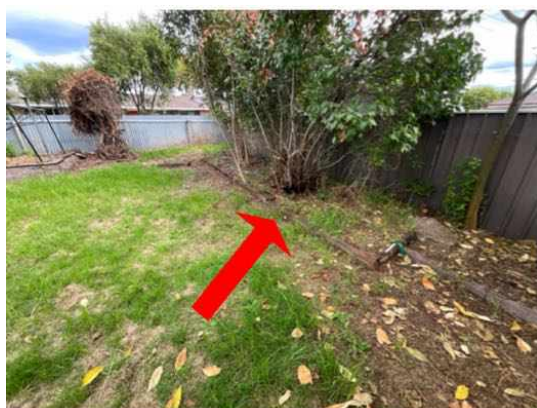
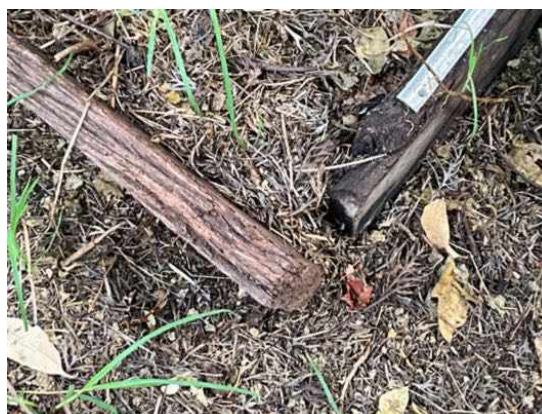
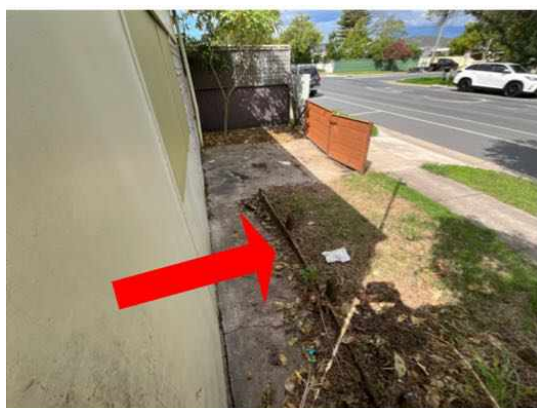
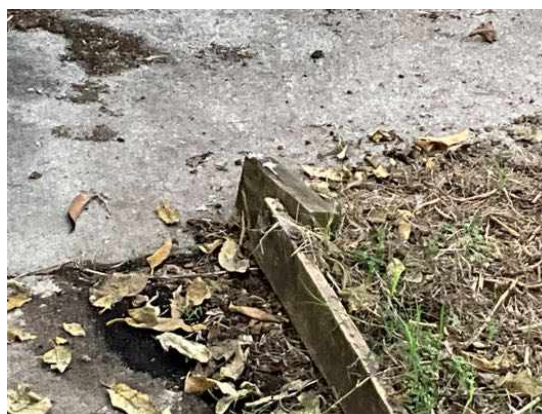
Finding 6.05

Building: Building 1
 Location: Yard - Back
 Finding: Untreated or non-durable timbers in a hazardous environment
 Information: To reduce the risk of timber pest attack it is essential that timber used in a hazardous environment (e.g. in direct contact with the ground or frequently exposed to damp conditions) is of sufficient durability and/or is adequately preservative treated.

Untreated timbers in direct contact with the ground are likely to develop severe wood rot and/or fungal decay if left unattended creating attraction for subterranean termites to infest the timbers from surrounding areas.

If untreated or non-durable timbers are found to be in a hazardous environment it is highly advised that replacement of these building elements be performed as soon as possible to aid the protection of the property against termite / timber pest attack.

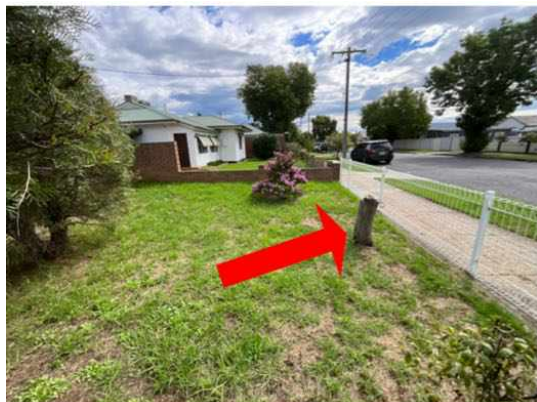
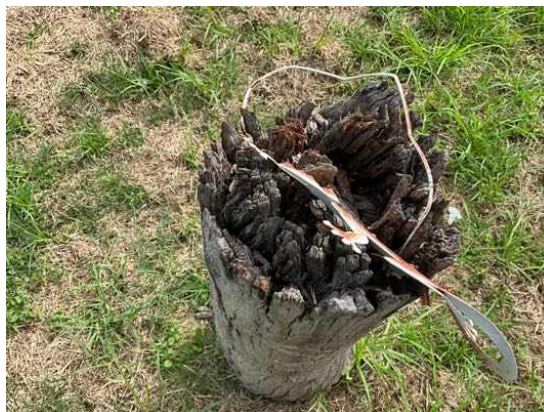
Finding 6.06

Building: Building 1
 Location: Yard - Front
 Finding: Tree Stump in Ground
 Information: Any tree stumps in the yard not removed during the tree removal process provides the opportunity for Termite infestation and is likely to be subject to decay from damp conditions against the stump.

All tree stumps should be removed by professional tree removal services where possible. Meanwhile regular inspections are advised to identify any termite activity in the areas identified.

Services for tree stump removal should be contacted as soon as possible to reduce the risk of timber pest attack.

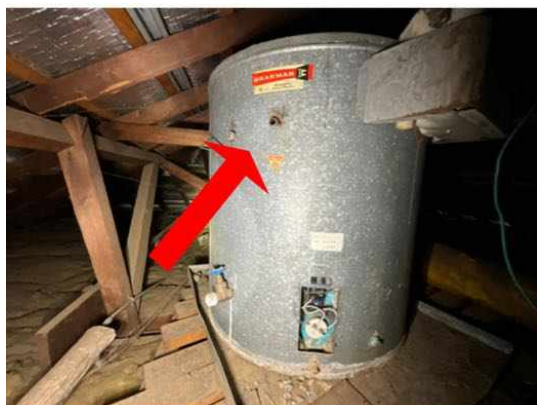
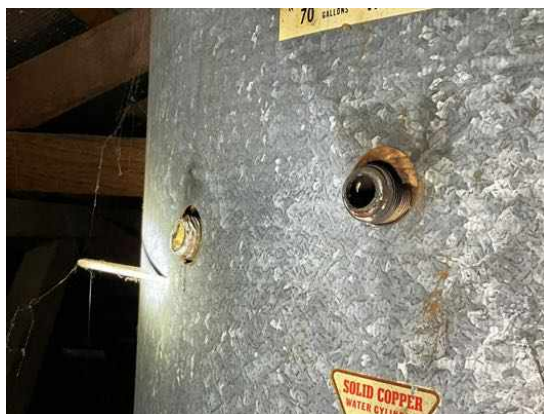
Finding 6.07

Building: Building 1
Location: Roof Void
Finding: Gravity-Fed HWS - Disconnected
Information: It was noted at the time of inspection that a disconnected gravity-fed hot water system (HWS) remains in this area.

Despite this plumbing structure being unused, it is likely to be storing residual water, and is therefore susceptible to rust and corrosion. If allowed to continue, rust and corrosion is likely to lead to damage to adjoining building elements, and may also make the area susceptible to termite or timber pest activity.

While it is a costly exercise to remove the disused gravity-fed HWS, it is advisable in the short-term future to prevent any further damage to the area. Further consultation with a licensed plumber is required to gain further advice on removal of the structure.

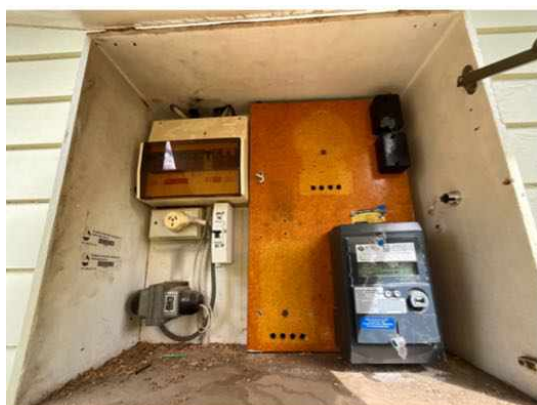
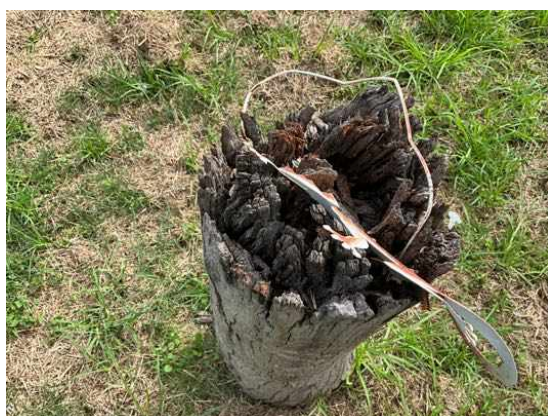
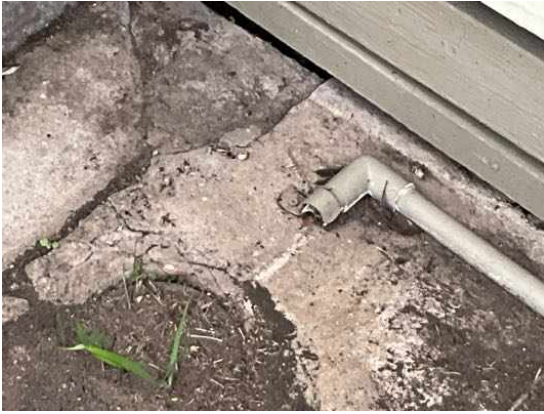
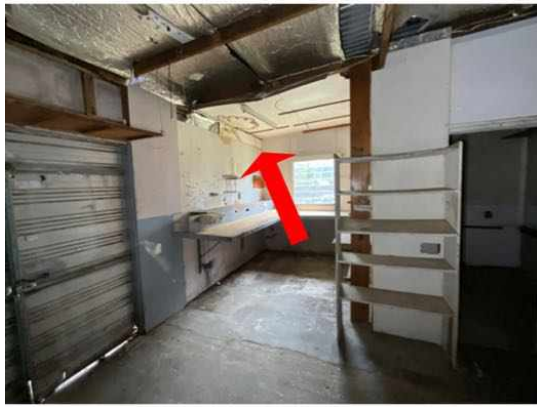
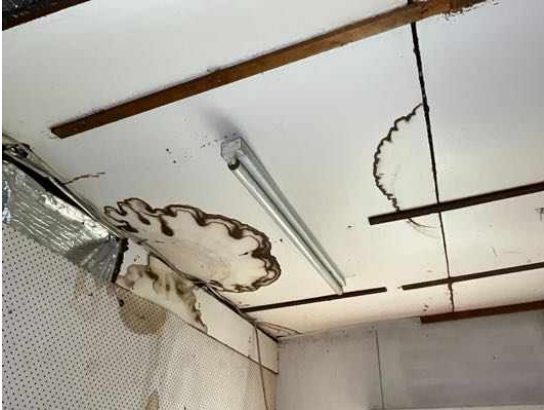
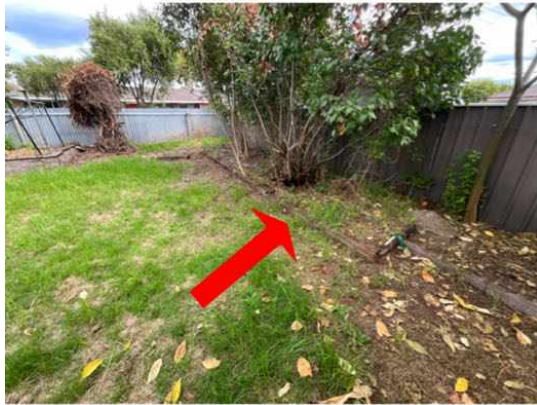
Finding 6.08

Building: Building 1
Location: All External Areas
Finding: Termite Management System - no evidence of a chemical installation
Information: The application of a post-construction chemical termite barrier is highly recommended for all properties, particularly if live termite activity has been found on the site previously. Such barriers are highly effective in preventing termite attack on any timber building elements throughout the property.

A durable notice should be placed in the switchboard unit to indicate current termite barriers. At the time of inspection, it appeared as though no termite management system has been installed, with no evidence to suggest preventative works taking place.

The client may consider gaining further advice from a pest controller as to the costs and procedures involved with this application. It is recommended that obtaining such advice be a short-term priority.

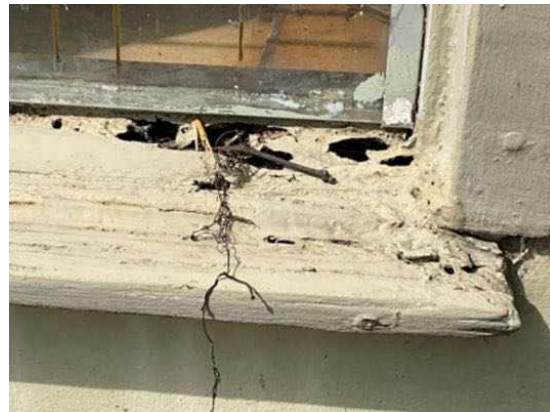
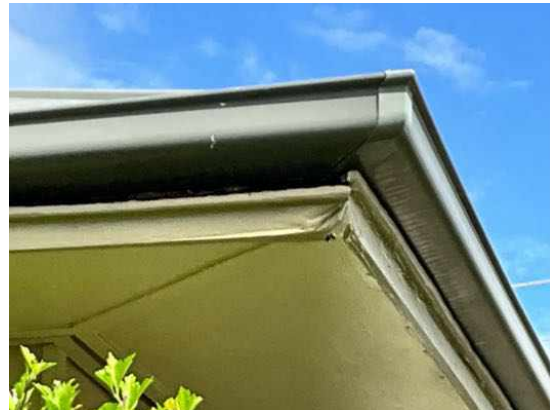
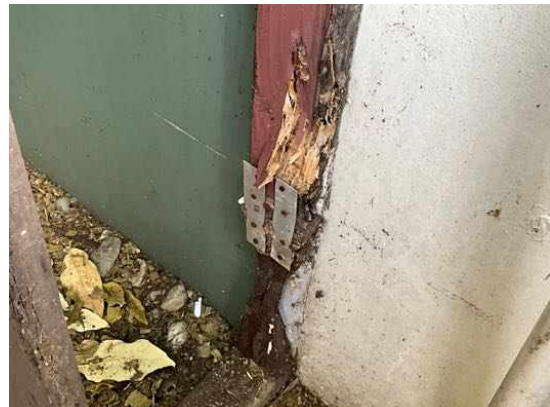
Finding 7.01

Building:	Building 1
Location:	Shed, eaves
Finding:	Fungal decay - present (localised)
Information:	Fungal decay also known as wood decay or wood rot generally refers to the deterioration of timber elements when in contact with excessive levels of moisture for a prolonged period of time.

The development of fungal decay is accelerated by temperatures in the range of 5degreeC to 40degreeC as well as the presence of oxygen. Generally fungal decay develops on timber elements that are in use in an external environment which are exposed to rain penetration.

In this case although the affected timber element is in a decaying state the extent of any visible damage appears to be localised to a specific area and is yet to spread to other parts of the building element or affect adjoining structures. The fungal decay is therefore likely to be of a relatively superficial nature with minimal impact on the structural integrity or tensile strength of the timber element.

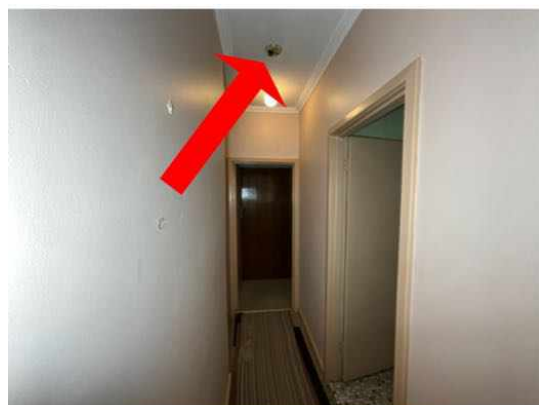
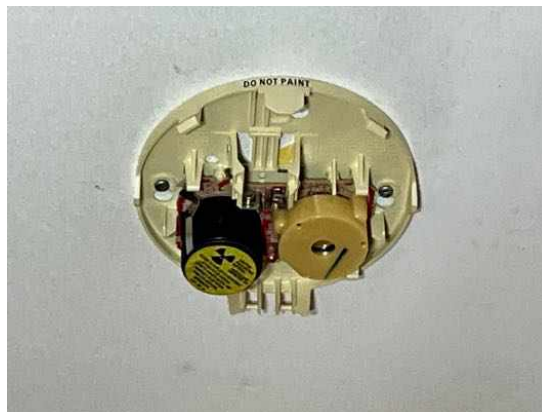
Please note that this defect is highlighted as a caution only. We suspect, based on our experience in the building industry, that the absence of smoke detectors, or their poor condition, should be addressed as a matter of urgency to improve occupant safety.

Please refer to AS3786 and state based legislation, which may also apply.

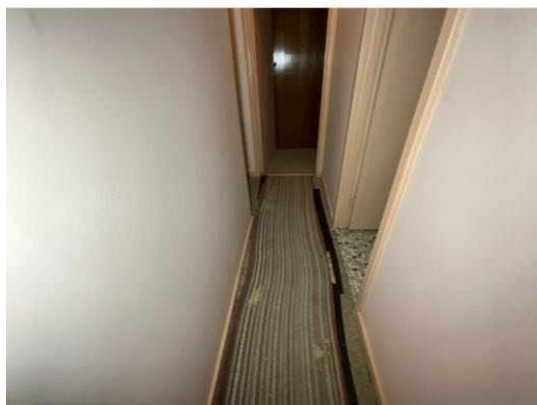
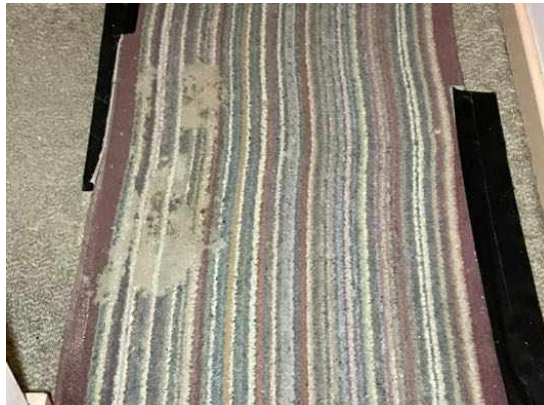
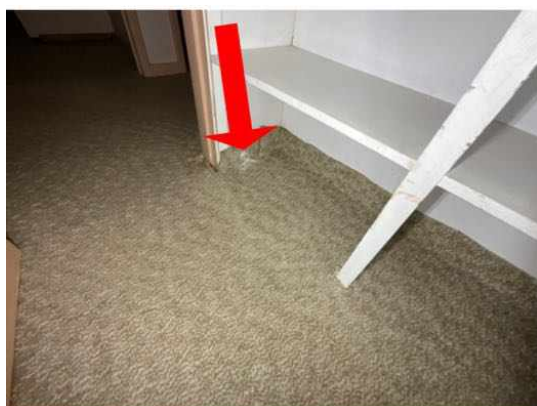
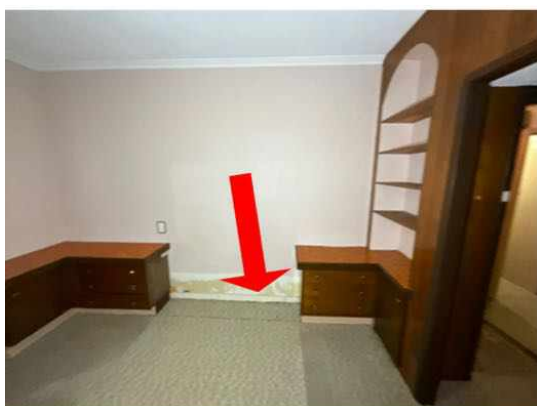
Building: Building 1
 Location: All Areas
 Finding: Carpet -deterioration
 Information: The carpet in these areas is deteriorated. Sections can be seen to be frayed or worn.

A carpet specialist should be contacted at the discretion of the client to make any improvements and prevent further deterioration.

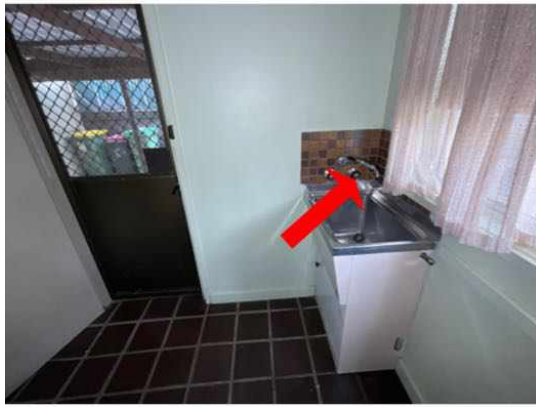
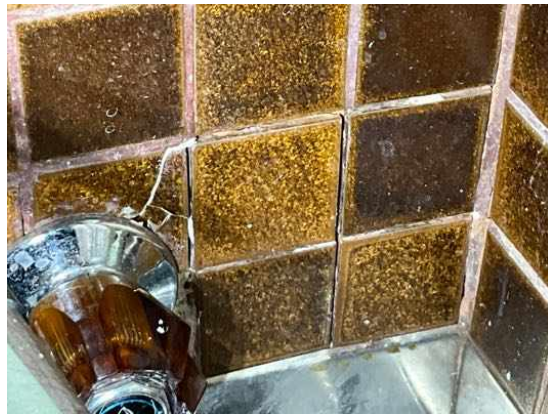
Building: Building 1
 Location: Laundry
 Finding: Inadequate sealant or Grout
 Information: This area has a lack of effective Sealant or Grout. This is allowing the ingress of water to the structure inside the wall.

The presence of water encourages Termite attack, Mould and Fungal Decay.

A Tiler or General Handy person must be contacted as soon as possible to effect repairs and prevent further deterioration.

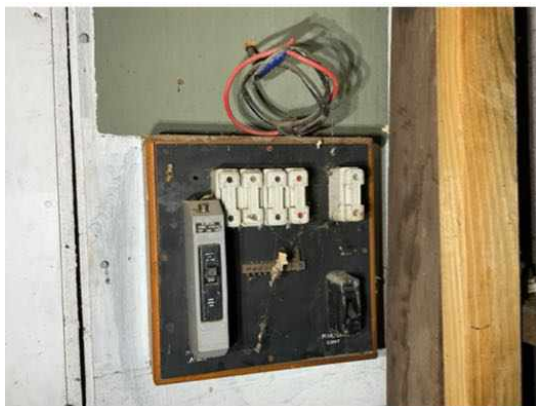
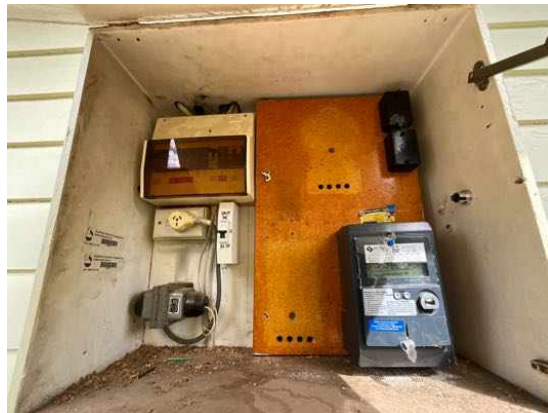
Building: Building 1
 Location: All Areas
 Finding: Electrical wiring dated
 Information: Old electrical wiring was identified. Old electrical wiring represents a potential safety hazard including for fire and personal contact. The safety and function of this wiring cannot be relied upon.

Contact a licensed electrician urgently for further inspection investigation and rectification.
