Building and Timber Pest Inspection Report

Inspection Date: Thu, 2 Apr 2026

Property Address: 18 Rhonda St, Revesby NSW 2212, Australia

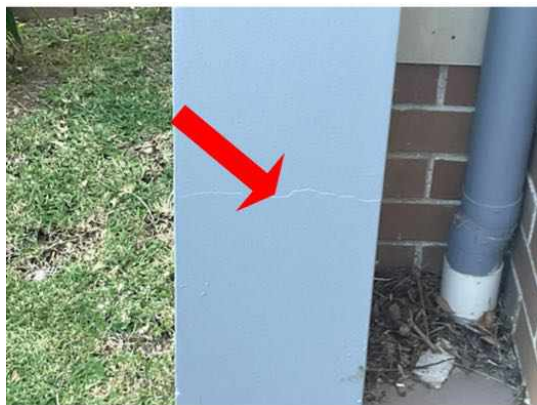
Building: Main Building
Location: All External Areas
Finding: Cracks to external render - Category 1
Information: It has been observed that cracking to external rendered surfaces has occurred. The degree of damage falls within Category 1, described as fine cracks that do not need repair and which are less than 1.0mm in width limit.

Damage of this category is not considered a defect for rectification. Always contact your building inspector should cracks widen, lengthen, or become more numerous.

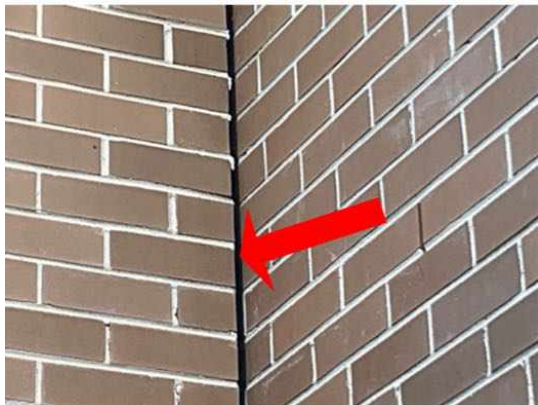
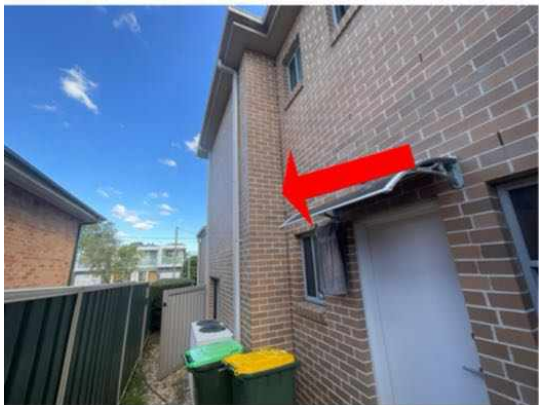
Finding 3.02

Building: Main Building
Location: All External Areas
Finding: Articulation joints - Inadequate of sealant
Information: Articulation joints must be cleaned of all non-compressive material and then sealed with an appropriate flexible sealant. Failure to perform these necessary works is likely to lead to excessive moisture ingress into these joints, or cracking to the brick walls during extreme weather conditions, which may carry major implications for associated building elements if left unmanaged.

Appointment of a qualified tradeperson is advised to perform remedial works as necessary.

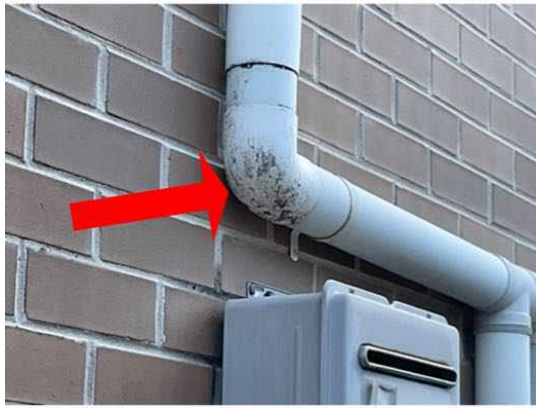
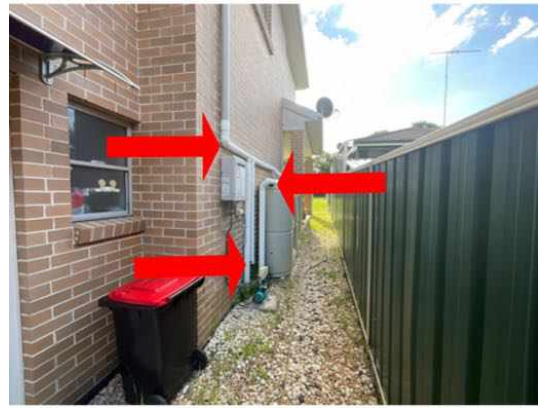
Finding 3.03

Building: Main Building
Location: All External Areas
Finding: Rain Water Tank - Leaking
Information: Dampness to localised sections of the rain water tank area was identified. It is suspected that this dampness has occurred due to leaking of the tank in this area. Excessive moisture also creates an environment which is conducive to termite and pest infestation.

A builder should be appointed immediately to replace the rain water tank. This will ensure a dry areas as well as improving the water efficiency of the property.

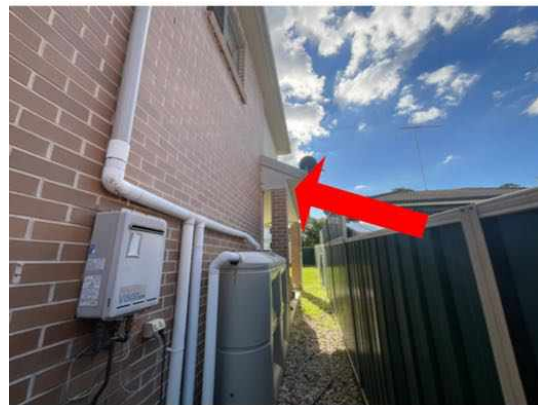
Finding 3.04

Finding: External Cladding - Damaged

Information: At the time of inspection, the external cladding at the front elevation was found to be damaged. Further inspection by Licensed Building or Qualified Carpenter is highly recommended to ensure its safety and structural integrity of the area. If left unmanaged, the area is likely to deteriorate further, potentially creating not weather tight.

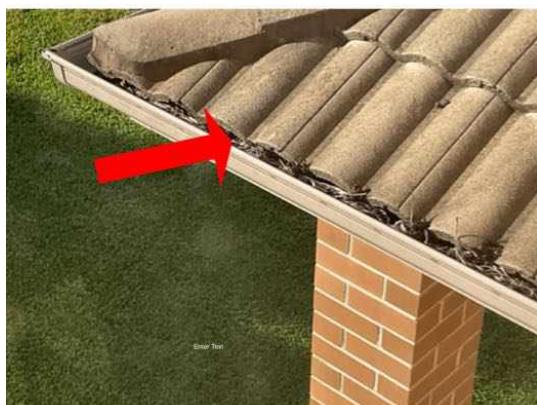
Finding 3.05

Blocked gutters are likely to lead to high levels of moisture in the affected areas. Such moisture will not only cause rust and decay of the associated building materials, but can also provide conditions that are conducive to termite and timber pest activity. Blockages in gutters should therefore be removed immediately to ensure dry conditions are maintained.

Consult a Licensed Plumber for further specific advice on remedial works that may be required. In the interim, it is highly advised that blocked gutters be removed by the homeowner or a general handyperson as a matter of urgency.

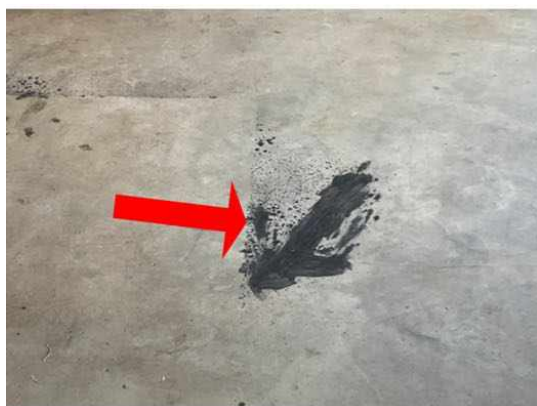
Building: Main Building
Location: All Internal Areas
Finding: Surface - Requires cleaning
Information: Regular cleaning and maintenance improves the longevity of all building elements. A build up of dirt and debris can reduce the useful life of building materials and may result in earlier replacement of items being required.

Excessive dirt is also likely to lead to secondary hazards, including potential health hazards, as the building elements begin to harbour bacteria and/or mould.

Remedial cleaning is recommended in order to improve the appearance of this area as well as to counteract the development of bacteria. Such works can be performed by a cleaning contractor and should be completed at the discretion of the client.

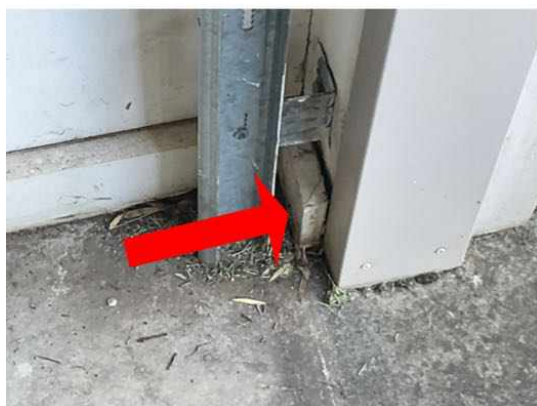
Building:	Main Building
Location:	Garage
Finding:	Excessive moisture - identified
Information:	Excessive moisture can attract termites and produce conditions that promote fungal growth and wood decay.

Excessive moisture is generally caused by deteriorated, inadequate or missing roof drainage, leaking plumbing pipes or fixtures, poorly plumbed HWS overflows or condenser units and poor site drainage.

If mould growth has been found there may be environmental biological or health issues involved. In these cases an appropriately qualified inspector should also be contacted.

Prior to any remedial works being performed a qualified plumber should be appointed to further inspect the property and to identify the cause of the excessive moisture. Works to remove affected building elements may then be necessary and should be performed by an appropriate tradesperson.

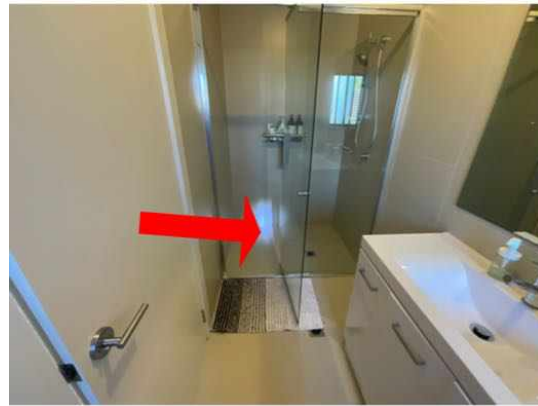
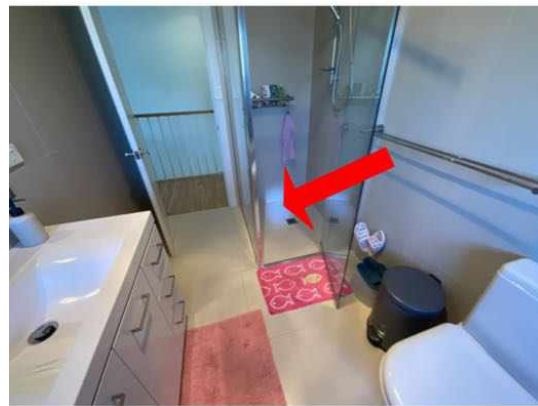
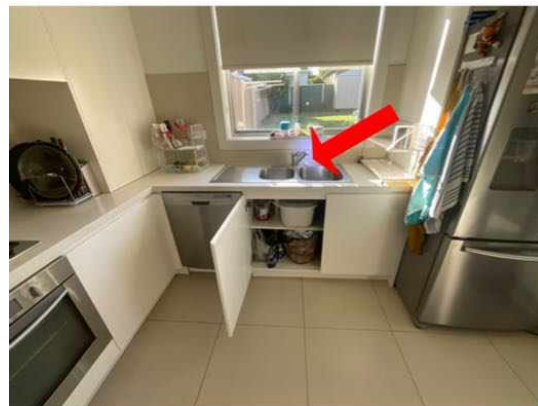
Finding 3.16

Building:	Main Building
Location:	Bathroom / Ensuite / Kitchen
Finding:	Sealant and grouting - Missing or damaged
Information:	It was noted on inspection that sealant or grout is degraded to the tiled shower alcove and or other areas of the bathroom.

Different materials and floor areas move at different rates, generally causing cracking to grout or sealant at this point. A flexible sealant is required to allow for expected expansion and contraction, while keeping the joint water tight and protective of all associated building materials.

There appears to be excessive mould to the sealant and grout which will likely require scraping out and replacement.

Flexible and mould resistant materials should be applied to affected areas to prevent any subsequent water damage that is likely to occur. Regular maintenance and replacement of damage or missing or damaged sealant and grout is highly recommended to the wet areas, as this is a regular wear and tear defect. Sealant and grouting in areas that come into regular contact with water should be maintained for the long term care of your property.

A sealant specialist or tiling contractor should be appointed to complete these works

as soon as possible

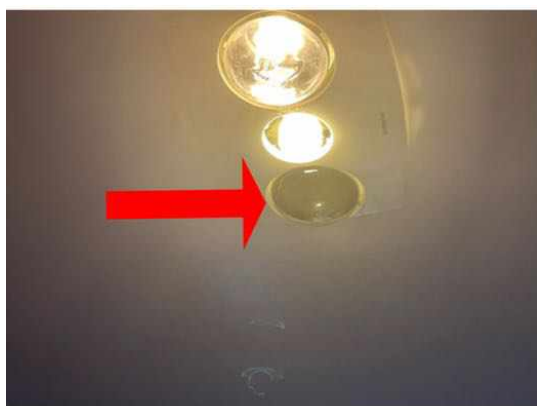
Building: Main Building
 Location: Bathroom / ENS
 Finding: Light fitting - Damaged
 Information: The light fitting in this area was found to be damaged at the time of inspection. Damage occurs generally when the building materials have aged and decayed, but may also be indicative of impact damage to the building element (accidental or deliberate).

Left unmanaged, the fitting is unlikely to cause further damage to surrounding building elements. However, the broken light fitting may expose electrical works, and may create a minor safety hazard if there is potential contact with persons in the area.

Repair and/or replacement of the damaged fitting is advised. A Licensed electrician should be appointed to repair/replace the light fitting at the client's discretion.

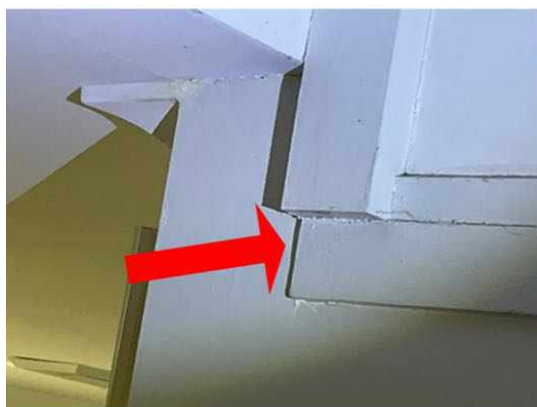
Finding 3.20

Building: Main Building
 Location: All Internal Areas
 Finding: Paint finish - Substandard, Wear and Tear
 Information: The paint finish in this area was found to have been completed to a substandard level or wear and tear as the normal deterioration of a property from ordinary, everyday use. Exposure to the elements, time, as well as day to day living can cause fair wear and

If this applies, further areas of poor and incomplete finishes could develop over time. Furthermore, substandard, wear and tear paint finishes in areas exposed to moisture, e.g. external areas or wet areas, could lead to deterioration of underlying building materials.

Substandard, wear and tear paint finishes should be sanded back, filled, leveled and repainted, as applicable. Where inadequate paint protection has led to the deterioration of the associated building element, repair and/or replacement of this building element may be required.

A painting contractor should be appointed as soon as possible to perform necessary works to aid the appearance of the affected area and to ensure that the area is protected against further deterioration. Alternatively, the homeowner following manufacturer instructions may be able to provide this service.

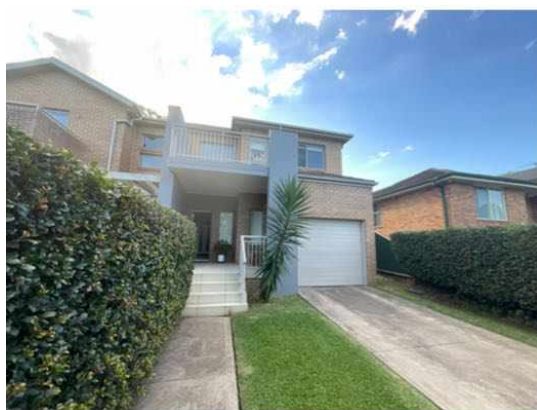
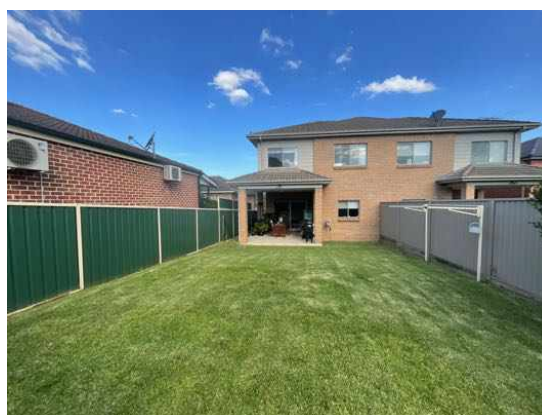
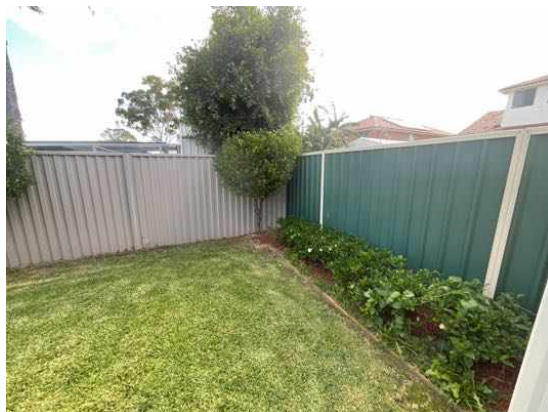
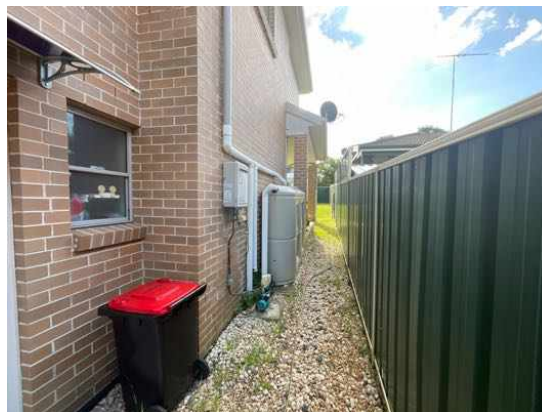
Finding 6.01

Building: Main Building
 Location: All Areas
 Finding: Garden Beds - Conditions Conducive to Termites
 Information: Garden beds were found to be evident in the garden area. These garden beds can include untreated timber, and with a combination of moisture from watering hosing can make conditions conducive to termite activity and termite ingress.

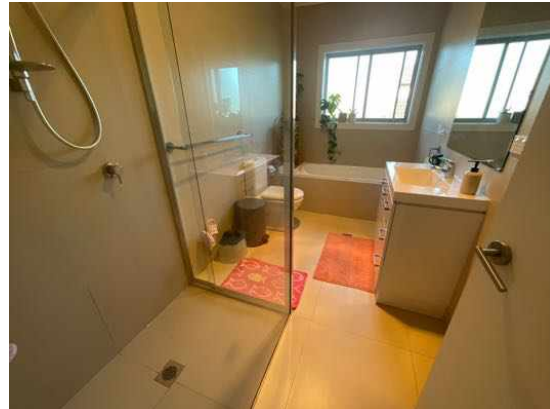
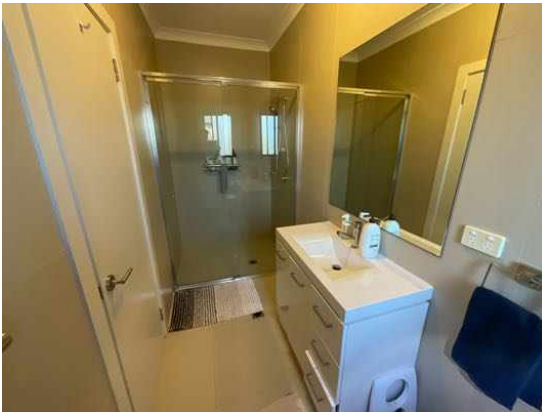
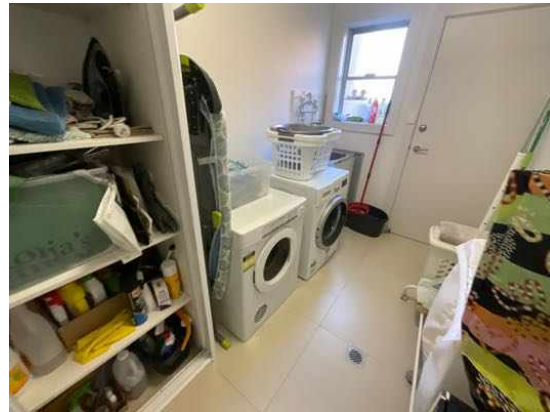
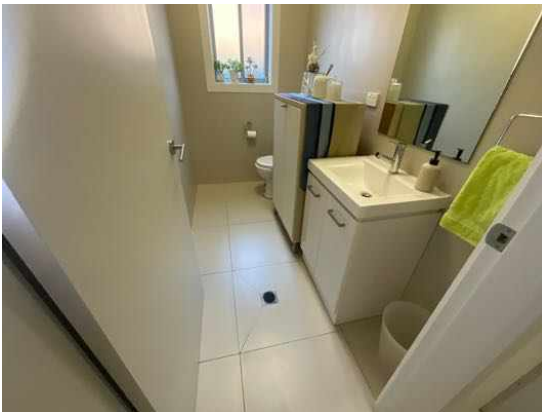
Building: Main Building
 Location: All Areas
 Finding: Water Proofing Membranes - Information Only
 Information: Internal Water Proofing Membranes, are crucial in preventing water ingress into the property is important to know that the Membrane System used is to Australian Standards and has been installed correctly. Please refer to the original Building Documents or Maintenance Schedule for the relevant information including; - Membrane used and Manufacturers Specifications. - The Installer and Installation Certification. Especially with older property's where this information is unavailable, all wet areas should be monitored. Generally new waterproofing with a certificate may

only have a guarantee of 8yrs. If any leaks, water staining, peeling or bubbling of the paint become evident to any adjacent walls or ceilings below a licensed builder or waterproofing specialist is recommended to investigate further.
