# Building and Timber Pest Inspection Report

Inspection Date: Sun, 8 Feb 2026

Property Address: 4/57A-61 millet street Hurstville

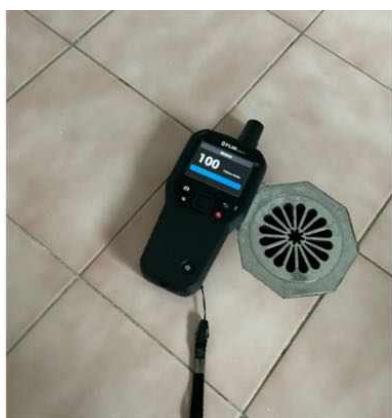
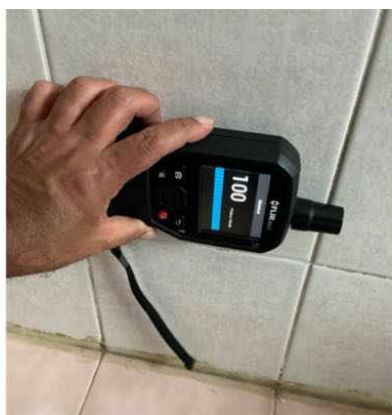
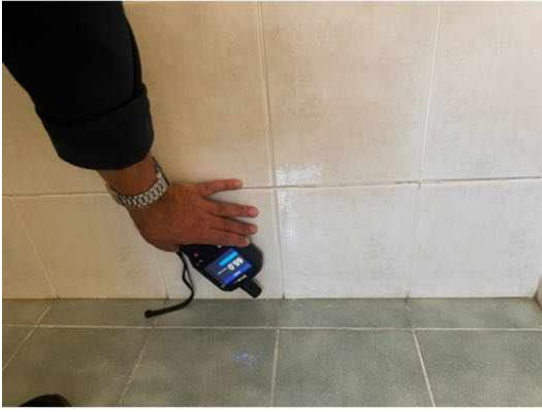
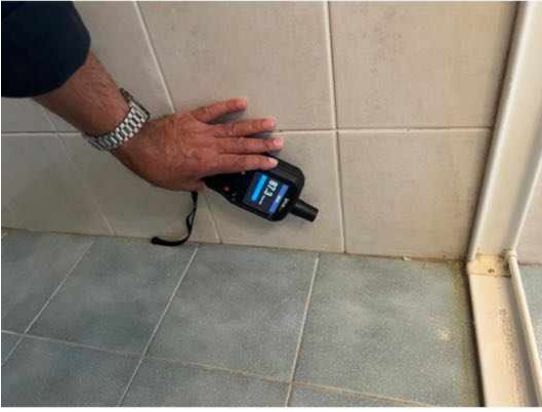
#### Finding 2.01

Building: Main Building  
Location: Bathroom, ensuite  
Finding: Elevated Moisture Bathroom & Back of shower  
Information: Elevated moisture levels were detected to tiled surfaces in bathroom/shower areas. This may be due to porous or missing grout, cracked tiles or recent use, however the possibility of waterproofing membrane failure or plumbing leaks cannot be excluded. Persistent moisture ingress can lead to concealed damage, including timber rot and mould growth. Further investigation by a licensed plumber and/or waterproofing contractor is recommended as soon as possible. The back of shower area also showed elevated moisture with minor surface deterioration evident at the time of inspection.

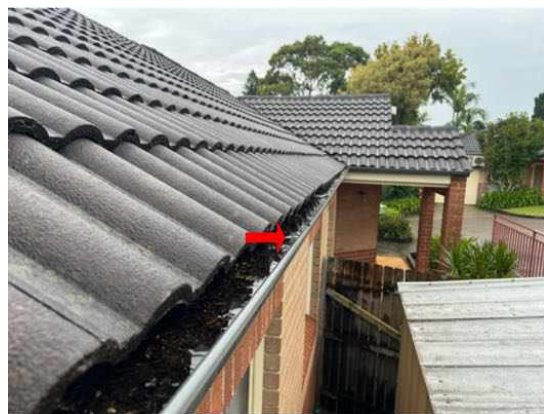
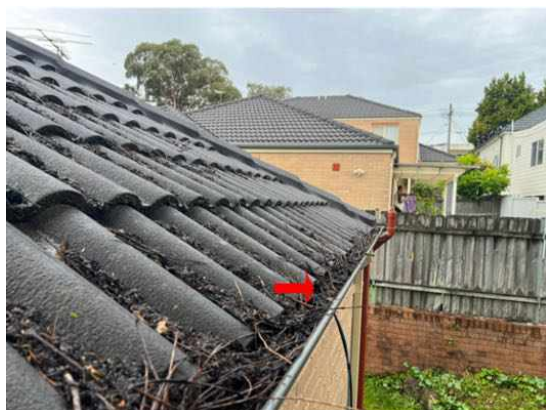
## Finding 2.02

Blocked gutters are likely to lead to high levels of moisture in the affected areas. Such moisture will not only cause rust and decay of the associated building materials, but can also provide conditions that are conducive to termite and timber pest activity. Blockages in gutters should therefore be removed immediately to ensure dry conditions are maintained.

Consult a Licensed Plumber for further specific advice on remedial works that may be required. In the interim, it is highly advised that blocked gutters be removed by the homeowner or a general handyperson as a matter of urgency.

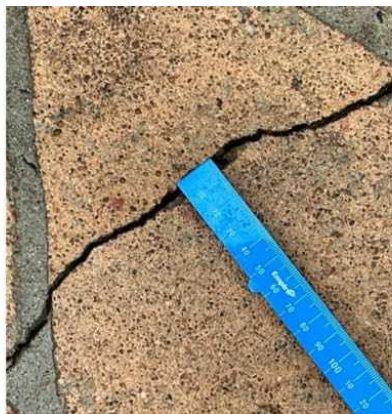
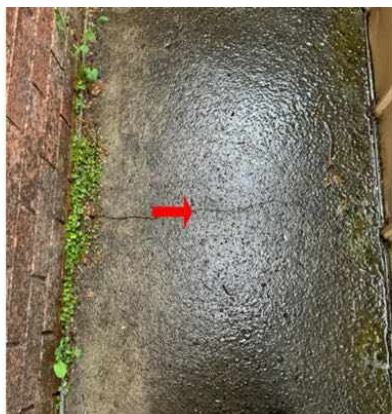
### Finding 3.01

| Finding: | Cracking - External Concrete Paving Damage Category 4 - Gaps in Slab (4mm - 10mm +) |
| Information: | Gaps in the slab were identified in external concrete paving. Gaps in the slab are significant and are likely to lead to the development of safety hazards and secondary defects if left unmanaged, such as the creation of a trip hazard. |

General age and expected deterioration of the paved areas is a common cause of this type of cracking. However, expansion and contraction of the slab may also have occurred due to environmental factors. Such factors include variable moisture and weather conditions, the presence of trees and their roots having a settling or lifting affect on the soil, or the effect of load bearing, e.g. heavy vehicles over a sustained period of time.

Cracking to this degree may also be due to poor original installation of the concrete. Factors such as poor compaction of the sub surface and/or inadequate reinforcing of the slab may create cracking and other secondary defects. Gaps in the concrete paving may also have a more significant structural cause, such as subsidence of soils.

Where gaps in the concrete paving are adjacent to structural elements of the building, the advice of a Structural Engineer is advisable before undertaking repairs. Significant repair and likely replacement of the concrete paving is probable.

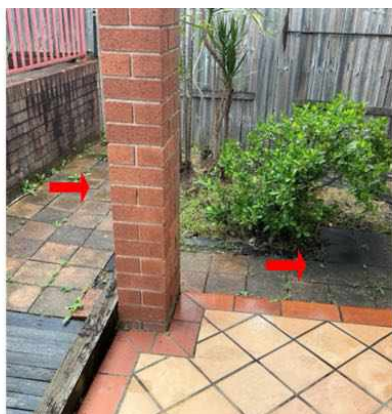
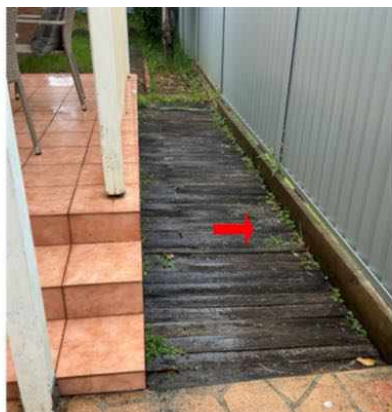
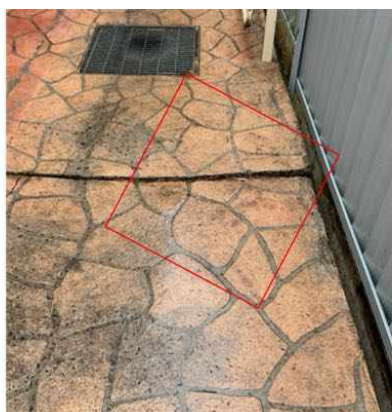
### Finding 3.02

| Information: | Sections of the external paved area are uneven, creating a potential trip hazard. It appears as though the area has been subject to rough installation, or that paving sections have lifted due to movements in the foundation of the property. |

Where paving creates a trip hazard, personal injury may ensue if due caution is not taken by all persons within this area.

Re-paving of the area is required as soon as possible to remedy this situation. Further consultation with a specialist concreter is advised.

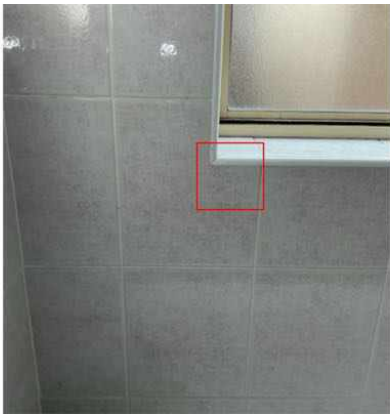
### Finding 3.03

Building: Main Building  
 Location: Bathroom, ensuite, kitchen, garage  
 Finding: Tiles - Cracked or damaged

Information: Cracking was evident to the tiling in this area at the time of inspection. While the cracking appears to be minor, this area is frequently exposed to water, allowing potential for water penetration into adjoining sections of walls or flooring.

If left unmanaged, water penetration to these areas may lead to subsequent water damage, which is likely necessitate repair work to affected building elements.

A tiling contractor should be appointed to ensure that no further water damage

Where water penetration has led to water damage, appointment of a relevant tradesperson may be required to repair damaged building elements.

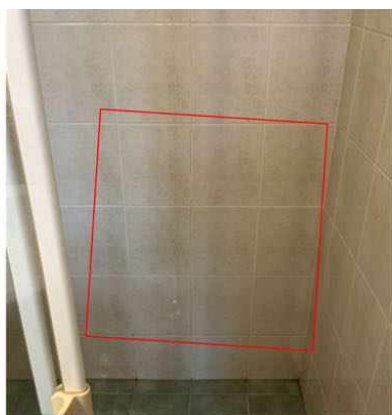
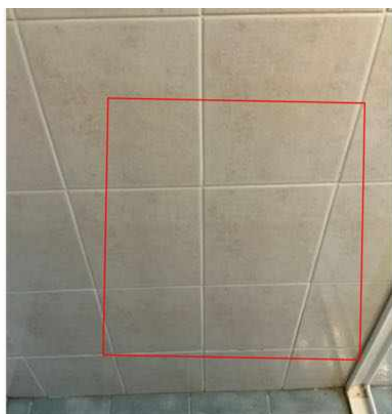
Information: Drummy tiled areas were identified at the time of inspection. The term 'drummy' refers to tiles that have become detached from their fixing, despite otherwise being in relatively good condition. Such defects are generally caused by physical or moisture damage to the area. Drummy tiled areas may also be a direct result of poor workmanship during the construction process.

Tiled areas may swell and shrink with changes in air humidity if the area has sustained moisture damage. Any exposure to moisture is capable of causing tiled areas to become drummy and/or cracked over a prolonged period of time. Drummy tiled areas generally require removal and replacement of affected tiles, with adequate sealant and grouting.

Specialist trades are available for these types of services. A registered builder may be required to undertake works if damage is extensive or if secondary building defects have resulted. Otherwise, it is advised that a tiling contractor be appointed to perform works as necessary. Immediate action is recommended to ensure that no further damage is sustained in the affected area.

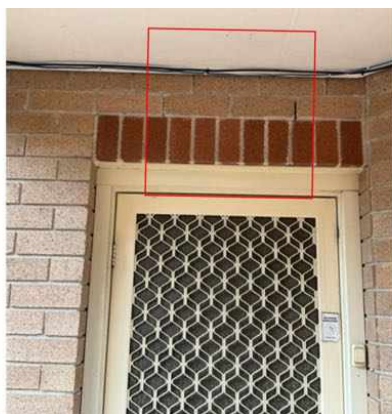
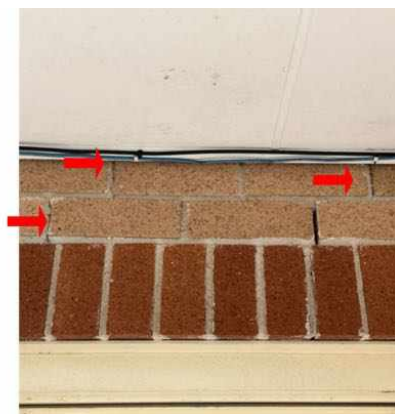
| Finding: | Brickwork - Step cracking |
| Information: | Step cracking was identified to the brickwork in this area at the time of inspection. Step cracking, which is similar to other forms of cracking, has a variety of possible causes. However, the most common is the subsidence of adjacent footings. |

Step cracking is a relatively common defect, and is most likely to occur adjacent to windows, doors and other openings. Mortar failure in the gaps between affected bricks indicates the stresses and tensions affecting the wall.

Where step cracking is extensive or severe, the client is advised to consult a structural engineer. Minor step cracking can be used as a warning sign to address factors causing stress to the wall, which can include the effect of surrounding trees, water leaks, soil erosion, or even the presence of reactive soils in the surrounding area.

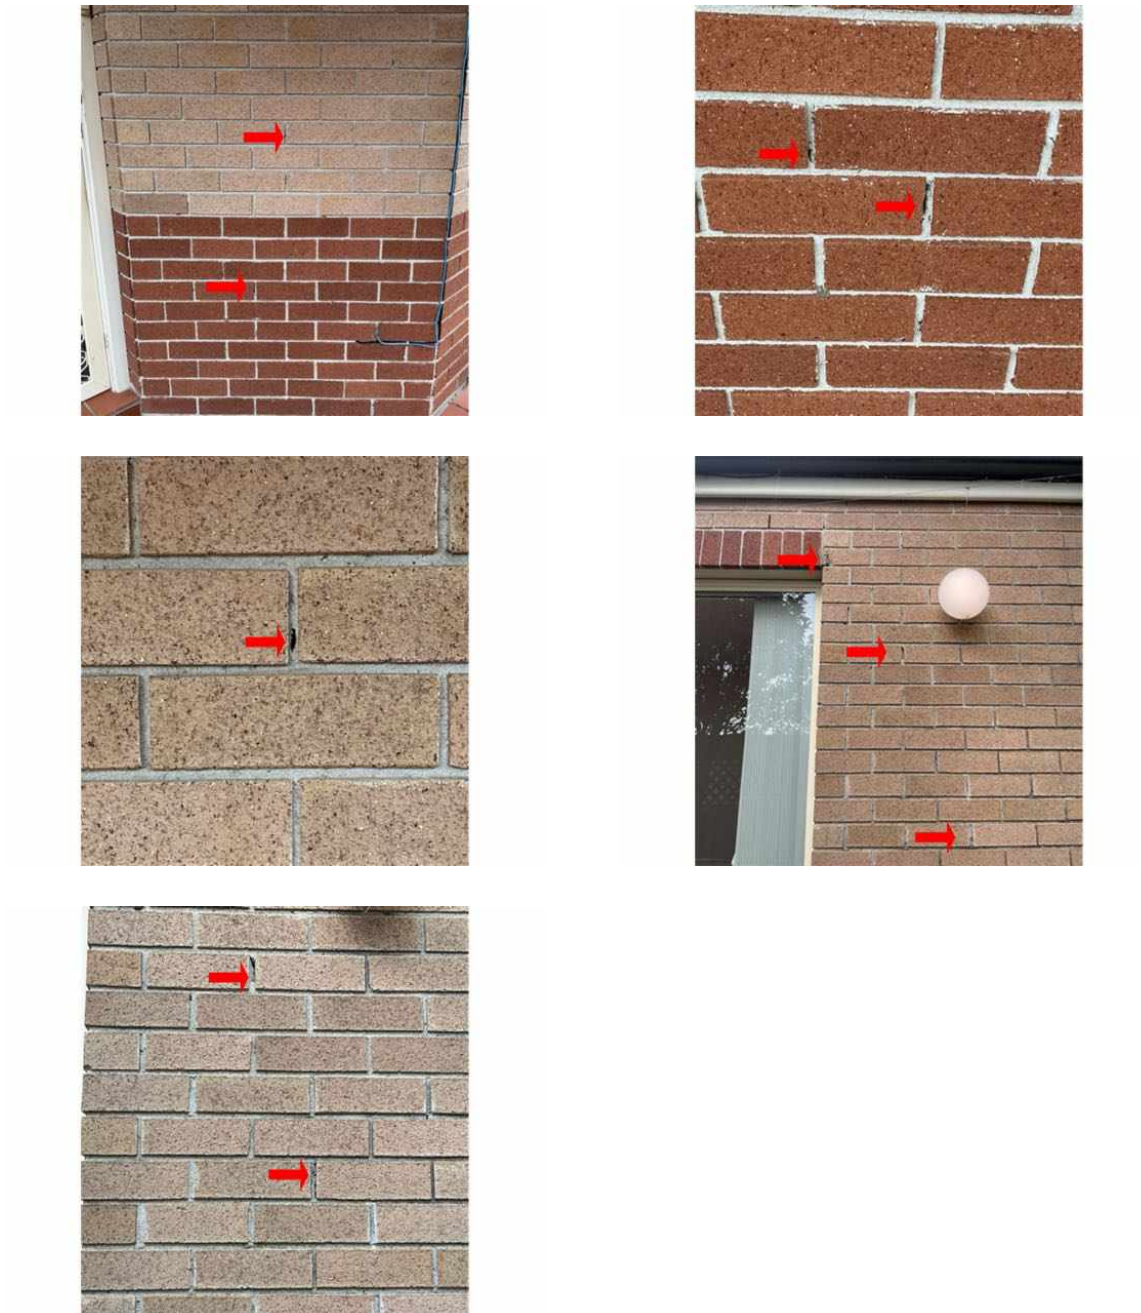
### Finding 3.07

| Finding: | Brickwork - Deteriorated mortar |
| Information: | Mortar, or 'bedding', is the material which fills joints and intersections between bricks in masonry walls and structures. Sections of mortar in this brickwork were identified as having deteriorated, which is generally expected for a property of this age and condition. |

Mortar deterioration can be addressed by a bricklayer where areas of deterioration are localised and easily accessible. Alternatively, appointment of a registered builder is advised, to repoint large areas of decaying mortar. Where secondary structural

defects have become evident, consultation with a structural engineer may be required.

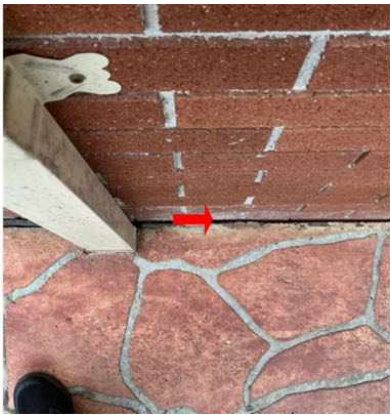
### Finding 3.08

Building: Main Building  
 Location: All External Areas  
 Finding: Gap Between Concrete and External Wall - to some areas  
 Information: Visible gaps were observed between the external masonry wall and adjacent concrete slab at the pathway.

The defect appears consistent with common differential settlement or poor sealant detailing at the slab-to-wall junction. Recommend a licensed contractor seal the gap with an appropriate flexible, UV-stable exterior-grade sealant to prevent moisture entry and pest intrusion.

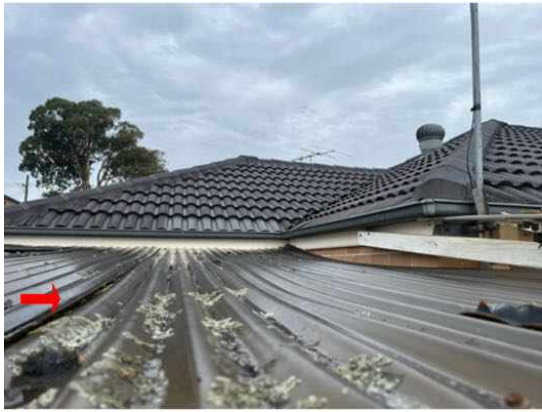
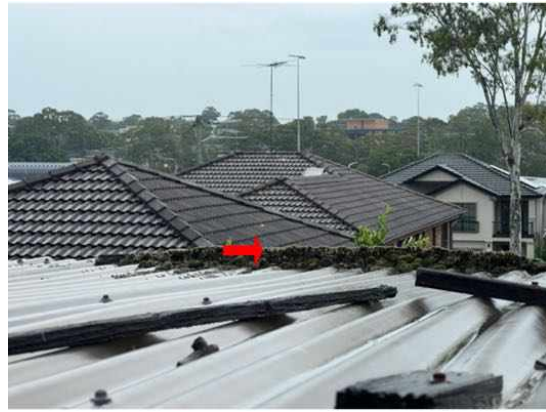
**Finding 3.09**

Building: Main Building  
Location: All External Areas  
Finding: Building element - Damaged - Shed Roof sheeting damaged requires replacement and wood rot to some areas  
Information: Breakage occurs generally when the building materials have either aged and decayed, or as a result of damage (accidental or deliberate).

A relevant tradesperson should be appointed to repair or replace the affected building element prior to any subsequent damage being caused.

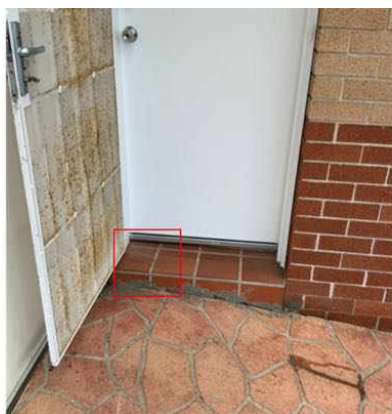
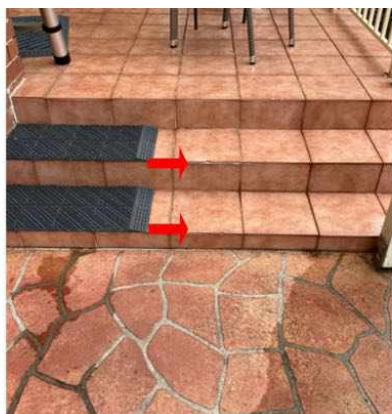
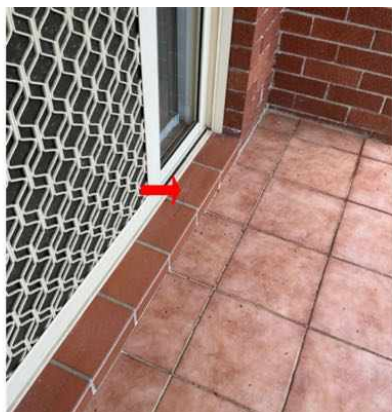
### Finding 3.10

| Finding: | Cracked floor tiles |

Cracked tiles throughout the household detract from the overall appearance of the affected areas however it is unlikely to create or lead to any secondary defects.

While not considered a matter of urgency, replacement of cracked floor tiles is recommended at the clients discretion. A tiling contractor may be appointed to perform these works. Where cracks become more numerous, contact a licensed building inspector for further investigation.

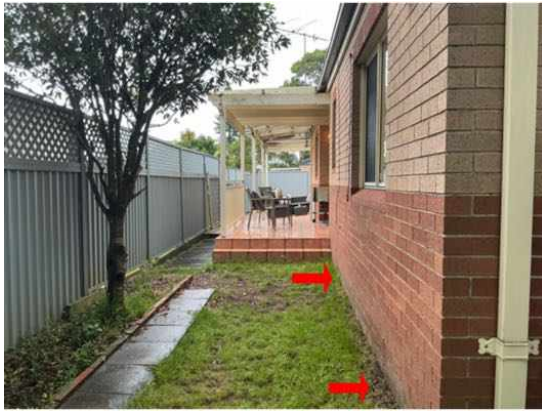
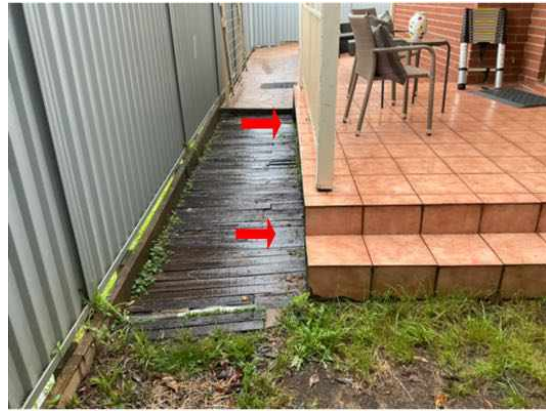
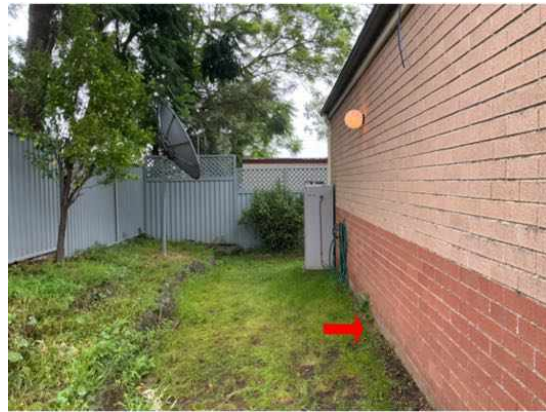
### Finding 3.11

It is important that water does not lie against the base of walls; surrounding paths and ground levels should be sloped to drain water away from walls. Downpipes should not discharge stormwater onto lower walls or plinths. Stormwater should be carried away by large, regularly cleaned drains. Ground levels may need to be lowered to expose a buried DPC.

Where site drainage is inadequate, installation of an Agricultural (Aggie) Drain may be required. A qualified plumber should be appointed to further inspect the property and perform any remedial works as necessary. Water damage and secondary defects are likely to occur if left unmanaged.

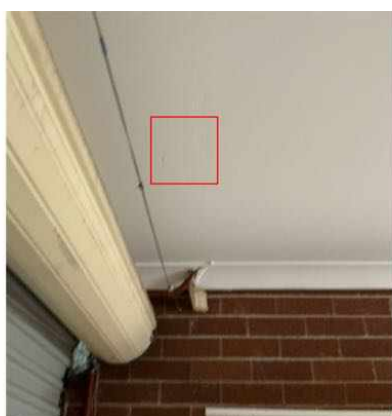
### Finding 3.18

Building: Main Building  
 Location: Garage, Bedroom  
 Finding: Ceiling nails - Popping To some areas  
 Information: Numerous popped nails were identified in the internal ceiling at the time of inspection. Nails and screws hold simply by the friction between them and the surface they are applied to. Over time, the nails and screws can back out, which is often a result of general ageing and deterioration of the building structure.

Re-fastening of popped nails will help to maintain the stability of the internal ceiling and associated building elements. Such minor works will also help to improve the appearance of the affected area and secure the ceiling sheets, so as to prevent the onset of ceiling sagging. These works should be performed by a qualified carpenter or plasterer at client discretion.

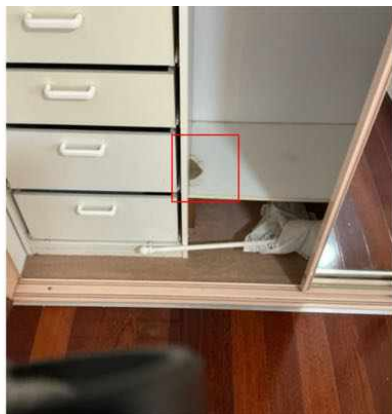
**Finding 3.21**

Building: Main Building  
Location: Bedroom - Master  
Finding: Building element - Damaged - Built in shelf damage , downlight broken lounge  
Information: Breakage occurs generally when the building materials have either aged and decayed, or as a result of damage (accidental or deliberate).

A relevant tradesperson should be appointed to repair or replace the affected building element prior to any subsequent damage being caused.

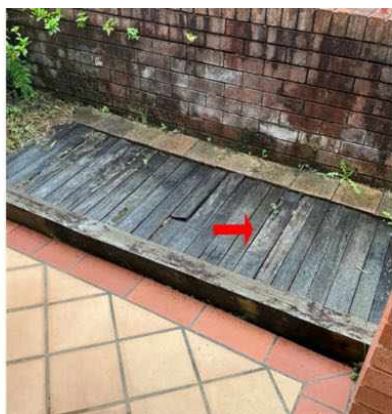
### Finding 6.04

**Building:** Main Building  
**Location:** All External Areas  
**Finding:** In ground contact - Timber  
**Information:** Any timbers in direct ground contact provide opportunity for concealed termite entry and are likely to be subject to premature rot and decay as the soil retains moisture or damp conditions against the timbers.

Remove untreated timber that is in direct contact with external grounds. Consider replacement with more durable materials i.e. treated timber or non timber elements. Frequent pest inspections are advised to readily identify any termite activity in these areas.

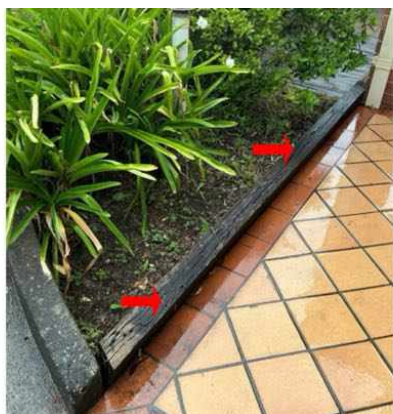
In this case although the affected timber element is in a decaying state the extent of any visible damage appears to be localised to a specific area and is yet to spread to other parts of the building element or affect adjoining structures. The fungal decay is therefore likely to be of a relatively superficial nature with minimal impact on the structural integrity or tensile strength of the timber element.

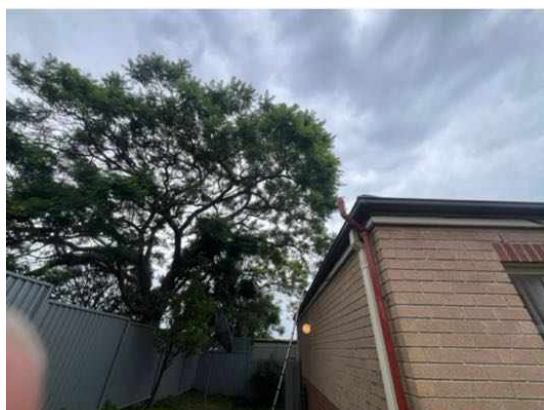
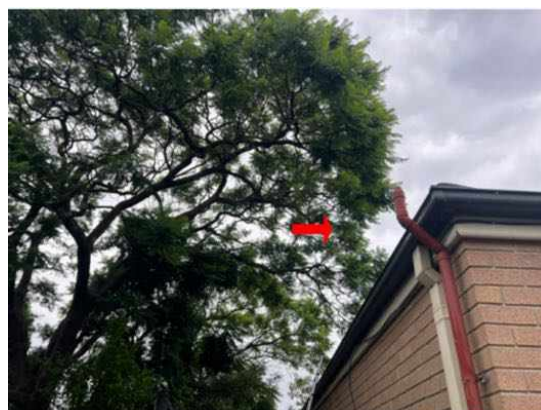
Building: Main Building  
Location: All External Areas  
Finding: Tree Branches  
Information: A mature tree is located in close proximity to the dwelling, with overhanging branches extending above the roofline and guttering, which increases the risk of leaf debris accumulation, gutter blockages, and overflow during rainfall, as well as potential damage to roofing, fascia, and stormwater components during high winds, ongoing shading and debris can also contribute to elevated moisture conditions and accelerated deterioration of roof coverings. While no direct structural damage attributable to the tree was evident at the time of inspection, the proximity of branches represents a risk item rather than a defect, and periodic pruning by a suitably qualified arborist is recommended to maintain adequate clearance from the roof and stormwater system and to reduce the likelihood of future damage or maintenance issues.

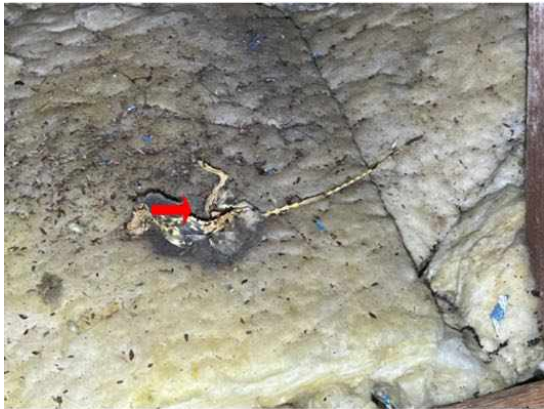
Building: Main Building  
Location: Roof Void  
Finding: Additional Photos - Dead animal  
Information: Additional photos are provided for your general reference

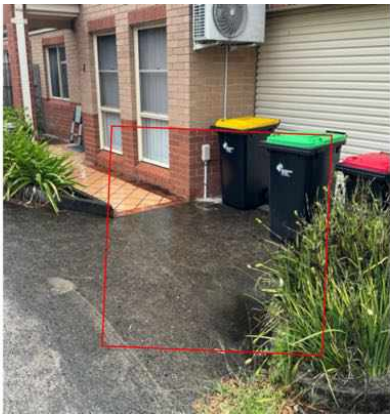
Building: Main Building  
Location: All External Areas  
Finding: Drainage Performance Risk  
Information: The driveway and entry path to the property are fitted with drainage provisions, however, due to the flat profile and proximity of the hard surfaces to the building façade, there remains a potential risk of water sheeting toward the garage during periods of heavy rainfall. While the area was dry at the time of inspection and no pooling was evident, it is recommended that drainage performance be monitored during large rain events to confirm effective surface runoff capture. This condition does not currently present as a defect, but proactive maintenance of drainage inlets and consideration of fall adequacy is advised to ensure long-term compliance with NCC FP1.4 and AS/NZS 3500.3 stormwater drainage provisions.
