# Building and Timber Pest Inspection Report

Inspection Date: Fri, 13 Feb 2026

Property Address: 31 Margherita Ave, Bateau Bay NSW 2261,  
Australia

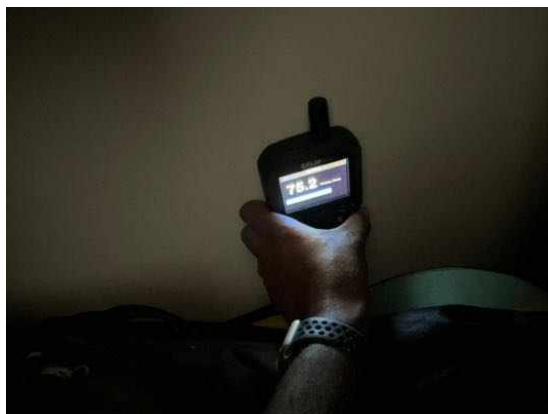
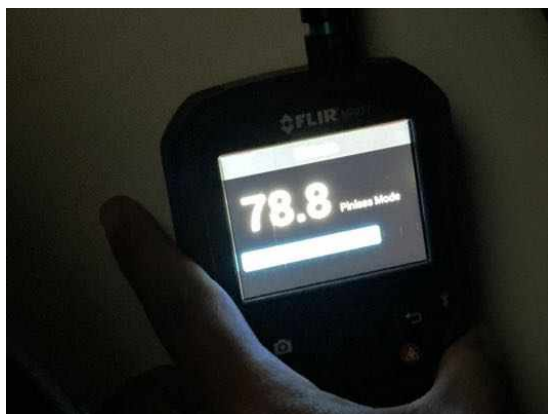
Building:	Main Building
Location:	Bedroom 3
Finding:	Lateral Damp/Rising Damp (Monitoring)
Information:	There are two possible reasons for the type of moisture staining observed: lateral damp or rising damp.

Lateral damp refers to moisture entering from the surrounding ground and moving sideways into the base of the wall. This often appears in walls that retain soil or are close to external ground levels. Over time, this can contribute to deterioration of internal finishes such as bubbling or peeling paint.

Rising damp occurs when moisture travels upward through porous materials like bricks or mortar. This can happen if the original damp proof course (DPC) has deteriorated, been bridged by external ground levels, or if moisture is entering from the opposite side of the wall.

At this stage, no immediate rectification work is required, but the area should be monitored over the next 12 months. If any signs of bubbling paint, peeling, or further moisture staining appear along the bottom of the wall, the client is advised to engage a damp-proofing specialist to confirm whether a membrane, DPC repair, or other moisture management works are required.

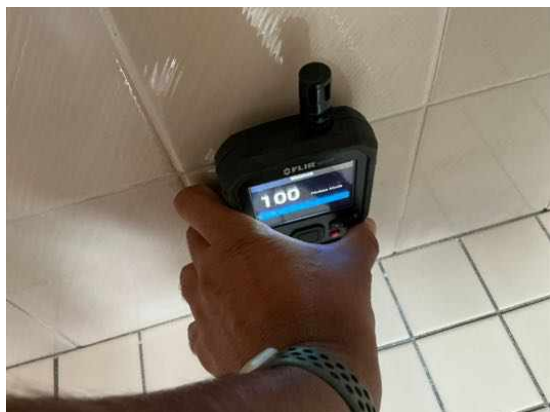
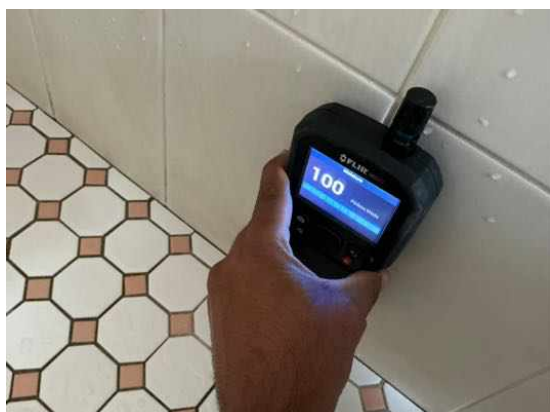
Building:	Main Building
Location:	Both Bathrooms
Finding:	Excessive Moisture - Shower Damp
Information:	At the time of inspection, excessive moisture was noted within the shower area, which is a common issue in wet areas due to the continual exposure to water. This condition is typically caused by moisture seeping through grout lines and settling behind tiles, resulting in localised high-moisture zones. Provided there is no evidence of water staining or elevated moisture readings on the opposite side of the wall, this is considered a minor defect.

However, persistently damp conditions may act as conducive conditions for termite activity, as termites are strongly attracted to moisture-rich environments. It is recommended that the client ensures regular use of the exhaust fan and maintains adequate ventilation after shower use to promote drying and reduce long-term moisture build-up, thereby also reducing the risk of attracting termites.

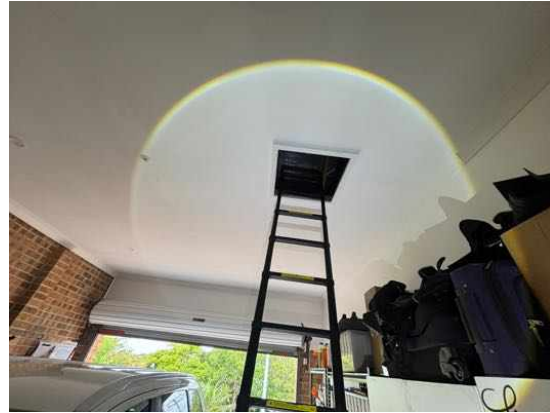
### Finding 3.16

Building: Main Building  
 Location: Roof Void  
 Finding: Sarking - Damaged  
 Information: Sarking, a laminated aluminium foil applied to the interior of the roof covering, assists in insulating the property and acting as a vapour-barrier to the roof void and, subsequently, to the household.

Where sarking is damaged, both insulation and moisture protection of the property are inhibited. This creates a loss of energy and thus negatively impacts the energy efficiency of the property, allowing potential for moisture ingress from condensation or leaking roof tiles.

It is important to repair any holes or damaged sections of sarking to ensure that the building material is fully functional. A registered roofer should be consulted to provide further advice on this defect and to perform rectification works at client discretion.

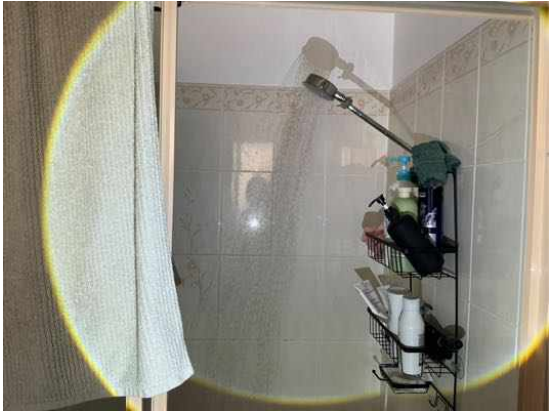
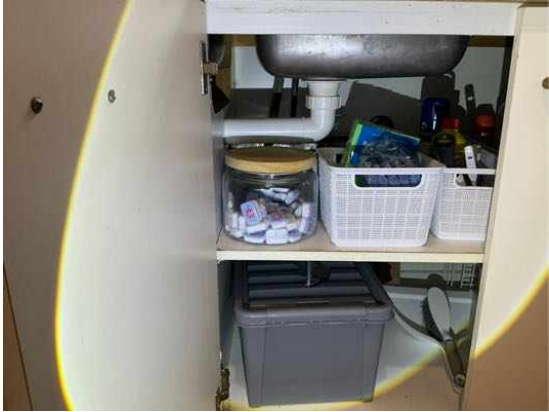
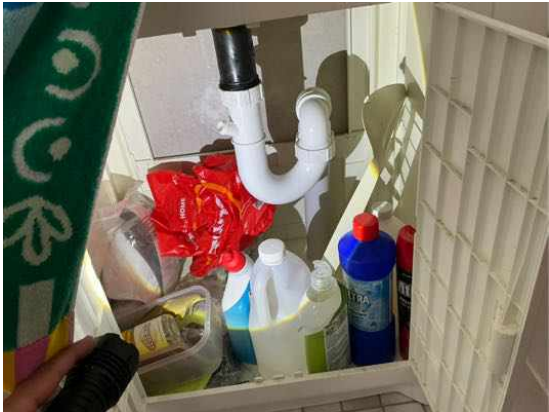
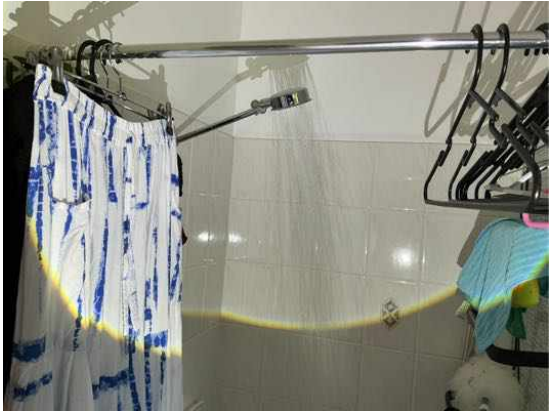
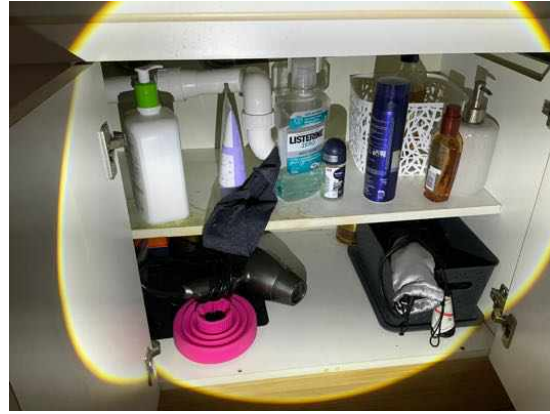
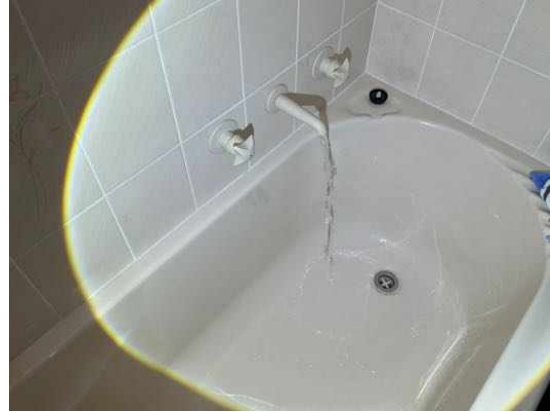
Building:	Main Building
Location:	All Areas
Finding:	Additional Photos - Moisture Meter Readings
Information:	Additional moisture meter reading photos have been provided for the property to offer further clarity on areas tested during the inspection. These photos are intended to give a visual reference for the specific locations where moisture levels were measured. These readings were taken at the time of the inspection to assess any potential moisture-related issues within the property. Any defects related to moisture that were identified during the inspection have been separately mentioned in the defect statements within the report.

It is important for the client to understand that moisture levels can fluctuate over time due to various factors, including changes in weather, humidity, and environmental conditions. While the readings reflect the property's moisture levels during the inspection, they may not represent future conditions, and increased moisture could lead to issues such as dampness, mould growth, or deterioration of building materials if left unmonitored.

For further clarification or additional information regarding the moisture readings, the client is encouraged to contact the building inspector directly. Regular monitoring of moisture-prone areas is recommended to ensure any emerging concerns are addressed promptly, particularly during wetter seasons or in high-humidity conditions.
