Building Inspection Report

Inspection Date: Tue, 10 Mar 2026

Property Address: 1/26 Narcissus Ave, Boronia VIC 3155,
Australia

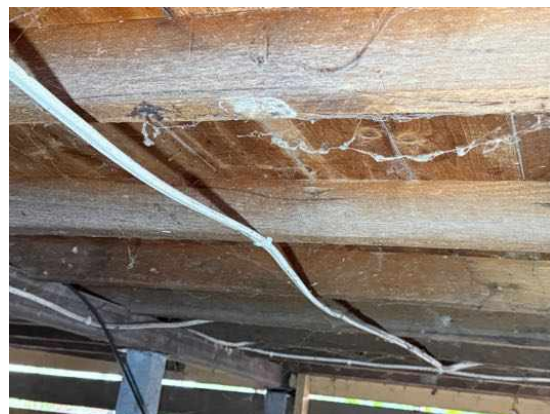
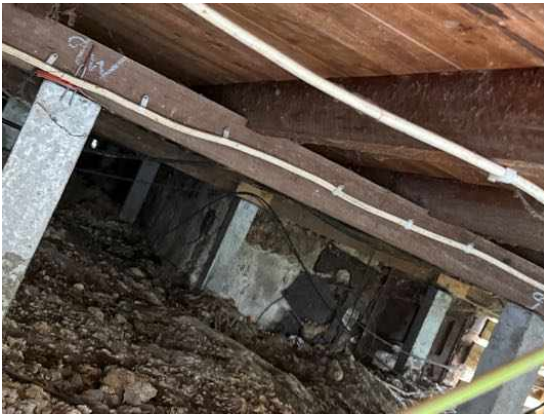
Defects 1.01

Building: Building 1
Location: All Areas > All Areas
Finding: Electrical wiring in subfloor area
Information: Please note that commenting on electrical works are outside the scope of this inspection. At the time of the inspection the subfloor area was considered to be a safety hazard to tradespersons and occupants that enter the subfloor area. Electrical wiring was observed in numerous areas not to be adequately clipped off and showed numerous areas of unprofessional work practices. Electrical wiring or fittings that are not installed in a tradesmen like manner may have been installed by un-registered persons.

With un-tradesmen like work practices shown in the subfloor areas, it is suspected that some areas may not have been installed by a licensed electrician and are considered a potential safety hazard including for fire and personal contact. It is recommended that the client contact a licensed electrician to investigate and carry out further inspection, where deemed necessary.

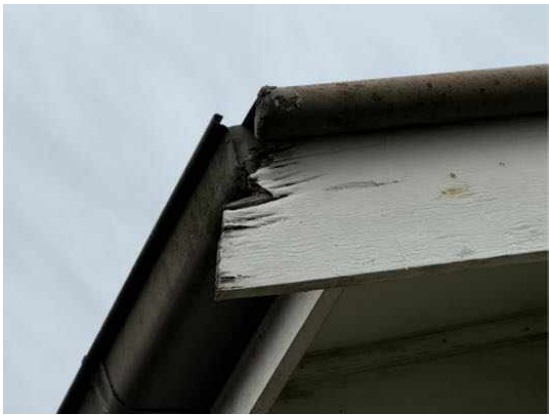
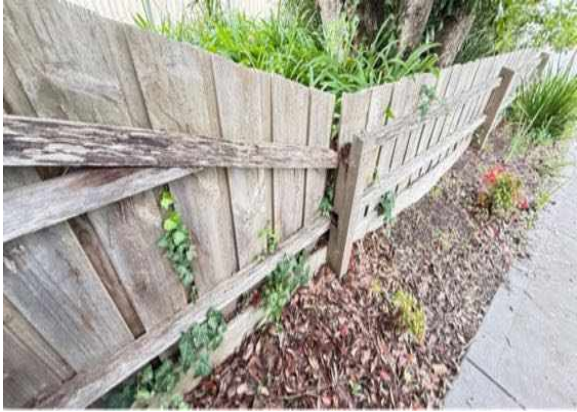
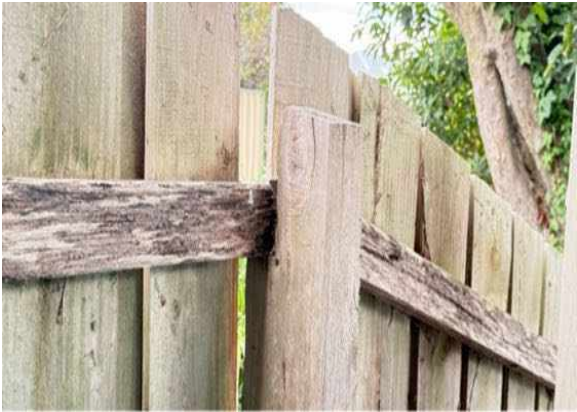
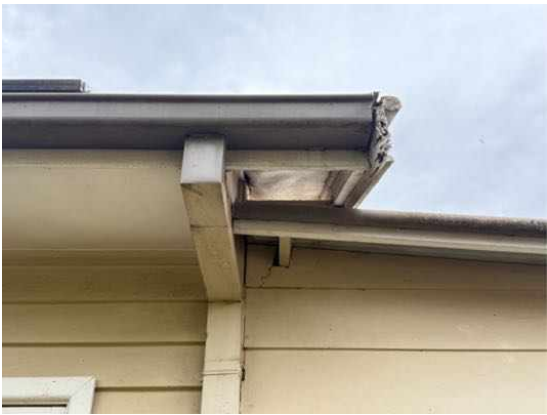
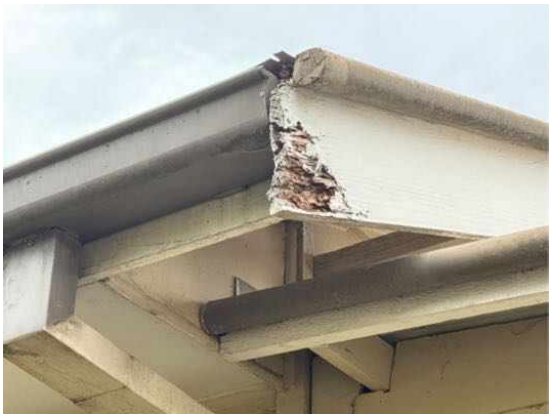
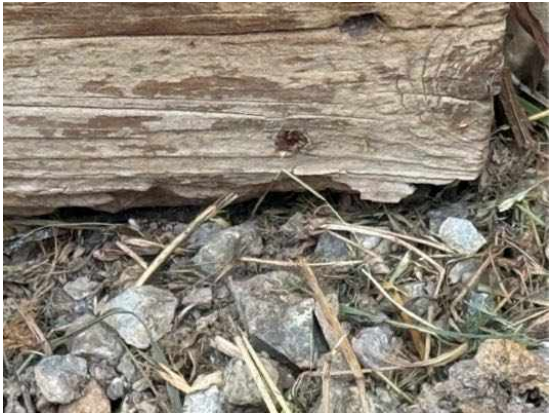
Defects 3.01

Building:	Building 1
Location:	All Areas > All Areas
Finding:	Wood rot
Information:	Wood rot was found to be affecting some fascias, decking timbers, fences and numerous other building elements around the exterior areas. The roof plumbing in these areas may be creating excessive moisture in this areas and or it may be due to frequent exposure to rain and other weather conditions, they also make fascias and other building elements susceptible to accelerated wood rot and further deterioration.

Wood rot, also known as Fungal Decay, occurs when timbers and other cellulose building materials are exposed to damp conditions on an ongoing basis. Early intervention and regular maintenance such as painting will prolong the useful life of these building elements. Prior to any works being performed, the cause of the moisture that has created the visible wood rot should be identified and addressed in a suitable manner.

It is advised that a licensed plumber be appointed to inspect all roof plumbing and subsequently identify the cause for the wood rot. Replacement of affected fascias and or other building elements may then be a necessary step in protecting surrounding areas from such deterioration. A qualified plumber may be appointed to assess the cause of excessive moisture and to provide advice on any remedial works as required. A qualified carpenter or registered builder may also be required to replace affected building materials.

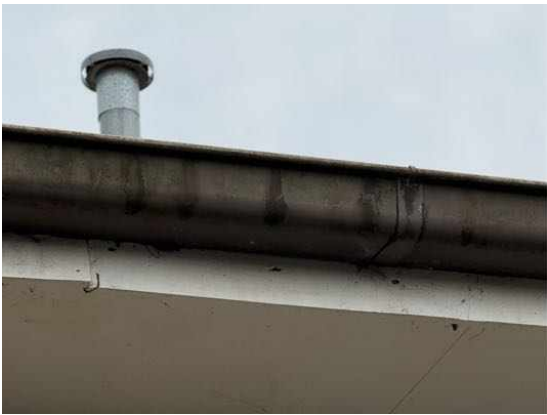
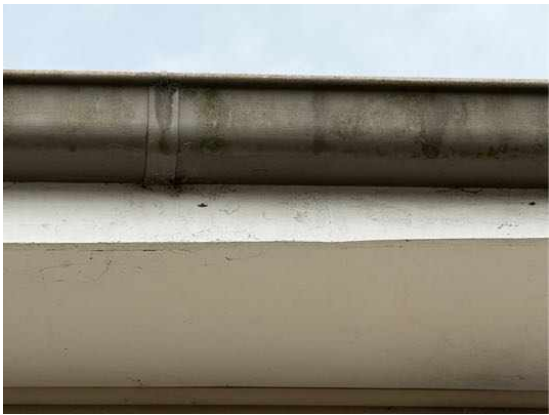
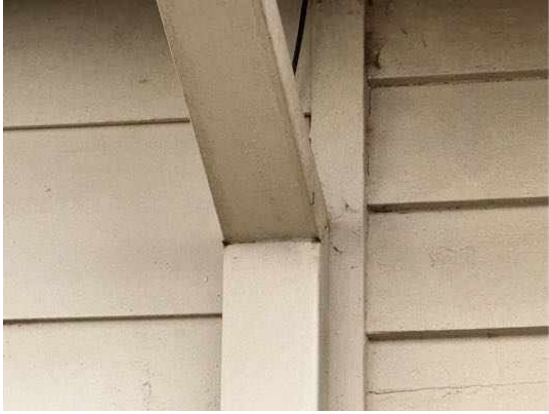
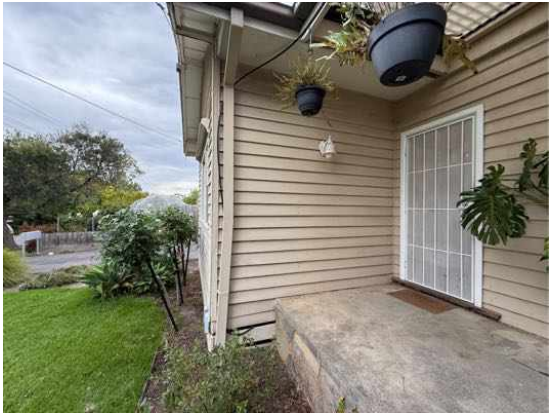
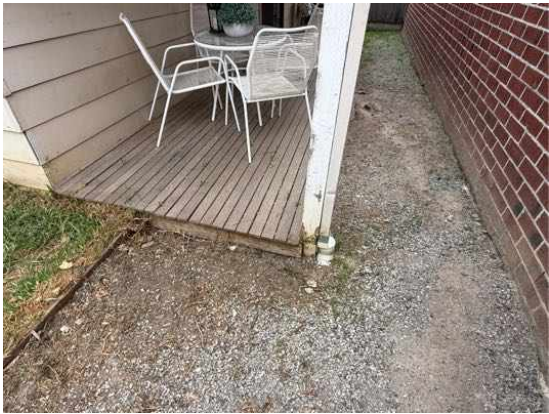
Defects 3.02

Building:	Building 1
Location:	All Areas > All Areas
Finding:	Gutters - Partially blocked
Information:	Roof plumbing structures, such as guttering and downpipes, should be free of all leaf matter and debris to prevent blockages. Blockages of the guttering and downpipes will lead to pooling and accumulated water overflows, which is likely to subsequently flood eaves and exterior walls. Blocked gutters are likely to lead to high levels of moisture in the affected areas. Such moisture will not only cause rust and decay at an accelerated rate to the associated building elements, but can also provide conditions that are conducive to termite and timber pest activity.

Blockages in gutters should therefore be removed immediately to ensure dry conditions are maintained at all times. Client should consider the appointment of a gutter cleaning company to carry out these works periodically or with a licensed plumber gain some further specific advice on remedial works that may be deemed to be required. In the interim, it is highly advised that blocked gutters be removed by the homeowner or others, a gutter cleaning company or a general handy-person in the short term future.

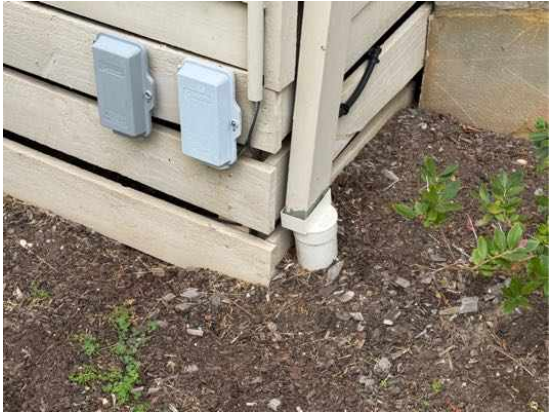
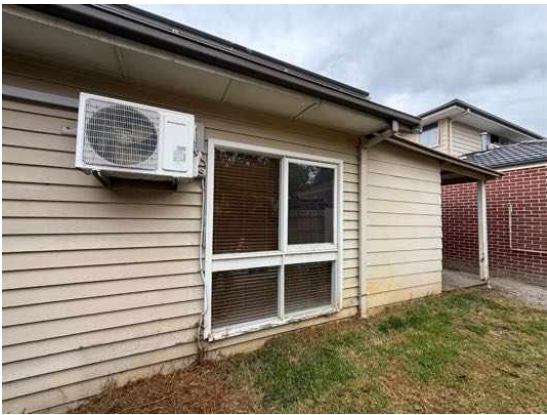
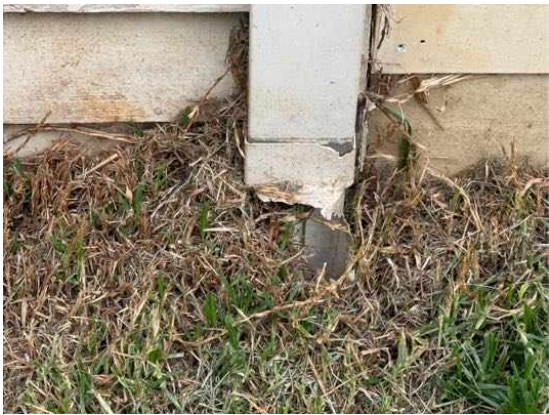
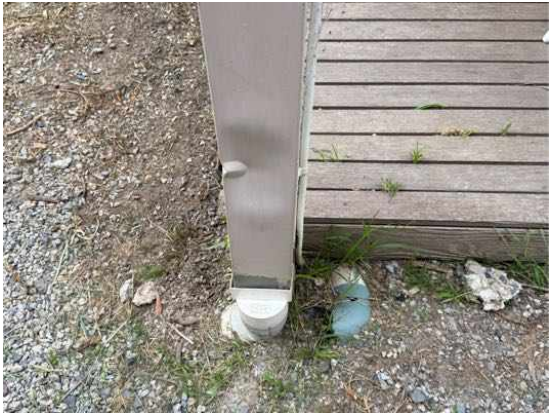
Defects 3.03

Building: Building 1
Location: All Areas > All Areas
Finding: Down-pipe boots broken and deteriorated
Information: It was observed at the time of inspection that the rear down-pipe boots at the bottom of the down-pipes were broken and deteriorated from suspected impact damage. These down-pipe boots are considered to be beyond repair and will need to be replaced, these broken down-pipe boots are making these areas susceptible to excessive water and moisture. This will therefore make these areas susceptible to excessive moisture, wood rot, rust, corrosion, termite and pest. If left unmanaged, the excessive moisture and water surrounding these adjacent areas is likely to lead to secondary damage to adjoining areas and or other building elements, this also makes these areas more susceptible to termite or timber pest activity. It is recommended that client appoint, seek advise from a licensed plumber to rectify and repair all deterioration in downpipes, gutters, fixtures and fittings.

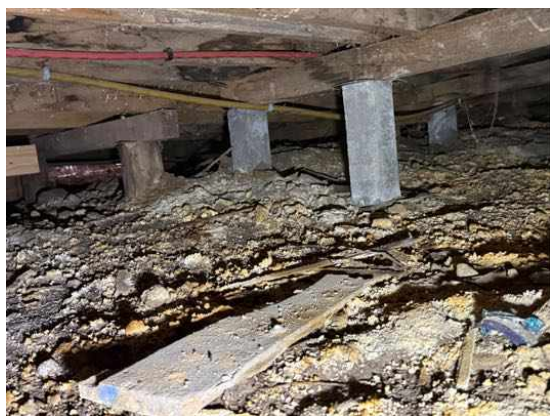
Defects 3.07

Building:	Building 1
Location:	All Areas > All Areas
Finding:	Timber stumps - Suspected deterioration
Information:	It was noted that the property has timber stumps at the rear areas of the home. Inspection of the condition of the timber stumps - below the surface of the ground - is excluded from the scope of this report. However, it is suspected that several timber stumps are deteriorating, evidenced by secondary defects such as uneven flooring, visually-observable subsidence or major cracking within the property. Even without these secondary defects, deteriorated stumps may still be present.

Where timber stumps are failing, a high degree of maintenance or even replacement of stumps may be required in the short- to medium-term future. It is probable that there is some degree of wood rot or deterioration beginning to occur in areas that are currently inaccessible for inspection. Timber stumps are no longer used in current building practices due to their susceptibility to wood rot and deterioration over a prolonged period of time.

invasive inspection of the timber stumps and provide estimates on any works that may be required.

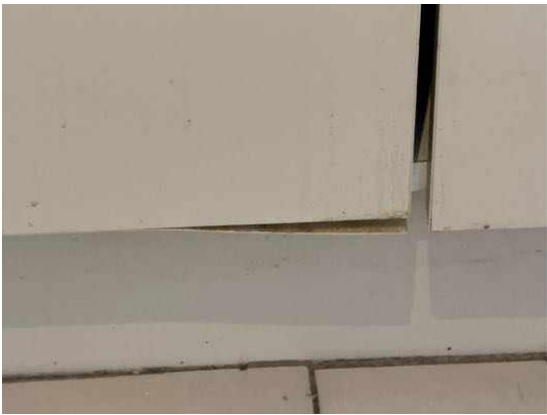
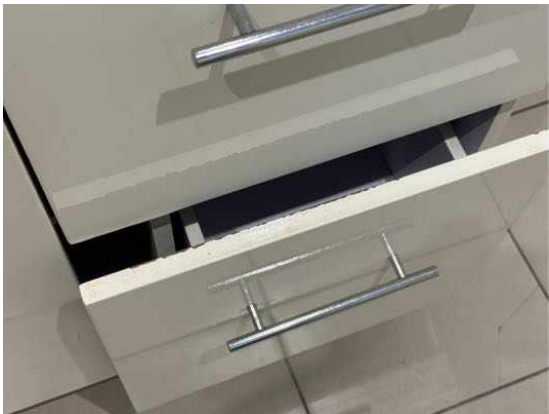
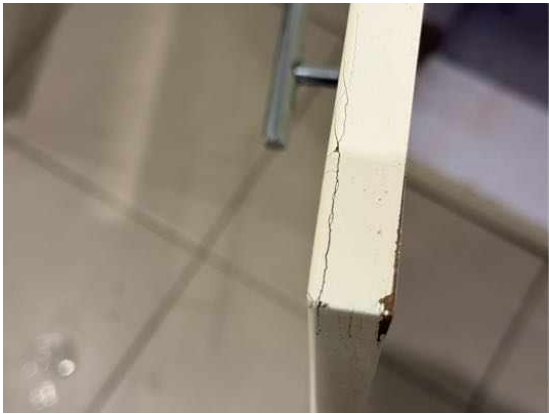
Defects 3.08

Building:	Building 1
Location:	Kitchen > All Areas
Finding:	Kitchen and bathroom cabinets
Information:	The kitchen and bathrooms cabinet doors showed signs of lack of maintenance to the doors, drawers and cabinet carcasses. These were observed to have some damage or wear and may require some maintenance, remedial work or repair to ensure further deterioration does not continue further. Although these defects may detract from the overall looks of the cabinetry, in most cases it does not necessarily affect the operational state of the cabinetry.

To improve the operation of these affected cabinets, cabinet doors or drawers, a qualified cabinet maker or carpenter may be appointed to either replace, rejuvenate, rectify or repair any cabinetry as deemed to be necessary. Such works should be completed at discretion of the client.

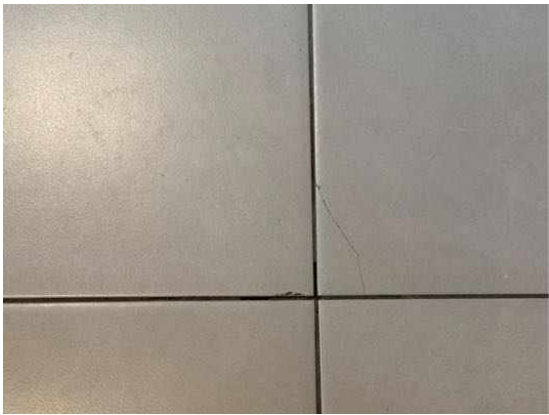
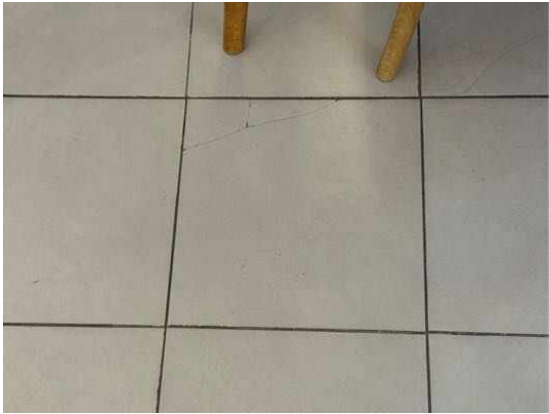
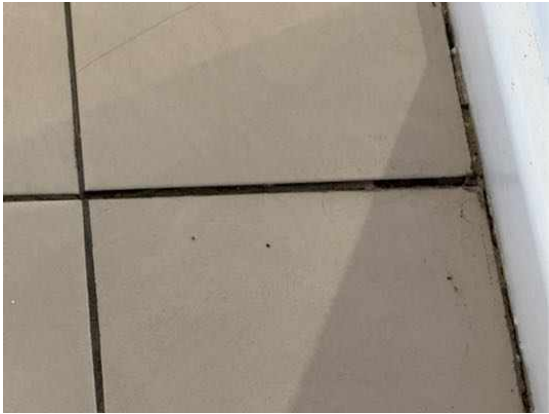
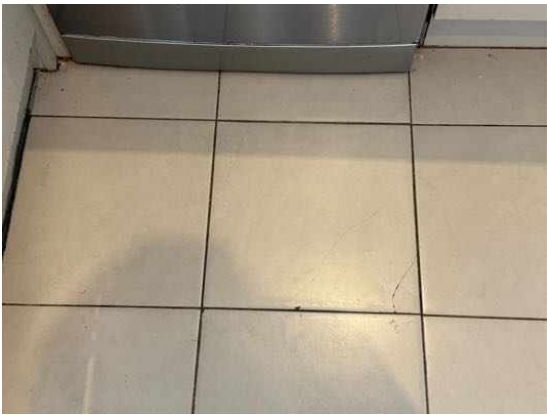
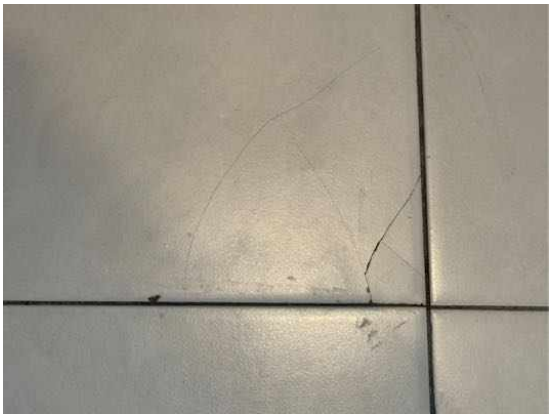
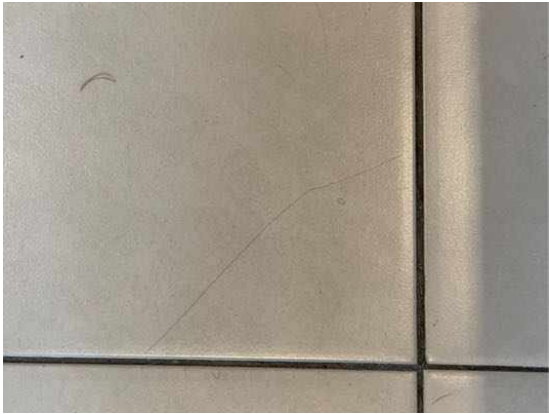
Defects 3.09

Building:	Building 1
Location:	Dining Room > All Areas
Finding:	Cracks in numerous floor tiles throughout the rear areas of the home
Information:	Cracked and poor substrate was suspected to be affecting the rear dining room and kitchen area floor tiles at the time of inspection. It is suspected that this cracking has occurred as a result of excessive movement of the substrate and flooring structures. Cracked tiles detract from the overall appearance of the affected areas, cracked tiles in this area may create or lead to secondary defects, due to the vicinity of moisture and wet areas, tiling should be rectified.

A qualified contractor or a licensed builder may be required to carry out an invasive inspection as to the cause of the numerous areas of cracking throughout the home. A tiling contractor should be appointed to perform the remedial works to the tiled areas. Although not considered to be a matter of high importance, replacement of cracked floor tiles is recommended in the short to medium term future. Where cracks become more numerous, contact a licensed Registered builder for further investigation.

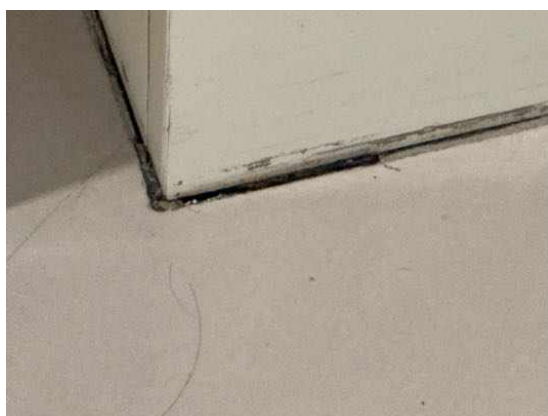
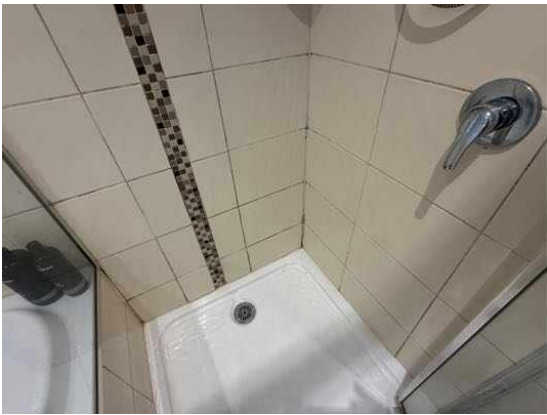
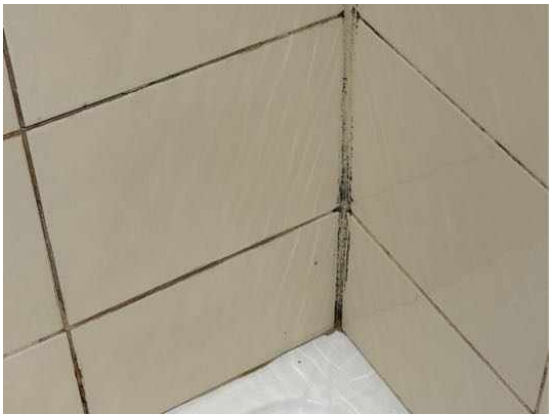
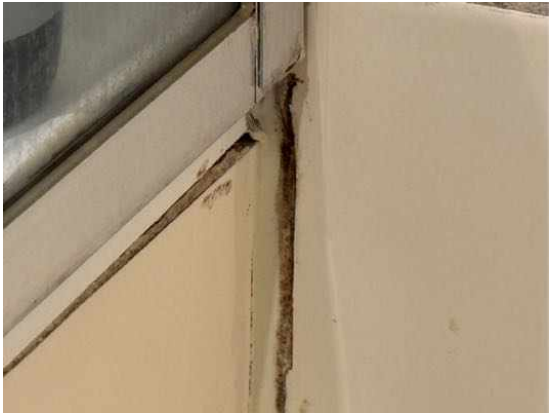
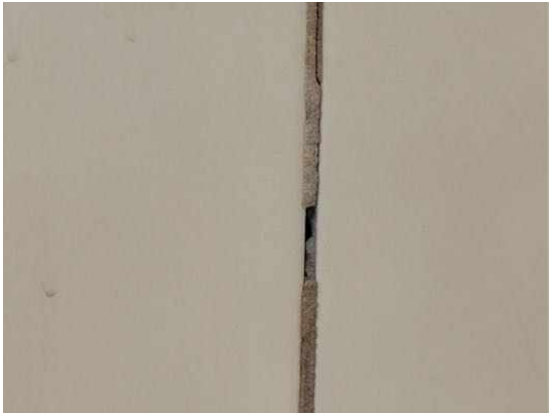
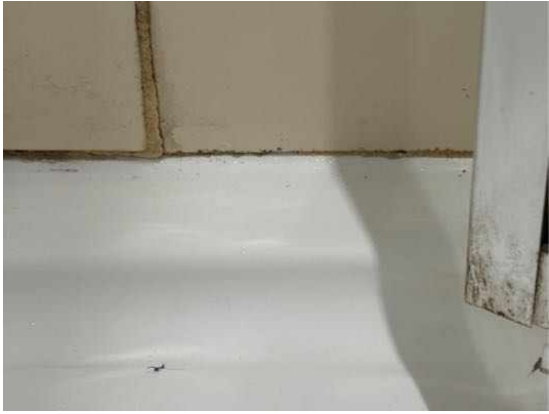
Defects 3.10

Building:	Building 1
Location:	All Areas > All Areas
Finding:	Maintenance on sealant and grout throughout the balcony areas
Information:	<p>It was observed at the time of the inspection that some of the sealant or grout is deteriorating through exterior weather conditions and normal age and deterioration. Different materials on the balcony areas will move at different rates, generally causing the sealant move and crack at these junctions and joints over time. It is essential that maintenance is kept up in these areas with the appropriate flexible sealants and materials where deemed to be required to allow for expected expansion and contraction, while keeping the joint water tight and protective of all associated building materials. Flexible and mould resistant materials should be applied to any affected areas to prevent any subsequent water damage that is likely to occur if not maintained.</p> <p>Regular maintenance and replacement of any missing or damaged sealant and grout is highly recommended to the wet areas, as this is a regular wear and tear defect. Sealant and grouting in areas that come into regular contact with water should be maintained for the long term care of your property. A sealant specialist or tiling contractor should be appointed to complete these works where deemed to be necessary.</p>

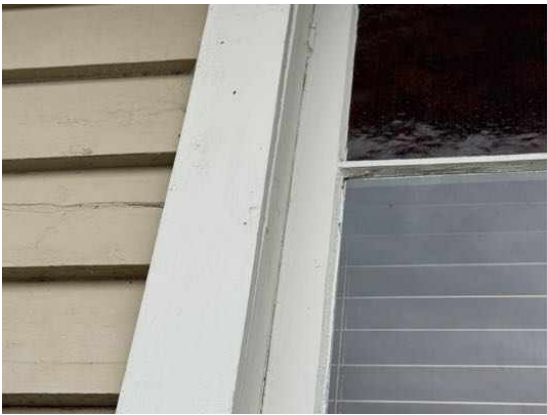
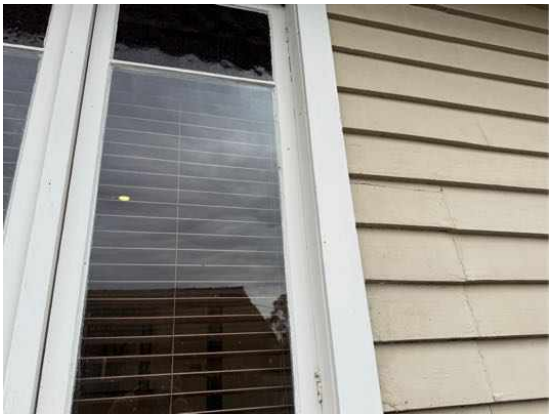
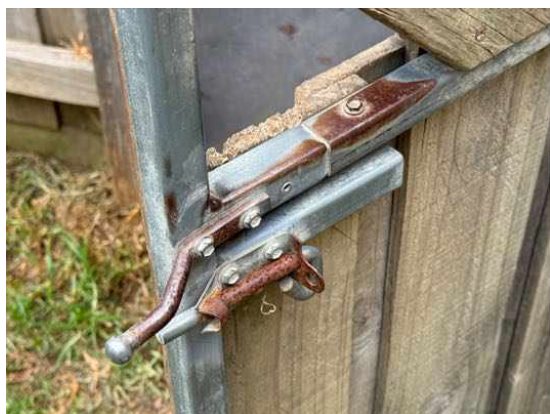
Defects 3.11

Building:	Building 1
Location:	All Areas > All Areas
Finding:	Building elements - Rusted or corroded
Information:	Some exterior building elements and materials that show evidence of rusting and corrosion, has likely developed as a result of excessive exposure to moisture, harsh weather conditions and or inadequate coatings. A surface that is found to be rusted provides no protection to the underlying iron, the deteriorating condition is likely to worsen if not addressed and left unmanaged, it is therefore recommended that the relevant tradespersons remove as much rust as possible, clean and re-paint these areas.

Where possible, the use of galvanized (treated) metals or aluminium coated metals aid in rust prevention, as does regular general maintenance. Rust formation can be controlled with coatings, such as paint, that isolate the iron from the environment. Rusting and corrosion should be managed by ideally removing or limiting the affected surface from exposure to moisture and harsh weather conditions. A qualified painter or other relevant tradespersons may be appointed to paint affected areas and a qualified carpenter to replace any building elements that have been severely affected by rust or water damage.

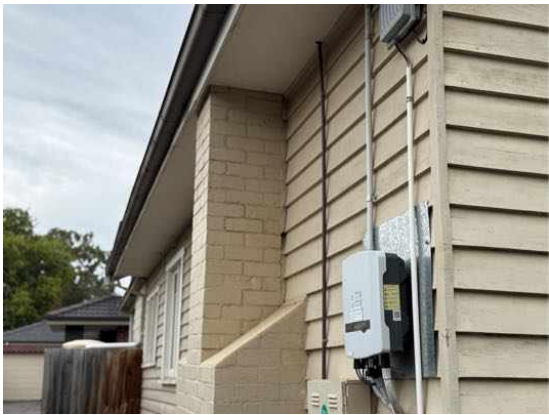
Defects 3.12

Building:	Building 1
Location:	Chimney > All Areas
Finding:	The chimney showed some movement
Information:	The exterior chimney was observed to show some damage from minor movement at the time of the inspection. This movement is expected to be from a change in the surrounding areas, either in moisture content in the surrounding soil or some foundation movement. The client is recommended to either appoint a structural engineer to further inspect or in the future carry out and repair work where deemed necessary and monitor for any future movement.

Structural issues are generally the underlying cause of such cracking. It is suspected that this damage has been created due to general subsidence in the associated footings, normal age and deterioration, general expansion, and/or contraction of building materials in different weather conditions. These types of cracks in brickwork may develop if left unattended, with potential for necessitating in major remedial works in the future or replacement of the brickwork.

The exterior chimney was observed to show some damage from minor movement at the time of the inspection. This movement may be from a change in moisture content in the surrounding soil or some foundation movement. The client is recommended to either appoint a structural engineer to check its structural integrity.

A structural engineer may be appointed, at the clients discretion, to inspect the structural integrity of the affected brickwork and to assess the safety of the associated structures. The structural engineer can also nominate a scope of works where required. Always contact a Registered builder or engineer should cracks widen lengthen or become more numerous, even after repair works have been completed.

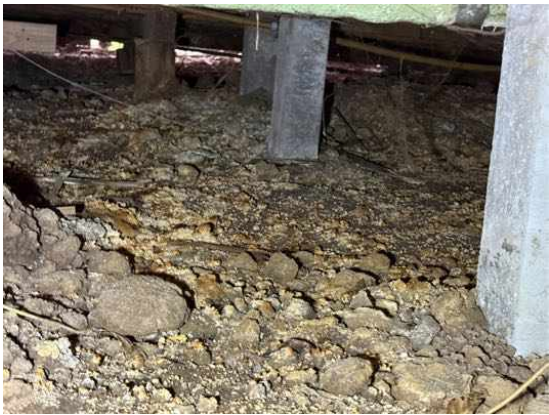
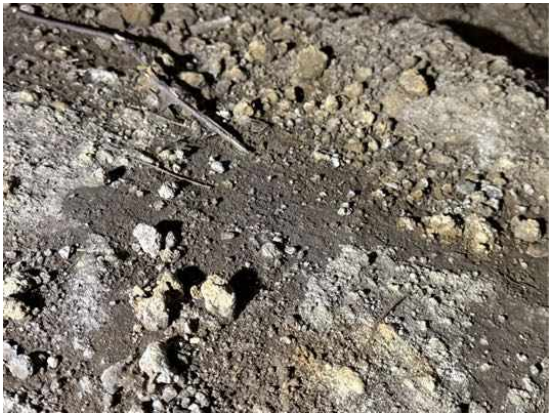
Defects 3.14

Building:	Building 1
Location:	All Areas > All Areas
Finding:	Subfloor excessive moisture producing mould
Information:	It was noted that moisture was travelling through the subfloor ground soil producing mould within the subfloor areas. Remedial work to rectify the moisture from entering the subfloor will be required in the medium term future. A plumbing contractor should be appointed to investigate the surrounding stormwater drainage around the home and if necessary add additional site drainage such as agriculture drainage and rectify any drainage not adequately working, broken or not connected to stormwater drainage on the site. Any disconnection or broken stormwater drainage problems can negatively impact the functional capacity of the site drainage system.

Where roof plumbing doesn't drain adequately, the area at the base perimeter can become excessively damp, potentially creating an environment that is susceptible to rust and corrosion of surrounding building elements, as well as attracting termites and other pests. It is highly recommended that a licensed plumber be appointed to further inspect the exterior and subfloor areas and to install adequate aggy drainage and equipment where deemed to be necessary.

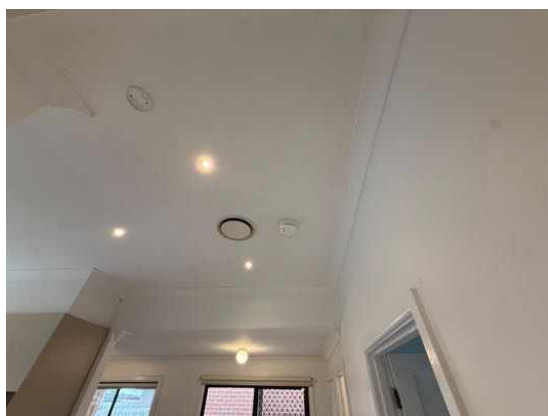
Noted Item

Building: Building 1
 Location: All Areas > All Areas
 Finding: Smoke detectors and alarms
 Information: Reporting on Smoke Detectors or Alarms, including hard wired smoke detection systems and their legislative requirements, is outside the Scope of this Report. Please note that this defect is highlighted as a caution only. We suspect, based on our experience in the building industry, that smoke detectors are sometimes get overlooked, or they may be in a poor condition, so we recommend that they always should be addressed prior to occupation to improve occupant safety.

Always ensure sufficient working and suitable smoke detectors are installed prior and during to occupying any building. Additionally, it is advised that all smoke detectors be tested by the homeowner on a monthly basis.

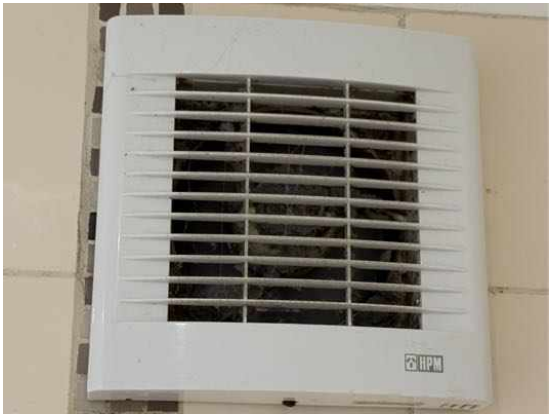
Noted Item

Building: Building 1
 Location: All Areas > All Areas
 Finding: Air filters, grilles and fans - require maintenance and cleaning
 Information: Air grilles and fan covers need regular maintenance and cleaning. Dust, debris and dirt accumulated on the grill mesh will obstruct the normal air flow, these should be cleaned to prevent impairment of their intended functions. This includes such grilles and air filters from rangehood sis, ducted heating / cooling units, ceiling and bathroom

fans.

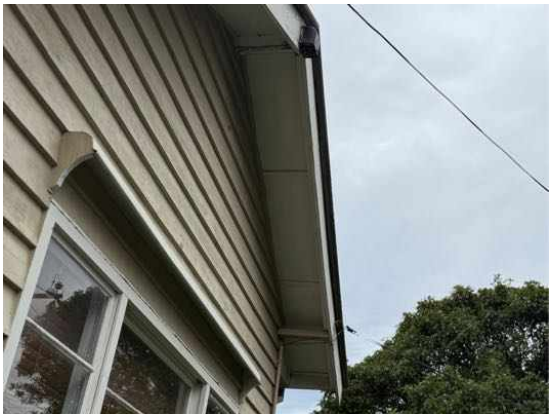
Noted Item

Building:	Building 1
Location:	All Areas > All Areas
Finding:	Asbestos - Suspected ACM Identified on Site
Information:	Reporting on Asbestos is outside the Scope of this Report. This suspected defect is highlighted as a caution only. We suspect, based on our experience in the building industry, that there is a higher risk of the identified building element containing asbestos.

As Asbestos Reporting is outside the scope of this report, we advise that you consider a separate Asbestos Inspection and Condition Audit, which can include the taking of samples for definitive confirmation of the presence of Asbestos. Asbestos sampling can only be taken upon ownership of the property only, due to being an invasive procedure.

In the interim, the client is advised to act with caution, especially when considering any damage to building materials general wear and tear renovations extensions demolition and general maintenance activities due to the suspected presence of Asbestos.

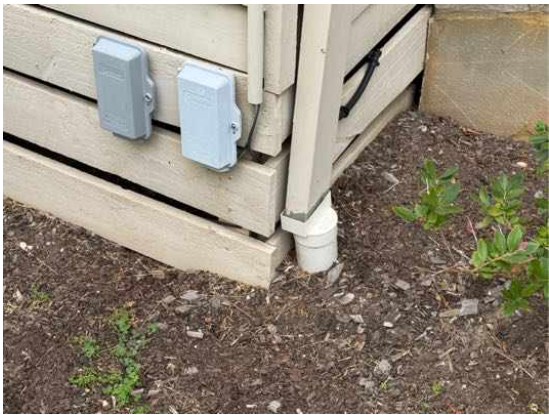
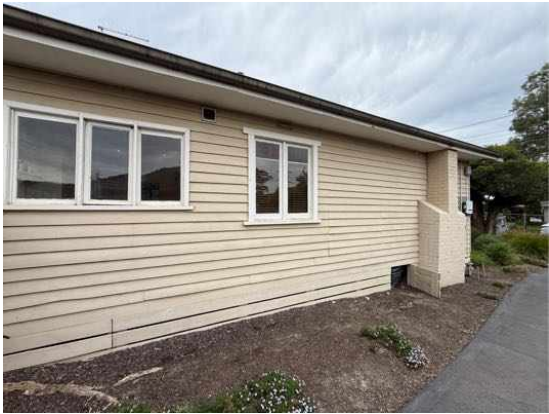
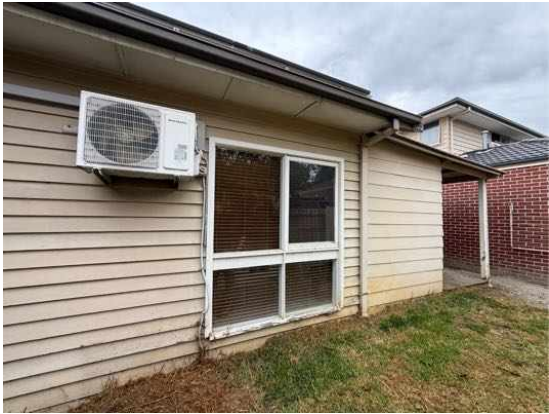
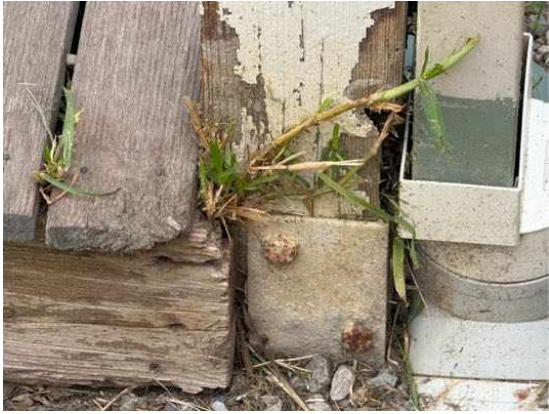
Noted Item

Building: Building 1
 Location: All Areas > All Areas
 Finding: Timber in the ground and exposed to excessive weather conditions
 Information: External timbers in the ground and are frequently exposed to harsh and extreme weather conditions, will require adequate protection and maintenance in order to maintain their condition. Other timbers are exposed to moisture from ground contact which exposes these areas to accelerated wood rot and decay, damage and deterioration. Where timbers have not been painted properly or treated adequately, general deterioration is likely to occur at an accelerated rate.

If left unattended, replacement of these timbers is likely to be necessary in the future. Adequate treatment of these timbers is required to ensure excessive weathering does not occur, painting of these areas may be carried out by the client or by a painting contractor or general handyman.

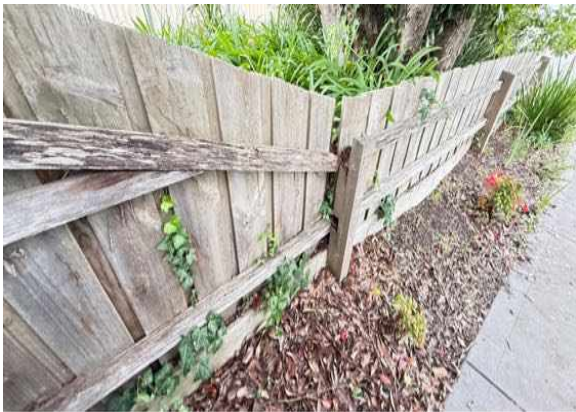
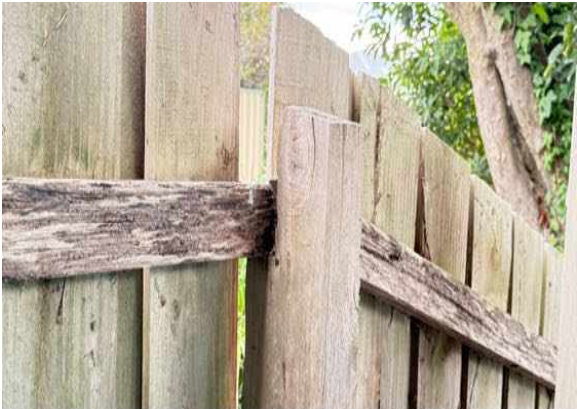
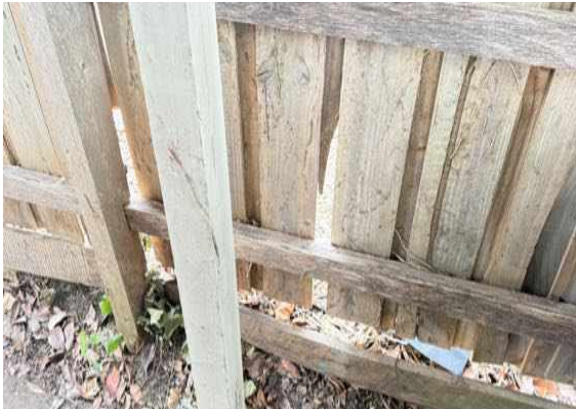
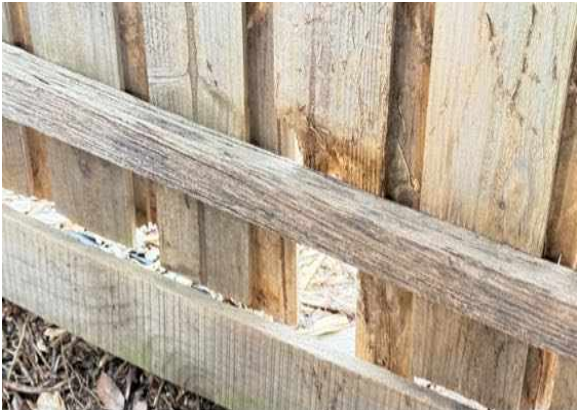
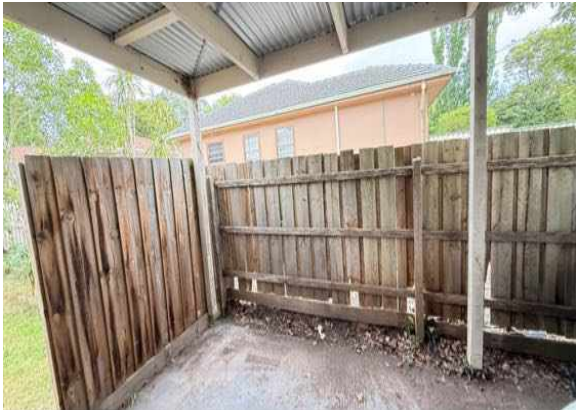
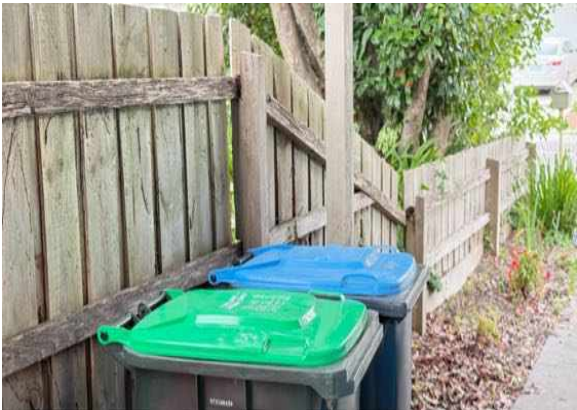
Noted Item

Building: Building 1
 Location: All Areas > All Areas
 Finding: Post and rail fences
 Information: Post and rail fences showed damage and deterioration at the time of the inspection. This deterioration is suspected to have developed over a prolonged period of time due to frequent weather exposure, which is expected in a property of this age and condition.

Left unmanaged, further deterioration is likely to develop further, necessitating in extensive repair or replacement areas of the timber fences, this will depend on the age and deterioration and or wood rot, further damage is suspected of occur.

To maintain the condition of the external timber building elements, any affected areas should be substituted as soon as possible with pre-treated replacements. A qualified fencing contractor should be appointed to repair and replace post and rail fencing where deemed to be necessary.
