Building and Timber Pest Inspection Report

Inspection Date: Wed, 8 Apr 2026

Property Address: 25 Tamarind Dr, Bellingen NSW 2454,
Australia

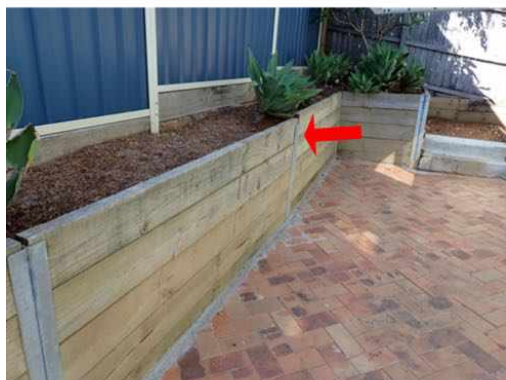
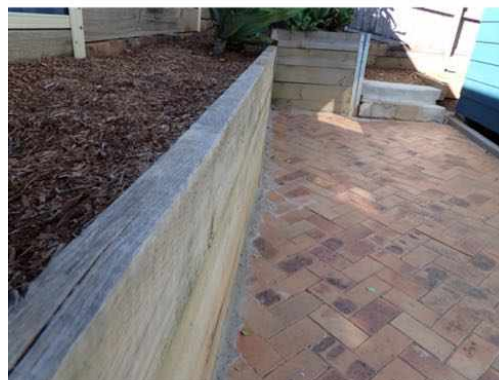
Finding 2.01

| Finding: | Rear Retaining Wall Leaning Out Of Plumb |
| Information: | The rear retaining wall has been identified as leaning out of plumb. This is typically associated with ground movement, inadequate drainage, or age-related deterioration. Movement of this nature may worsen over time and could affect the performance of the wall if left unaddressed. It is recommended that a licensed builder or structural landscaper assess the wall and carry out necessary repairs or reconstruction as required. Prompt attention is recommended to prevent further movement and potential failure. |

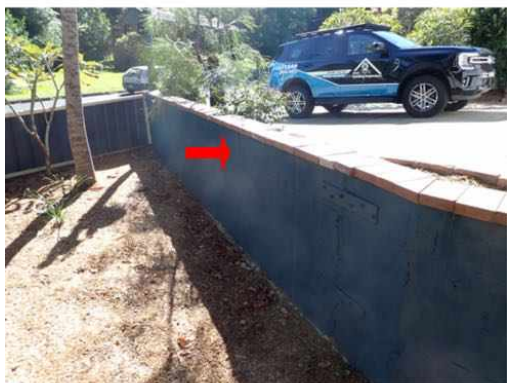
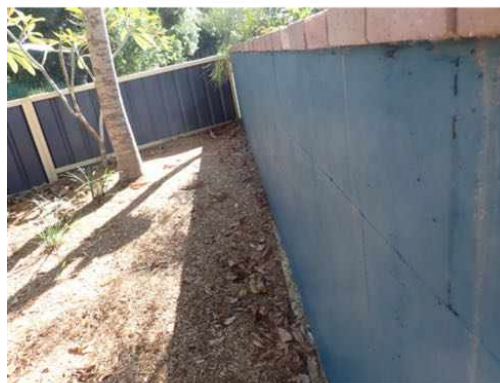
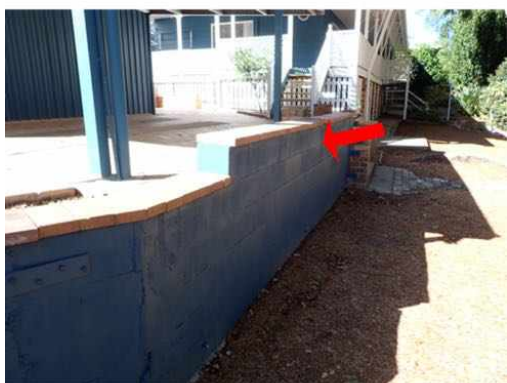
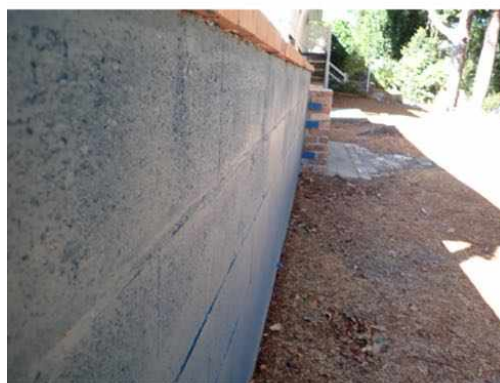
Finding 2.02

| Finding: | Blockwork Retaining Wall Leaning Out Of Plumb |
| Information: | The blockwork retaining wall has been identified as leaning out of plumb. This is typically associated with ground movement, inadequate drainage, or age-related deterioration. Movement of this nature may worsen over time and could affect the performance of the wall if left unaddressed. It is recommended that a licensed builder or structural landscaper assess the wall and carry out necessary repairs or reconstruction as required. Prompt attention is recommended to prevent further movement and potential failure. |

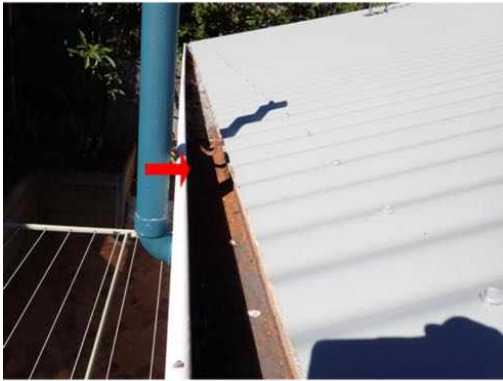
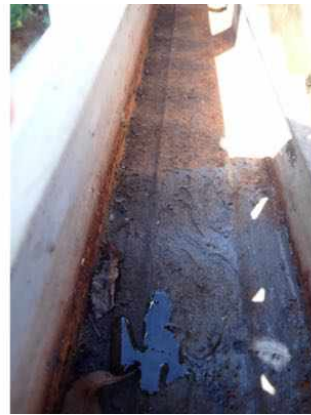
Finding 2.03

| Finding: | Rust And Excessive Silicone To Rear Gutter |
| Information: | Rust has been identified to the rear gutter, and an excessive amount of silicone has been applied internally, likely as an attempt to stop a leak. This is typically associated with age-related deterioration and previous temporary repairs. Such measures are generally ineffective long term and may mask underlying defects. If left unaddressed, the gutter may continue to deteriorate and leak. It is recommended that a licensed plumber replace or properly repair the affected gutter sections to ensure a durable and functional drainage system. Prompt repairs are recommended to prevent further deterioration and potential damage. |

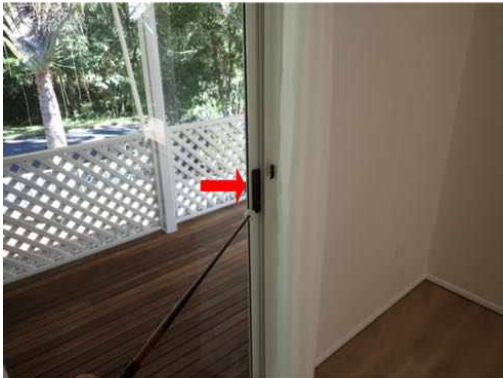
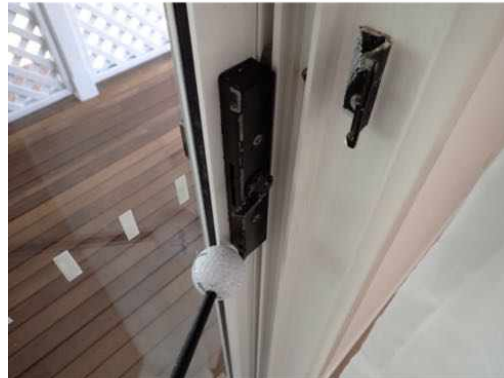
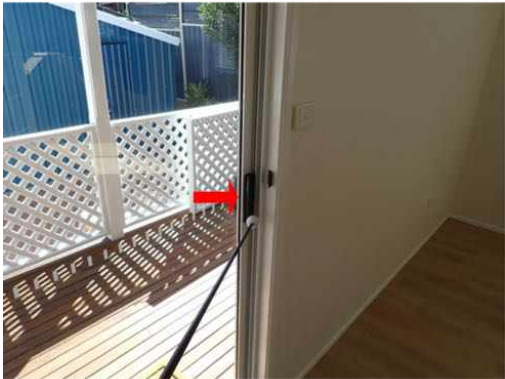
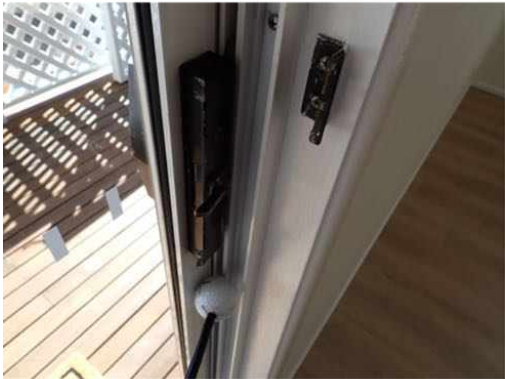
Finding 3.01

Finding: Broken Handle Pulls To Living Room Sliding Doors (Locking Functional)

Information: The handle pulls to the living room sliding doors have been identified as broken, although the locking mechanisms were functional at the time of inspection. This is typically associated with wear and tear or impact damage. The defect may affect ease of operation of the doors. It is recommended that a carpenter or suitably experienced handyman repair or replace the handle pulls as required. Repairs can be carried out at the owner's discretion.

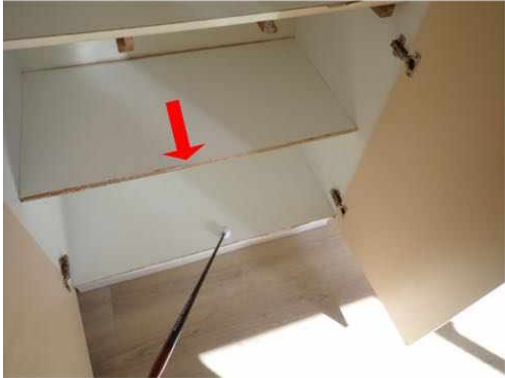
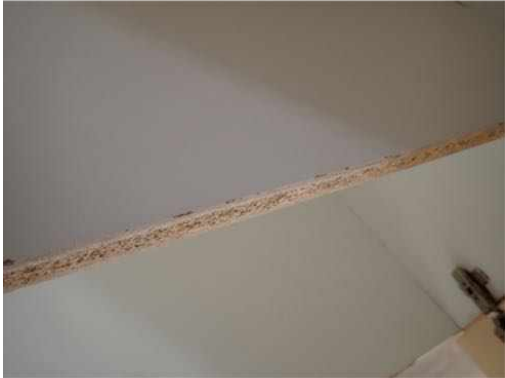
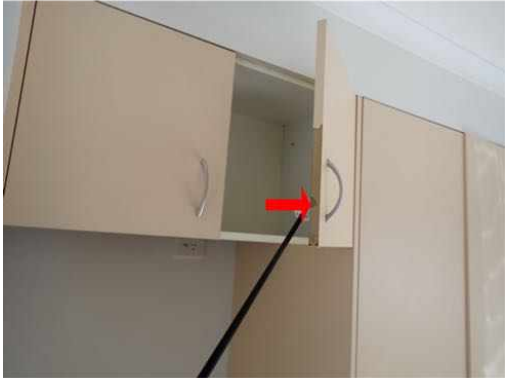
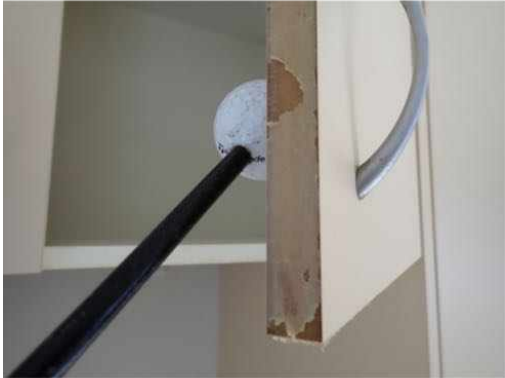
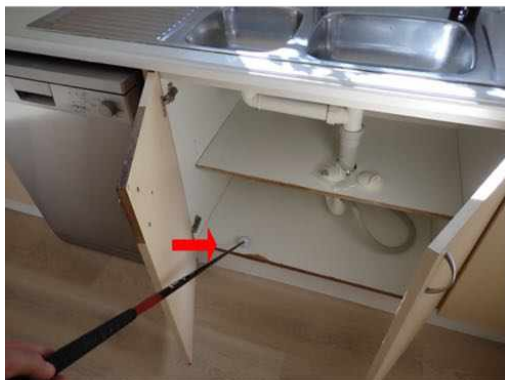
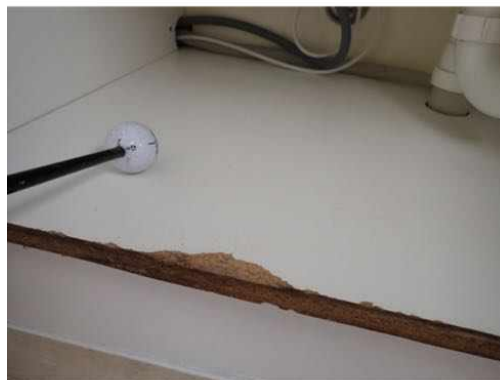
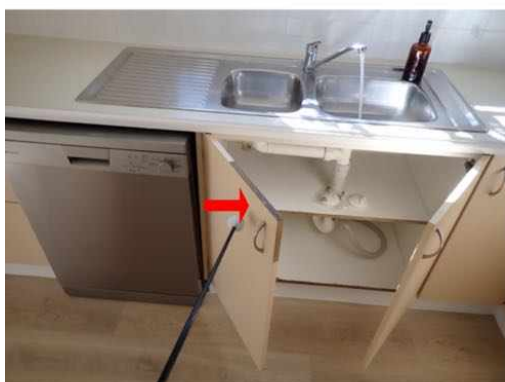
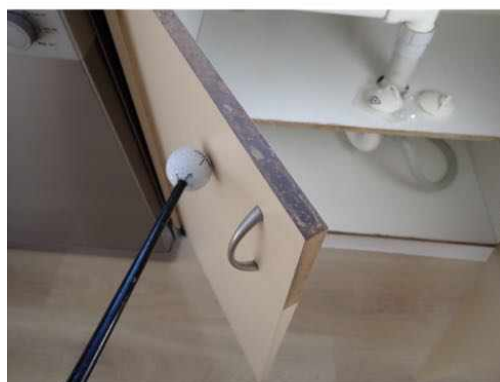
Finding 3.02

Building: Main Building
Location: Kitchen
Finding: Kitchen In Fair Condition With Minor Age-Related Defects
Information: The kitchen was observed to be in fair condition overall, with minor defects including damaged edge tape to cabinet doors and shelving. These issues are typically associated with age-related wear and tear. While generally cosmetic, deterioration may continue over time if left unaddressed. It is recommended that a carpenter or suitably experienced handyman repair or replace the affected components as required. Repairs can be carried out at the owner’s discretion.

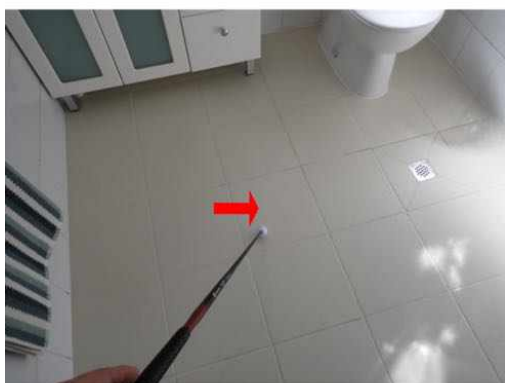
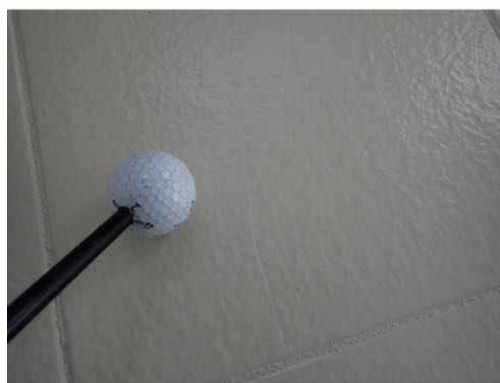
Finding 3.03

Finding: Crack To Bathroom Floor Tile

Information: A crack has been identified to a floor tile in the bathroom. This is typically associated with minor impact, substrate movement, or age-related deterioration. If left unaddressed, the crack may worsen over time and affect the integrity of the tile. It is recommended that a tiler or suitably experienced handyman repair or replace the affected tile as required. Repairs can be carried out at the owner's discretion.

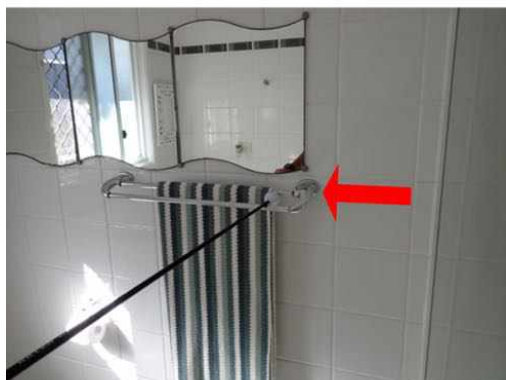
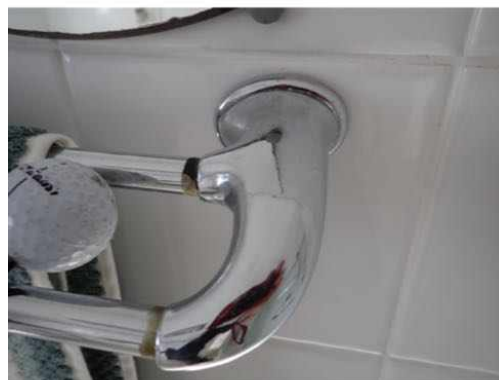
Finding 3.04

| Finding: | Loose Towel Rail |
| Information: | The towel rail has been identified as loose. This is typically associated with wear and tear, failed fixings, or poor installation. Continued use may cause further loosening or damage to the wall surface. It is recommended that a carpenter or suitably experienced handyman secure or refix the towel rail and repair any associated wall damage as required. Repairs can be carried out at the owner's discretion. |

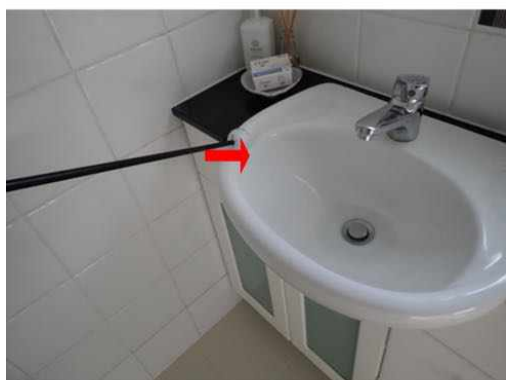
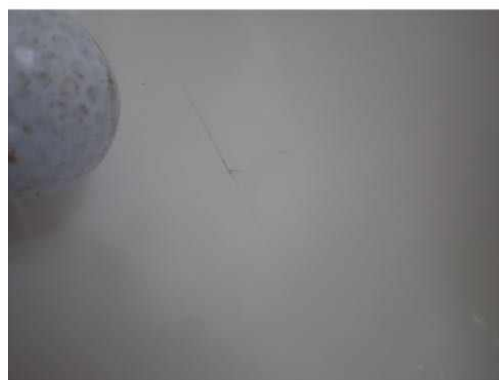
Finding 3.05

| Finding: | Crack To Bathroom Vanity Basin |
| Information: | A small crack has been identified to the bathroom vanity basin. This is typically associated with impact damage or age-related wear. Cracks in sanitary fixtures may worsen over time and can lead to leakage or hygiene concerns if left unaddressed. It is recommended that a licensed plumber or suitably experienced handyman repair or replace the affected basin as required. Repairs can be carried out at the owner's discretion. |

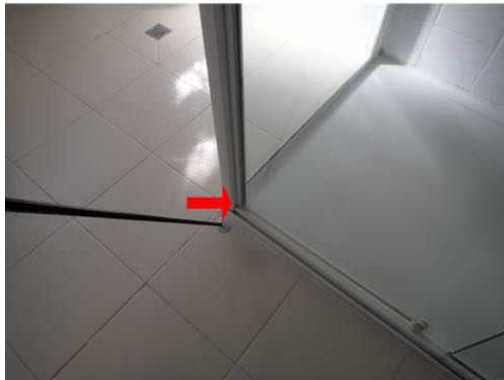
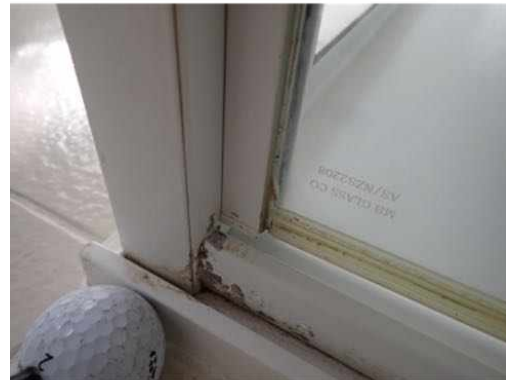
Finding 3.06

| Finding: | Shower Door Catching On Frame |
| Information: | The shower door has been identified as catching on the door frame. This is typically associated with misalignment, worn hinges, or minor movement in the structure. Continued use may cause further damage to the door or frame. It is recommended that a shower screen installer or suitably experienced handyman adjust, repair, or realign the door to ensure smooth operation. Repairs can be carried out at the owner's discretion. |

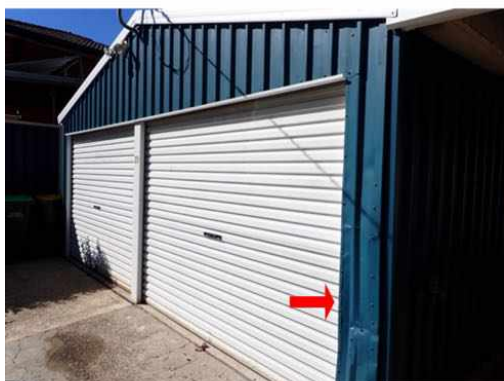
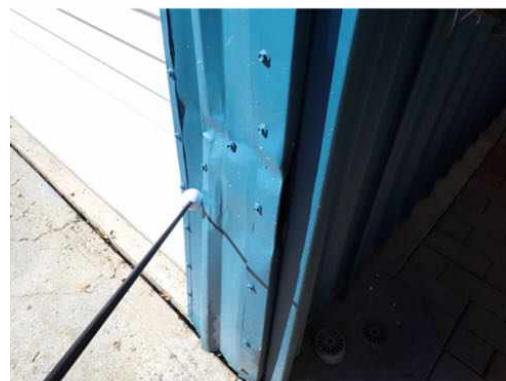
Finding 3.07

| Finding: | Isolated Impact Damage To Garage External Cladding (Right-Hand Front Corner) |
| Information: | Isolated impact-related damage has been identified to the external cladding of the garage at the right-hand front corner. This is typically associated with accidental contact or external force. The damage may allow deterioration of the cladding over time if left unaddressed. It is recommended that a carpenter or suitably experienced handyman repair or replace the affected cladding as required. Repairs can be carried out at the owner's discretion. |

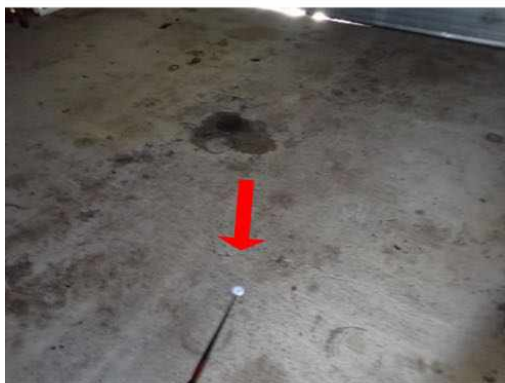
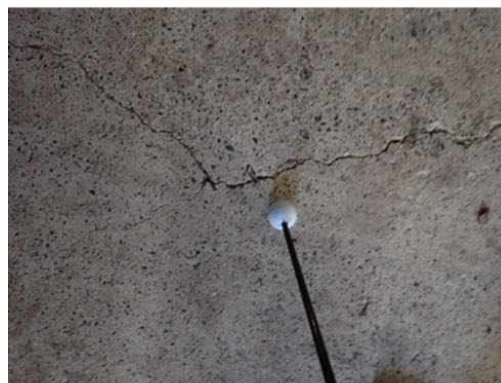
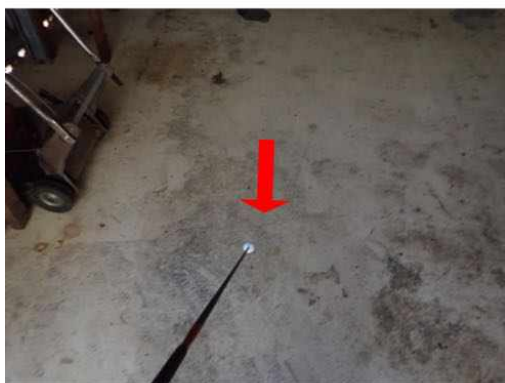
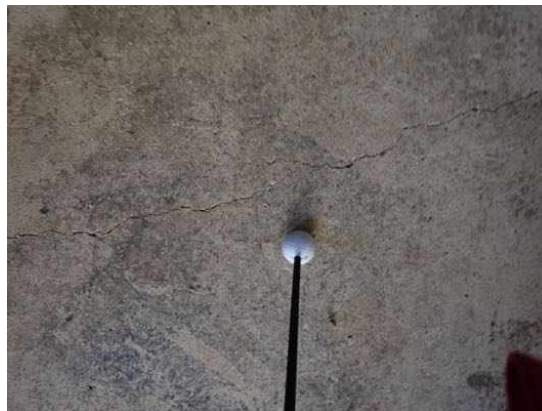
Finding 3.08

| Finding: | Minor Cracking To Garage Concrete Floor |
| Information: | Minor cracks have been identified to the garage concrete floor. This is typically associated with normal shrinkage, minor movement, or age-related deterioration and is considered a common defect. If the cracks worsen over time, they may allow moisture ingress and further deterioration. It is recommended that a concreter or suitably experienced handyman monitor and repair the cracks as required. Repairs can be carried out at the owner's discretion. |

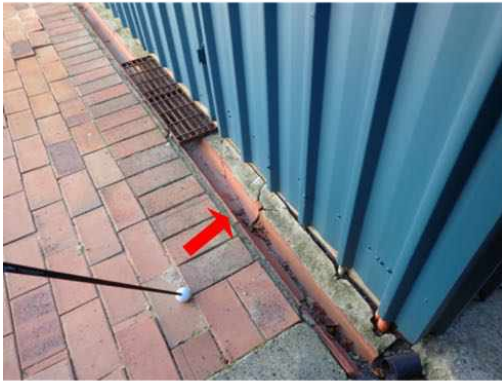
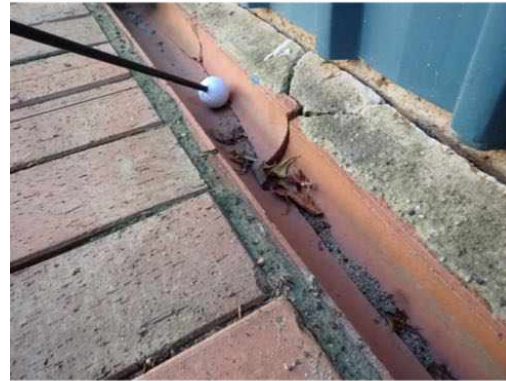
Finding 3.09

| Finding: | Cracking To Terracotta Drain And Adjacent Concrete At Rear Of Garage |
| Information: | Cracks have been identified to the terracotta drain and associated concrete at the base of the rear wall to the garage. This is typically associated with age-related deterioration, ground movement, or wear over time. If left unaddressed, cracking may worsen and affect drainage performance or lead to further deterioration of surrounding materials. It is recommended that a licensed plumber or suitably experienced |

handyman assess and repair the affected drain and concrete as required. Repairs can be carried out at the owner's discretion.

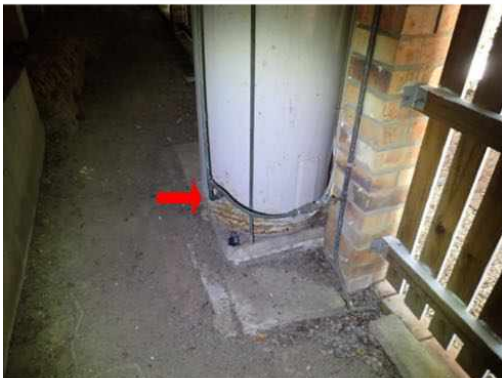
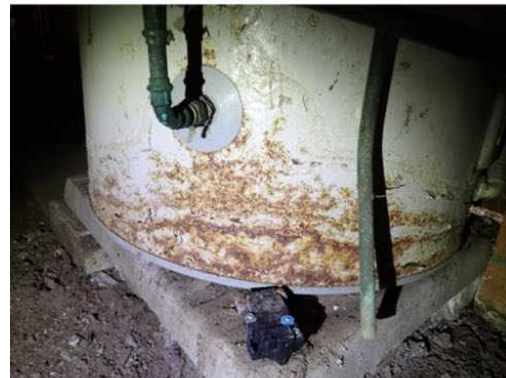
Finding 3.10

| Finding: | Rust To Hot Water Unit |
| Information: | Rust has been identified to the hot water unit. This is typically associated with age-related deterioration and prolonged exposure to moisture. Corrosion of this nature may indicate the unit is nearing the end of its serviceable life and may continue to deteriorate if left unaddressed. It is recommended that a licensed plumber assess the condition of the unit and carry out repairs or replacement as required. Repairs can be carried out at the owner's discretion. |

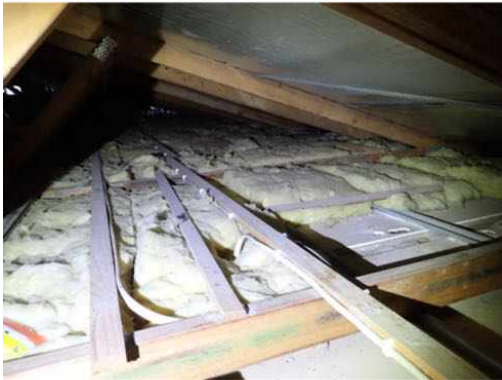
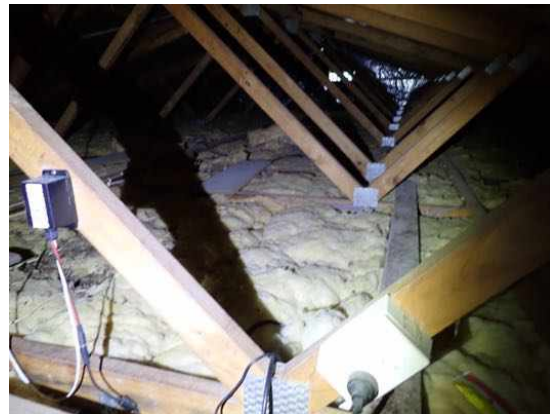
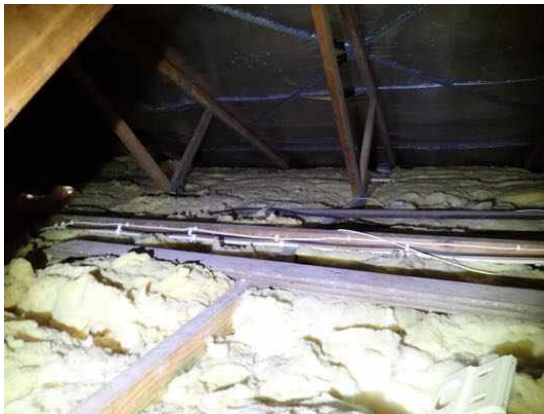
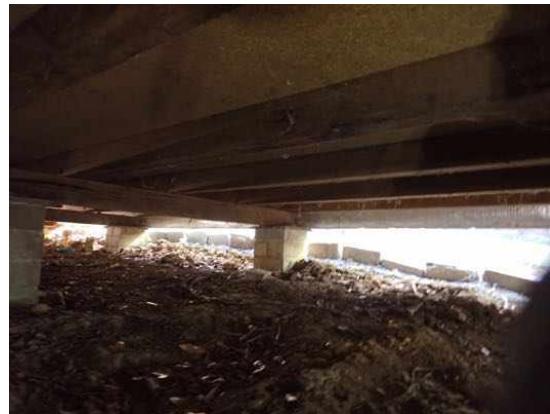
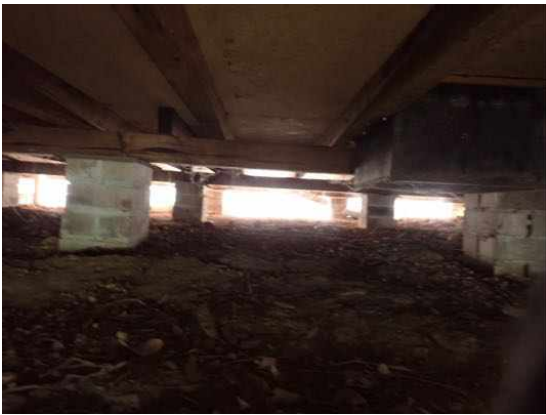
Noted Item

Building: Main Building
Location: All Areas
Finding: Additional Photos - Obstructions and Limitations
Information: These photographs are an indication of the obstructions and limitations which impeded full inspection of the area at the time of inspection. These obstructions can hide an array of defects and should be removed to allow full inspection to be carried out. A re-inspection is recommended once the areas are made accessible.
