Building and Timber Pest Inspection Report

Inspection Date: Fri, 27 Mar 2026

Property Address: 131 Woodcourt Rd, Berowra Heights NSW
2082, Australia

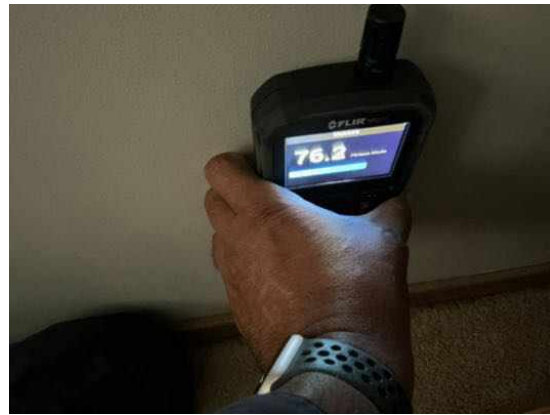
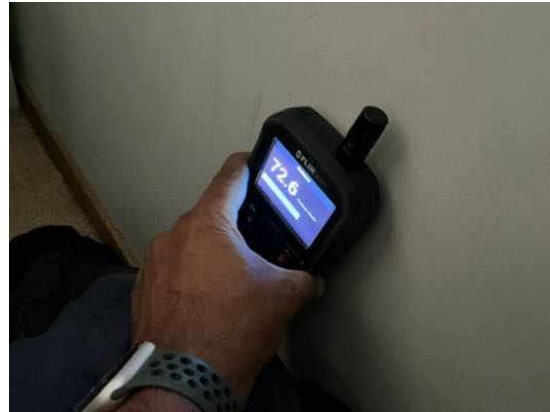
Finding: Moisture Ingress to Wall and Window Frame

Information: At the time of inspection, elevated moisture readings were recorded to the internal wall adjacent to the window, indicating the presence of excessive moisture. Water staining was also observed on the timber window frame, which is consistent with previous or ongoing moisture ingress.

Upon external inspection, it was noted that sections of the cladding above the window are damaged, particularly at the corner areas. These defects may allow rainwater penetration, which could be contributing to the moisture detected internally.

If left unaddressed, this condition may lead to deterioration of internal finishes, timber elements, and potential mould growth. It is recommended that the client engage the services of a qualified builder to inspect and repair the damaged external cladding and ensure all areas are properly sealed to prevent further water ingress.

The client is also advised to monitor the internal wall over the next 12 months for any signs of deterioration such as bubbling paint, staining, or changes in surface texture, and take further action if conditions worsen.

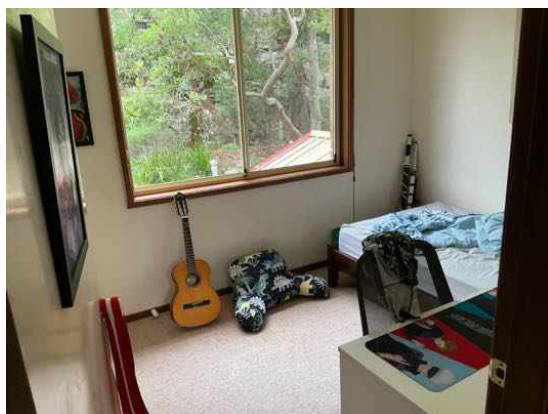
Building:	Main Building
Location:	Bedroom 2
Finding:	Minor Roof Leak – Bedroom Two Ceiling
Information:	At the time of inspection, a minor leak was noted on the ceiling of Bedroom Two, evidenced by visible staining. Thermal imaging indicated a temperature variation consistent with possible moisture presence. Upon inspection of the roof space directly above this area, damaged sarking was observed along with staining to the insulation, which is indicative of previous or ongoing water ingress.

This condition suggests that water may be entering through compromised roofing components such as loose flashings, deteriorated seals, or gaps in roof coverings. Although currently minor, this issue may worsen over time and lead to further internal damage if not addressed.

It is recommended that the client engage the services of a qualified roofer to inspect the affected roof area, identify the exact point of entry, and carry out necessary repairs, including sealing any gaps or loose sections to prevent further water ingress.

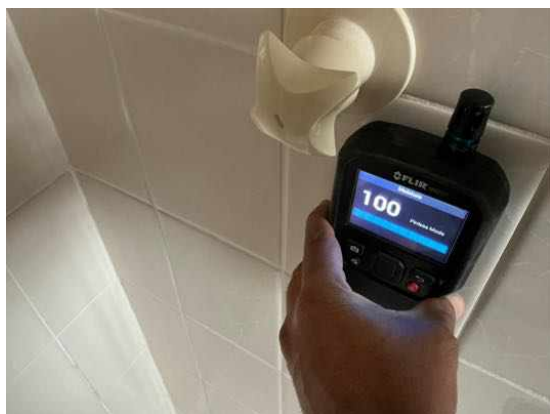
Building:	Main Building
Location:	Ensuite - Master
Finding:	Excessive Moisture - Shower Damp
Information:	At the time of inspection, excessive moisture was noted within the shower area, which is a common issue in wet areas due to the continual exposure to water. This condition is typically caused by moisture seeping through grout lines and settling behind tiles, resulting in localised high-moisture zones. Provided there is no evidence of water staining or elevated moisture readings on the opposite side of the wall, this is considered a minor defect.

However, persistently damp conditions may act as conducive conditions for termite activity, as termites are strongly attracted to moisture-rich environments. It is recommended that the client ensures regular use of the exhaust fan and maintains adequate ventilation after shower use to promote drying and reduce long-term moisture build-up, thereby also reducing the risk of attracting termites.

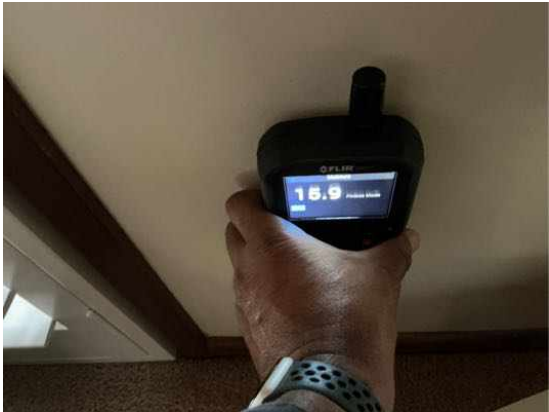
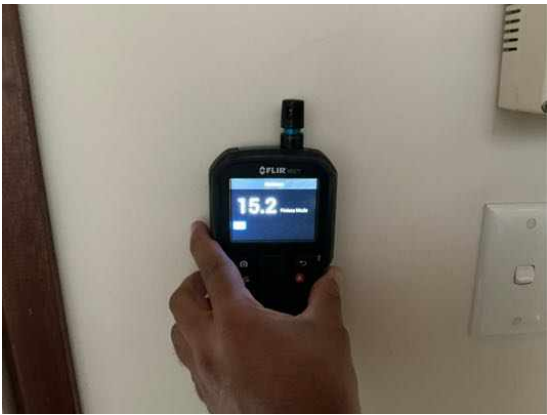
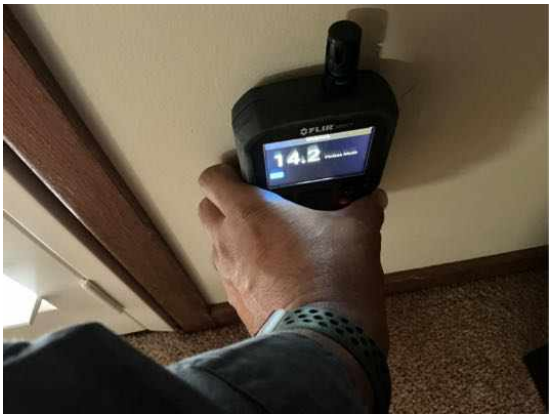
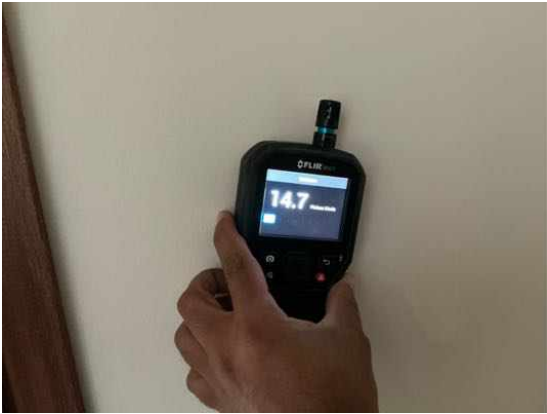
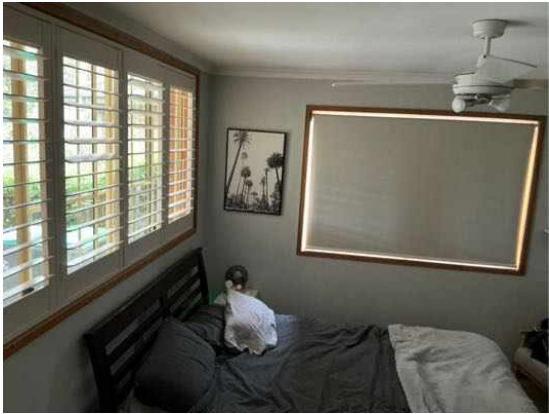
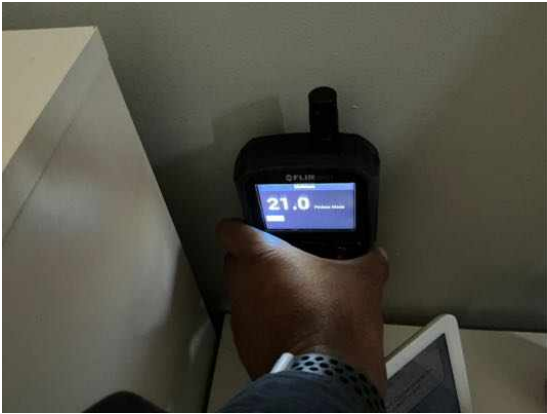
Building: Main Building
Location: All Areas
Finding: Additional Photos - Moisture Meter Readings
Information: Additional moisture meter reading photos have been provided for the property to offer further clarity on areas tested during the inspection. These photos are intended to give a visual reference for the specific locations where moisture levels were measured. These readings were taken at the time of the inspection to assess any potential moisture-related issues within the property. Any defects related to moisture that were identified during the inspection have been separately mentioned in the defect statements within the report.

It is important for the client to understand that moisture levels can fluctuate over time due to various factors, including changes in weather, humidity, and environmental conditions. While the readings reflect the property’s moisture levels during the inspection, they may not represent future conditions, and increased moisture could lead to issues such as dampness, mould growth, or deterioration of building materials if left unmonitored.

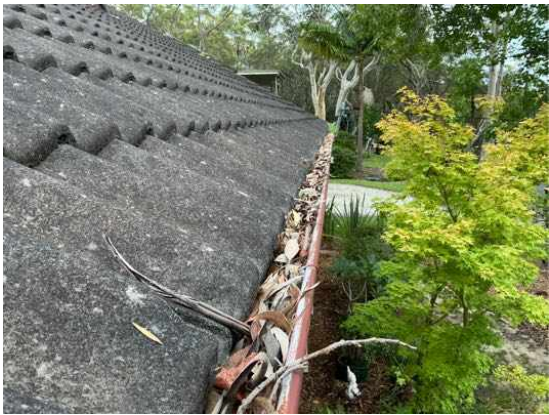
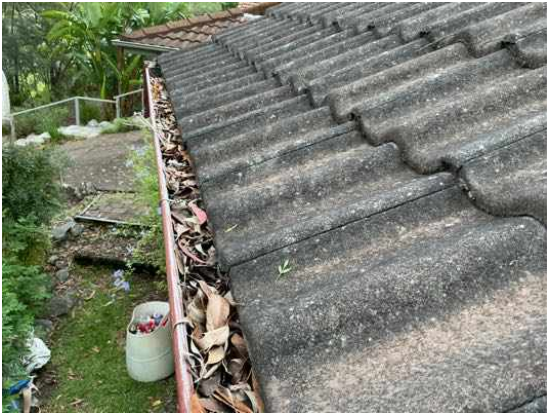
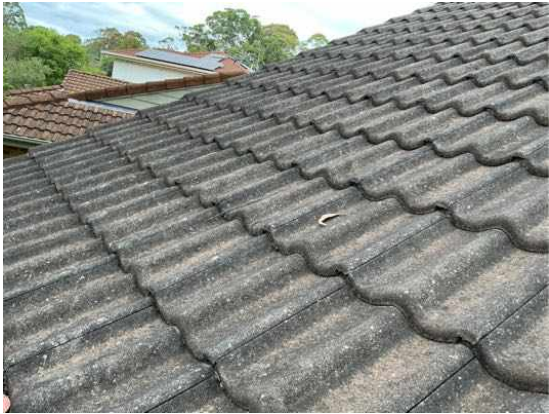
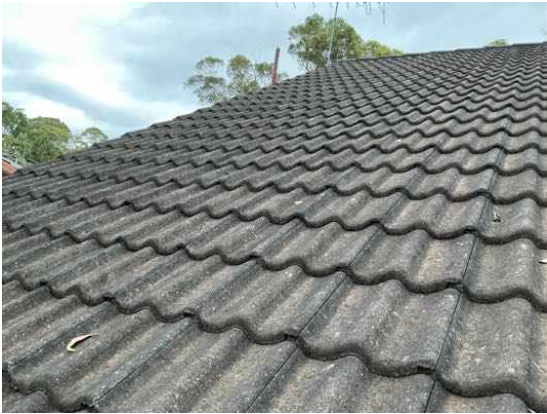
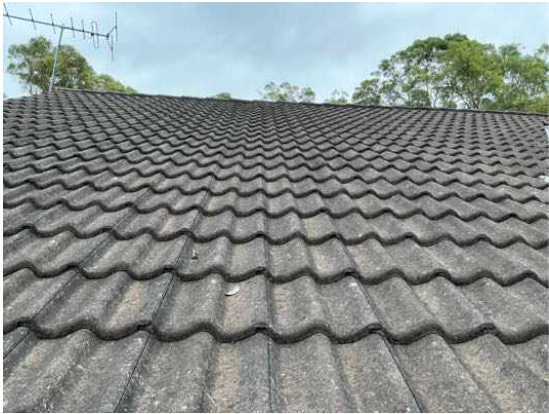
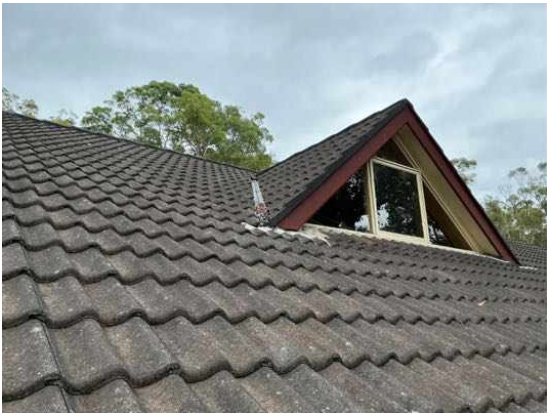
Information: As part of the information provided, please note that the attached roof photos represent the condition of the roof at the time of inspection. These photos are for visual reference only and do not constitute a detailed roofing assessment. Any defects or issues identified with the roof are mentioned separately in the defect statements. It is strongly recommended that the client engage a qualified roofer to conduct a thorough inspection of the roof, ensuring that any potential issues, such as leaks, structural integrity, or wear and tear, are properly identified and addressed.

Additionally, the condition of the roof may change over time due to weather, natural wear, or other unforeseen factors. Regular maintenance and inspections by a licensed professional are advised to ensure the roof remains in good condition and to avoid costly repairs in the future. The information provided in these photos should be considered a snapshot of the roof's condition during the time of inspection and not a guarantee of its future performance.
