Building and Timber Pest Inspection Report

Inspection Date: Tue, 27 Jan 2026

Property Address: 16 Ingham St, Capalaba QLD 4157,
Australia

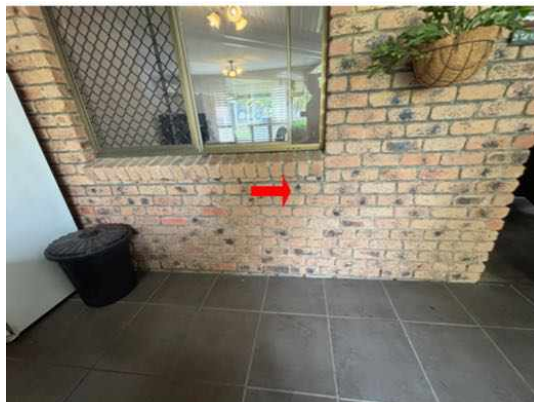
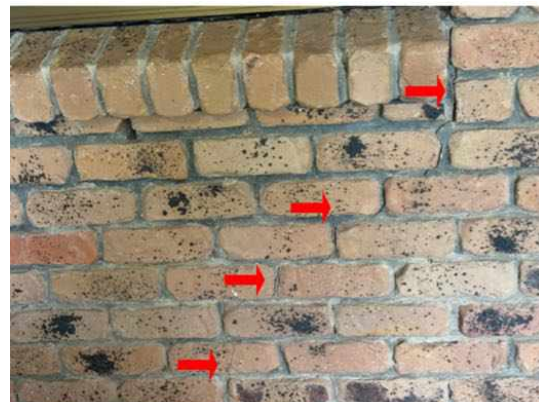
Finding 3.01

Building:	Main Building
Location:	Rear elevation
Finding:	Brickwork - Step cracking
Information:	At the time of the inspection, it was noted that there was minor step cracking to the brickwork at the rear of the dwelling. This appears to be historic. The client should monitor this area for any change to the step cracking.

Step cracking, which is similar to other forms of cracking, has a variety of possible causes. However, the most common is the subsidence of adjacent footings.

Step cracking is a relatively common defect, and is most likely to occur adjacent to windows, doors and other openings. Mortar failure in the gaps between affected bricks indicates the stresses and tensions affecting the wall.

Where step cracking is extensive or severe, the client is advised to consult a structural engineer. Minor step cracking can be used as a warning sign to address factors causing stress to the wall, which can include the effect of surrounding trees, water leaks, soil erosion, or even the presence of reactive soils in the surrounding area.

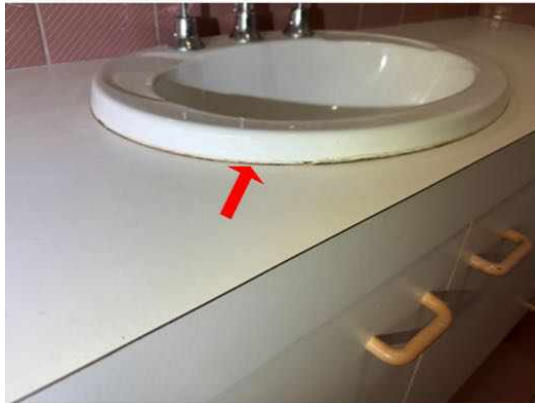
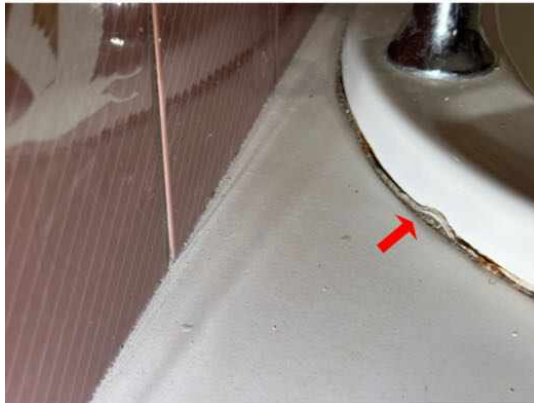
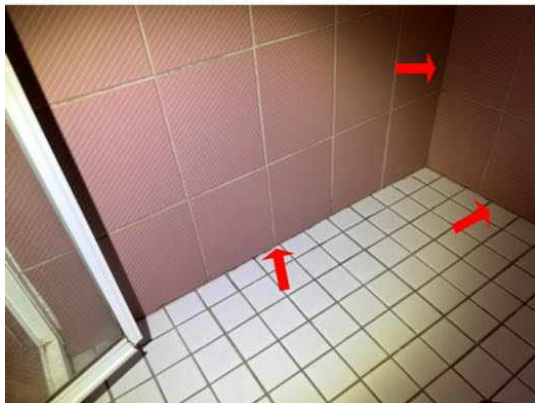
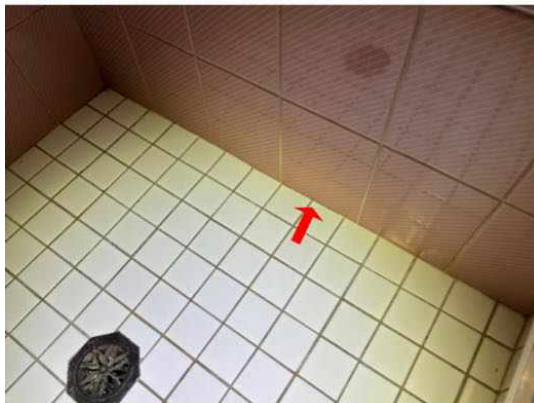
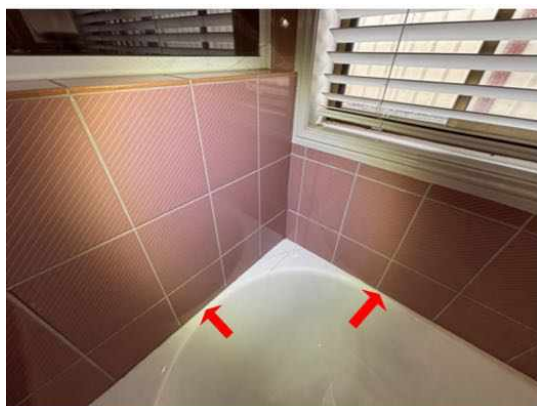
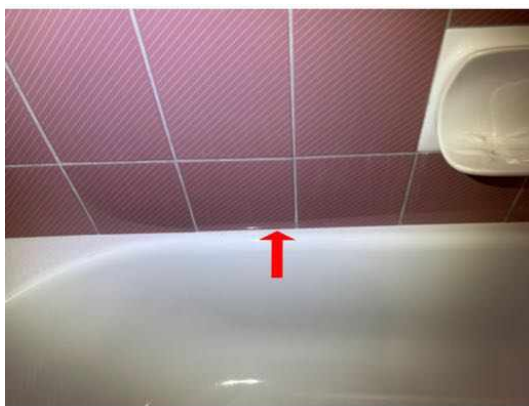
Finding 3.02

Building: Main Building
Location: Bathrooms
Finding: Bathrooms - sealant deteriorating
Information: At the time of the inspection it was noticed that the sealant in the bathrooms was deteriorating. In the family bathroom, the sealant to the vanity basin, bathtub and shower cubicle is affected. In the ensuite, the sealant to the shower cubicle is affected.

Sealant is used in tiled areas to prevent moisture from entering the wall cavity and causing damage to the building elements. A moist environment in the wall cavity may also be a conducive condition for termite activity.

If it is not addressed, damage to building elements will occur and would require invasive works to rectify any damage.

A building maintenance professional or sealant applicator should be appointed to replace all sealant as a matter of urgency.

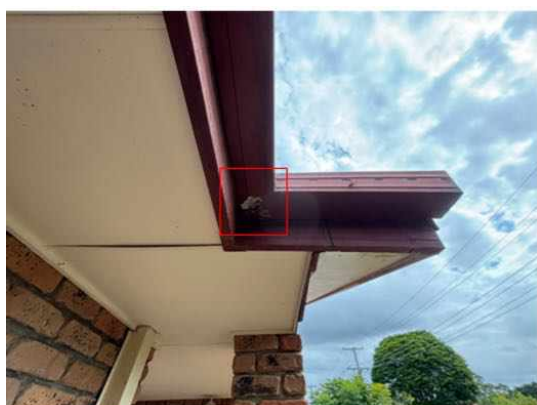
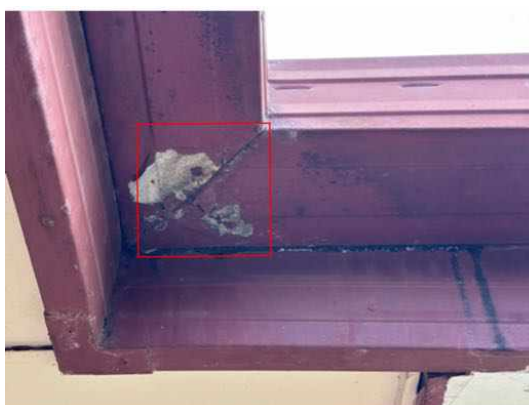
Finding 3.03

Building:	Main Building
Location:	Front elevation
Finding:	Gutters - rusting
Information:	At the time of the inspection, it was noted that a section of the gutters was rusting at the front of the dwelling. The joint is not sealed and will moisture to leak from this point.

Gutters need to be in good working order to drain the roof properly.

If gutters are leaking, moisture may get to areas of the building that are meant to be kept dry. Damage to building elements may result of moisture ingress.

A licensed roof plumber should be appointed to inspect the gutters and advise on necessary rectification works. This should be done as a matter of urgency.

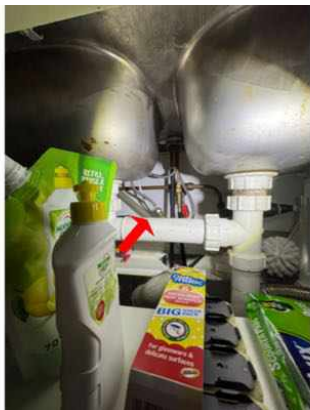
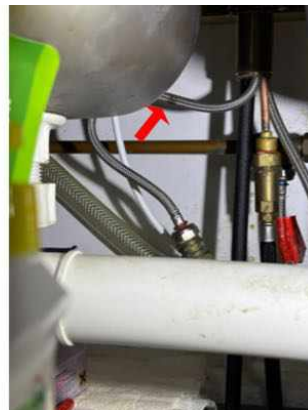
Finding 3.04

Building:	Main Building
Location:	Kitchen
Finding:	Kitchen - flexible hose has signs of rust
Information:	At the time of the inspection, it was noted that a flexible hose to the kitchen mixer had signs of rusting. This may be due to the age of the hose. Flexible hoses typically have

a 5 - 10 year lifespan. It is recommended that they be changed if they have signs of bulging, fraying, kinking or rust.

A licensed plumber should be engaged to replace both the flexible hoses to the kitchen mixer. This should be done as a matter of urgency.

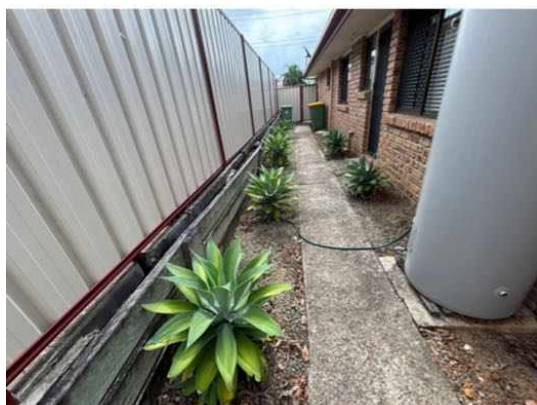
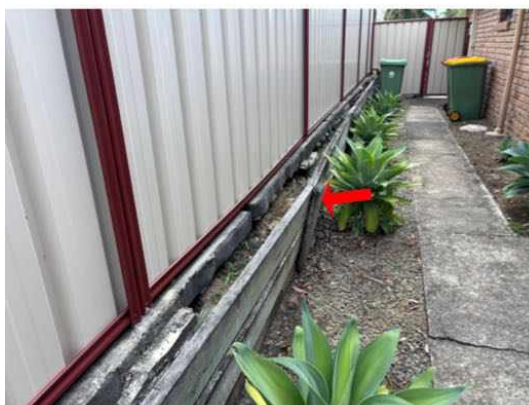
Finding 3.05

Building: Main Building
 Location: Side yard
 Finding: Retaining wall - movement
 Information: At the time of the inspection, it was noted that the low timber retaining wall on the right hand side of the dwelling has moved from its original position. This may be due to the age of the materials and general weathering. The client should monitor this low timber retaining wall for any further movement.

A retaining wall specialist or landscaper could be engaged to replace this timber retaining wall. This can be done at the clients discretion.

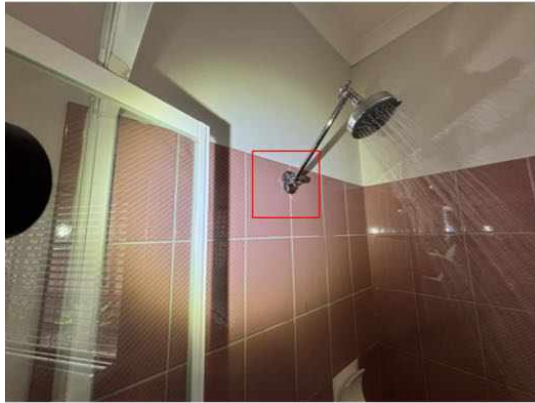
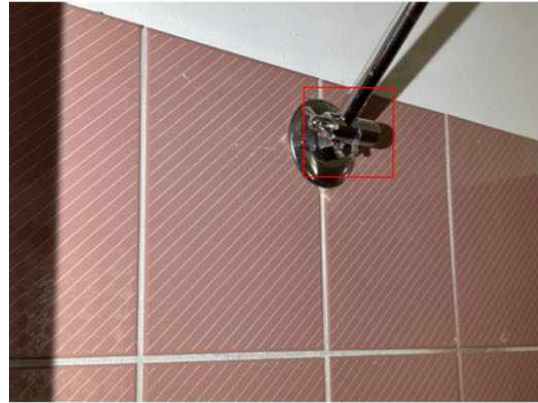
Finding 3.06

Building: Main Building
 Location: Family bathroom

Finding: Family bathroom - shower head leaking
 Information: At the time of the inspection, it was noted that there was a leak from the base of the shower head when it is turned on. This may be due to general wear and tear.

A licensed plumber should be engaged to replace the leaking shower head. This can be done at the clients discretion.

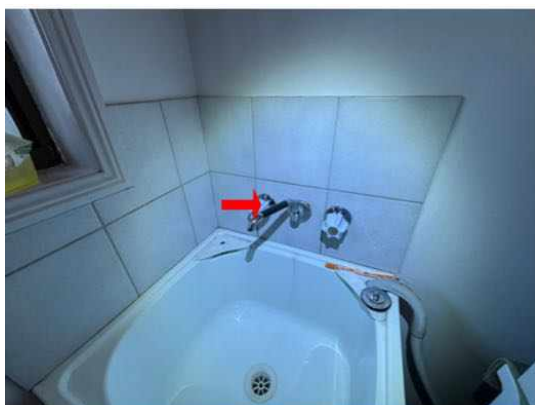
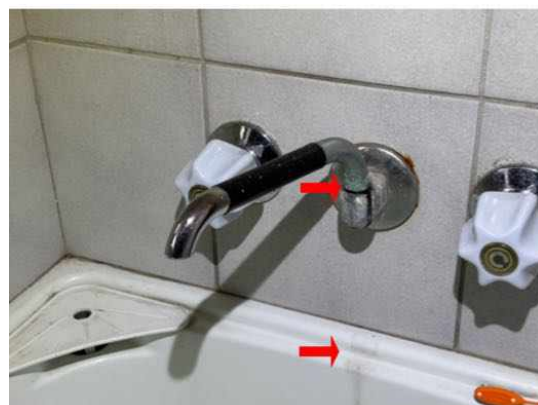
Finding 3.07

Building: Main Building
 Location: Laundry
 Finding: Laundry - spout leaking
 Information: At the time of the inspection, it was noted that the spout to the laundry tub shows signs of leaking. Water staining can be seen on the plastic tub.

A licensed plumber should be engaged to replace the laundry tub spout. This can be done at the clients discretion.

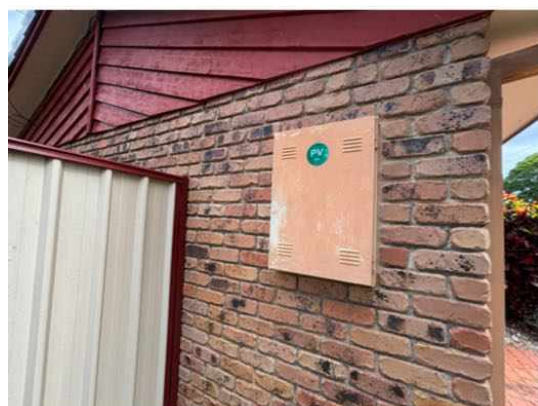
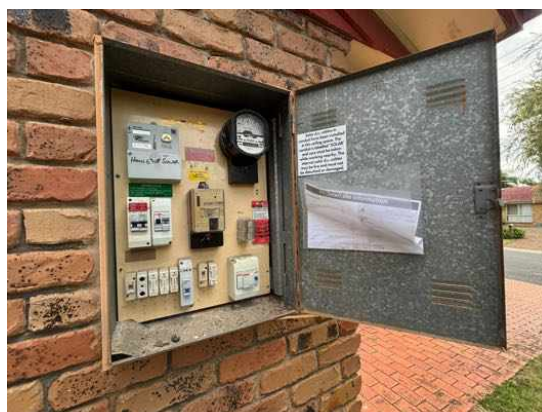
Finding 6.01

Building:	Main Building
Location:	All External Areas
Finding:	Termite Management System - no evidence of a chemical installation
Information:	At the time of the inspection, no evidence of a chemical termite management system was found. There is no durable notice in the meter box.

The application of a post-construction chemical termite barrier is highly recommended for all properties, particularly if live termite activity has been found on the site previously. Such barriers are highly effective in preventing termite attack on any timber building elements throughout the property.

A durable notice should be placed in the switchboard unit to indicate current termite barriers. At the time of inspection, it appeared as though no termite management system has been installed, with no evidence to suggest preventative works taking place.

The client may consider gaining further advice from a pest controller as to the costs and procedures involved with this application. It is recommended that obtaining such advice be a short-term priority.

A termite treatment system and annual termite inspections are important parts of an ongoing termite management plan.

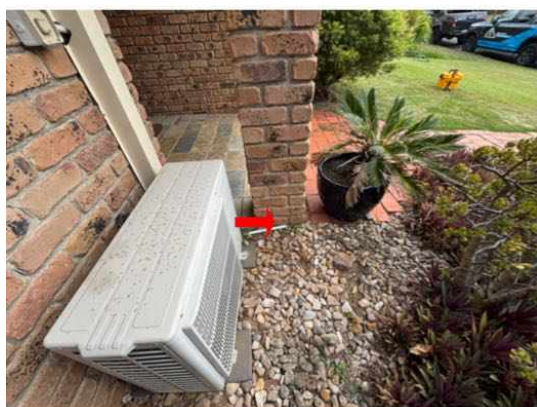
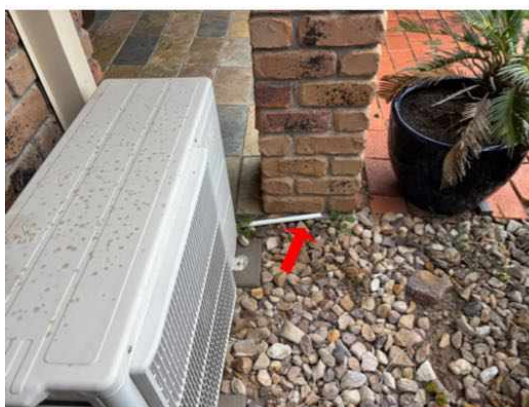
Finding 6.02

Location: Front elevation
Finding: Air conditioner - Disconnected overflow
Information: At the time of the inspection, it was noted that the air conditioner drain overflow to the unit at the front of the dwelling was not connected to the storm water drainage and as a result are draining next to the foundations of the dwelling.

Air conditioning overflows that are not connected to the storm water drainage and are draining near the foundation can create excessive moisture in the surrounding area.

Such leaking creates an environment which is conducive to an array of defects, including water damage to associated building elements and the attraction of termite or timber pest infestation.

It is highly recommended that a licensed plumber be appointed to connect the A/C overflow in order to prevent such an environment from being created. These minor works should be carried out as soon as possible.

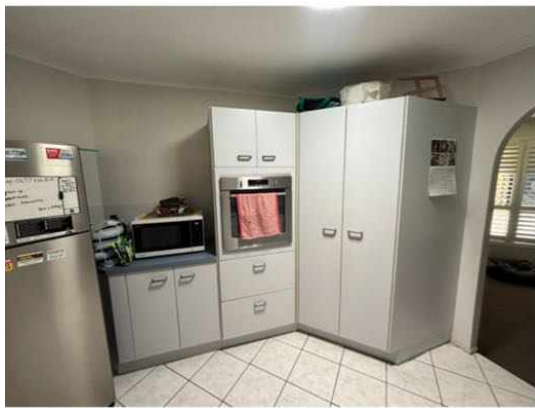
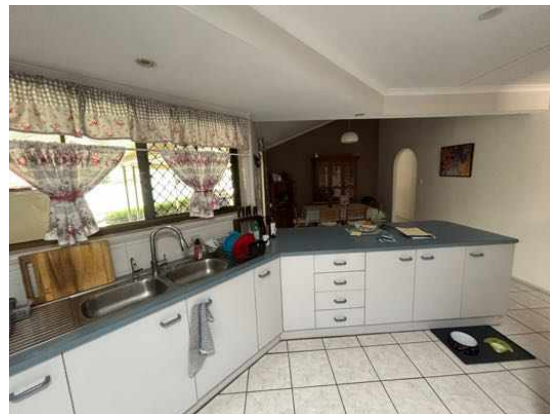
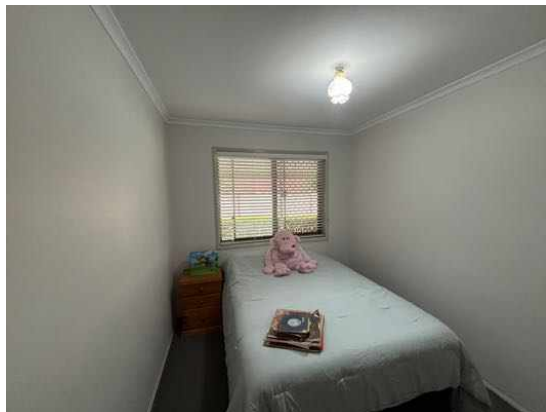
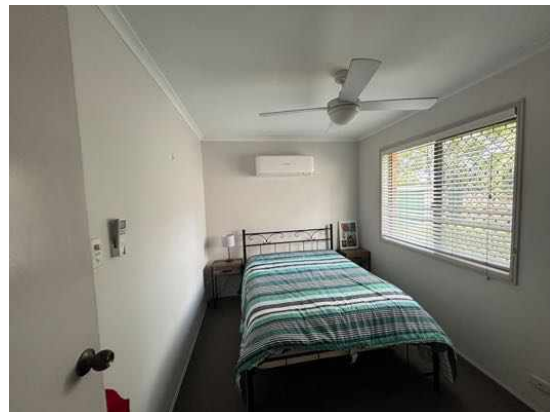
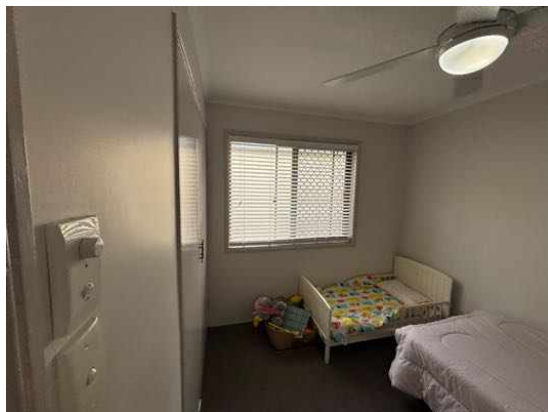
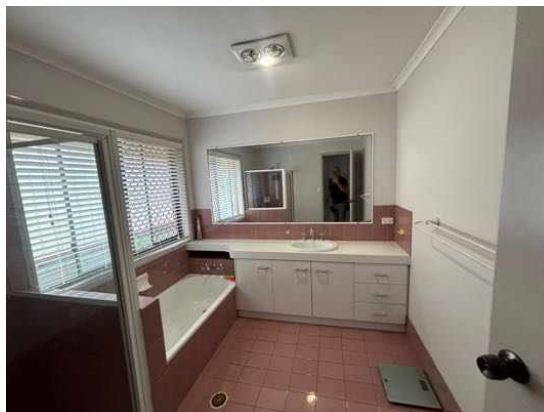
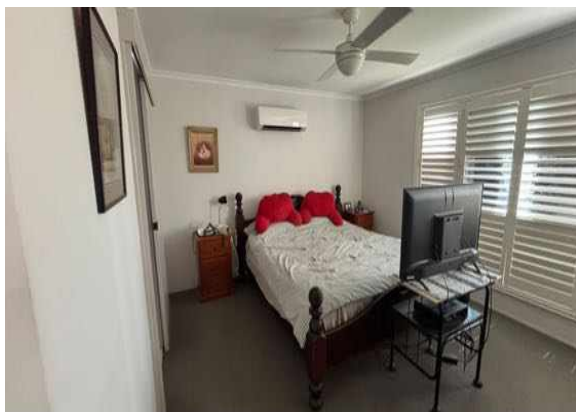
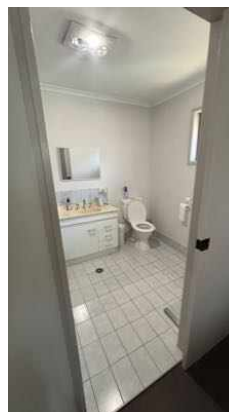
Noted Item

Building: Main Building
Location: All Internal Areas
Finding: Obstructions and Limitations - Internal areas
Information: These photographs are an indication of the obstructions and limitations which impeded full inspection of the property of the internal areas at the time of inspection. These obstructions can hide an array of defects and should be removed to allow full inspection to be carried out. A re-inspection is recommended once the areas are made accessible.

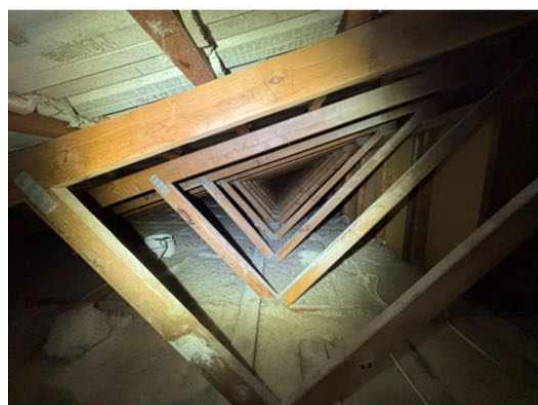
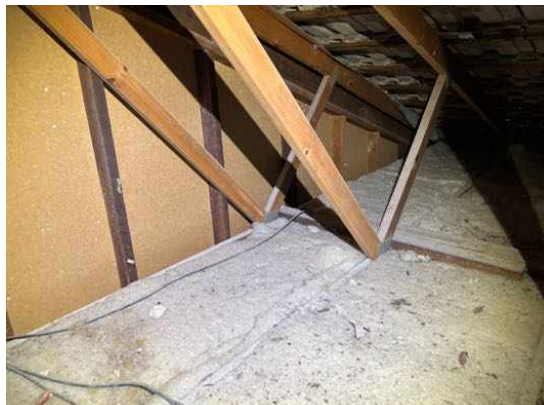
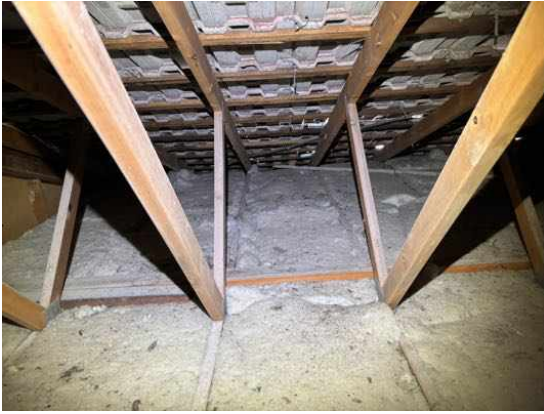
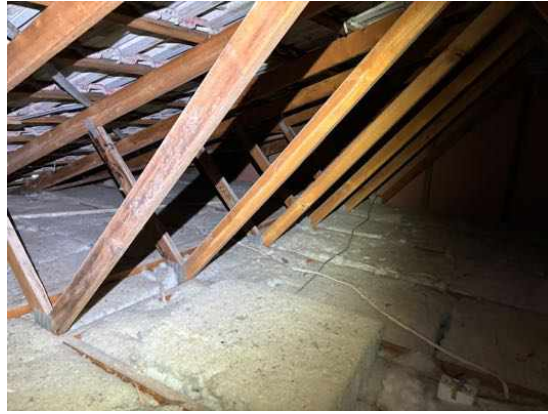
Noted Item

Building: Main Building
Location: Roof Void
Finding: Obstructions and Limitations - Roof cavity
Information: These photographs are an indication of the obstructions and limitations which impeded full inspection of the property of the roof cavity

at the time of inspection. These obstructions can hide an array of defects and should be removed to allow full inspection to be carried out. A re-inspection is recommended once the areas are made accessible.

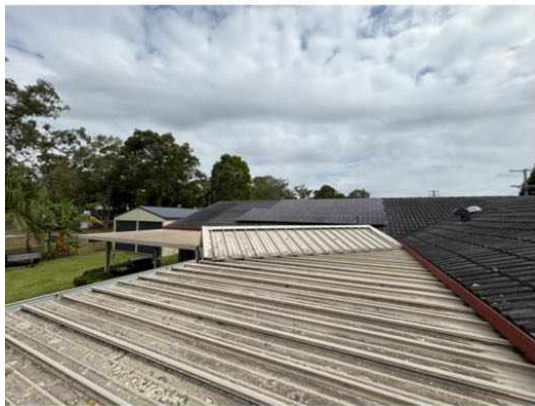
Noted Item

Building: Main Building
Location: Roof Exterior
Finding: Obstructions and Limitations - Roof exterior
Information: These photographs are an indication of the obstructions and limitations which impeded full inspection of the property of the roof exterior

at the time of inspection. These obstructions can hide an array of defects and should be removed to allow full inspection to be carried out. A re-inspection is recommended once the areas are made accessible.
