Building and Timber Pest Inspection Report

Inspection Date: Thu, 19 Mar 2026

Property Address: 10A Stables Ln, South Yarra VIC 3141,
Australia

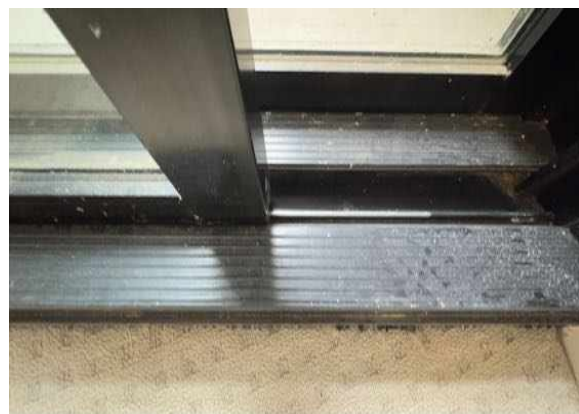
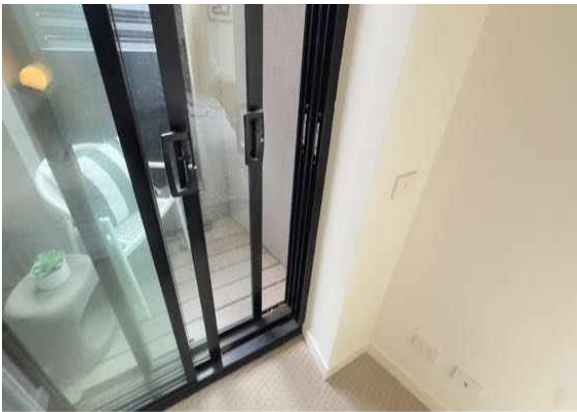
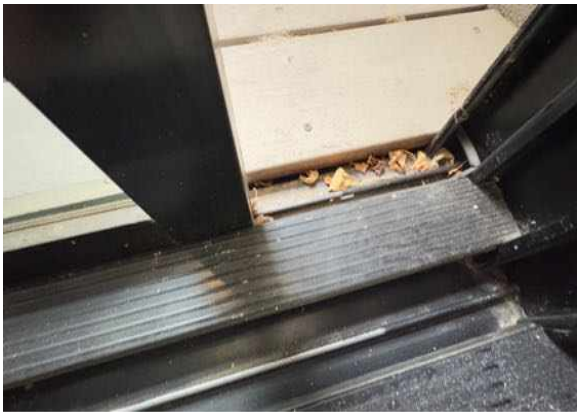
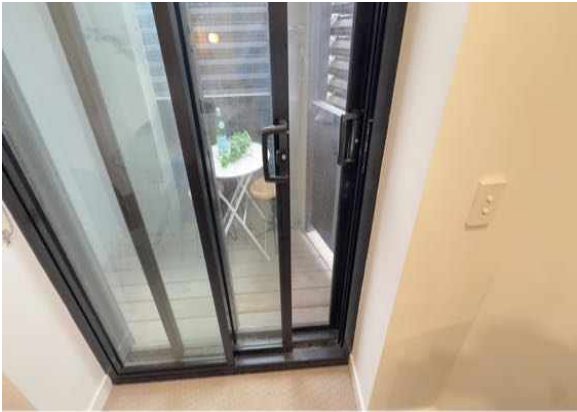
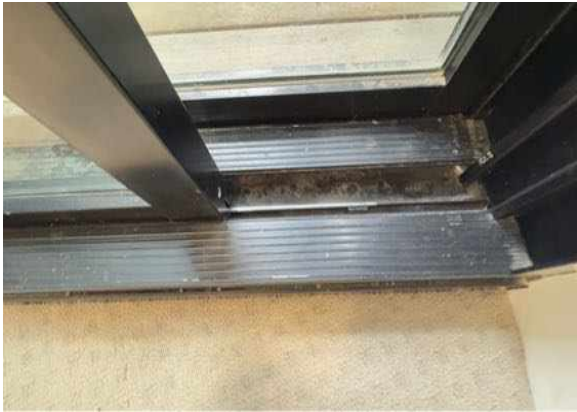
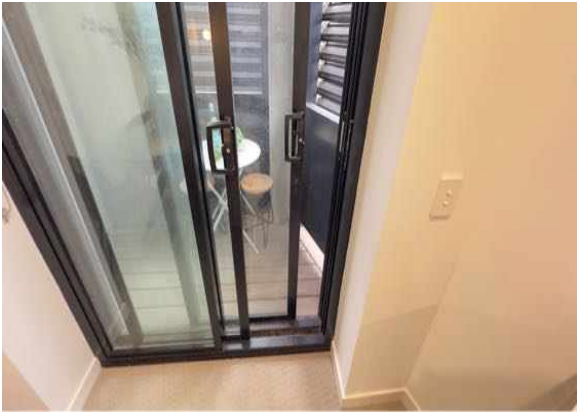
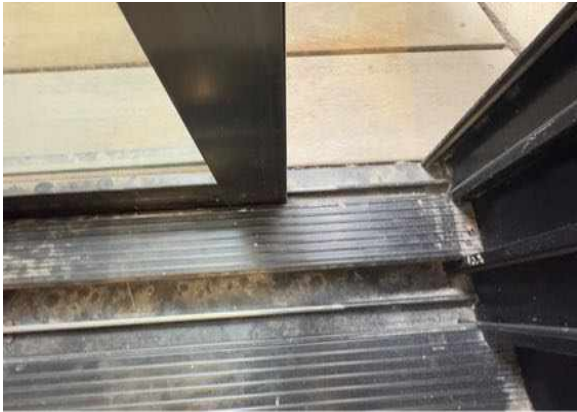
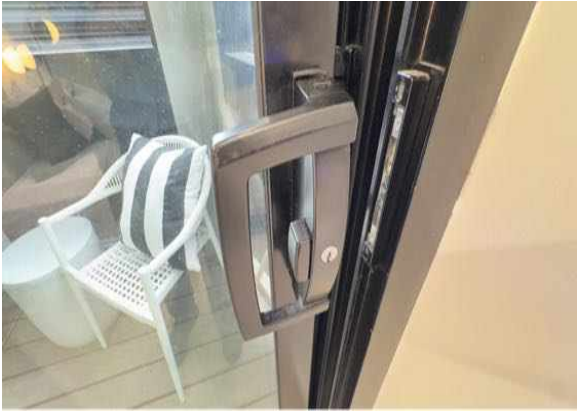
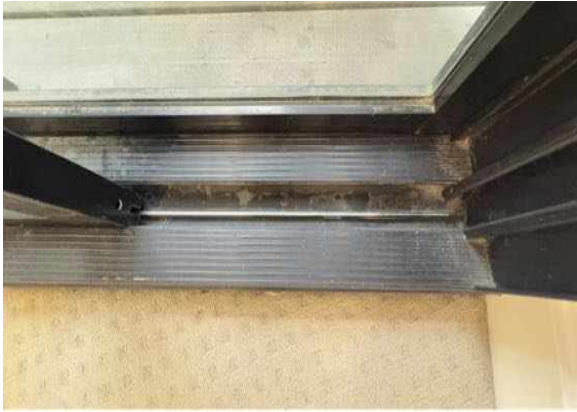
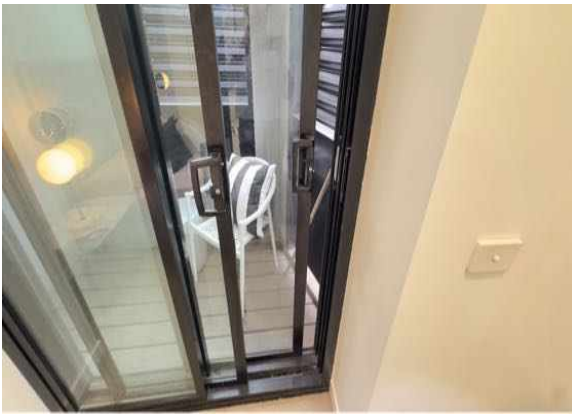
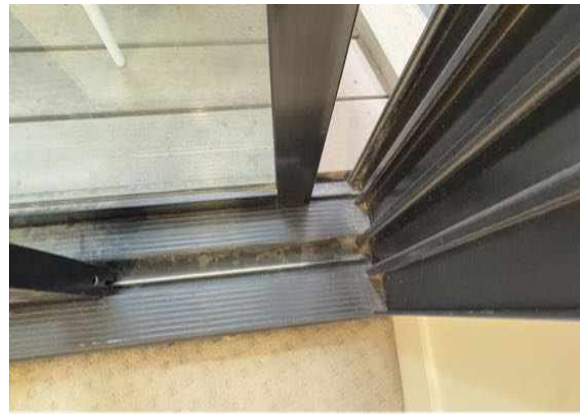
Building: Main Building
Location: All Sliding Door Areas
Finding: Doors - Doors Binding
Information: Binding or jamming of the door was observed in this area. This affects door functionality and may cause secondary damage to surrounding building elements, such as floor coverings.

Binding can result from minor issues, including poor installation, worn hinges, or misalignment, or from more significant structural problems, such as subfloor movement or damage.

When practical, a qualified carpenter should be engaged to inspect and carry out necessary repairs. If the door continues to bind after repair, or if further movement is observed, a registered builder or structural engineer should be engaged immediately to inspect for underlying structural issues.

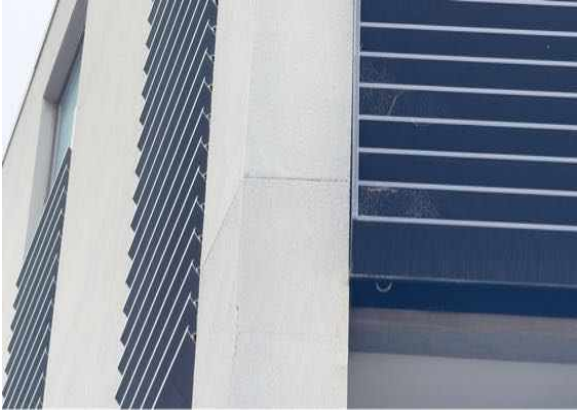
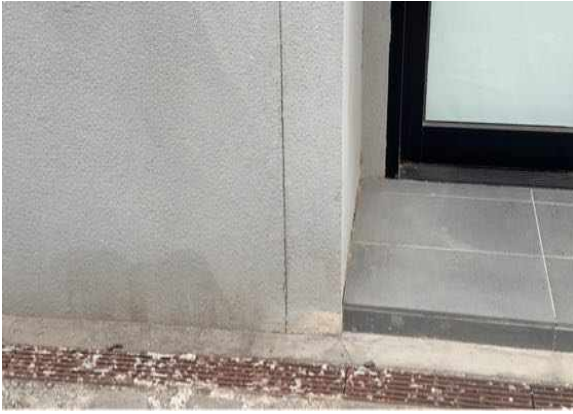
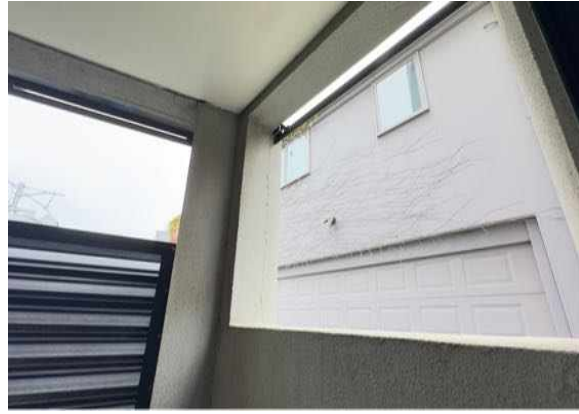
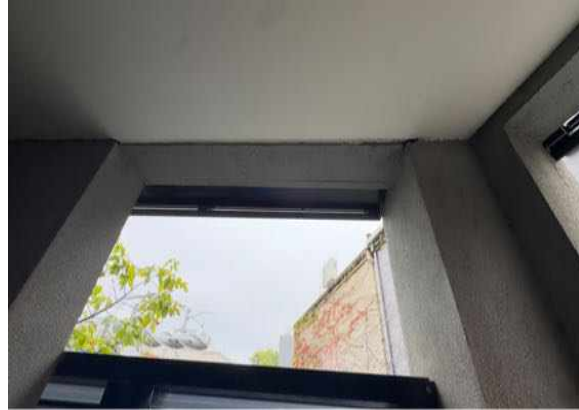
Building: Main Building
Location: All External Areas >
Finding: External Walls - Minor Cracking To Wall Claddings
Information: Minor cracking was observed to the external walls in this area. The cracking appeared superficial and did not indicate significant structural movement; however, such cracking can allow moisture ingress if left unaddressed.

The cracking is likely due to building movement or minor settlement.

When practical, a registered builder should assess and repair the cracking, which may include sealing and repainting. The area should be monitored, and any increase in cracking or signs of movement should be further investigated immediately by a Structural Engineer.

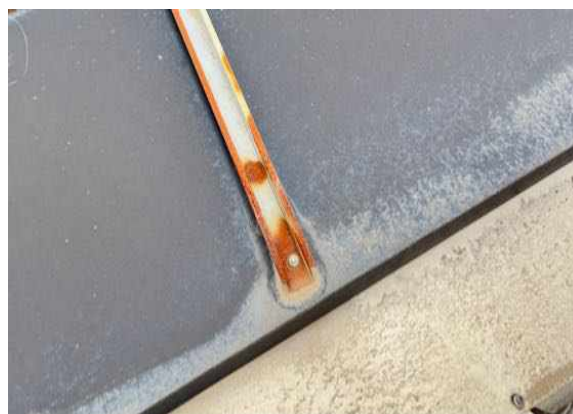
Building: Main Building
 Location: Roof Exterior
 Finding: Roof Plumbing - Rusted & Corroded
 Information: The roof plumbing has areas of rust and corrosion. It is suspected that this has been caused by blockages, resulting in pooling or standing water, that have prematurely rusted elements of the roof plumbing.

Rusted roof plumbing will generally develop holes and leaks that can affect other building elements with poor drainage of storm water. Poorly drained roof areas will

also lead to damp conditions surrounding the base perimeter of the building which, if left unmanaged, can lead to a range of secondary building defects.

Repair and/or replacement of rusted roof plumbing is highly required in order to reinstate the roof drainage system to a fully operational level. To further maintain these areas, gutters should be cleaned frequently, allowing the avoidance of any partial blockages.

A licensed plumber or specialist roof restoration company should be appointed to undertake these works. It is advised that such works be completed as soon as possible to prevent any further damage and deterioration.

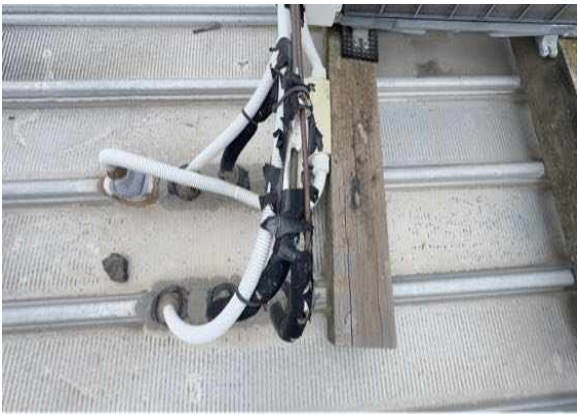
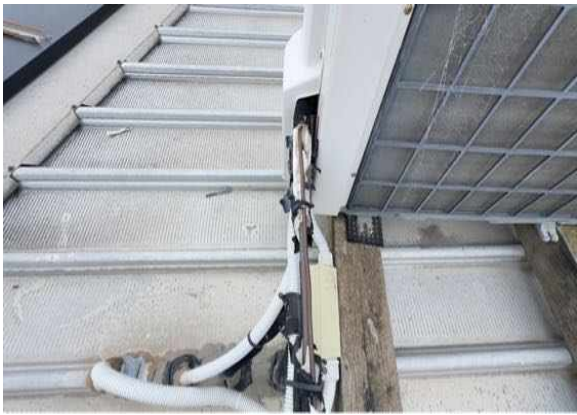
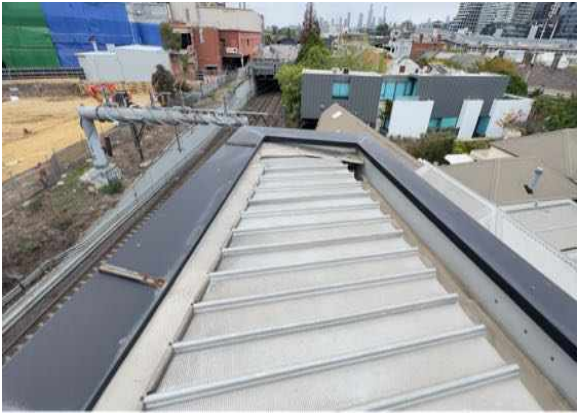
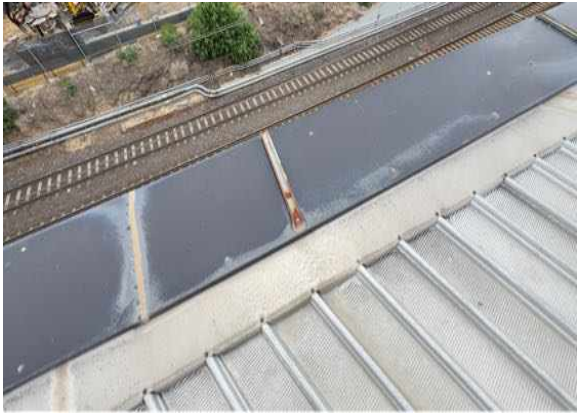
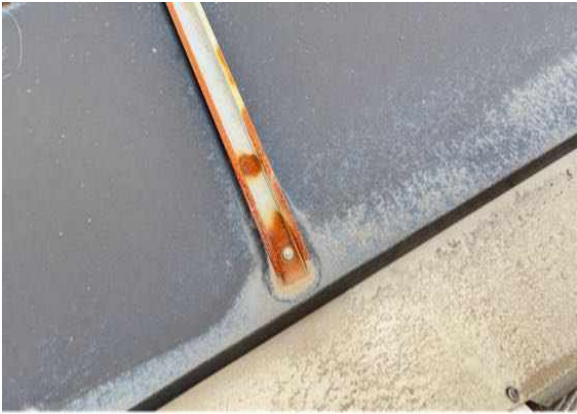
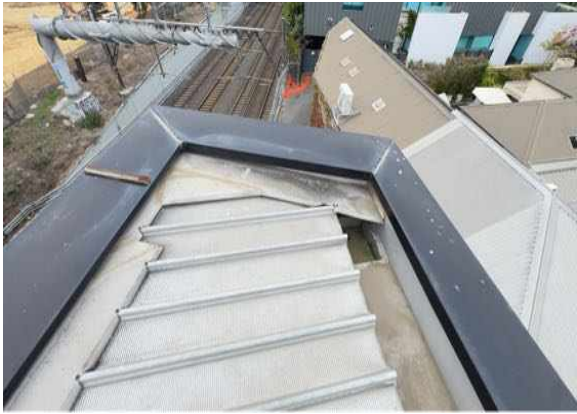
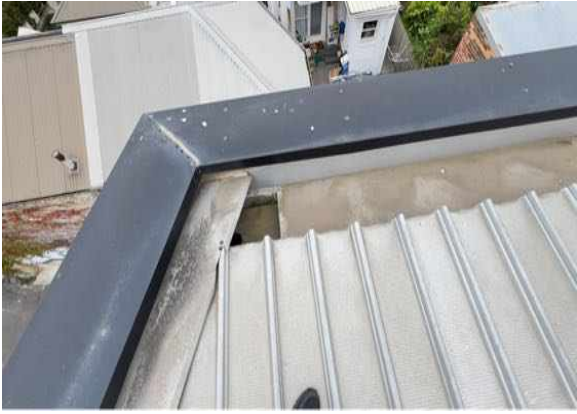
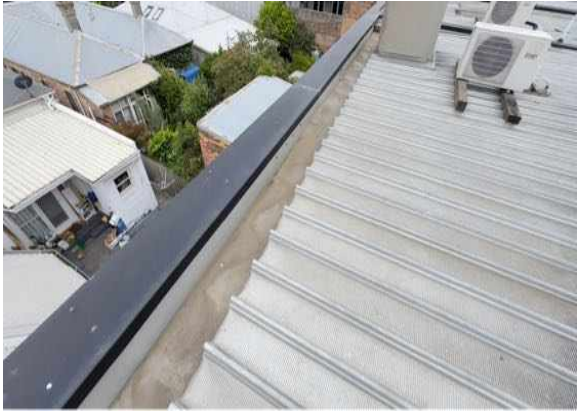
Finding 3.20

Building:	Main Building
Location:	Roof Exterior
Finding:	Roof Plumbing - Roof Images For Your Information Only
Information:	Roof Images For Your Information Only

If there are any concerns regarding the roof structure, coverings, flashings, drainage, or associated elements, further assessment by a licensed roofing contractor is recommended immediately.

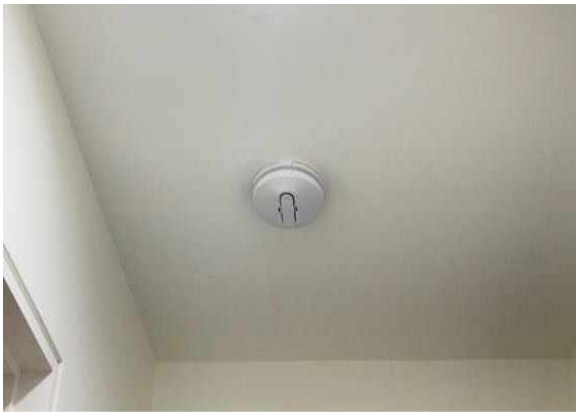
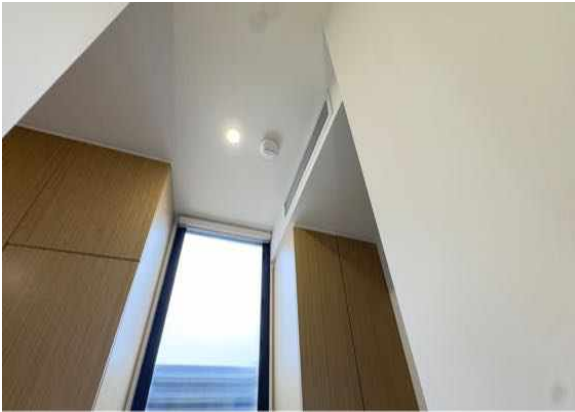
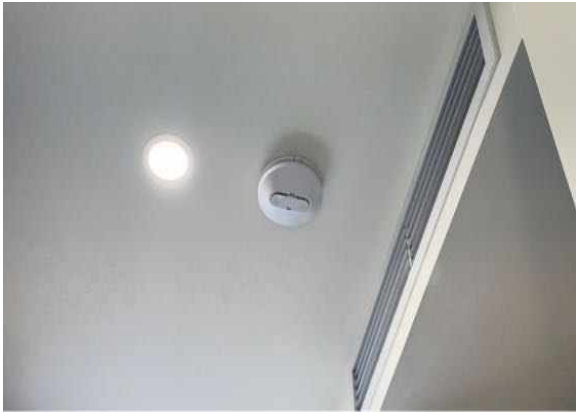
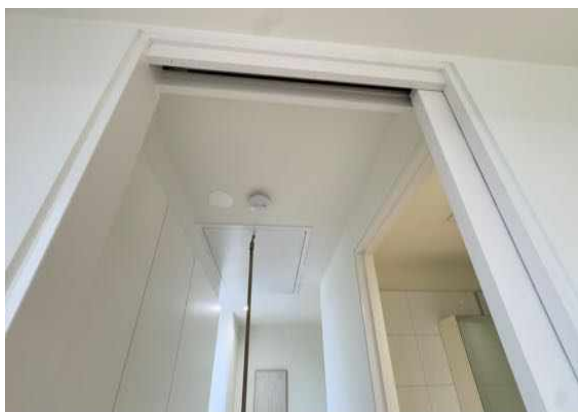
Smoke detectors are critical life-safety devices, and non-compliant, outdated, or non-operational units may not provide adequate warning in the event of a fire.

It is recommended that a licensed electrician be engaged immediately to test, service, and upgrade smoke detectors as required to ensure correct operation and compliance with current safety requirements.
