Building and Timber Pest Inspection Report

Inspection Date: Thu, 19 Mar 2026

Property Address: 79 Greenwood Parkway, Jordan Springs
NSW 2747

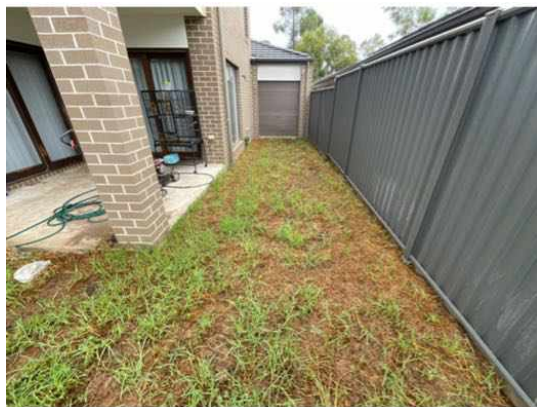
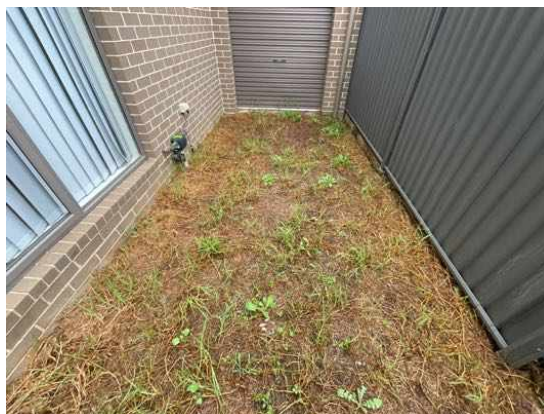
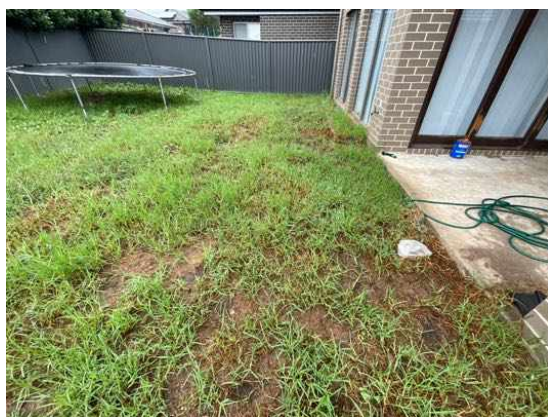
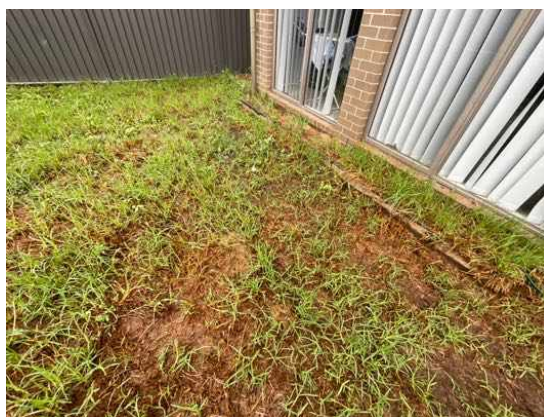
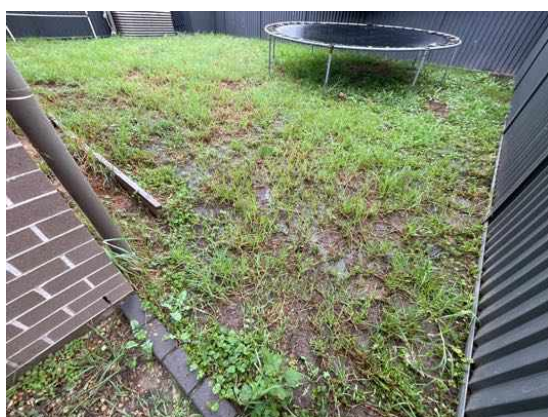
Building: Main Building
 Location: All External Areas
 Finding: Site/Yard Drainage – Below Average.
 Information: Defect – Below Average Site Drainage

Site drainage in the inspected areas appears to be below average, with no surface drains observed at the time of inspection. Ground surfaces and paved areas adjacent

Failure to meet these minimum drainage falls increases the risk of water ingress, foundation issues, and secondary building defects.

- A licensed plumber and/or landscaping contractor should be engaged to:
 - Evaluate the current site grading and surface runoff conditions
 - Install or upgrade surface water drainage (e.g. strip drains, spoon drains, grated

- Improve grading around the building to ensure water flows away from the structure

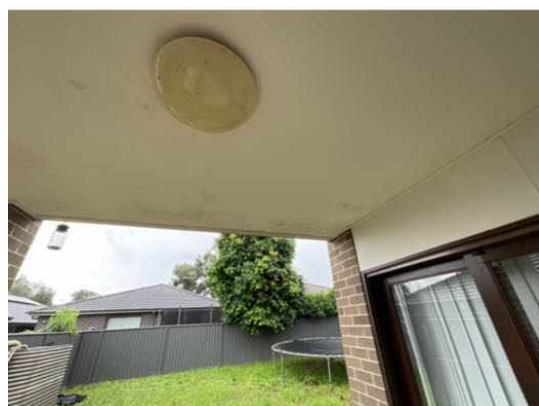
Finding 3.03

Finding: Ceiling - Water stained.

Water staining was noted to ceiling linings in the inspected area(s) at the time of the inspection. These stains present as discoloured or patchy areas and suggests a history of moisture ingress, most commonly associated with exposure to external elements.

Water staining is typically the result of prolonged exposure to moisture, which allows minerals and other contaminants carried by the water to accumulate on surfaces, leaving visible marks. If ongoing or left untreated, moisture ingress can lead to more serious issues such as:

- Where the staining appears to be historical (i.e., dry and showing no recent progression), reparation of affected ceiling materials (such as repainting or patching) may be carried out at the client's discretion.

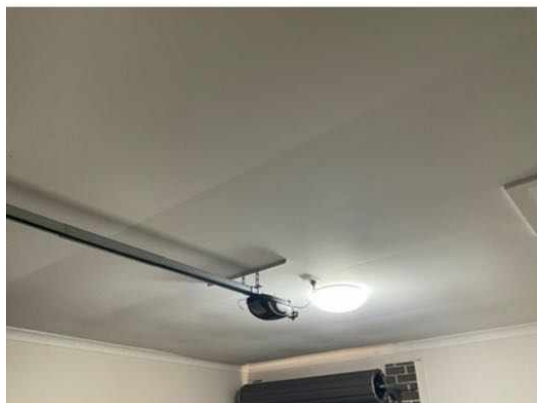
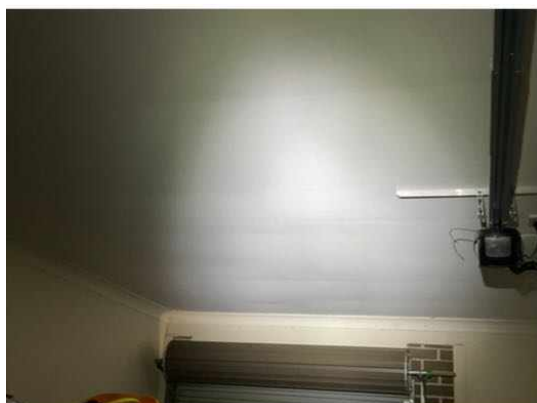
Finding 3.04

Uneven sagging ceiling linings were observed in the garage at the time of inspection, the condition appeared to be minor and cosmetic in nature.

This is a common occurrence in homes of similar age and construction, often caused

by the gradual deterioration or loosening of original fixings, such as nails, screws, or adhesives used to secure ceiling sheets.

- Remedial works may be recommended to improve appearance and prevent further sagging. These may include:

Further investigating Structural roofing elements

- Re-gluing or re-adhering the ceiling sheeting
- Re-securing sheets using appropriate modern fixings
- These works can be carried out by a qualified plasterer or painter,
- Ongoing monitoring is advised to detect any worsening of the condition or further movement over time.

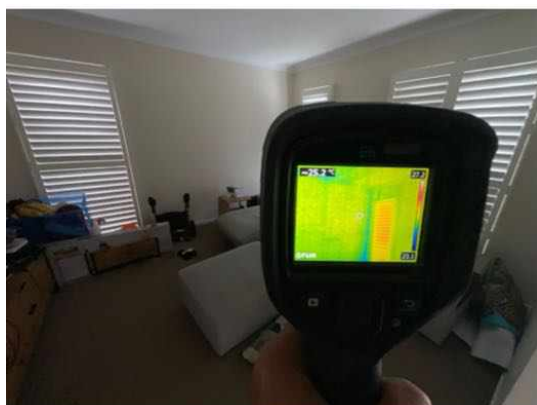
Building:	Main Building
Location:	All Areas
Finding:	Thermal Imaging – Termite Activity Assessment..
Information:	During the inspection, a Flir E6 Thermal Imaging Camera was used to detect irregularities in the internal walls and ceilings.

At the time of the inspection, no abnormalities indicating live termite activity were observed. However, it's important to note that various factors—such as obstructions, ambient temperature, and wall material/thickness—can impact the accuracy of thermal readings. In cases where surfaces are visually restricted or obstructed, a comprehensive thermal scan may not always be feasible.

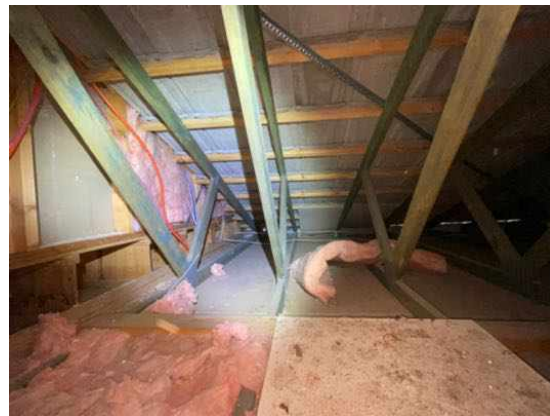
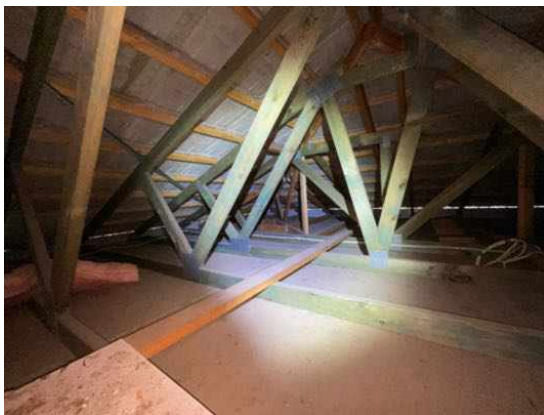
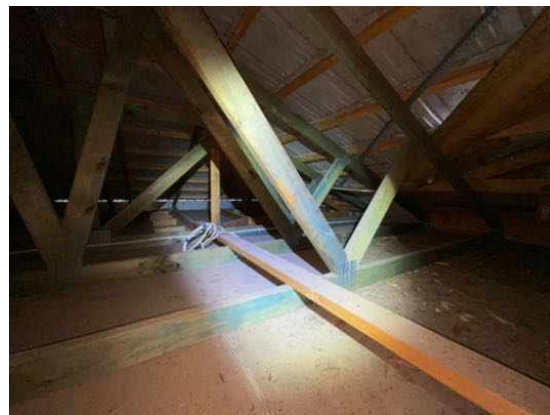
Building: Main Building
 Location: Roof Void > Basement
 Finding: Roof Void – Limited Accessibility..
 Information: Observation:

Installation of an additional manhole is recommended to facilitate a re-inspection and enable a more thorough assessment of the roof void in the future. This will help ensure that all structural elements and concealed areas are properly evaluated.

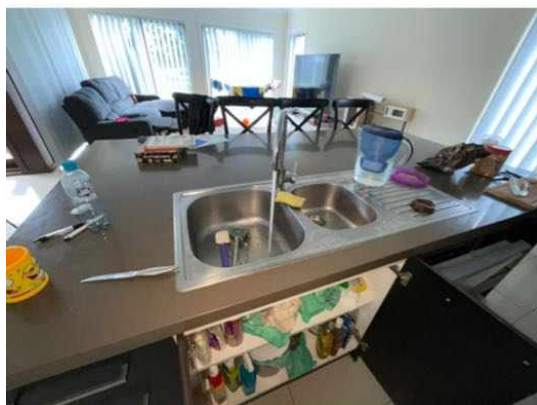
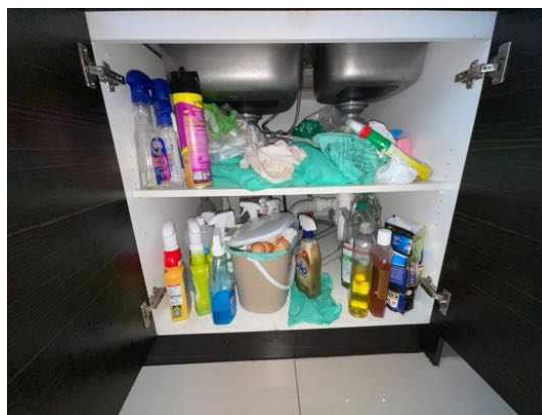
Building: Main Building
 Location: Kitchen
 Finding: Kitchen Sink – Overall Condition & Recommendations.
 Information: Observations:

- Further monitoring and testing are recommended once the tap(s) are in constant use, to identify any drainage issues or signs of slow leaks not evident during the limited inspection.
- It is recommended that the stored items beneath the sink be removed to allow for a full re-inspection of the plumbing and cabinetry, ensuring no concealed defects are

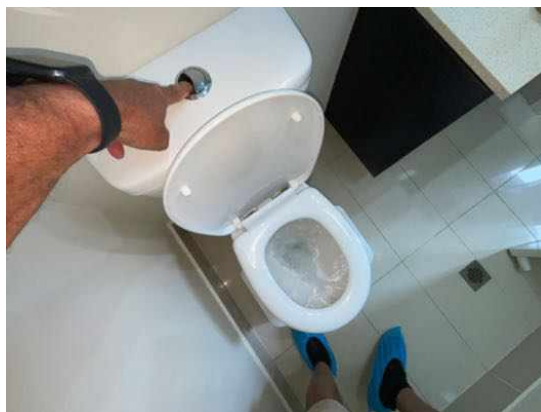
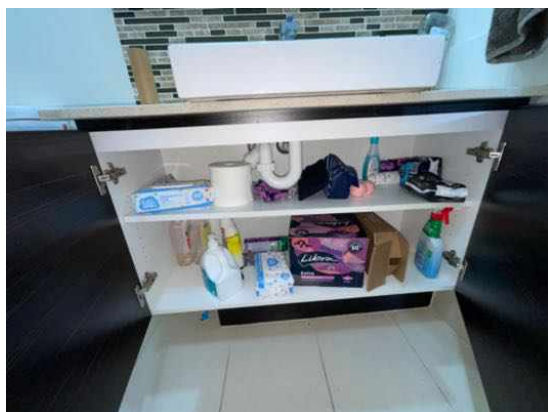
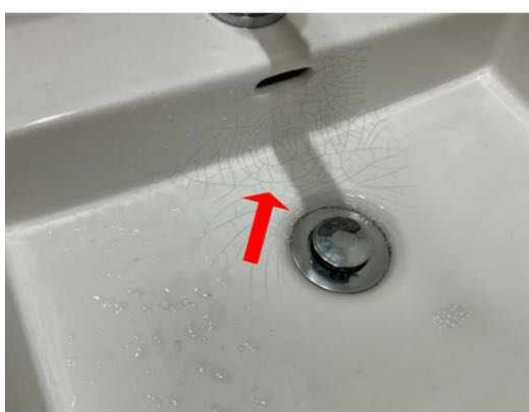
Building: Main Building
 Location: Toilet (WC)
 Finding: Overall Condition: Toilet & Basin.
 Information: TOILET & BASIN ASSESSMENT

- Sealant around the basin and wall junctions appeared to be in serviceable condition.

- Regular maintenance of sealant and grouting in wet areas is essential to prolong the life of surrounding materials and reduce the risk of water damage.

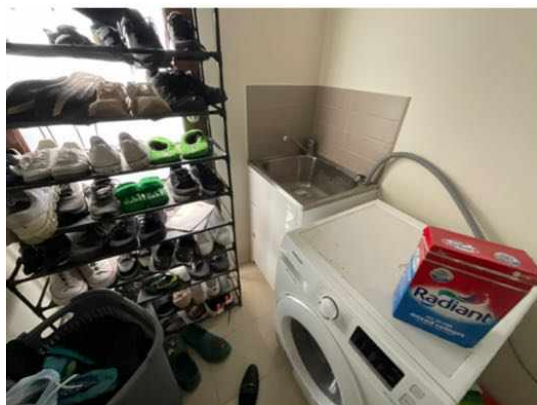
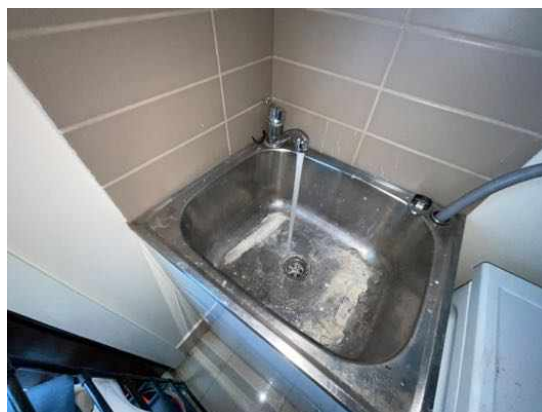
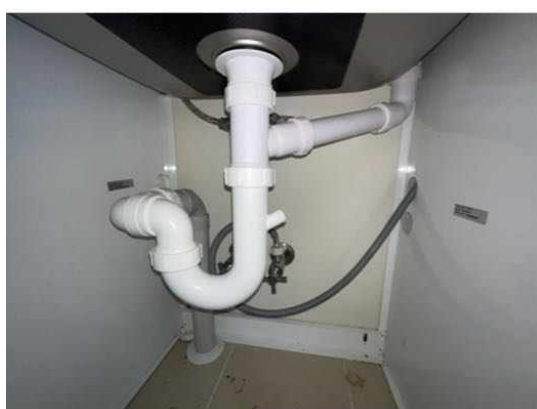
Building: Main Building
 Location: Laundry
 Finding: Laundry - Taps/Plumbing/Drainage.
 Information: Observation: Laundry Tub – Taps, Plumbing, and Cabinetry

- Further monitoring or testing is recommended once the taps are placed into regular use, to ensure no leaks develop over time and that the drainage system continues to perform adequately.

- Sealant and grouting in wet areas should be maintained as part of the long-term care and upkeep of the property.

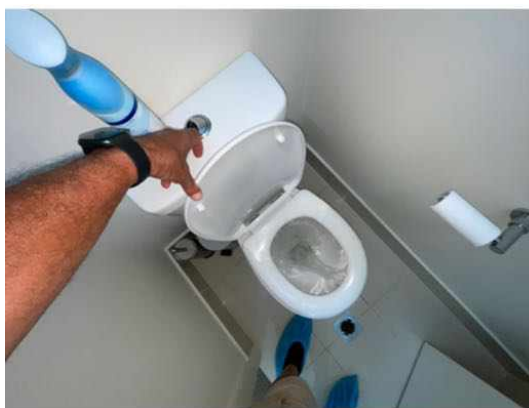
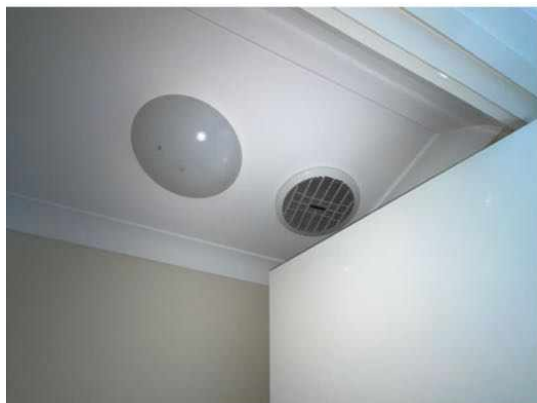
Building: Main Building
Location: Toilet (WC)
Finding: Overall Condition: Toilet.
Information: TOILET ASSESSMENT

- No leaks were observed during the flushing process.
- The toilet operated normally with no signs of malfunction or abnormal water flow.
- The toilet pan was securely fixed to the floor at the time of inspection.
- The exhaust fan appeared to be operational
