# Building and Timber Pest Inspection Report

Inspection Date: Wed, 25 Mar 2026

Property Address: 6 Evans St, Sans Souci NSW 2219, Australia

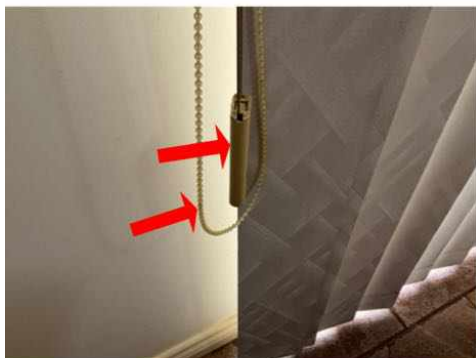
Building: Main Building  
 Location: All Areas  
 Finding: SAFETY HAZARD: Blind/ Curtain Cords- Not Secured  
 Information: If a cord or chain for a blind or curtain hangs lower than 1.6m from the floor then it

As it may become a hanging hazard for young children.

Securing cords to all blind or curtain cords hanging 1.6m or lower to the floor must be completed immediately as a matter of urgency.

A qualified tradesperson should be appointed to rectify this safety

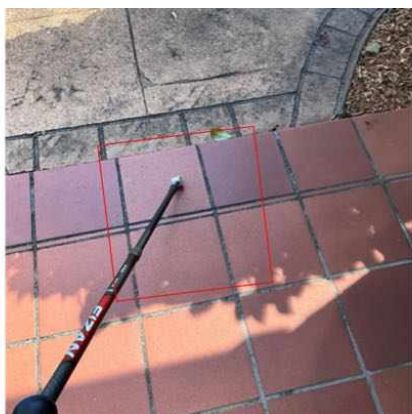
Building:	Main Building
Location:	Porch
Finding:	Tiles - Drummy
Information:	Drummy tiled areas were identified at the time of inspection. The term 'drummy' refers to tiles that have become detached from their fixing, despite otherwise being in relatively good condition. Such defects are generally caused by physical or moisture damage to the area. Drummy tiled areas may also be a direct result of poor workmanship during the construction process.

Tiled areas may swell and shrink with changes in air humidity if the area has sustained moisture damage. Any exposure to moisture is capable of causing tiled areas to become drummy and/or cracked over a prolonged period of time. Drummy tiled areas generally require removal and replacement of affected tiles, with adequate sealant and grouting.

Specialist trades are available for these types of services. A registered builder may be required to undertake works if damage is extensive or if secondary building defects have resulted. Otherwise, it is advised that a tiling contractor be appointed to perform works as necessary. Immediate action is recommended to ensure that no further damage is sustained in the affected area.

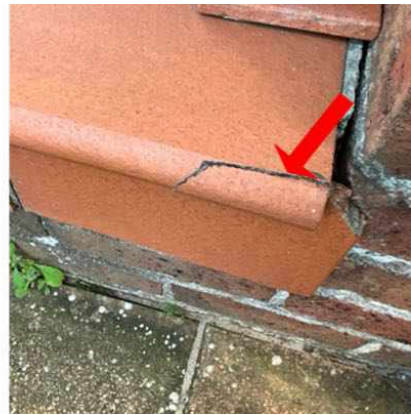
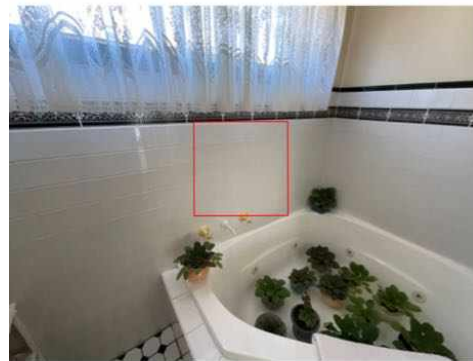
### Finding 3.02

Building:	Main Building
Location:	All Areas
Finding:	Tiles - Cracked, Damaged or Missing
Information:	At the time of inspection cracked, damage or missing tiles were evident to the tiling in several areas throughout the property. While this appears to be minor, there are some areas that are frequently exposed to water, allowing potential for water penetration into adjoining sections of walls or flooring. If left unmanaged, water penetration to these areas may lead to subsequent water damage, which is likely necessitate repair work to affected building elements. A tiling contractor should be appointed to replace cracked, damaged or missing tiles to ensure that no further water damage occurs. The re-application of silicone and grouting throughout remaining tile work is also advised, to further protect the area against water penetration.

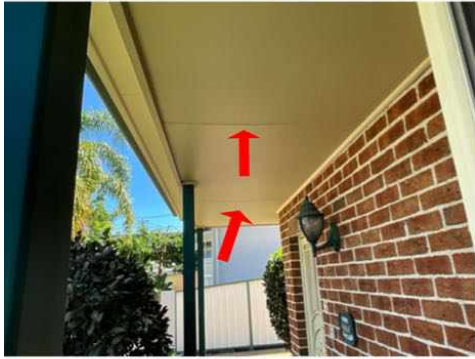
### Finding 3.03

Information: Sagging to the eaves was evident in this area at the time of inspection. This type of defect is generally consistent with older properties, where the eave sheeting has worn over time.

Eaves are important in preventing water ingress to associated walls by promoting adequate water run-off from roofing structures. Their secondary function is to prevent shelter to adjoining structures from excessive moisture and hence prevent water damage to these areas.

Sagging eaves are susceptible to the attraction of excessive moisture, and are therefore considered non-functional. This defect also detracts from the overall appearance and condition of the roofing structure and any associated structures.

A qualified carpenter is recommended to perform rectification works as soon as possible. Subsequent water damage is likely to result over time if left unattended.

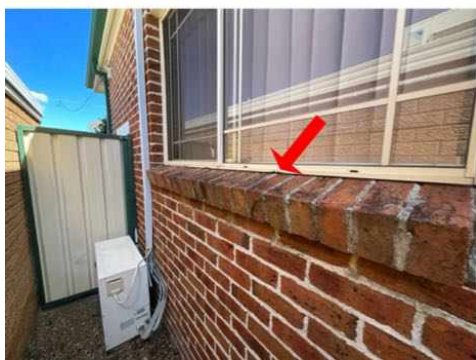
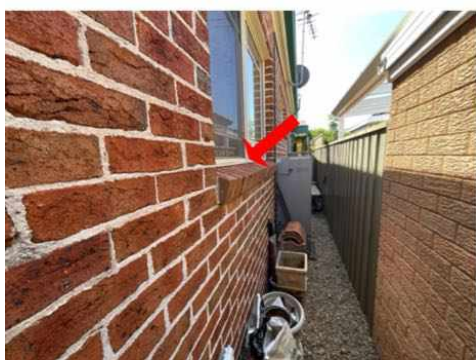
Building:	Main Building
Location:	All Areas
Finding:	Rubber window seal deteriorated
Information:	The rubber window seal to the brickwork appears to have deteriorated.

This is generally a wear and tear defect which is a result from exposure to the elements over a long period of time.

If left unmanaged the possibility of pest and water ingress into the cavity is highly likely.

Where the seal has deteriorated the client should contact a caulking technician or window installer for rectification.

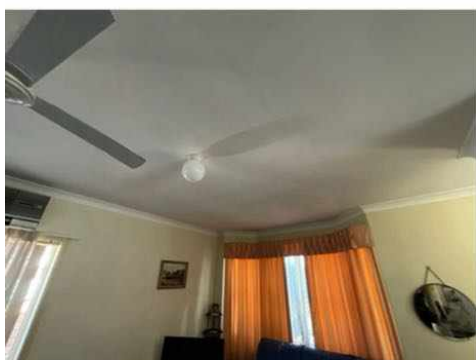
In some cases, sagging ceiling linings may also indicate that there are structural issues, causing surfaces to warp, twist or sag. Where sagging appears to be major, appointment of a structural engineer is advised to further inspect the property and identify the source and rectification works required.

The appropriate action should be taken by the client as soon as possible to ensure that any potential further damage is limited.

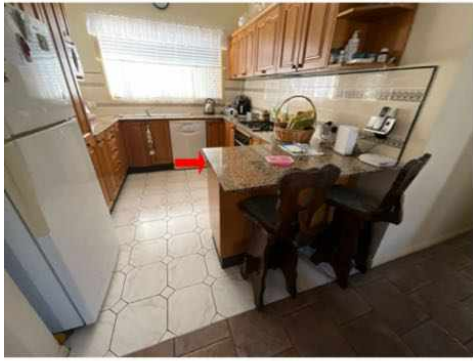
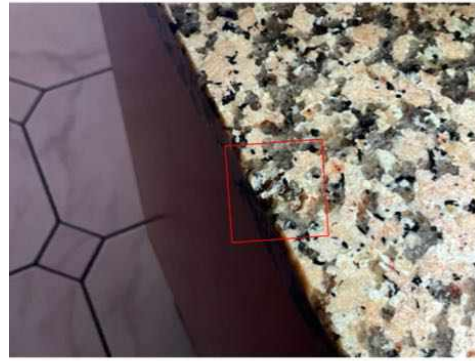
### Finding 3.09

Building:	Main Building
Location:	Kitchen
Finding:	Stone Bench top - Chipped
Information:	Chipping was evident to the bench top at the time of inspection, which is suspected to have been caused by minor impact damage.

This is generally only ever an appearance defect and no secondary defects are likely to occur

Consultation with a cabinet maker or stone specialist regarding repair or replacement is required. Remedial works may be required to protect against any further damage.

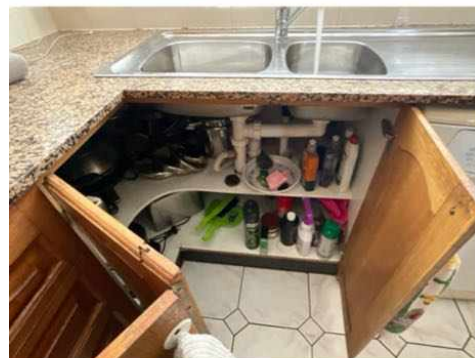
### Finding 3.10

Building:	Main Building
Location:	Kitchen
Finding:	Deteriorated-Cabinetry
Information:	The cabinetry in several areas has deteriorated.

Rectification works may include minor repair work or replacement of the cabinetry depending on the extent of the damage.

It is highly advised to engage a remedial builder to determine and rectify what is causing the deterioration prior to any rectification work to the cabinetry

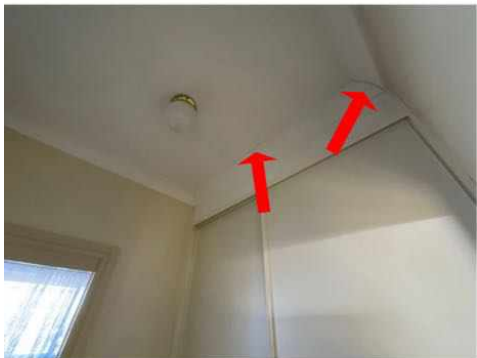
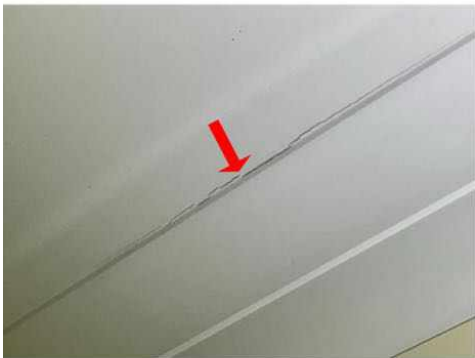
**Finding 3.11**

Building: Main Building  
Location: All Areas  
Finding: Cracking - Damage Category 2 - Noticeable (up to 5mm)  
Information:

Noticeable cracks are easily filled and repaired. A plasterer can be consulted to install an expansion joint at this point to allow for this movement during different weather conditions.

Monitoring of all cracking should be conducted frequently. Always contact a building inspector should cracks widen, lengthen, or become more numerous.

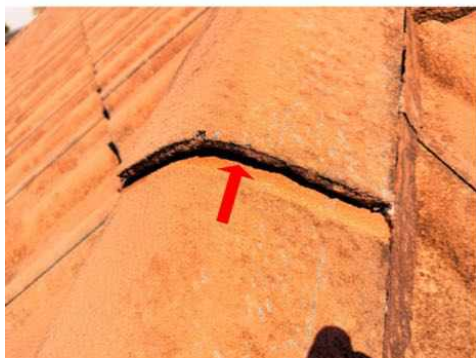
### Finding 3.19

water damage. Deteriorated mortar also detracts from the functionality of roof tiles and other roofing elements, potentially decreasing weather tightness and roof drainage.

Mortar deterioration can be attended by a roofing contractor.

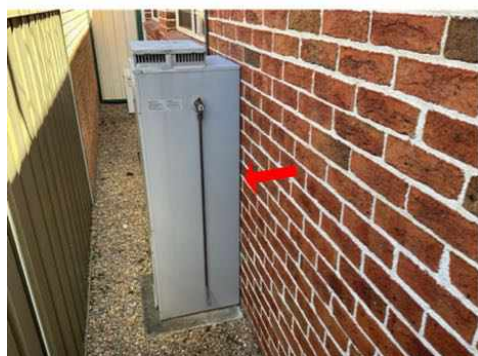
Where bridging has occurred, full inspection is prevented and termites may enter a property in a concealed or undetectable manner.

It is recommended that minimum 75mm clearance below the bottom of weep or ventilation holes be maintained where possible, otherwise annual inspections should be conducted by a licensed pest control company. Vegetation should also be kept clear of walls to allow regular inspection of all areas.

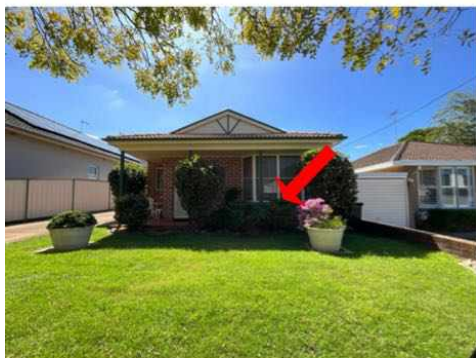
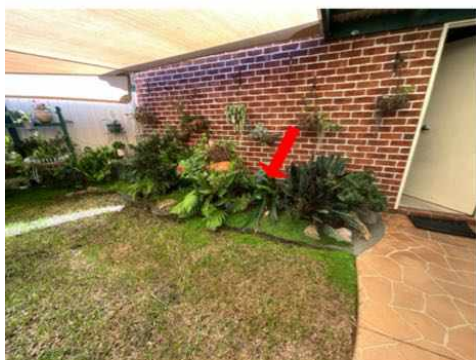
### Finding 6.03

Building:	Main Building
Location:	All Areas
Finding:	Garden bed- conducive to timber pest activity.
Information:	Garden beds were found to be evident in the garden area. These garden beds which lay against the building and allow easy undetected ingress for termites can include untreated timber, and with a combination of moisture from watering can make conditions conducive to termite activity.

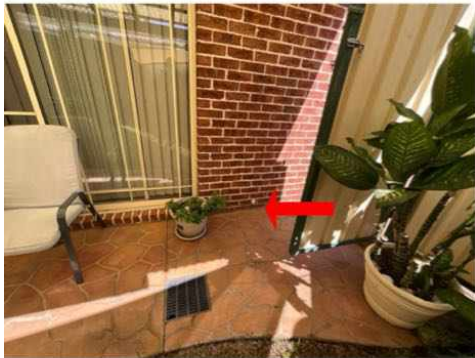
## Finding 6.04

Building:	Main Building
Location:	All Areas
Finding:	Slab Edge - Exposure
Information:	An inspection zone of at least 75mm in relation to the exposed slab edge, between the bottom brick and the perimeter pavement, is required. This inspection zone should be maintained in order to force termites into the open where they can be detected more readily during regular inspections. The slab edge should not be concealed by anything that may prevent inspection of the area, including render, landscaping, soil, turf, paving, concrete cladding or other structures.

If the slab edge is not properly exposed there is a high risk of termite attack. Sometimes, in order to determine the type of slab, a suitably qualified person such as an architect or builder may be required to consult the construction plans.

Where the slab edge cannot be properly inspected, it is highly recommended that termite or timber pest inspections be carried out every 6-12 months to aid protection of the property against infestation.

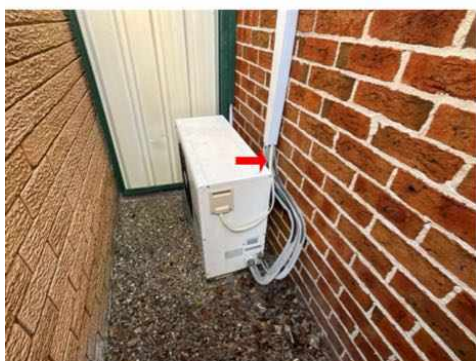
### Finding 6.05

Building:	Main Building
Location:	Exterior walls - right side
Finding:	HWS/AC overflow not connected
Information:	The Hot Water System (HWS) and A/C overflows were found to be disconnected from storm water drainage and is creating excessive moisture in the surrounding area. These damp conditions can lead to secondary defects such as rot, rust or corrosion

of associated building elements, the formation of fungal decay, or even the creation of potential slip hazards. When coupled with poor site drainage, pooling of water may also attract termite activity to this area. It is highly recommended that a licensed plumber be appointed to connect the HWS and A/C overflows in order to prevent such an environment from being created. These minor works should be carried out as soon as possible.
