## Building and Timber Pest Inspection Report

Inspection Date: Tue, 3 Feb 2026

Property Address: 6 Lambert Rd, Bardwell Park NSW 2207,  
Australia

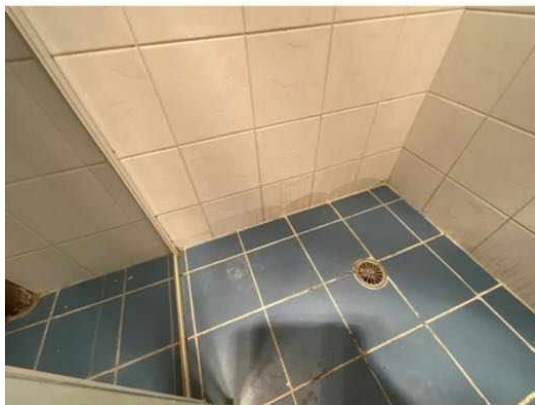
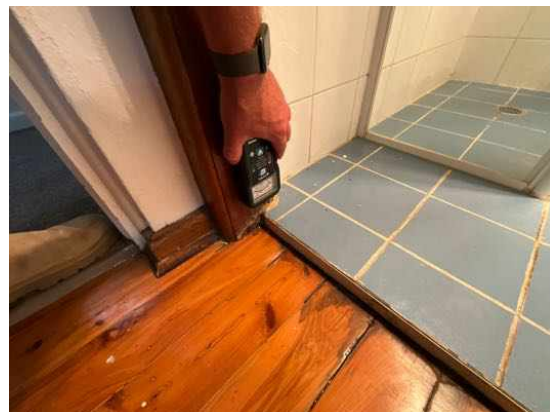
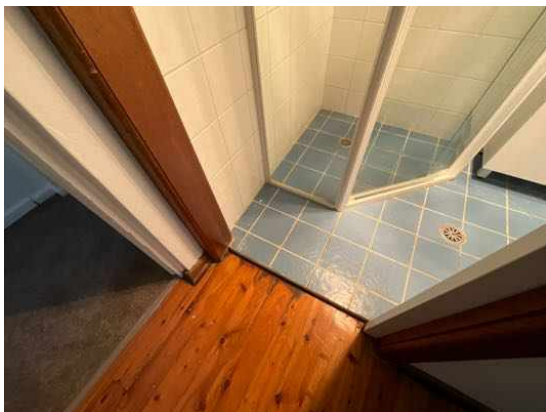
Building: Main Building  
Location: Bathroom  
Finding: Cracked Shower Tiles and Timber Deterioration at Doorway  
Information: Tiles are cracked within the bathroom shower area. Wood rot was also observed at the doorway adjacent to the bathroom. No active moisture was detected at the time of inspection.

Cracked tiles and timber deterioration may indicate a failure of the waterproofing membrane, allowing moisture to penetrate behind finishes. Even without current moisture readings, the condition suggests possible historic or intermittent water ingress.

Further investigation by a licensed waterproofing contractor is recommended to assess the integrity of the shower waterproofing. Rectification may include removal of affected tiles, repair or replacement of damaged timber, and reinstatement of compliant waterproofing as required.

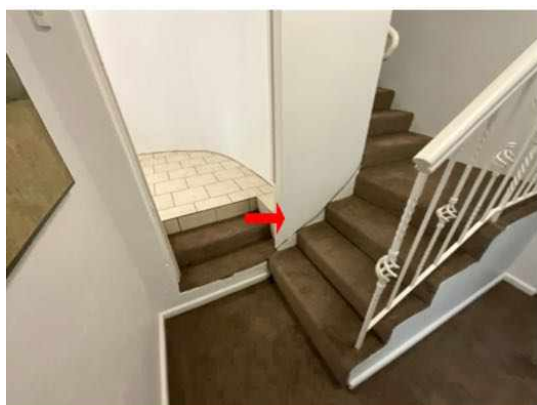
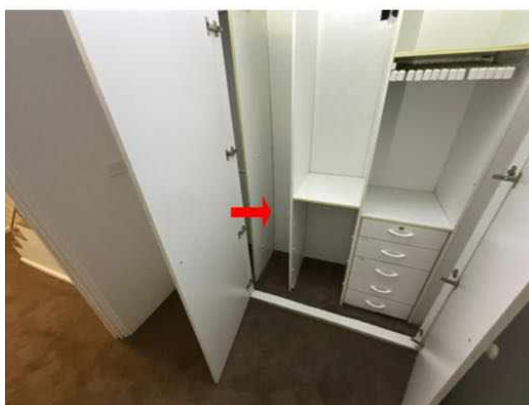
### Finding 2.02

Building:	Main Building
Location:	Lower Level
Finding:	Interior walls - Lateral damp
Information:	Lateral penetrating damp refers to the sideways movement of moisture. The implications of unmanaged damp range from mould fungi growth, wood rot and decaying building materials, to finishes including lifting, bubbling, peeling and staining of paint, plaster and wallpaper.

Consultation with a damp proofing contractor is advised to address the cause of the damp and to perform remedial works as necessary.

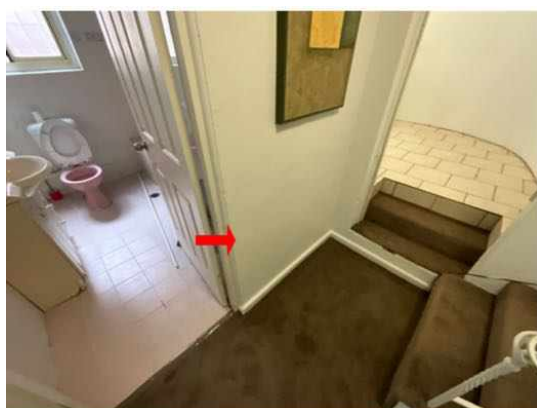
### Finding 2.03

Building:	Main Building
Location:	Bathroom
Finding:	Water proofing - Failed
Information:	The waterproofing membrane in this area appears to have failed. Generally this could

occur from substandard installation or through damage from physical force.

The failure of the waterproofing membrane system be it in a bathroom, balcony or basement can lead to severe consequences and costly repair. Waterproofing is an essential part of any construction in a wet environment and its installation should be truly sustainable. Unfortunately, despite the best intentions, failures tend to occur.

It is advised that a builder be appointed to see what necessary works are required.

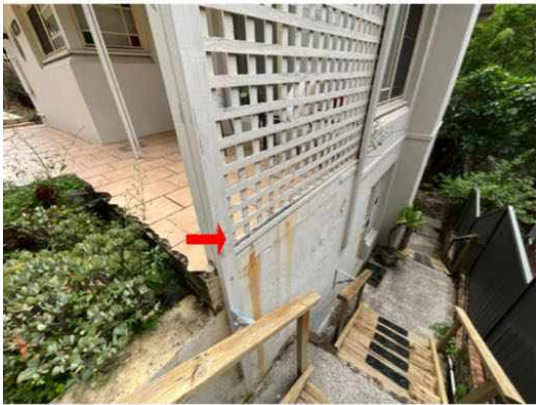
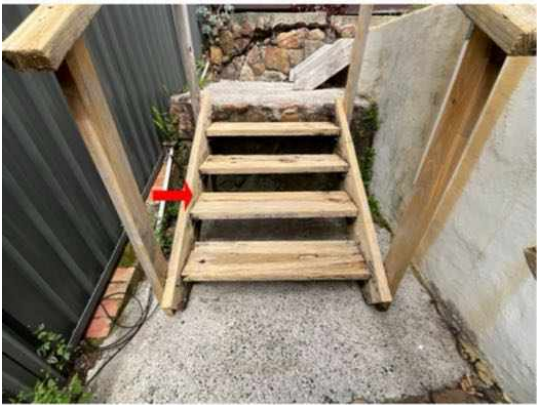
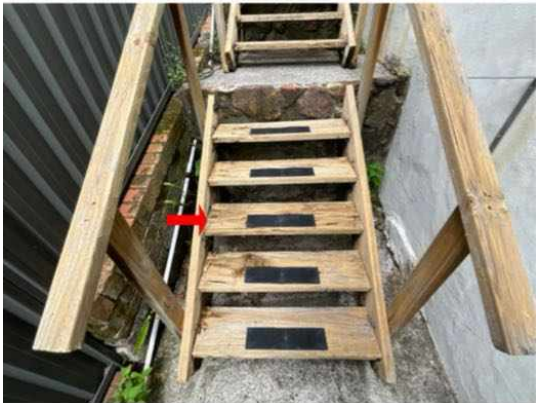
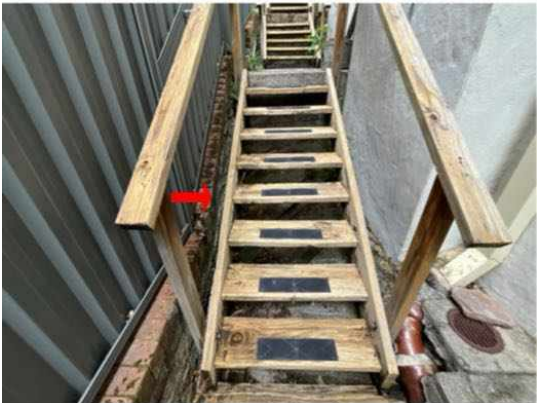
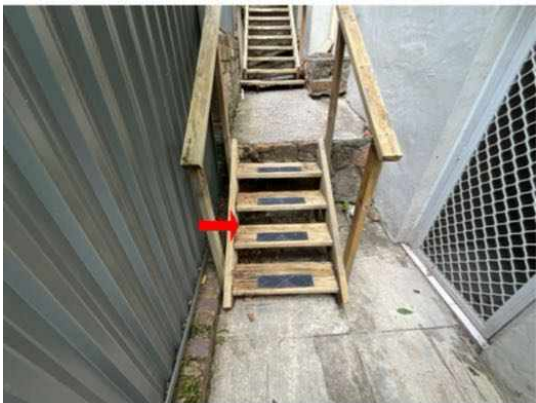
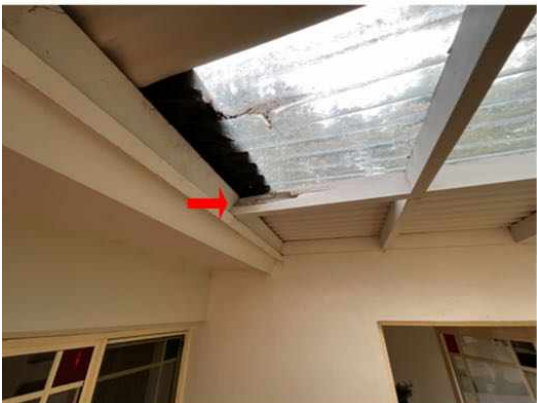
### Finding 3.01

Building:	Main Building
Location:	External Areas
Finding:	Wood rot
Information:	This building element shows evidence of wood rot. Wood rot, also known as Fungal Decay, occurs when timbers and other cellulose building materials are exposed to damp conditions on an ongoing basis. This could be the result of exposure to weathering over a prolonged period of time, or the attraction of excessive moisture from other abutting building materials.

Early intervention and regular maintenance, particularly of exterior timbers, will prolong the useful life of these building elements. Prior to any works being performed, the cause of the moisture that has created the visible wood rot should be identified and addressed in a suitable manner. Replacement of affected timbers may then be a necessary step in protecting surrounding building elements from such deterioration.

A qualified carpenter or registered builder may also be required to replace affected building materials.

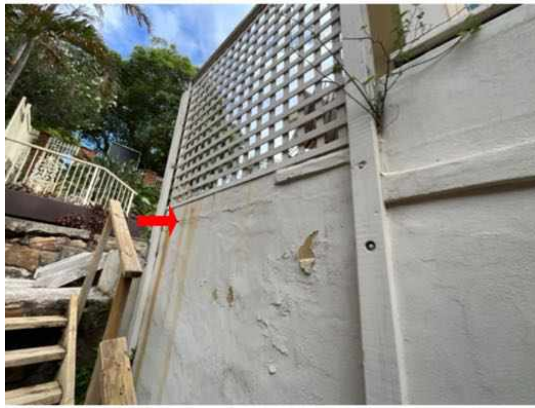
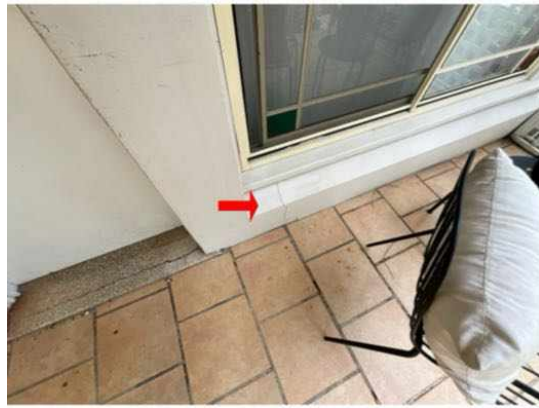
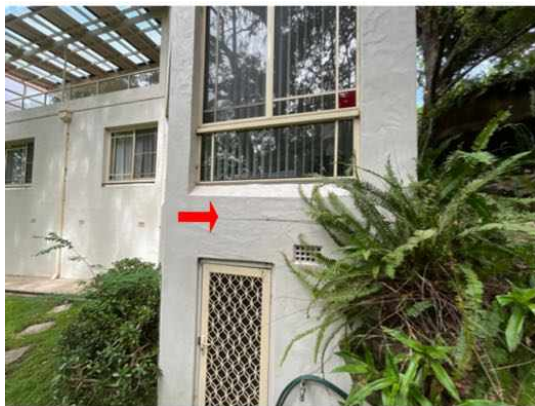
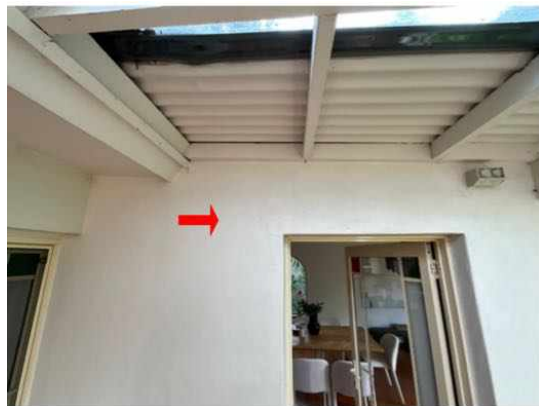
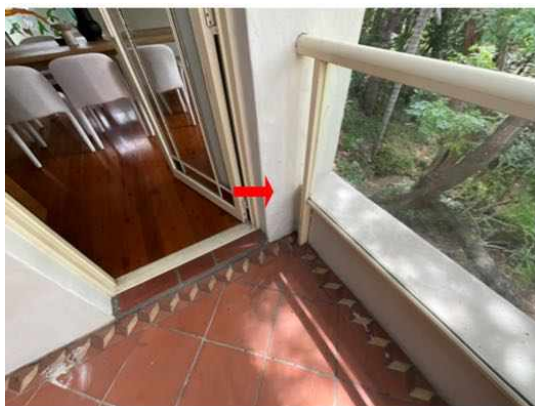
**Finding 3.02**

Building: Main Building  
Location: Exterior walls  
Finding: Cracking - Damage Category 2 - Noticeable (up to 5mm)  
Information: Noticeable cracks are a common occurrence as a result of many primary defects. Such causes may include age, general wear and tear, expected building movement, general expansion/contraction of building materials in different weather conditions, and/or minor failings in the installation or application of building materials.

I recommend monitoring and if further cracking is evident appoint a bricklayer to see what works are required.

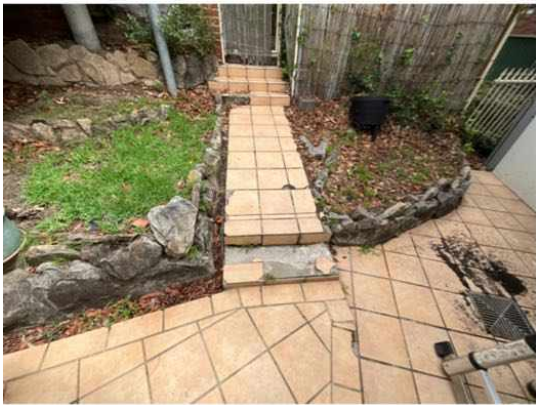
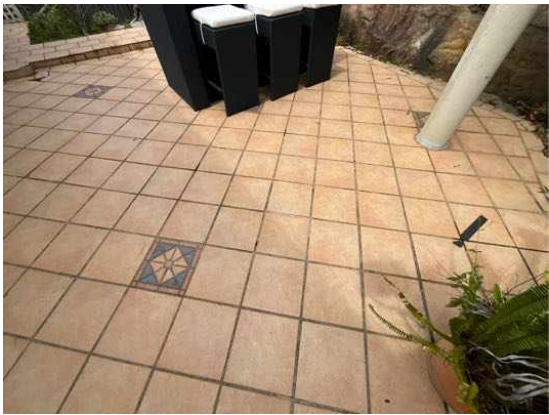
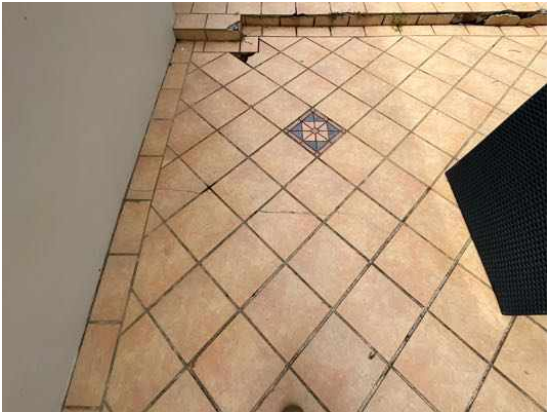
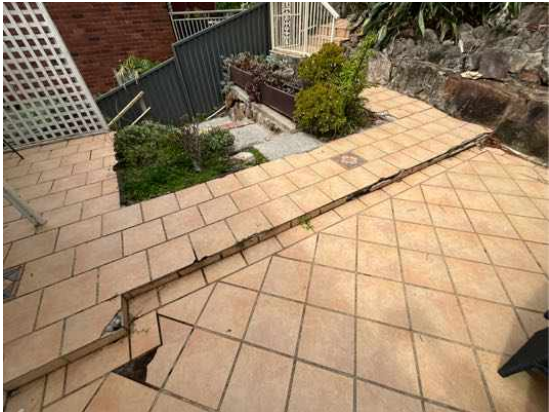
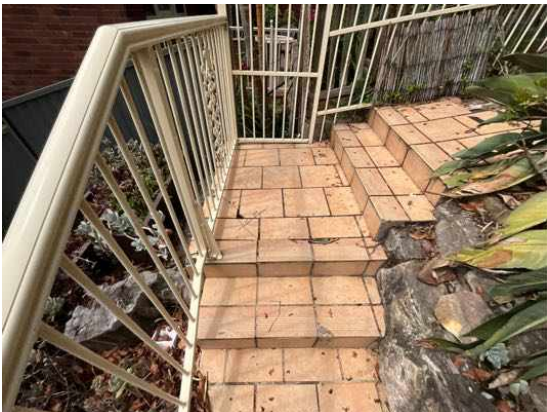
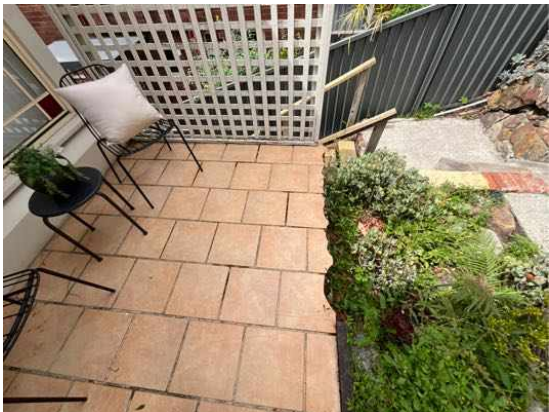
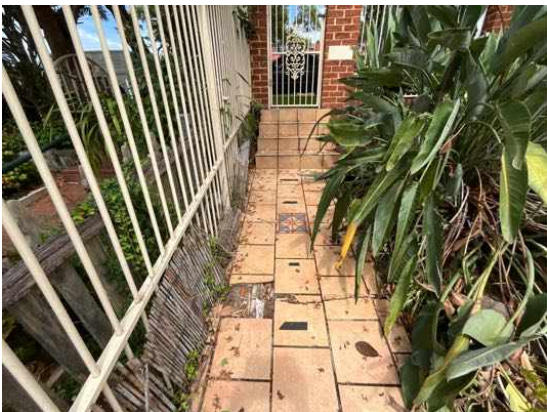
### Finding 3.03

Building: Main Building  
Location: External Areas  
Finding: Tile - Cracked or damaged  
Information: Cracking was evident to the tiling in this area at the time of inspection.

I recommend appointing a tiling contractor to see what necessary works are required to replace any damaged tiles.

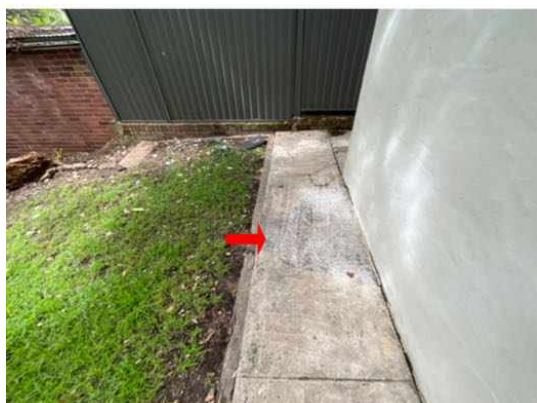
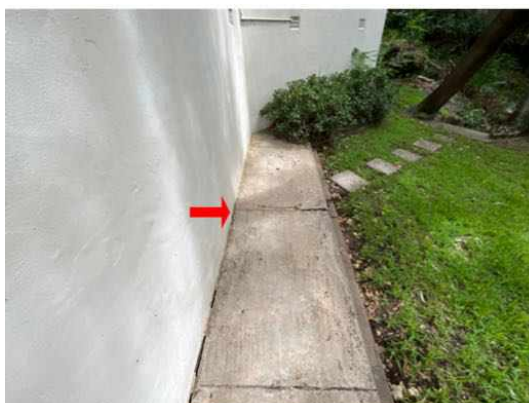
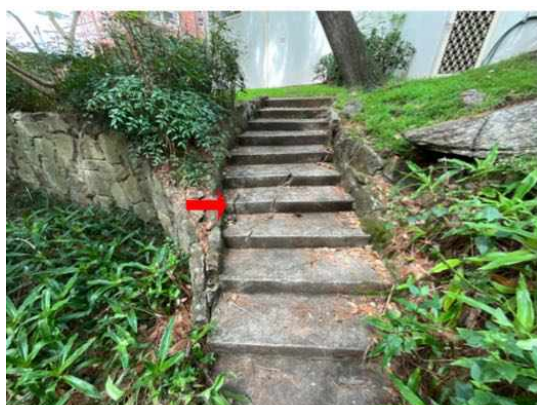
Finding 3.04

Building: Yard  
Location: Yard - Back  
Finding: Cracking - External Concrete Paving Damage Category 1 - Fine (less than 2mm)  
Information: Fine cracks were identified in external concrete paving. Although fine cracks are quite noticeable, they are often only considered to be an appearance defect, and usually do not indicate any structural damage. To be considered a Category 1 or fine crack, the crack is found to be less than 2mm in width.

Generally the cause of a hairline crack in existing concrete paving such as driveways and pathways is indicative of the expansion and contraction of the concrete. Such causes are generally due to environmental factors, such as moisture levels, weather conditions, root systems of nearby trees or the soil types on which they are laid.

Fine cracks may also be due to poor original installation of the concrete. Factors such as poor compaction of the sub surface and/or inadequate reinforcing of the slab may create cracking and other secondary defects.

Monitoring of all cracking should be conducted frequently. Always contact a building inspector should cracks widen, lengthen, or become more numerous.

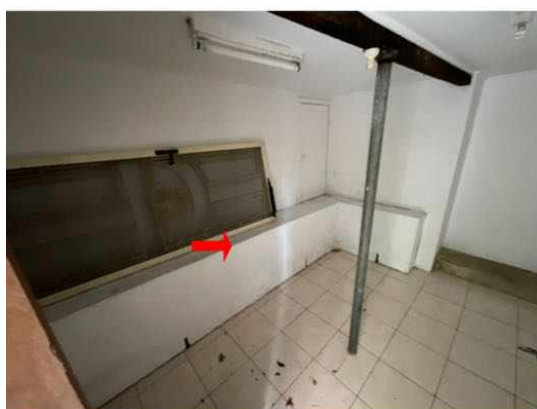
### Finding 3.05

Building: Main Building

Location: Laundry  
 Finding: Interior walls - Lateral damp  
 Information: Lateral penetrating damp refers to the sideways movement of moisture. The implications of unmanaged damp range from mould fungi growth, wood rot and decaying building materials, to finishes including lifting, bubbling, peeling and staining of paint, plaster and wallpaper.

Consultation with a damp proofing contractor is advised to address the cause of the damp and to perform remedial works as necessary.

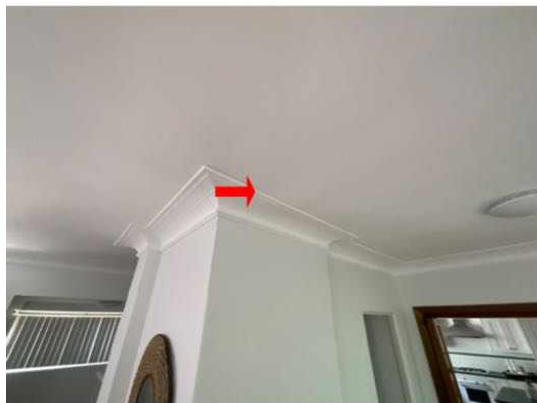
### Finding 3.06

Building: Main Building  
 Location: Lounge Room  
 Finding: Ceiling - Water stained  
 Information: Water staining to ceiling linings in this area was evident at the time of inspection. Water staining indicates that surfaces have been exposed to excessive moisture over time. The minerals and other elements in the water lead to staining, which may graduate to corrosion and deterioration if left unmanaged.

Although there was no moisture detected in the ceiling I would recommend monitoring and acting on one of the following.

Where water staining is active, a licensed plumber must be consulted to identify the cause of the staining and to provide advice on any reparation works that may be required. Replacement of any damaged structures is advised.

Conversely, where water staining is old and inactive, affected building materials may be repaired or replaced at client discretion.

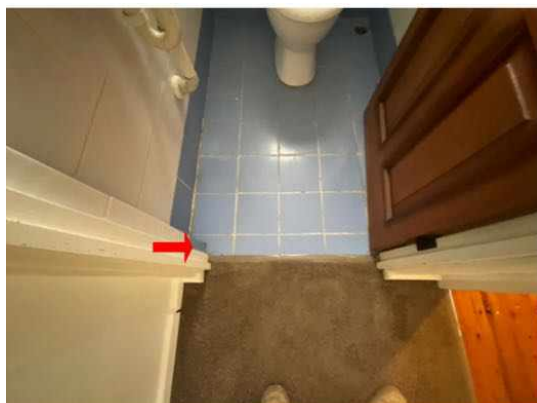
### Finding 3.07

Building:	Main Building
Location:	Internal Tiled Areas
Finding:	Tile - Cracked or damaged
Information:	Cracking was evident to the tiling in this area at the time of inspection.

I recommend appointing a tiling contractor to see what necessary works are required to replace any damaged tiles.

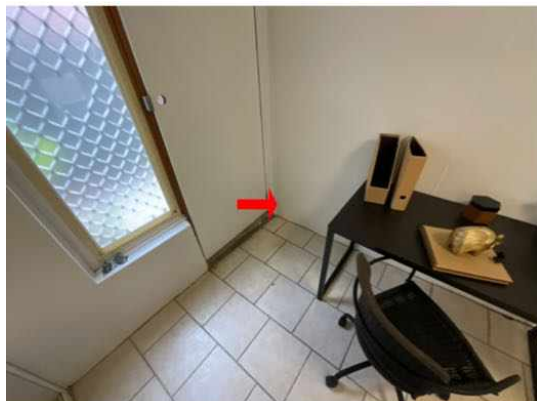
### Finding 3.08

Building:	Main Building
Location:	Study
Finding:	Water staining - No Moisture Detected
Information:	Water staining was evident in this area at the time of inspection. Water staining indicates that surfaces have been exposed to excessive moisture over time. The minerals and other elements in the water lead to staining, which may graduate to corrosion and deterioration if left unmanaged.

Although there was no moisture I would recommend acting on the following.

Where water staining is active, a builder must be consulted to identify the cause of the staining and to provide advice on any reparation works that may be required.

Replacement of any broken or damaged structures is advised.

Conversely, where water staining is old and inactive, affected building materials may be repaired or replaced at client discretion. A qualified carpenter or registered builder may be appointed to perform these works.

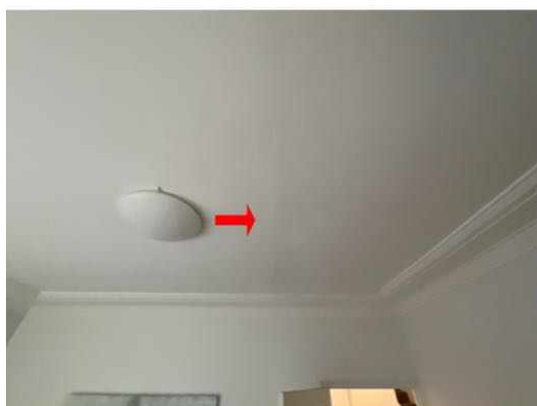
### Finding 3.09

Building:	Main Building
Location:	Internal Areas
Finding:	Cracking - Damage Category 1 - Fine (up to 1mm)
Information:	Although fine cracks are quite noticeable, they are often only considered to be an appearance defect, and usually do not indicate any structural damage. Generally, the cause of a fine crack is indicative of a separation between building materials and finishes (e.g. paint, plaster, etc.) along joins.

Cracking of this nature can generally be repaired with minor sanding, filling and/or repainting. Such works should be performed by a qualified painter or a general handyman.

Monitoring of all cracking should be conducted frequently. Always contact a building inspector should cracks widen, lengthen, or become more numerous.

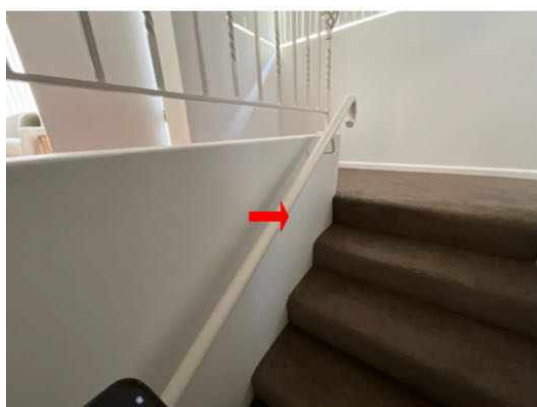
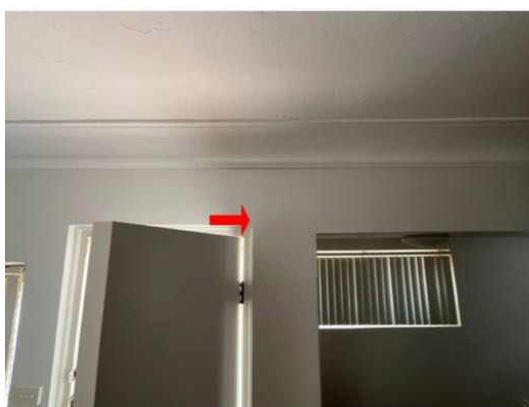
### Finding 3.10

Building:	Main Building
Location:	Internal Areas
Finding:	Cracking - Damage Category 2 - Noticeable (up to 5mm)
Information:	<p>Noticeable cracks are a common occurrence as a result of many primary defects. Such causes may include age, general wear and tear, expected building movement, general expansion/contraction of building materials in different weather conditions, and/or minor failings in the installation or application of building materials.</p> <p>I recommend monitoring and if further cracking is evident appoint a bricklayer to see what works are required.</p>

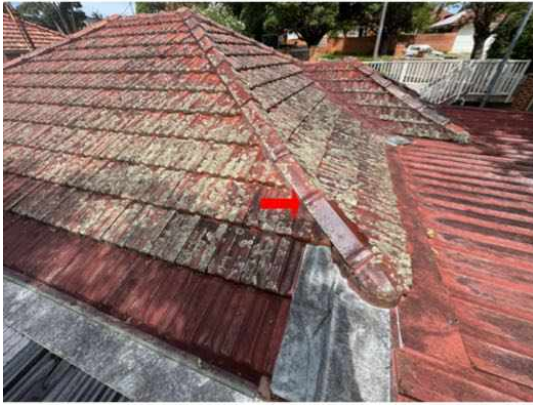
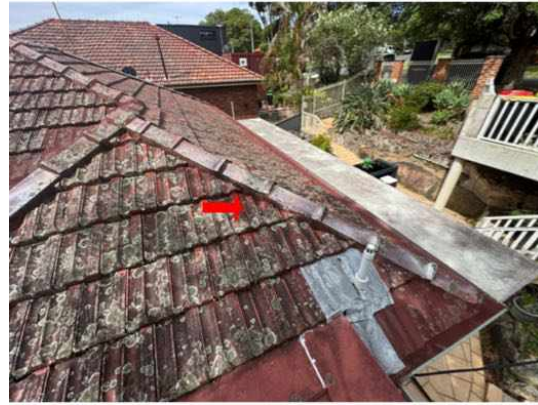
### Finding 3.11

Building:	Main Building
Location:	Roof Exterior
Finding:	Mortar - Deterioration
Information:	<p>Mortar, or 'bedding', is the material which fills joints and intersections between tiles and other building elements on the exterior roof covering, such as gable ends, hip capping and valleys. Upon inspection of the exterior roof, it was noted that sections of the mortar show varying levels of deterioration.</p>

Mortar generally deteriorates as a result of frequent exposure to weather conditions over a prolonged period of time. Mortar that is deteriorating may allow water ingress into the roof void, putting associated building elements and roofing structures at risk of water damage. Deteriorated mortar also detracts from the functionality of roof tiles and other roofing elements, potentially decreasing weather tightness and roof drainage.

Mortar deterioration can be attended to by a handyperson where areas of deterioration are localised and easily accessible. Otherwise, consultation with a roofing contractor is advised where greater works are required.

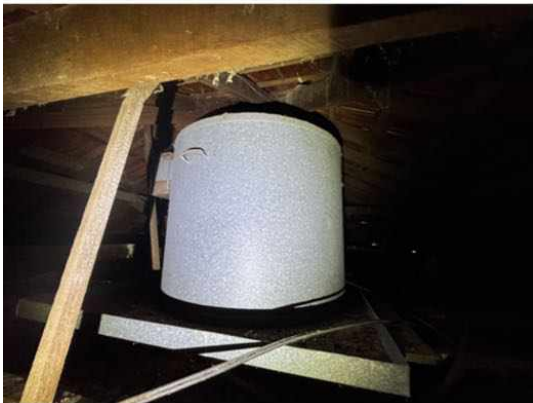
### Finding 3.12

Building: Main Building  
 Location: Roof Void  
 Finding: Gravity-Fed HWS - Disconnected  
 Information: It was noted at the time of inspection that a disconnected gravity-fed hot water system (HWS) remains in this area.

I recommend appointing a plumber to see what necessary works are required to remove the unit from the area.

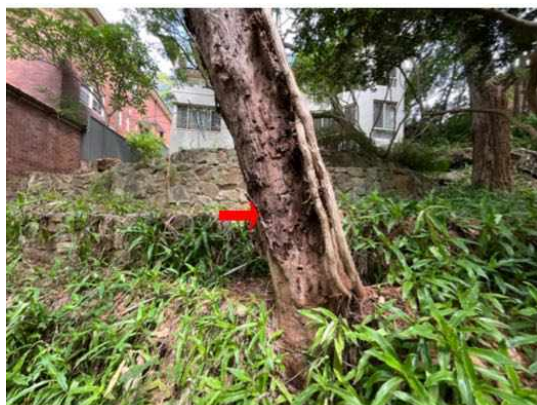
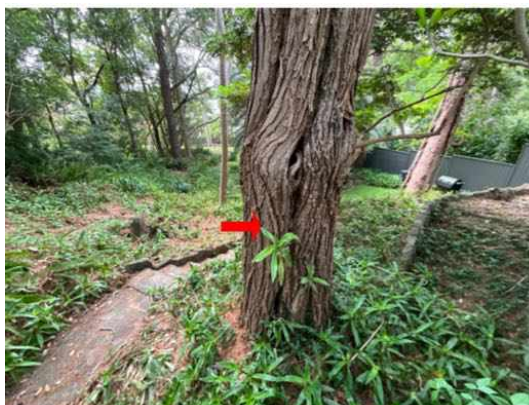
Building: Yard  
 Location: Yard - Back  
 Finding: Pest Damage in Tree

Information: Visible signs of pest damage were observed in the tree, including holes, decay, and weakened timber.

Pest activity can weaken the tree structure, increasing the risk of falling branches or complete tree failure, which may pose a safety hazard to nearby structures or people.

An arborist should inspect the tree to assess the extent of damage and carry out or recommend an appropriate pest treatment. Ongoing monitoring and maintenance may also be required to prevent further infestation.

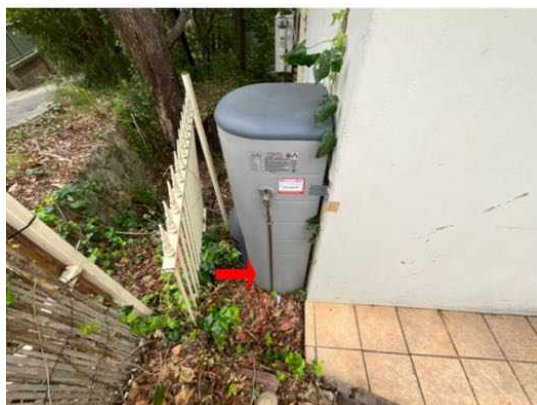
### Finding 6.01

Building: Yard  
 Location: Yard - Front  
 Finding: HWS Overflow - Not Connected  
 Information: The Hot Water System (HWS) overflow was found to be disconnected from storm water drainage and is creating excessive moisture in the surrounding area.

It is highly recommended that a licensed plumber be appointed to connect the HWS overflow in order to prevent such an environment from being created.

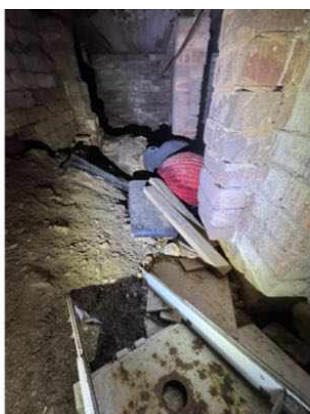
## Finding 6.02

Building:	Main Building
Location:	Subfloor
Finding:	Subfloor - Debris
Information:	An array of debris was found in the subfloor area at the time of inspection. Debris in this area restricts subfloor ventilation and creates potential for concealed pest entry. Stored timbers and other materials may also make the area susceptible to termite activity and wood rot.

A clear and empty subfloor will be better ventilated and easier to maintain in a dry condition. The removal of any timber debris is vital in minimising the risk of termite or wood borer activity.

Debris in the subfloor should be removed as soon as possible. Depending on the location and amount of debris and stored items, the homeowner may elect to undertake this task. Alternatively there are a large number of rubbish removal subcontractors that could undertake these works.

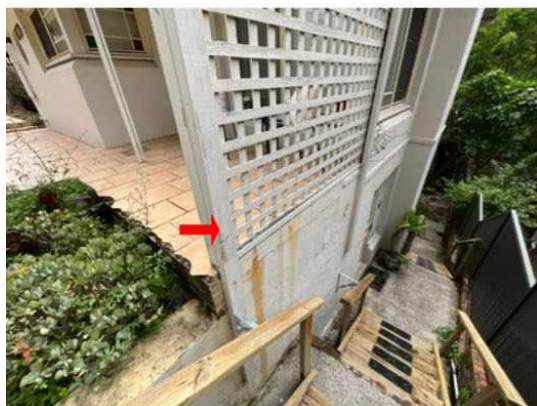
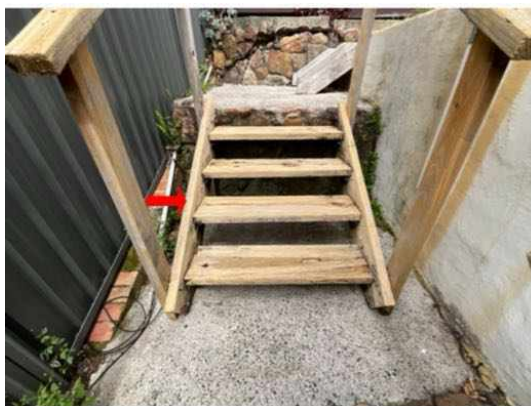
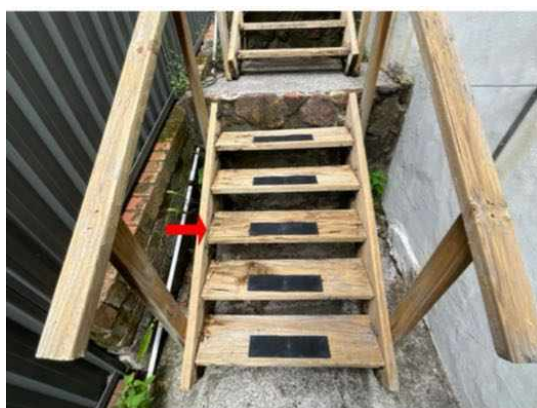
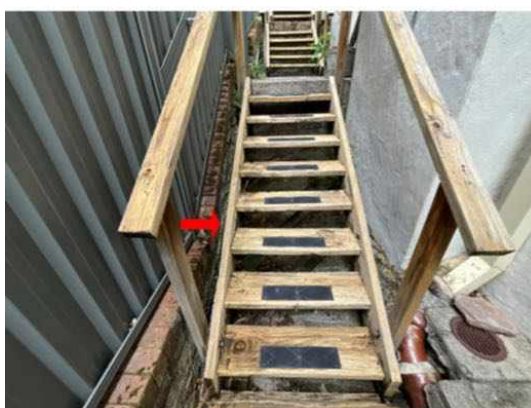
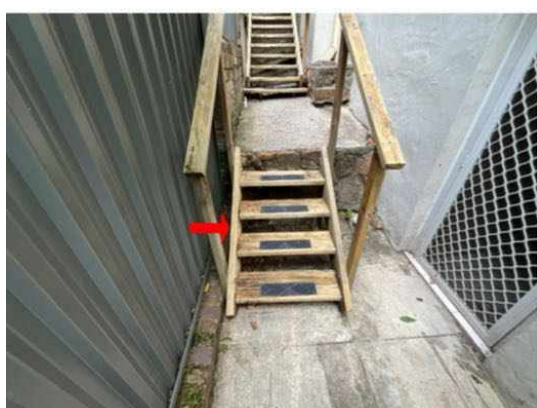
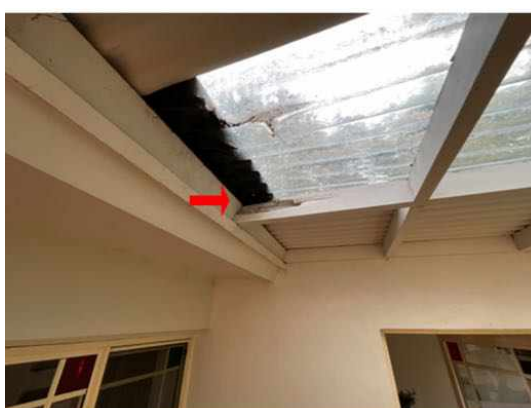
### Finding 7.01

Building:	Main Building
Location:	External Areas
Finding:	Fungal decay - present (localised)
Information:	Fungal decay also known as wood decay or wood rot generally refers to the deterioration of timber elements when in contact with excessive levels of moisture for a prolonged period of time.

The development of fungal decay is accelerated by temperatures in the range of 5degreeC to 40degreeC as well as the presence of oxygen. Generally fungal decay develops on timber elements that are in use in an external environment which are

exposed to rain penetration.

In this case although the affected timber element is in a decaying state the extent of any visible damage appears to be localised to a specific area and is yet to spread to other parts of the building element or affect adjoining structures. The fungal decay is therefore likely to be of a relatively superficial nature with minimal impact on the structural integrity or tensile strength of the timber element.
