## Building Inspection Report

Inspection Date: Sat, 31 Jan 2026

Property Address: 34 Montpelier Dr, Berwick VIC 3806,  
Australia

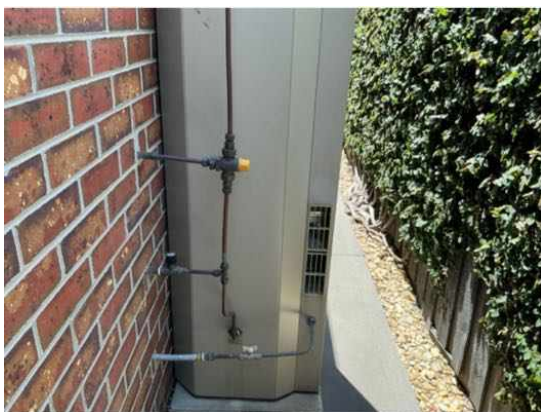
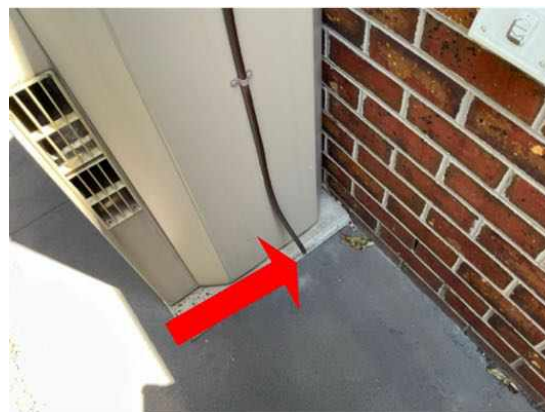
#### Defects 3.01

Building: Main Building  
 Location: Yard - Side  
 Finding: HWS Overflow - Not Connected  
 Information: The Hot Water System (HWS) overflow was found to be disconnected from storm water drainage and is creating excessive moisture in the surrounding area.

These damp conditions can lead to secondary defects such as rot, rust or corrosion of associated building elements, the formation of fungal decay, or even the creation of potential slip hazards. When coupled with poor site drainage, pooling of water may also attract termite activity to this area.

It is highly recommended that a licensed plumber be appointed to connect the HWS overflow in order to prevent such an environment from being created. These minor works should be carried out as soon as possible.

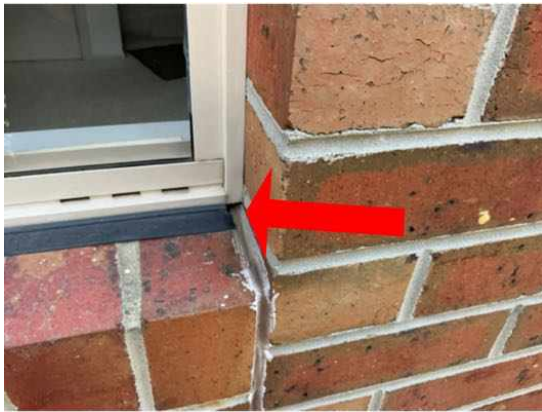
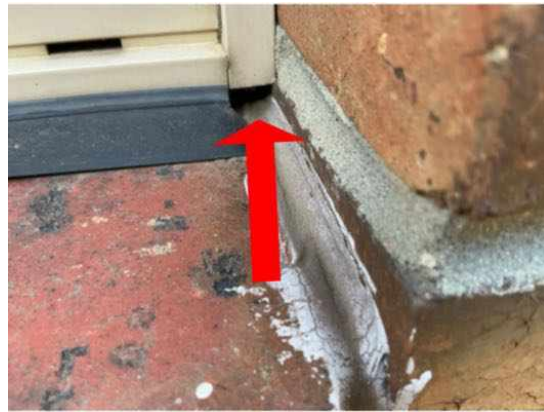
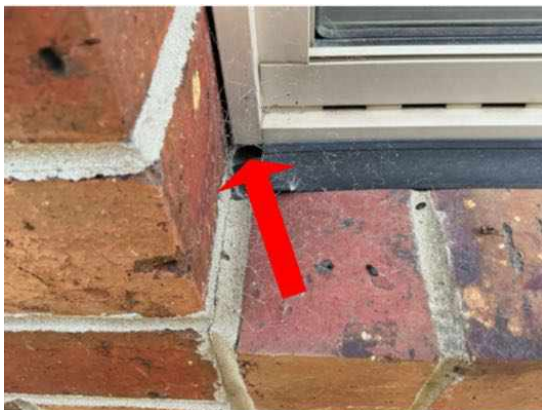
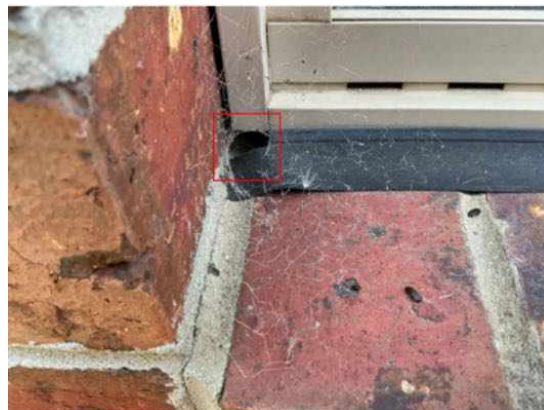
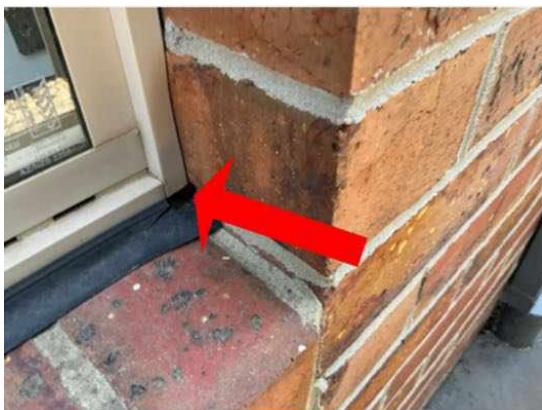
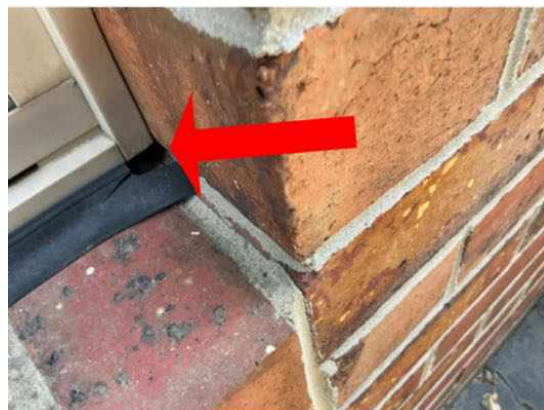
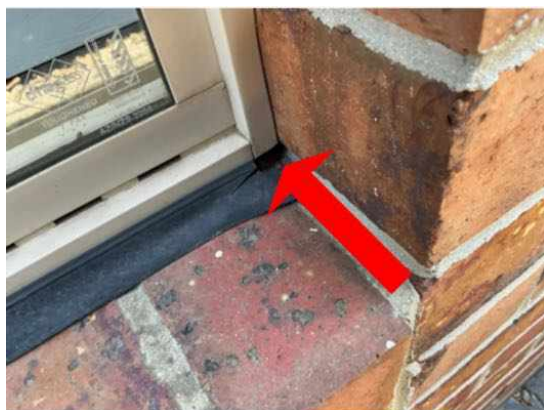
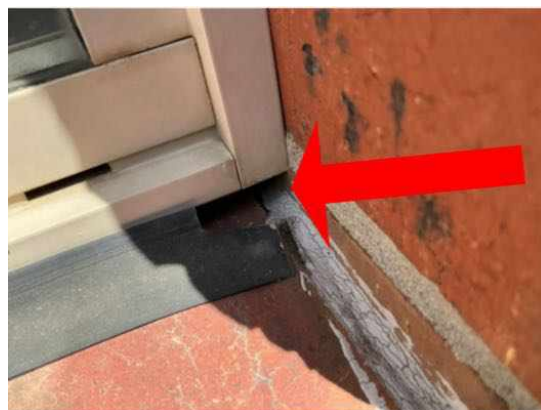
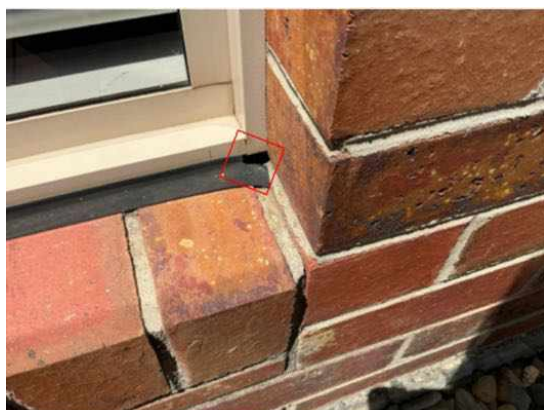
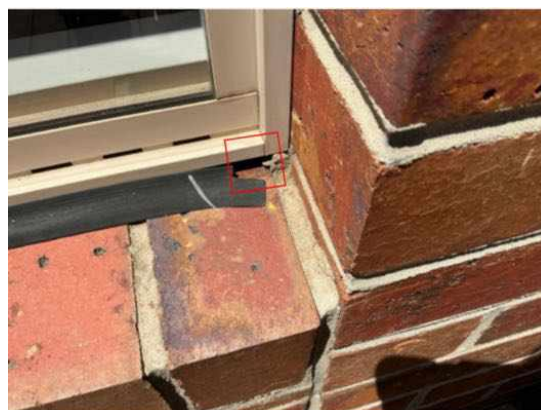
#### Defects 3.02

Building: Main Building  
 Location: All External areas  
 Finding: Gaps Below External Windows – Inadequate Sealing

Information: Gaps were observed beneath some external windows, indicating insufficient or deteriorated sealing in these areas. These openings may allow moisture ingress, air drafts, and potential pest entry, particularly during adverse weather conditions.

Unsealed or poorly sealed gaps can lead to internal water damage over time and reduce the overall thermal efficiency of the building envelope.

It is recommended that a qualified contractor or sealant specialist be engaged to properly seal all visible gaps using appropriate weather-resistant materials to restore protection and prevent future issues.

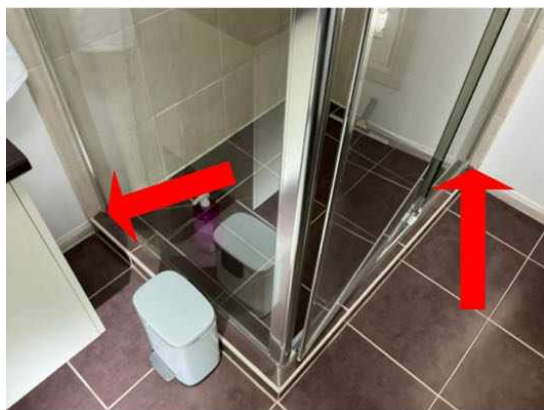
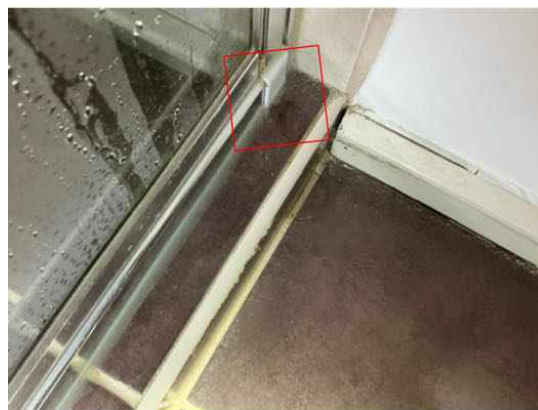
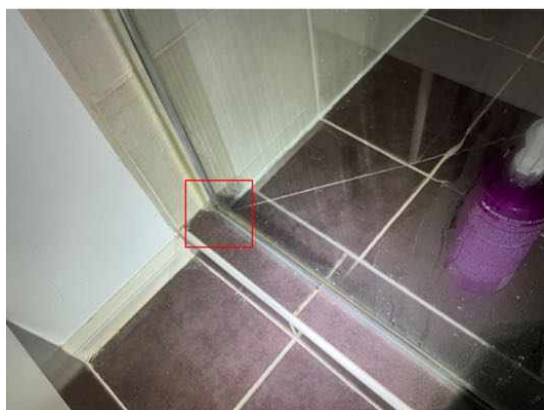
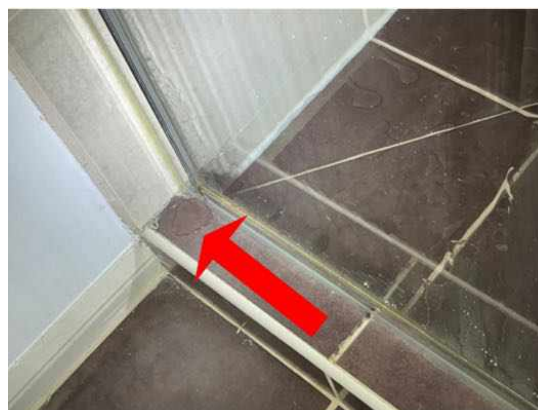
### Defects 3.03

Building:	Main Building
Location:	Ensuite
Finding:	Shower screen - Sealing required
Information:	Leaking was evident to the ensuite's shower screen at the time of inspection. It is suspected that the leaking has occurred as a result of deteriorated or missing caulking to the shower or general ageing of the building elements.

Leaking from the shower where left unattended, is likely to lead to water damage to adjoining flooring and walls. Such damage can lead to water damage and necessitate extensive remedial works being required. Active water leaks may also create an environment that is susceptible to the formation and development of mould.

Appointment of a caulking contractor is required to repair or replace the caulking to the shower area. Such works should be performed as soon as possible to ensure that no further damage occurs.

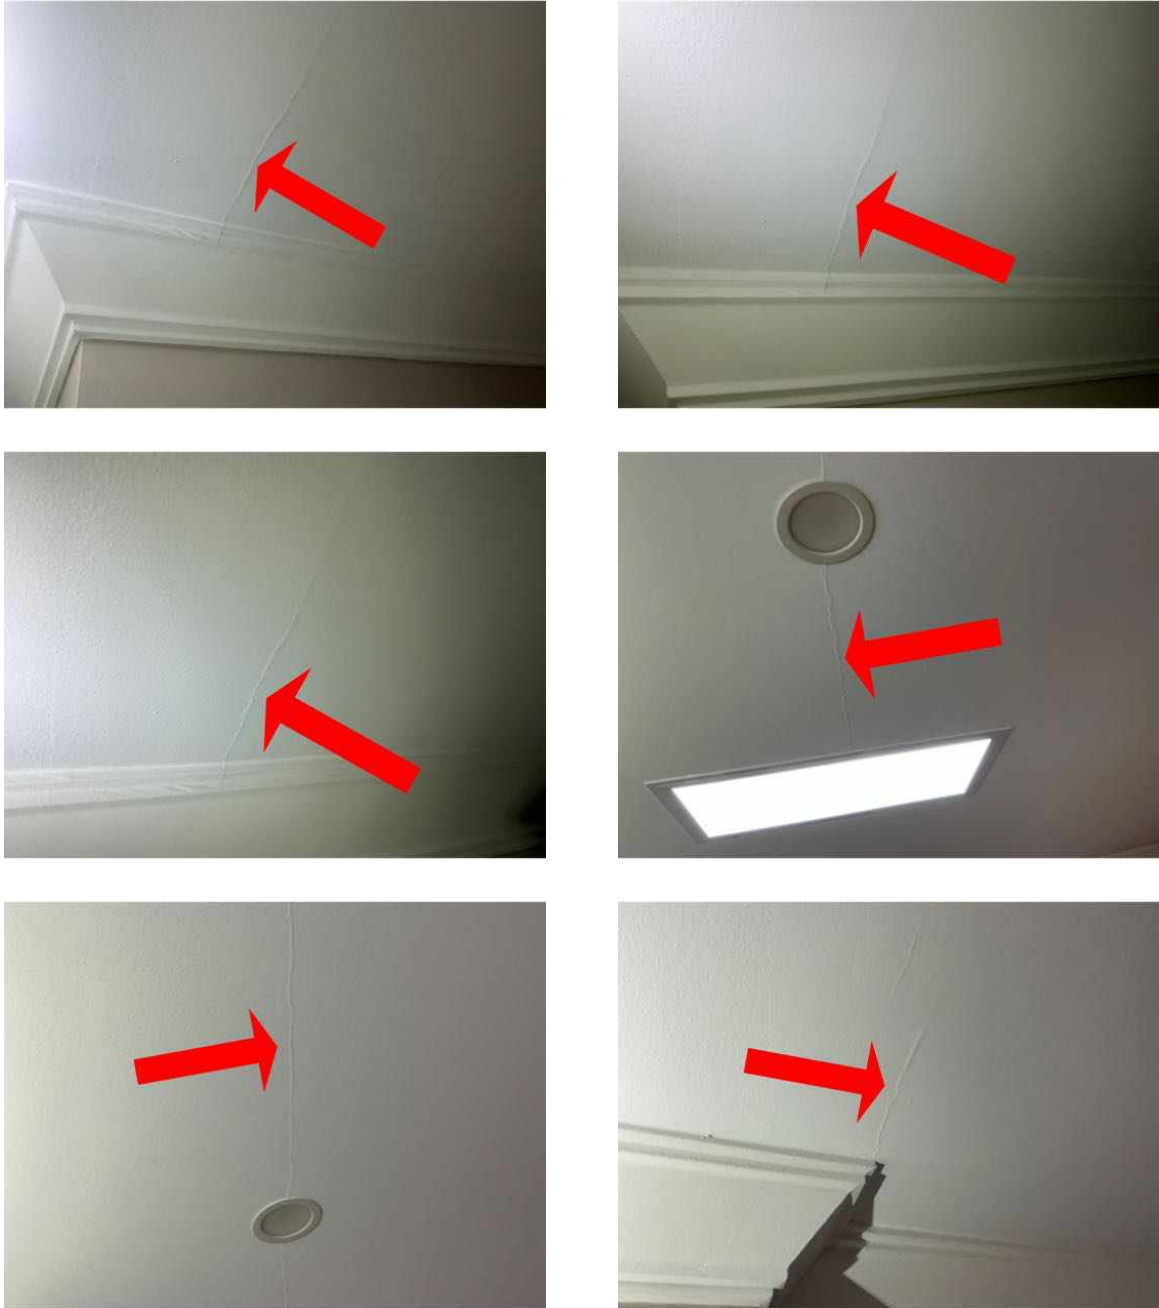
### Defects 3.04

Building:	Main Building
Location:	Dining/living room
Finding:	Ceiling Cracking – Dining and Living Areas
Information:	Multiple cracks were identified to the ceiling linings within the dining and living areas. The cracks are generally narrow, approximately 1mm in width, and observed at multiple locations across the ceiling surface.

Hairline ceiling cracking of this nature is commonly associated with normal building movement, minor settlement, seasonal expansion and contraction of framing timbers, and general ageing of materials. However, where alterations such as the installation of a skylight have been undertaken, modifications to ceiling framing and roof structure may influence load distribution and support to the surrounding plasterboard. In some cases, inadequate trimming, insufficient framing support, or movement around altered sections can contribute to cracking patterns. While the cracking observed appears minor at the time of inspection, ongoing movement or insufficient structural support may lead to progressive deterioration if not addressed.

It is recommended that a qualified carpenter or registered builder assess the ceiling framing above, particularly in areas surrounding any structural alterations, to confirm that adequate support and trimming members are installed in accordance with standard building practice. Subject to confirmation that no structural concerns exist, the cracks can be filled, sanded and repainted by a qualified painter to restore

appearance. Ongoing monitoring is also advised to ensure the cracking does not widen or reoccur.

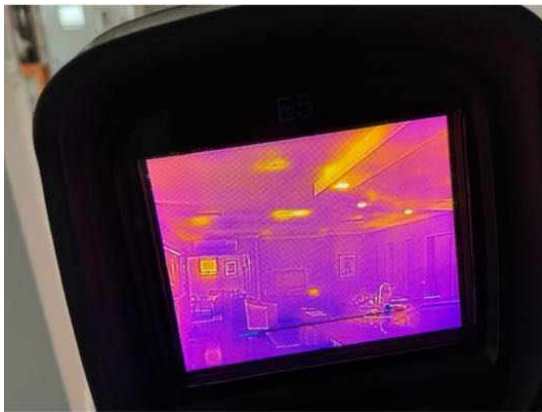
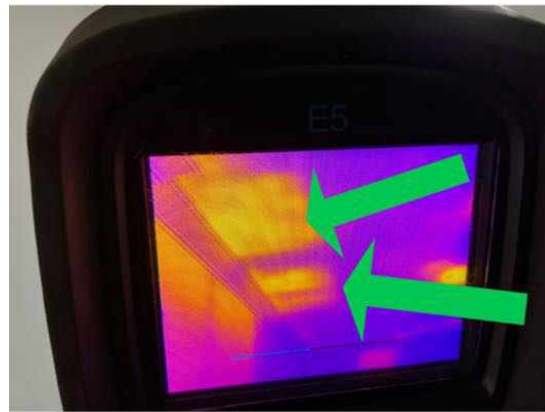
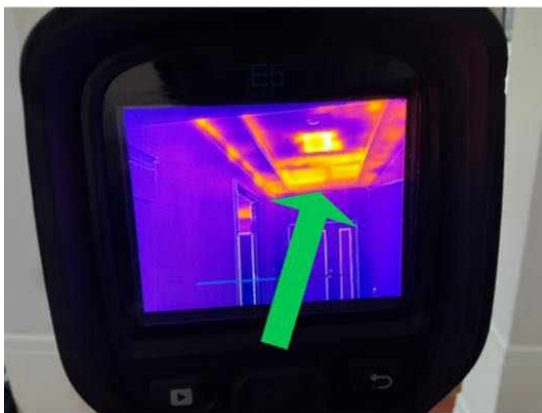
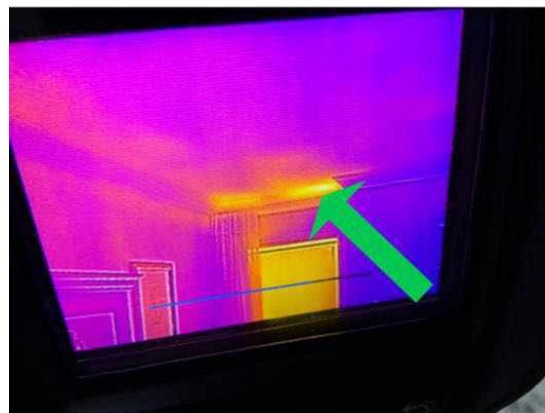
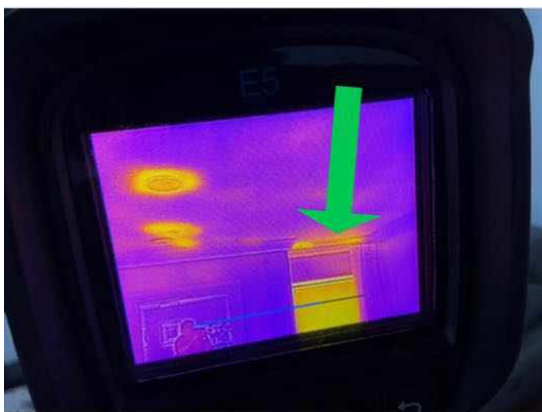
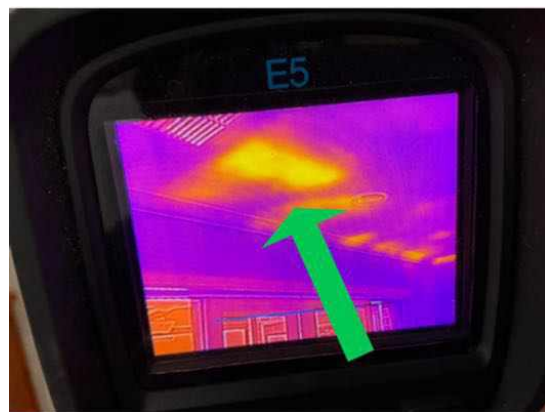
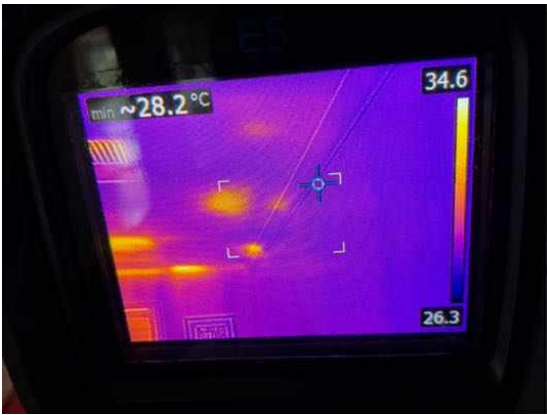
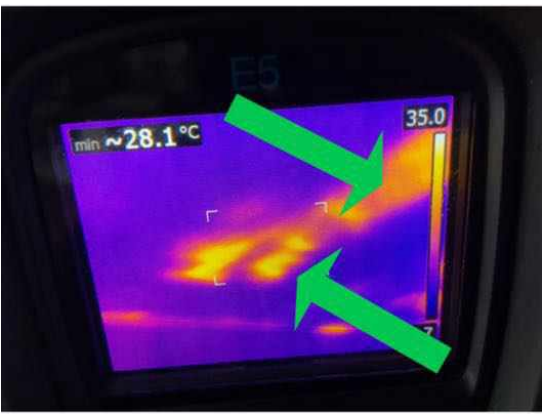
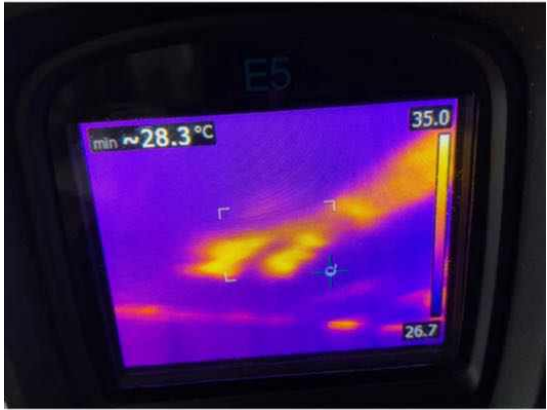
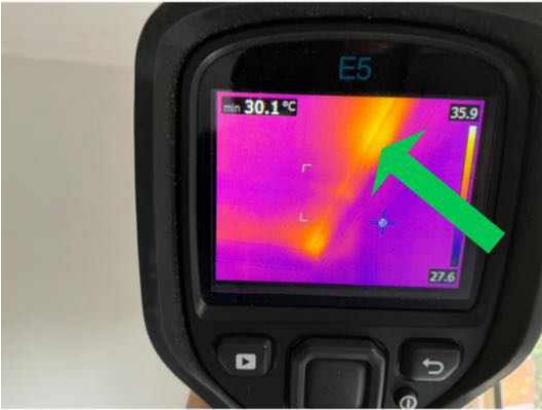
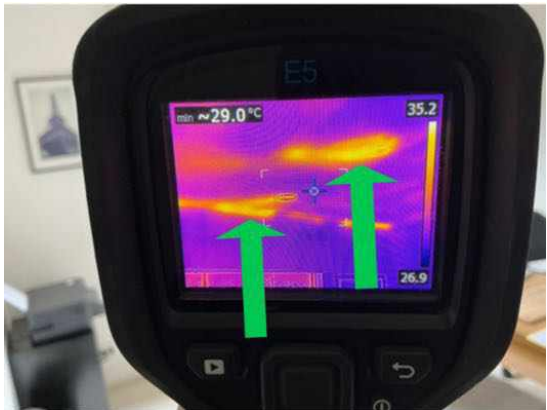
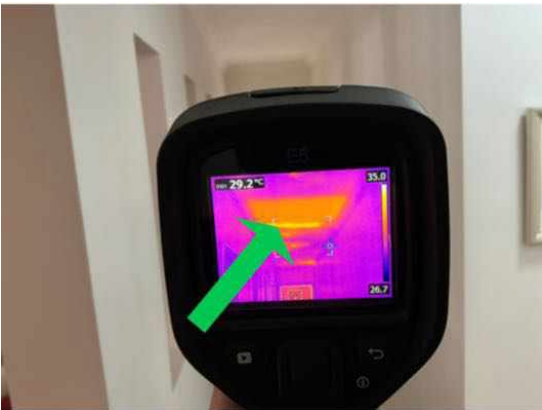
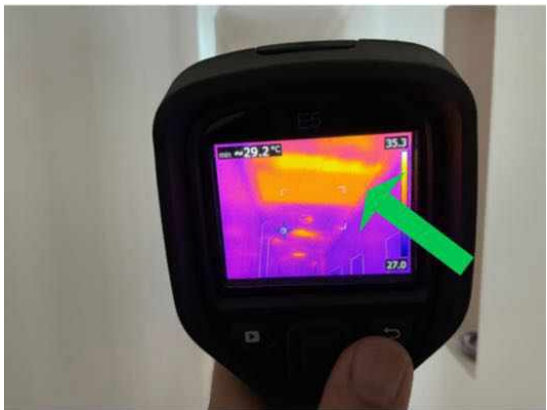
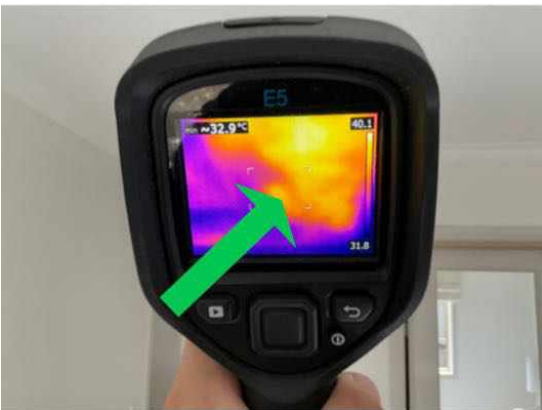
**Defects 3.05**

Building: Main Building  
Location: All Internal Areas  
Finding: Inconsistent Thermal Performance to Ceiling Areas – Suspected Insulation Deficiencies  
Information: Thermal imaging conducted to internal ceiling areas at the time of inspection identified inconsistent heat patterns, which are indicative of variations in thermal performance across the roof space. These patterns are commonly associated with areas of

missing, displaced, or insufficient insulation above the ceiling linings.

Inadequate or uneven insulation coverage can reduce the energy efficiency of the dwelling, contribute to heat loss in cooler periods and heat gain in warmer conditions, and may result in reduced occupant comfort and increased heating and cooling costs. Due to the non-invasive nature of the inspection, the exact extent and condition of insulation could not be confirmed visually in all affected areas.

It is recommended that a qualified insulation contractor inspect the roof space, assess insulation coverage and condition, and top up or reinstate insulation where required to achieve consistent thermal performance throughout the property.

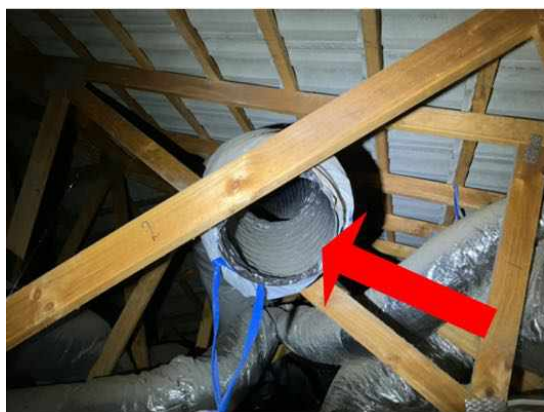
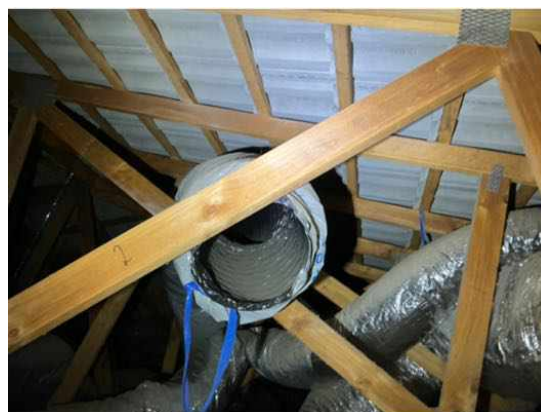
Defects 3.06

Building: Main Building  
 Location: Roof Void  
 Finding: Disconnected Ducting on Roof  
 Information: Upon visual inspection of the roof, it was observed that the ducting system has become disconnected. This disconnection can lead to several issues, including compromised heating and cooling efficiency, as conditioned air may escape into the attic space rather than being delivered to the intended areas of the building. Consequently, this may result in increased energy consumption and higher utility costs.

Furthermore, disconnected ducting can create an unbalanced airflow within the system, leading to inconsistent temperatures throughout the building. Inadequate airflow may cause some areas to become excessively hot or cold, affecting overall comfort levels and placing undue strain on the HVAC system, which may lead to premature wear and tear.

To address this issue, it is recommended that a licensed HVAC technician be engaged to inspect the ducting system thoroughly. The technician should reconnect any disconnected ducts and assess the entire system for any additional repairs or maintenance that may be necessary. Ensuring that the ducting is properly sealed and insulated will enhance the system's efficiency and prolong its lifespan.

Regular inspections and maintenance of the ducting system are essential to prevent similar issues from occurring in the future. Engaging professionals for routine check-ups will help ensure optimal performance and comfort within the building.

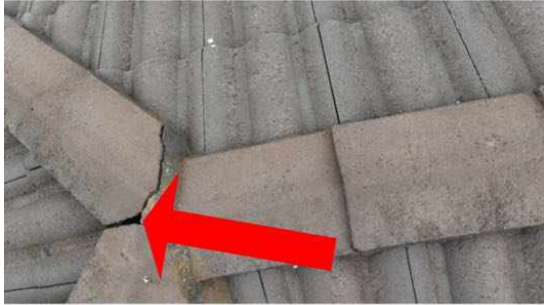
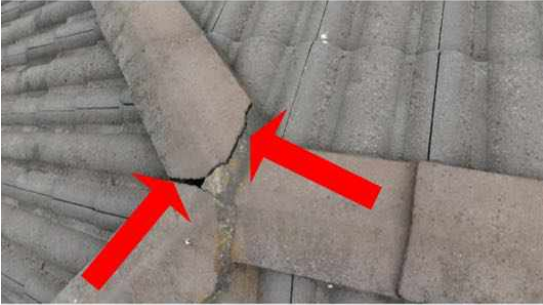
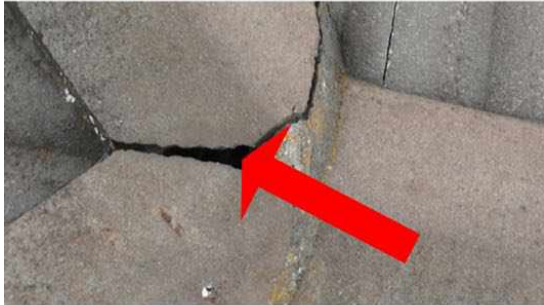
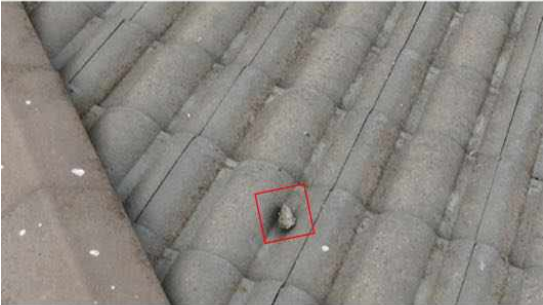
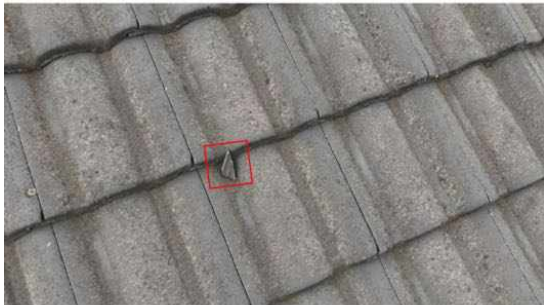
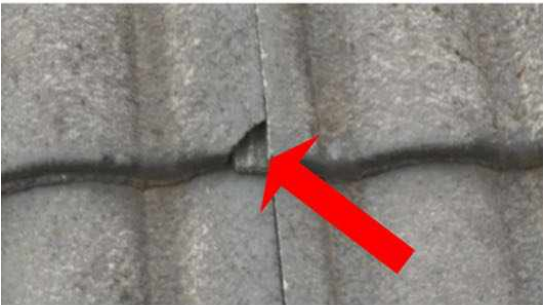
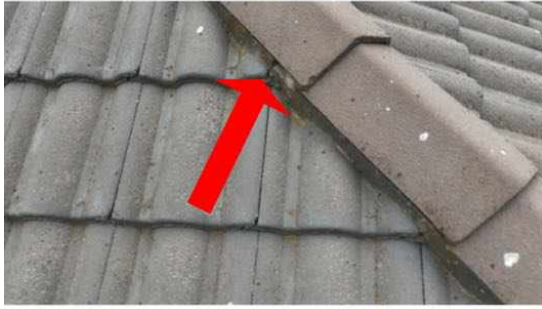
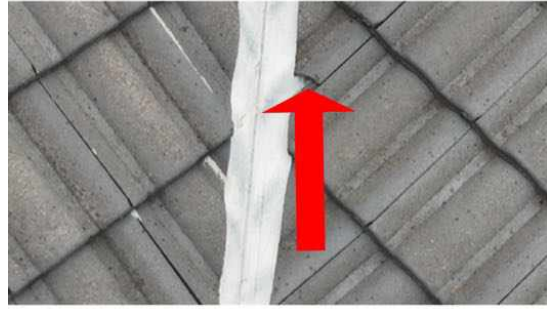
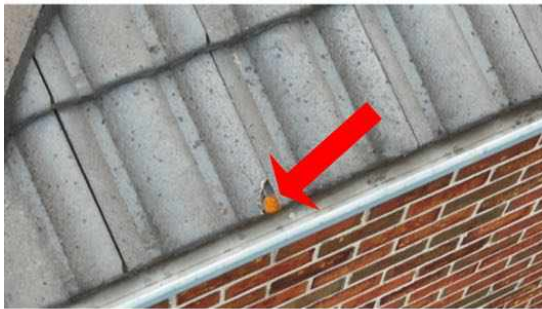
### Defects 3.07

Building: Main Building  
 Location: Roof Exterior  
 Finding: Roof tiles - Broken  
 Information: Upon inspection of the exterior roof covering, broken roofing tiles were identified. Broken and friable roof tiles are generally the result of ageing and weathering of what is essentially a porous material.

If left to further deteriorate, broken and brittle roof tiles are likely to lead to water penetration via the roof into the ceiling space, causing secondary damage to ceiling linings, insulation and roof structures. Broken roof tiles are also likely to detract from the effectiveness of the roof drainage system, creating potential for secondary damage to the exterior roof covering and roof plumbing.

Replacement of broken tiles is required and should be performed by a roofing contractor as soon as possible.

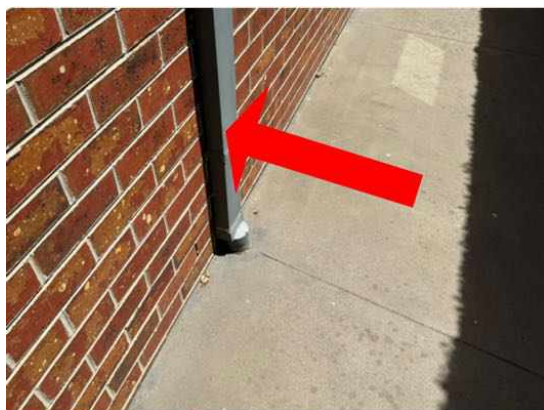
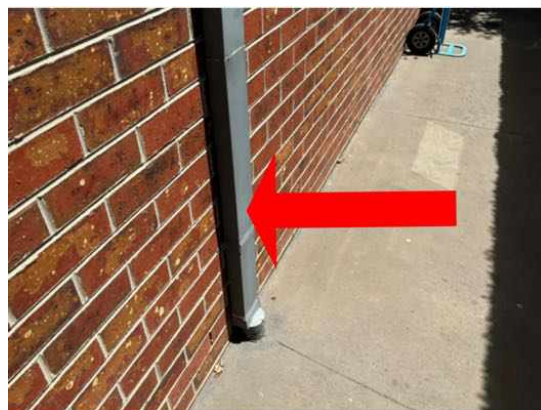
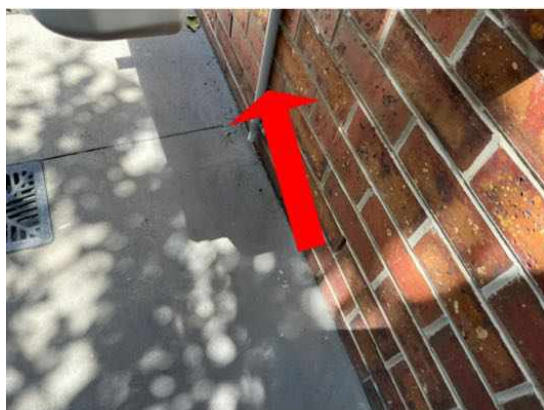
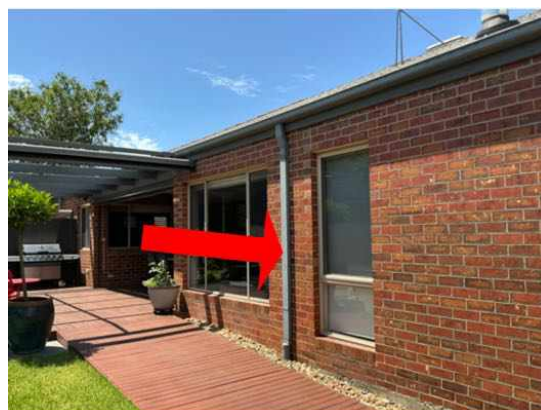
### Defects 3.08

Building:	Main Building
Location:	All External areas
Finding:	Bridging attachments to buildings - Conducive conditions to Timber pest activity
Information:	Bridging occurs when items against a building provide a concealed entry point for termites into the building or by passing around a termite management system. Where any part of an attachment to a building is not isolated and is not provided with a clear gap of not less than 25mm from building, bridging occurs. Attachments to buildings such as hot water services, downpipes, verandahs, decks, steps, fences, service conduits and the like provide the opportunity for concealed entry. Building attachments of this nature need to be frequently inspected for termite activity by a qualified inspector.

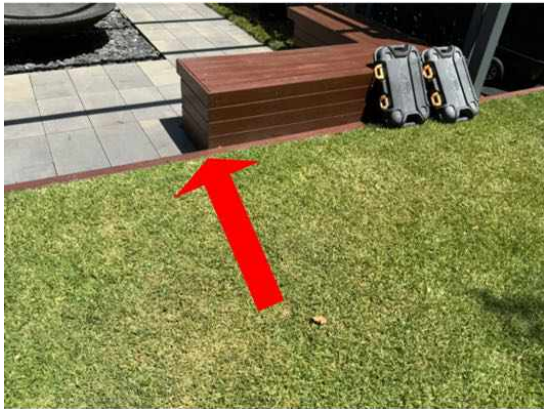
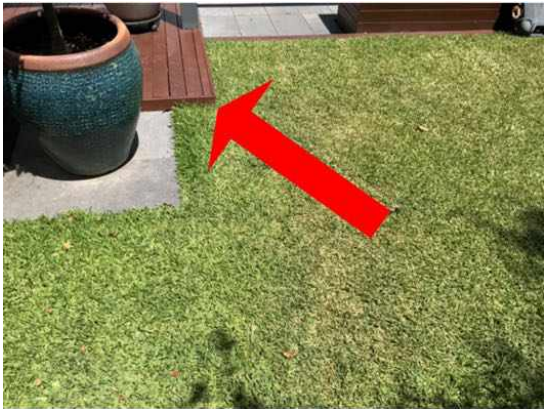
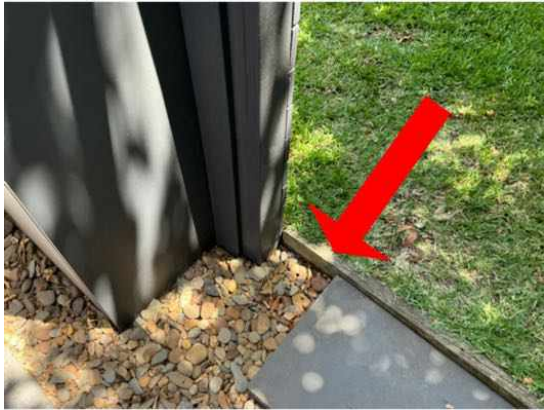
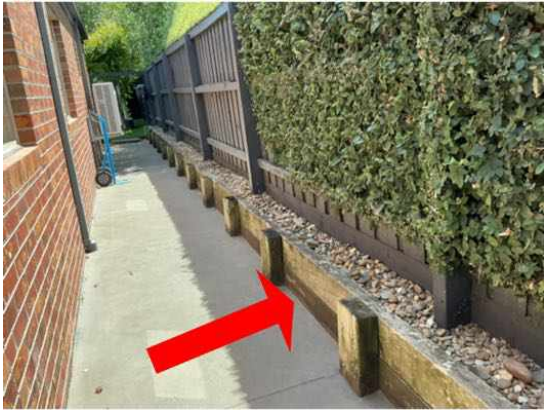
### Defects 3.09

Building:	Main Building
Location:	All External areas
Finding:	In Ground Contact - Conducive conditions to Timber pest activity
Information:	Any timbers in direct ground contact provide an opportunity for concealed termite entry and are likely to be subject to premature rot and decay due to soil retaining moisture or creating damp conditions against the timber surfaces.

Untreated timber in direct contact with the external ground should be removed. Consider replacing with more durable materials, such as appropriately treated timber or non-timber elements, to reduce the risk of decay and termite attack.

Frequent pest inspections by a licensed pest control technician are recommended to readily identify any termite activity in these areas and ensure early intervention if required.

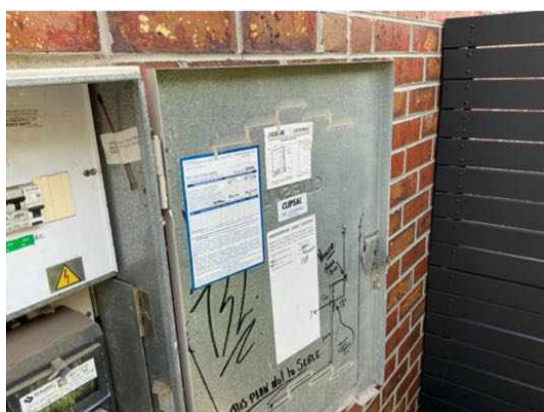
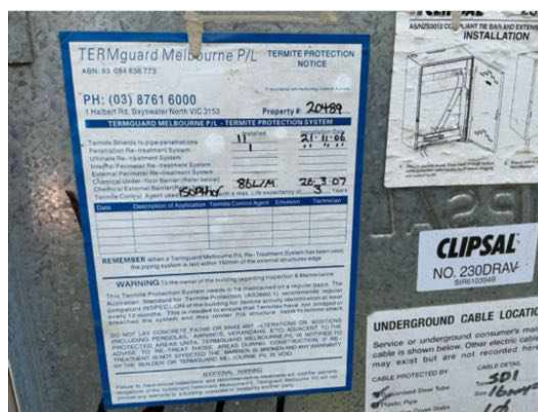
Building: Main Building  
 Location: All External Areas  
 Finding: Evidence of Termite Management Protection System  
 Information: During the inspection, evidence of a termite management protection system was observed within the meter box. No active termite activity was detected at the time of inspection. The presence of the system indicates that preventative measures have been installed to protect the property from potential timber pest activity.

It is recommended that the termite management system be regularly maintained and inspected in accordance with the manufacturer’s guidelines and industry standards to ensure continued effectiveness. Routine inspections by a licensed pest control professional are advised to monitor for any signs of termite activity.

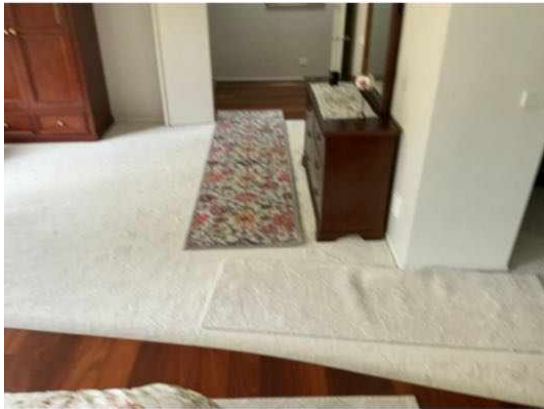
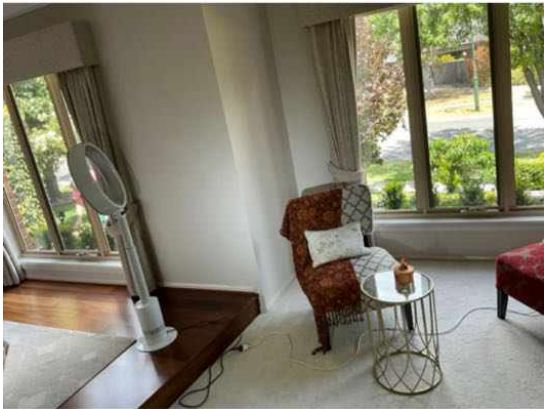
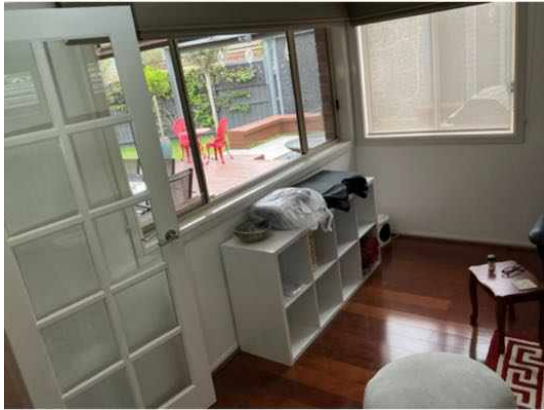
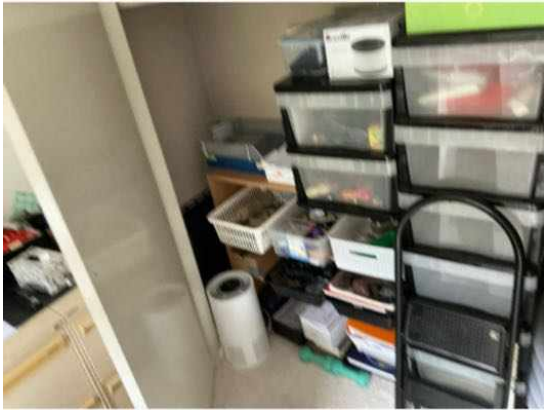
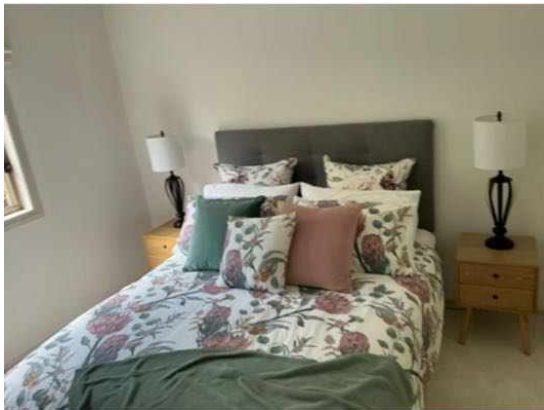
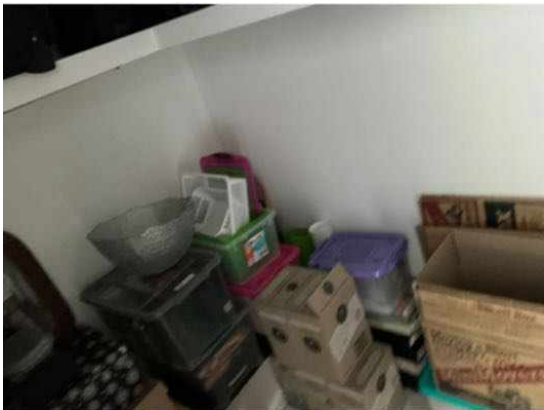
Building: Main Building  
 Location: All Internal Areas  
 Finding: Obstructions and Limitations - Interior  
 Information: These photographs are an indication of the obstructions and limitations which impeded the inspection of the internal areas of the property at the time of inspection. These obstructions can hide an array of defects and should be removed to allow full inspection to be carried out. A re-inspection is recommended once the areas are made accessible.

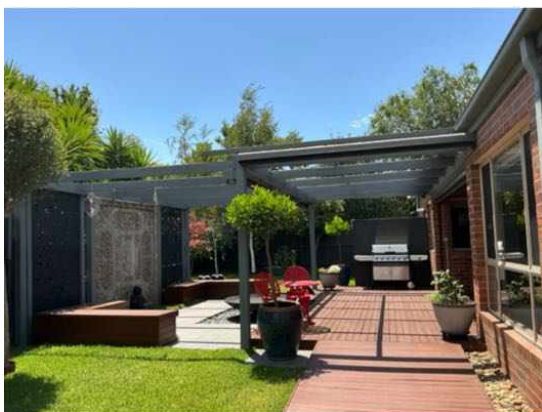
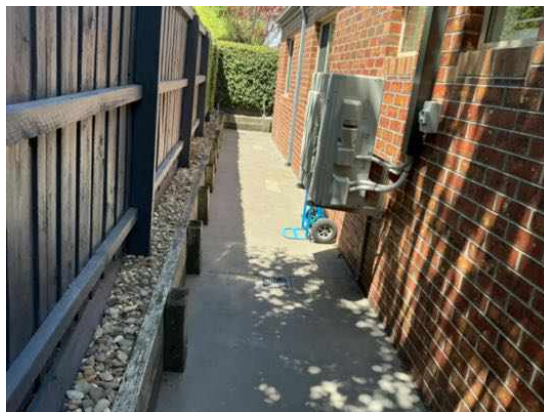
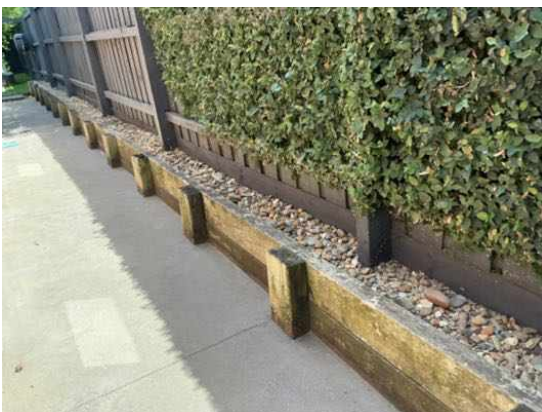
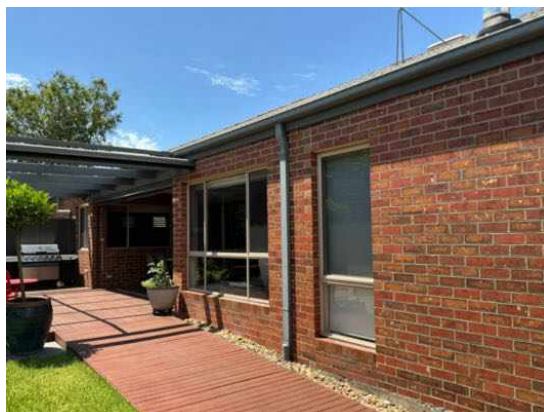
Building: Main Building  
Location: All External Areas  
Finding: Obstructions and Limitations - Exterior  
Information: These photographs are an indication of the obstructions and limitations which impeded the inspection of the external areas of the property at the time of inspection. These obstructions can hide an array of defects and should be removed to allow full inspection to be carried out. A re-inspection is recommended once the areas are made accessible.

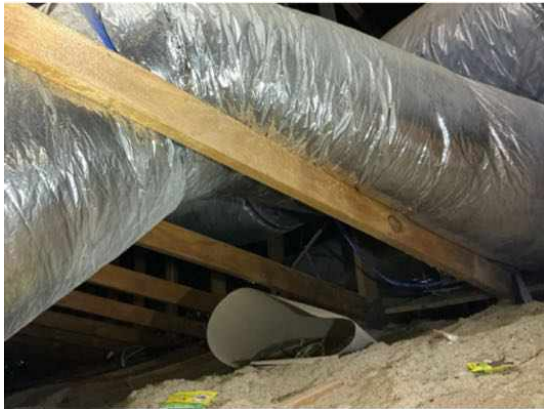
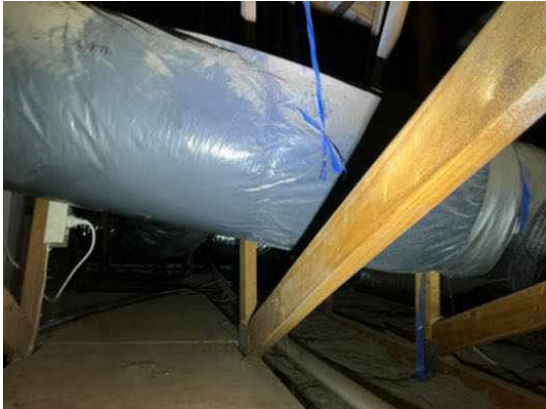
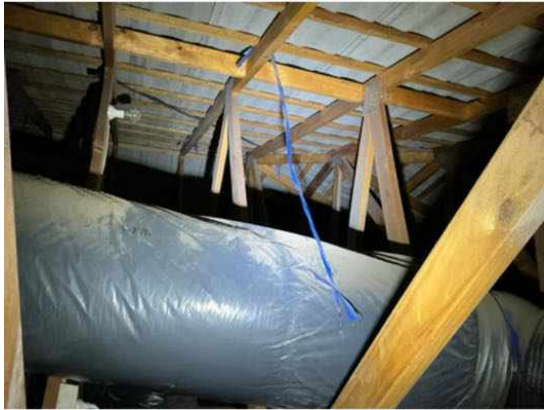
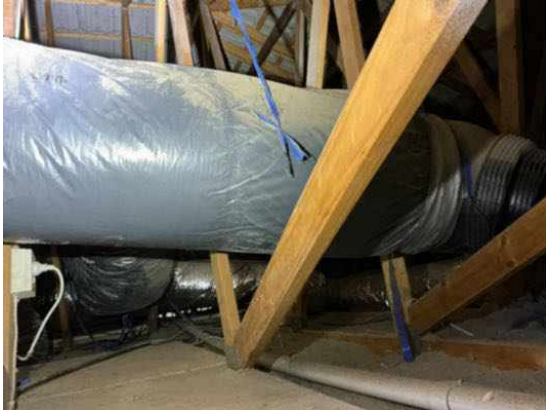
Building: Main Building  
 Location: Roof Void  
 Finding: Obstructions and Limitations - roof cavity  
 Information: These photographs are an indication of the obstructions and limitations which impeded the inspection of the roof cavity area of the property at the time of inspection. The roof manhole opening was particularly narrow and provided restricted entry dimensions. In addition, fixed laundry cabinetry and a benchtop were installed directly beneath the manhole, significantly limiting safe and practical access into the roof space.

These obstructions can conceal an array of defects including structural deficiencies, moisture ingress, insulation concerns, timber pest activity and non-compliant building alterations. Although reasonable attempts were made to access and inspect the roof cavity to the extent safely possible, inspection coverage was limited due to the restricted entry conditions.
