Building and Timber Pest Inspection Report

Inspection Date: Thu, 15 Jan 2026

Property Address: 16 Sophia St, Shellharbour NSW 2529,
Australia

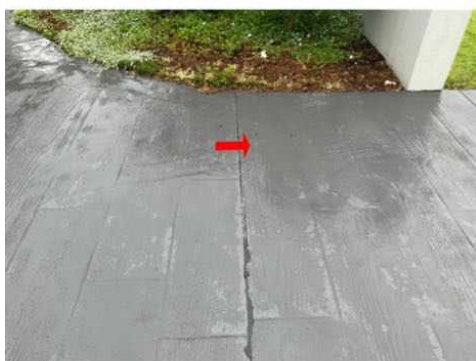
Finding 3.01

Building: Building 1
 Location: Driveway
 Finding: Crack in concrete slabs - Category 1
 Information: Cracks coded as Category 1 was identified in these pictured slabs. A Category 1 crack is described as a fine but noticeable crack, with the slab at an otherwise reasonable level. To be considered Category 1, the approximate width of the crack is less than 1.0mm, or a less than 10mm change in offset when a 3m straight edge is placed over the defect.

Category 1 cracks should be monitored for a period of 12 months. At the end of the monitoring period, identified cracks that are rated greater than Category 2 are considered defects, and require rectification.

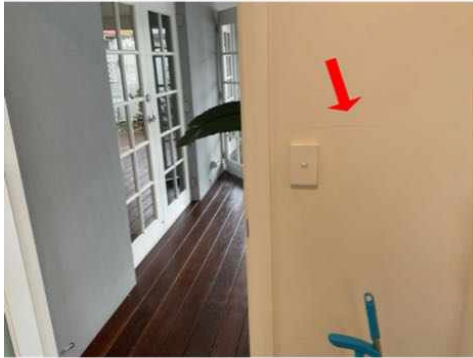
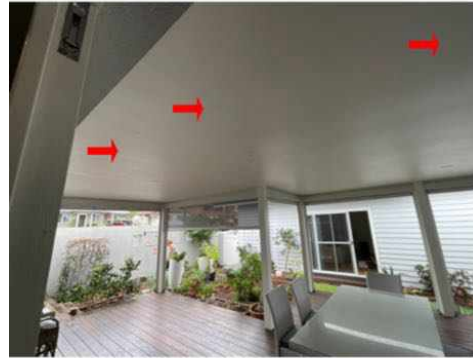
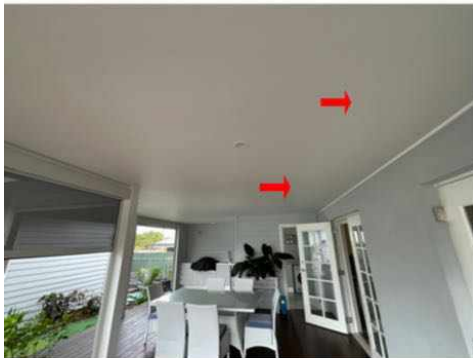
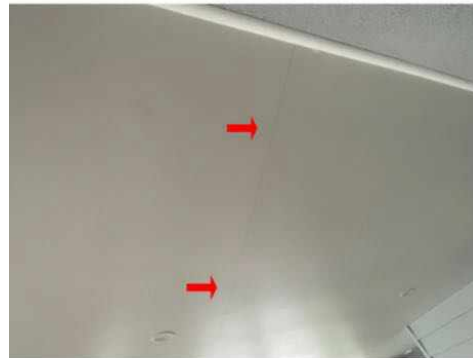
Finding 3.02

Building: Building 1
 Location: Rear balcony ceiling and other small areas
 Finding: Cracking - Damage Category 1 - Fine (up to 1mm)
 Information: Although fine cracks are quite noticeable, they are often only considered to be an appearance defect, and usually do not indicate any structural damage. Generally, the

cause of a fine crack is indicative of a separation between building materials and finishes (e.g. paint, plaster, etc.) along joins.

Cracking of this nature can generally be repaired with minor sanding, filling and/or repainting. Such works should be performed by a qualified painter or a general handyman.

Monitoring of all cracking should be conducted frequently. Always contact a building inspector should cracks widen, lengthen, or become more numerous.

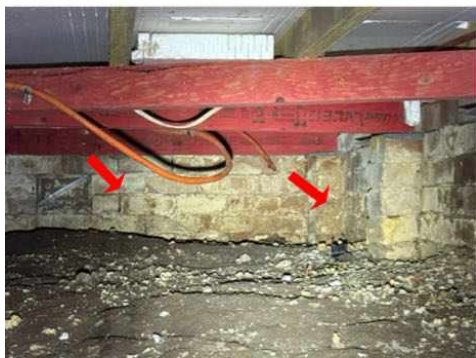
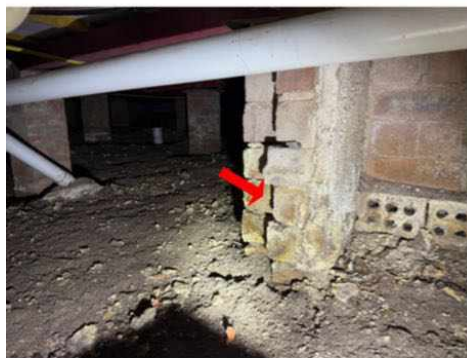
Finding 6.01

Building:	Building 1
Location:	Subfloor
Finding:	Damp - Rising
Information:	Rising damp describes the upward movement of water in low sections of building elements (e.g. walls) by capillary action - the movement of water through porous materials such as bricks, sandstone or mortar.

Rising damp is generally managed by the installation of a damp proof course during construction. A Damp Proof Course (DPC) is an impermeable barrier at the base of the wall above ground level. However, many 19th Century buildings have no damp course installed, or the materials have failed. The DPC may have been omitted as a consequence of poor workmanship, or it may have been bridged where materials built up against the side of the house allow moisture ingress above the DPC level.

Left unmanaged, rising damp can lead to health problems resulting from mould growth and can have major implications on affected building elements, including wall finishes like paint and plasterwork.

The first step in addressing rising damp is to diagnose the cause. The identified cause should be addressed first before addressing the appearance and other defects which have resulted from the rising damp. If the original cause is not resolved, further cases of damp are likely to ensue, resulting in secondary defects.

Consultation with a qualified plumber is advised immediately to identify the cause of the damp and perform remedial works as required.

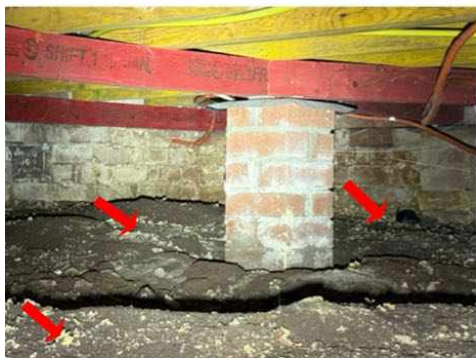
Finding 6.02

Building:	Building 1
Location:	Subfloor
Finding:	Mould - Present in subfloor
Information:	Where evidence of mould growth was noted in many areas of the subfloor. Generally, the client is advised to ensure that the general environment is free of moisture and humidity to aid in the prevention of mould formation and development.

Subfloor mould is generally caused by a lack of external drainage and lack of adequate ventilation. Where these issues exist, rectification is required to stop mould development. Any mould found during the inspection should be cleaned immediately by a cleaning contractor or the homeowner as applicable.

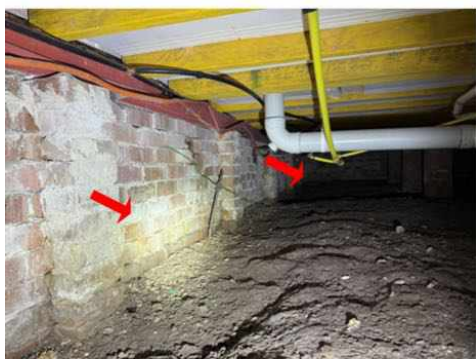
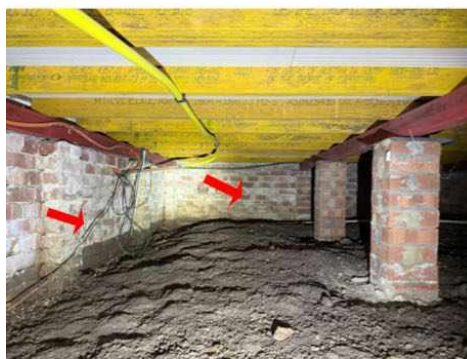
Finding 6.03

Finding: Subfloor - Lack of ventilation

Information: It was noted at the time of inspection that the subfloor area lacks adequate ventilation. Ventilation can be restricted by a variety of minor defects, including obstructions in the subfloor space, a lack of vents or a low clearance. A well ventilated subfloor aids in maintaining dry conditions, preventing secondary damage such as wood rot and pest activity, as well the development of mould. The owner has just installed a mesh subfloor door to increase ventilation.

It is recommended to install additional brick vents. The client may also consider mechanical ventilation (powered fans) to improve subfloor airflow. Remedial works should be conducted to reduce the subfloor mould present.

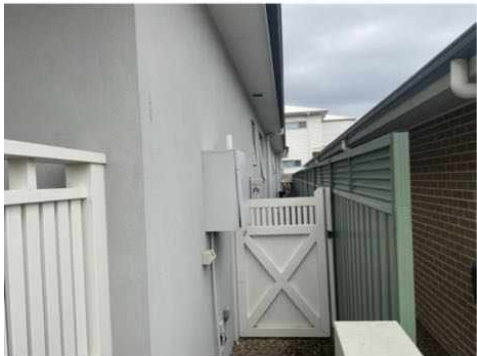
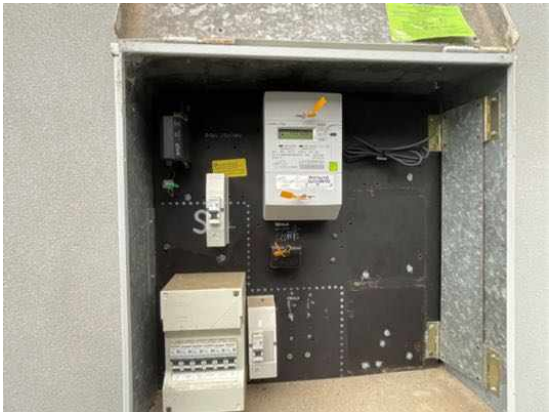
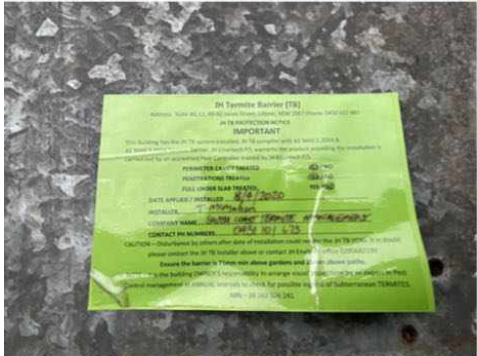
Building: Building 1
 Location: Meter Box
 Finding: Termite Management System - a chemical barrier installation is recommended
 Information: The application of a post-construction chemical termite barrier is highly recommended for all properties. Such barriers are highly effective in preventing termite attack on any timber building elements throughout the property.

A durable notice should be placed in the switchboard unit to indicate current termite barriers. At the time of inspection, the durable notice was evident and it appeared as though a termite treatment has occurred.

The client may consider gaining further advice from a pest controller as to the costs and procedures involved with a 'chemical' application. It is recommended that obtaining such advice be a short-term priority as this is the best protection against termites for most houses.

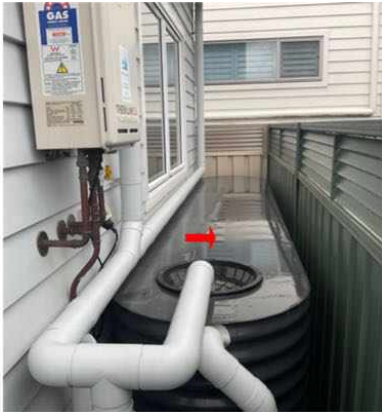
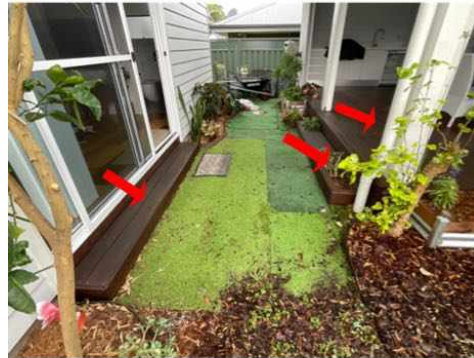
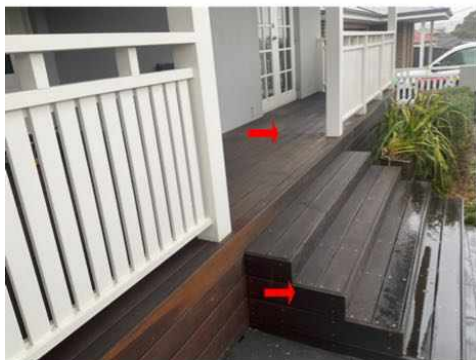
Building: Building 1
 Location: All External Areas
 Finding: Additional Photos - Obstructions and Limitations of EXTERNAL AREAS
 Information: These photographs are an indication of the obstructions and limitations which impeded full inspection of external areas at the time of inspection. These obstructions can hide an array of defects and should be removed to allow full inspection to be carried out. A re-inspection is recommended once the areas are made accessible.

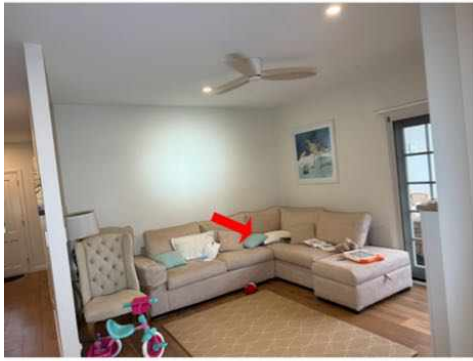
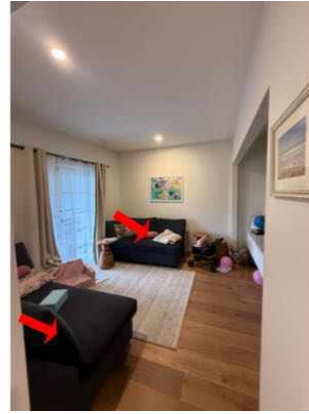
Building: Building 1
 Location: All Internal Areas
 Finding: Additional Photos - Obstructions and Limitations of INTERNAL AREAS
 Information: These photographs are an indication of the obstructions and limitations which impeded full inspection of Internal areas at the time of inspection. These obstructions can hide an array of defects and should be removed to allow full inspection to be carried out. A re-inspection is recommended once the areas are made accessible.

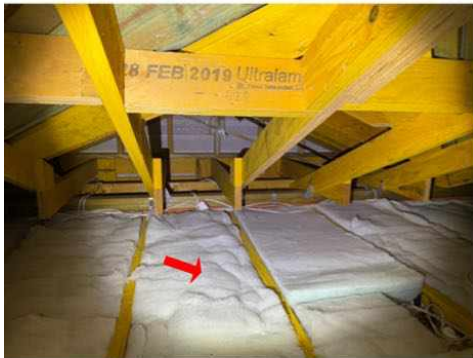
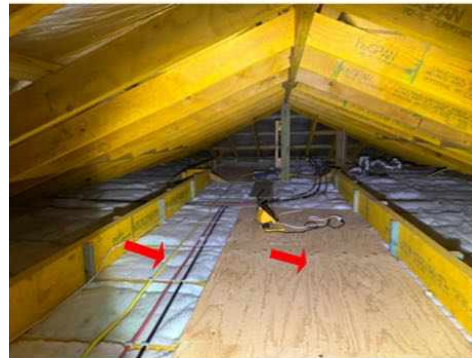
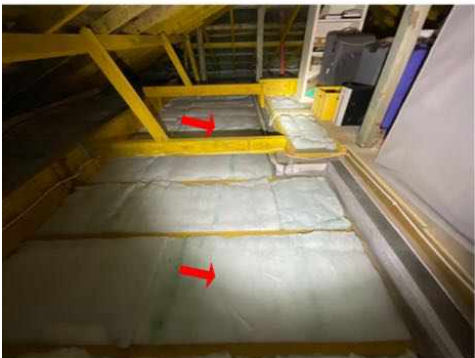
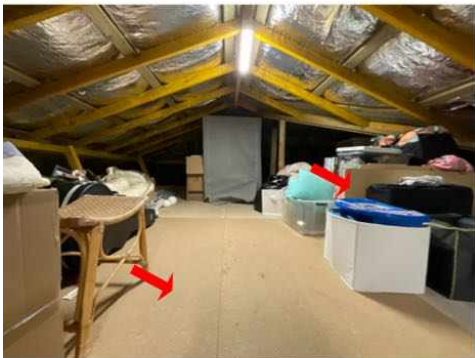
Building: Building 1
 Location: All Roof cavity areas
 Finding: Additional Photos - Obstructions and Limitations of the ROOF CAVITY
 Information: These photographs are an indication of the obstructions and limitations which impeded full inspection of roof cavity areas at the time of inspection. These obstructions can hide an array of defects and should be removed to allow full inspection to be carried out if applicable. A re-inspection is recommended once the areas are made accessible.

The inspection was also limited to areas with an allowable crawl space of 600mm x 600mm, in particular towards the external walls where the roof line diminishes, these areas were not accessible.

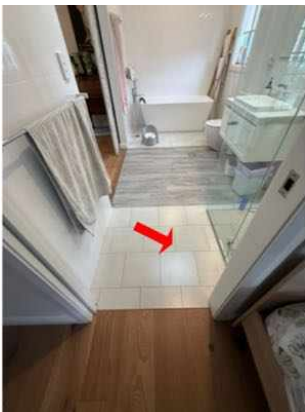
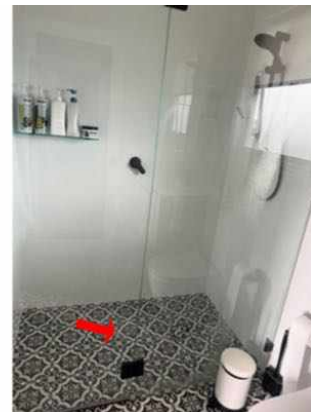
Building: Building 1
 Location: Bathrooms and laundry
 Finding: Waterproofing membranes - Information Only
 Information: Internal Water Proofing Membranes, are crucial in preventing water ingress into the property is important to know that the Membrane System used is to Australian Standards and has been installed correctly.

With older property's where this information is unavailable all wet areas should be monitored. If any leaks, water staining, peeling or bubbling of the paint become evident to any adjacent walls or ceilings below a licensed builder or waterproofing specialist is recommended to investigate further.
