Building and Timber Pest Inspection Report

Inspection Date: Wed, 25 Mar 2026

Property Address: 1 Dickson St E, Woomargama NSW 2644,
Australia

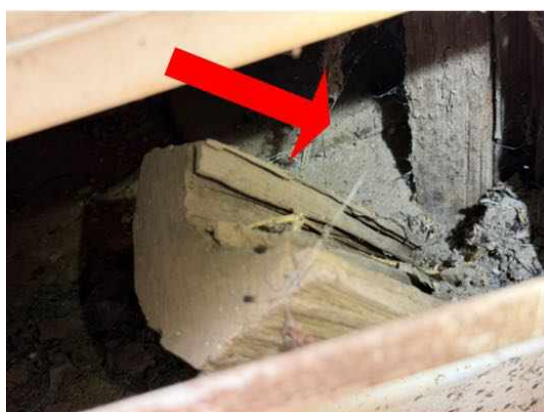
Finding 2.01

Building: Main Building
 Location: Subfloor
 Finding: Timber stumps - Deterioration / Termite Damage
 Information: Although the subfloor was unable to be inspected due to no access, it appears that a timber stump on the edge of the subfloor has deteriorated and is affected by termite damage, inhibiting its structural integrity.

Recommend that access be gained to the subfloor and a further inspection be conducted to identify the extent of the damage /deterioration. A registered builder should be engaged promptly to replace any affected timber stumps, to avoid the development of secondary building defects.

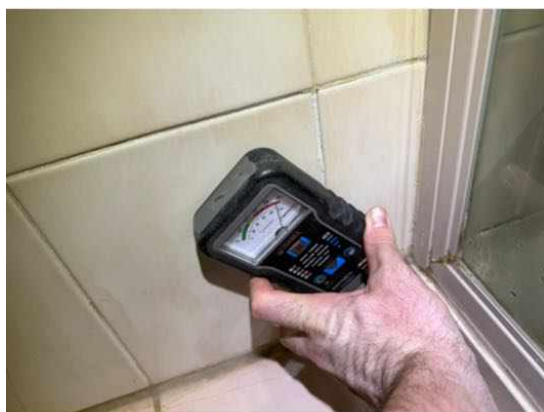
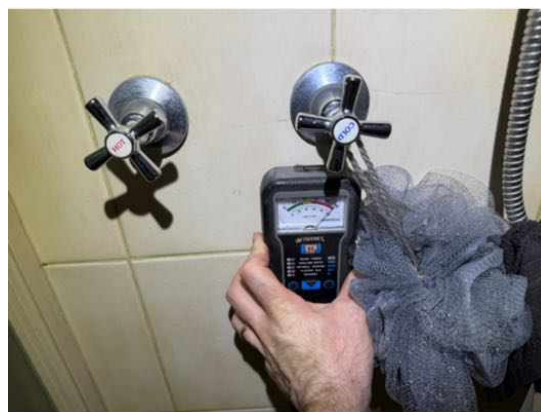
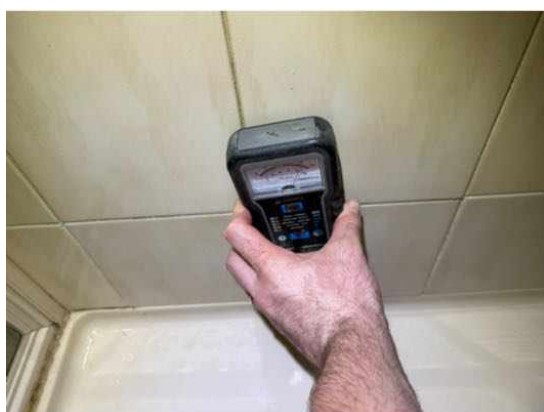
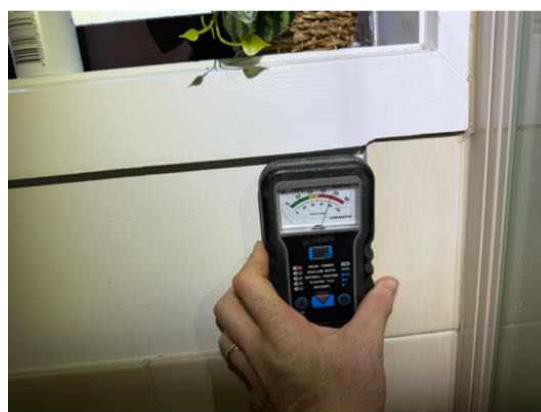
Finding 2.02

Building: Main Building
 Location: Shower
 Finding: Shower - Leaking / High Moisture
 Information: It appears that high moisture is present at but not limited to, the shower walls, and adjacent walls. Potential causes of leaking include but are not limited to loose or damaged plumbing fittings and fixtures, and/or deteriorated seals or waterproofing.

Areas of leaking and high moisture create an environment conducive to termite activity and therefore should not be neglected. A licensed plumber and/or tiling contractor is required promptly, to provide remedial works where necessary. A more invasive

inspection may reveal secondary building defects.

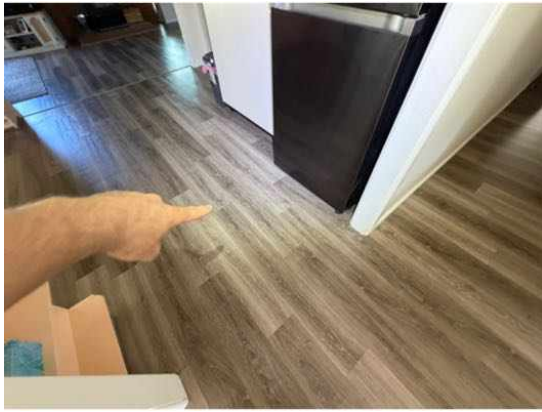
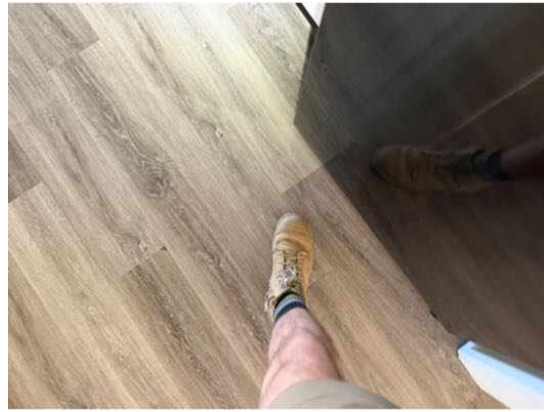
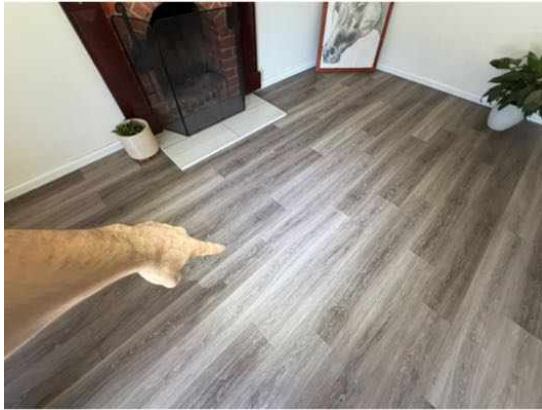
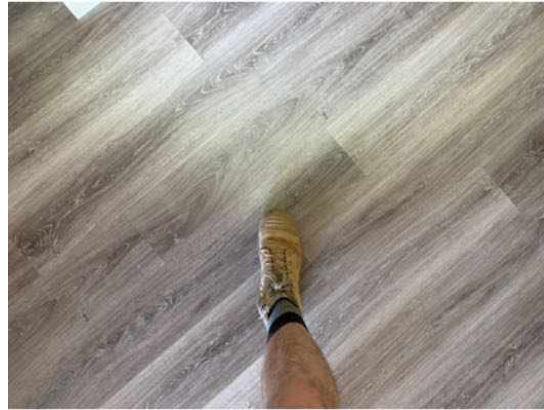
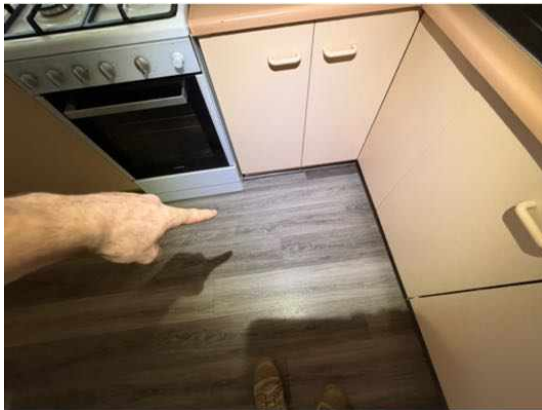
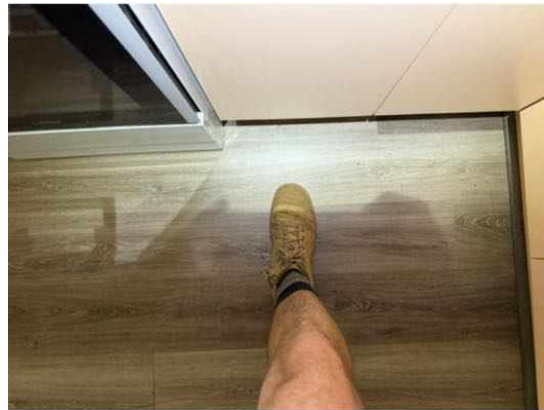
Finding 3.01

Building: Main Building
 Location: All Areas
 Finding: Flooring - Uneven
 Information: Some areas, of the flooring throughout the building appear to be uneven / springy. Recommend gaining access to the subfloor and a reinspection be conducted to identify the cause of the sagging.

In the interim, the client should monitor the flooring to identify any further movement. Should further movement and unevenness occur, a structural engineer should be engaged promptly for further evaluation.

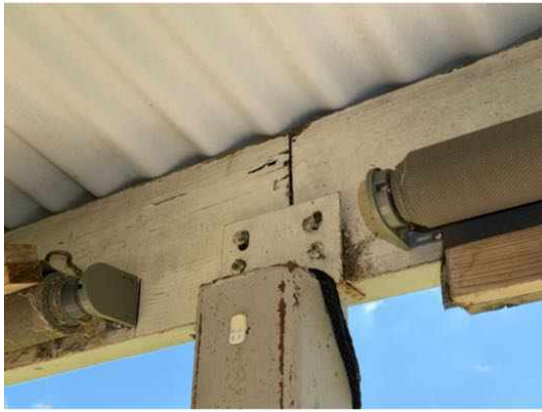
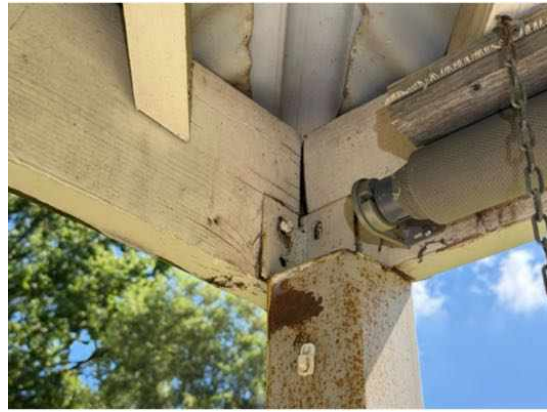
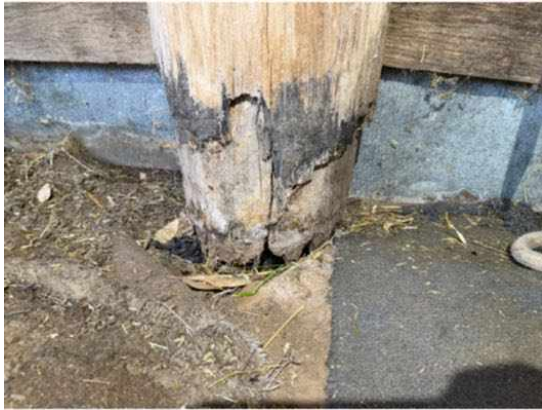
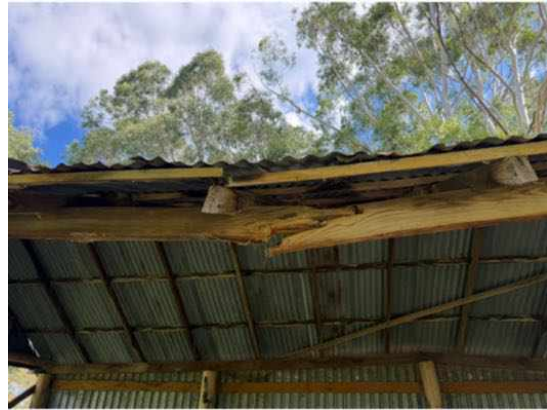
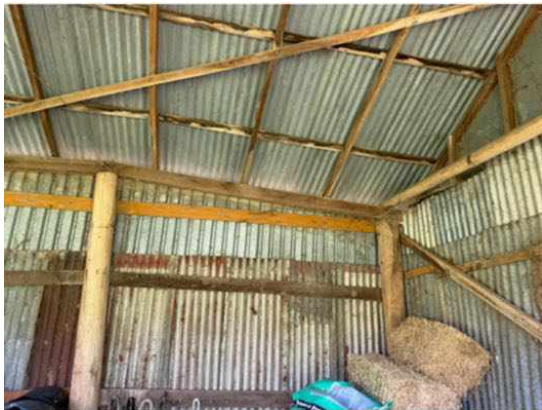
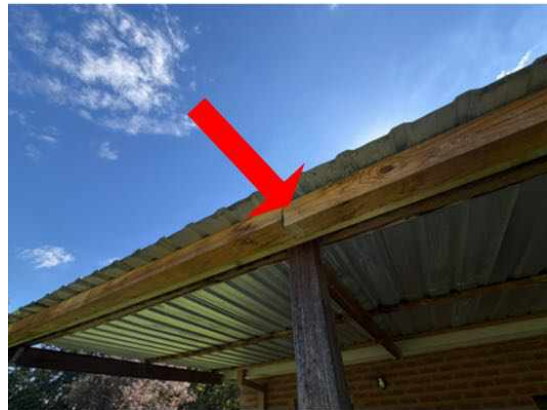
Finding 3.02

Building:	Main Building
Location:	Shed framing & verandah beams
Finding:	Insufficient / Loose Fixings & Deteriorated Shed Framing
Information:	Loose and insufficient fixings were noted at but not limited to the verandah beams. The shed framing / posts were also found to be deteriorated and rotting. A licensed carpenter should be engaged promptly, to replace any rotting materials and install sufficient fixings where necessary, to ensure the structures are secure.

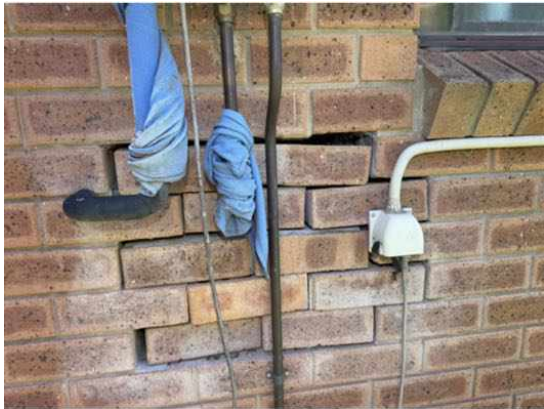
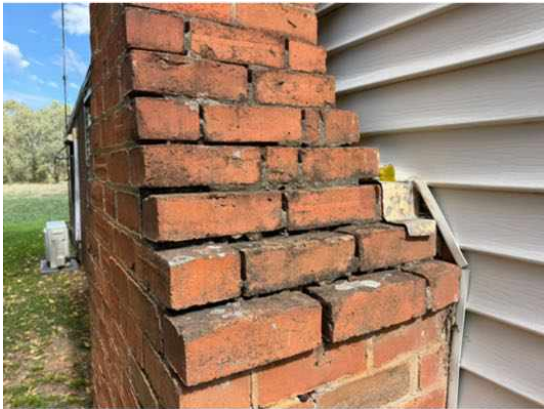
Finding 3.03

Building:	Main Building
Location:	Brickwork
Finding:	Brickwork - Loose & Deteriorated Mortar
Information:	Loose bricks and deteriorated mortar were evident to some areas of the brickwork. A licensed bricklayer should be engaged in the short term to provide remedial works where necessary, to avoid further deterioration and the development of secondary building defects.

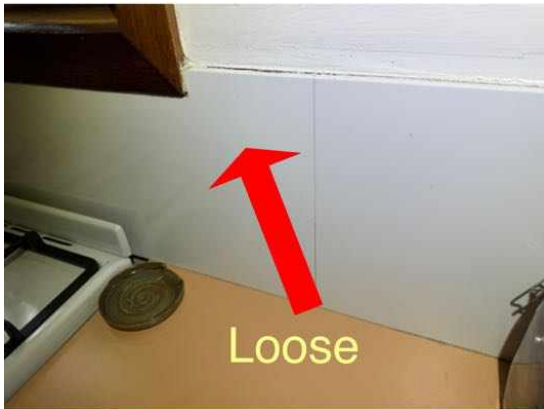
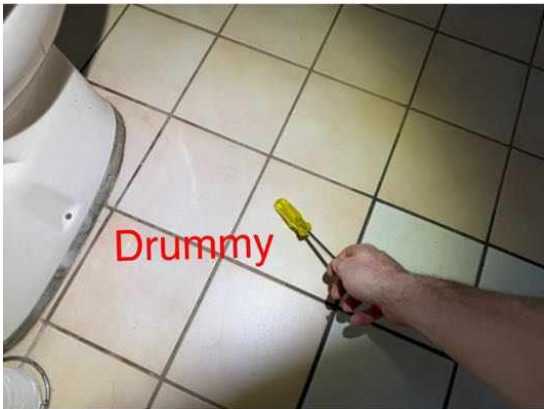
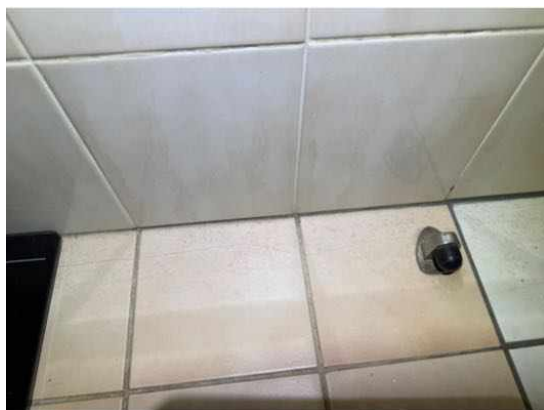
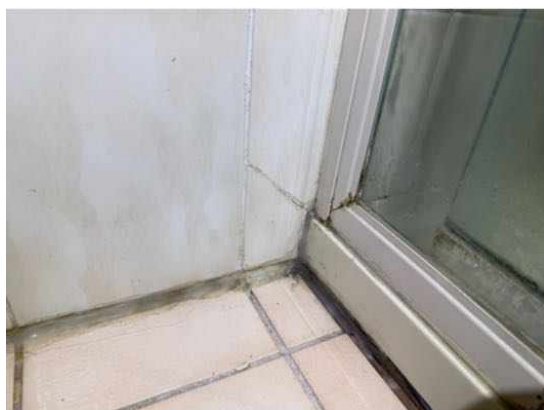
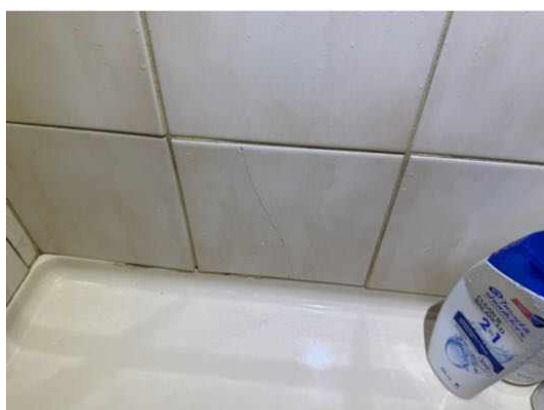
Finding 3.04

Building: Main Building
Location: Tiled Areas
Finding: Sealant / grouting - deteriorated or missing & Cracked/Drummy Tiles
Information: It appears that the sealant and grout has deteriorated or is missing throughout the tiled areas. Several cracked, drummy and loose tiles were also noted, which can allow for moisture ingress behind the tiles, if neglected.

Sealant and grouting in areas that come into regular contact with water should be maintained for the long term care of your property. Recommend engaging a licensed tiling contractor promptly, to provide remedial works, to ensure all tiled areas are sufficiently grouted sealed and waterproofed.

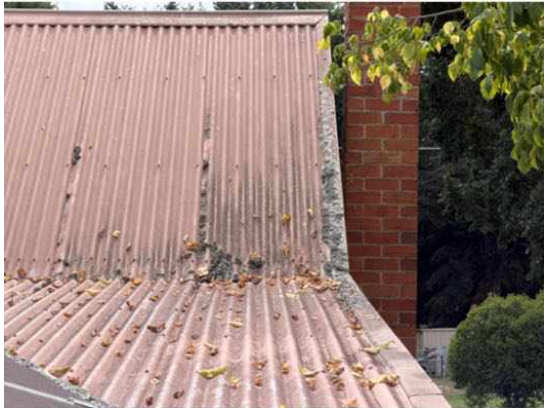
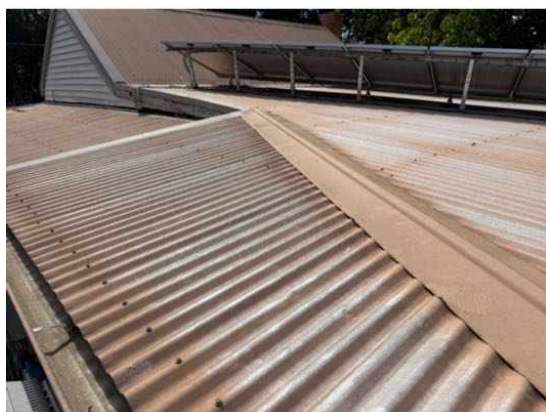
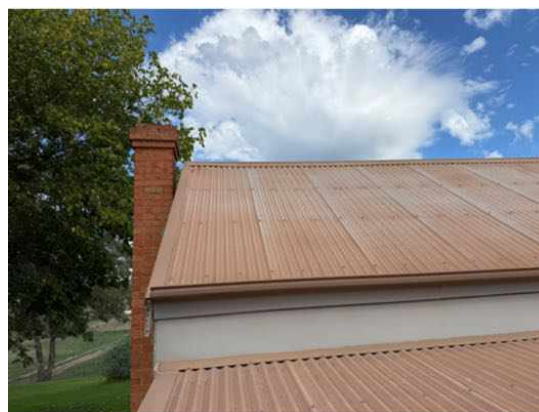
Finding 3.06

Building: Main Building
Location: Roof Exterior
Finding: Roof Exterior - Weathered & Faded
Information: The roof exterior was found to be in a weathered condition, evidenced by general fading of the coating. While weathering of the roof exterior is consistent with the age of the property, maintenance works are advised, to avoid further deterioration.

Recommend engaging a licensed roofing contractor in the short term, to provide remedial advice and maintenance works.

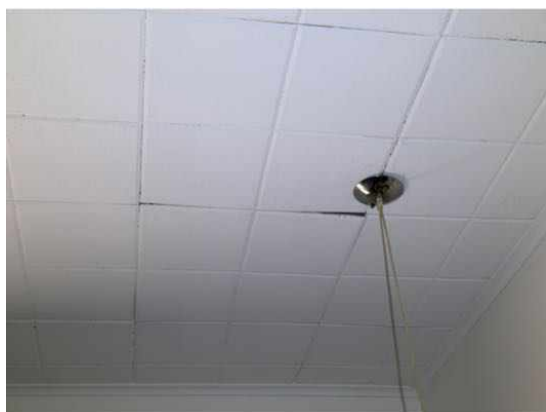
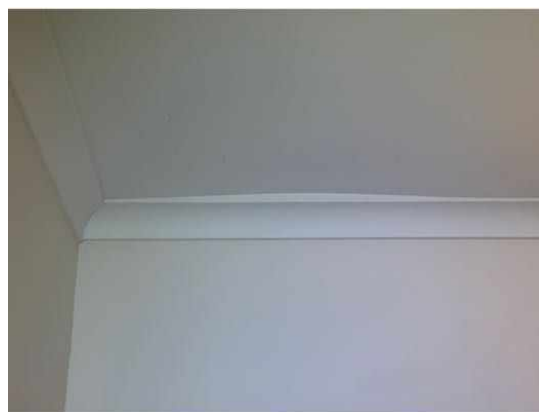
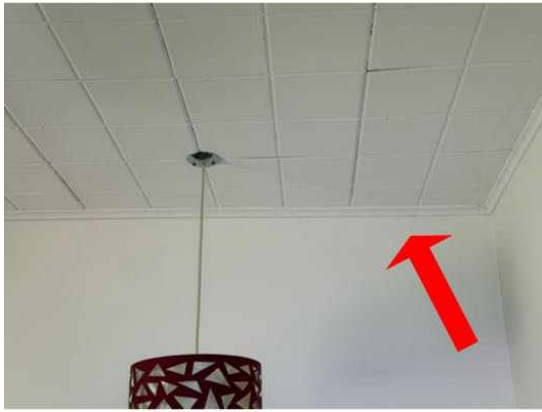
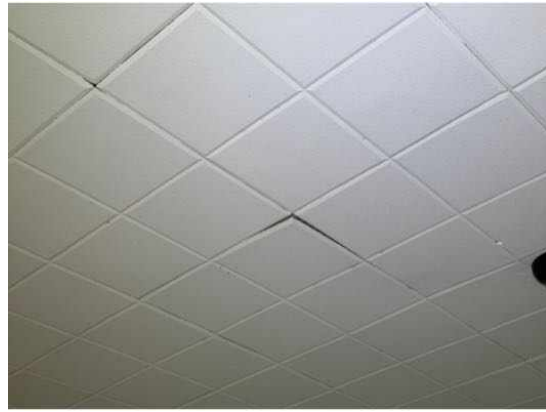
Finding 3.07

Building:	Main Building
Location:	Lounge room & bedroom ceiling
Finding:	Ceiling - Sagging
Information:	Sections of the ceilings at but not limited to, the lounge room & bedroom ceiling were found to be slightly sagging. Causes of ceiling sagging include fixings (e.g. nails or glue) that have become loose and require re-fixing. Recommend that the client monitor the sagging.

Should the sagging develop, a licensed plasterer and/or licensed carpenter should be engaged to provide maintenance works where necessary.

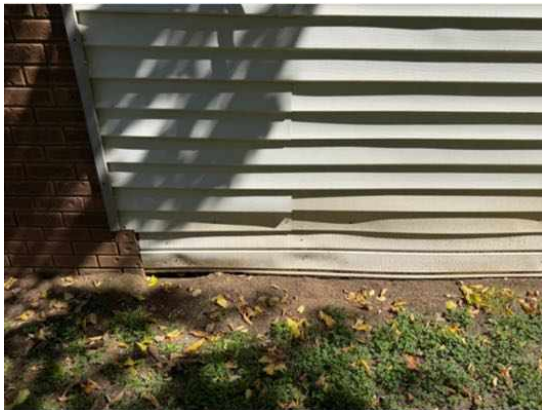
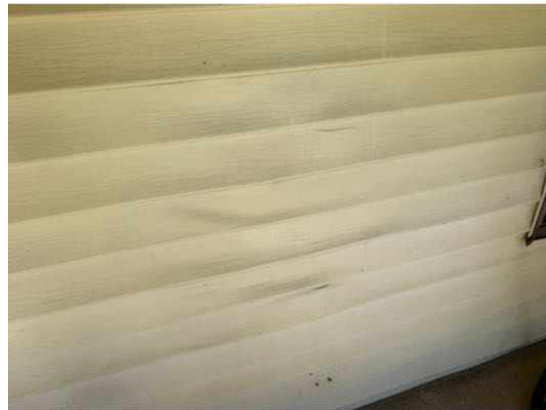
Finding 3.08

Building:	Main Building
Location:	External Cladding
Finding:	Cladding - Weathered / Loose
Information:	It appears that the exterior cladding is loose & weathered in several areas. External cladding should be secure and sufficiently sealed to prevent moisture ingress from harsh weather conditions. Recommend engaging a licensed carpenter in the short term, to provide further advice and remedial works where necessary.

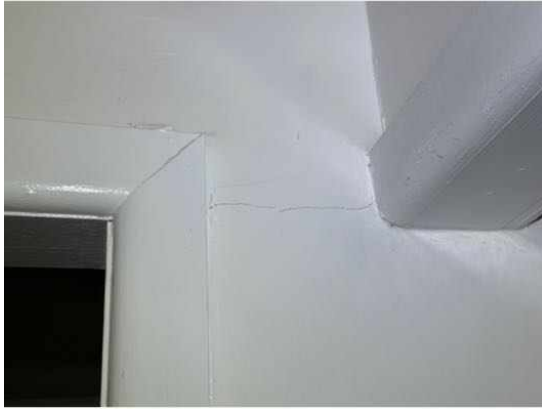
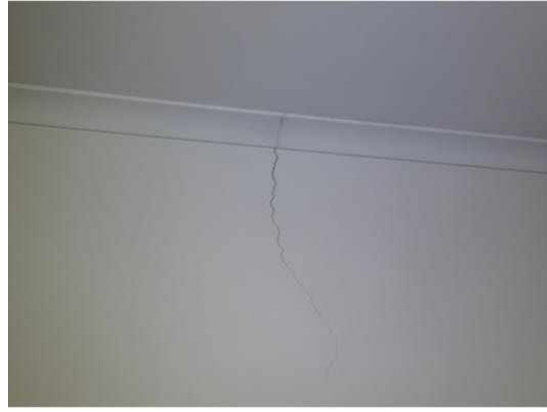
Finding 3.09

Building:	Main Building
Location:	All Internal Areas
Finding:	Plaster - Cracking
Information:	There appears to be cracking in areas of the wall linings throughout the building, a common finding in buildings of a similar age. Recommend that the client monitor these areas. Should cracking widen, lengthen, or become more numerous, the client should consult with a structural engineer promptly, for further evaluation.

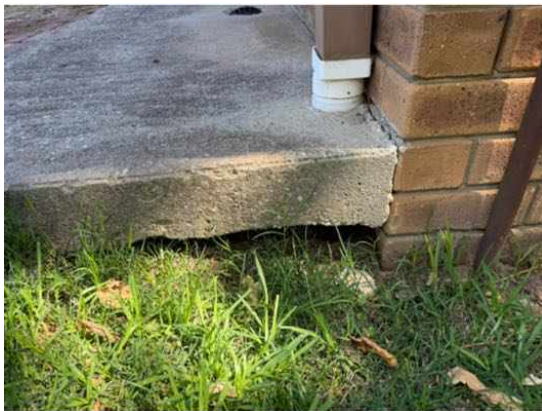
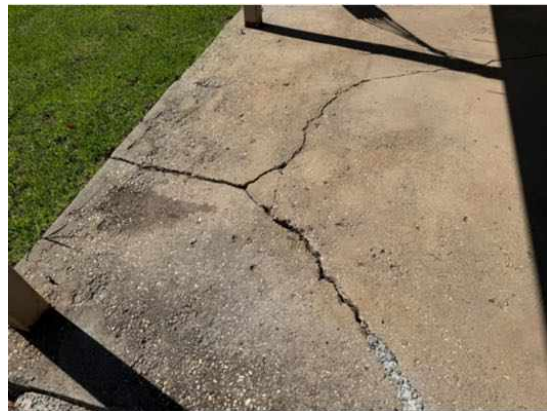
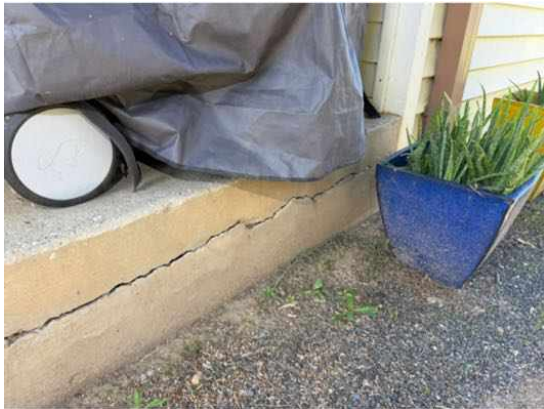
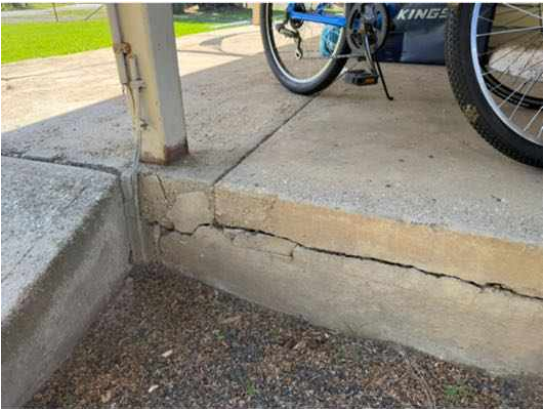
Finding 3.10

Building:	Main Building
Location:	Pavement, Porch slab
Finding:	Cracking & Undermining - Porch Slab & Pavement
Information:	Cracking was identified in the porch slab and throughout the external pavement. A section of the porch slab also appeared to be undermined, and should be backfilled by a licensed tradesperson.

The client should monitor the cracking. Should further cracking occur, a concrete specialist and/or structural engineer should be engaged promptly to provide further advice and remedial works where necessary.

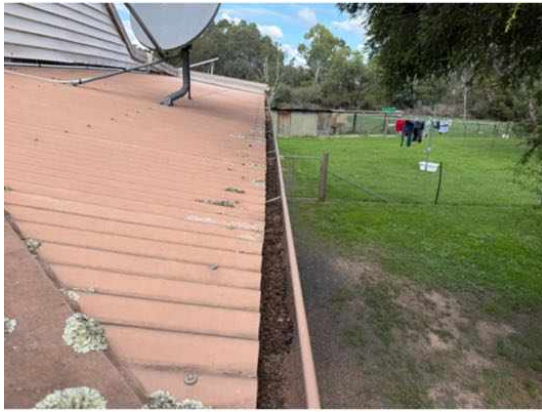
Finding 3.11

Building: Main Building
Location: Gutters
Finding: Debris in Gutters
Information: It appears that there is some debris in the gutters. Accumulation of debris can lead to blockages of the gutters & water overflows, if neglected.

Recommend engaging a general handyman to remove all debris from the gutters promptly to prevent overflows & blockages.

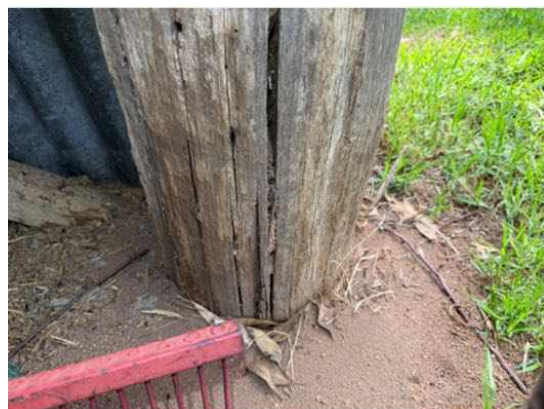
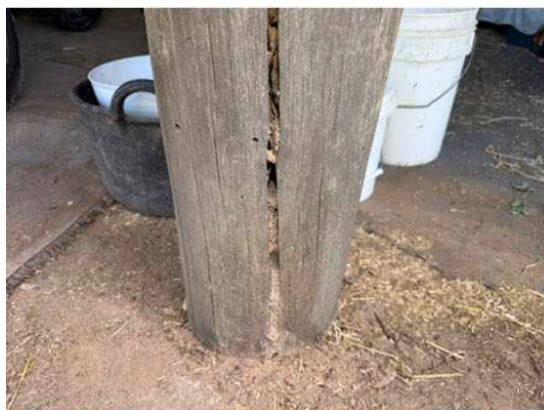
Finding 5.01

Building: Main Building
Location: Subfloor, Shed
Finding: Evidence of termite workings & damage
Information: Termite damage & workings were identified at, but not limited to, a timber stump to the edge of the subfloor and to the shed posts. The client should engage a licensed pest controller at their earliest convenience to provide further advice regarding installation of a termite treatment.

6 monthly ongoing termite inspections, conducted by a qualified termite inspector, are also recommended

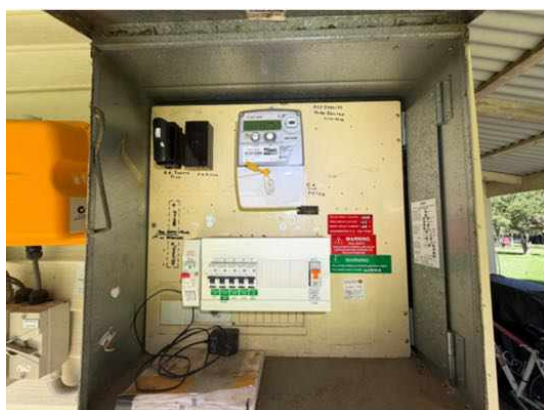
Finding 6.01

Building:	Main Building
Location:	Switchboard
Finding:	Termite Management System - no evidence of a chemical installation
Information:	The application of a termite barrier is strongly recommended, as it appears no termite management system has been installed, with no evidence or durable notice to suggest works taking place. Generally, a durable notice is placed in the meter box to indicate current termite barriers.

Such barriers are highly effective in preventing termite attack on the building and therefore should be installed.

Recommend seeking further advice from a licensed pest controller.

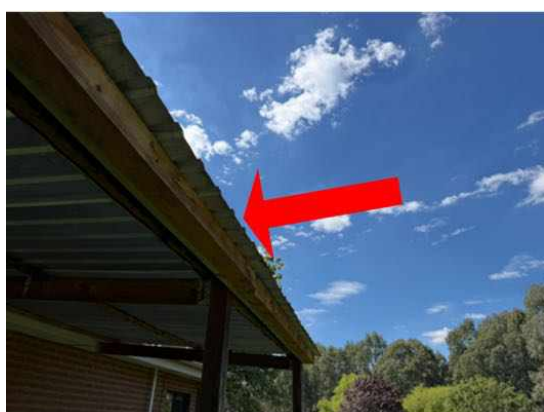
Finding: Gutters - Missing

Information: It was found that there are no gutters installed to the rear verandah, allowing stormwater run-off to pool on the ground. This creates an environment conducive to timber pest activity. A licensed roof plumber should be engaged in the short term, to provide further advice regarding installation of sufficient roof drainage systems.

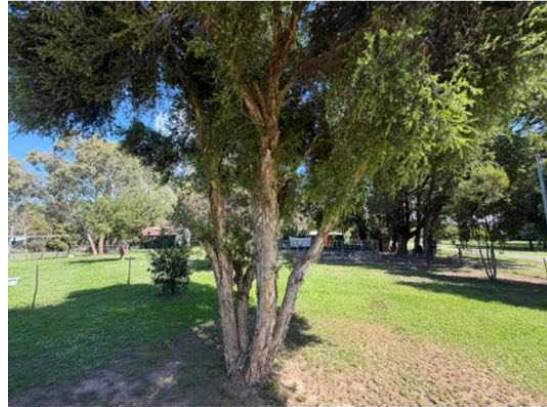
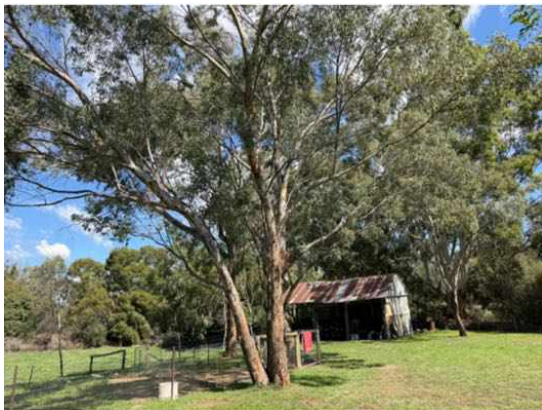
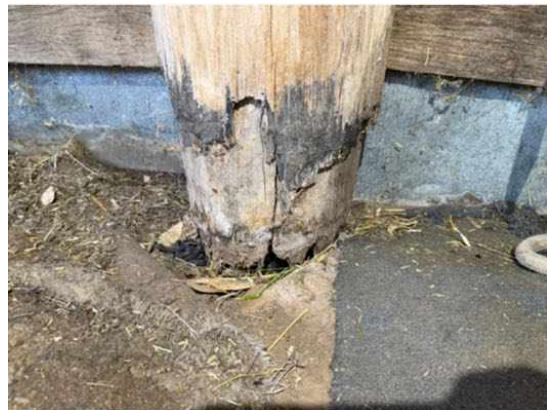
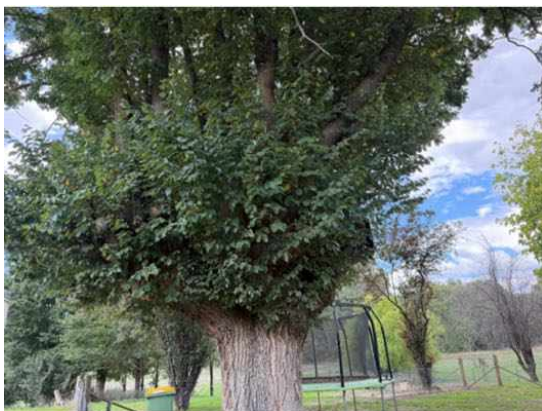
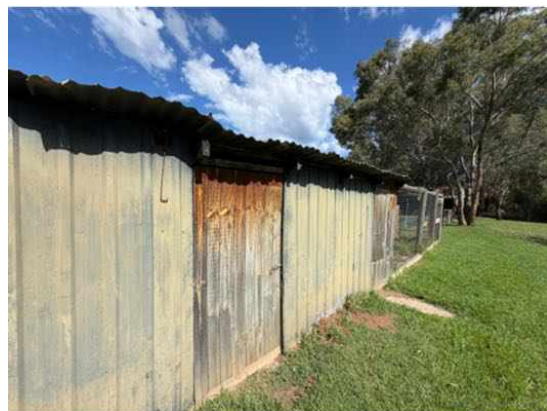
Finding 6.04

Information: Where timber materials are in direct contact with the ground and consequently moisture, they become conducive to termite activity. The verandah posts, chicken coop, shed framing and trees surrounding the building create an environment conducive to termite infestation.

Where feasible, any timbers in direct contact with the ground should be removed and any trees in close proximity to the building should be removed or test drilled (inspected) at least annually to reduce the risk of termite infestation & detect any early signs of termite activity.

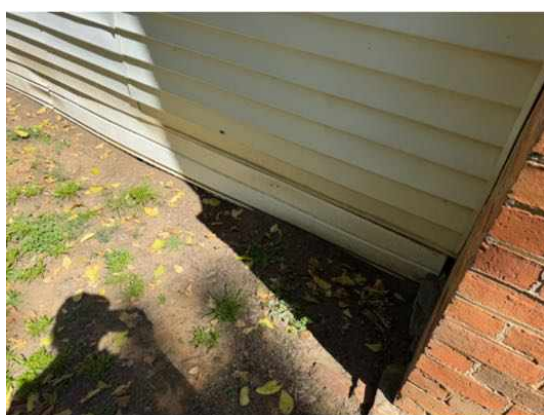
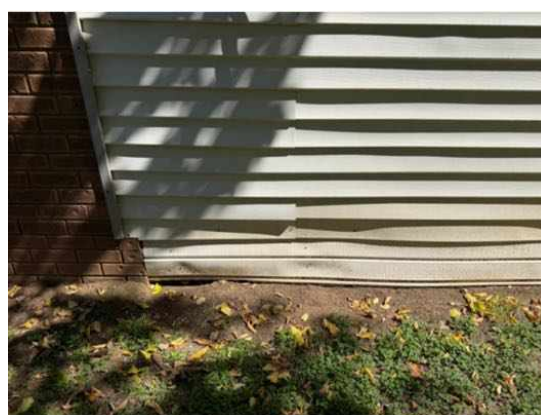
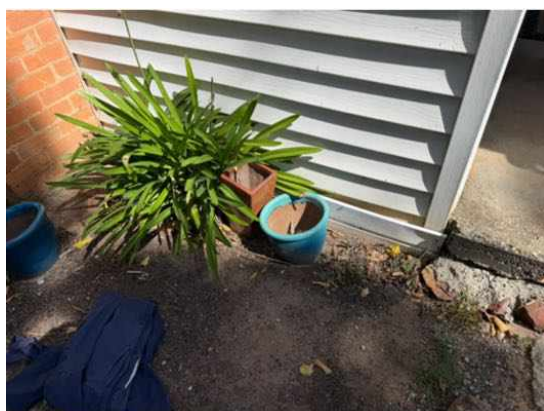
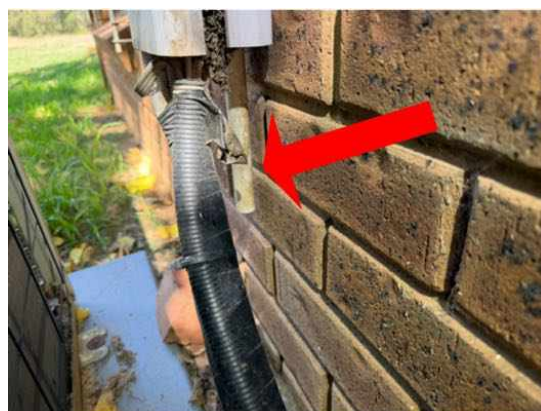
Finding 6.05

Building:	Main Building
Location:	All external areas
Finding:	Potential Water pooling - against property
Information:	It appears that there are potential areas around the perimeter of the property that could be susceptible to water pooling.

Where insufficient site drainage, and insufficient drainage of aircon overflows, and garden beds against the house are present, water pooling is likely to occur, and can create areas conducive to timber pests and potential damage to the subfloor structure overtime, if neglected.

Recommend consulting with a licensed plumber in the short term to further assess and provide remedial advice.

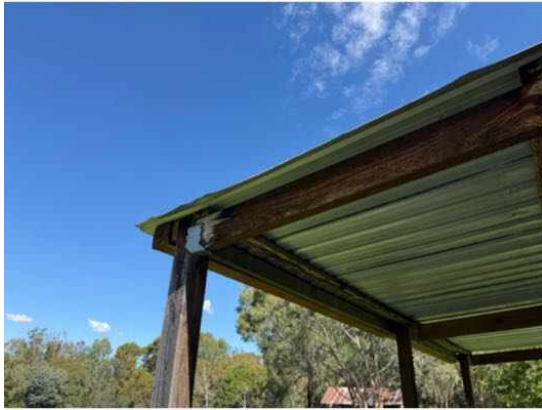
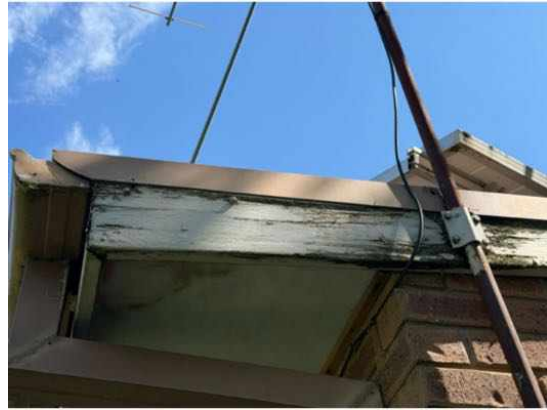
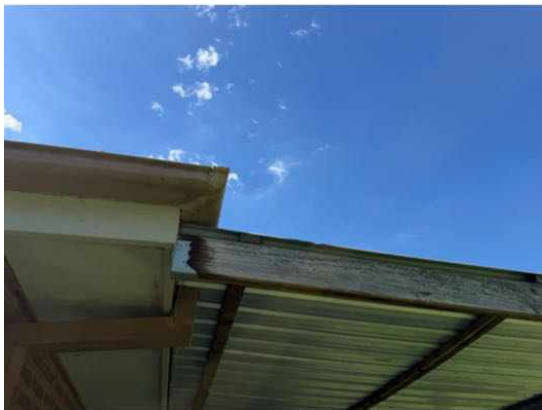
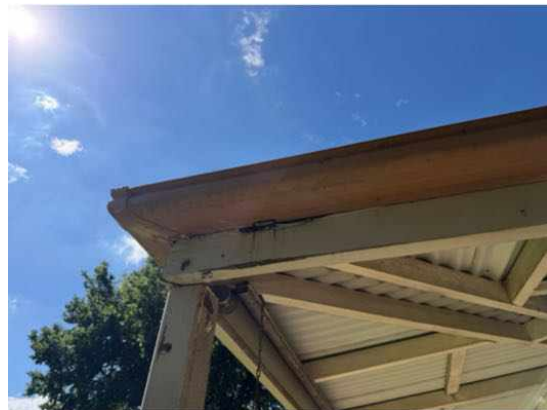
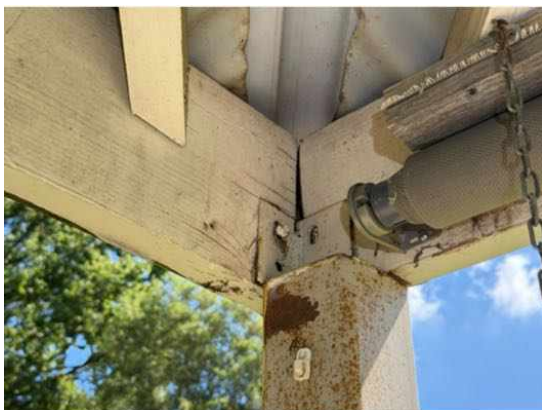
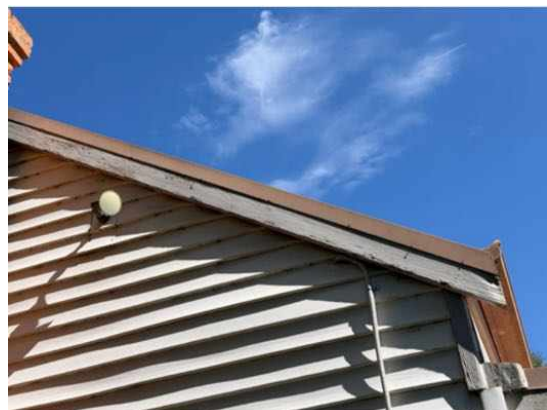
Finding 7.01

Building:	Main Building
Location:	Fascias, verandah posts and framing, shed posts
Finding:	Fungal decay & weathering
Information:	Areas of fungal decay (wood rot) & weathering were identified at but not limited to the

verandah beams & posts, shed posts, and fascias. For areas of fungal decay, the client should engage a licensed carpenter in the short term, to replace any affected materials.

For areas of general weathering, it is advised the client engage a licensed painter to apply protective sealant or coating to areas of weathered external timbers.

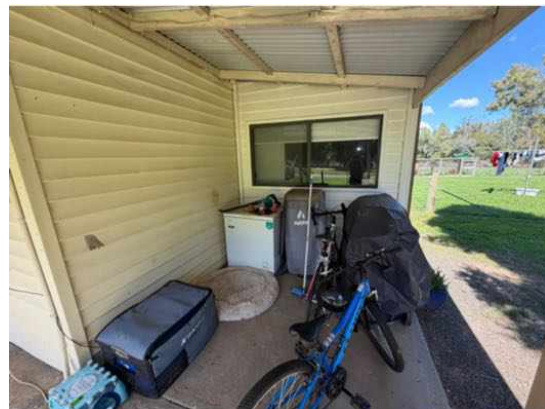
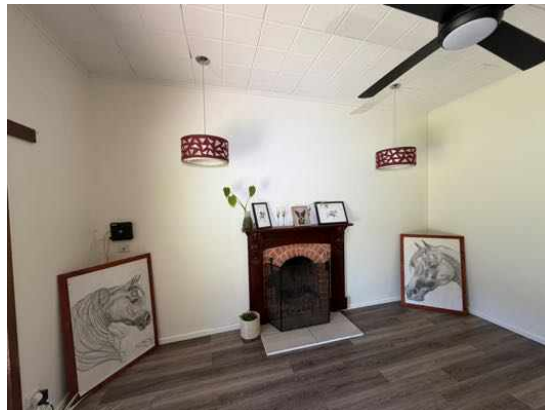
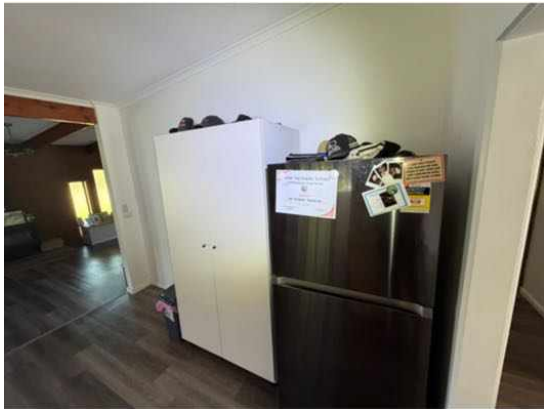
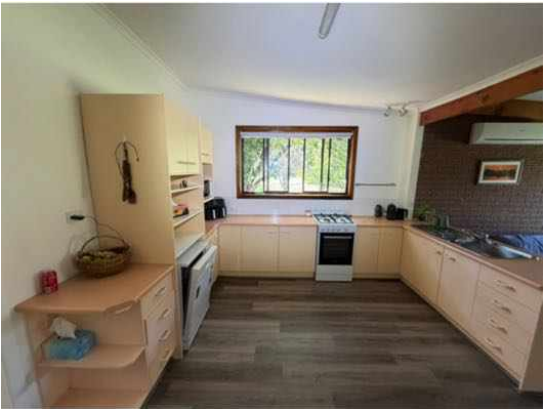
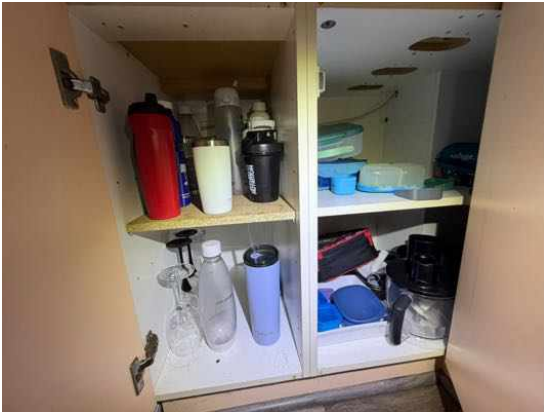
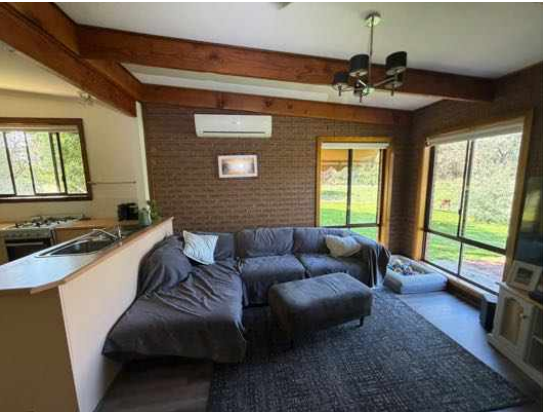
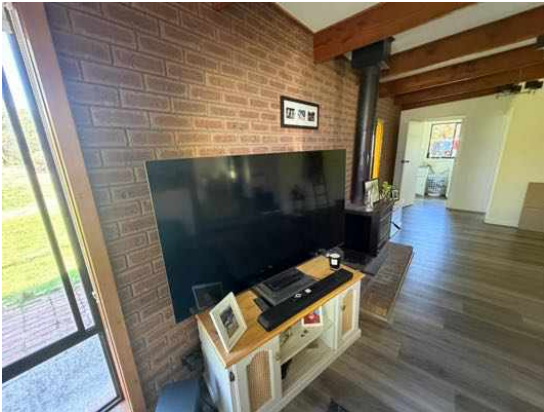
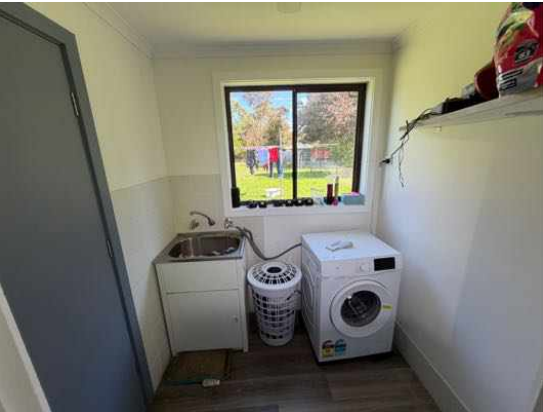
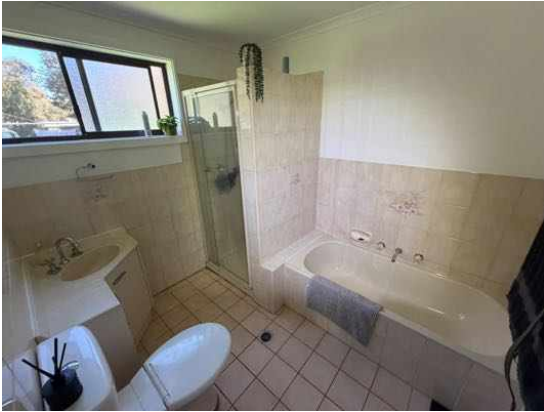
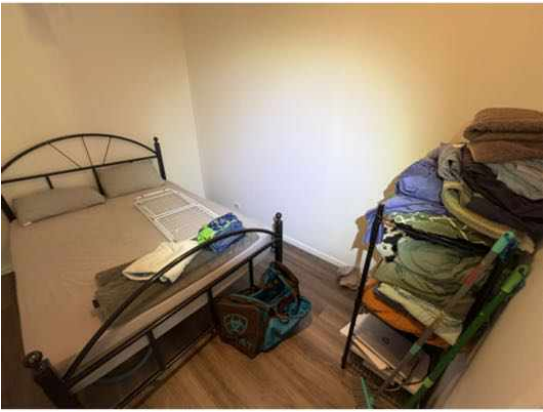
Building: Main Building
Location: All Areas
Finding: Additional Photos - Obstructions and Limitations
Information: These photographs are an indication of the obstructions and limitations which impeded full inspection of the property at the time of inspection. These obstructions can hide an array of defects and should be removed to allow full inspection to be carried out. A re-inspection is recommended once the areas are made accessible.

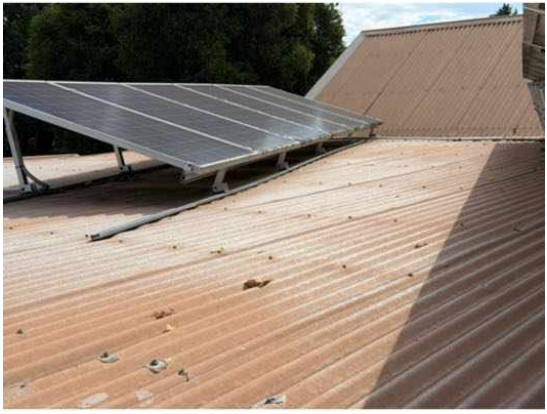
Roof framing not trafficable
