# Building and Timber Pest Inspection Report

Inspection Date: Wed, 25 Mar 2026

Property Address: 4 Kurrajong St, Dorrigo NSW 2453,  
Australia

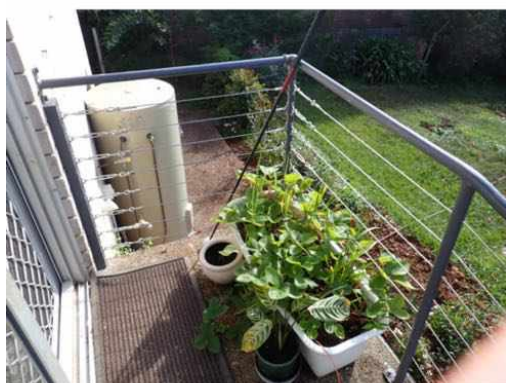
#### Finding 1.01

Building:	Main Building
Location:	Rear external ramp
Finding:	Non Compliant Balustrade To Rear Ramp
Information:	The balustrade to the rear ramp was identified as non compliant at the time of inspection. This may be associated with inadequate height, spacing, or construction that does not meet current building standards. Non compliant balustrades can present a safety risk. This is a common defect with a home of this age. Rectification should be carried out by a licensed builder or suitably qualified tradesperson to ensure compliance with current standards and improve safety. Repairs should be carried out as soon as possible.

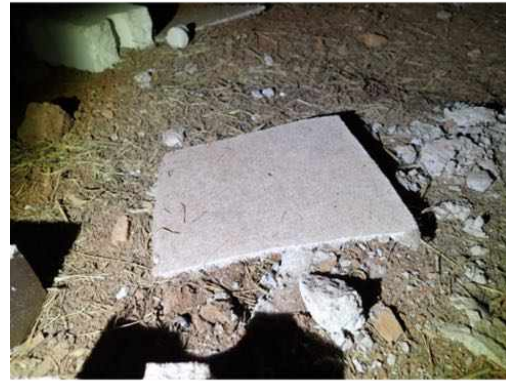
#### Finding 1.02

Building:	Main Building
Location:	Subfloor
Finding:	Suspected Asbestos Containing Materials To Subfloor
Information:	Suspected asbestos containing building materials were identified within the subfloor area at the time of inspection. Materials of this nature were commonly used in older construction and may pose a health risk if disturbed. No sampling or testing was carried out as part of this inspection. A licensed asbestos assessor or hygienist should be engaged to confirm the presence of asbestos, and if required, removal or management should be carried out by a licensed asbestos removal contractor in accordance with relevant regulations. Further action should be carried out at the owner's discretion.

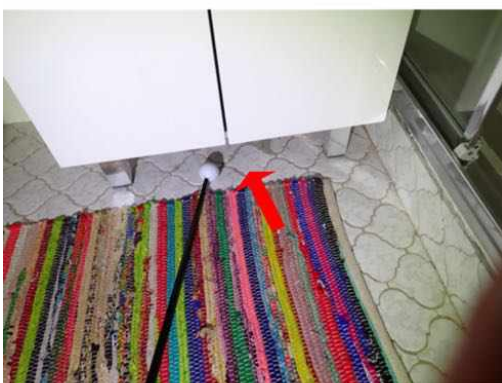
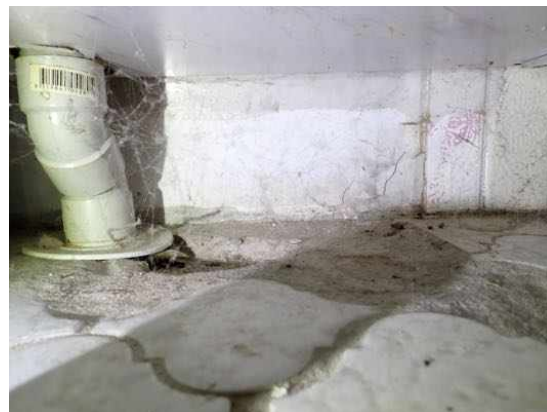
### Finding 3.01

Building:	Main Building
Location:	Bathroom
Finding:	Missing Tiles Beneath Bathroom Vanity Cupboard
Information:	Missing floor tiles were identified beneath the bathroom vanity cupboard. This appears to be due to incomplete installation or prior modification works and may allow moisture ingress and deterioration of the underlying substrate. A licensed tiler or suitably qualified tradesperson should be engaged to install appropriate tiles and ensure the area is properly sealed.

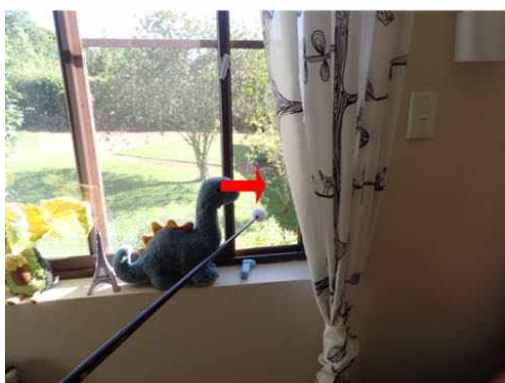
### Finding 3.03

Building: Main Building  
 Location: Bedroom  
 Finding: Damaged Flyscreen to Bedroom Window  
 Information: Damage was identified to the flyscreen on the bedroom window. This may allow insect ingress and is likely due to general wear and tear or impact. A handyman or suitably qualified tradesperson should be engaged to repair or replace the flyscreen. Repairs may be carried out at the owner's discretion.

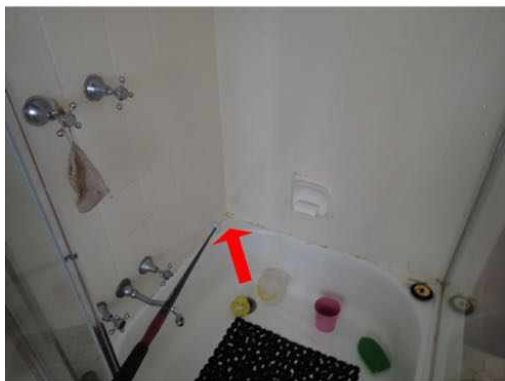
### Finding 3.04

Building: Main Building  
 Location: Bathroom  
 Finding: Deteriorated Silicone to Bath Tub Tiled Area  
 Information: Deteriorated silicone was identified around the bath tub tiled area. This appears

consistent with age-related deterioration and may allow moisture ingress, potentially leading to damage of adjoining building materials. A licensed tiler or suitably qualified tradesperson should be engaged to remove and replace the silicone to ensure a watertight seal. Maintenance should be carried out in due course.

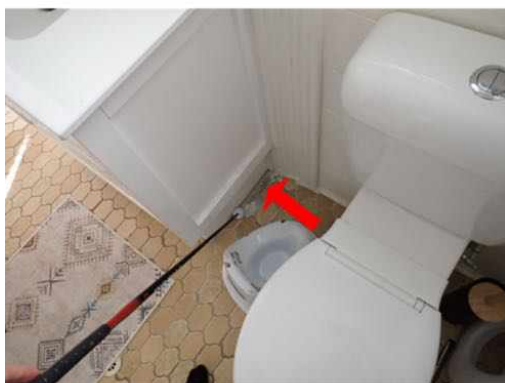
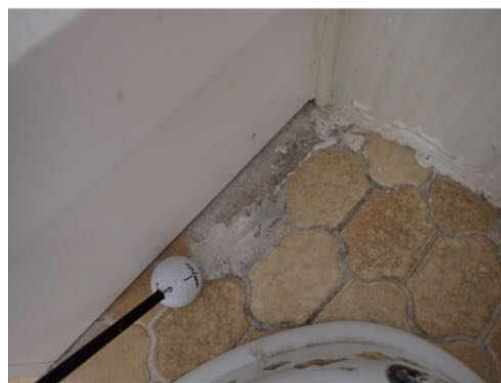
### Finding 3.05

Building:	Main Building
Location:	Bathroom
Finding:	Missing Floor Tiles Adjacent to Bathroom Vanity
Information:	Missing floor tiles were identified next to the bathroom vanity. This appears to be due to incomplete installation or prior modification works and may allow moisture ingress and deterioration of the underlying substrate. A licensed tiler or suitably qualified tradesperson should be engaged to install suitable replacement tiles and ensure the area is properly sealed.

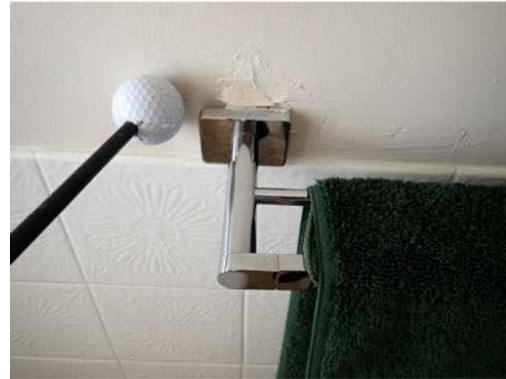
### Finding 3.06

Building:	Main Building
Location:	Bathroom
Finding:	Loose Towel Rail
Information:	The bathroom towel rail was loose at the time of inspection. This is commonly

associated with loose fixings, deterioration of the wall lining or mounting points, or general wear and tear from use over time. The towel rail should be repaired or refixed by a handyman or suitably qualified tradesperson to restore proper function and help prevent further damage to the wall surface. Repairs should be carried out at the owner's discretion.

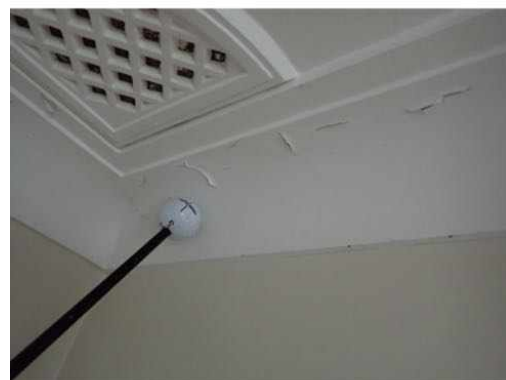
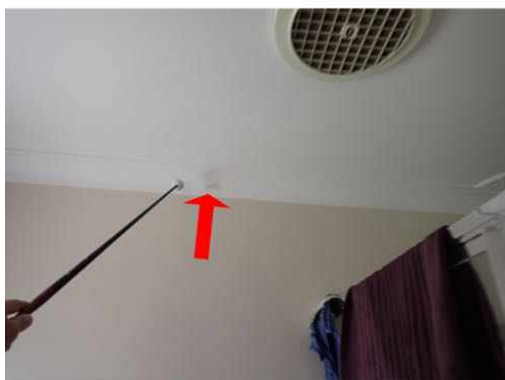
### Finding 3.07

Finding: Minor Paint Deterioration To Laundry Walls

Information: Paint deterioration was identified to the laundry walls at the time of inspection. This is typically associated with age related wear and tear, moisture exposure, or inadequate surface preparation during previous painting works. Maintenance and repainting should be carried out by a painter or suitably qualified tradesperson to protect the underlying surfaces and improve overall condition. Repairs should be carried out at the owner's discretion.

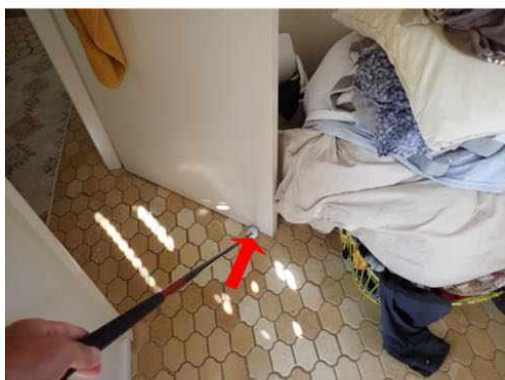
### Finding 3.08

Building:	Main Building
Location:	Laundry
Finding:	Laundry Door Catching On Floor Tiles
Information:	The laundry door was observed catching on the floor tiles at the time of inspection. This is commonly associated with movement in the building, swelling of the door material due to moisture, or misalignment of hinges or door frame. Adjustment or repair should be carried out by a carpenter or suitably qualified tradesperson to ensure smooth operation and prevent further wear or damage. Repairs should be carried out at the owner's discretion.

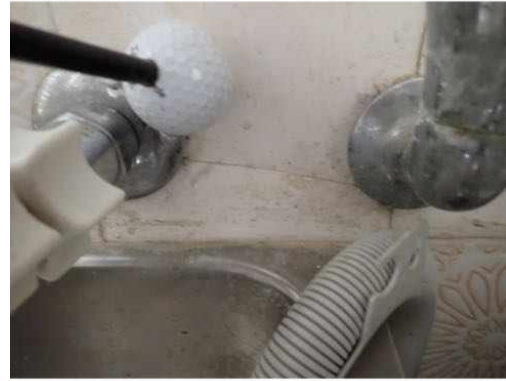
### Finding 3.09

Building:	Main Building
Location:	Laundry
Finding:	Cracked Laundry Splashback Tile
Information:	A cracked tile was identified to the laundry splashback at the time of inspection. This is commonly associated with impact damage, movement in the wall substrate, or poor installation. The affected tile should be replaced by a tiler to maintain the integrity of the splashback and help prevent moisture ingress to the underlying materials. Repairs should be carried out at the owner's discretion.

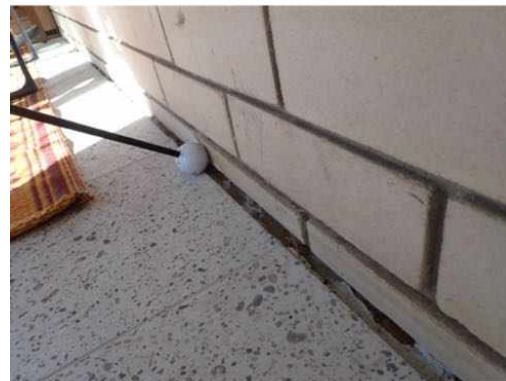
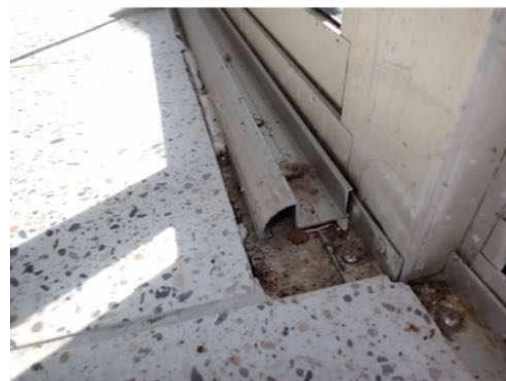
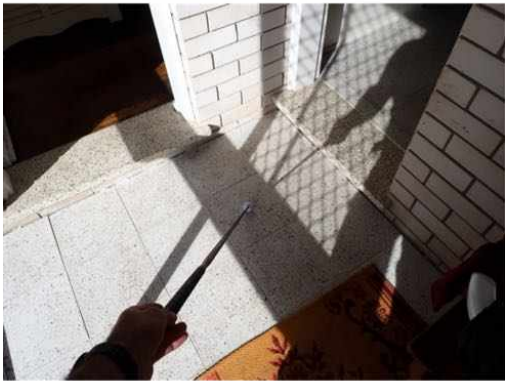
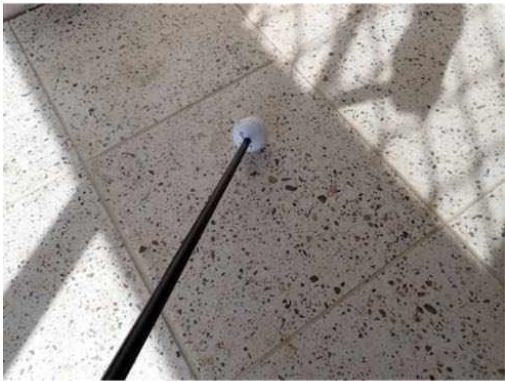
### Finding 3.10

Finding: Poorly Finished And Drummy Tiles To Enclosed Rear Balcony

Information: Poorly finished tiling and sections of drummy tiles were identified to the enclosed rear balcony at the time of inspection. This is commonly associated with inadequate surface preparation, insufficient adhesive coverage, or poor installation practices. Drummy tiles may become loose over time and can lead to further deterioration if not addressed. Repairs should be carried out by a tiler or suitably qualified tradesperson to rectify the affected areas and ensure a durable finish. Repairs should be carried out at the owner's discretion.

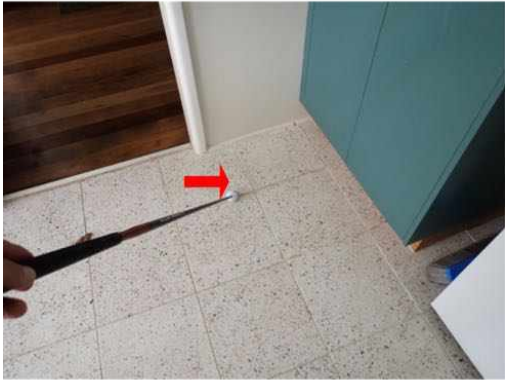
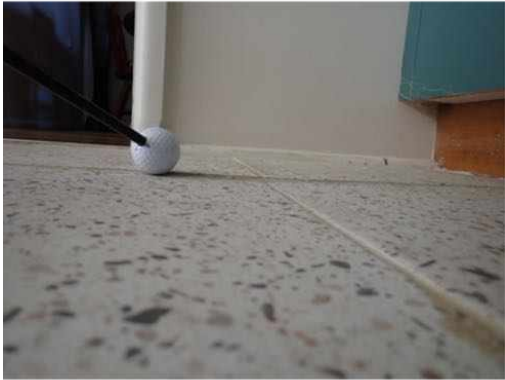
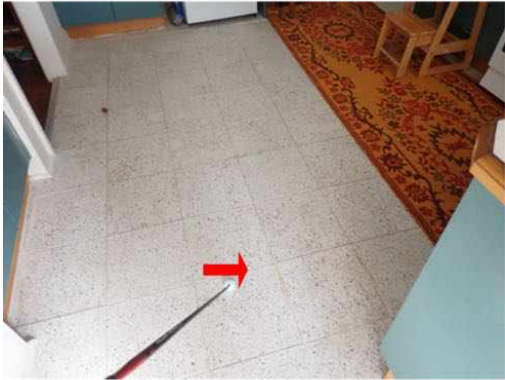
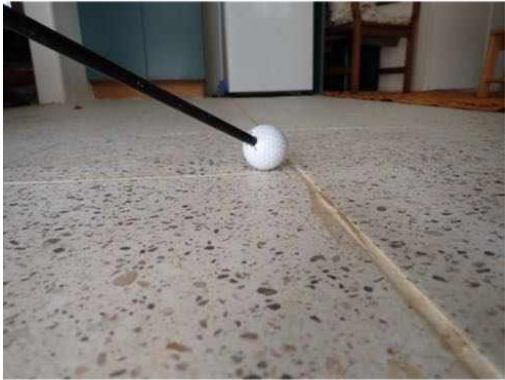
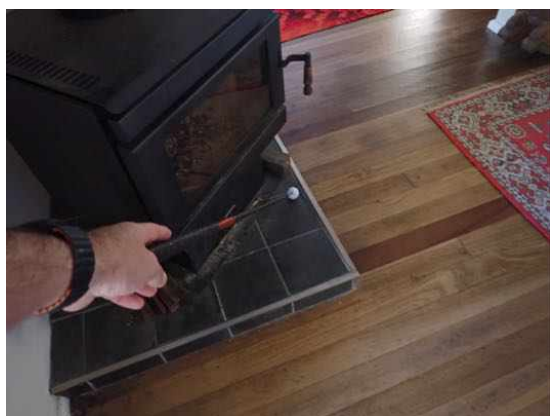
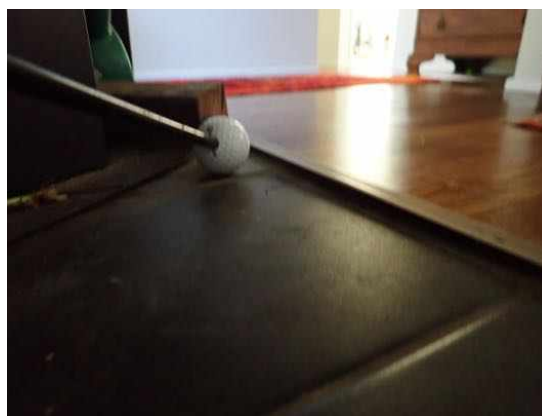
**Finding 3.11**

Building: Main Building  
Location: Kitchen and living room  
Finding: Poorly Finished Floor Tiles  
Information: Poorly finished floor tiling was identified at the time of inspection. This is commonly associated with poor installation practices, inadequate surface preparation, or substandard workmanship. The affected areas may be prone to premature wear, unevenness, or loosening over time. Repairs or rectification should be carried out by a tiler or suitably qualified tradesperson to improve durability and finish. Repairs should be carried out at the owner's discretion.

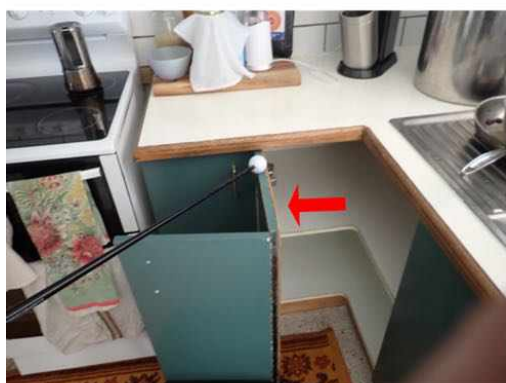
### Finding 3.12

Building:	Main Building
Location:	Kitchen
Finding:	Swelling To Kitchen MDF Cupboard Doors
Information:	Swelling was identified to several kitchen MDF cupboard doors at the time of inspection. This is commonly associated with moisture ingress, prolonged exposure to humidity, or general age related deterioration of the material. Continued exposure may lead to further deterioration and reduced functionality of the doors. Repairs or replacement should be carried out by a cabinet maker or suitably qualified tradesperson to restore condition and functionality. Repairs should be carried out at the owner's discretion.

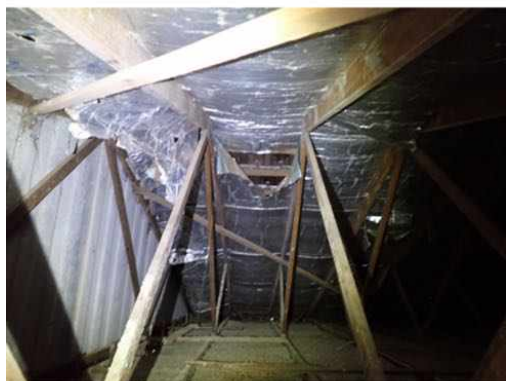
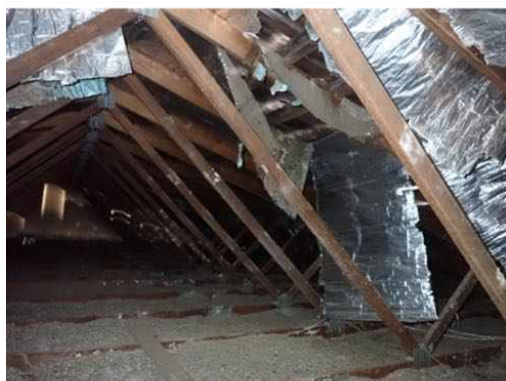
### Finding 3.13

Building:	Main Building
Location:	Ceiling space
Finding:	Damaged Ceiling Foil
Information:	Damage to the ceiling foil insulation was identified at the time of inspection. This is commonly associated with previous works in the roof space or age related deterioration and is a common defect with a home of this age. Damaged foil may reduce the effectiveness of insulation and can impact the thermal performance of the

building. Repairs or replacement should be carried out by an insulation installer or suitably qualified tradesperson to restore performance. Repairs should be carried out at the owner's discretion.

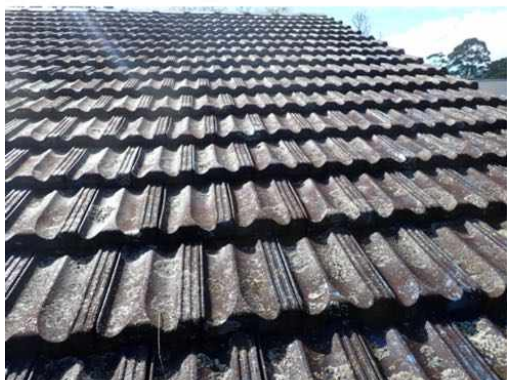
### Finding 3.14

Building:	Main Building
Location:	Roof
Finding:	Lichen Growth To Roof Tiles
Information:	Lichen growth was identified to the roof tiles at the time of inspection. This is commonly associated with age related deterioration, moisture retention, and lack of regular maintenance. Lichen can retain moisture on the tile surface which may contribute to accelerated wear and potential deterioration over time. Cleaning and maintenance should be carried out by a roofing contractor or suitably qualified tradesperson to restore condition and prolong the lifespan of the roof covering. Repairs should be carried out at the owner's discretion.

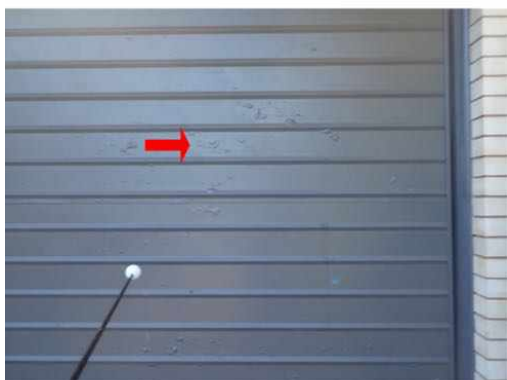
**Finding 3.15**

Building: Main Building  
 Location: Garage door  
 Finding: Bubbling Paint To Garage Door  
 Information: Bubbling paint was identified to the garage door at the time of inspection. This is commonly associated with moisture ingress, inadequate surface preparation, or age related deterioration of the coating. Continued deterioration may lead to further paint failure and potential corrosion of the underlying material. Preparation and repainting should be carried out by a painter or suitably qualified tradesperson to restore protection and appearance. Repairs should be carried out at the owner’s discretion.

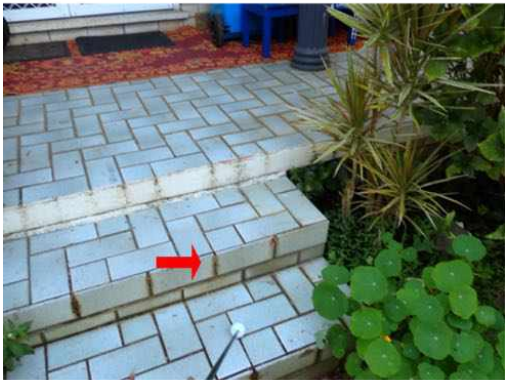
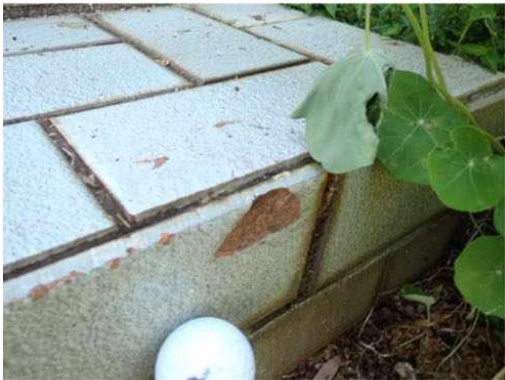
**Finding 3.16**

Building: Main Building  
 Location: Front porch stair tiles  
 Finding: Damaged Floor Tiles To Front Porch Step  
 Information: Damaged floor tiles were identified to the front porch step at the time of inspection. This is commonly associated with impact damage, wear and tear, or movement in the underlying substrate. The damage can deteriorate further if not addressed. Repairs or replacement should be carried out by a tiler or suitably qualified tradesperson to restore condition. Repairs should be carried out at the owner’s discretion.

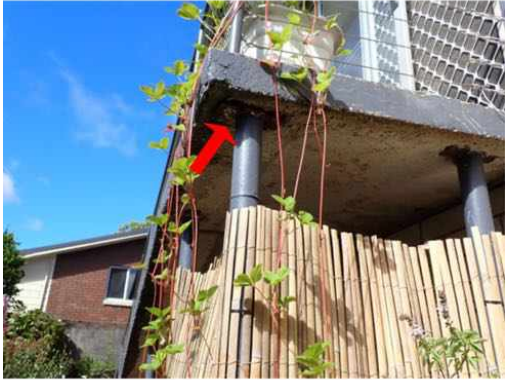
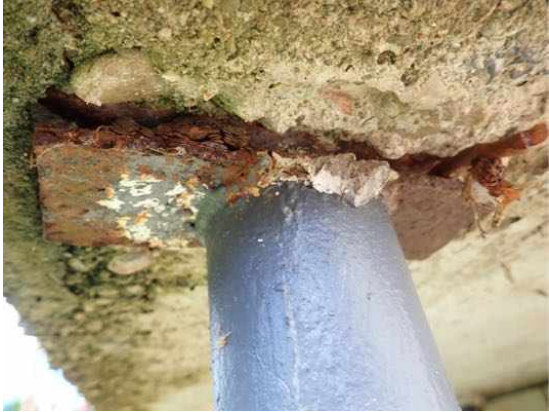
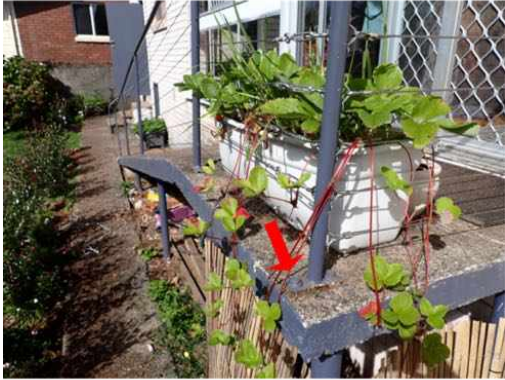
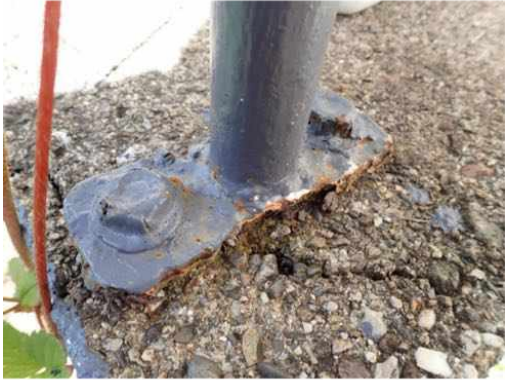
**Finding 3.17**

Building: Main Building  
Location: Rear ramp  
Finding: Rust To Rear Ramp Steel Posts And Balustrade Base Plates  
Information: Rust was identified to the steel posts of the rear ramp and the steel balustrade base plates at the time of inspection. This is commonly associated with prolonged exposure to weather conditions, moisture, and deterioration of protective coatings. Continued corrosion may lead to loss of structural integrity over time if not addressed. Cleaning, treatment, and repainting or replacement should be carried out by a licensed builder, metal fabricator, or suitably qualified tradesperson to restore condition and provide ongoing protection. Repairs should be carried out at the owner's discretion.

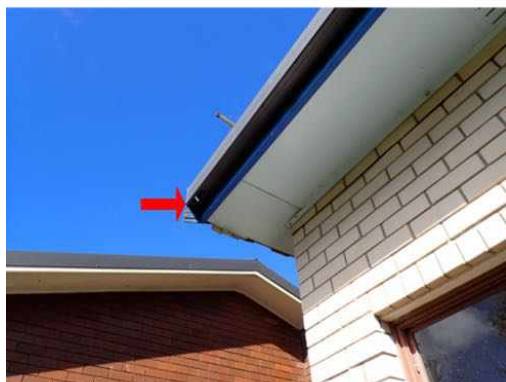
### Finding 3.18

Building:	Main Building
Location:	Roof rear right hand corner
Finding:	Missing Downpipe To Rear Right Hand Corner
Information:	A downpipe was missing to the rear right hand corner of the building at the time of inspection. This is commonly associated with previous damage, removal, or incomplete installation. The absence of a downpipe may result in uncontrolled discharge of roof water which can contribute to moisture issues around the building, including potential damage to footings, walls, or surrounding surfaces. Installation of a compliant downpipe should be carried out by a licensed plumber or suitably qualified tradesperson to ensure proper drainage. Repairs should be carried out at the owner's discretion.

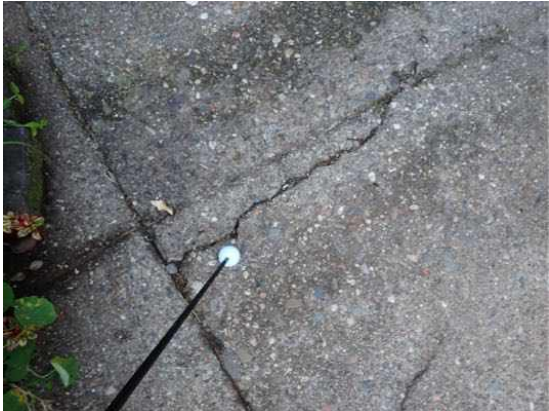
**Finding 3.20**

Building: Yard  
Location: Driveway  
Finding: Cracks To Concrete Driveway  
Information: Cracks were identified in the concrete driveway at the time of inspection. This is commonly associated with age related shrinkage, ground movement, or normal settlement of the supporting materials. Such cracking is a common defect in concrete surfaces over time. Repairs or sealing should be carried out by a concreter or suitably qualified tradesperson if considered necessary to maintain condition and limit further deterioration. Repairs should be carried out at the owner's discretion.

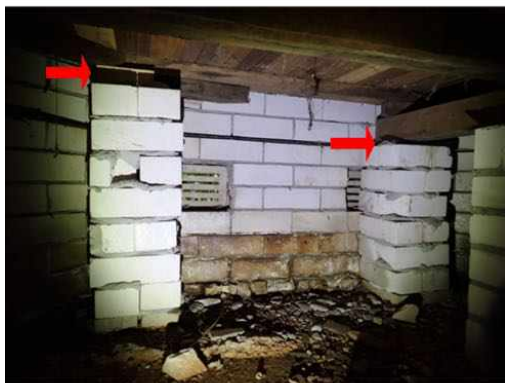
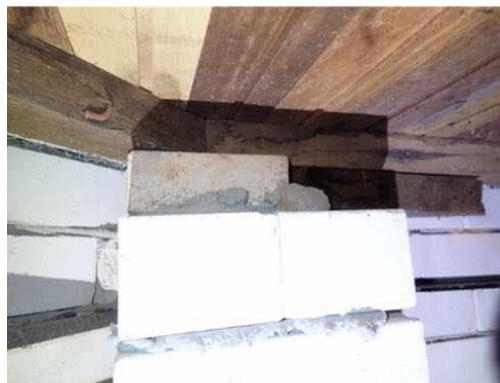
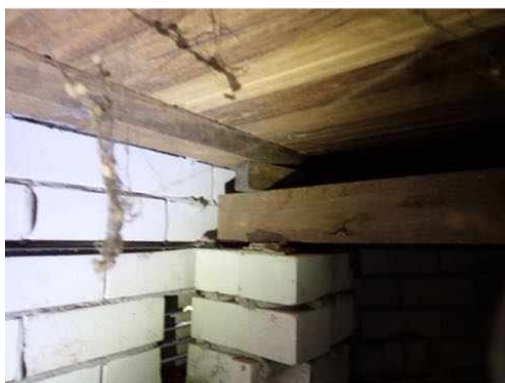
### Finding 6.01

Building:	Main Building
Location:	Subfloor
Finding:	Missing Ant Caps To Brick Piers
Information:	Ant caps were missing to the brick piers at the time of inspection. Ant caps are an important component of termite management systems and their absence may allow concealed termite entry into the structure. This is commonly associated with older construction or previous alterations. Installation of compliant ant caps should be carried out by a licensed builder or suitably qualified tradesperson to improve termite protection and allow for easier detection of termite activity. Repairs should be carried out at the owner's discretion.

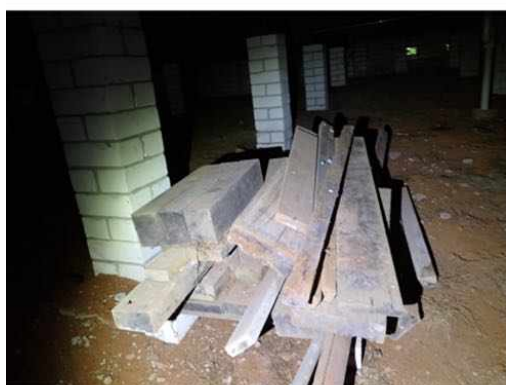
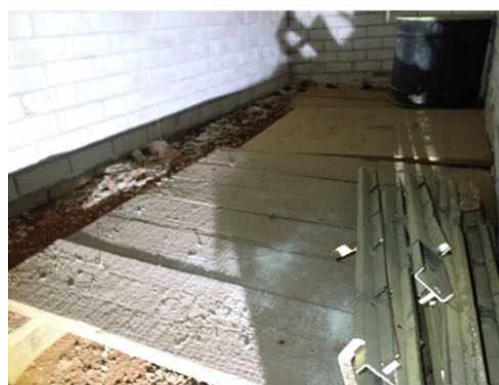
## Finding 6.02

Building:	Main Building
Location:	Subfloor
Finding:	Stored Timber In Contact With Ground In Subfloor
Information:	Stored timber was identified within the subfloor area in contact with the ground at the time of inspection. This condition is conducive to termite attack and may increase the risk of concealed termite activity within the structure. This is commonly associated with poor site maintenance or storage practices. The timber should be removed and the area cleared by a licensed pest control specialist, or suitably qualified tradesperson to reduce the risk of termite infestation. Works should be carried out at the owner's discretion.

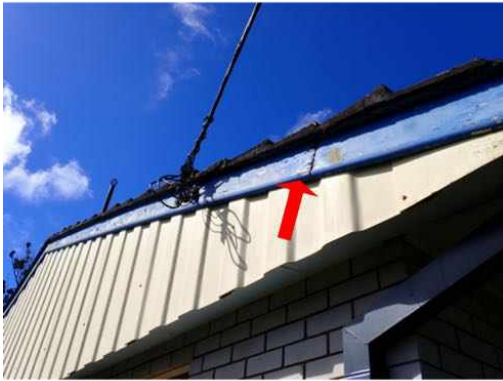
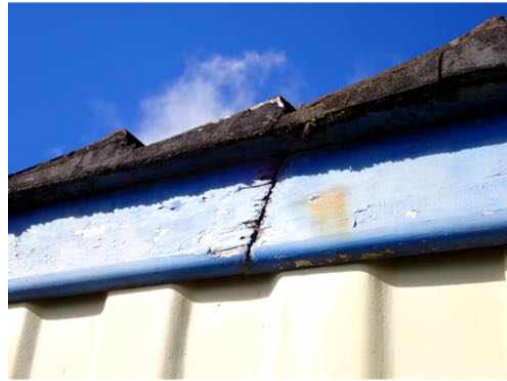
### Finding 7.01

Building:	Main Building
Location:	Fascia boards
Finding:	Wood Rot And Deteriorated Paintwork To Timber Fascia Boards
Information:	Wood rot and deteriorated paintwork were identified to the timber fascia boards at the time of inspection. This is commonly associated with prolonged moisture exposure, inadequate maintenance, or failure of protective coatings. Continued deterioration may lead to further decay of the timber and potential damage to adjoining building elements. Repairs or replacement should be carried out by a carpenter and painter, or suitably qualified tradespersons, to restore condition and protect the timber. Repairs should be carried out at the owner's discretion.

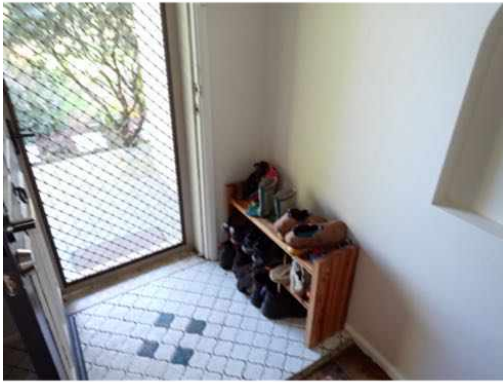
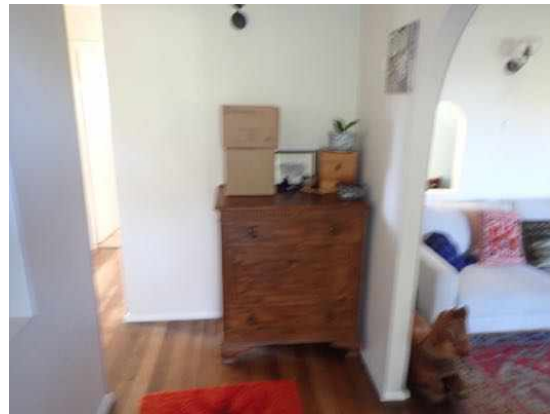
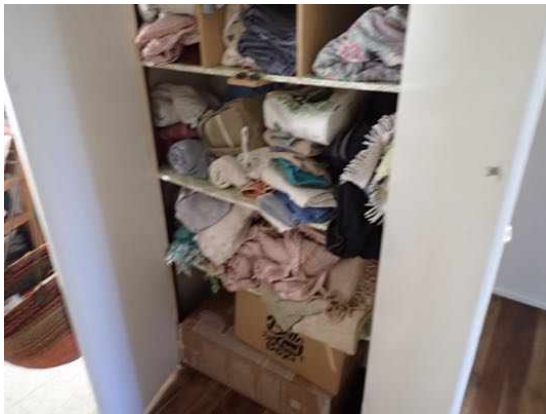
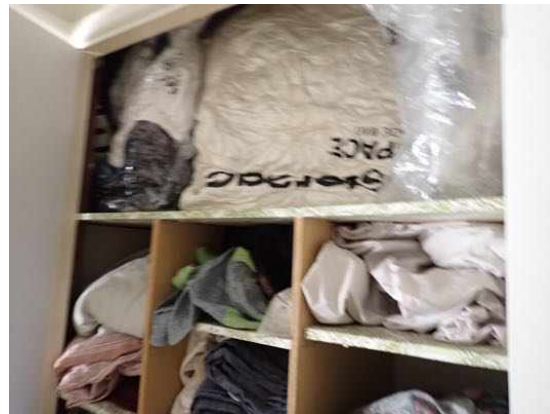
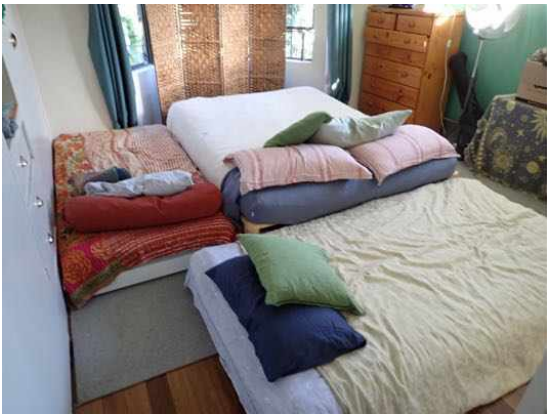
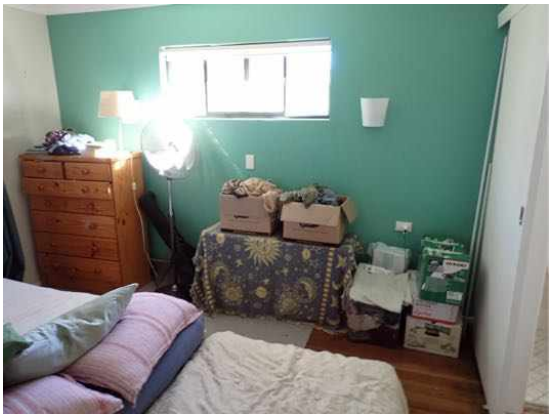
#### Noted Item

Building: Main Building  
Location: All Areas  
Finding: Additional Photos - Obstructions and Limitations  
Information: These photographs are an indication of the obstructions and limitations which impeded full inspection of the area at the time of inspection. These obstructions can hide an array of defects and should be removed to allow full inspection to be carried out. A re-inspection is recommended once the areas are made accessible.

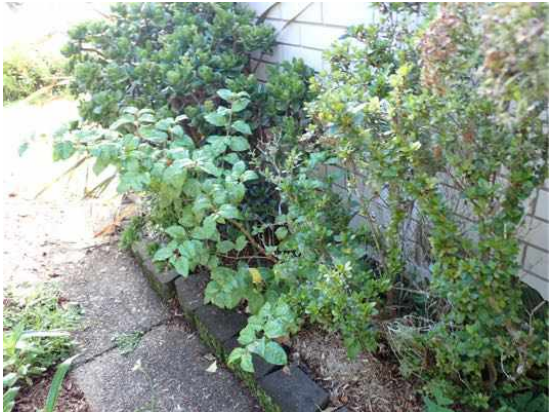
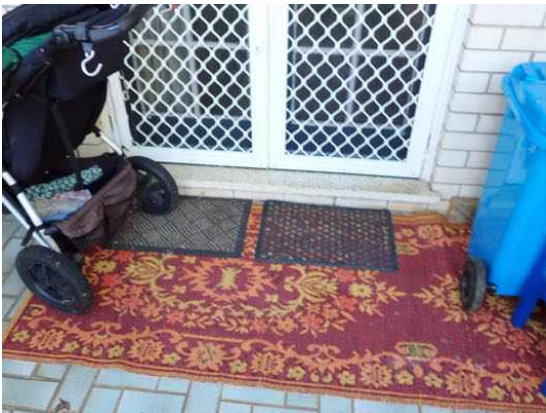
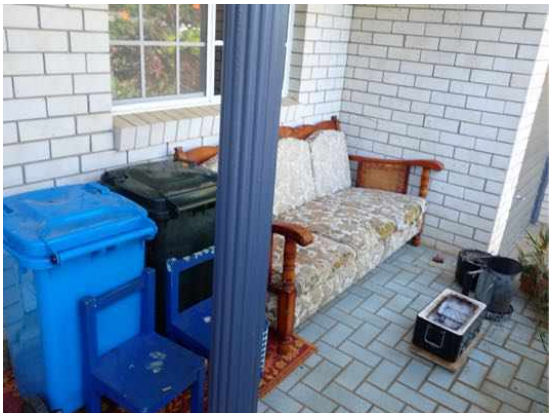
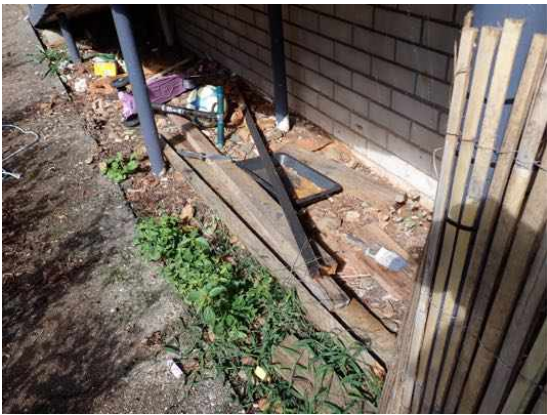
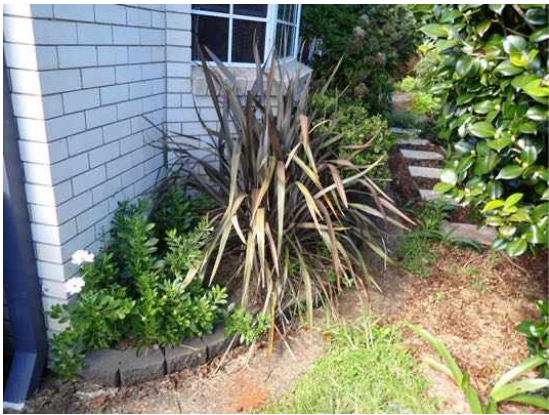
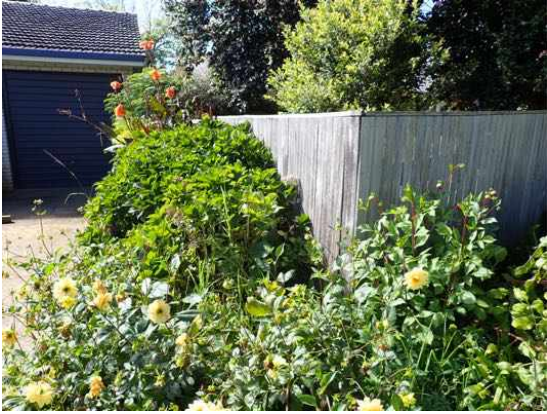
**Noted Item**

Building: Main Building  
Location: All Areas  
Finding: Additional Photos - Obstructions and Limitations  
Information: These photographs are an indication of the obstructions and limitations which impeded full inspection of the area at the time of inspection. These obstructions can hide an array of defects and should be removed to allow full inspection to be carried out. A re-inspection is recommended once the areas are made accessible.
