Building Inspection Report

Inspection Date: Thu, 12 Feb 2026

Property Address: 48/18 Colless St, Penrith NSW 2750,
Australia

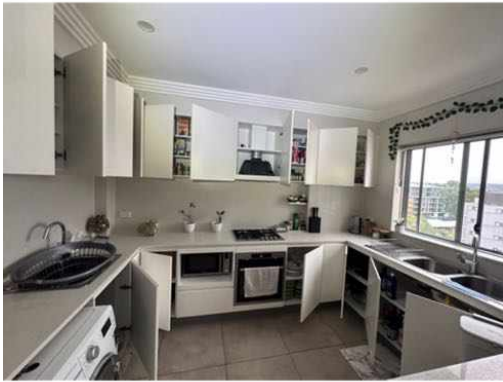
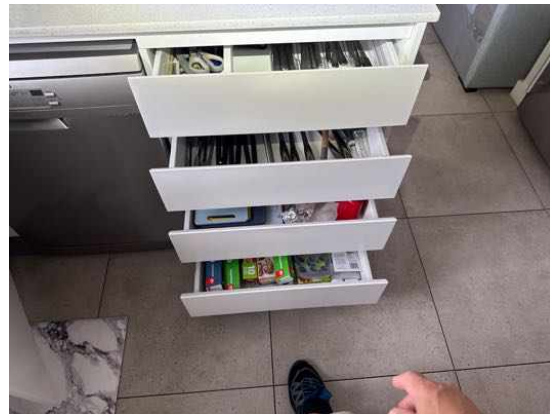
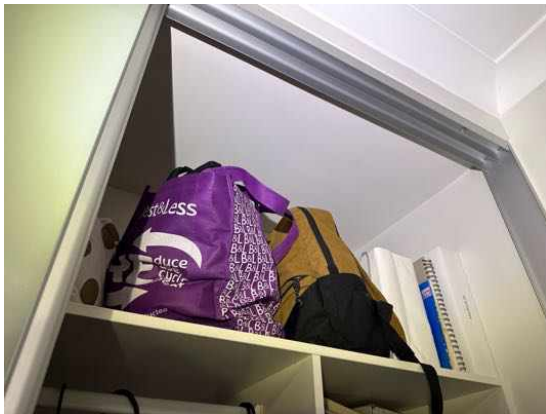
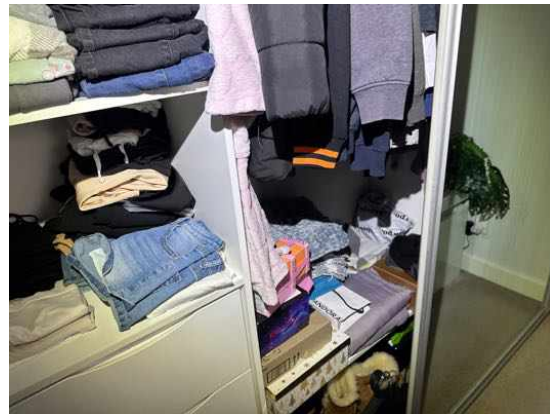
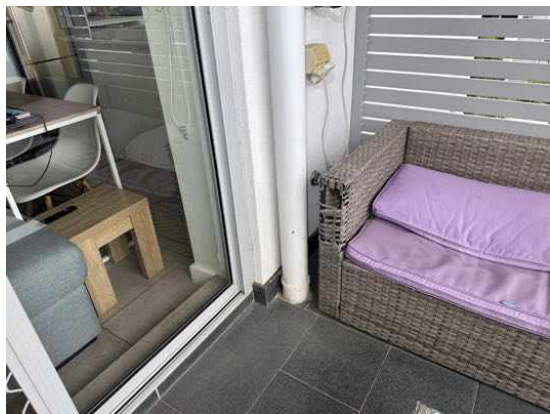
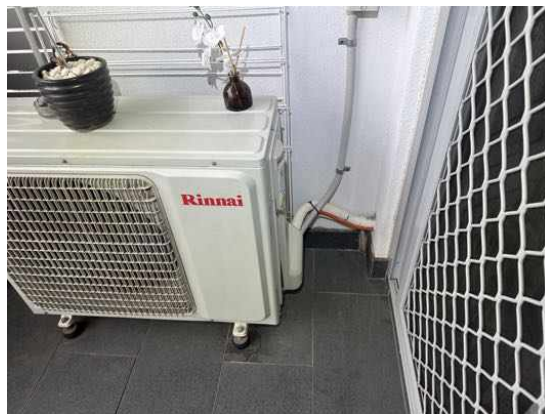
Building: Main Building
Location: All Areas > All Areas
Finding: Additional Photos - Obstructions and Limitations
Information: These photographs are an indication of the obstructions and limitations which impeded full inspection of the property at the time of inspection. These obstructions can hide an array of defects and should be removed to allow full inspection to be carried out. A re-inspection is recommended once the areas are made accessible.

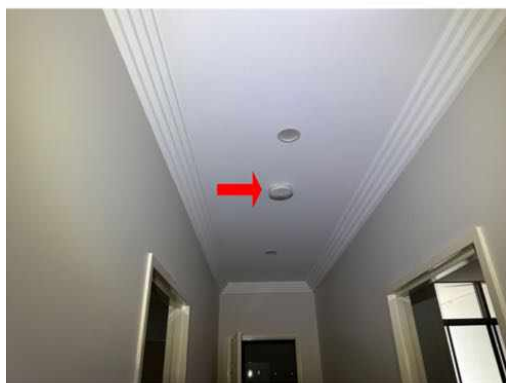
Building: Main Building
Location: All Areas > All Areas
Finding: Smoke Detectors and Alarms
Information: Reporting on Smoke Detectors or Alarms, including hard wired smoke detection systems and their legislative requirements, is outside the Scope of this Report.

Please note that this defect is highlighted as a caution only. We suspect, based on our experience in the building industry, that the absence of smoke detectors, or their poor condition, should be addressed as a matter of urgency to improve occupant safety.

Further Inspection and/or advisory services is necessary to provide advice on the sufficiency, type and location of smoke detectors, and to test the functionality of all devices. Greater requirements for fire safety and detection exist for commercial buildings.

Always ensure sufficient working and suitable smoke detectors are installed prior to occupying any building. Additionally, it is advised that all smoke detectors be tested by the homeowner on a monthly basis.

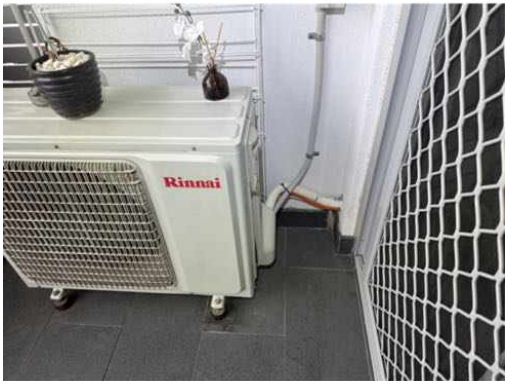
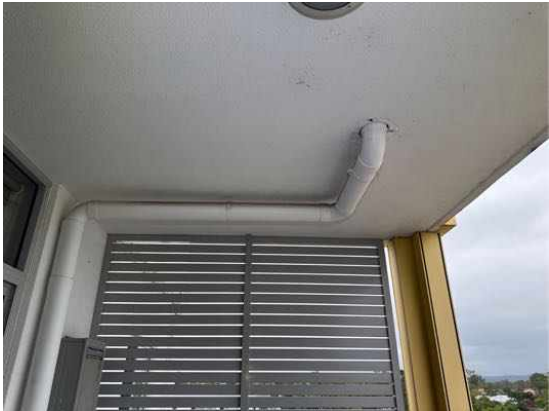
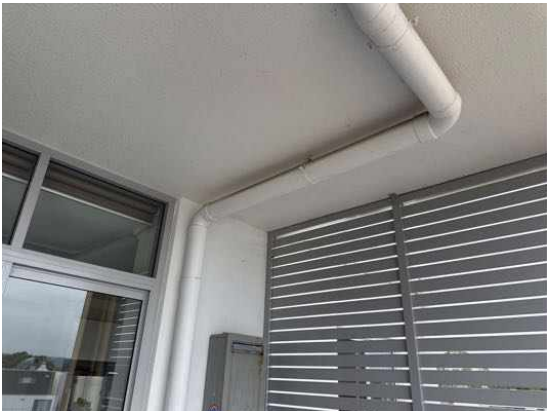
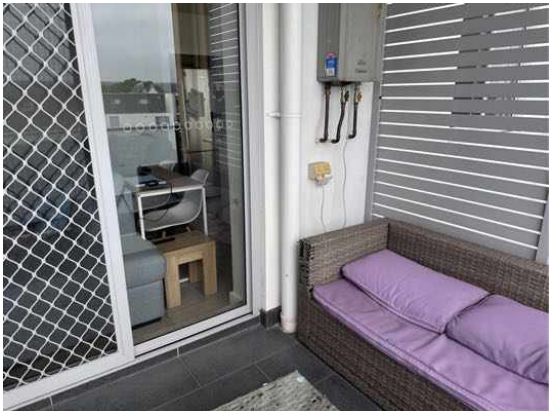
Building: Main Building
Location: Verandah > Rear
Finding: Additional Photos
Information: Additional photos are provided for your general reference

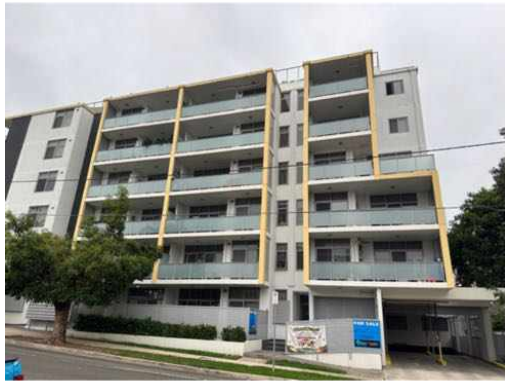
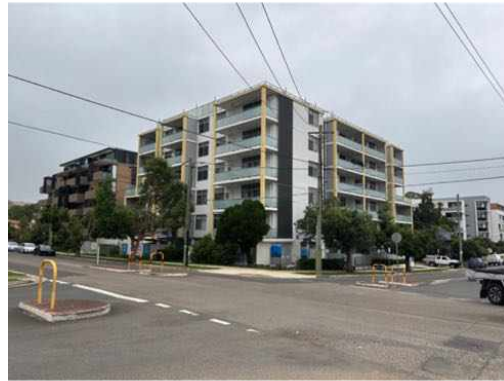
Location: All Areas > All Areas
Finding: Additional Photos
Information: Additional photos are provided for your general reference

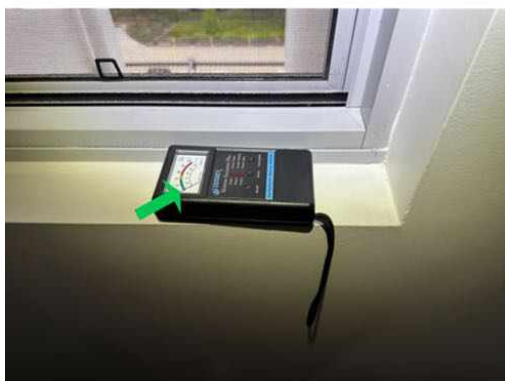
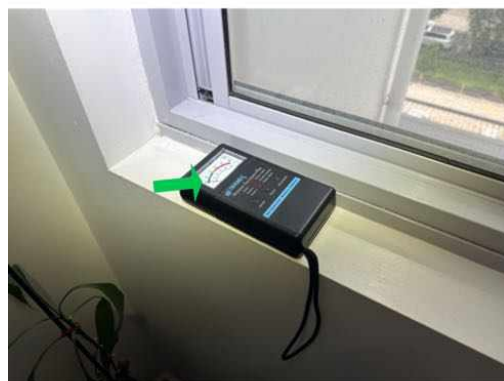
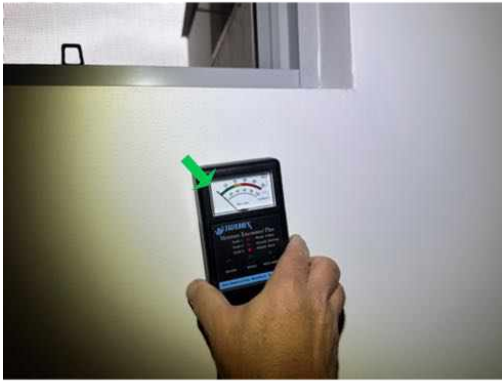
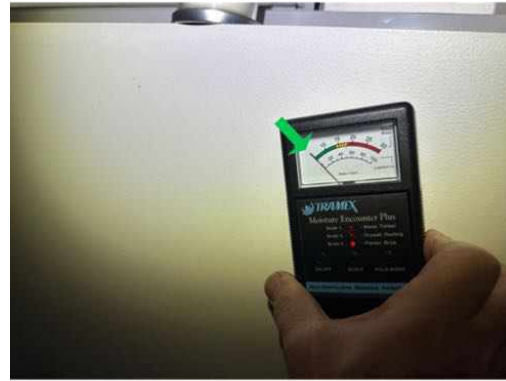
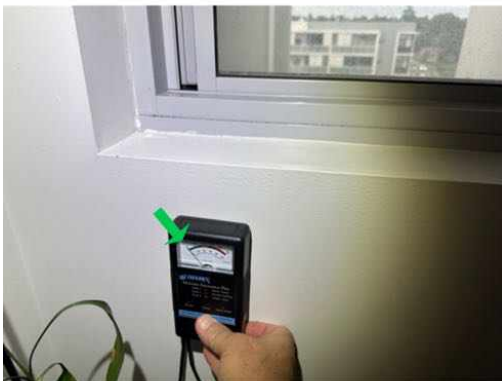
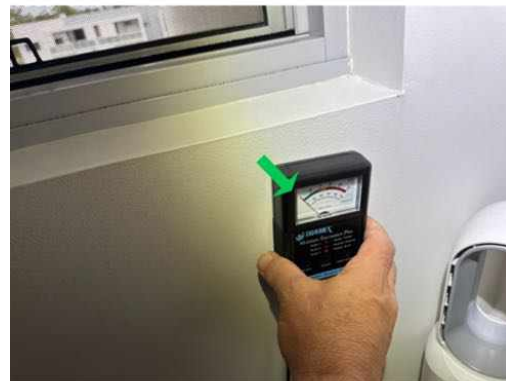
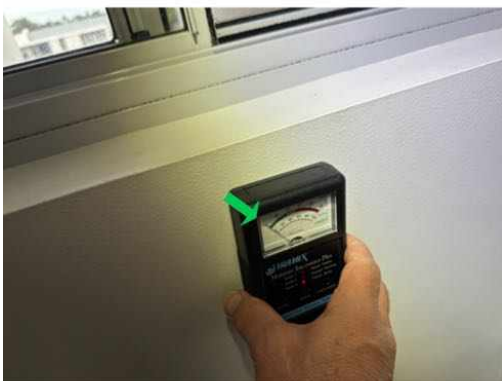
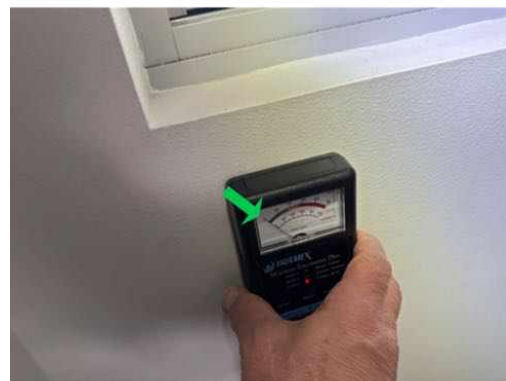
Building: Main Building
Location: All Areas > All Areas
Finding: Moisture Meter used: No Moisture Detected.
Information: Moisture meter was used during the inspection and no excessive moisture was detected to accessible walls inside the property at the time of inspection.

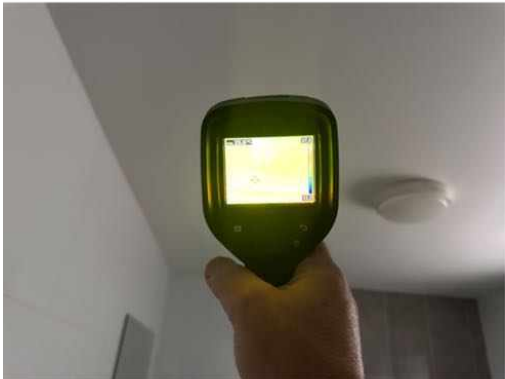
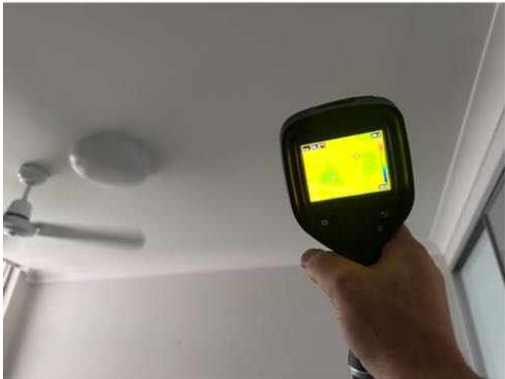
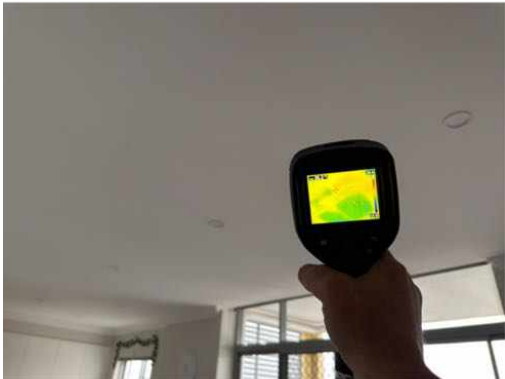
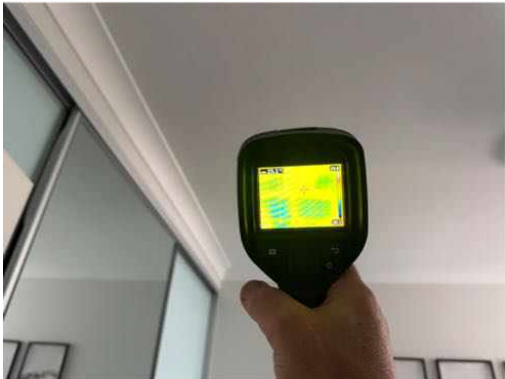
Building: Main Building
 Location: All Areas > All Areas
 Finding: Thermal imaging: No excessive moisture presentation.
 Information: At the time of inspection there appeared to be no excessive moisture presentation in this area.

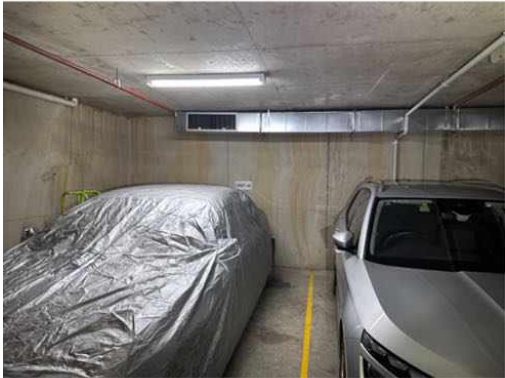
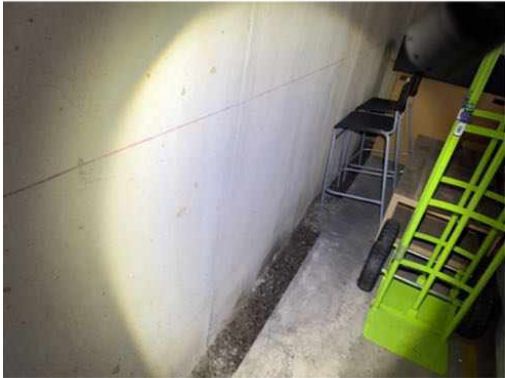
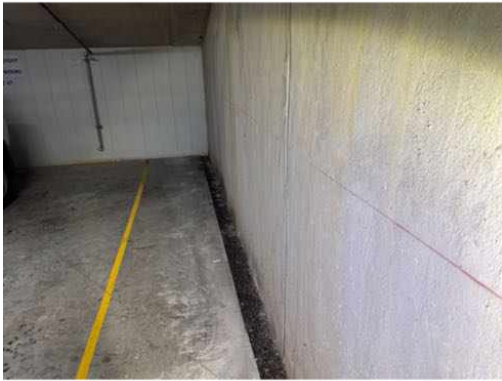
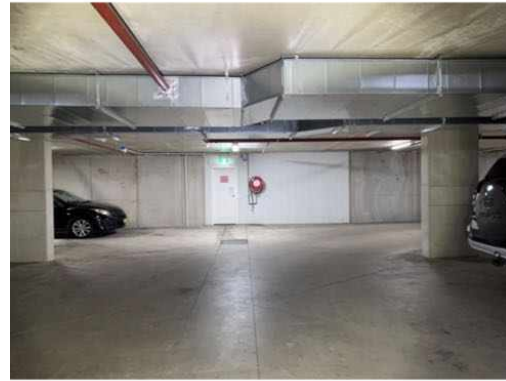
Building: Main Building
Location: Basement > All Areas
Finding: Basement Car Park:
Information: At the time of inspection the basement car park appeared to be in a fair condition.

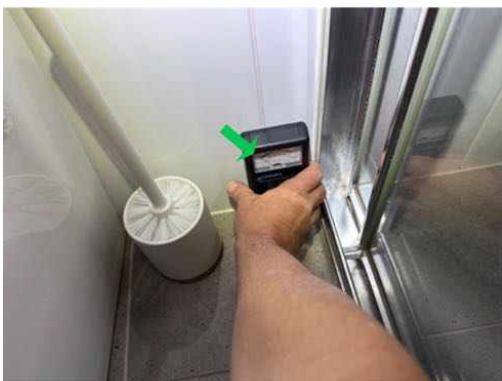
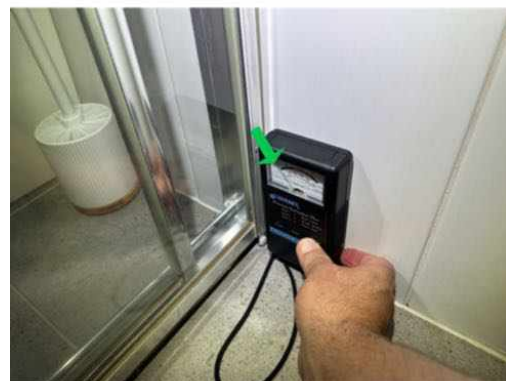
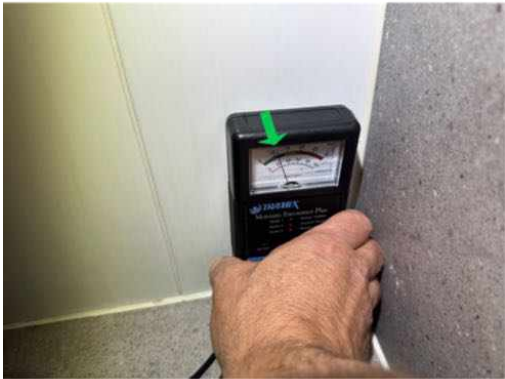
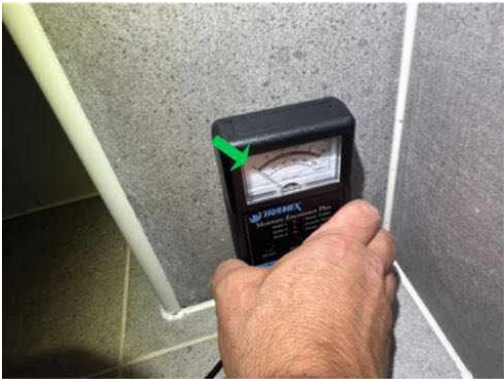
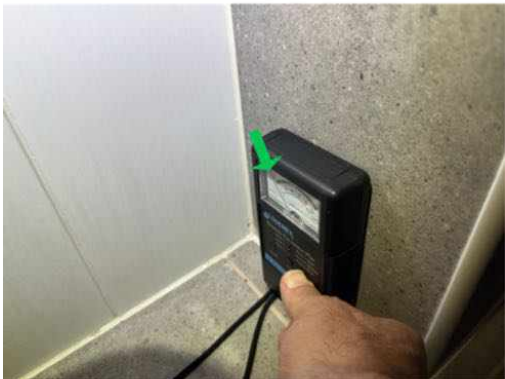
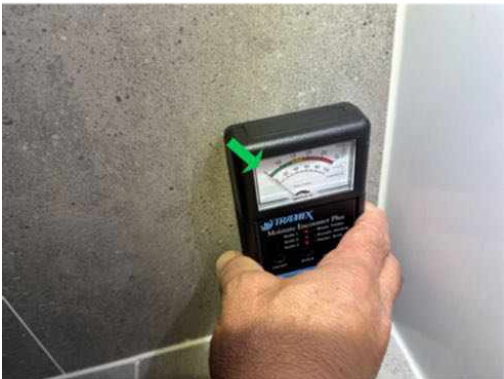
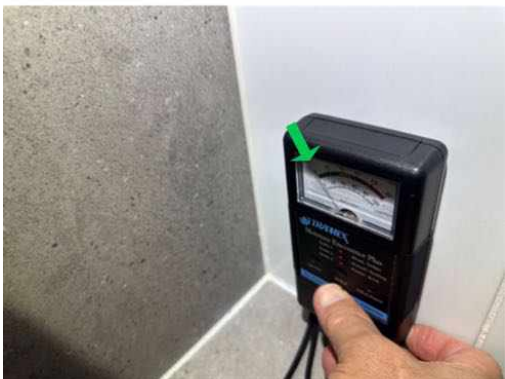
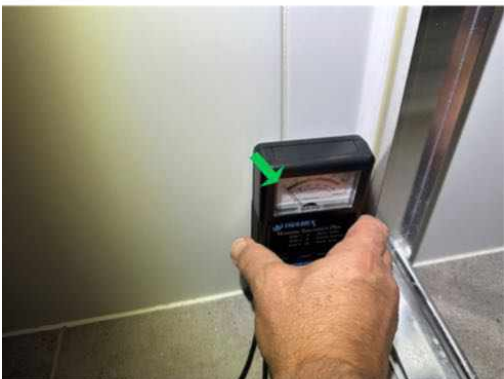
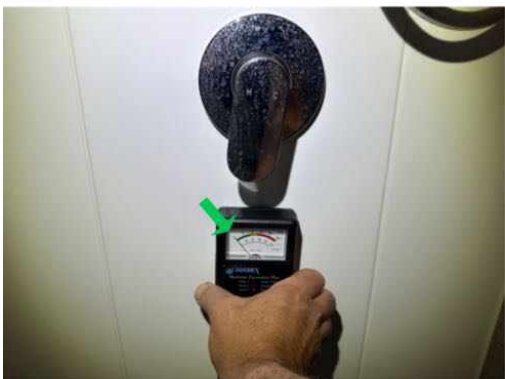
Building: Main Building
 Location: Ensuite - Master > Front Left
 Finding: Moisture Meter used: No Moisture Detected.
 Information: Moisture meter was used during the inspection and no excessive moisture was detected to accessible walls inside the shower recess at the time of inspection.

The grout and tiles in this area appear to be in good condition at the time of inspection.

Monitoring the area is advised and if any visual signs of excessive moisture appear (peeling paint, mould) then consultation with a qualified plumber or bathroom specialist would be advised to identify the cause of damp and to perform remedial works as required.

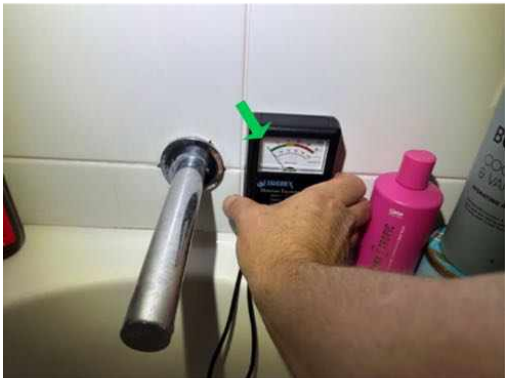
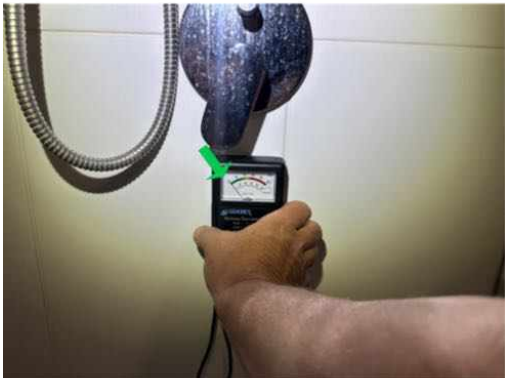
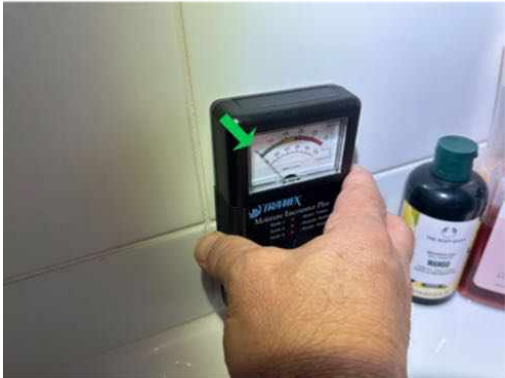
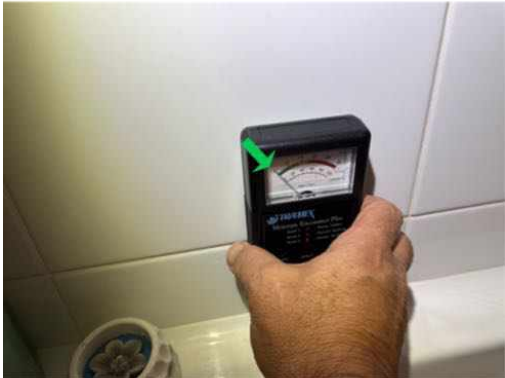
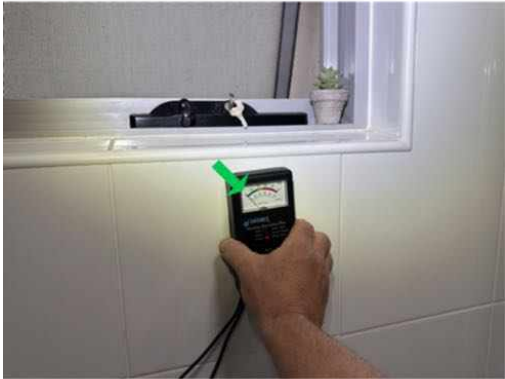
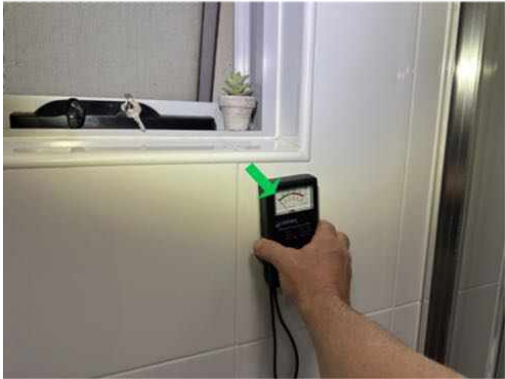
Building: Main Building
Location: Bathroom > Centre Left
Finding: Moisture Meter used: No Moisture Detected.
Information: Moisture meter was used during the inspection and no excessive moisture was detected to accessible walls inside the shower recess at the time of inspection.

The grout and tiles in this area appear to be in good condition at the time of inspection

Monitoring the area is advised and if any visual signs of excessive moisture appear (peeling paint, mould) then consultation with a qualified plumber or bathroom specialist would be advised to identify the cause of damp and to perform remedial works as required.
