Building and Timber Pest Inspection Report VR

Inspection Date: Thu, 8 Jan 2026

Property Address: 97 Bainbridge Dr, Pullenvale QLD 4069,
Australia

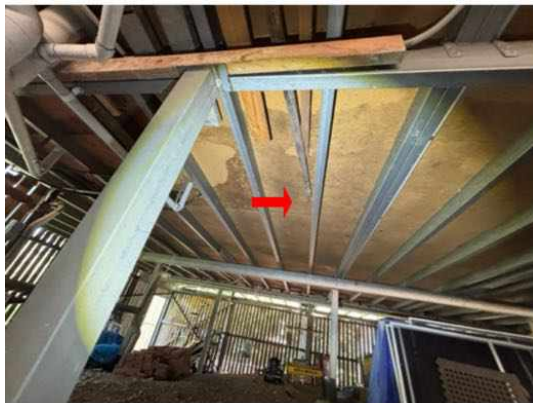
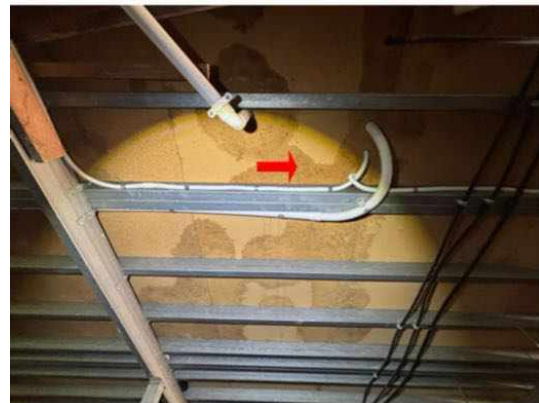
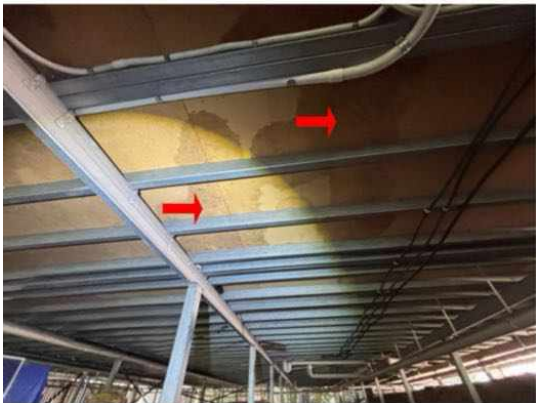
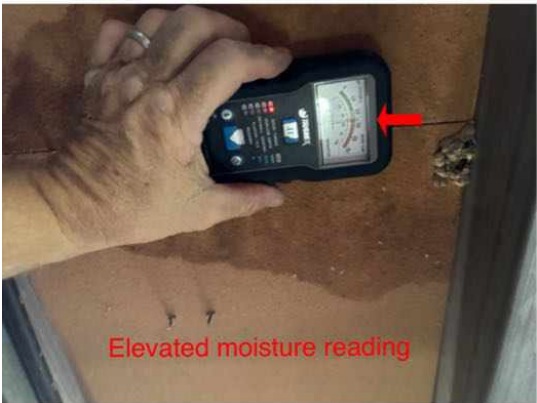
Building: Main Building
Location: Subfloor
Finding: Subfloor - water stain to underside of master bedroom floor
Information: At the time of the inspection, it was noted that there was evidence of a water stain to the underside of the master bedroom floor. The water staining appears to be historic and no evidence of a current leak was noted.

Information received from the vendor suggests that a burst flexible hose in the ensuite was responsible for this water stain. The flexible hoses to the ensuite have been replaced. Elevated moisture readings were recorded in this area.

The client should monitor this area for any change to the appearance of the water staining.

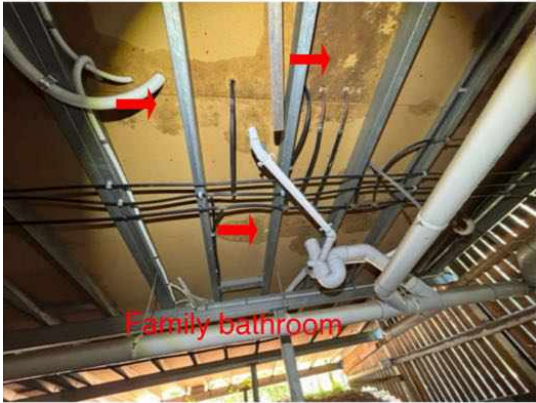
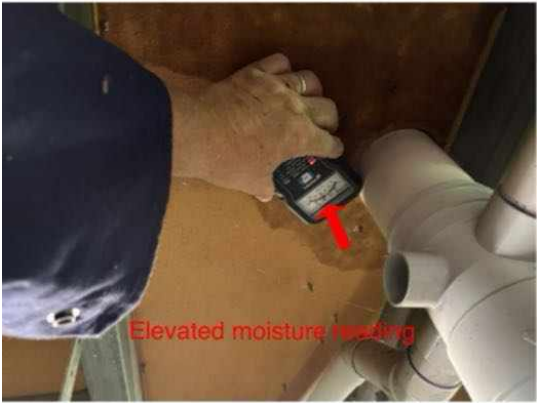
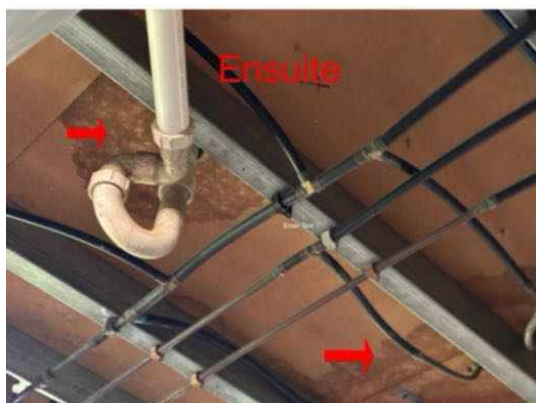
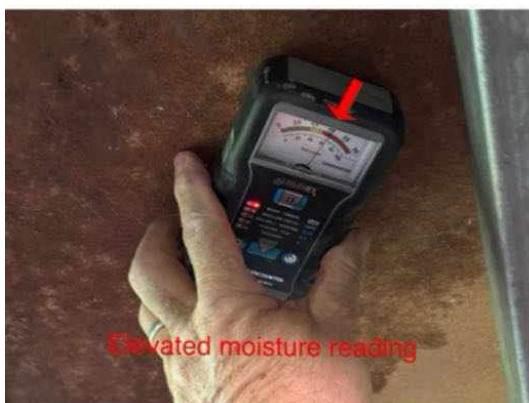
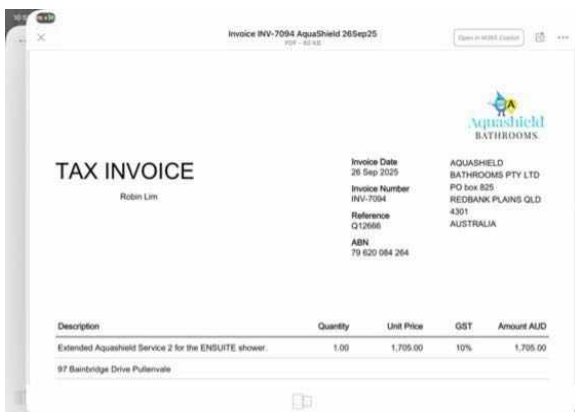
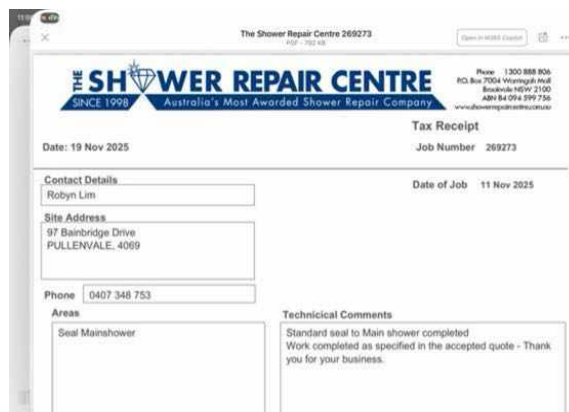
Finding 3.02

Building: Main Building
 Location: Subfloor
 Finding: Subfloor - water stains to underside of flooring to the family bathroom and ensuite
 Information: At the time of the inspection, it was noted that there was evidence of water staining to the underside of the flooring to the family bathroom and ensuite. The water stain appears to be historic, no evidence of a current leak was noted. Elevated moisture readings were recorded in these areas.

Information received from the vendor shows that remedial works have been performed to both bathrooms. As per the attached invoices, sealing of the ensuite shower was performed on the 26/09/2025. And sealing of the family bathroom shower was carried out on the 11/11/2025. Warranties will be attached to this work.

The client should monitor these areas for any change to the appearance of the water staining.

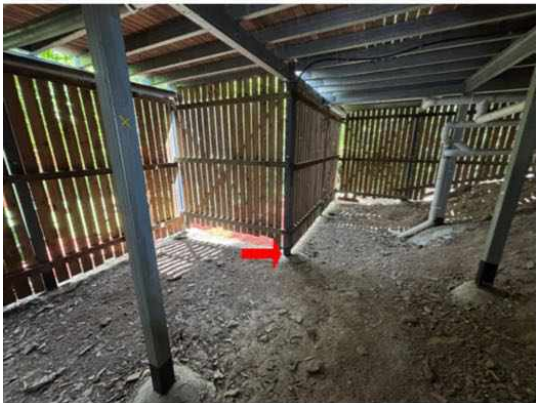
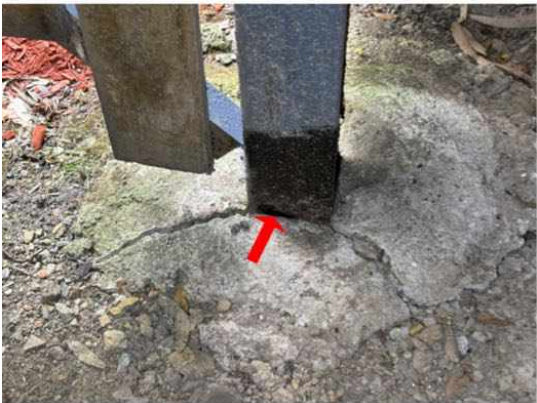
Finding 3.03

Building: Main Building
 Location: Subfloor
 Finding: Subfloor - steel post rusted
 Information: At the time of the inspection, it was noted that a steel post in the subfloor area has rusted creating a hole in the base of the steel post.

If left unaddressed this will become a major defect.

A building maintenance professional should be engaged to carry out the necessary repairs to the steel post to stop further deterioration. This should be done as a matter of urgency.

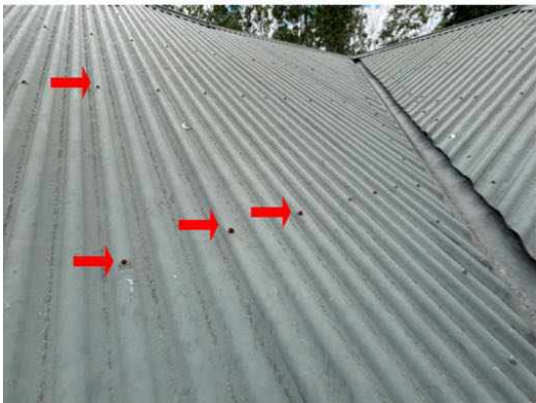
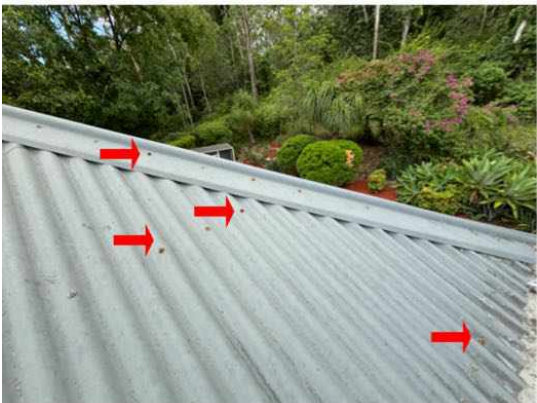
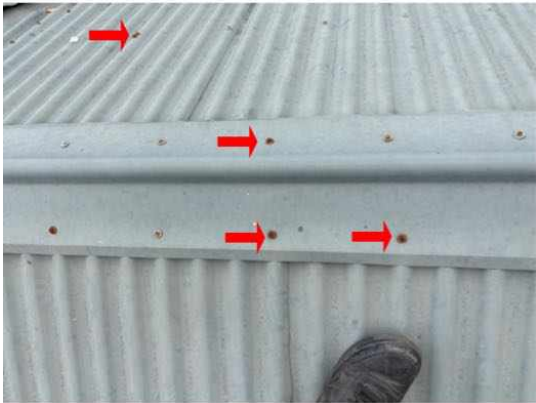
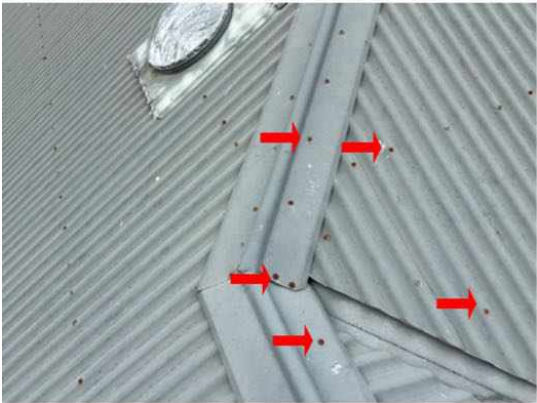
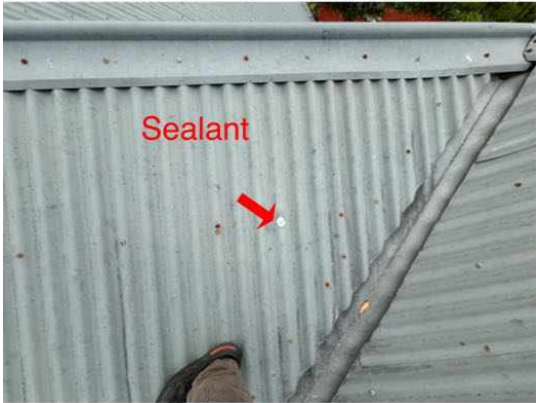
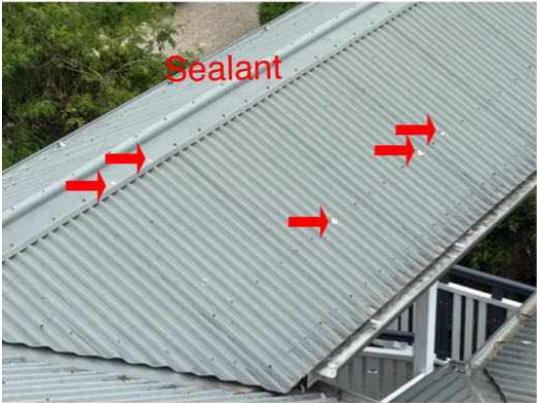
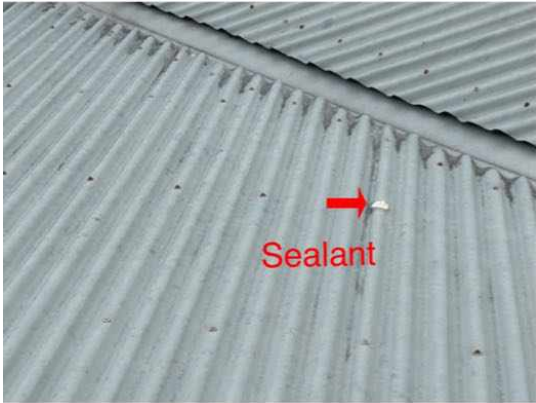
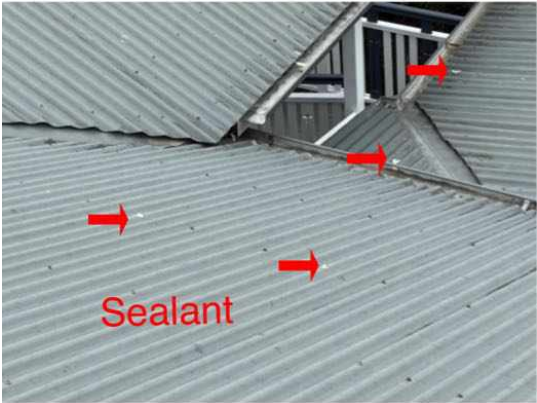
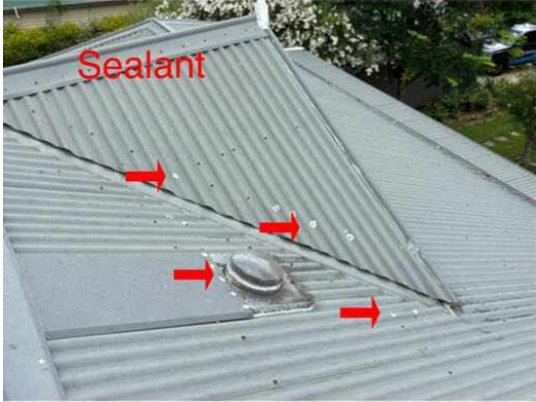
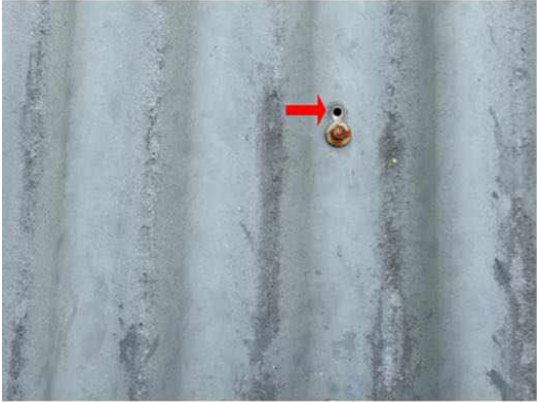
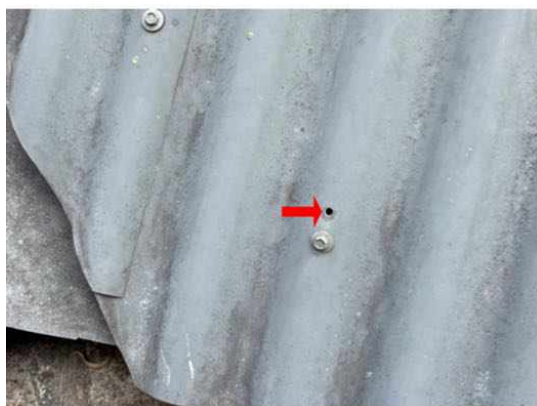
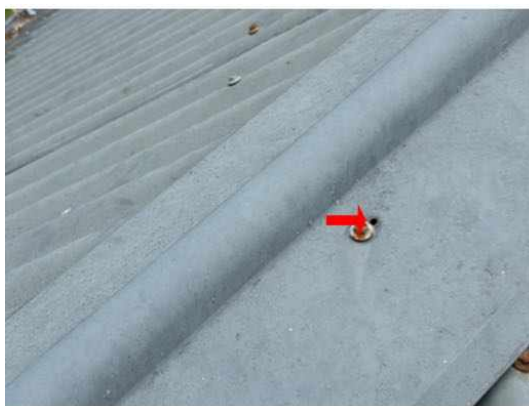
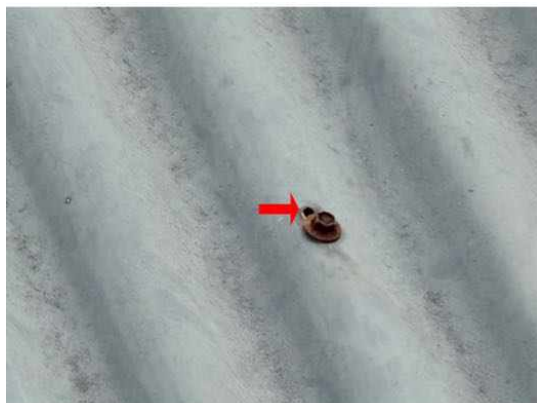
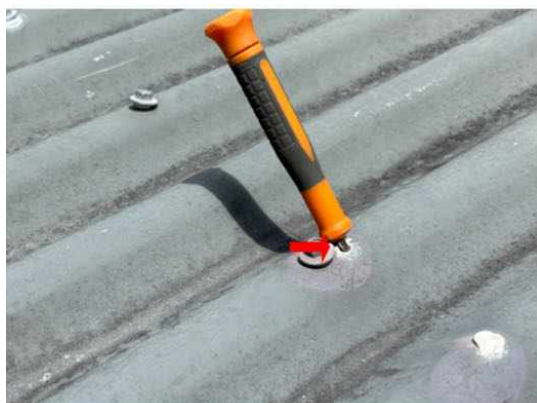
Finding 3.04

Building: Main Building
 Location: Roof exterior
 Finding: Metal roof covering - Weathered
 Information: Upon inspection of the exterior roofing, the majority of the metal roof sheets were considered to be in a fair condition. While weathering of the metal roof sheets is consistent with the age of the property, maintenance works are required.

Numerous metal roof fasteners were found to be rusting and should be replaced to avoid the rust transferring to the metal roof sheets. Sealant was noted to other roof fasteners, this sealant has deteriorated. The reason for the sealant should be determined to ensure that this is the most effective fix. Several holes from roof fasteners would be found and should be sealed to avoid moisture entering the roof void.

Where left unmanaged, deteriorating metal roof sheets are likely to lead to a number of secondary defects, including minor water leaks and weather exposure to internal roofing structures.

Consultation with a roofing contractor is highly advised to gain advice on cost of remedial works that may be required in the short to medium term. Remedial works are likely to increase the longevity of the exterior roofing structure.

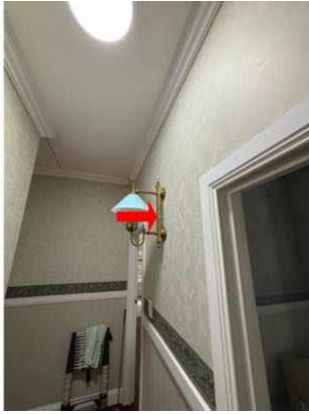
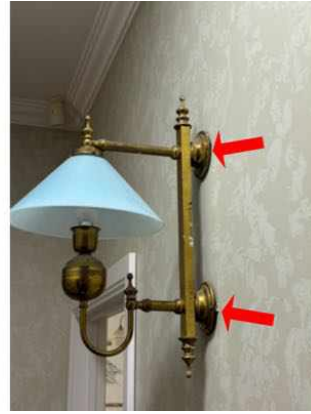
Finding 3.05

Finding: Hallway - light fixture loose

Information: At the time of the inspection, it was noted that one of the light fixtures in the hallway was loose. The light fixture should be re-secured to the wall to ensure that it does not fall off the wall.

A licensed electrician should be engaged to carry out this repair. This should be done as a matter of urgency.

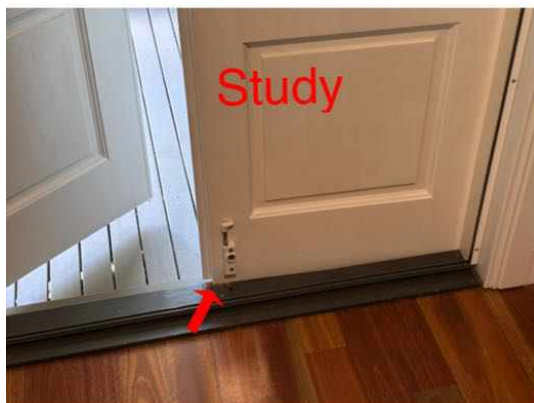
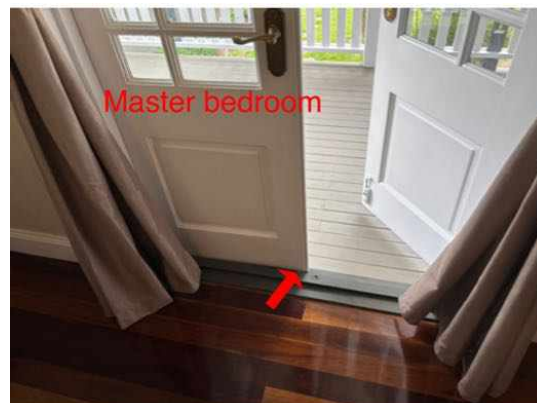
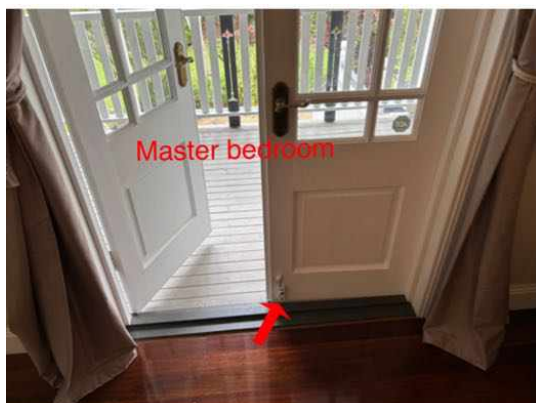
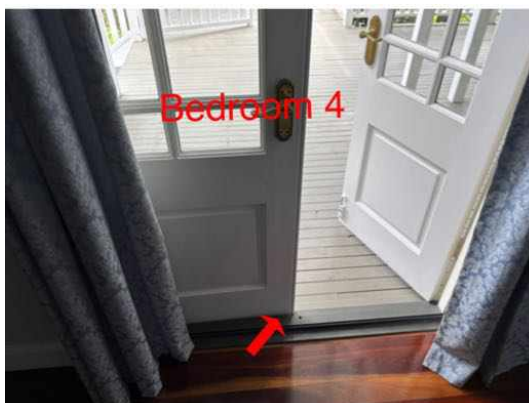
Finding 3.06

Building:	Main Building
Location:	All Internal Areas
Finding:	Internal areas - doors binding on the door sill
Information:	At the time of the inspection, it was noted that several french doors were binding on the door sills during normal operation. A small amount of material should be removed from the bottom of the affected doors to restore normal operation.

Binding doors were found in the study, master bedroom and bedroom 4. French doors in the lounge were locked and as a result, the operation of these doors could not be checked.

A building maintenance professional should be engaged to carry out these minor repairs. This can be done at the clients discretion.

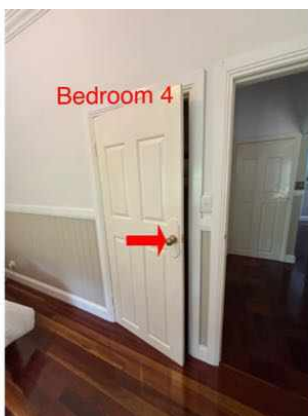
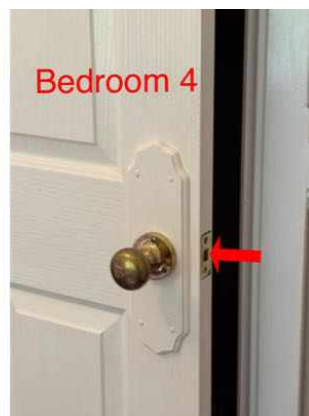
Finding 3.07

Building:	Main Building
Location:	All Internal Areas
Finding:	Door handle - Not latching
Information:	At the time of the inspection, it was noted that the door to the cupboard in bedroom 4 and the master walk in robe were not latching during normal operation. The functionality of this building element is affected. This appears to be from general wear and tear.

A qualified carpenter or building maintenance professional may be appointed to perform rectification works as necessary, at client discretion. If left unattended, further functional impairment is likely to occur.

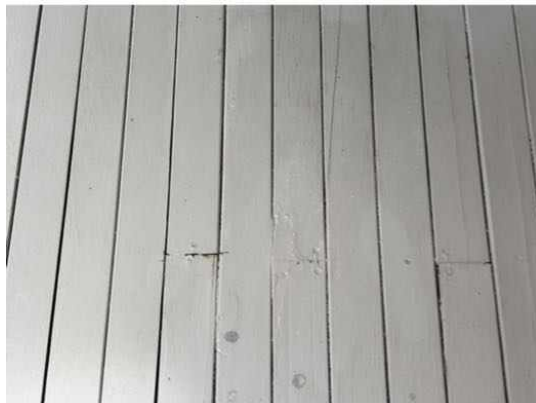
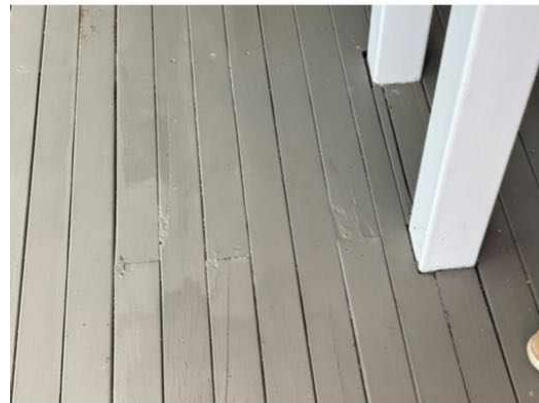
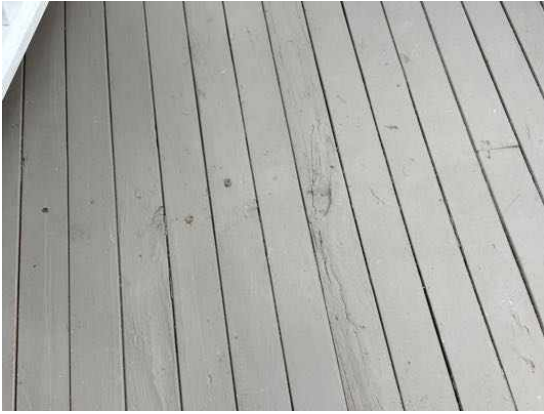
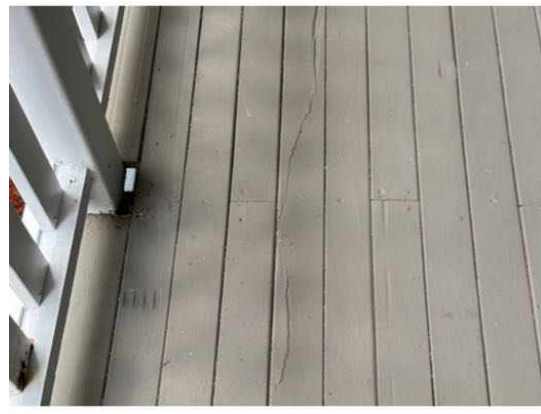
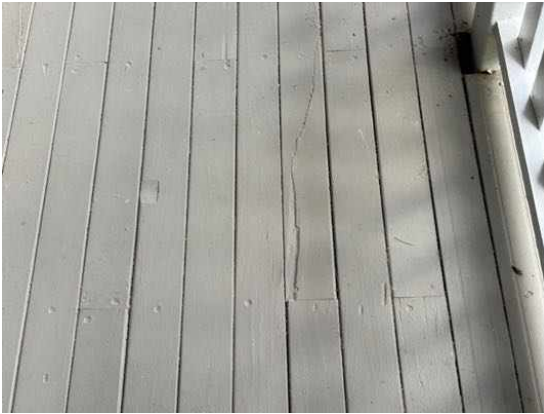
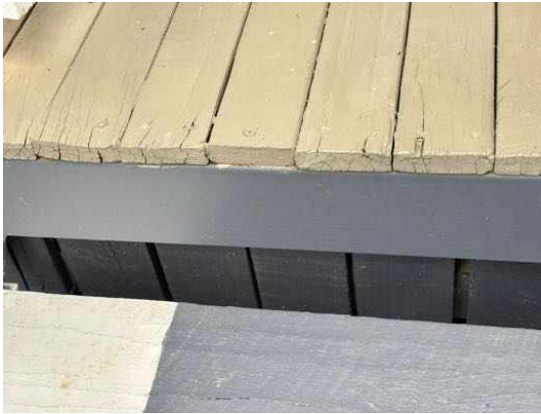
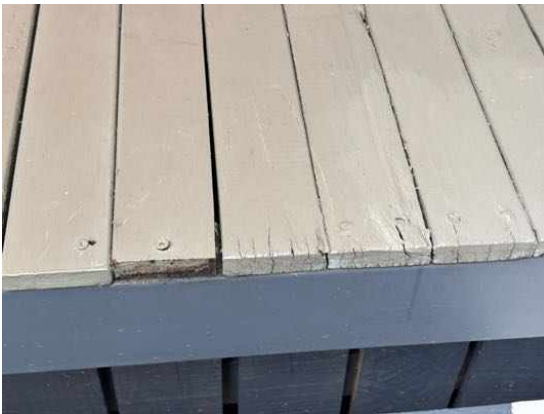
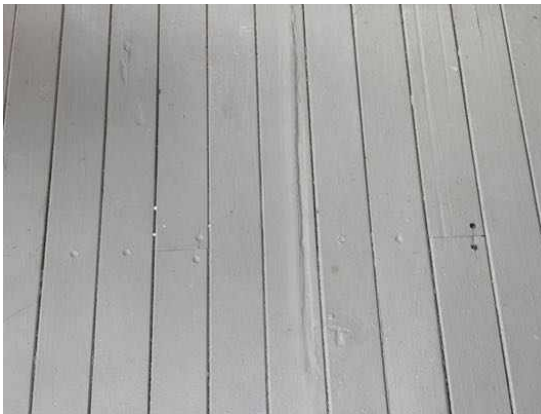
Finding 3.08

Finding: Front deck - deterioration

Information: At the time of the inspection, it was noted that the front deck shows signs of deterioration which may be due to wood rot. It appears that the affected areas have been repaired and painted. This may be due to general weathering and the age of the materials.

The client should monitor the decking boards for any change to their appearance.

A licensed carpenter could be engaged to replace any affected timber decking boards. This can be done at the clients discretion.

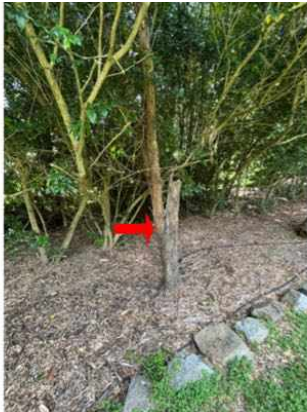
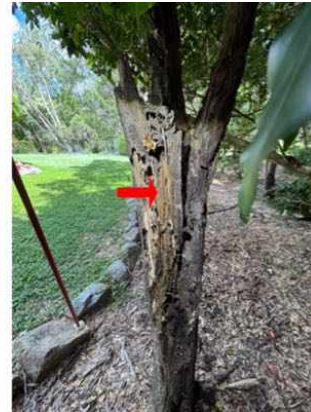
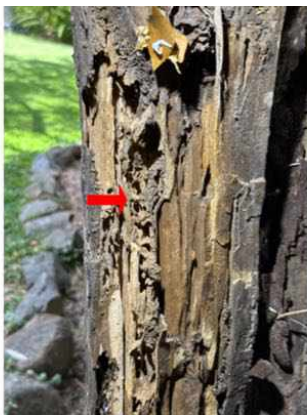
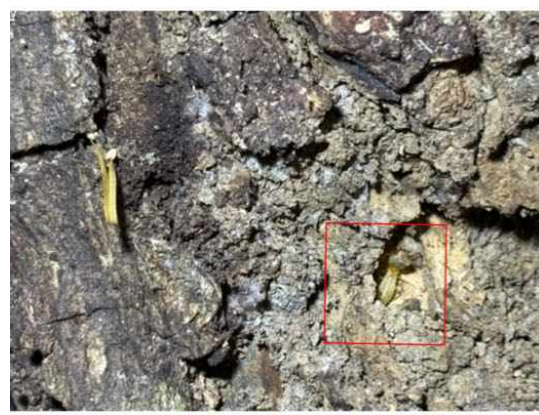
Finding 4.01

Building:	Main Building
Location:	Front yard
Finding:	Evidence of live termite activity was identified (species unknown)
Information:	At the time of the inspection, it was noted that there was live termite activity in a dead tree in the front yard to the left of the dwelling.

The species of the termites could not be identified at the time of inspection which may

impact on the mode of eradication. Works to eradicate live termites should be undertaken immediately to prevent any further damage that will inevitably ensue.

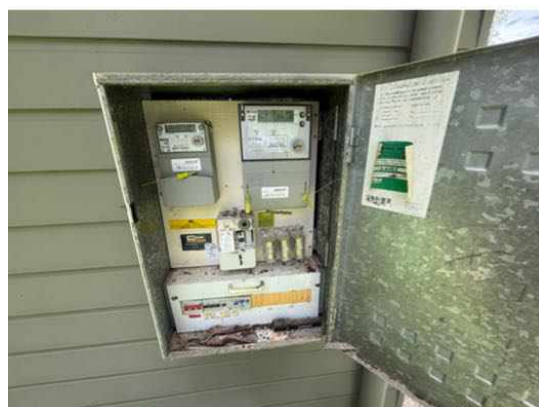
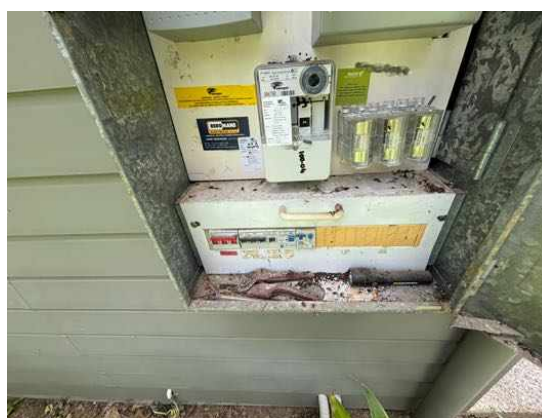
Building:	Main Building
Location:	All External Areas
Finding:	Termite Management System - no evidence of a chemical installation
Information:	At the time of the inspection, no evidence of a chemical termite management system was found. There is no durable notice in the meter box. No record of annual termite inspections was found onsite.

The application of a post-construction chemical termite barrier is highly recommended for all properties, particularly if live termite activity has been found on the site

The client may consider gaining further advice from a pest controller as to the costs and procedures involved with this application. It is recommended that obtaining such advice be a short-term priority.

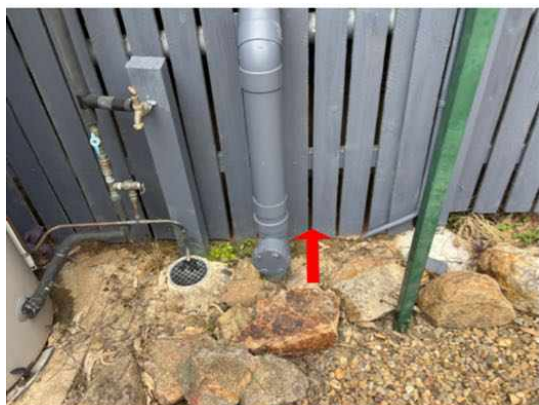
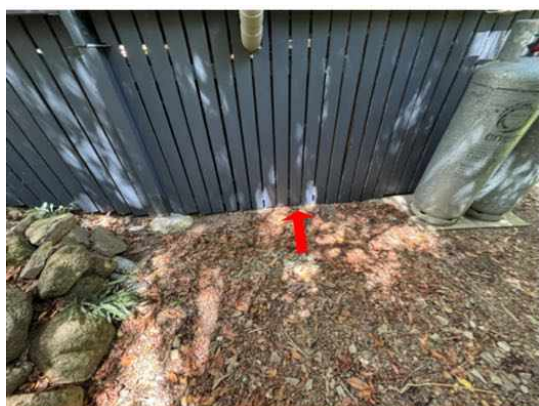
Finding 6.02

Building:	Main Building
Location:	Subfloor
Finding:	Building materials in direct ground contact - conducive to termites
Information:	At the time of the inspection, it was noted that there was timber in contact with the ground at the sides of the dwelling. The subfloor timber battens are touching the ground.

Where timber elements are in direct contact with the ground and consequently moisture or dampness they become conducive to termite activity. Whether timber is used as a building element part of a fencing structure or stored as an unused item they can provide an environment that is attractive to termite infestation.

When met with excessive moisture timber begins to decay and develop wood rot. Any timbers that are in direct contact with external grounds especially if left untreated or non-durable also provide ingress for subterranean termites into that particular element.

The removal of any such materials that may be conducive to termite activity should be removed as soon as possible to minimise the risk of termite attack.

Annual termite inspections should be carried out in order to further protect the dwelling.

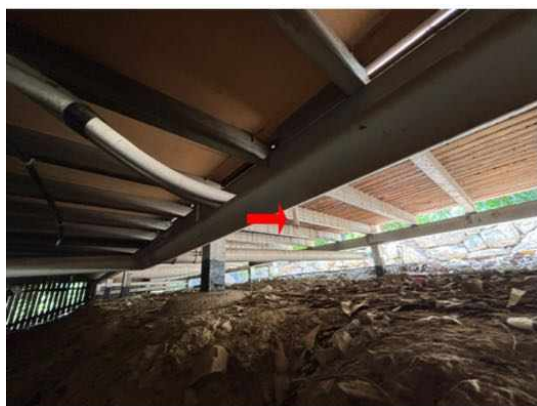
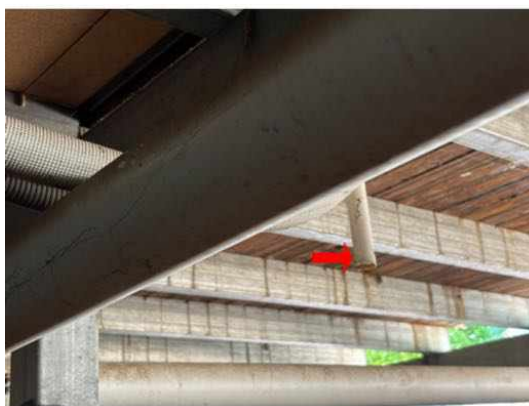
Finding 6.03

Finding: Air conditioner - Disconnected overflows

Information: At the time of the inspection, it was noted that the air conditioner drain overflows to all the units were not connected to the storm water drainage and as a result are draining next to the foundations of the dwelling.

Air conditioning overflows that are not connected to the storm water drainage and are draining near the foundation can create excessive moisture in the surrounding area.

Such leaking creates an environment which is conducive to an array of defects, including water damage to associated building elements and the attraction of termite or timber pest infestation.

It is highly recommended that a licensed plumber be appointed to connect the A/C overflow in order to prevent such an environment from being created. These minor works should be carried out as soon as possible.

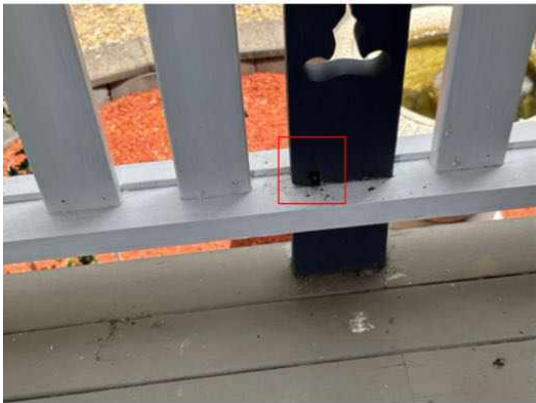
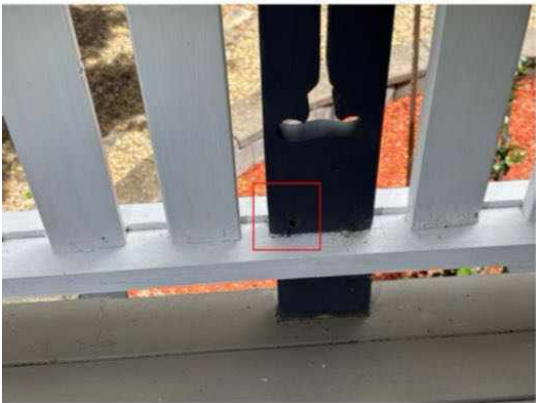
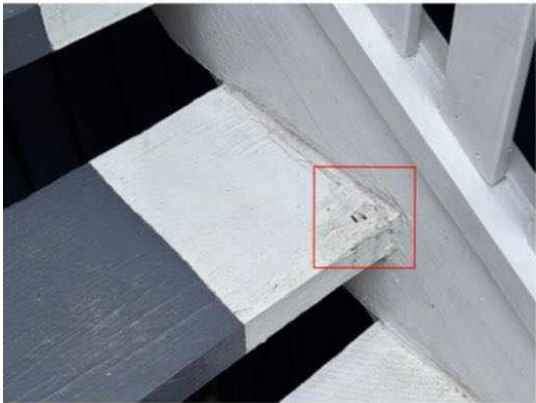
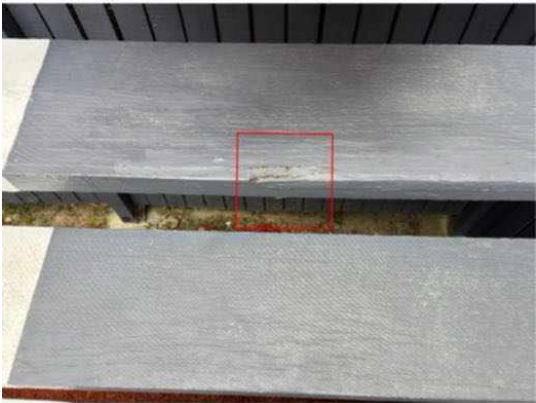
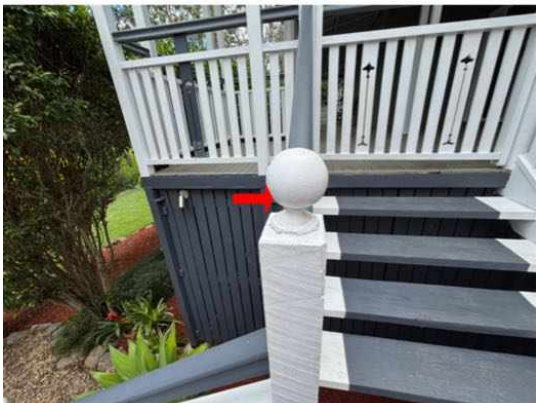
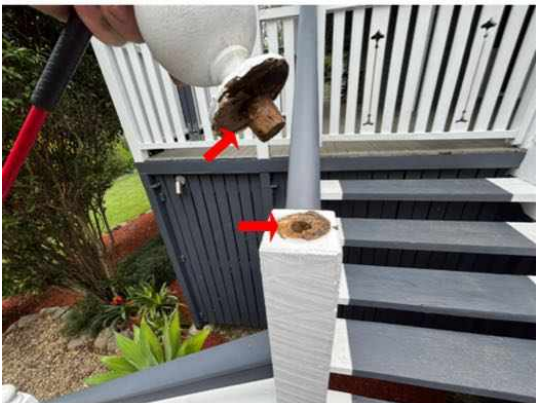
Finding 7.01

Building:	Main Building
Location:	Front elevation
Finding:	Wood rot - timber building materials
Information:	At the time of the inspection, it was noted that there was evidence of minor wood rot to decorative balusters and two stair treads at the front of the dwelling. The decorative ball on top of the post on the front stairs needs to be treated and re-attached. This may be due to the age of the timber building elements and general weathering.

This building element shows evidence of wood rot. Wood rot, also known as Fungal Decay, occurs when timbers and other cellulose building materials are exposed to damp conditions on an ongoing basis.

Wood rot is often associated with general damp problems and is evidenced by a 'musty' smell or mould and mildew occurring on surfaces. If left unmanaged, damp conditions can lead to further health problems and the decay of timbers will continue.

Early intervention and regular maintenance, particularly of exterior timbers, will prolong the useful life of these building elements. Prior to any works being performed, the cause of the moisture that has created the visible wood rot should be identified and addressed in a suitable manner. Replacement of affected timbers may then be a necessary step in protecting surrounding building elements from such deterioration.

A qualified carpenter or registered builder may also be required to replace affected building materials.

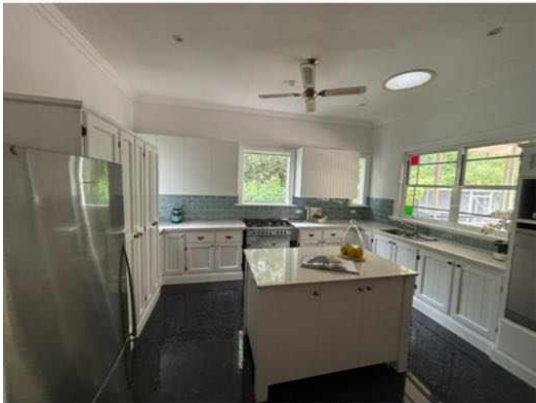
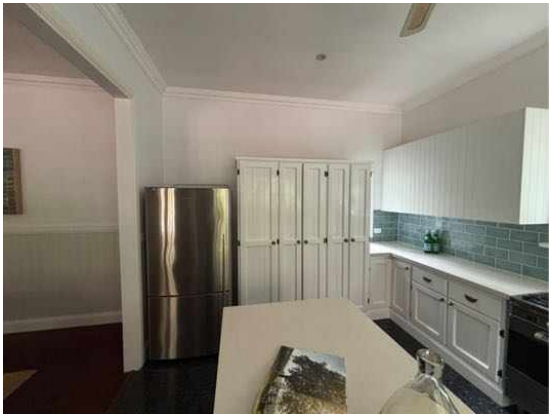
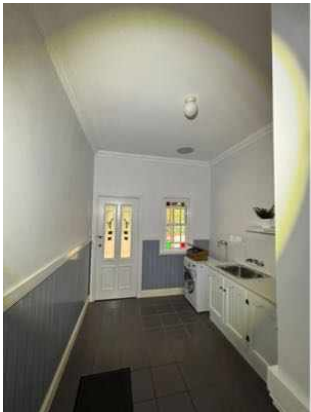
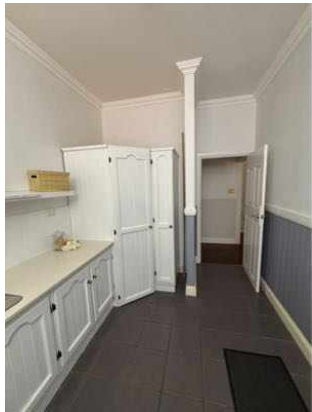
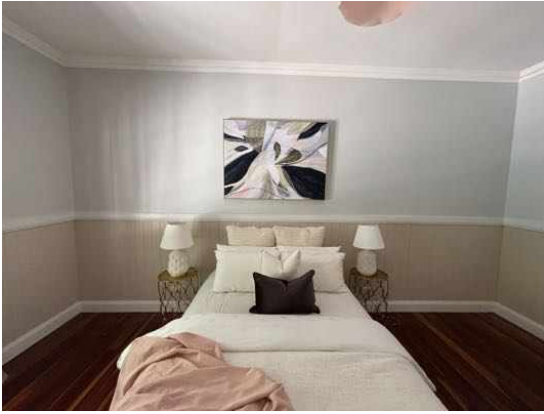
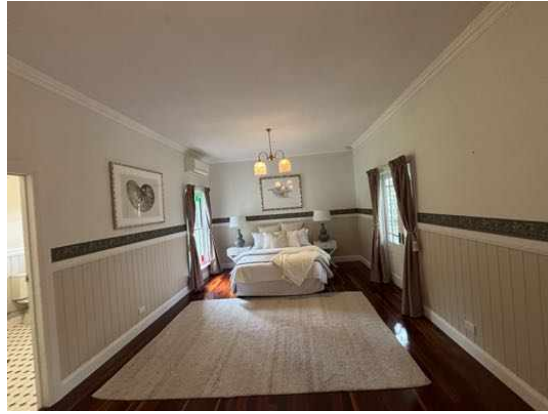
Building: Main Building
Location: All Internal Areas
Finding: Obstructions and Limitations - Internal areas
Information: These photographs are an indication of the obstructions and limitations which impeded full inspection of the property of the internal areas at the time of inspection. These obstructions can hide an array of defects and should be removed to allow full inspection to be carried out. A re-inspection is recommended once the areas are made accessible.

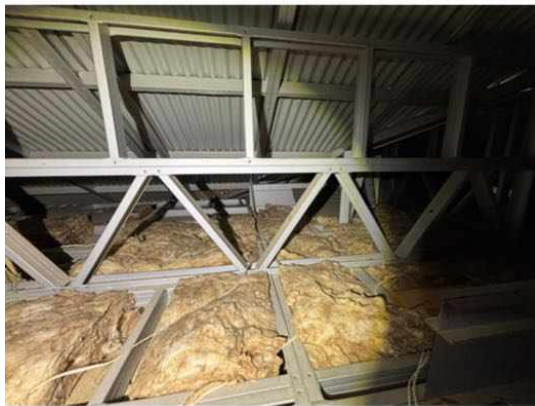
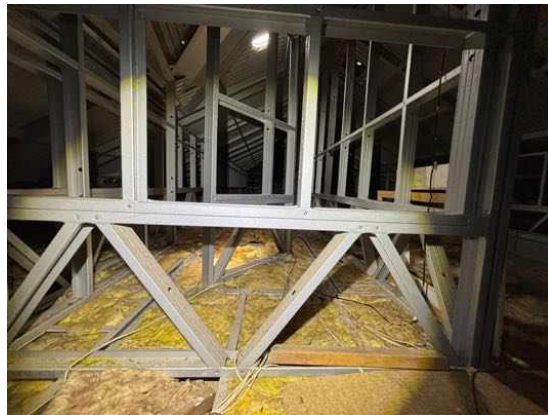
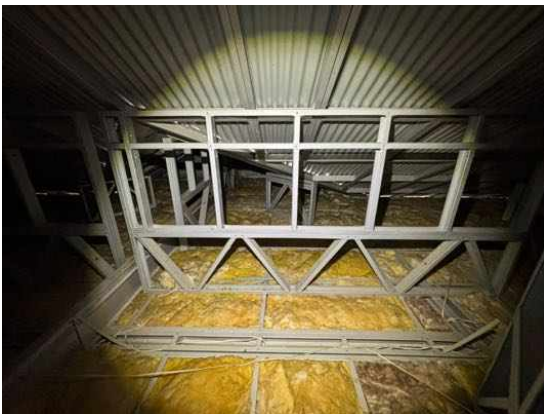
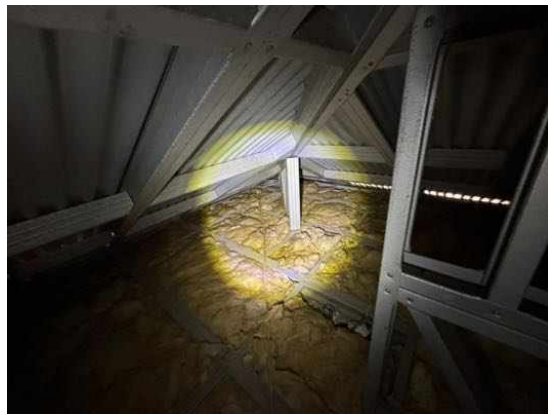
Building: Main Building
 Location: Roof Void
 Finding: Obstructions and Limitations - Roof cavity
 Information: These photographs are an indication of the obstructions and limitations which impeded full inspection of the property of the roof cavity

at the time of inspection. These obstructions can hide an array of defects and should be removed to allow full inspection to be carried out. A re-inspection is recommended once the areas are made accessible.
