# Building and Timber Pest Inspection Report

Inspection Date: Thu, 26 Mar 2026

Property Address: 79/69-73 Elizabeth Dr, Liverpool NSW  
2170, Australia

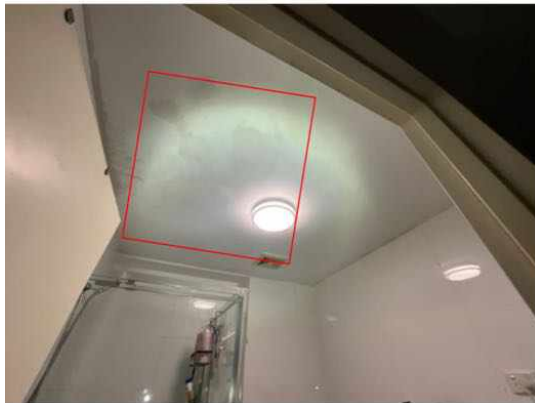
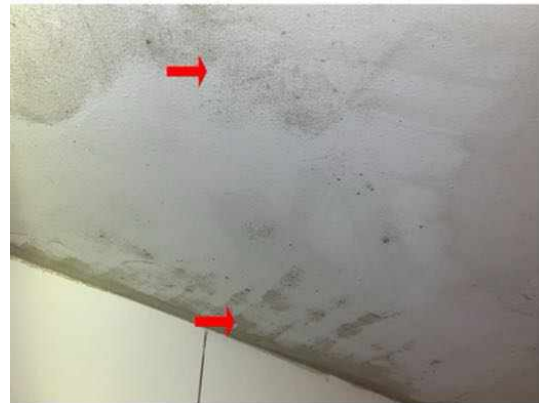
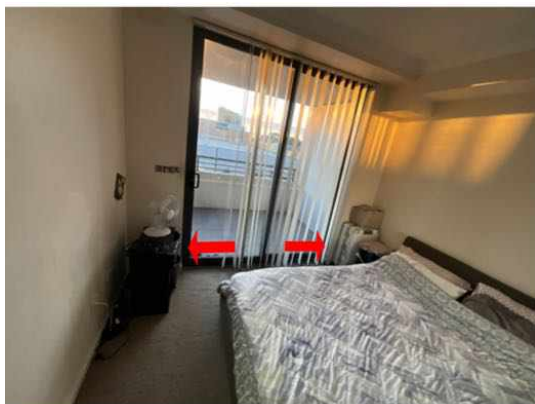
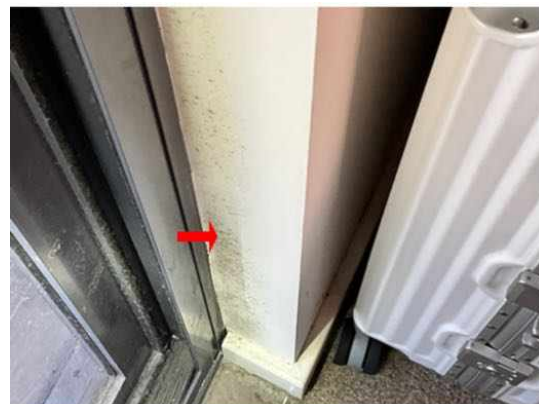
#### Finding 1.01

Building: Main Building  
Location: Bathroom, bedroom  
Finding: Mould - Present  
Information: Evidence of mould growth was noted, which is believed to have grown due to lack of ventilation to the area. Where evidence of mould growth was noted, there may be environmental, biological or health issues associated with the report. A specialist inspection by a suitably qualified environmental health inspector is warranted, where mould is extensive or where any queries regarding air quality spores or other related issues apply.

A safety hazard is due to mould. A mould remediation contractor is required to treat this mould urgently.

Generally, the client is advised to ensure that the general environment is free of moisture and humidity to aid in the prevention of mould formation and development. Any mould found during the inspection should be cleaned immediately by a cleaning contractor or the homeowner as applicable.

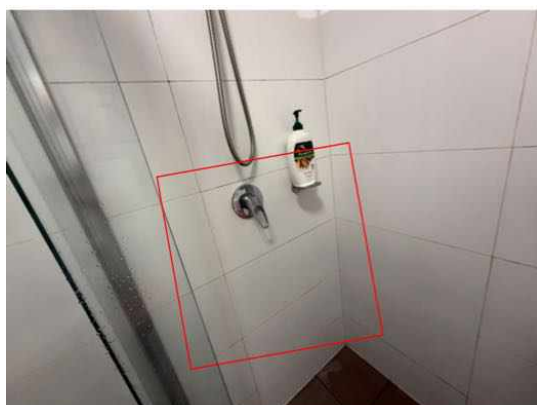
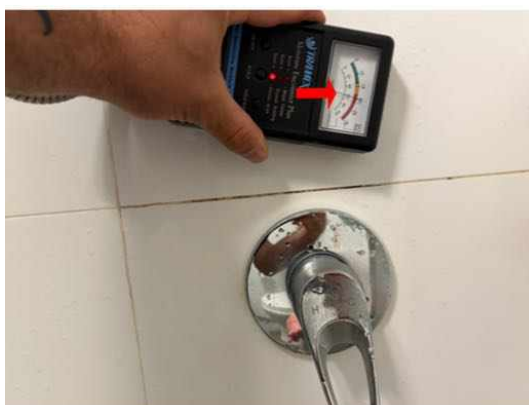
## Finding 2.01

Building:	Main Building
Location:	Bathroom
Finding:	Water leak - Suspected
Information:	A water leak is suspected in this area as excessive moisture was detected at the time of inspection. Another potential cause maybe moisture ingress behind the tiles from around the wall fittings and penetrations.

Internal water leaks can be detrimental to surrounding building elements; their potential causes include damage to plumbing fittings and fixtures, through to water damage and deterioration of associated building elements.

Attracting termites, corrosion, mould, decay and water damage are potential outcomes where a minor water leak is left unattended. More serious defects may also result, such as electrical hazards, or water damage to structural building elements.

Excessive moisture was identified to the walls in the bathroom shower. There maybe a water leak OR otherwise moisture maybe penetrating around the fittings. A licensed plumber must be appointed urgently for further assessment and repairs.

In extreme cases, structural damage may develop due to a prolonged water leak. It is highly advised that internal water leaks be addressed by a licensed plumber as a matter of relative urgency.

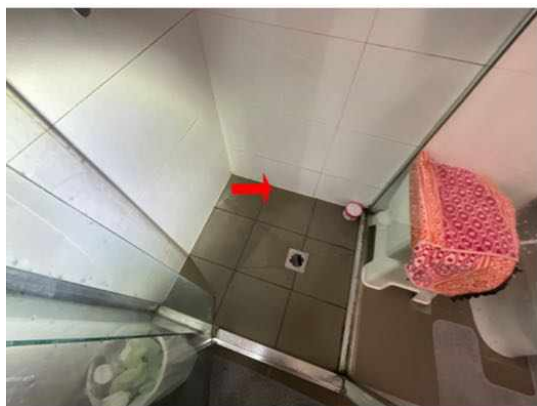
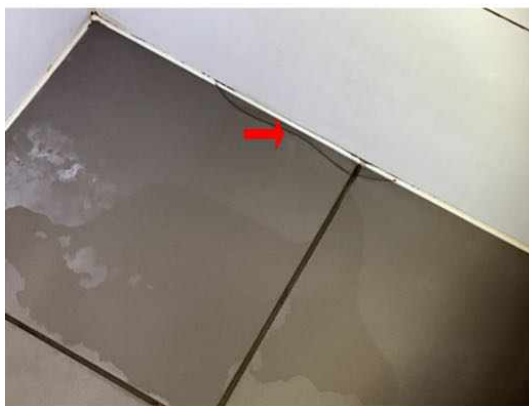
### Finding 3.01

Building:	Main Building
Location:	Bathroom
Finding:	Wet area tiles - Cracked or damaged
Information:	Cracking was evident to the tiling in this area at the time of inspection. While the cracking appears to be minor, this area is frequently exposed to water, allowing potential for water penetration into adjoining sections of walls or flooring.

If left unmanaged, water penetration to these areas may lead to subsequent water

damage, which is likely necessitate repair work to affected building elements.

A bathroom specialist should be appointed to determine the integrity of the bathroom waterproofing membrane. If the membrane was found to be intact then relatively minor works to replace the cracked tiles should be carried out to ensure no further damage occurs. The re-application of silicone and grouting throughout remaining tile work is also advised, to further protect the area against water penetration.

- Replace cracked shower tiles
- Ensure wet area sealant and grouting is in serviceable condition

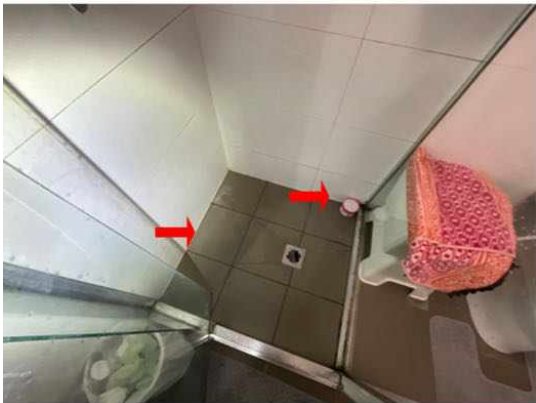
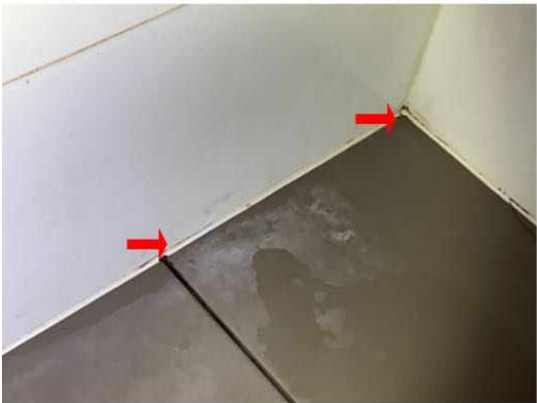
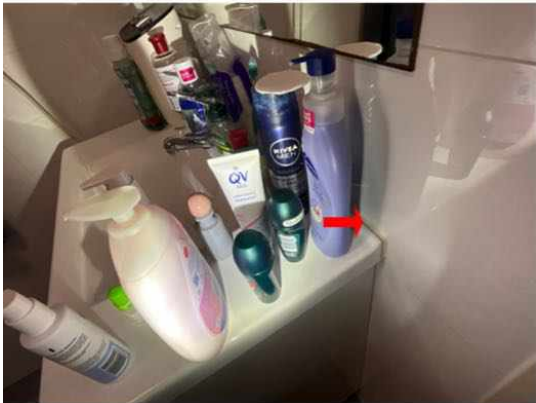
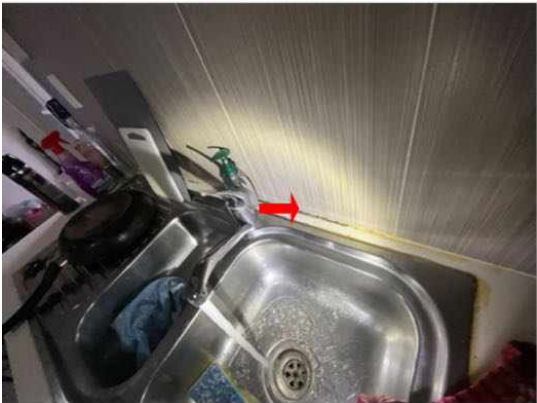
### Finding 3.02

Building: Main Building  
 Location: All Wet Areas  
 Finding: Sealant and grouting - Missing or damaged  
 Information:

It was noted on inspection that sealant or grout is degraded to this area.

Different materials and floor areas move at different rates, generally causing cracking to grout or sealant at this point. A flexible sealant is required to allow for expected expansion and contraction, while keeping the joint water tight and protective of all associated building materials.

Flexible and mould resistant materials should be applied to affected areas to prevent any subsequent water damage that is likely to occur. Regular maintenance and replacement of damage or missing or damaged sealant and grout is highly recommended to the wet areas, as this is a regular wear and tear defect. Sealant and grouting in areas that come into regular contact with water should be maintained for the long term care of your property.

A sealant specialist should be appointed to complete these works as soon as possible.

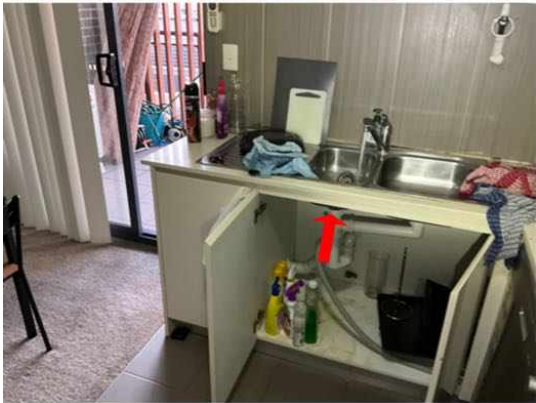
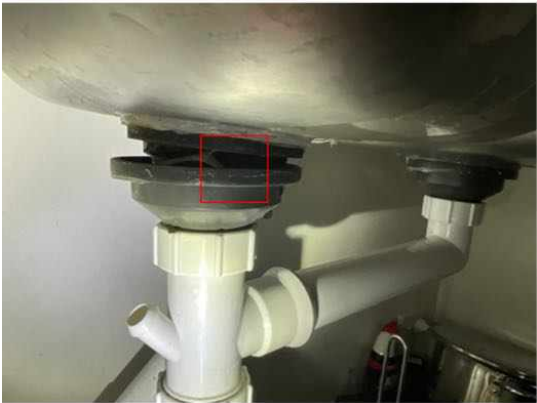
**Finding 3.03**

Building: Main Building  
Location: Kitchen  
Finding: Fitting or fixture - Loose  
Information: The fitting in this area is loose and requires adjustment to tighten.

If left unmanaged, the fitting may further deteriorate, causing potential for the development of other minor secondary defects.

A licensed plumber or a general handyman should be appointed to perform these rectification works at discretion of the client.

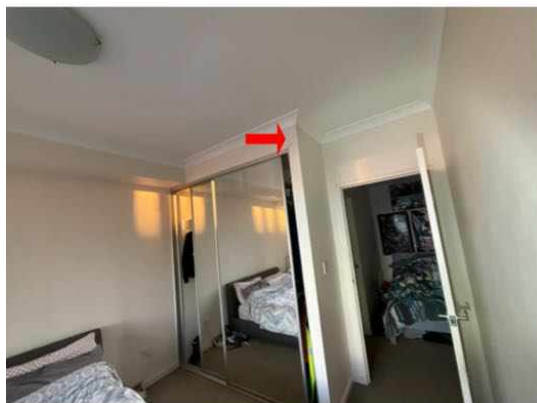
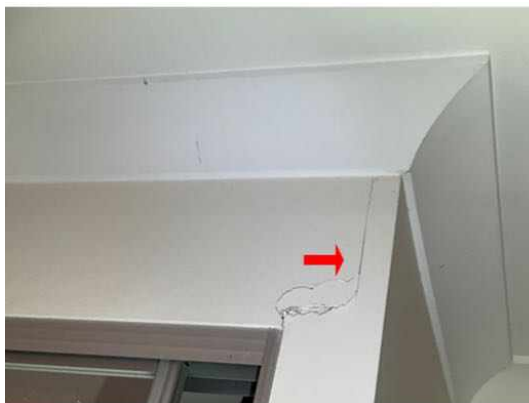
### Finding 3.04

Building:	Main Building
Location:	Bedroom
Finding:	Cracking - Damage Category 1 - Fine (up to 1mm)
Information:	Although fine cracks are quite noticeable, they are often only considered to be an appearance defect, and usually do not indicate any structural damage. Generally, the cause of a fine crack is indicative of a separation between building materials and finishes (e.g. paint, plaster, etc.) along joins.

Cracking of this nature can generally be repaired with minor sanding, filling and/or repainting. Such works should be performed by a qualified painter or a general handyman.

Monitoring of all cracking should be conducted frequently. Always contact a building inspector should cracks widen, lengthen, or become more numerous.

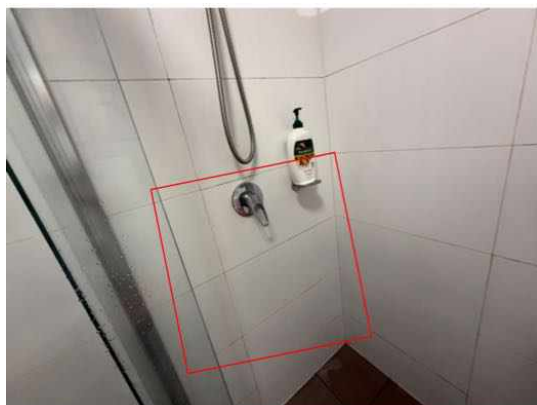
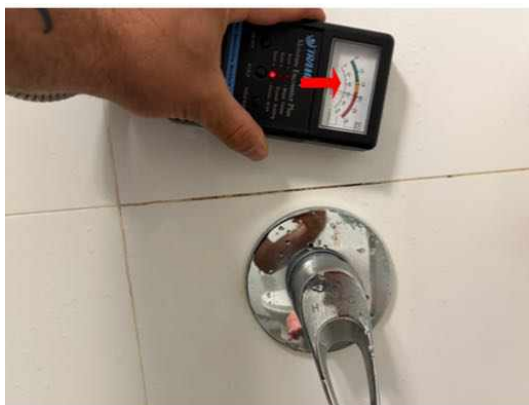
### Finding 6.01

Building:	Main Building
Location:	Bathroom
Finding:	Water leak - Suspected
Information:	A water leak is suspected in this area as excessive moisture was detected at the time

of inspection. Another potential cause maybe moisture ingress behind the tiles from around the wall fittings and penetrations.

Internal water leaks can be detrimental to surrounding building elements; their potential causes include damage to plumbing fittings and fixtures, through to water damage and deterioration of associated building elements.

Attracting termites, corrosion, mould, decay and water damage are potential outcomes where a minor water leak is left unattended. More serious defects may also result, such as electrical hazards, or water damage to structural building elements.

In extreme cases, structural damage may develop due to a prolonged water leak. It is highly advised that internal water leaks be addressed by a licensed plumber as a matter of relative urgency.

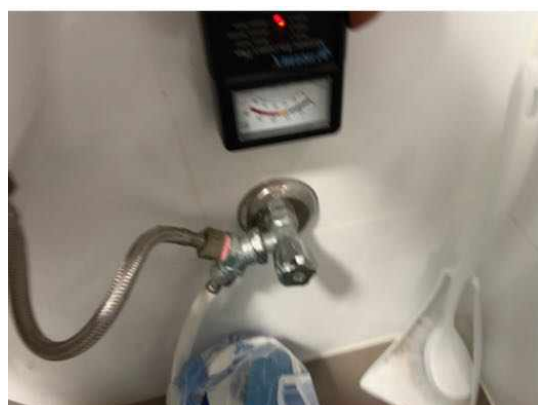
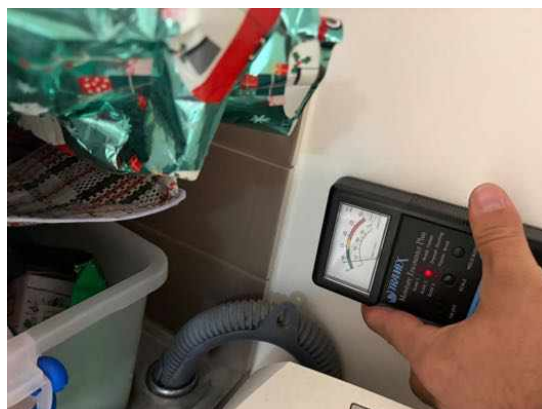
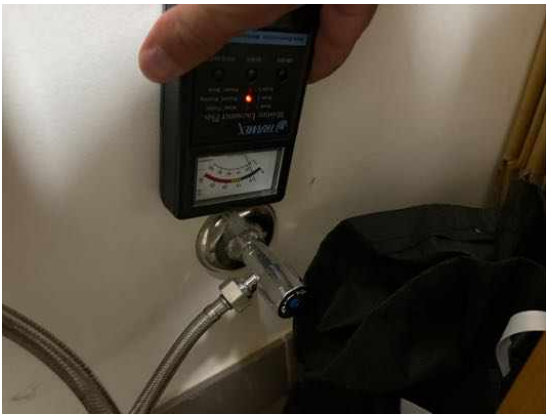
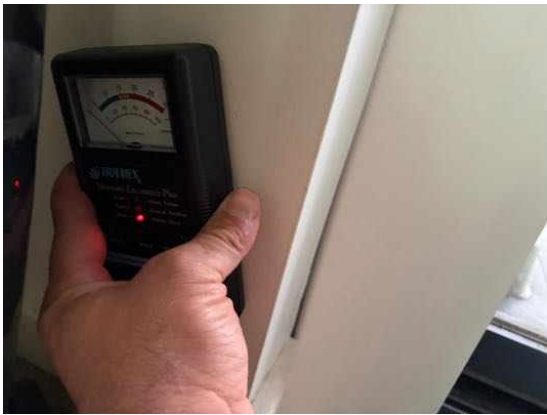
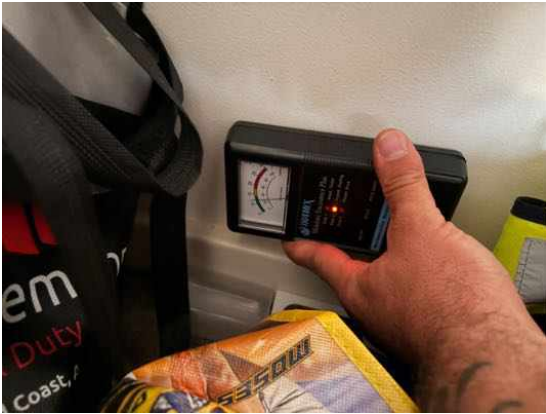
Building: Main Building  
 Location: All Areas  
 Finding: Moisture metre  
 Information: During the inspection the property was checked for moisture using a moisture metre.

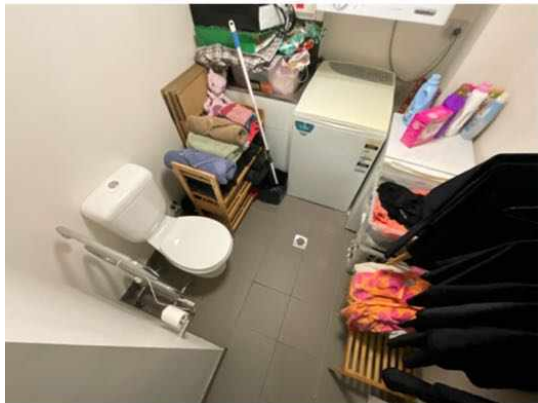
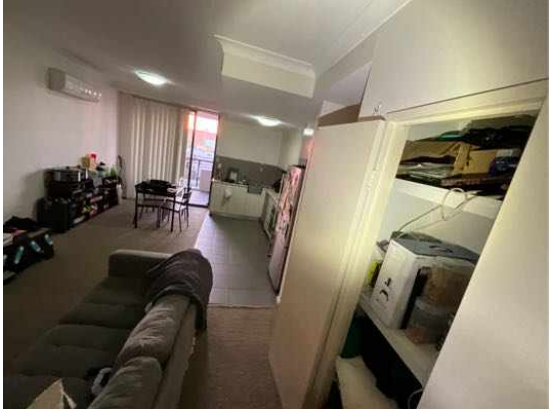
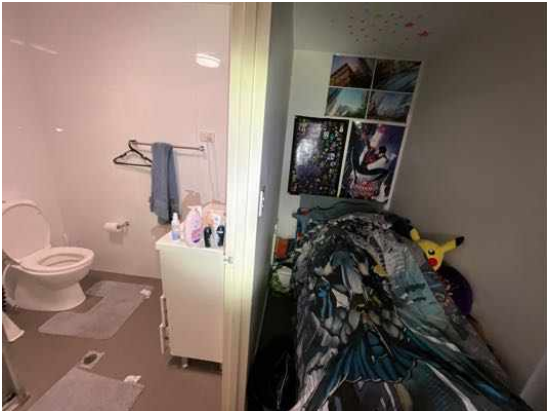
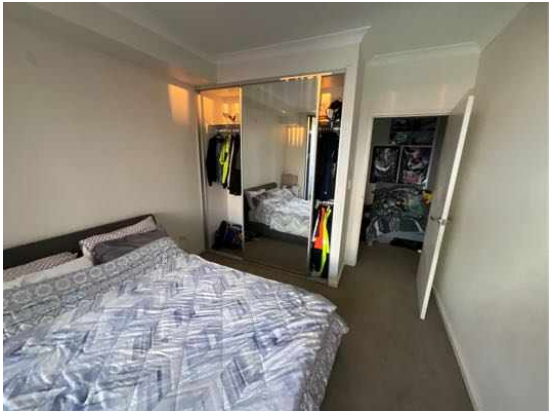
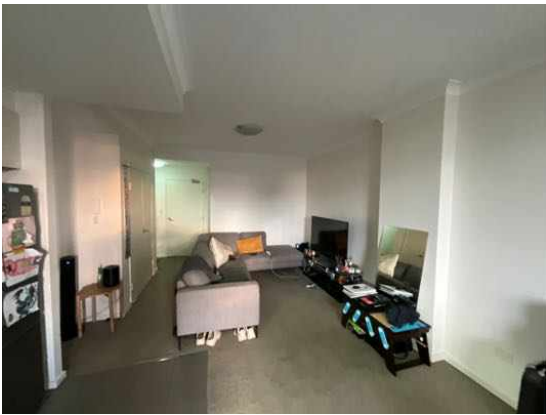
Building: Main Building  
Location: All Areas  
Finding: Additional Photos - Obstructions and Limitations  
Information:

These photographs are an indication of the obstructions and limitations which impeded full inspection of the property at the time of inspection. These obstructions can hide an array of defects and should be removed to allow full inspection to be carried out. A re-inspection is recommended once the areas are made accessible.
